**REPORT PREPARED FOR:  
Fulton Hogan Land Development Ltd**

**PRELIMINARY SITE INVESTIGATION  
TE KOROWAI O MARAEARIKI  
WAINUI**

**Prepared by:  
Groundwater and Environmental Services  
PO Box 190  
Cambridge  
7 August 2026**

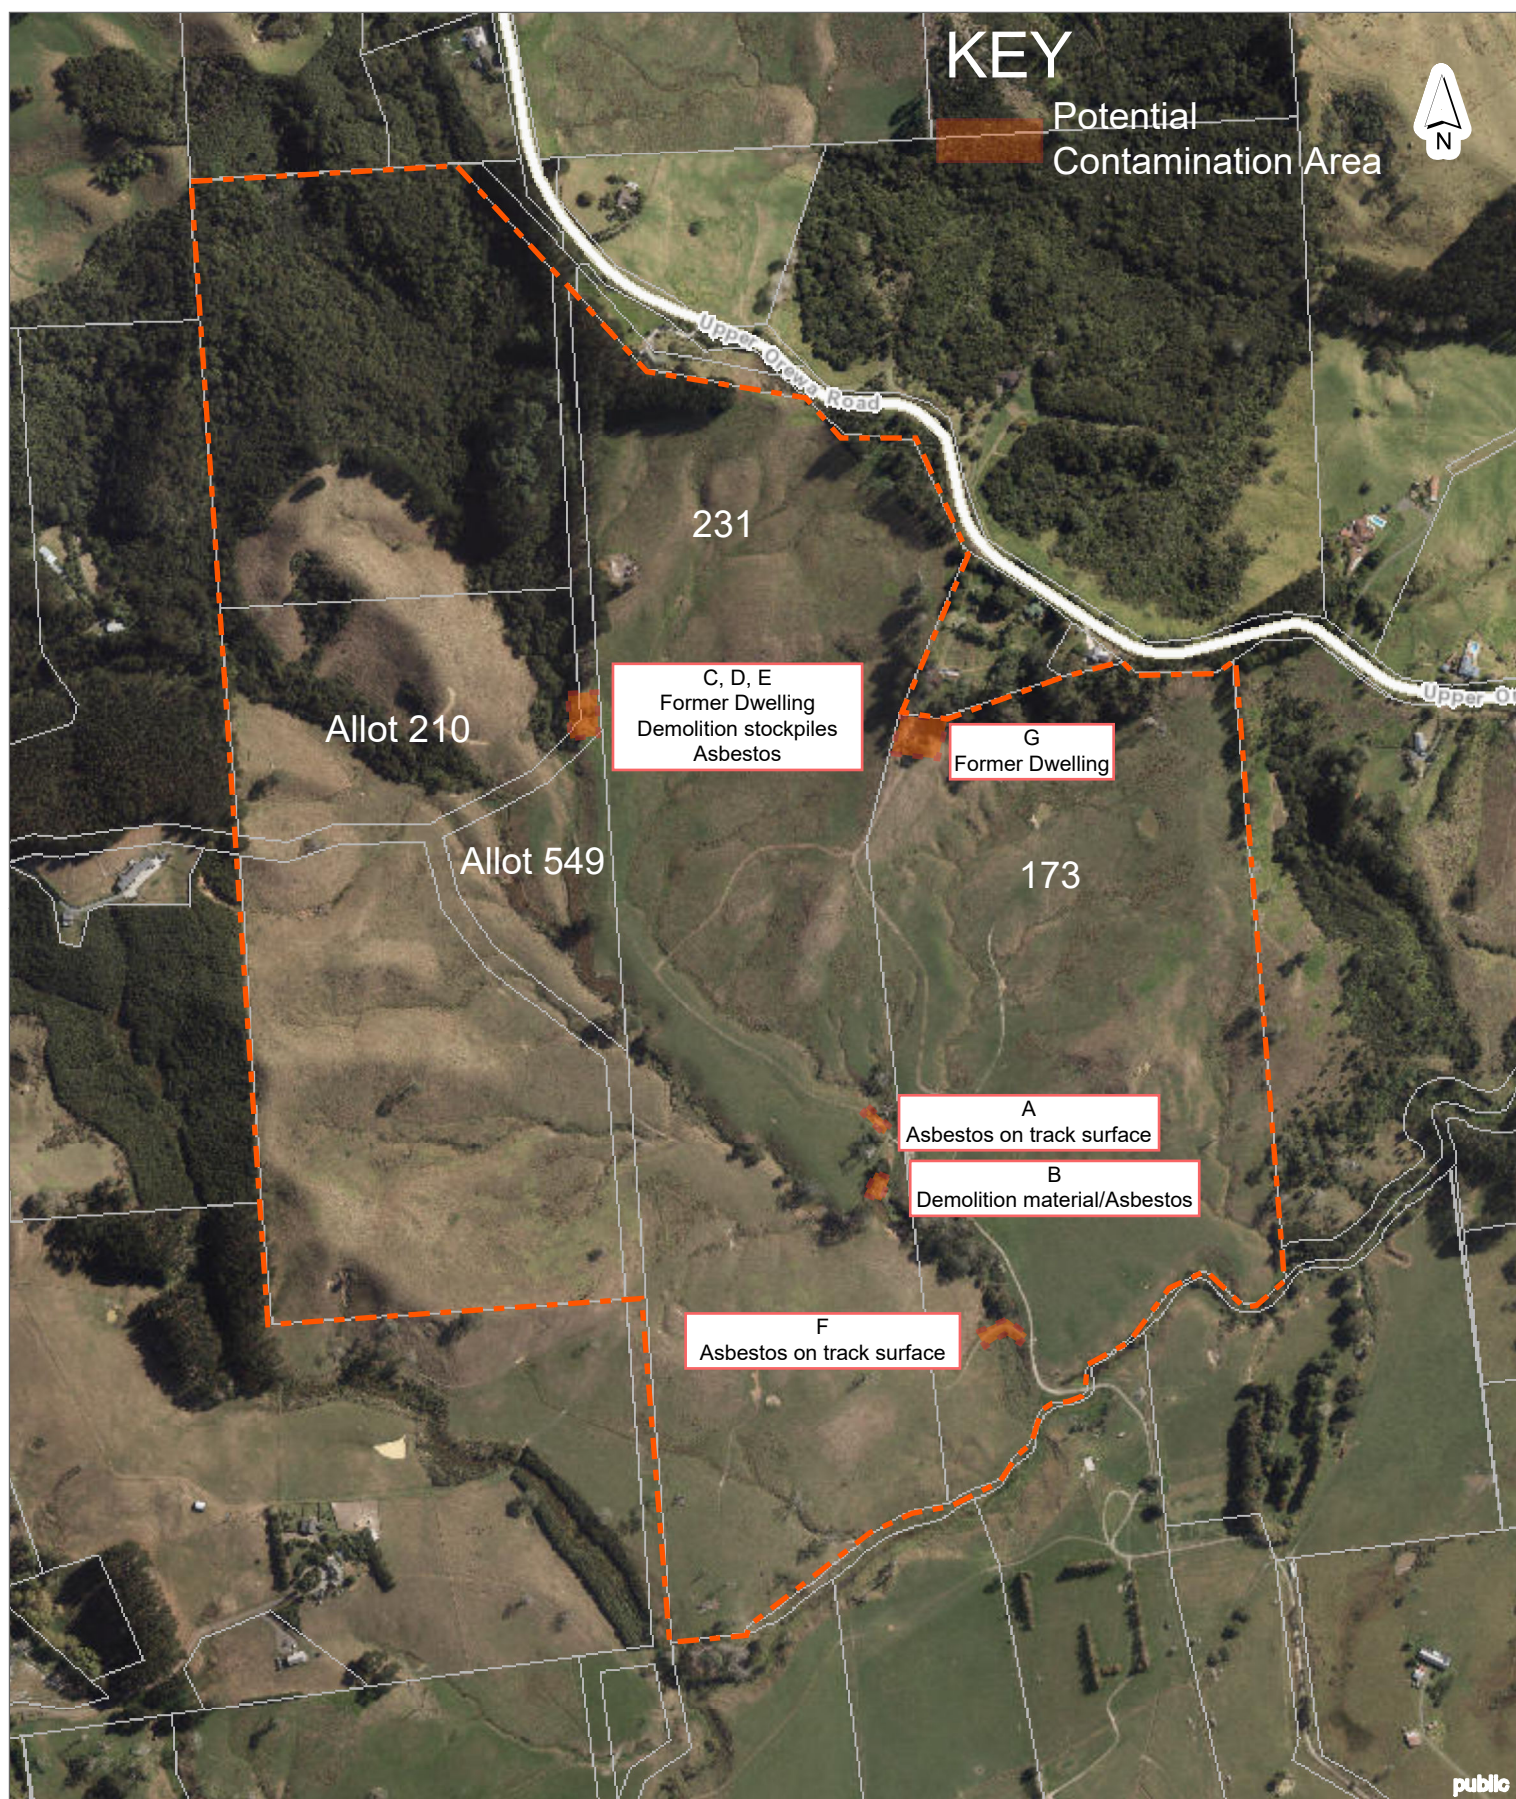
**Figure 4**  
**Potential Contamination Areas**

The presence of asbestos-containing material in soil in isolated areas at Allot 210 SO 836, 173 Upper Orewa Road, and 231 Upper Orewa Road presents a potential risk to human health if the material is disturbed.

5. Remediate asbestos-containing materials and contamination at levels above the NES recreational or outdoor worker protection guideline levels, and/or the permitted activity criteria for environmental protection.

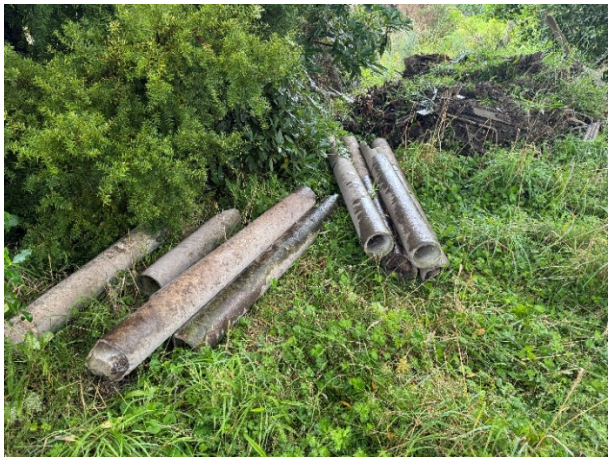
| Location | Aerial Observations | Walkover Observations |
|---|---|---|
| 1 | Former dwelling/shed location by east boundary in northern section of property – 1980. Removed by 2024.<br>(Partly on paper road and 231 Upper Orewa Road) | <p>Soil, demolition material, and household rubbish stockpiles around former dwelling location. Material includes <b>fibrolite cement sheet pieces</b>, timber, and soil. Some grass-covered. Nine asbestos cement pipe sections (&lt;2 m long) stacked next to the first stockpile.</p> <p><b>Sample 003 (red 0.4 cm thick fibrolite cement sheet with coating) – No asbestos detected</b></p> <p><b>Sample 004 (white 0.5 cm thick fibrolite cement sheet with coating) – No asbestos detected</b></p> <p><b>Sample 005 (white 0.3 cm thick fibrolite cement sheet) – No asbestos detected</b></p> <p><b>Sample 006 (asbestos cement pipe fragment) – Asbestos detected.</b></p> |

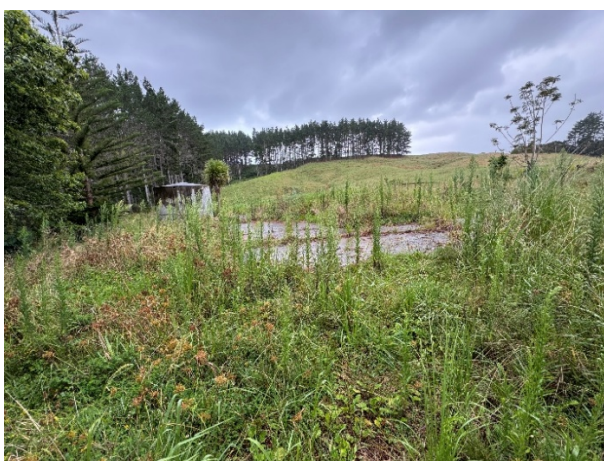
| 4 | Dwelling in west of property - accessed by driveway from Upper Orewa Road – 1980s<br>Removed by 2024 | Concrete water tank & remaining concrete slab<br> |

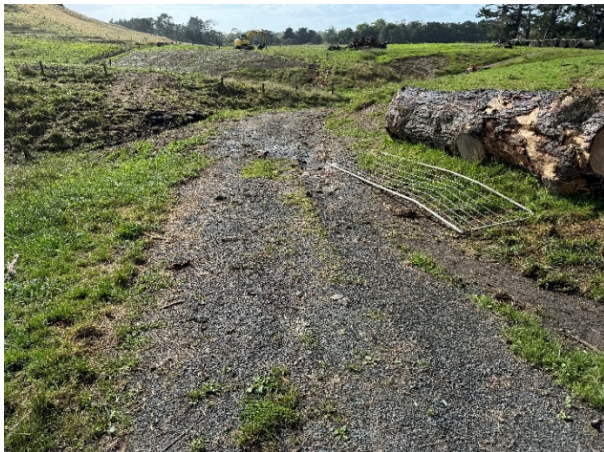
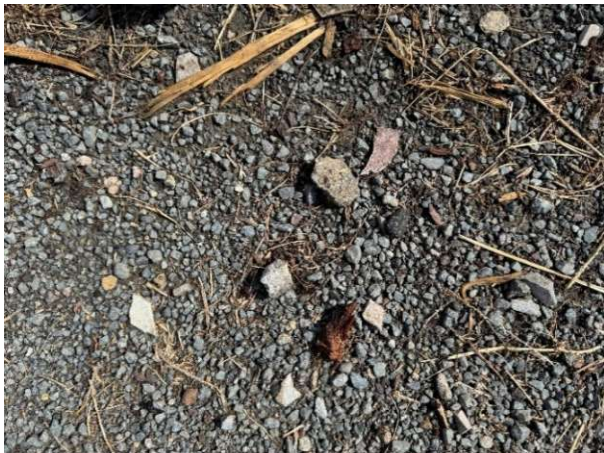
| 117 | Track – 1970s | <p>Several <b>asbestos cement sheet pieces and asbestos cement pipe fragments</b> on track surface. Track consists of demolition concrete, brick, and gravel</p> |

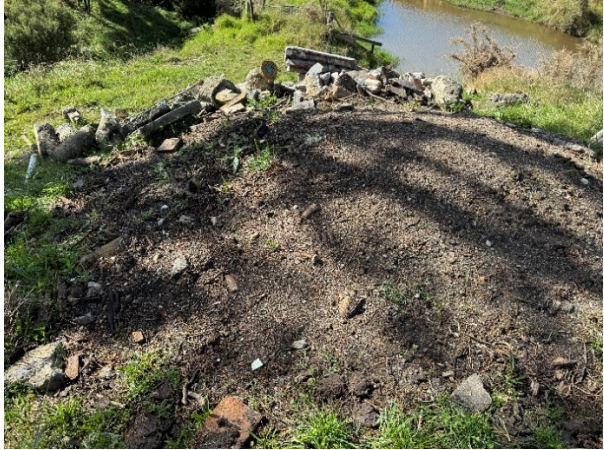
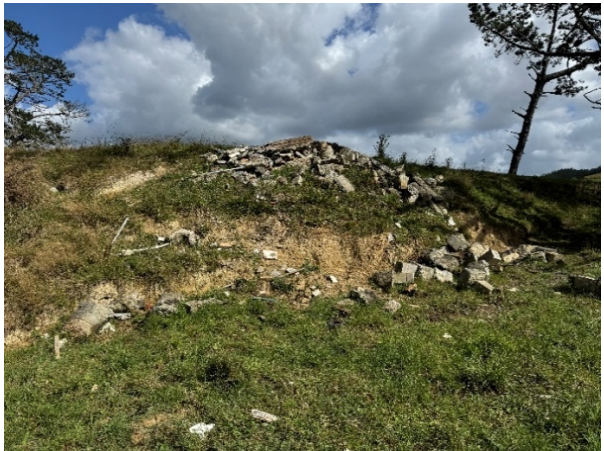
| 119 | | <p>Soil stockpile (3 m x 3 m by less than 1 m) on top of bank. <b>Isolated asbestos cement sheet pieces.</b> Demolition rubble (including concrete) on the bank below soil stockpile – extends down bank to track below.</p> <p>Buried rubbish/demolition material below the concrete – <b>includes potential asbestos cement sheet pieces</b></p> |

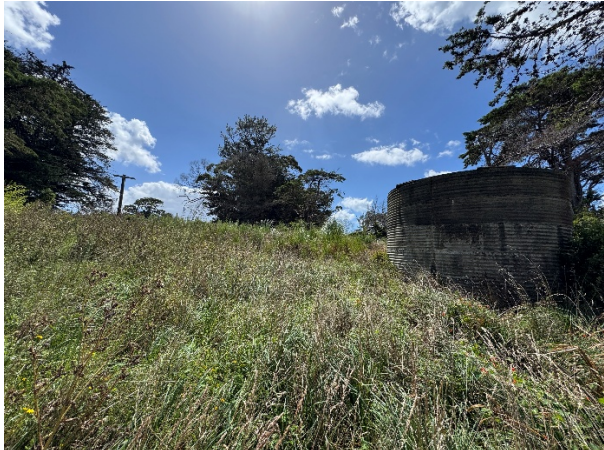
| 7 | <p>Dwelling in NW corner (south of sheds/glasshouses on the adjacent property to the north) – 1950s</p> <p>Most sheds on property to north removed by 1980s</p> <p>Dwelling removed by 2024</p> | <p>Former dwelling location. Large concrete water tank and power pole remain. Remaining garage Slab and footing – concrete demolition material placed outside east end of former garage.</p> |

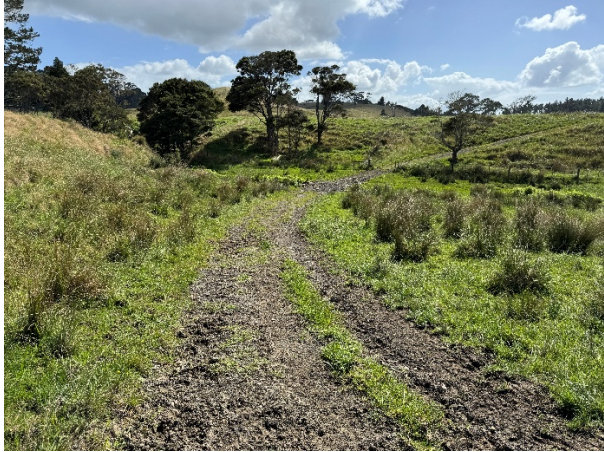
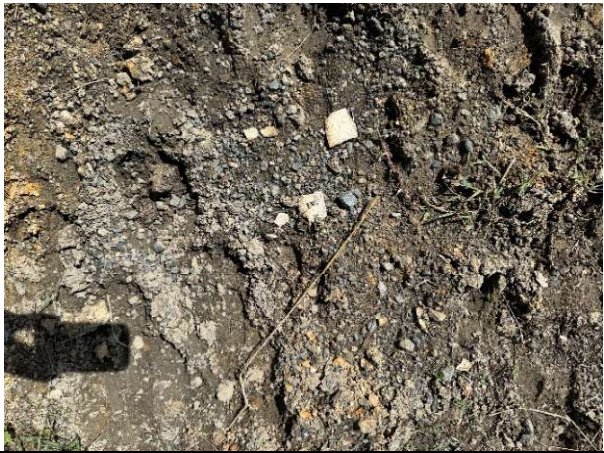
| 120 | Stream crossing – 1960s | <p>Recently reworked stream crossing.</p> <p><b>Isolated and dispersed asbestos cement sheet and pipe fragments on the west and east approaches to crossing.</b></p> |

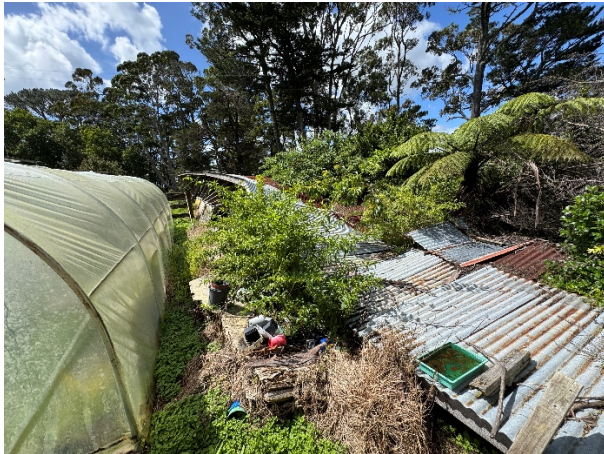
| 121 | Sheds on 163 Upper Orewa Road – 1970s | <p>Plastic shade house and partially collapsed shed on adjacent property to the north. Shed cladding includes ACM sheet</p> |
