# Millerton Road Ngakawau LCSIA

Bathurst Resources Limited

Project Number 310206316

## Millerton Road Ngakawau (#1410) LCSIA

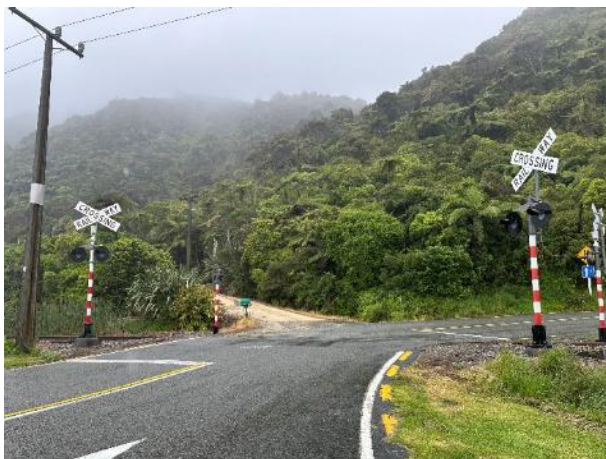
Figure 3-3: Western approach to level crossing from SH67

The level crossing is controlled by duplicated FLBs on both approaches to the level crossing as shown in Figure 3-3 and Figure 3-4. Of interest on the eastern approach, is the primary FLBs are facing a private accessway and the secondary FLBs are facing the oncoming Millerton Road traffic. This is not of particular concern as there is a set of FLBs facing the approaching traffic, it is just noted as being unique. We also note that KiwiRail have informed in the past that they do not install FLBs to face private accessways, therefore it makes this situation even more unique.

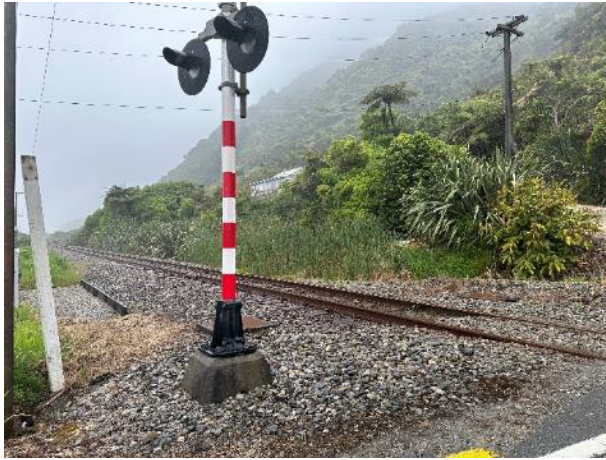
Figure 3-5: UP track sightline on western approach

The sightlines from the western approach both up and down track have good visibility with no vegetation obstruction as shown in Figure 3-5 and Figure 3-6. However, it is possible to envisage the vegetation in both directions could grow higher and become a sight distance restriction in the future.

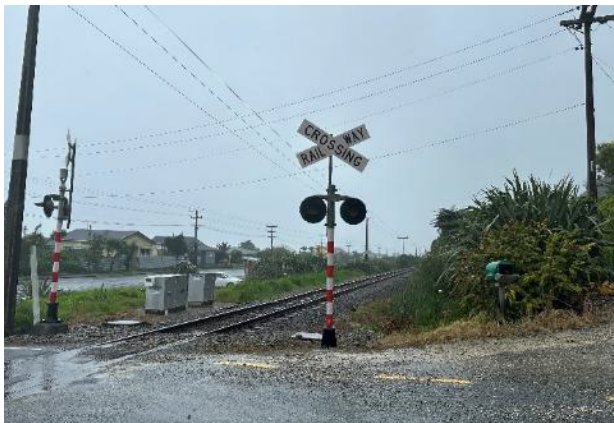
Figure 3-7: UP track sightline on eastern approach

The sightlines up track from the eastern approach has an obstructed view of oncoming trains (UP track) due to vegetation as shown in Figure 3-7. There is good sightline visibility down track from the western approach as shown in Figure 3-8. However, there is a possibility that the vegetation around could grow and become a sight distance restriction in the future.

| No. | Recommendation | Level of Necessity |
|---|---|---|
| 2. | Trim vegetation along northeast quadrant to improve sightlines, and to improve visibility of advanced warning sign on SH67 southern approach | Maintenance |

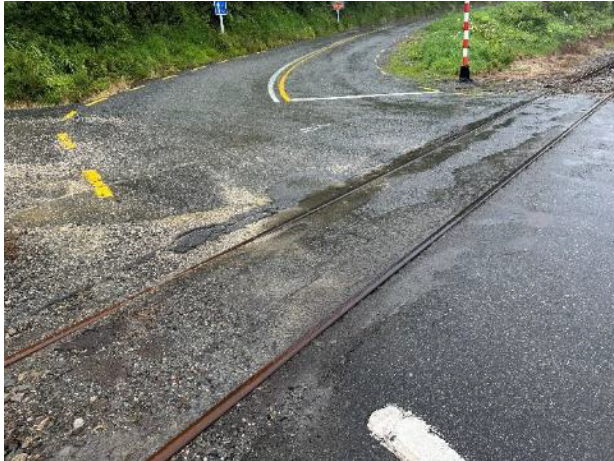
Figure 3-9 shows the condition of the crossing panel to be in a bad condition with some parts breaking up. There is also some ponding occurring around the tracks which could accelerate pavement failures. This image also shows the narrow width of the crossing, which is exacerbated by the sharp bend in the road, that will have HCV already tracking over the centreline to negotiate the bend. There is some tracking of gravel from the adjacent private entrance onto the road surface which impacts skid resistance and reduces effective width further.

Figure 3-9: Track panel is breaking up

5. **Damaged crossing panel.** Areas of the crossing panel are showing some signs of wear / deterioration with failure at the joint of the crossing panel and pavement approach. Some ponding is also occurring near the tracks. Renewal of the crossing panel may be required in the coming years.

| Safety Recommendation | Necessity |
|---|---|
| Review pavement integrity and repair any minor effects across the level crossing, repair failure at joint of the crossing panel and pavement approach, and issues of ponding by the tracks. With increased HCV movements deterioration could happen at a faster rate. | |

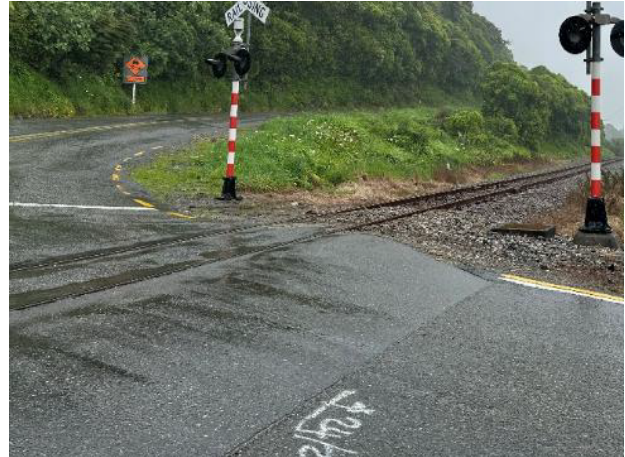
There are gouge marks on the road over the crossing panel, possibly caused by heavy vehicles grounding out on the hump at the level crossing, as shown in Figure 3-10.

Figure 3-10: Small hump over crossing with gouge marks

| No. | Recommendation | Level of Necessity |
|---|---|---|
| 6. | Investigate reducing the hump over the level crossing to stop possibility of heavy vehicles grounding out | |

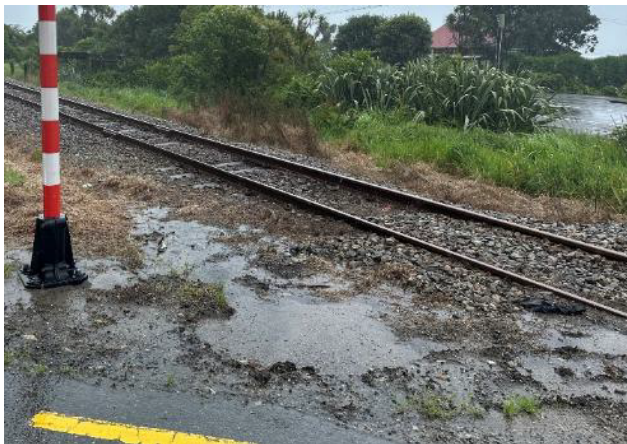
There is additional water ponding occurring near the level crossing on the downtrack side and at the SH67 intersection as seen in Figure 3-11 and in Figure 3-12 respectively.

Figure 3-11: Water ponding on left side of road from eastern approach

10. **No street lighting of level crossing.** There is no street lighting provision at, or near, the level crossing.
11. **Ponding occurring around the level crossing.** Ponding was occurring around the south-east quadrant at the intersection of SH67 and Millerton Road between the highway and the level crossing and on the south eastern side of the level crossing which could accelerate pavement failures.

| No. | Recommendation | Level of Necessity |
|---|---|---|
| 13. | Conduct drainage improvements where water is ponding near the level crossing and at the SH67 / Millerton Road intersection | Maintenance |

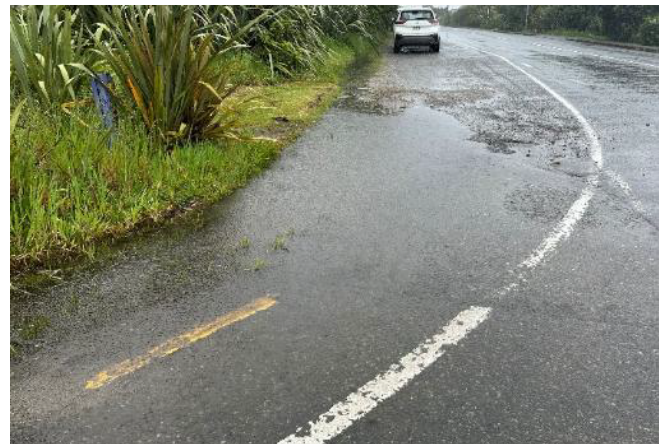
Figure 3-12: Water ponding on eastern side of road exiting into SH67

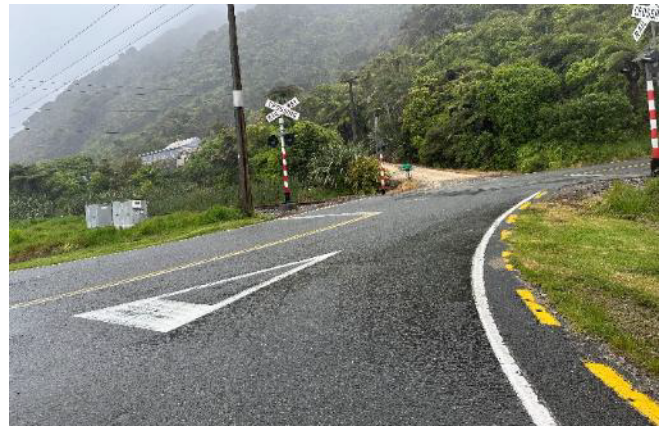
The FLBs facing traffic approaching the level crossing from SH67 are on slight angles to provide better visibility for turning traffic off SH67. There is a short stacking length of 20m between the tracks and GIVE WAY limit line for the SH67 intersection as shown in Figure 3-15. Note there is no right turn bay into Millerton Road on SH67. The short length steepens the gradient of the western approach as see in Figure 3-16.

Figure 3-16: Steep gradient on western approach

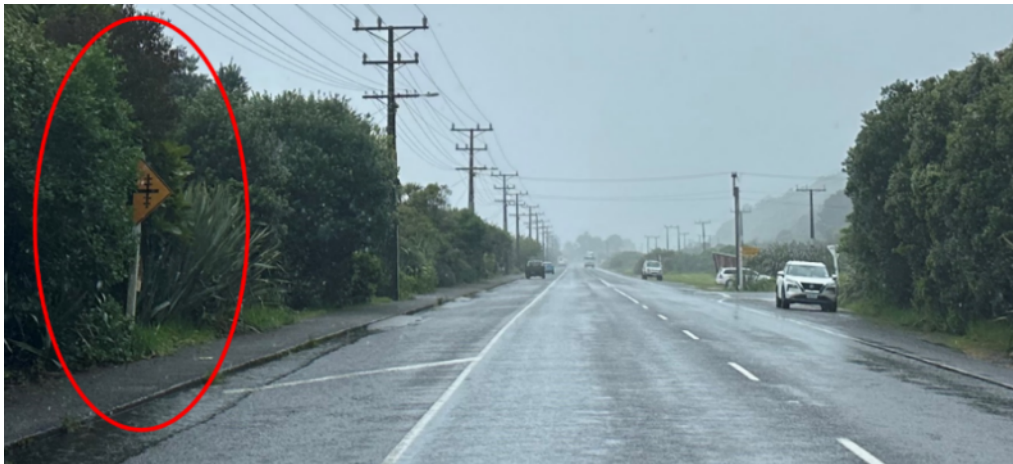
The WXR2 advanced warning sign on the southern approach of SH67 is shown in Figure 3-17. The sign is hidden to road users by vegetation. The sign is also in average to poor condition, with lichen growing on the post and possible loss of night-time reflectivity due to it being installed in October 1999. The same sign on the northern approach is also 25 years old and in a poor state.

Figure 3-17: WXR2 sign on approach from south of SH67 hidden behind vegetation

| Safety Recommendation | Necessity |
|---|---|
| Many signs are past their best and need to be replaced with new signs that meet current NZTA standards. | |

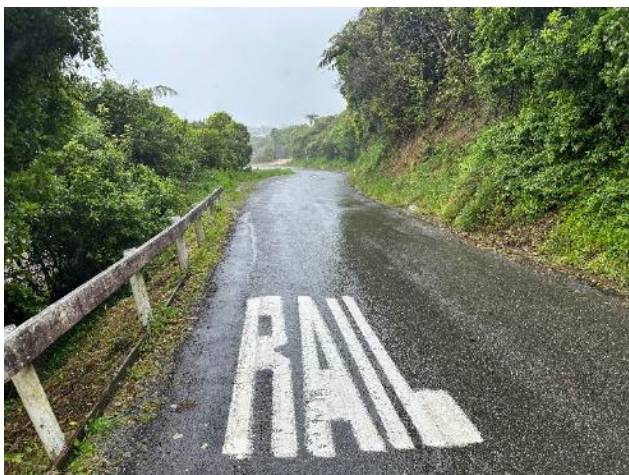
Figure 3-18: 'Rail X' road marking on Millerton Road

Figure 3-18 shows the 'Rail X' road marking on the eastern approach via Millerton Road to be in a good condition. There are no other advanced warning signs from this approach. As can be seen, the road is very narrow at this point and two HCVs would not be able to pass each other in opposite directions safely.

8. **Missing advanced warning signage on Millerton Road.** There is no advanced warning signs on Millerton Road which goes against TCD requirements.
9. **Damaged, non-reflective and old signage.** Majority of the signage for the level crossing dates to 1999, has lichen growing on both the sign and the pole, have lost their night-time reflectivity as well as being damaged.

| Safety Recommendation | Necessity |
|---|---|
| Install missing advanced warning signage as per TCD Pt.9, at a minimum a WX1L sign. It is accepted there is limited space available on the outside of Millerton Road due to the hill edge, and this could be difficult to implement in reality. | |

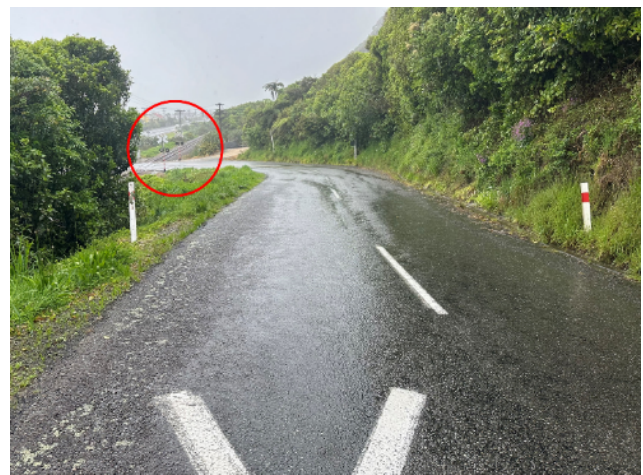
Figure 3-19: Visibility of FLBs from 'Rail X' marking

Figure 3-19 shows the FLBs can be seen from the 'X' road marking closer to the level crossing.
