# **WAIHI NORTH PROJECT – FAST TRACK APPROVAL: ASSESSMENT OF HISTORIC HERITAGE AND ARCHAEOLOGICAL EFFECTS**

## **APPENDICES**

Prepared for Oceana Gold (New Zealand) Ltd  
Document Number:

January 2025

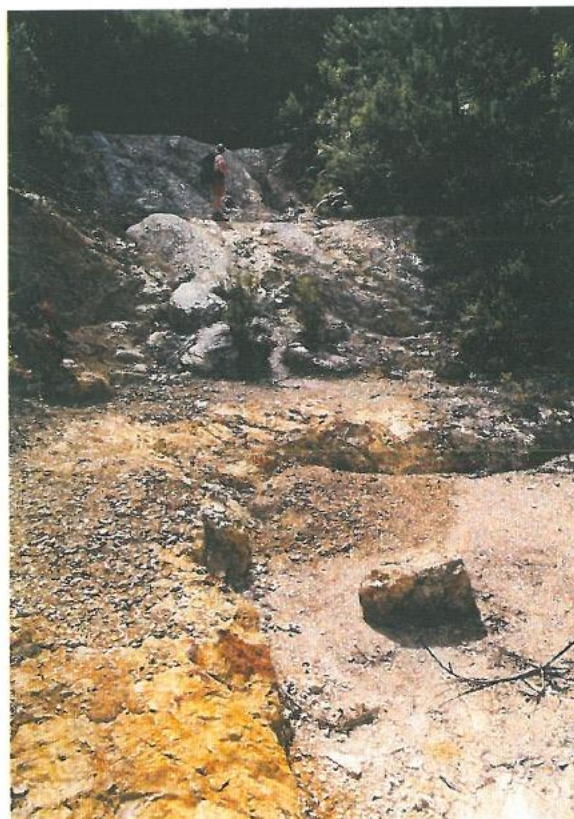
FIGURE 11.11 The Royal Standard Battery site. Three levels were excavated into the hillside, but no concrete was ever poured, no building erected, and none of the machinery ever used.

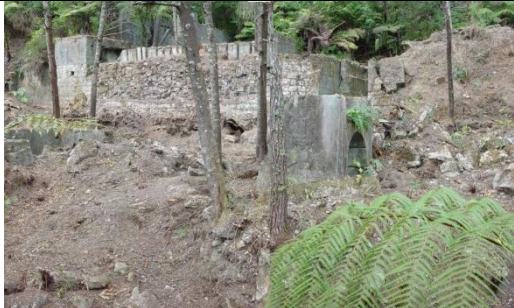
Land owner	Feature	Description	Photo	Condition
<b>Remains within Union Hill (Waihi Battery) Historic Area scheduled in the Hauraki District Plan</b>				
WGCL	Battery foundations	Masonry and concrete foundations for upper and lower stampers, tube mill, engine house, boiler house; on three levels, with timber, metal (machine bolts, 2 stamper dies, chassis of mine truck) and brick elements; concrete A frame structure, chute, stone breaker, tanks, and possible additional machine foundations; over an area of c.85mx45m. (See Appendix A, Figures A, B and C)

Relatively stable condition, but facing stones missing on much of main wall, crack evident along face of tube mill floor, collapsed tube mill floor at southern end, collapsed masonry/foundations at engine house end. Encroaching exotic (pine, wattles) and native vegetation on the structures. In situ and displaced metal elements. Timber elements deteriorating. Boiler room floor covered by tailings and bulldozed material. Visible and semi-accessible, with dangerous areas (concrete tanks) fenced off. Stability of masonry wall being monitored during Trio mine operations (2004 photo at top; 2012 photos below)

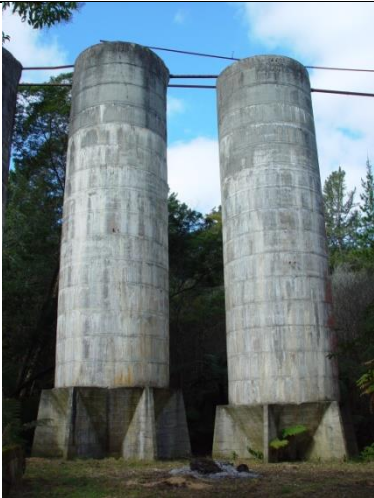
Good/stable condition, but concrete has been broken away from parts of bases; legs of one tank damaged by explosives. Stability is being monitored during Trio mine operations. Clear of vegetation externally but not internally. Tall pines located nearby with potential to fall and damage the tanks. Visible and easily accessible. (2004 photo)

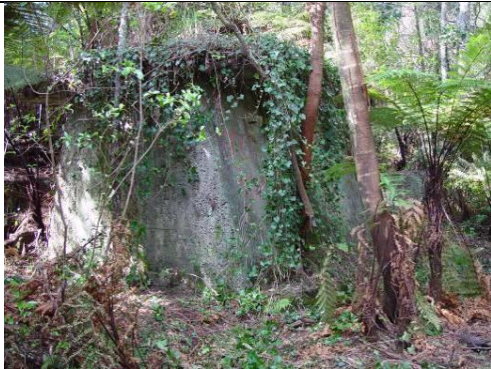
WGCL	Structure 1 and associated structures	Substantial concrete structure c.15m east of the cyanide tanks, Almost square, nearly 4m by 4m, with 2.35m high inward sloping plinth and 0.18m thick cover; hollow in the centre; 2 rectangular and 1 arch openings on the sides; short wall on one side with square post slots c.90mm square. (See Appendix A, Figure F). Two smaller associated concrete foundations immediately to the north (c.1.2m x 3m and 0.84m x 2m) and east (c.3.4m x 1.2m). Part of the cyanide treatment plant.

Stable condition but encroaching exotic and native vegetation. Potentially damaging vegetation on roof of structure. 5 tall pines nearby with potential to fall in the direction of the cyanide tanks or onto these structures. Accessible and partly visible (2004 photo)
WGCL	Structure 2	Concrete rectangular tank with iron-lined slots, 6-7m west of the cyanide tanks; c.6.5m by 4m, c.0.8m high, interior over 1m deep. Part of the cyanide treatment plant. (see Appendix A, Figure E)

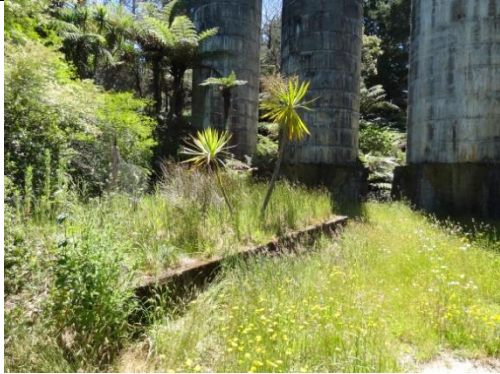
Stable condition, but infilled with soil and vegetation encroachment obscures visibility. Accessible. (2012 photo)

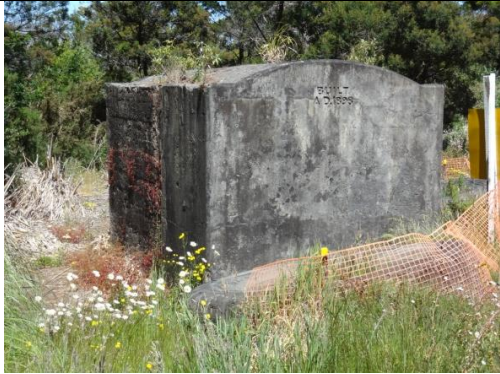
WGCL	Strongroom	Concrete structure c.2.8m 3.8m by 2.6m high; low arched roof; doorway at W end; 50cm thick walls; two internal rooms separated by steel door; plastered exterior except on SE wall; 'Built AD 1898' impressed in plaster at SE end. Reused by MR, who installed a concrete bench with steel cylinder embedded into it, and added a concrete floor in front and on SE side. (See Appendix A, Figure G)

Stable condition, some cracking in exterior plaster, damage around doorway with reinforcing iron exposed, outer door missing. Some vegetation beginning to establish on roof. Visible and accessible (2012 photo)

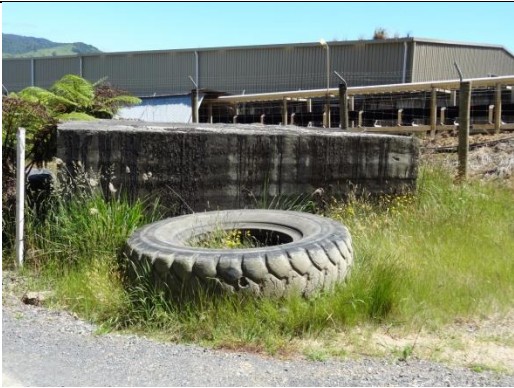
Good condition. Visible and accessible. (2012 photo)
WGCL	Smoke chamber	Square concrete structure on northern side of conveyor, c.7.5m square by 4m high, with an internal brick wall, 4 external openings, an external flue and chimney base, and ground level vents above the flue. Part of the 3 <sup>rd</sup> (final) refinery. (See Appendix A, Figure H)

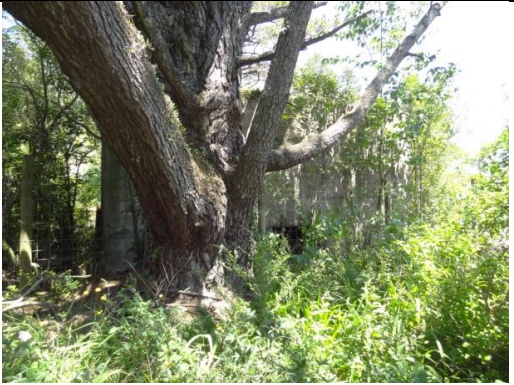
Cracking of concrete on two corners and around main opening, most internal brickwork removed. Large pine immediately adjacent may be cause of cracking. Currently fenced off, not visible or accessible (2012 photo)
WGCL	Displaced strongroom	Concrete structure near conveyor and Strongroom, c.3m by 2.7m and 3.6m high, with curved roughly plastered roof. Moved from original position by MR and tipped on end as part of ramp for tipping ore into crusher. (See Appendix A, Figure I)

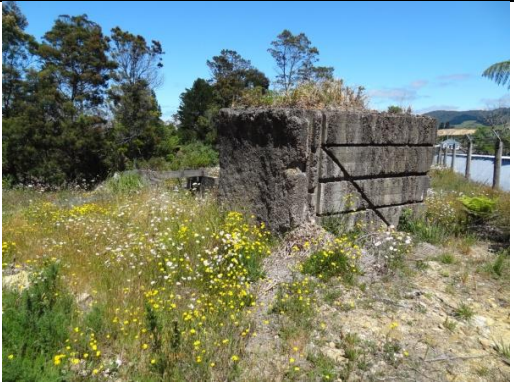
Exterior in good condition, interior unknown. Vegetation growth on top of structure. Visible and accessible (2012 photo)

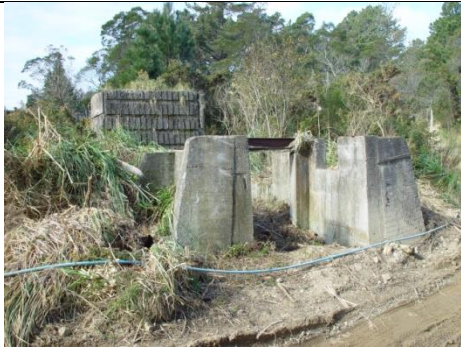
Stable condition, now overgrown with vegetation partially obscuring the structure. Visible and accessible (2004 photo)
WGCL	Refinery safe	Concrete structure; c.5.5m by 2.5m, by c.5m high; with a flat roof and internal arched ceiling; doorway at E end and open arch at W end; concrete retaining wall perpendicular to S side. Associated with disturbed concrete foundations and a terrace/building platform nearby. Part of the 3 <sup>rd</sup> (final) refinery. (See Appendix A, Figure J)

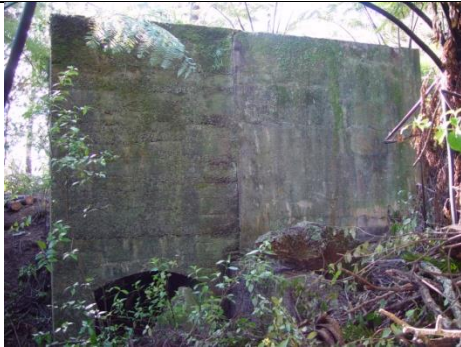
Exterior in good condition, plaster on interior walls and ceiling cracked and falling away. Outer steel door missing. A large pine has fallen on structure and vegetation has encroached since 2004 so that it is no longer visible or accessible (2004 photo)

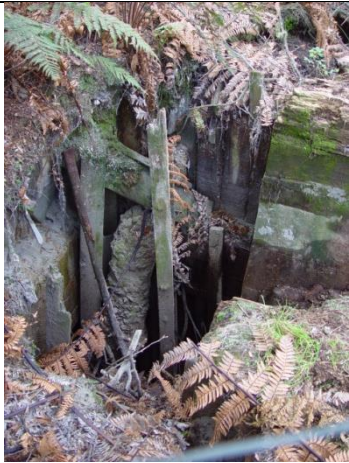
WGCL	Old No. 1 shaft	2.4m by 1.2m, braced with kauri timber and divided into 3 compartments, northern one containing a ladder; E structure is a timbered trough 4m x 0.6m, opening into a c.2.4m by 2m timber lined pit of unknown depth. Probably associated with a beam pumping engine; shaft recorded as 38m deep. (See Appendix A, Figures A and K)

Timbers in reasonable condition, vegetation encroaching and obscuring visibility. Fenced off, not easily visible unless accessed from battery (2004 photo)

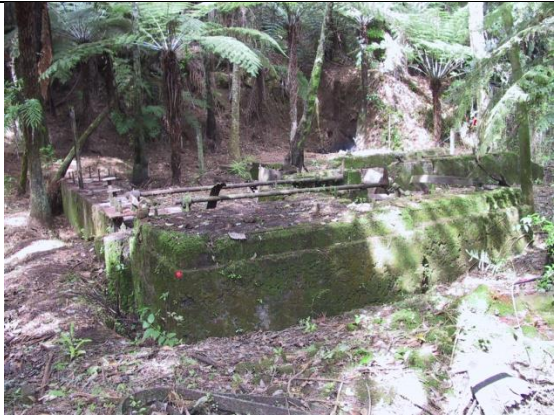
WGCL	New No. 1 shaft	Shaft c.4.3m by 1.8m with 3 separate compartments – a 1.8m x 1.8m pumping compartment and two 1.8m x 1.1m winding shafts; associated concrete foundations with steel bolts spread over area c.13m by 11m for pump and pump engine, compressor, winding engine and winch; clutch rods and control pedals still in original position; remains of boiler house in a pile of brick/concrete/metal to W. Shaft recorded as 198-204m deep. (See Appendix A, Figure L)

Shaft still open, but fenced off; some caving in of sides. Concrete foundations in good condition, but encroaching vegetation; visible and semi-accessible, partially fenced off and no obvious path access (2004 photo)
WGCL	Mullock dump at New No. 1 shaft	Large mullock dump (waste rock from New No. 1 shaft) extending W to upper vehicle track and for some distance SW; several tipheads evident		Accessible and visible on upper vehicle track behind Trio vent shaft

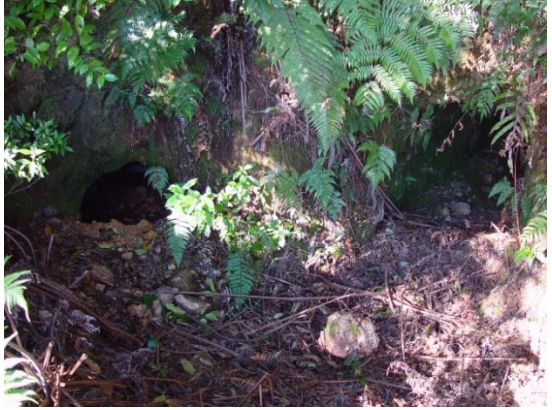
Loose rock blocking entrance to No. 1 drive; Bulls drive partly filled with mud (2004 photo)
WGCL	Chappell's shaft	S of No. 1 drive and Bulls drive, near middle vehicle track; open shaft c.2m x 1.5m; no visible timbering or surrounding foundations; possible collapsed adit upslope from shaft

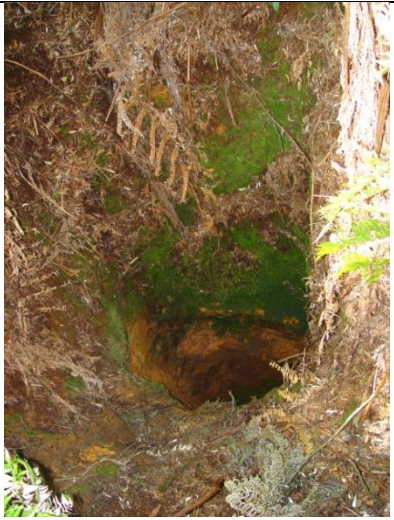
Open shaft; fenced off (2004 photo)

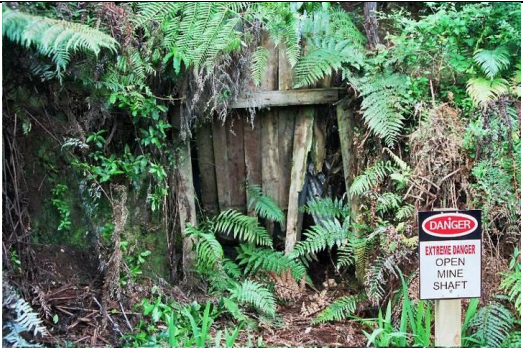
Both adits in good condition; timbering of E adit in fair condition; MR's timber bridge rotting and collapsing; wire mesh gate across entrance to E adit, and pile of loose rock in front, but still accessible (2004 photo, not reinspected in 2012)
WGCL	No. 2 drive	SE of Chappell's shaft near LINZ/WGCL boundary; portal re-timbered by MR; mullock dump c.15m x 12m forming flat area in front of portal, with shallow depression in N corner; small tip head and corrugated iron ore chute at NW end from MR period; shallow trench to S of tiphead

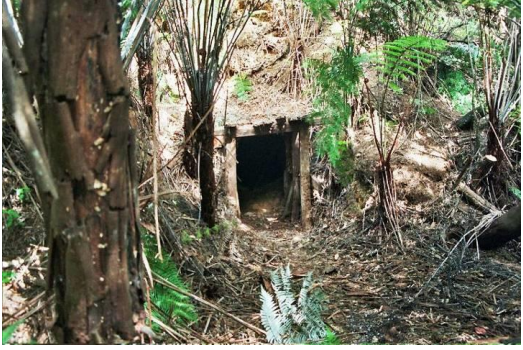
Timber rotting and collapsing; adit blocked by rock fall c.3-4m in; ore chute rusting and only partly intact (2004 photo, not reinspected in 2012)

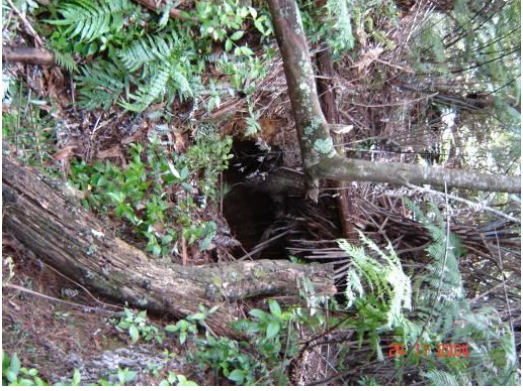
Portal trench partly collapsed (2004 photo, not reinspected in 2012)
LINZ	No. 3 shaft	Southernmost shaft on LINZ land; open shaft; small mullock dump c.6-7m x 1.5-2m extending from SE corner of shaft		Fenced off; not reinspected in 2012

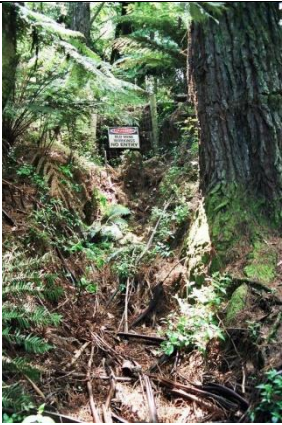
Collapsed portal; mullock heap in good condition (2004 photo, not reinspected in 2012)
LINZ	No. 2 drive east	NE of No. 1 drive east; partially collapsed portal trench c.12m x 1.5-2m; adit portal not visible; small mullock dump

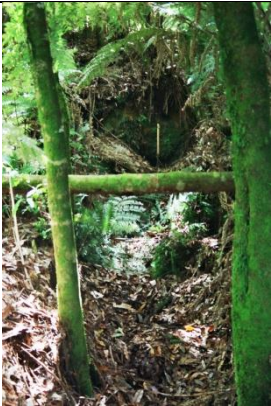
Poor condition; adit not visible or accessible (2004 photo, not reinspected in 2012)
LINZ	No. 6 drive	NE of No. 2 drive east; portal trench c.10m x 1.5m; collapse around portal, but still open; no timbering; mullock dump c.12m x 1-4m extending from portal trench

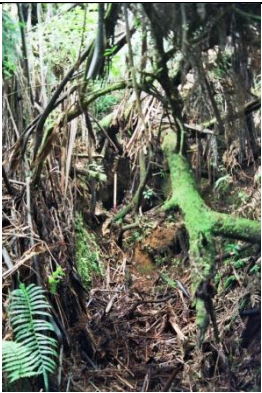
Partly collapsed portal trench; well preserved mullock dump (2004 photo, not reinspected in 2012 )

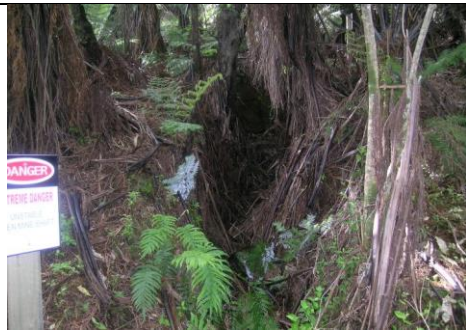
Partly collapsed portal trench and access to adit blocked; condition of adit and possible ore skip not known; mullock dump in good condition (2004 photo, not reinspected in 2012)
LINZ	Prospecting trenches (P1-P3)	Small collapsed adits or prospecting trenches; P1 SW of No. 4 drive, 7m x 1m trench; P2 between No. 5 drive and No. 1 drive east, 4m x 1-.15m trench; P3 near No. 8 shaft, 3-4m x 1m.

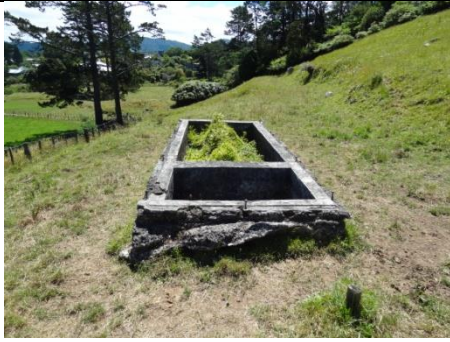
Good condition; visible but not accessible as near existing house (2012 photo)

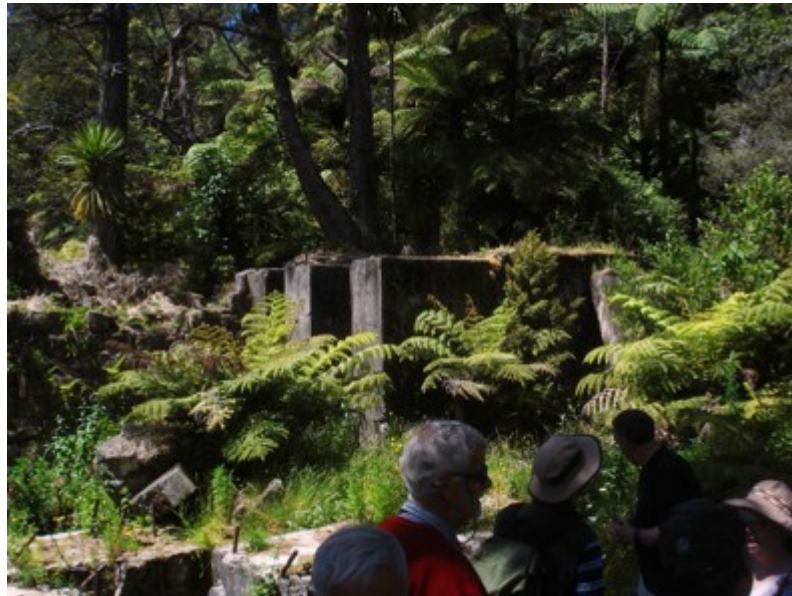
**Waihi Company's Battery site.  
Just in front of the people is a 2 metre approx drop. This would need to be fenced.**

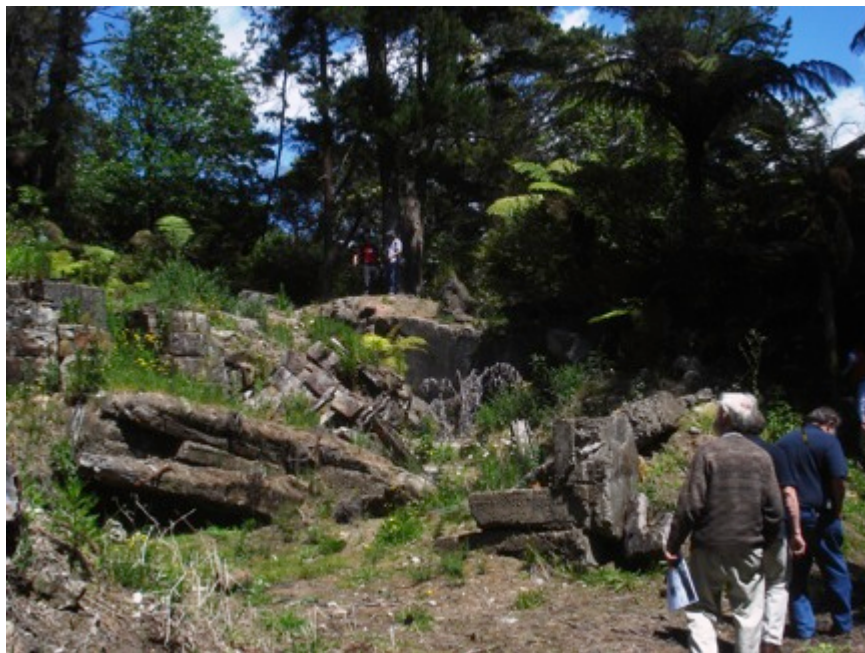
**Another area that will require fencing.**
