12 January 2024

## **UPDATED - SUTTON BLOCK EXTENSION TO DRURY QUARRY - PRELIMINARY SITE INVESTIGATION**

Pattle Delamore Partners Limited (PDP) has been engaged by Stevenson Aggregates Limited (SAL) to undertake a Preliminary Site Investigation (PSI) of the Sutton Block, which comprises part properties located at 1189 Ponga Road, 121 MacWhinney Drive and Quarry Road, Drury, Auckland (collectively referred henceforth as 'the site'; refer white outline of property parcels in Figure 1). It is understood that that works proposed in the Sutton Block are to extend the current Drury Quarry with similar quarry operations including stripping of overburden and mining of aggregate, along with ancillary quarrying activities (refer to Section 1.1 below for a summary of the 2023 revised Sutton Block pit extension proposal). Key areas of interest for the further use of the two properties are the future quarry pit extension (refer to Figure 1), which is expected to cover:

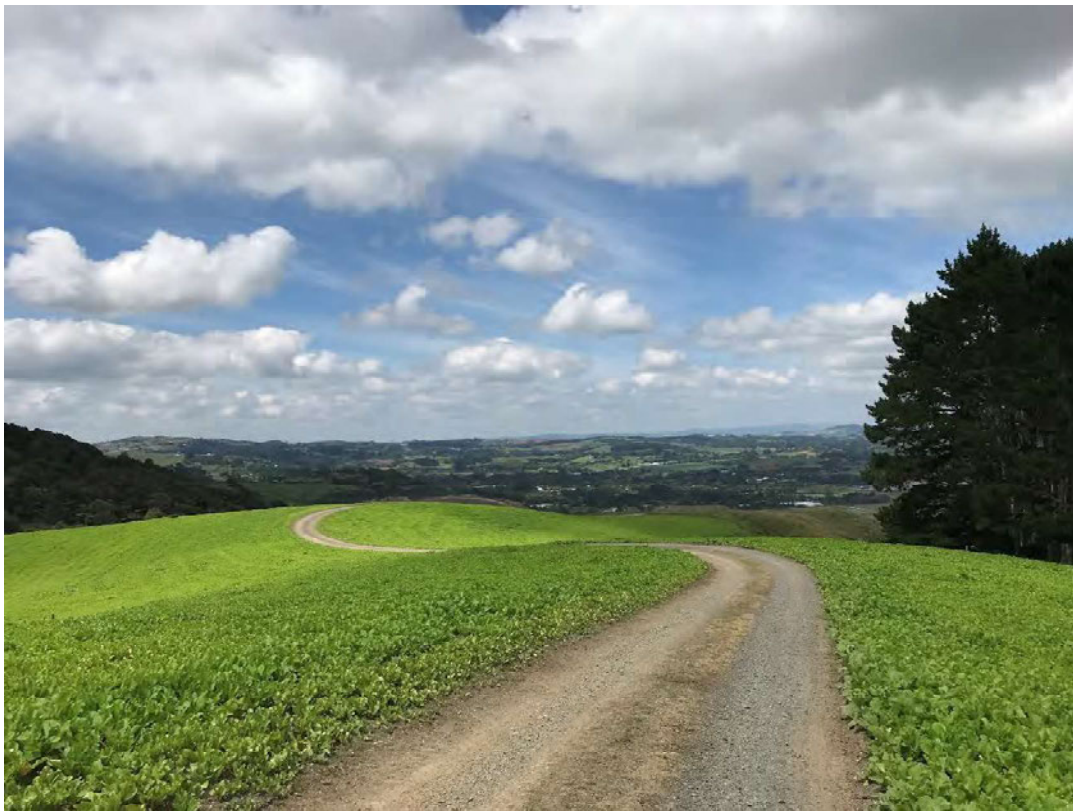
Based on historical aerials, the site has been used for pastoral purposes from at least 1942. Cropping of higher protein feed (i.e. chicory) in the northern central section of 121 MacWhinney Drive was observed during the site visit but could not be identified on historical aerial images, which suggests a relatively recent use in this area (i.e. under modern practises outside of the considerations for ground impacts from horticultural purposes).

**Photograph 2:** Looking south at the northern central section of 121 MacWhinney Drive showing high-protein cattle feed.

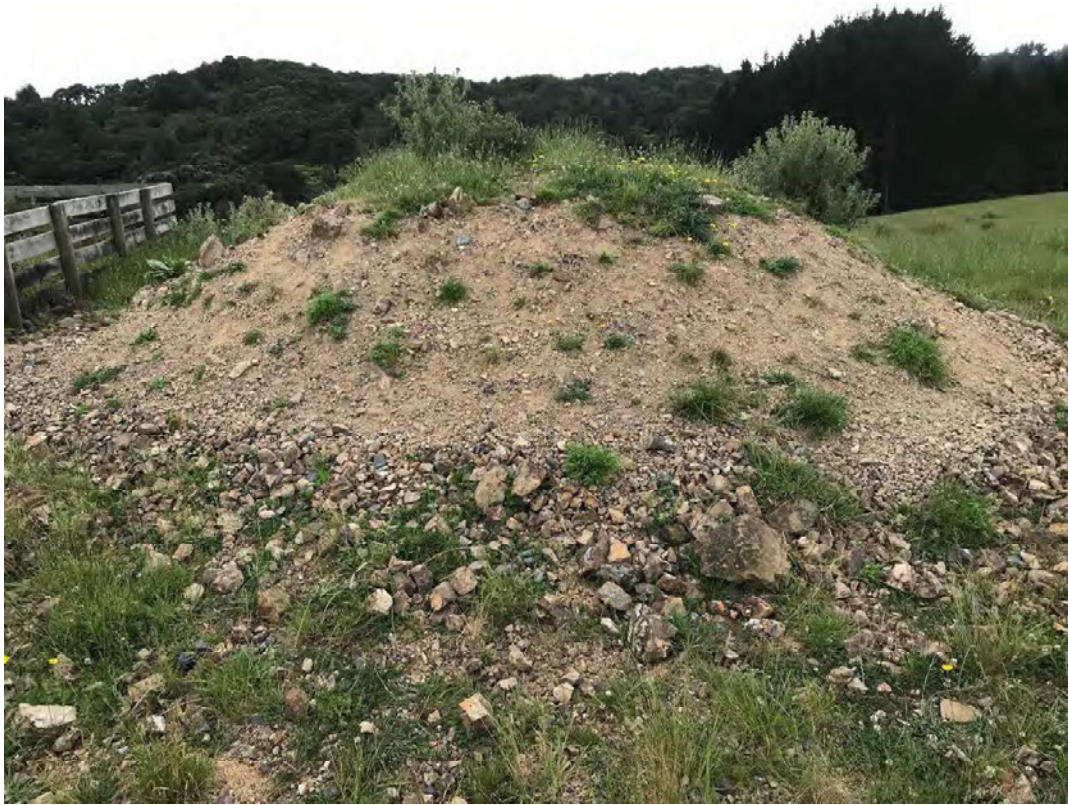
The earthworks occurring at the site are small in their scale and appear to occur within natural material and are therefore not expected to pose a risk to human or environmental health. The small soil stockpile identified appears to be comprised of natural material and no refuse, odour nor PACM was noted. The risk of ground impacts as a result of these activities is considered to be low.

**Photograph 3:** The small stockpile located east of the shearing shed at 1189 Ponga Road.

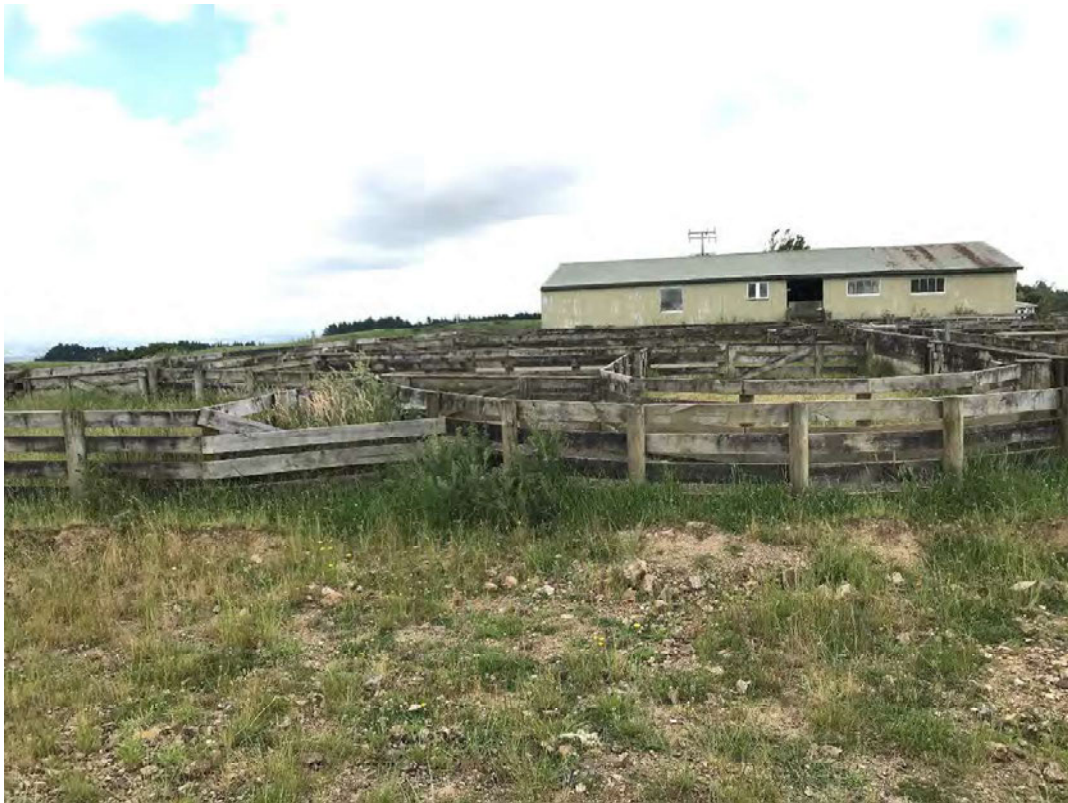
| Table 3: Site Visit Summary | |
|---|---|
| <b>Eastern Potential Spray Race/Sheep Dip</b> | A wooden structure which could potentially have been used as a spray race/sheep dip was observed (see Appendix C: Photographs 4 and 5). Some stressed/dying grass within the structure was noted. |

**Photograph 4:** Looking west at the potential location of the former spray race/sheep dip structure with the shearing shed in the background.

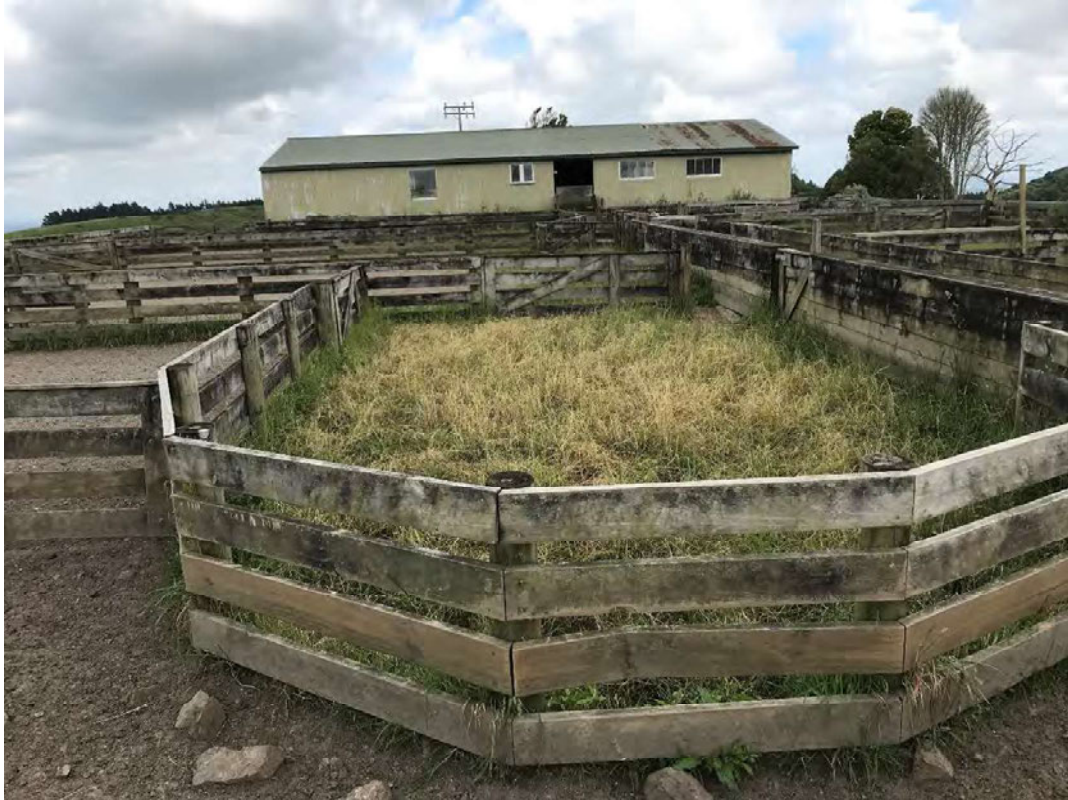
**Photograph 5:** Stressed grass within the potential location of the former spray race/sheep dip structure.

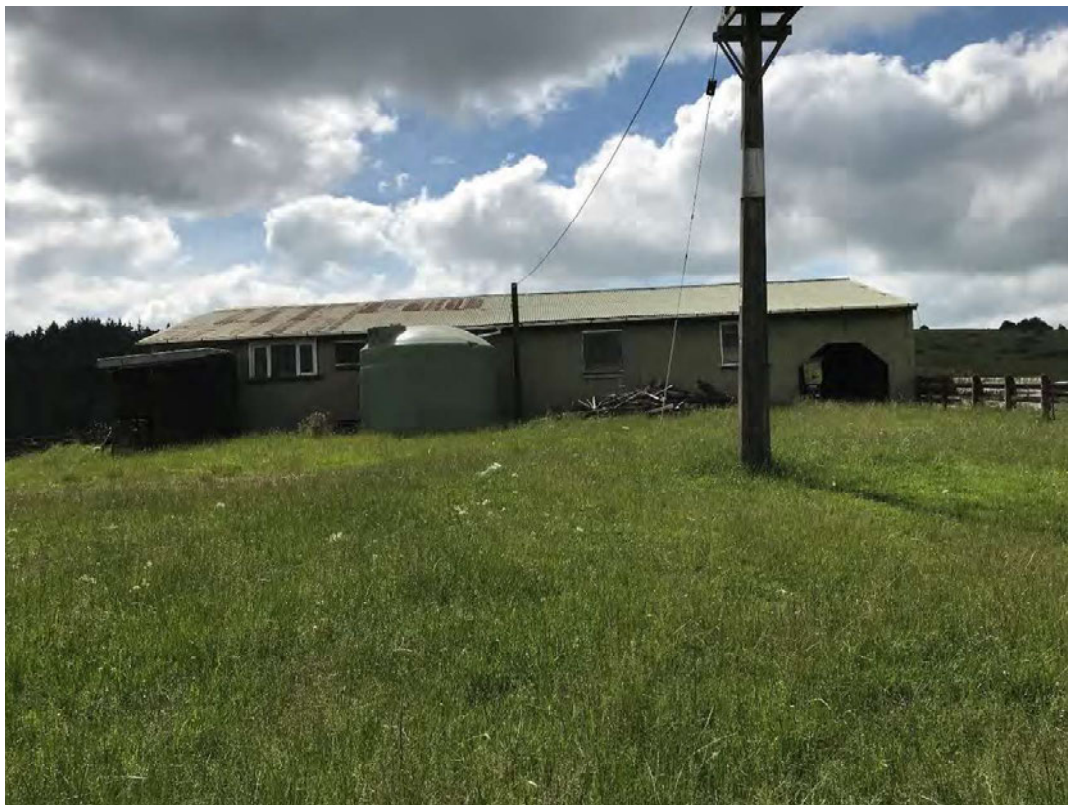
| <b>Shearing Shed</b> | A shearing shed was observed with painted metal cladding and roof (see Appendix C: Photographs 6,7 and 8). Three small chemical containers noting modern sheep and cattle pesticides were observed within the shed. Several pieces of PACM were observed on the ground within and immediately adjacent to the shed with no obvious source of this material being identified. No ground staining or other PACM was observed. |

**Photograph 6:** Looking east at the shearing shed.

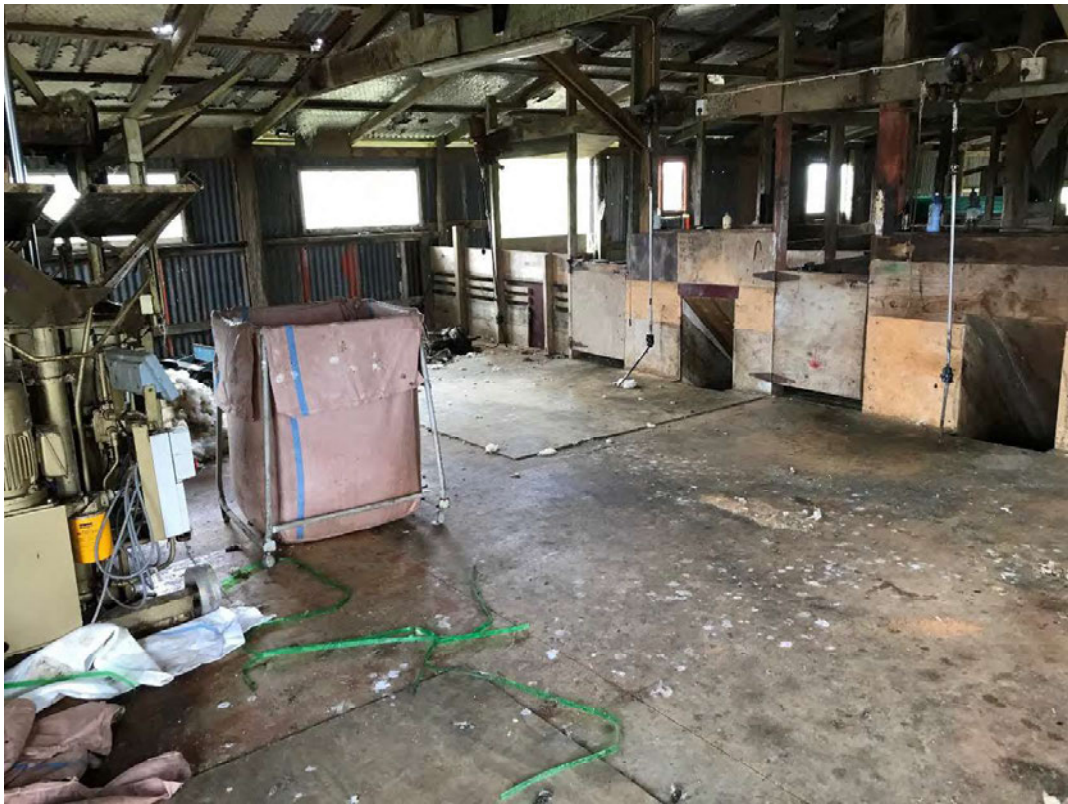
**Photograph 7:** Interior of the shearing shed.

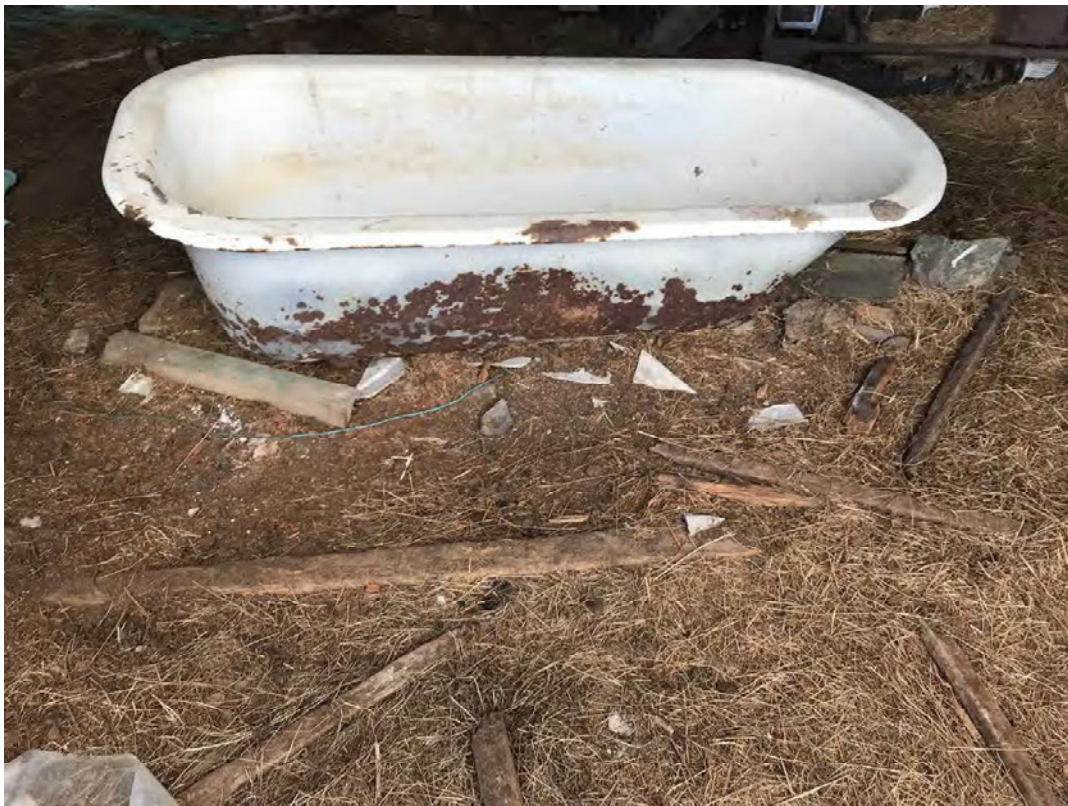
**Photograph 8:** Interior of the shearing shed with PACM fragments observed on the ground.

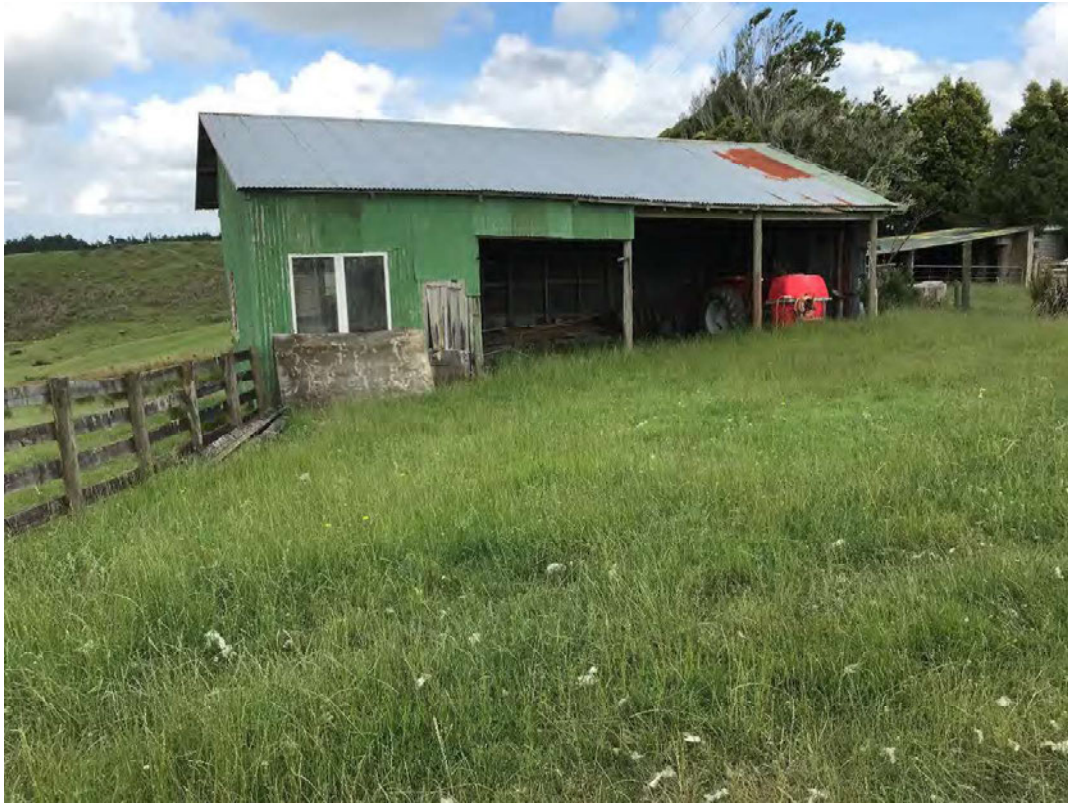
| <b>Storage Shed 1</b> | A storage shed with painted metal cladding and roof was observed (see Appendix C: Photograph 9). A tractor, wood and metal were stored inside the shed. No signs of ground staining or PACM were observed. |

**Photograph 9:** Looking west at Storage Shed 1.

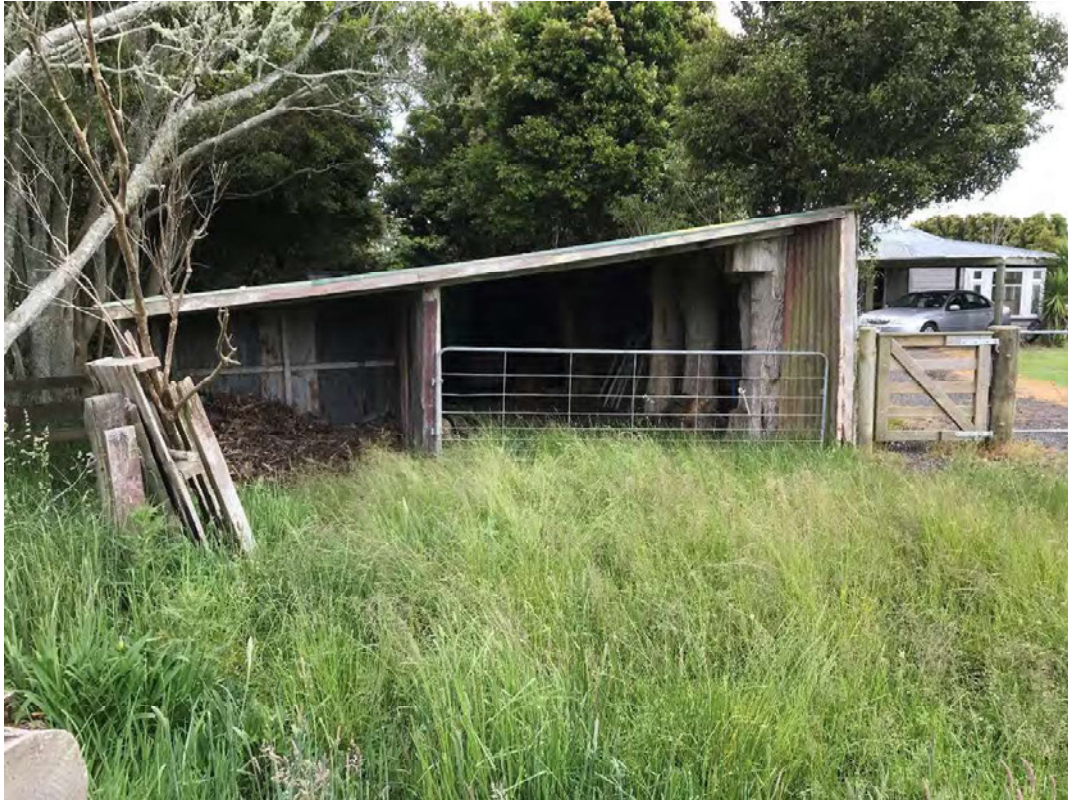
| <b>Storage Shed 2</b> | A storage shed with metal cladding (unpainted) and painted metal roof was observed (see Appendix C: Photograph 10). A lawn mower and wood were stored within the shed. No signs of ground staining or PACM were observed. |

**Photograph 10:** Looking west at Storage Shed 2.

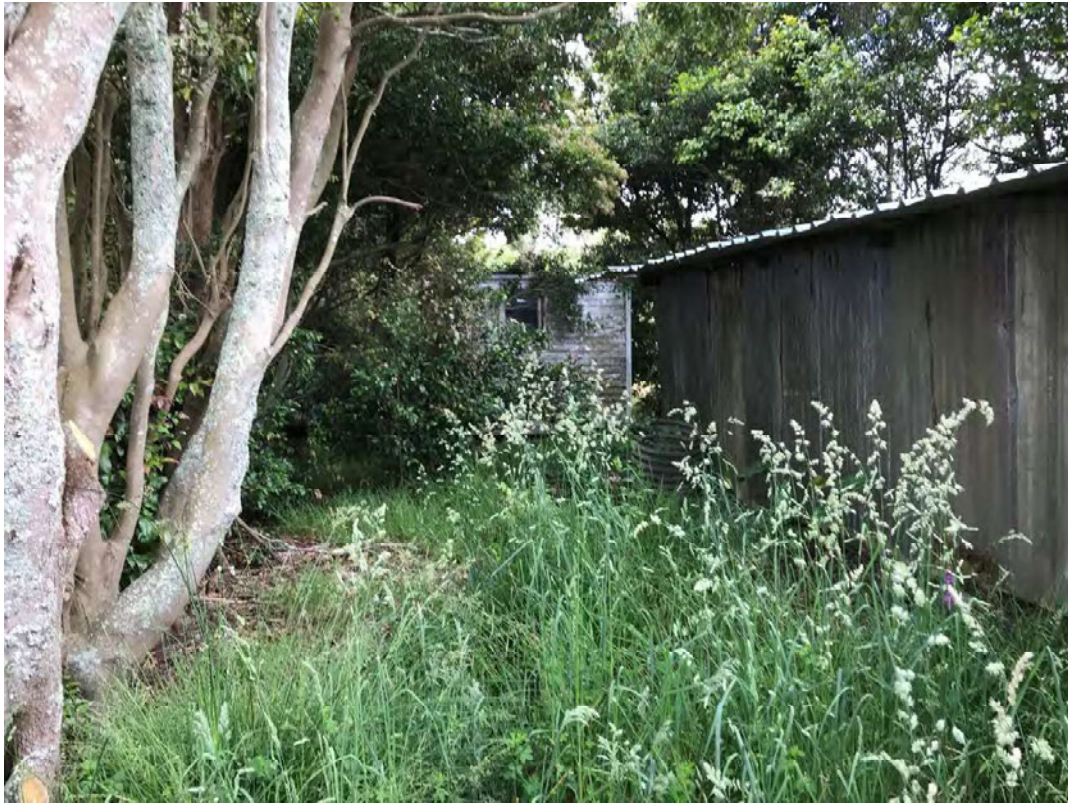
| <b>Storage Shed 3</b> | A painted wooden shed with metal roof was observed (see Appendix C: Photograph 11). The shed interior could not be accessed as it was located behind the locked fence of the dwelling. |

**Photograph 11:** Looking west at Storage Shed 3 in the background and the southern side of Storage Shed 2 to the right.

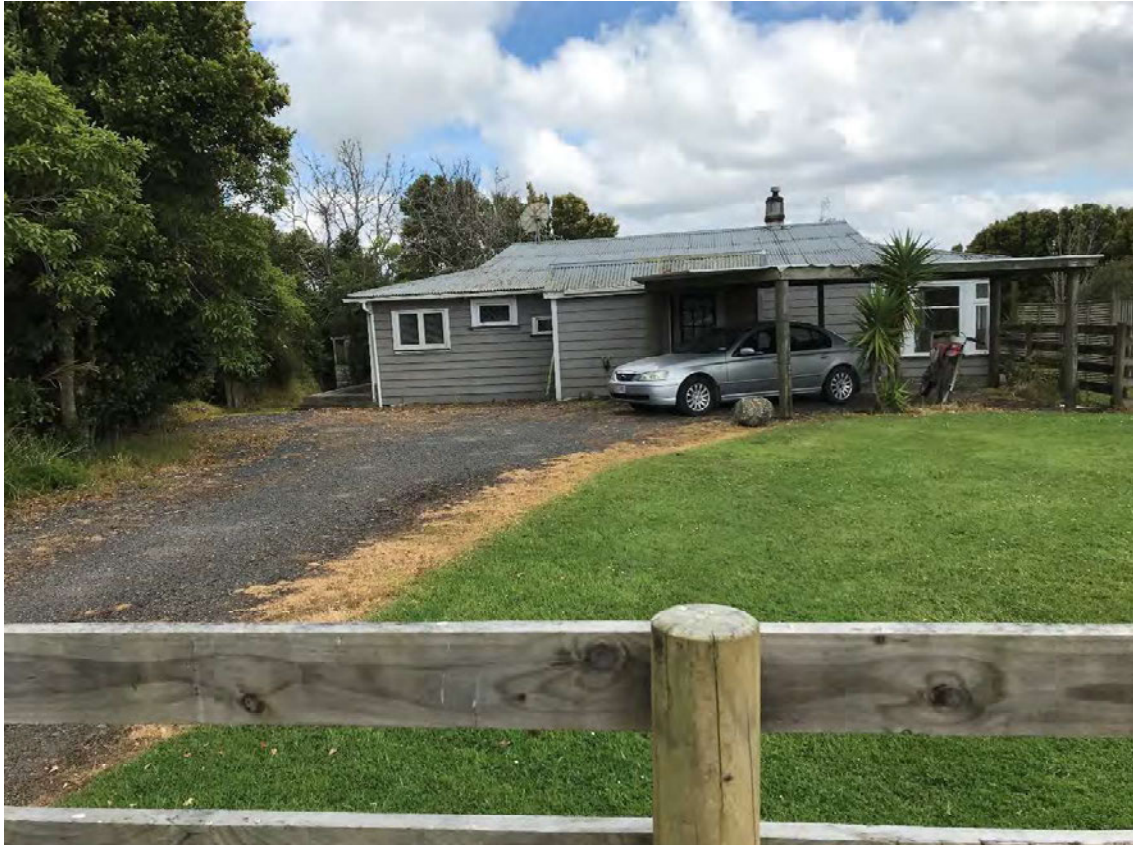
| Table 3: Site Visit Summary | |
|---|---|
| <b>Main Dwelling</b> | The main dwelling consisted of painted weatherboard cladding and a painted metal roof (see Appendix C: Photograph 12). The building material of the gable and baseboard of the dwelling could not be clearly identified and have the potential to be either painted cement sheet (i.e. PACM) or wood. Closer inspection was not possible due to the property fence being locked at the time of the site visit. The gable and baseboard were noted to be in good condition. A carport with metal roof was located adjacent to the main dwelling. |

**Photograph 12:** Looking west at the main dwelling and carport.

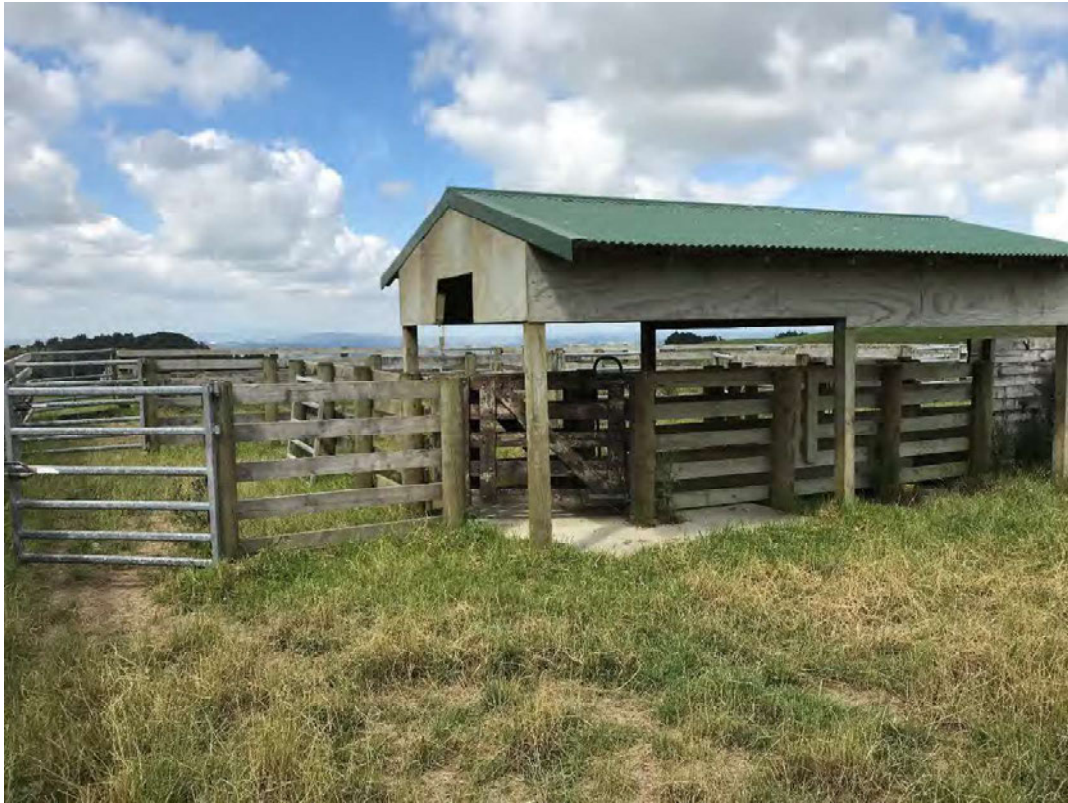
| Table 3: Site Visit Summary | |
|---|---|
| <b>Western Potential Spray Race/Sheep Dip</b> | A wooden structure which could potentially have been used as a spray race/sheep dip operation was observed, including a metal roofed shelter structure without walls (see Appendix C: Photographs 13 and 14). |

**Photograph 13:** Looking south at the potential location of the former spray race/sheep dip structure.

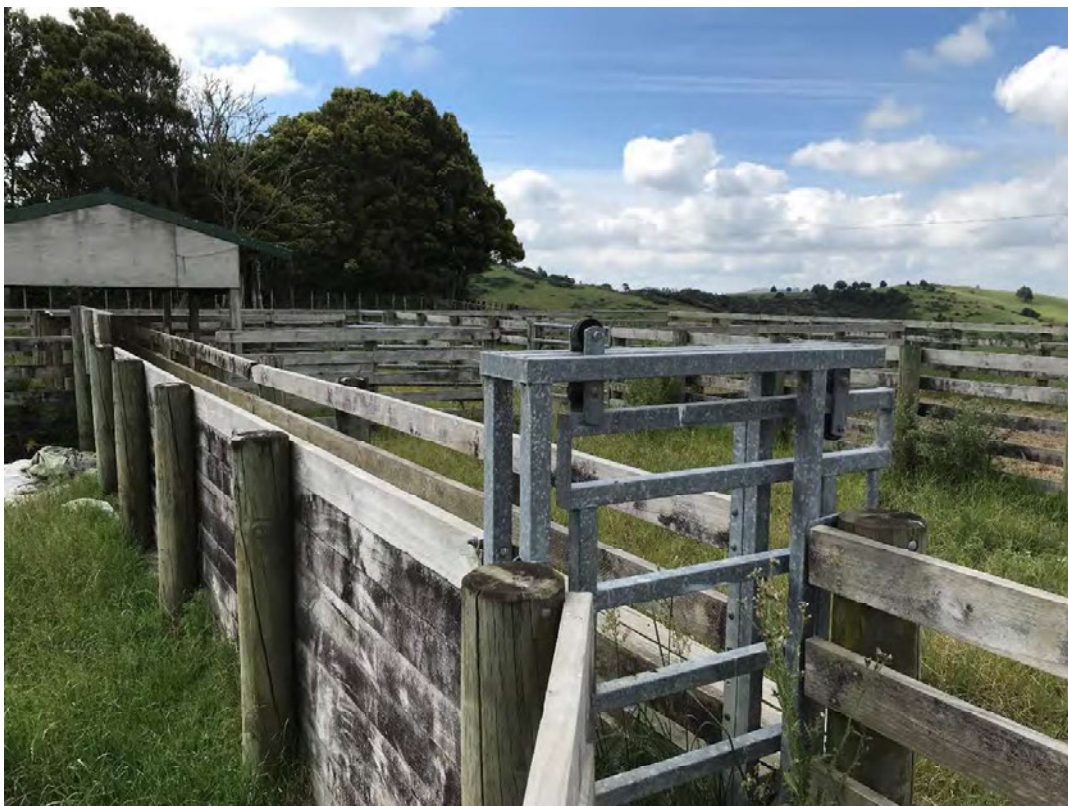
**Photograph 14:** Looking southeast at the potential location of the former spray race/sheep dip structure.

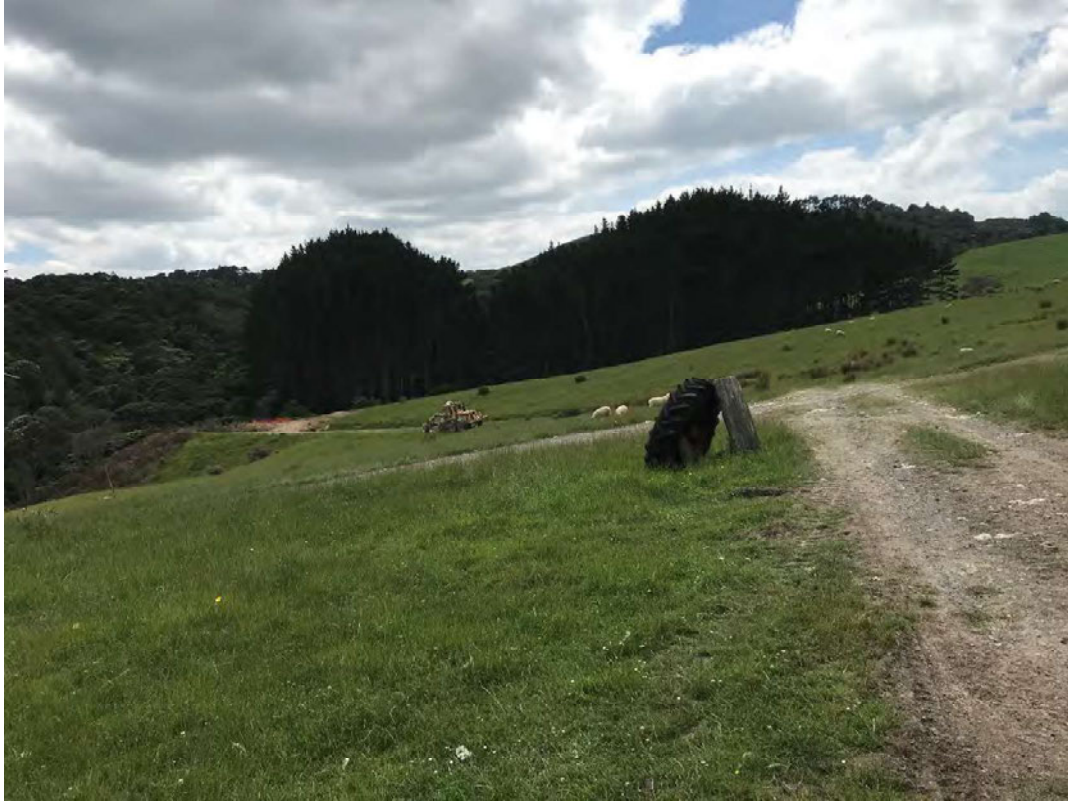
**Photograph 15:** Looking northeast towards the small earthworks area 1189 Ponga Road.
