## **Delmore Subdivision, Ōrewa**

## **Preliminary Site Investigation (Ground Contamination)**

VINEWAY LTD WWLA1147 | Rev. 3 13 February 2025

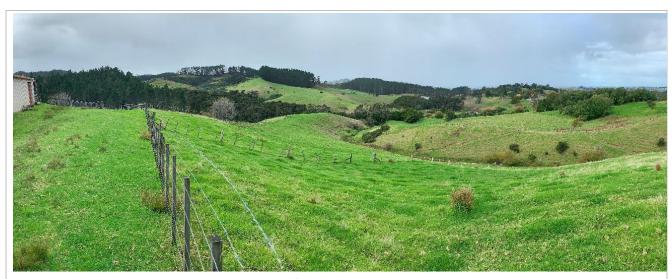
Photograph 1. View to northeast from the accessway to 130 Upper Ōrewa Road showing general topography.

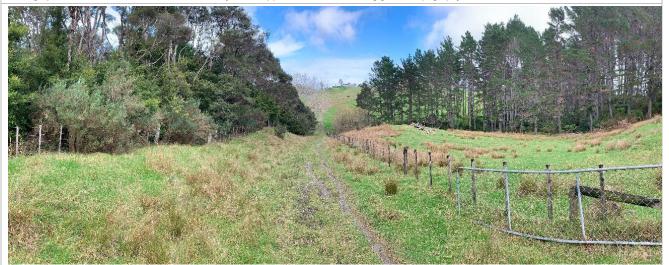
- As described in in the preceding sections, the site comprises 6 adjoining properties located on the northern side of Upper Ōrewa and Russell Roads.
- All of the properties were being used for rural and rural residential purposes with pasture being the dominant use (see **Photograph 1**). Several small stands of both plantation forestry (pine) and native bush are present across the wider site (see **Photograph 2**).

Photograph 2. View of the south from accessway to 130 Upper Ōrewa Road showing stands of both native and plantation forestry.

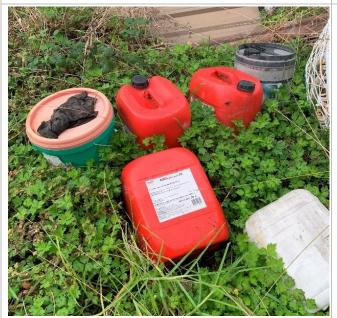
- Several small ponds are present across the wider site, apparently utilised for water supply for stock watering purposes.
- No evidence of onsite disposal of wastes (e.g. farm dumps) was observed. But storage of fuel and/or oil at residential volumes was noted in some localised areas (see Photograph 9, Photograph 10 and Photograph 15).

Photograph 9. Containers of waste oil being stored adjacent to sheds at 55 Russell Road.

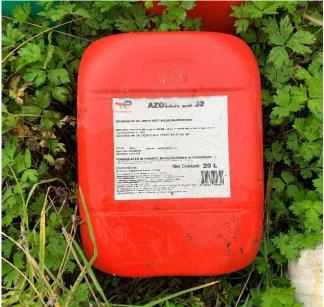
Photograph 10. Closeup of waste oil being stored adjacent to sheds at 55 Russell Road.

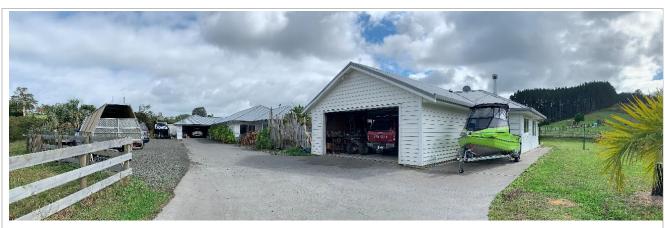
Photograph 11. View of the main and minor dwelling at 53b Russell Road.

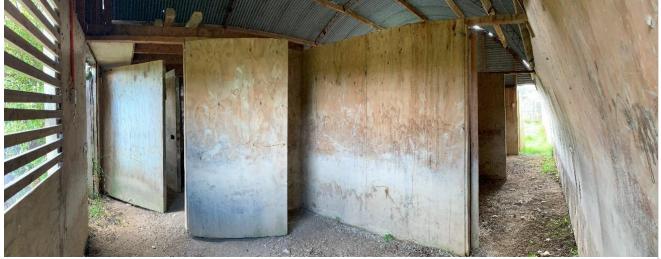
- A half round bard and associated stockyard at 130 Upper Ōrewa Road is configured for handling deer with facilities indicating that animal treatments were administered by oral or pour on application (see **Photograph 18** to **Photograph 22**).

Photograph 20. View of the interior of the half round barn at 130 Upper Ōrewa Road.

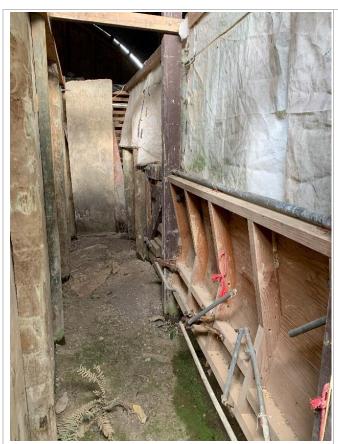
Photograph 21. Stock handling facilities in half round barn at 130 Upper Ōrewa Road.

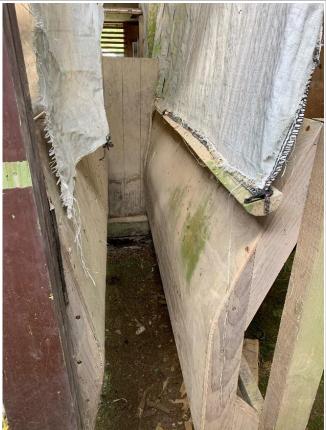
Photograph 22. Stock handling facilities in half round barn at 130 Upper Ōrewa Road.

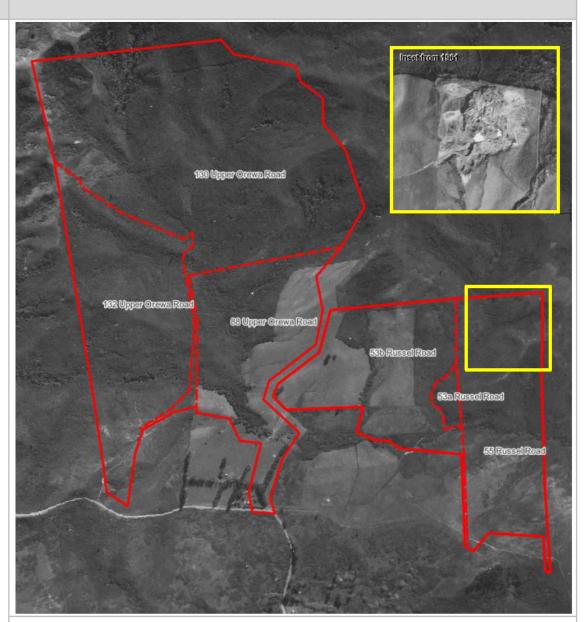
### 1940 Retrolens (SN143/83/38)

- · The property was primarily undeveloped, comprising a mixture of pasture and regenerating bush at this time.
- Upper Örewa Road has been formed but Russell Road appears to be a farm track.
- A single dwelling and shed were present on the road frontage of 88 Upper Örewa Road, otherwise structures are limited to occasional small barns or sheds.

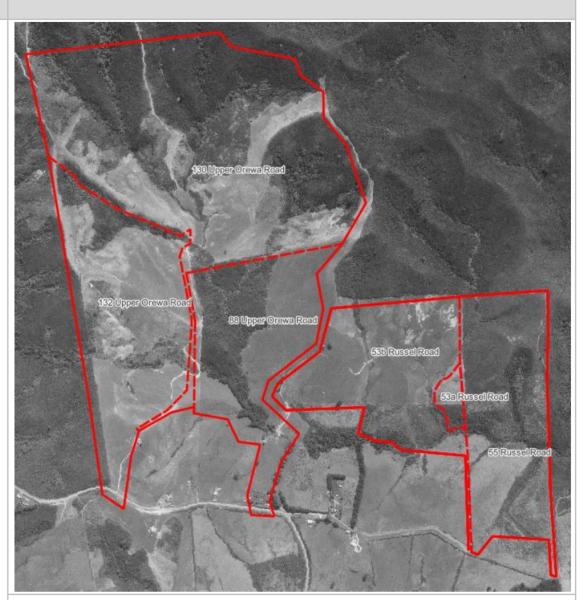
**1963**Retrolens
(SN1565/C/5)

- Much of the regenerating bush has been cleared with pastoral use becoming dominant
- · Russell Road has now been formed.
- Quarry operations have ceased on 55 Russell Road and the accessway appears to have fallen into disuse.
- A large shed or barn, accessed from Upper Ōrewa Road, has been constructed near the southern end of 132
   Upper Ōrewa Road.

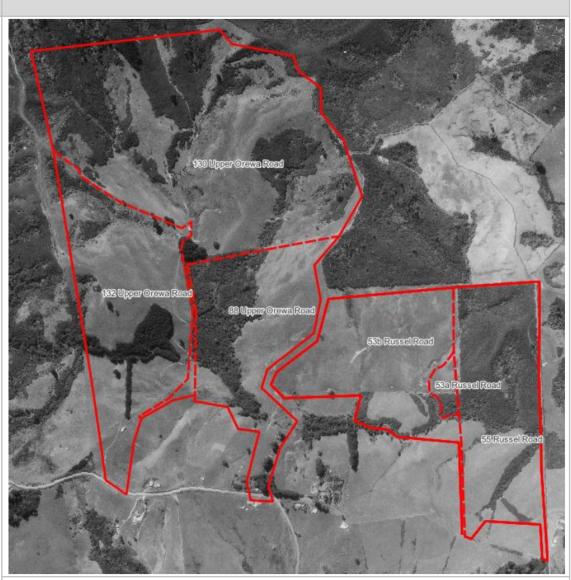
**1981** Retrolens (SN5783A/F/18)

- A large shed or barn has been constructed in northeastern corner of 132 Upper Ōrewa Road, where it adjoins
  the southern end of 130 Upper Ōrewa Road. It is not clear from this image which property the structure was
  associated with.
- An area of plantation forest has been established near the centre of 132 Upper Ōrewa Road.
   No other notable changes are evident.

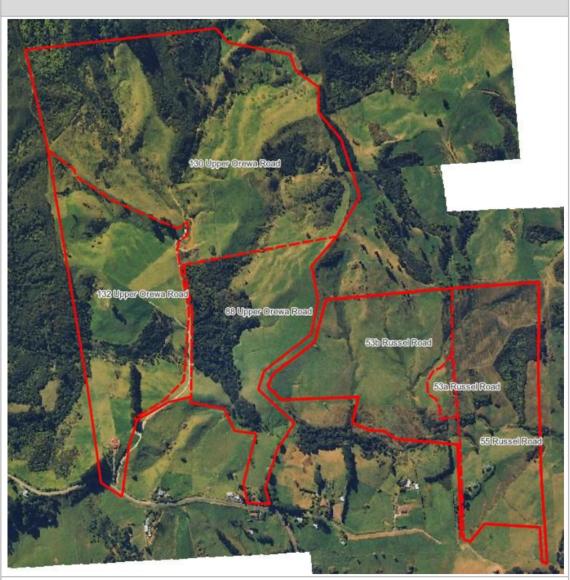
1996 GeoMaps

- Dwellings has been constructed near the southern end of the following properties:
   55 Russell Road a dwelling was first constructed in the mid-1980s (between 1981 and 1988); and
   132 Upper Ōrewa Road a dwelling was first constructed in the late 1980s-early 1990s.
- The northern portion of 55 Russell Road has bee cleared of scrub / bush.

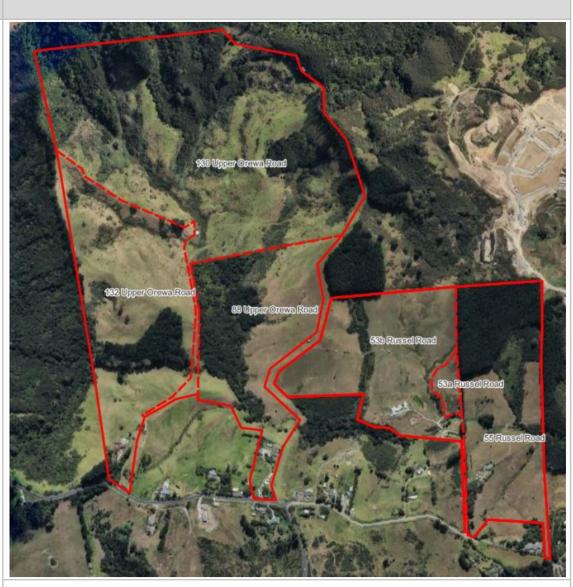
2023

- 53b Russell Road an accessway and building platform were constructed at near the southern end of this
  property in 2013. The property was occupied by a shed (near its southeastern corner) and various smaller
  structures (possibly tiny houses) until a main dwelling and adjacent minor dwelling were constructed in 2017. A
  small residential orchard was established near the building platform for the dwellings in 2015.

- 88 Upper Örewa Road the original roadside dwelling and shed were removed from this property in the early 2000s, after which time a small stockyard is evident. A single dwelling was constructed near the southern end of the site around 2009/2010. A pool, shed and landscaping were added to the site over time, but it has otherwise not change materially since 2010.

- 132 Upper Örewa Road the original barn near the southern end of the property was replaced by more modern
  farm sheds in the 1990s or 2000s, these sheds are now located outside of the property, immediately adjacent to
  its eastern boundary.
