GORDONTON RETIREMENT VILLAGE PRELIMINARY SITE INVESTIGATION

**57 Piako Road
Gordonton**

BARKER AND ASSOCIATES LTD
June 2024 | V1

Client: Barker and Associates Ltd
Project Location: 57 Piako Road, Gordonton
Job Number: J5420
Document: Gordonton Retirement Village | Preliminary Site Investigation
Version: V1
Document Status: Final - Approved for Issue
Date: June 2024

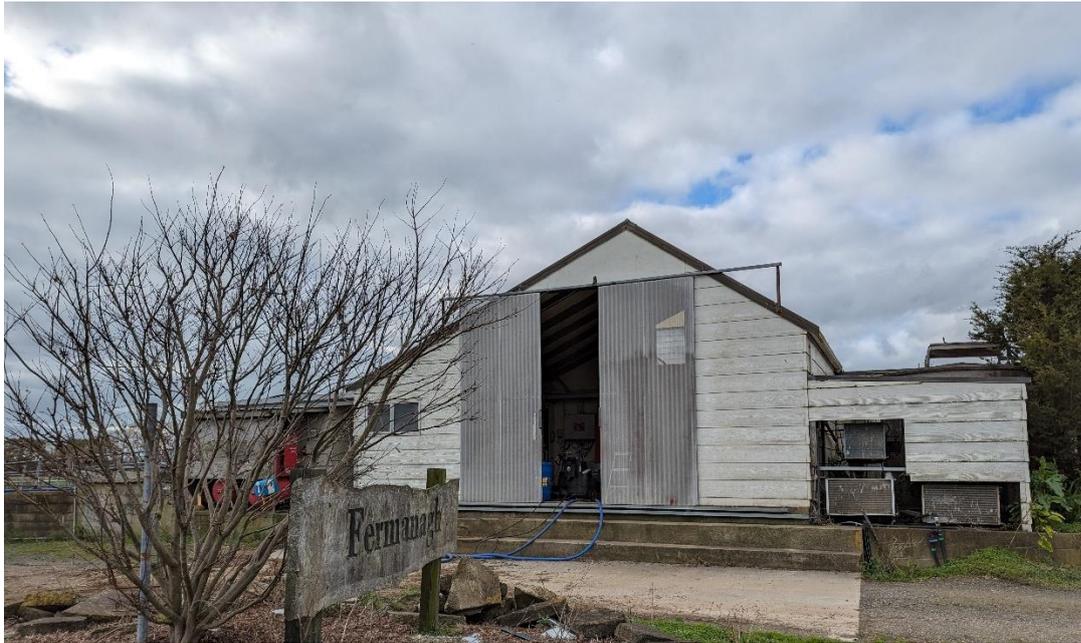
Image 1. View of the milking shed

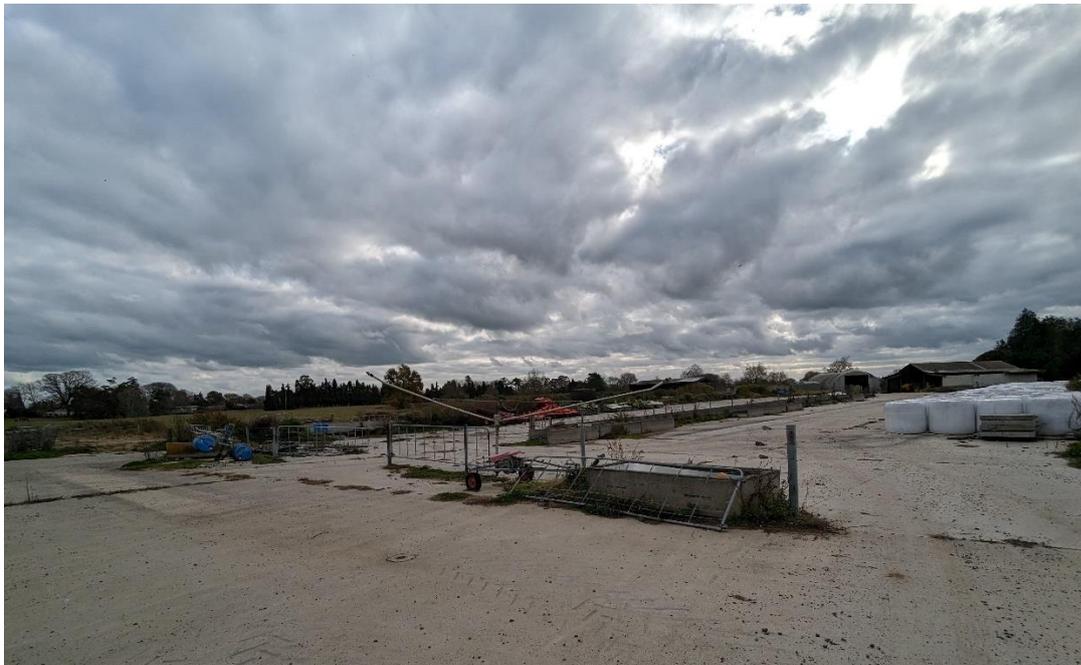
Image 2. View of the feedlot with stormwater/washdown collection pond in the left of image

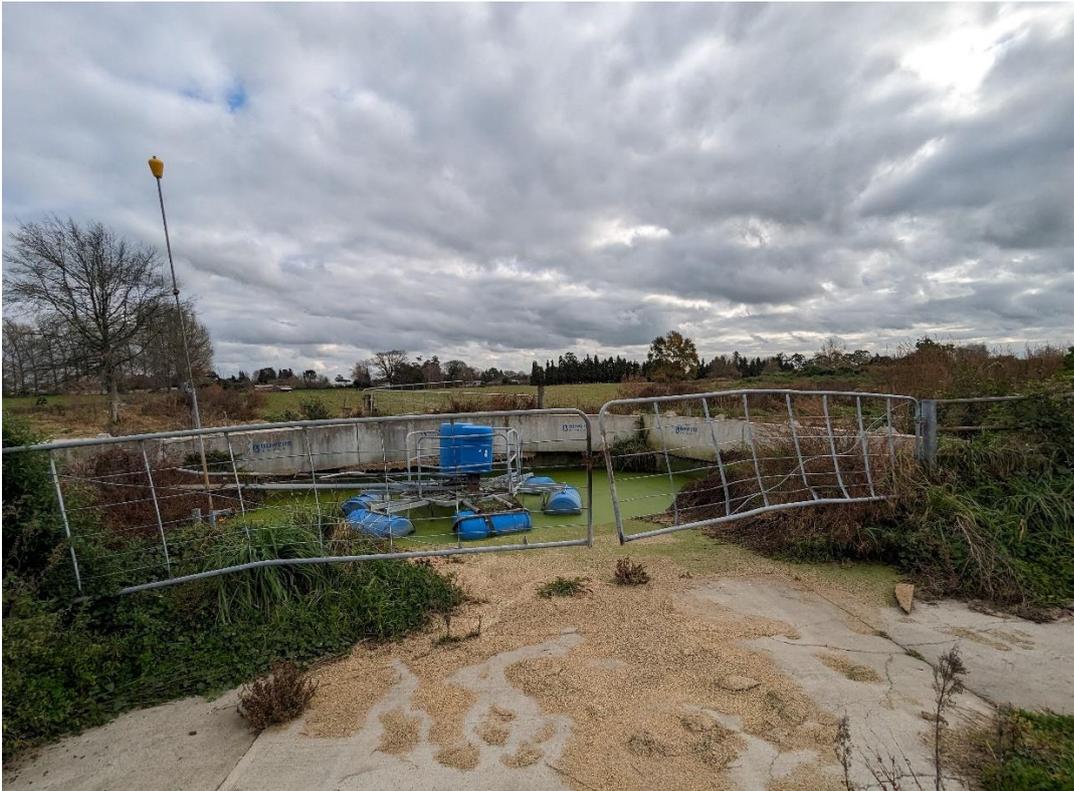
Image 3. View of stormwater/washdown collection pond

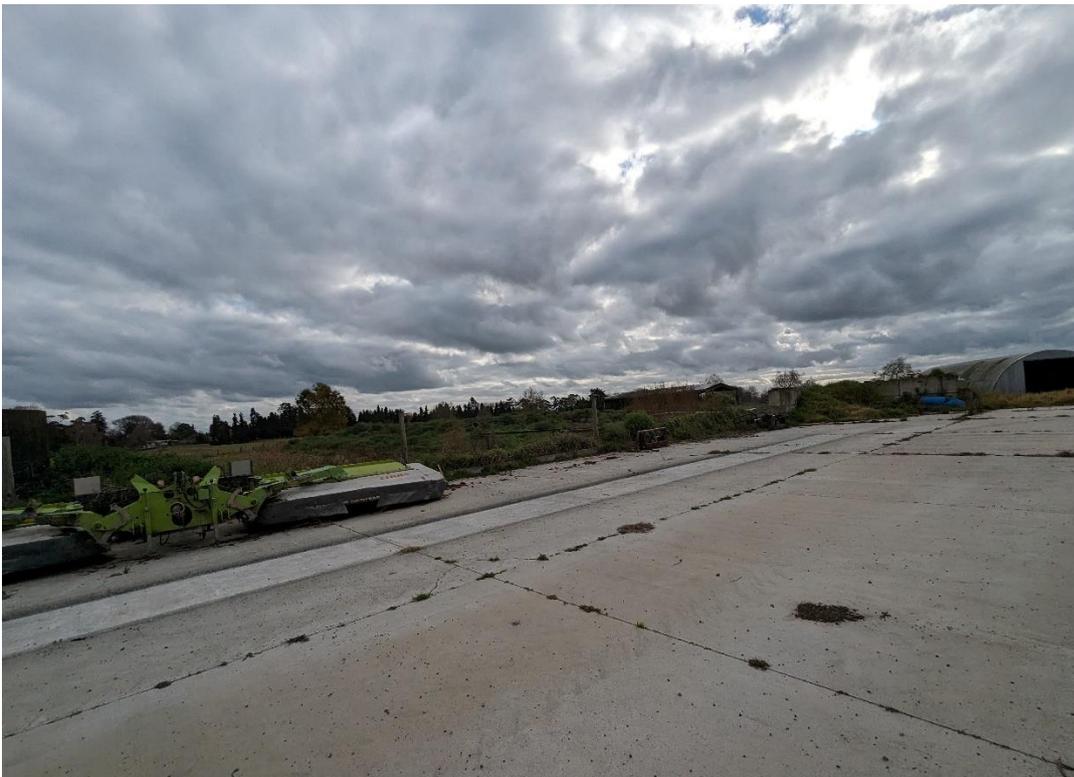
Image 4. View of decommissioned dairy waste treatment pond.

2. We recommend ascertaining the exact location, depth and dimensions of in-ground structures including the former effluent pond, septic tanks and disposal fields using ground penetrating radar (or similar) If possible, to ascertain investigative requirements, if any.

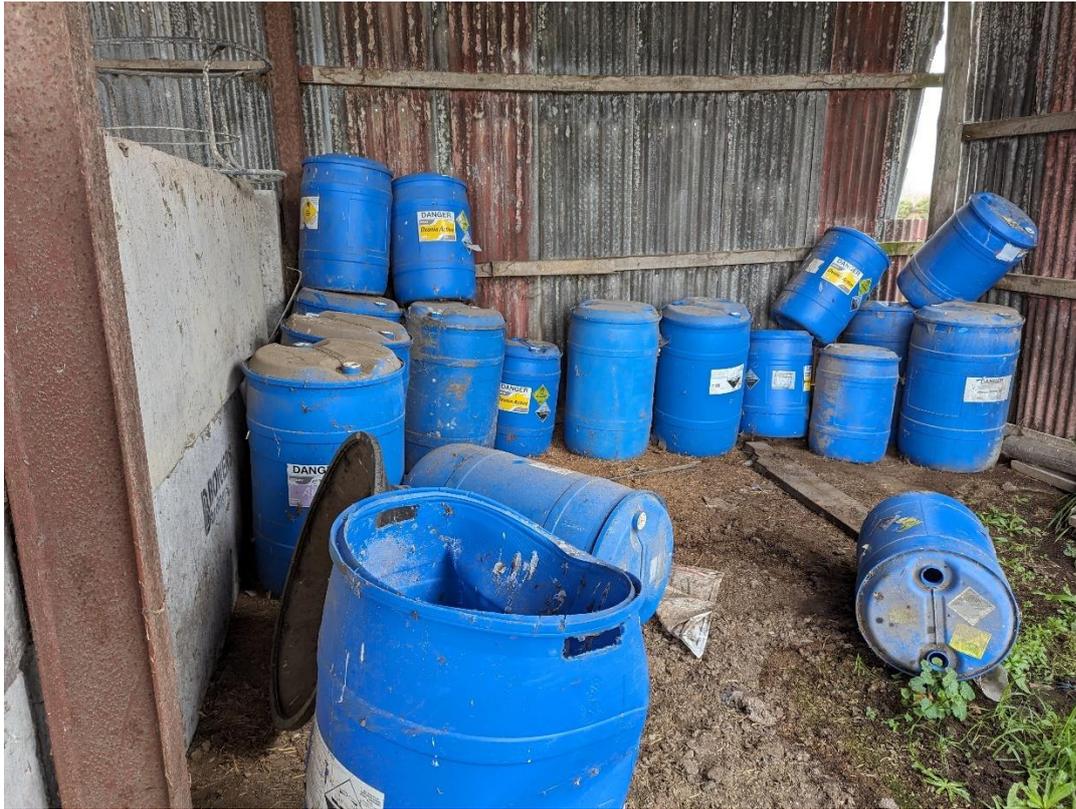
Image 7. Chemical drum storage area

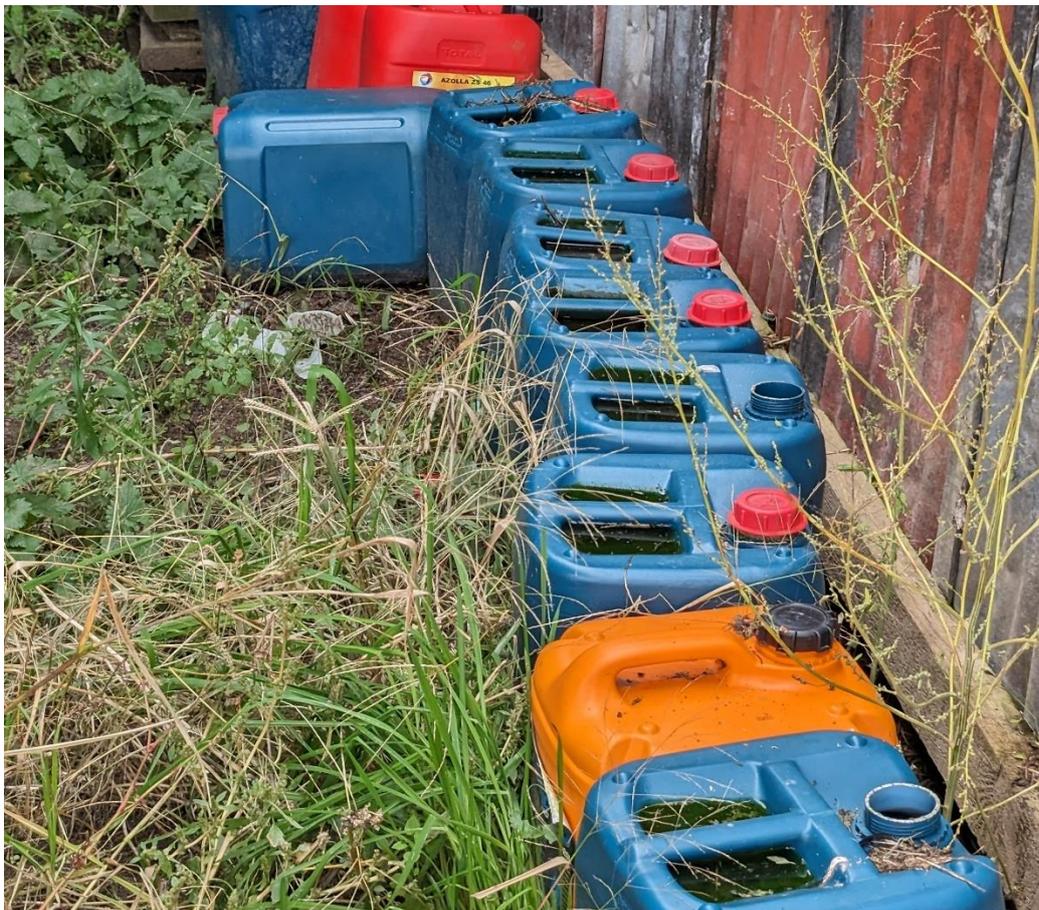
Image 8. Chemical drum storage area

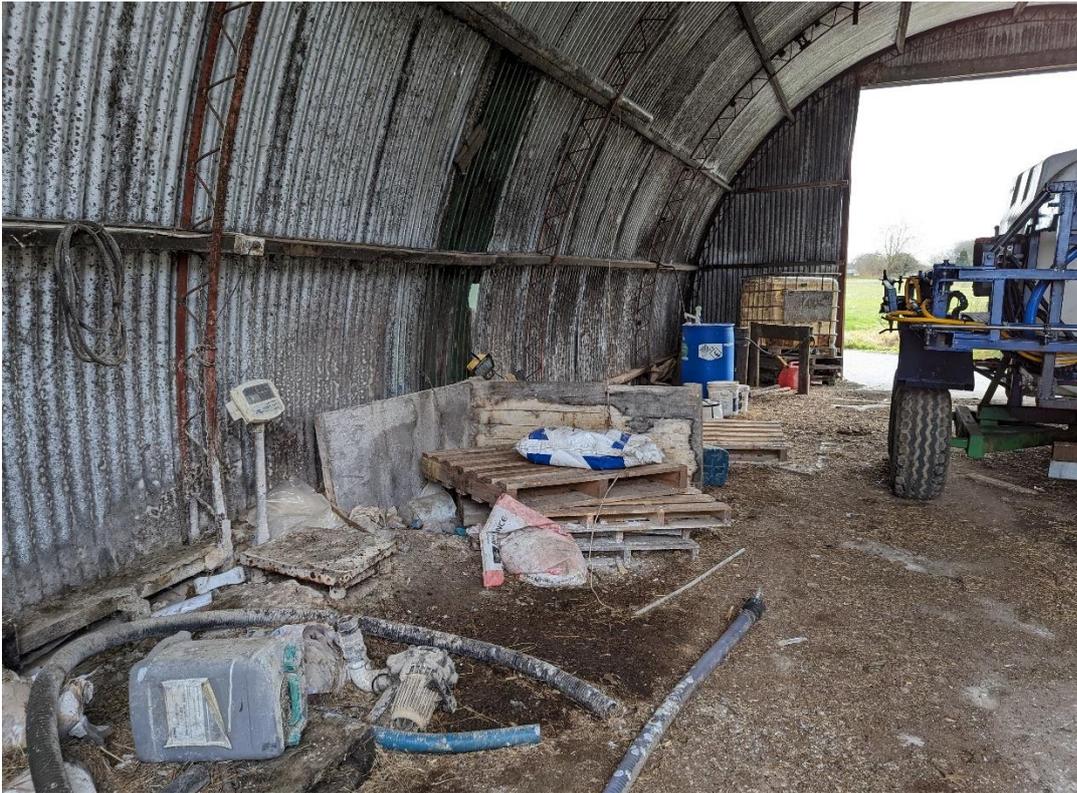
Image 9. Chemical mixing area

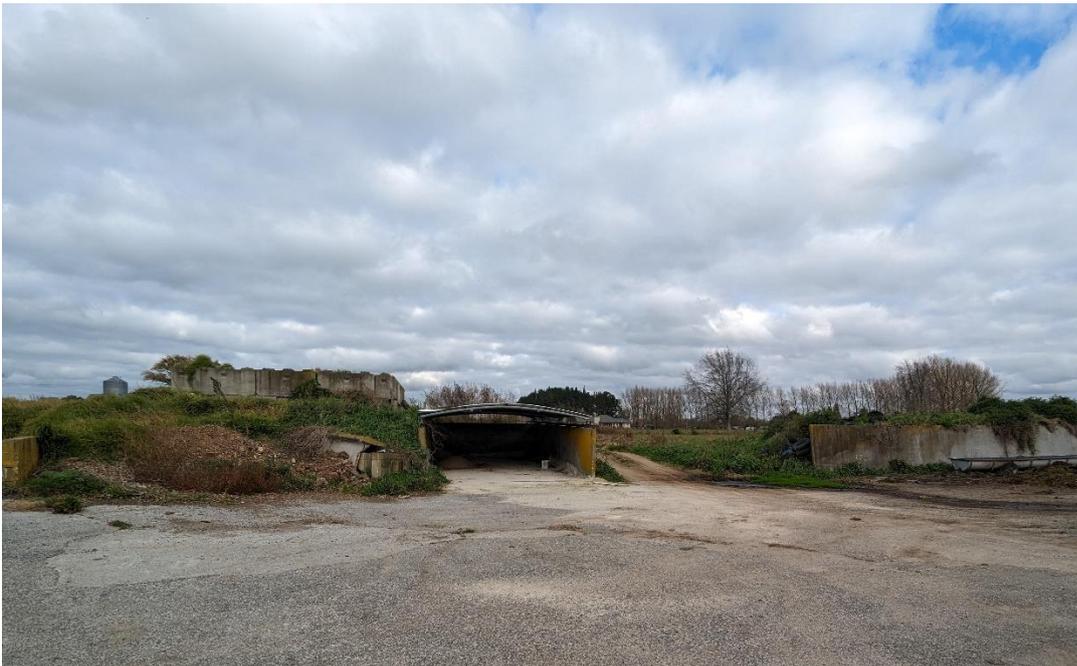
Image 10. Fertiliser bunker

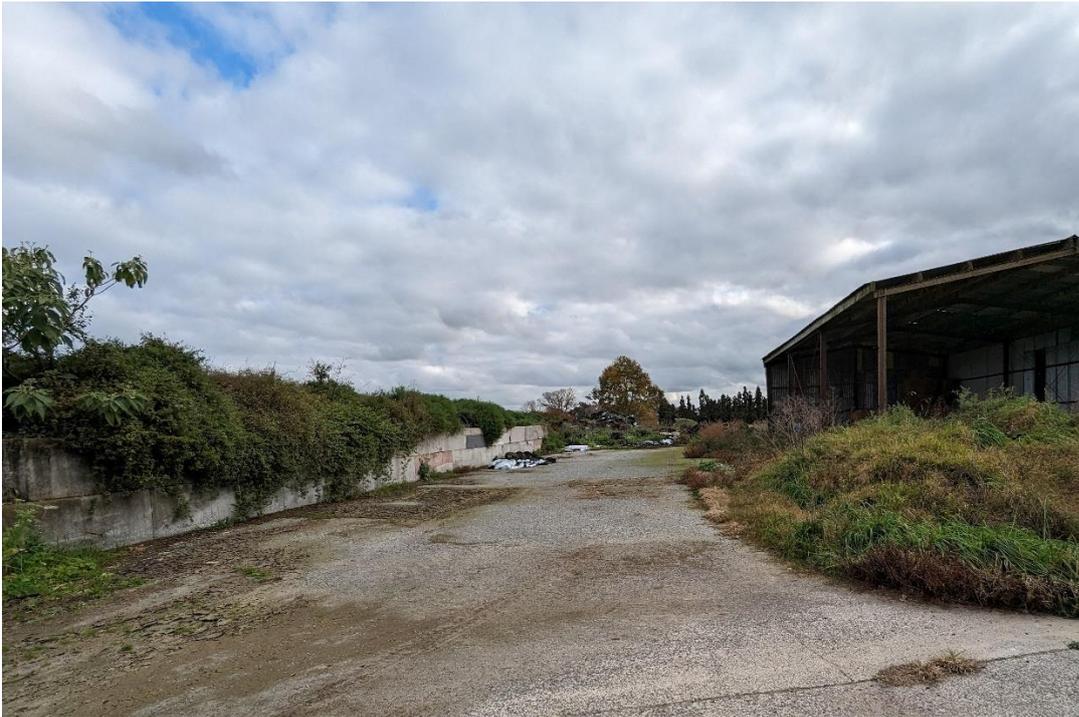
Image 11. Tyre storage adjacent to silage silo

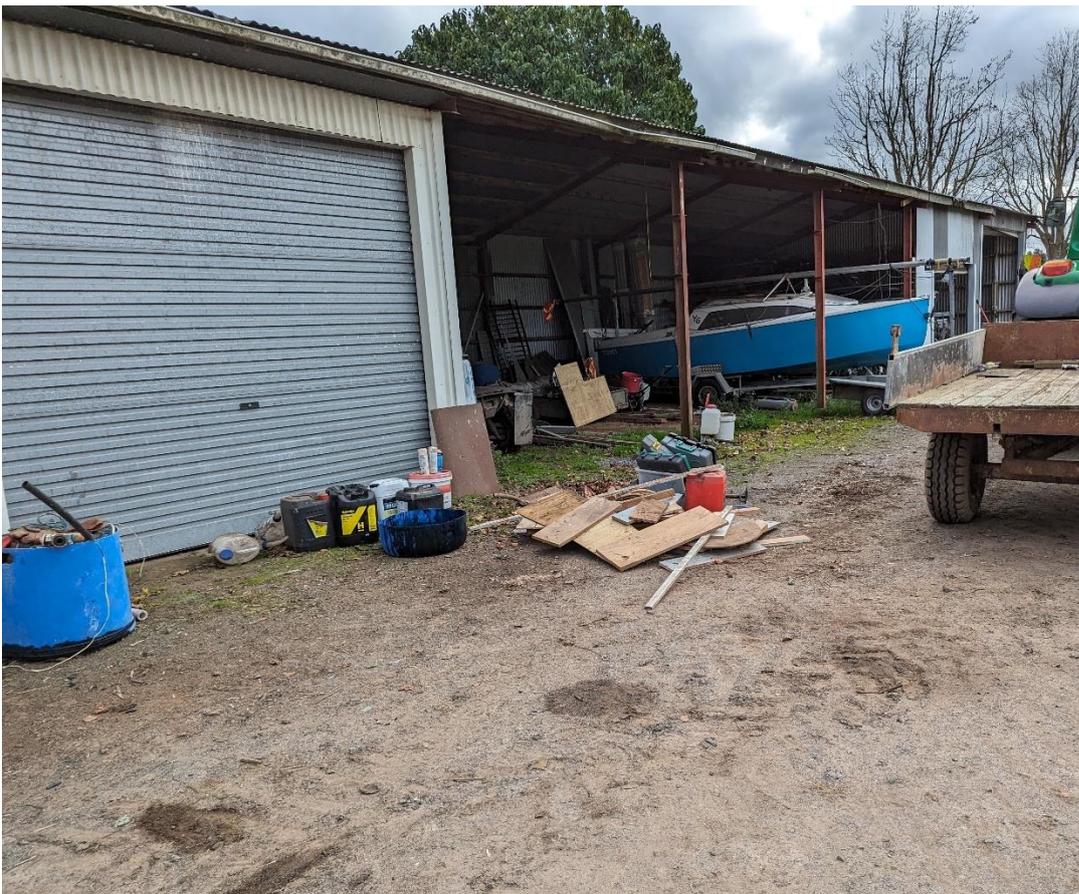
Mechanical repairs	F4 - Motor vehicle workshop	Small scale repairs are undertaken on hardstand adjacent to the sheds. There was evidence of localised spills associated with this work.

Image 12. View of shed in maintenance area.

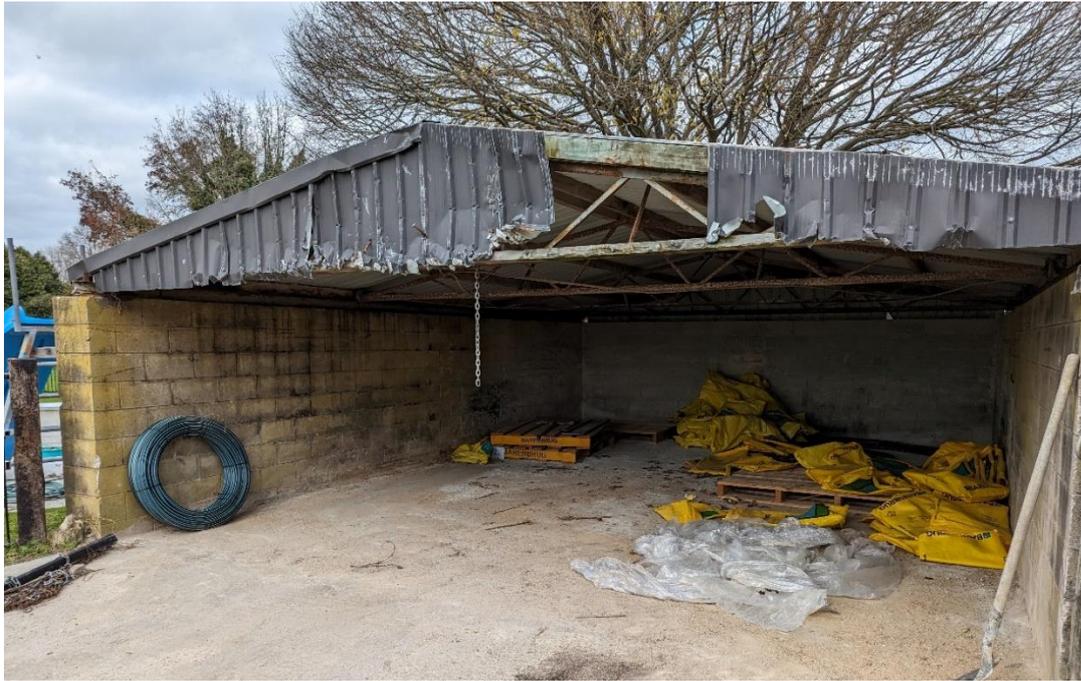
Image 13. Fertiliser bunker

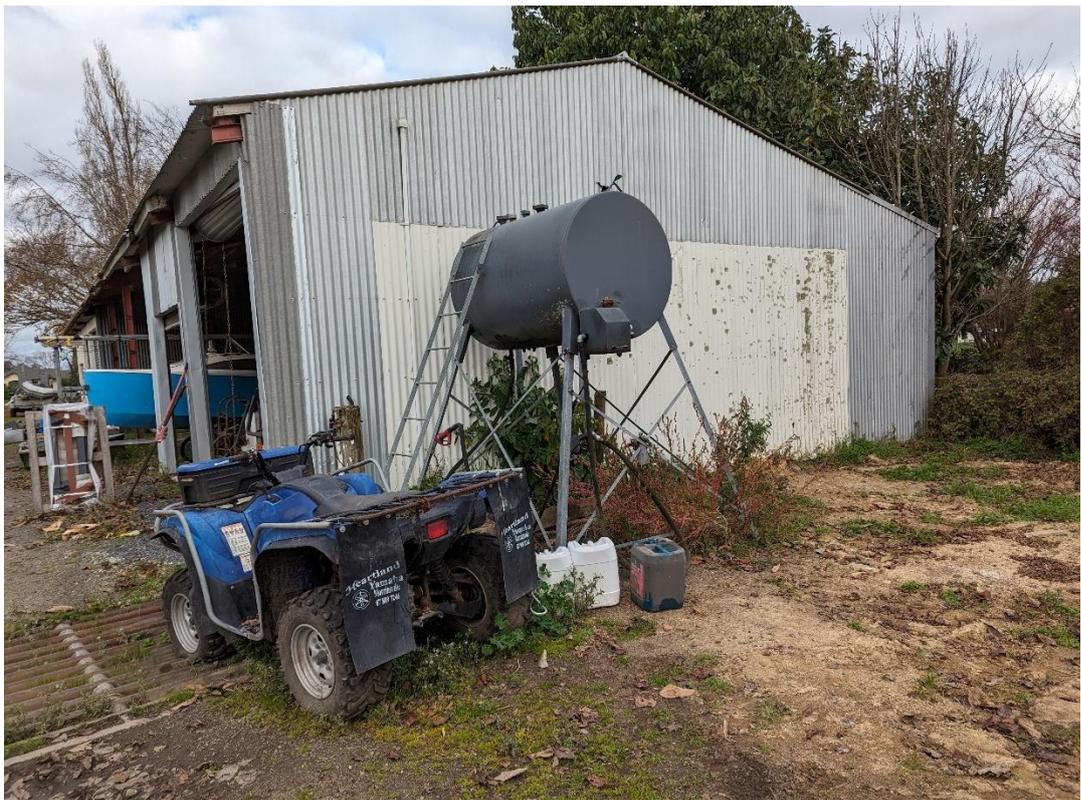
Image 14. Above ground fuel storage tank

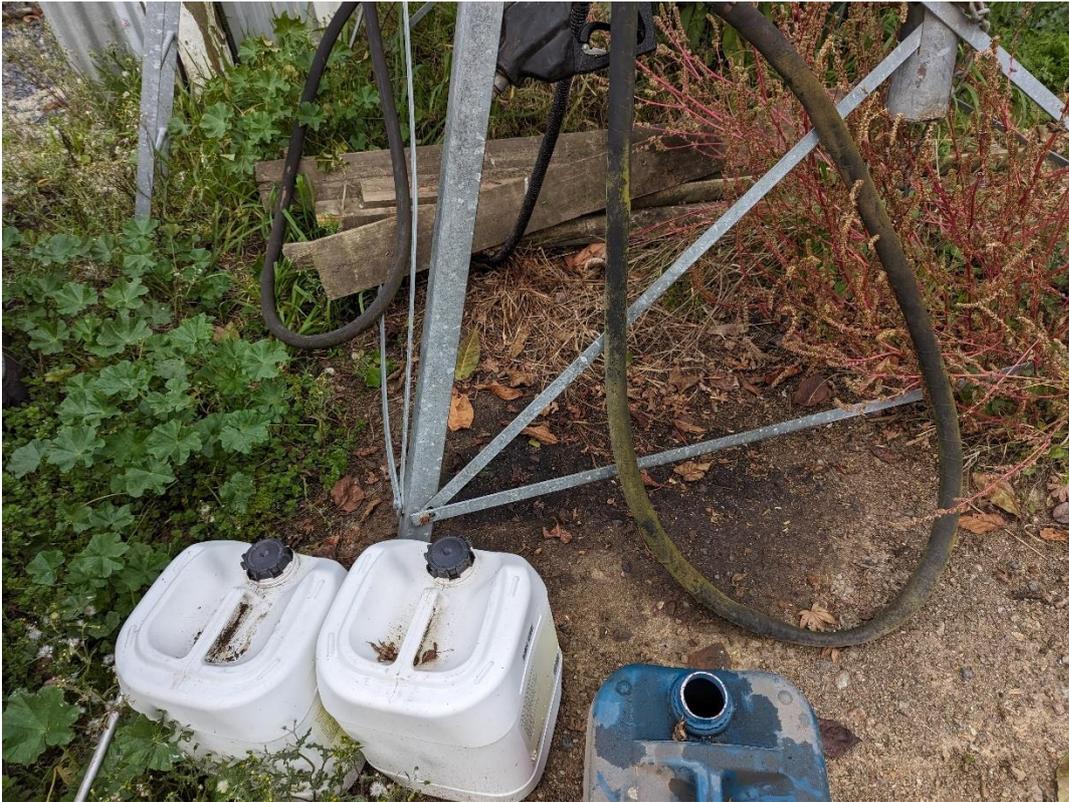
Green Waste	the site visit the silos appeared to be used for the dumping of green waste.
57 Piako Road Sheds	Machinery store	The site owner indicated that the sheds were the workshop for his farm equipment. To the west of the fertiliser bunker (below) is a 6-bay shed with the southern two bays inaccessible with locked roller doors, and concreted floors. The remaining bays were used for storing quad bikes, a boat and various quad bike trailers and other farm equipment. The area between the fertiliser bunker and the farm shed was gravelled and showed staining with what appears to be engine oil and other lubricants.
	Fertiliser bunker	A fertiliser bunker was located between the two dwellings.
	Above ground fuel storage tank (AST)	A mixed Diesel and petrol above ground storage tank (estimated 1,500L total) was located to the north of the farm shed. Some staining was observed beneath the bowsers, but not within the refuelling area.

Image 15. Staining beneath fuel tank
