ASBESTOS MANAGEMENT PLAN

Downtown Carpark

Prepared for Auckland Transport | 07-Feb-2020

Asbestos Management Survey

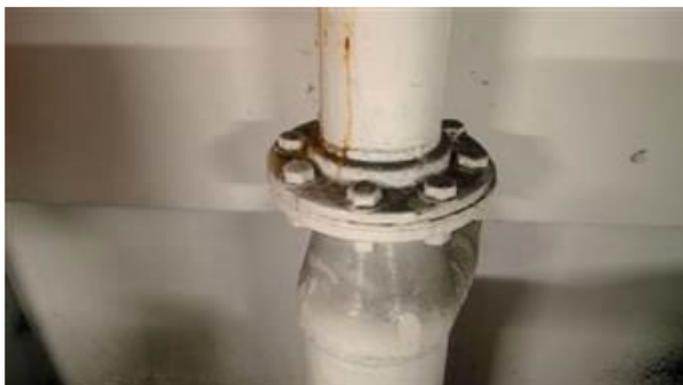
Photo No: S-002

**Asbestos Type: No Asbestos
Detected**

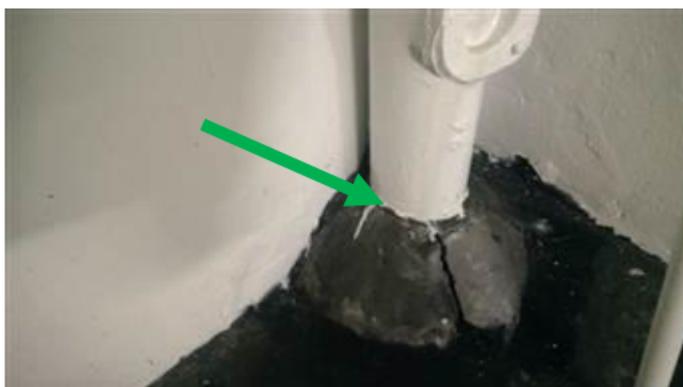
Photo No: S-003

**Asbestos Type: No Asbestos
Detected**

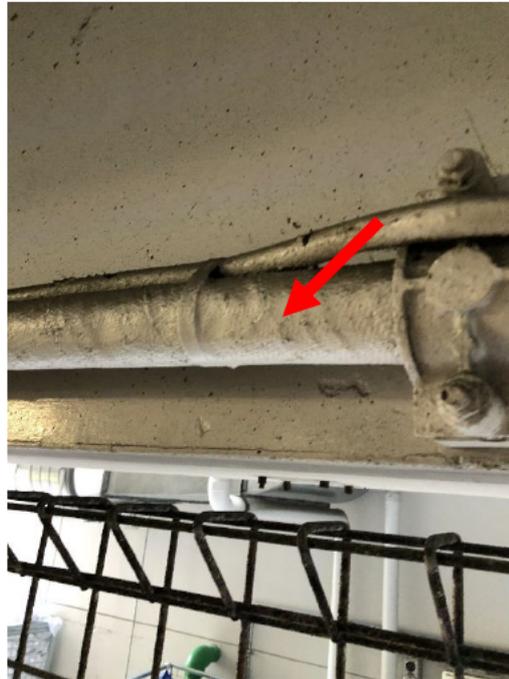
Photo No: S-004

Asbestos Type: Chrysotile

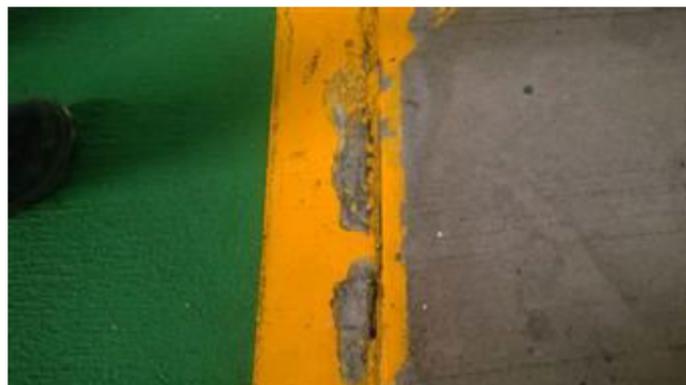
Photo No: S-005

**Asbestos Type: No Asbestos
Detected**

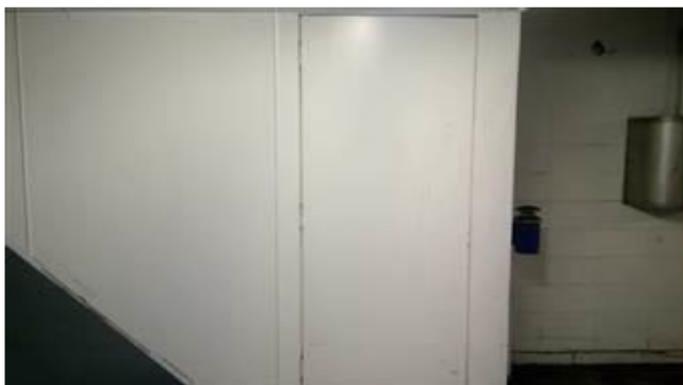
Photo No: S-006

Asbestos Type: No Asbestos Detected

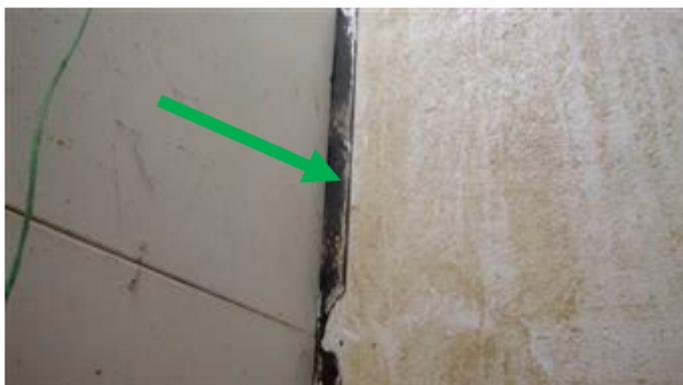
Photo No: S-010

Asbestos Type: No Asbestos Detected

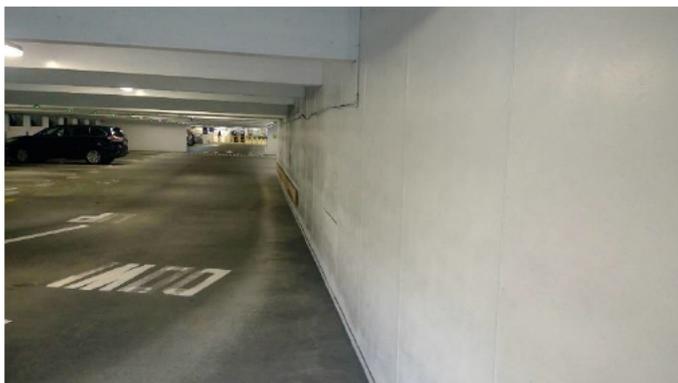
Photo No: S-011

Asbestos Type: No Asbestos Detected

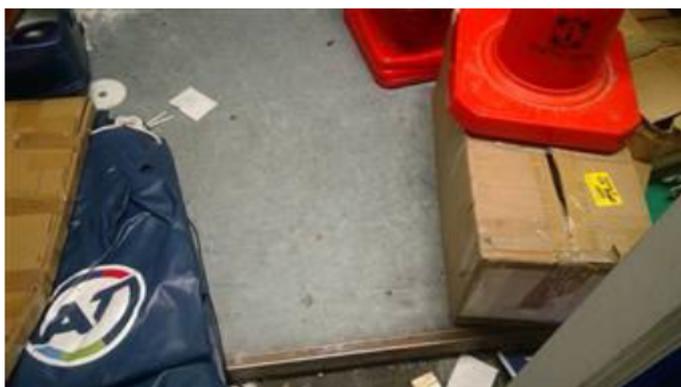
Photo No: S-012

Asbestos Type: No Asbestos Detected

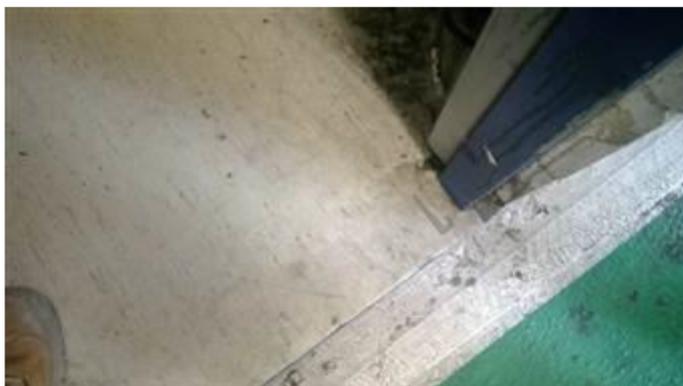
Photo No: S-013

Asbestos Type: No Asbestos Detected

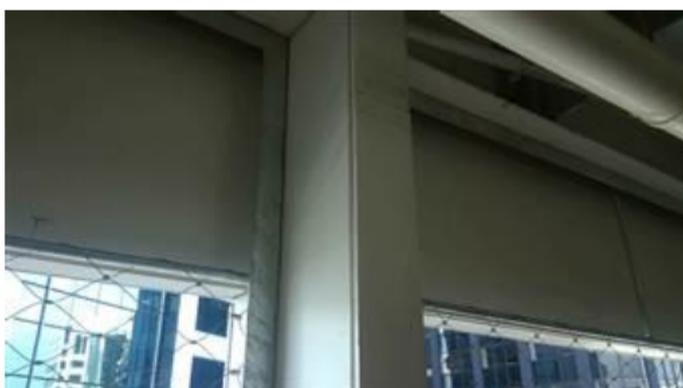
Photo No: S-014

Asbestos Type: No Asbestos Detected

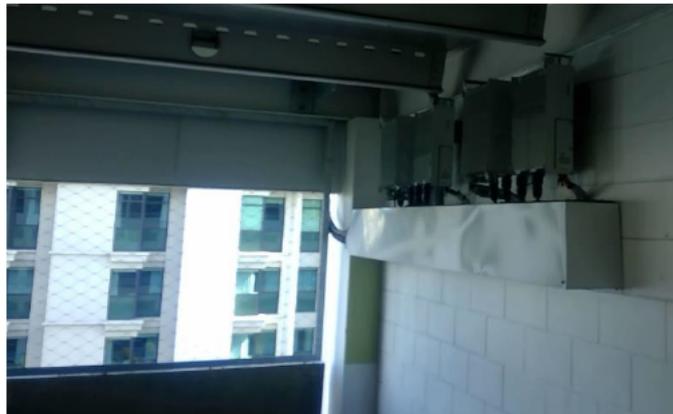
Photo No: S-016

Asbestos Type: No Asbestos Detected

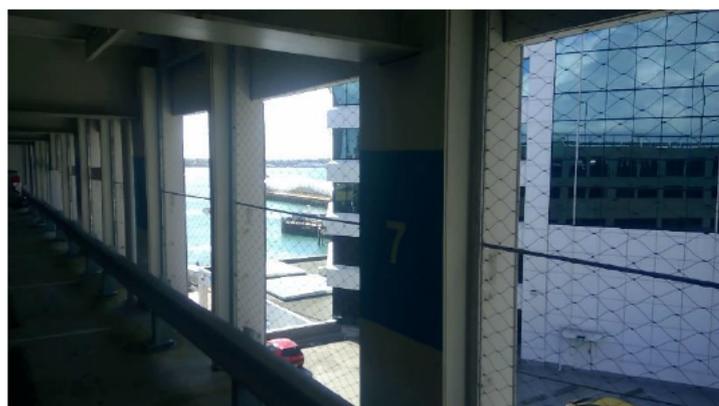
Photo No: S-017

Asbestos Type: No Asbestos Detected

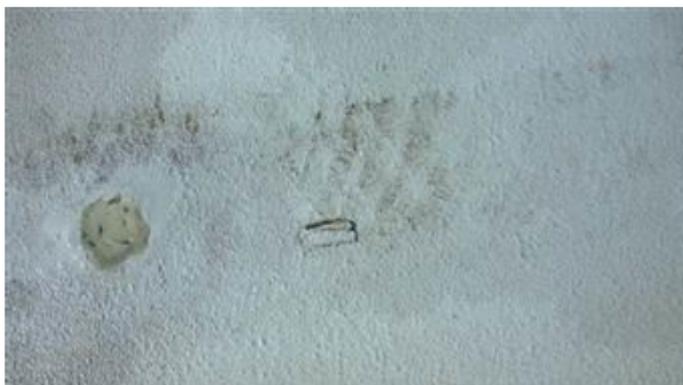
Photo No: S-018

**Asbestos Type: No Asbestos
Detected**

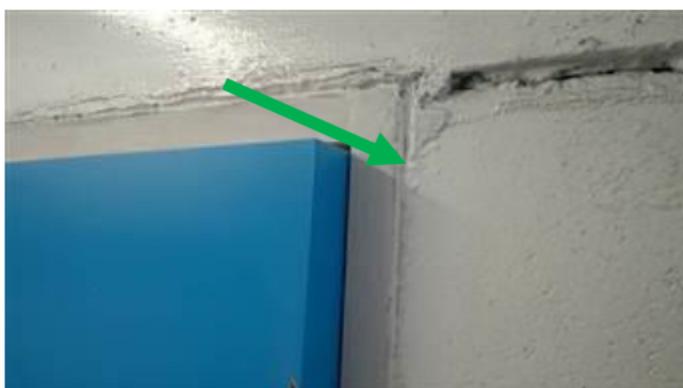
**Asbestos Type: No Asbestos
Detected**
