Waihi North Project

Preliminary Site Investigation (Ground Contamination)

**WAI-985-000-REP-LC-0026_RevC.1
TECHNICAL REPORT
Waihi North Project - Preliminary Site
Investigation - Ground Contamination
GENERAL AREA 000**

17 December 2024

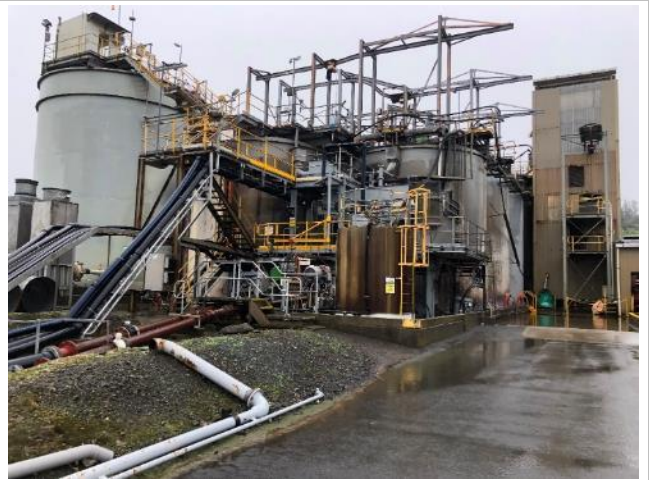
- Gold and silver is recovered from ore through a Carbon-in-Leach (“CIL”) process which involves grinding and chemical leaching (**Photograph 2**), the key constituent of which is cyanide. Cyanide is obtained in powdered form in isotainers (**Photograph 4**) and made up into liquid form on site. Purple painted liquid storage tanks (approximately 100,000 L each) are part of the cyanide process area (**Photograph 3**). All above-mentioned chemical treatment and storage areas are bunded and paved with no evidence of significant spills or leaks.

Photograph 2. Chemical treatment area (leaching tanks and processing).

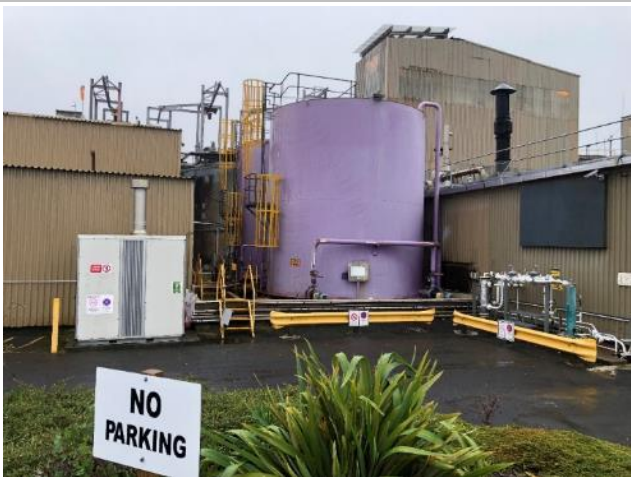
Photograph 3. Liquid cyanide tanks (purple).

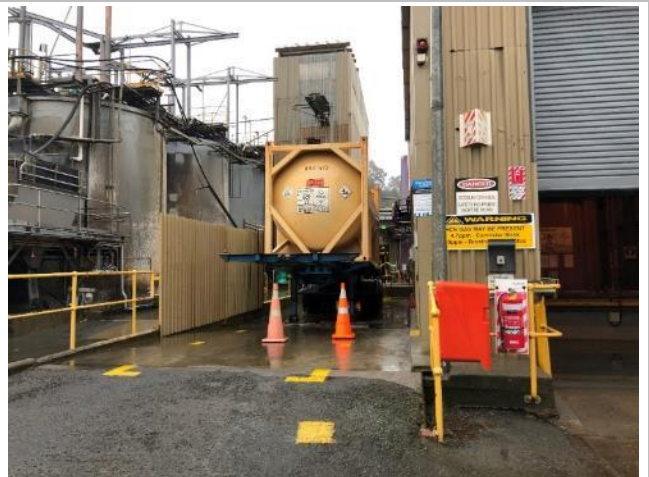
Photograph 4. Powdered cyanide adjacent to the cyanide plant.

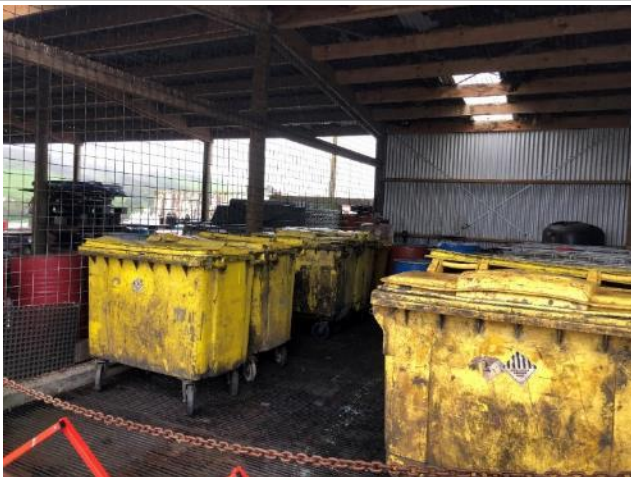
Photograph 5. Waste oil collection area (yellow bins have oil-soaked rags and debris).

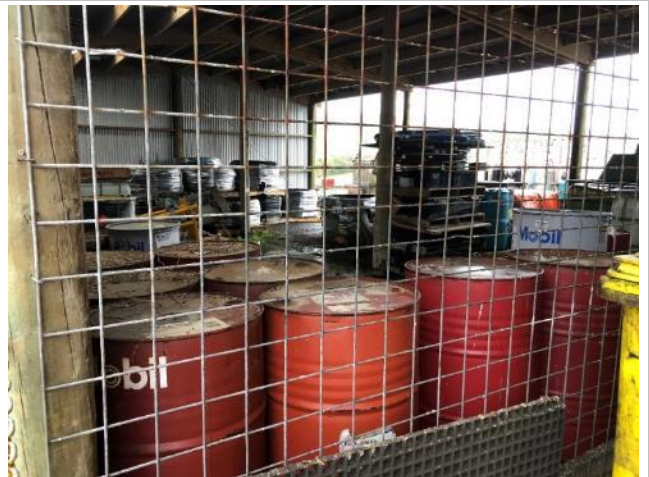
Photograph 6. Oil storage drums in the waste oil collection area.

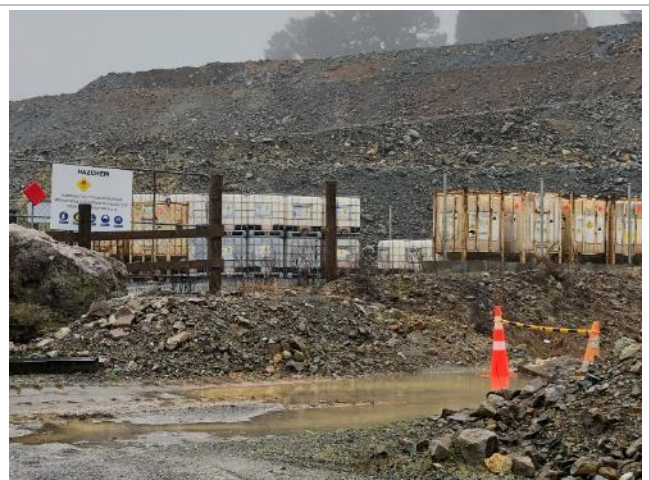
Photograph 18. Explosive storage northwest of the WTP. Polishing Pond Stockpile is in the background.

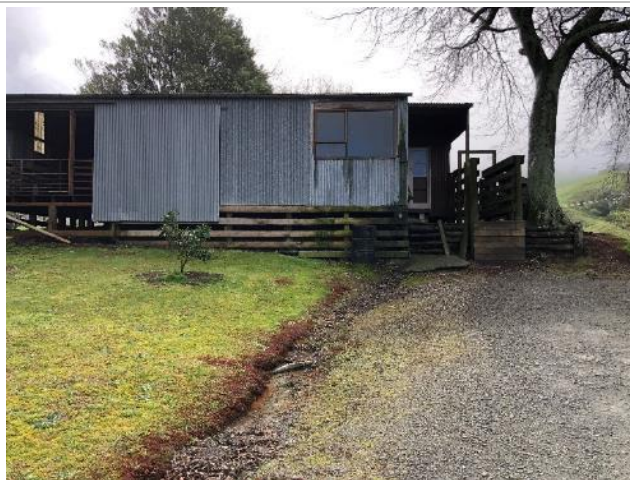
- The woolshed is timber framed and corrugated iron clad (**Photograph 44**) with timber sheep/ cattle pens and loading races located to the rear (**Photograph 45**). No livestock dips were noted within the sheep pen complex.
- The implement and dairy shed have concrete floors, the implement shed being a half round corrugated iron and steel framed structure (**Photograph 46**), the cowshed being concrete block, iron and timber. The facing boards are fibre cement, potentially containing asbestos (**Photograph 43**).
- An effluent system is located next to the dairy shed. It consists of an in-ground sump that collects dairy effluent for irrigation onto paddocks.
- The hayshed is of steel and corrugated iron construction with an earth floor.
- No ofal pit was noted but the presence of one cannot be ruled out.

Photograph 44. Woolshed.

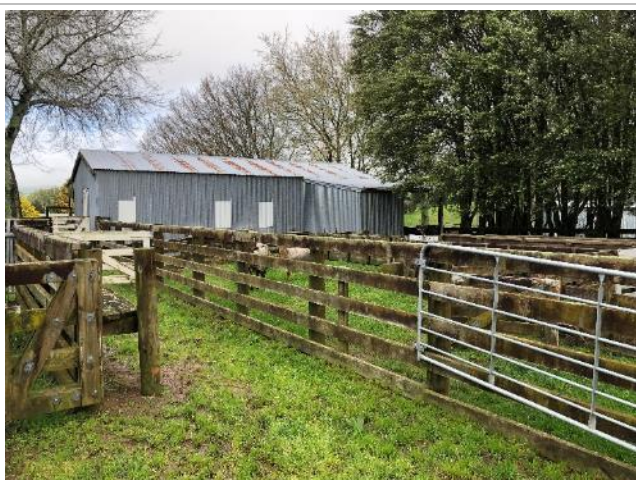
Photograph 45. Sheep and cattle pens at the rear of woolshed.

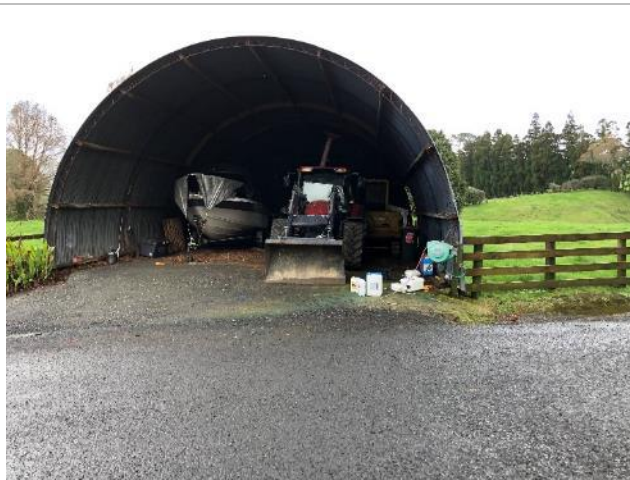
Photograph 46. Implement shed with spray and waste oil storage.

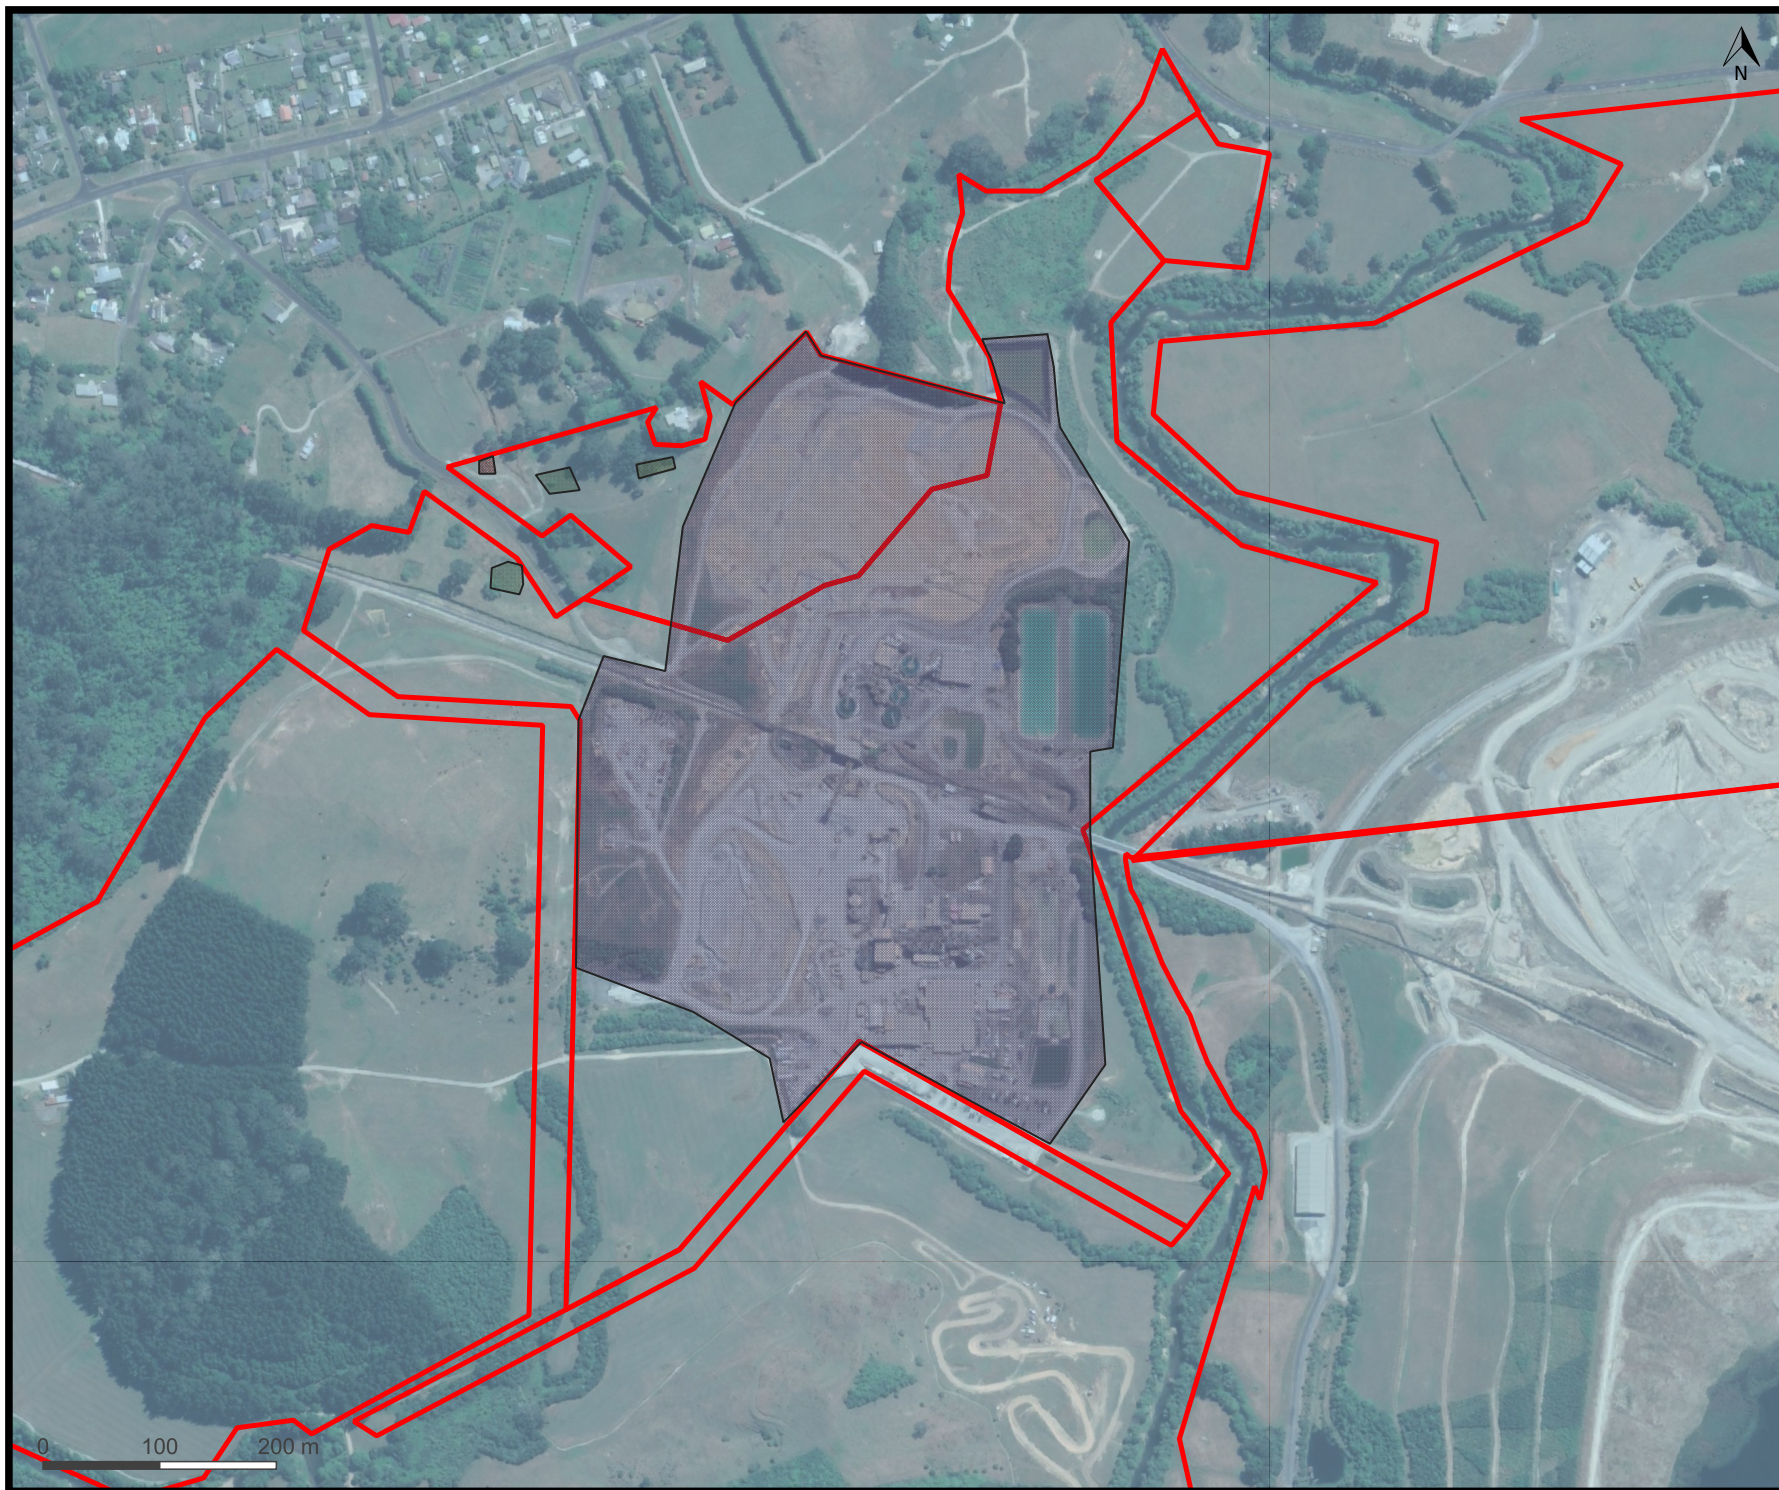
Map Title:
**HAIL Activities:
 Processing Plant and WTP**
 Project:
Waihi North Project
 Client:
OceanaGold

Land use	Potential contaminants	Possible extent of contamination	HAIL Assessment	Areas potentially impacted
Asbestos use in buildings (historic) <i>HAIL Activity E1: Asbestos in a degraded condition</i>	Asbestos	No asbestos was observed on current buildings and given their age of construction (1990s onwards) asbestos use is unlikely. Historic buildings that may have contained asbestos have been long demolished and the ground beneath heavily modified such that there is no potential for contamination to remain.	HAIL Activity E1 <u>does not apply</u> to the site.	-
Mining <i>HAIL Activity E7: Mining industries</i>	Wide ranging, refer to all other activities.	Activity E7 is a 'catch all' for a range of mining activities, many of which are categorised elsewhere in this table with more specificity. Potential for contamination is limited to areas of workshops, dangerous goods storage, and water treatment, with other parts of site largely just used for ancillary activities, offices, etc.	HAIL Activity E7 <u>applies</u> to the site.	All processing plant areas.

Chemical and fuel spills <i>HAIL Activity I: Accidental release of a contaminant in sufficient quantity to present a risk to human health or the environment</i>	Wide ranging but largely hydrocarbons and metals.	While there have been a number of spills over the history of the Processing Plant's operation, there are very few that have the potential to have resulted in contamination at levels that are likely to be high enough to present a risk to human health or the environment. While some surface contamination may have resulted from spills, it is sediment within the various ponds and the WTP that are most likely to have been impacted as these will be accumulation points for contaminants.	HAIL Activity I <u>likely applies</u> to the site.	WTP, cyanide mixing area.

Localised pre-works investigations are recommended to enable any actual contamination in the identified HAIL areas (refer **Figures 12 – 17**) to be understood, and conversely eliminate uncontaminated areas.

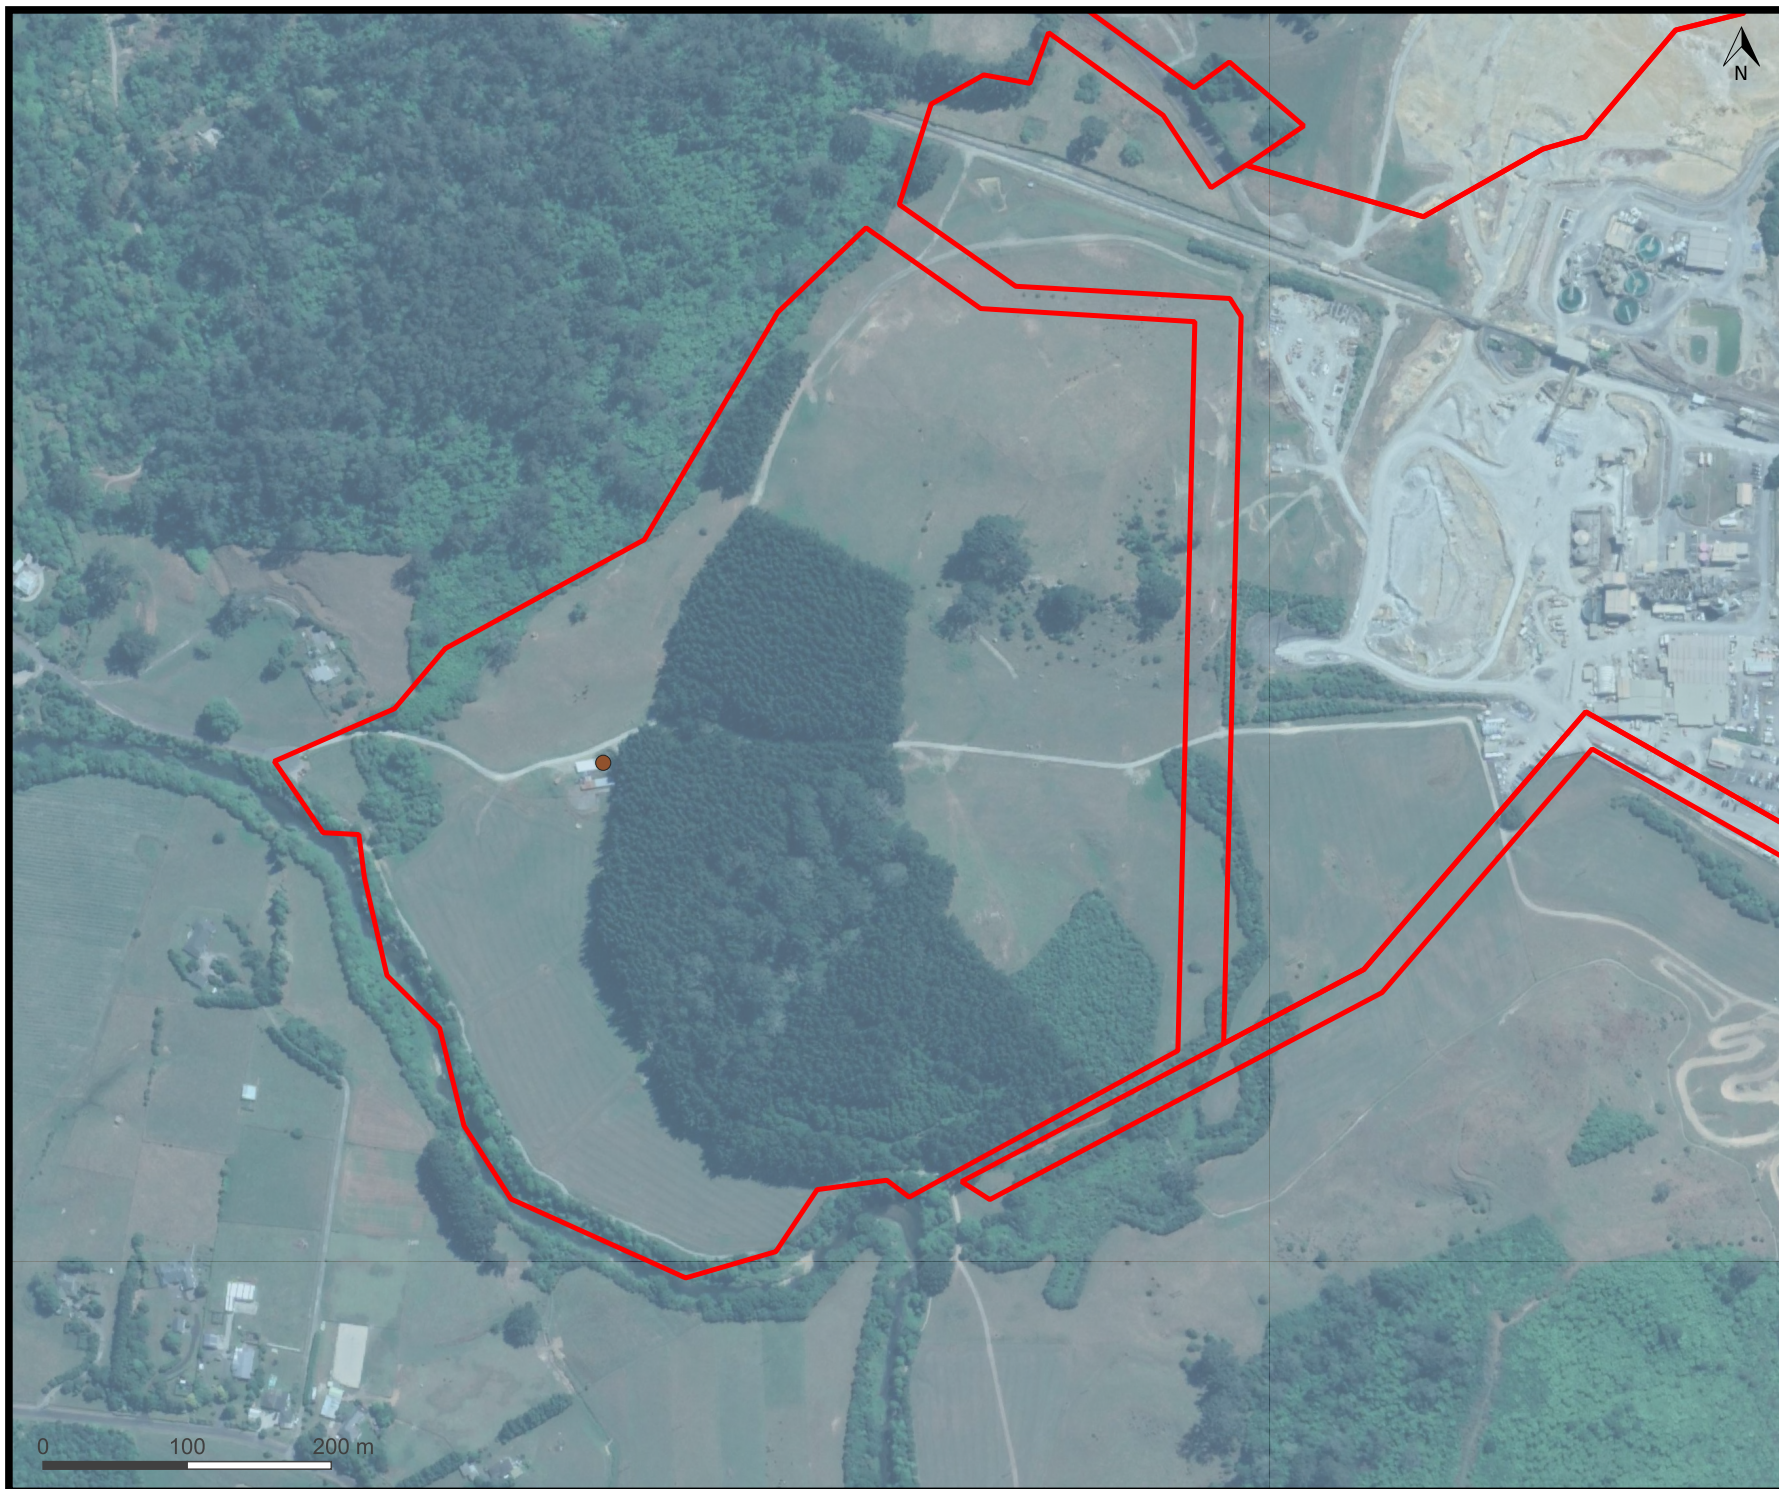
Map Title:
**HAIL Activities: Gladstone
Open Pit**

Land use	Potential contaminants	Possible extent of contamination	HAIL Assessment	Areas potentially impacted
Drench use in yards <i>HAIL Activity A8: Livestock dip or spray race operations</i>	Arsenic, organochlorines	No livestock dips were noted but it is likely that pour-on drenches have been used in the cattle yards. Most modern formulations have very low residence times in soil but given that the yards have been in existence since the 1960s, it is possible that persistent chemicals have been used historically. Any contamination is likely confined to surface soils in the immediate vicinity of the yards.	HAIL Activity A8 <u>applies</u> to wider site.	Yards adjacent to cow and hay shed.
Asbestos use in buildings (historic) <i>HAIL Activity E1: Asbestos in a degraded condition</i>	Asbestos	No asbestos was observed on current buildings. Historic buildings that may have contained asbestos were demolished approximately 40 years ago so potential for contamination to remain is negligible.	HAIL Activity E1 <u>does not apply</u> to the site.	-

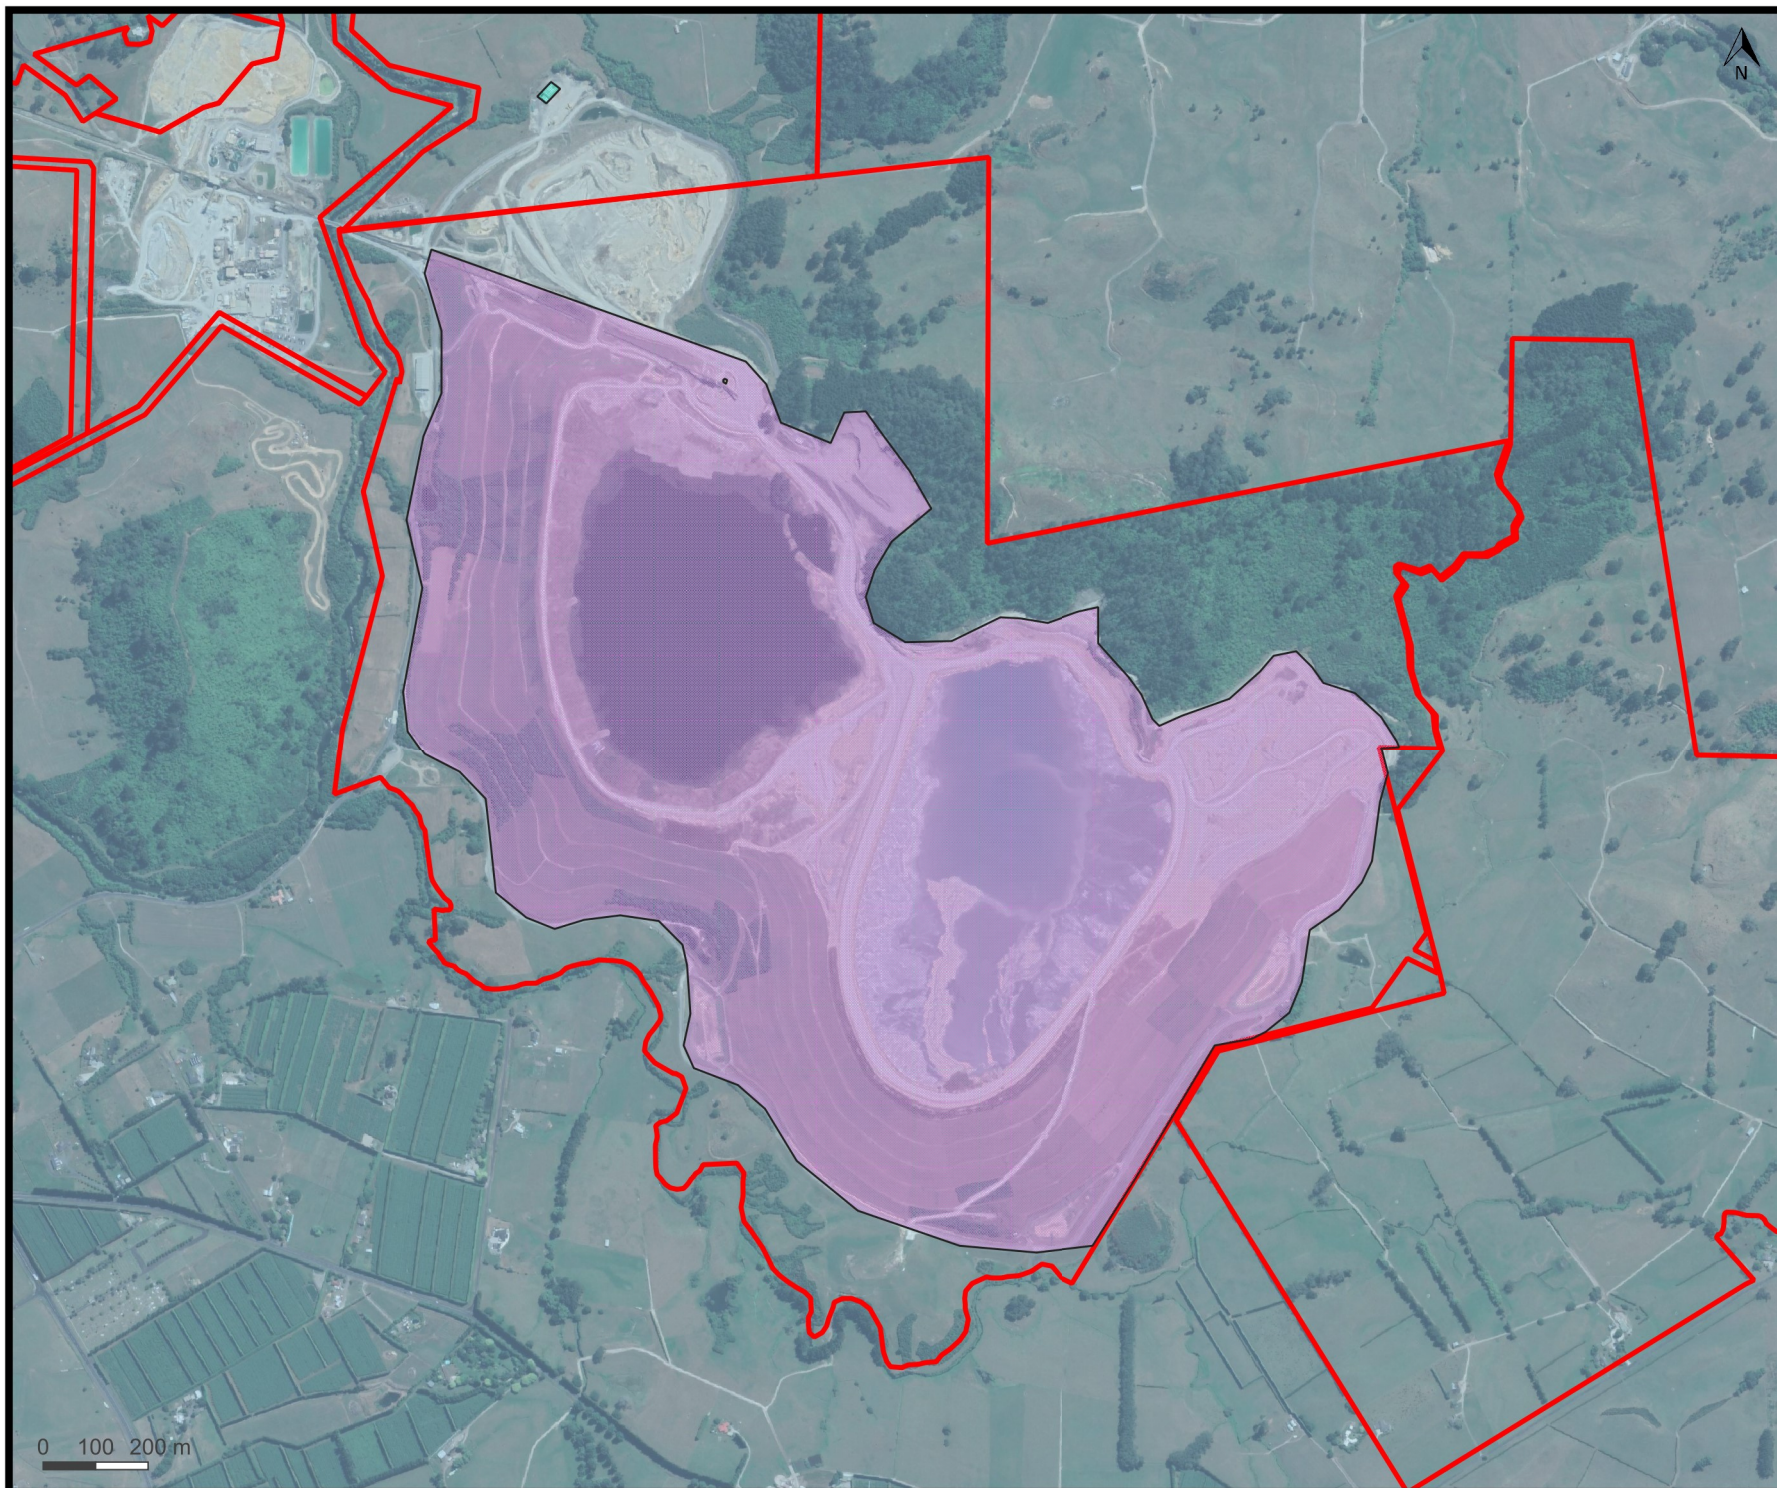
Map Title:
**HAIL Activities: Existing
Tailings Storage Facilities**

Land use	Potential contaminants	Possible extent of contamination	HAIL Assessment	Areas potentially impacted
Transformer <i>HAIL Activity B2: Electrical transformer</i>	Metals, hydrocarbons, PCBs (unlikely given age)	Potential for contamination from the transformer is limited given its modern nature (post-dating PCBs) and high level of maintenance. However, isolated contamination in the immediate footprint cannot be ruled out.	HAIL Activity B2 <u>applies</u> to site.	Transformers
Asbestos use in buildings (historic) <i>HAIL Activity E1: Asbestos in a degraded condition</i>	Asbestos	No asbestos was observed on current buildings. Historic buildings that may have contained asbestos were demolished approximately 40 years ago so potential for contamination to remain is negligible.	HAIL Activity E1 <u>does not apply</u> to the site.	-
Mining <i>HAIL Activity E7: Mining industries</i>	Wide ranging but including cyanide, acids, metals, hydrocarbons and a range of other contaminants used in processing	Tailings comprise all of the wastes associated with the ore processing activities. These are confined to the existing TSF1A and TSF2 footprints. The TSFs are constructed according to a landfilling standard with clean water diversion, basal lining and underdrainage collection and treatment. While they are themselves contaminated the affected materials are contained and managed. These are not expected to be disturbed.	HAIL Activity E7 <u>applies</u> to the site.	All tailings storage areas.

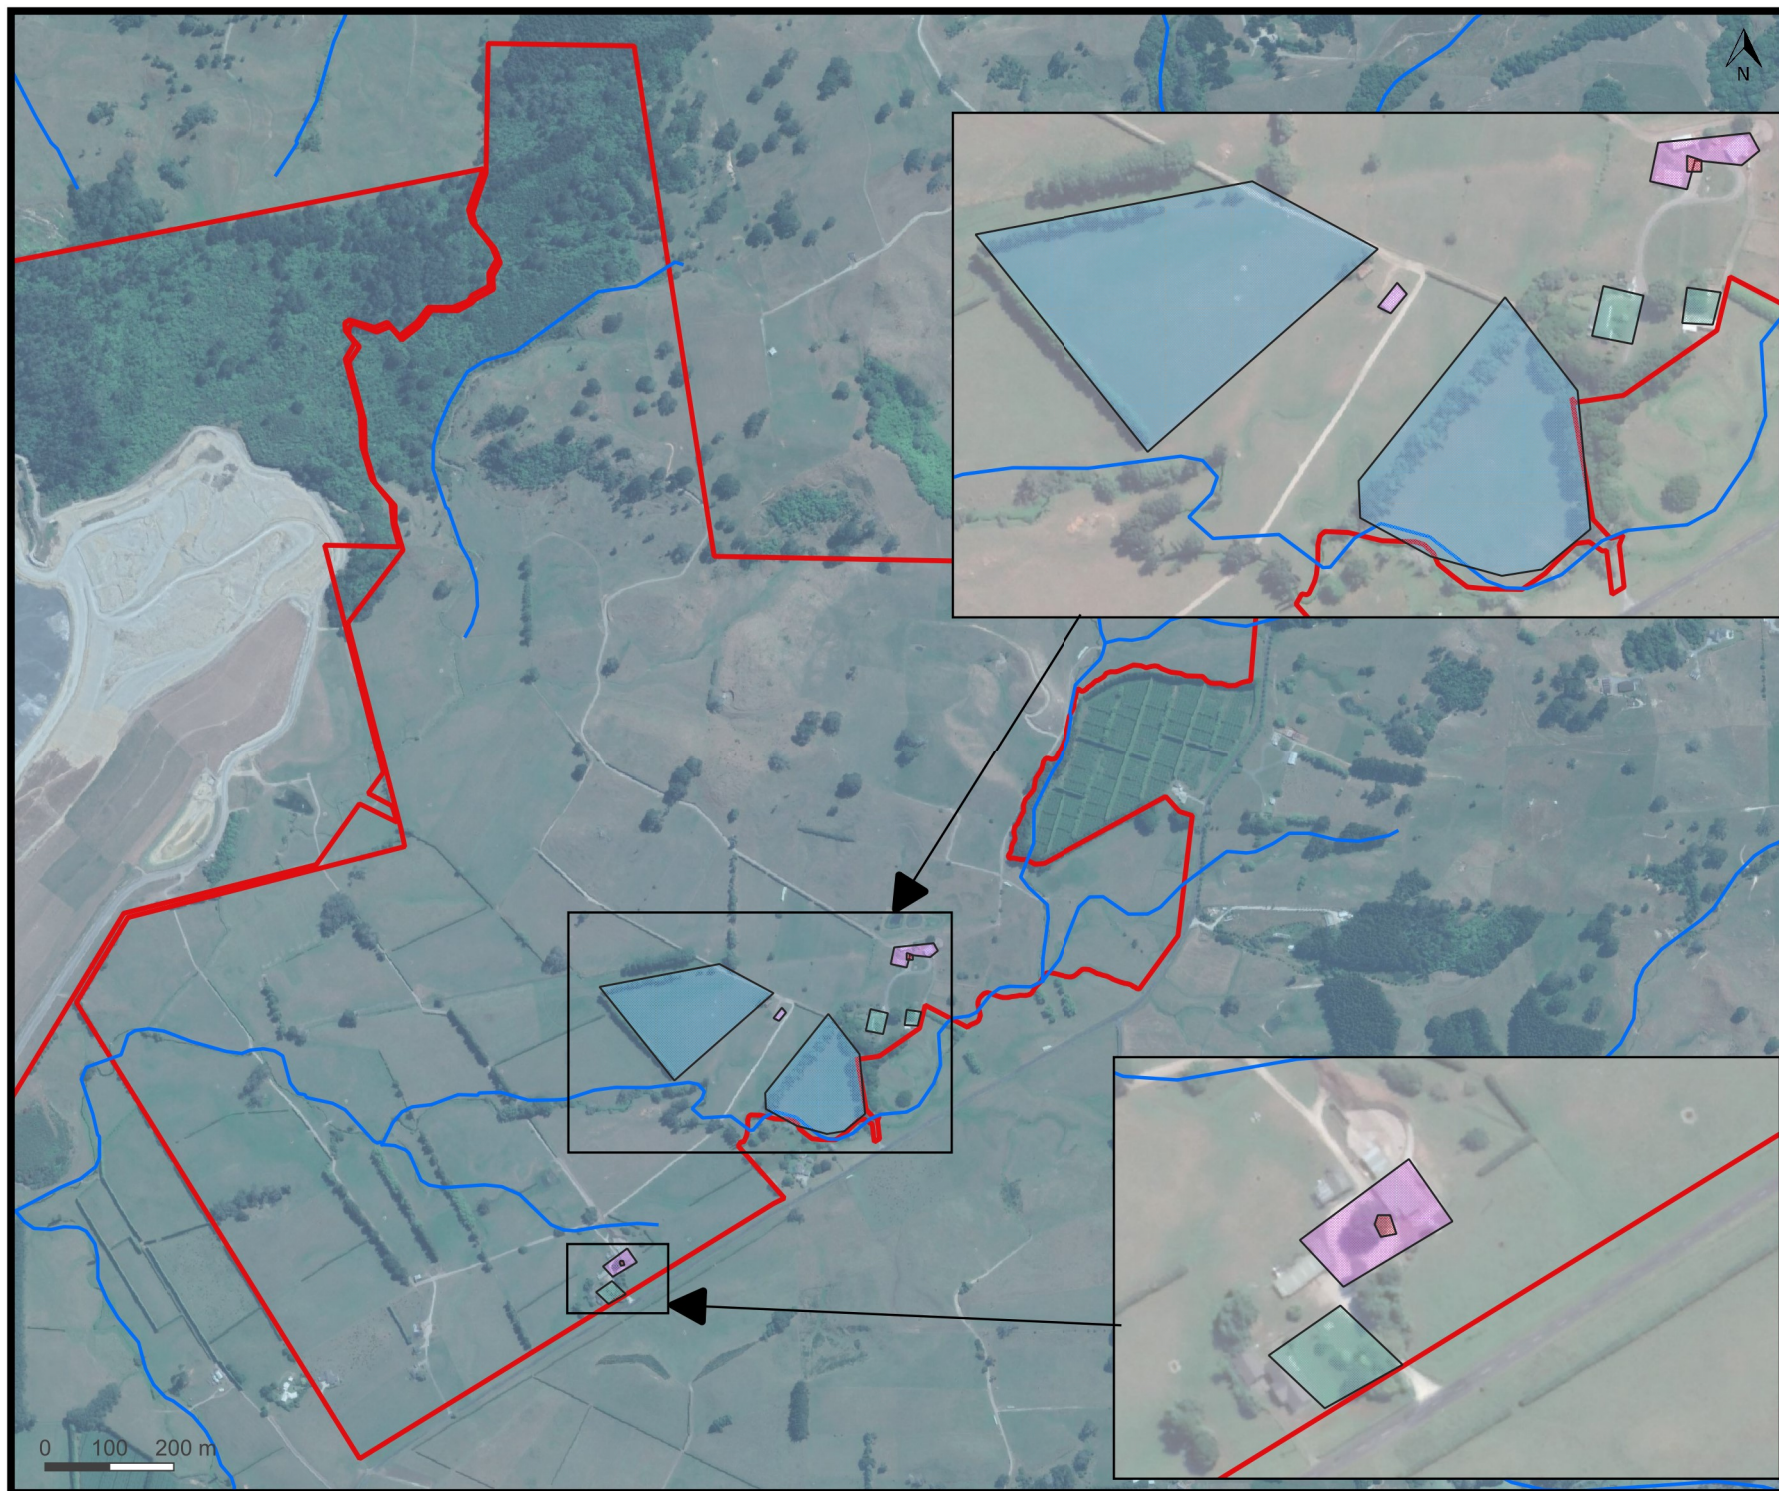
Map Title:
HAIL Activities: TFS3

Land use	Potential contaminants	Possible extent of contamination	HAIL Assessment	Areas potentially impacted
Drench use in yards and storage in sheds <i>HAIL Activity A8: Livestock dip or sprayrace operations</i>	Arsenic, organochlorines	It is likely that pour-on drenches have been used in cattle yards. No livestock dips were noted. Given the more modern use, contamination is unlikely and if present, confined to surface soils in the immediate vicinity of the yards.	HAIL Activity A8 <u>applies</u> to site.	Yards adjacent to cow sheds, implement shed where drench is stored.
Market gardening <i>HAIL Activity A10: Persistent pesticide use</i>	Copper, organochlorine pesticides.	Market gardening activities were relatively short-lived and post-date use of arsenic and lead, although there may have been some limited use of organochlorines as these were often still in use after they were banned in the 1970s/ 1980s. Any contamination is likely to be limited to surface soils and localised.	HAIL Activity A10 <u>applies</u> to site.	Two areas of market gardening in the centre and centre-east of the site.

Diesel storage <i>HAIL Activity A17: Storage tanks or drums for fuel</i>	Hydrocarbons, lead	Two ASTs were observed, within each dairy shed complex. In our experience there is typically low to moderate levels of contamination beneath farm ASTs, but typically isolated to surface soils immediately beneath the ASTs.	HAIL Activity A17 <u>applies</u> to the site.	Immediately beneath ASTs.
Asbestos use in buildings <i>HAIL Activity E1: Asbestos in a degraded condition</i>	Asbestos	There is potential for asbestos to be present on the two dwellings and possibly ancillary buildings (garages and garden sheds). If contamination is present, it is likely confined to surface soils immediately surrounding the dwellings.	HAIL Activity E1 <u>applies</u> to the site.	Immediately surrounding buildings.

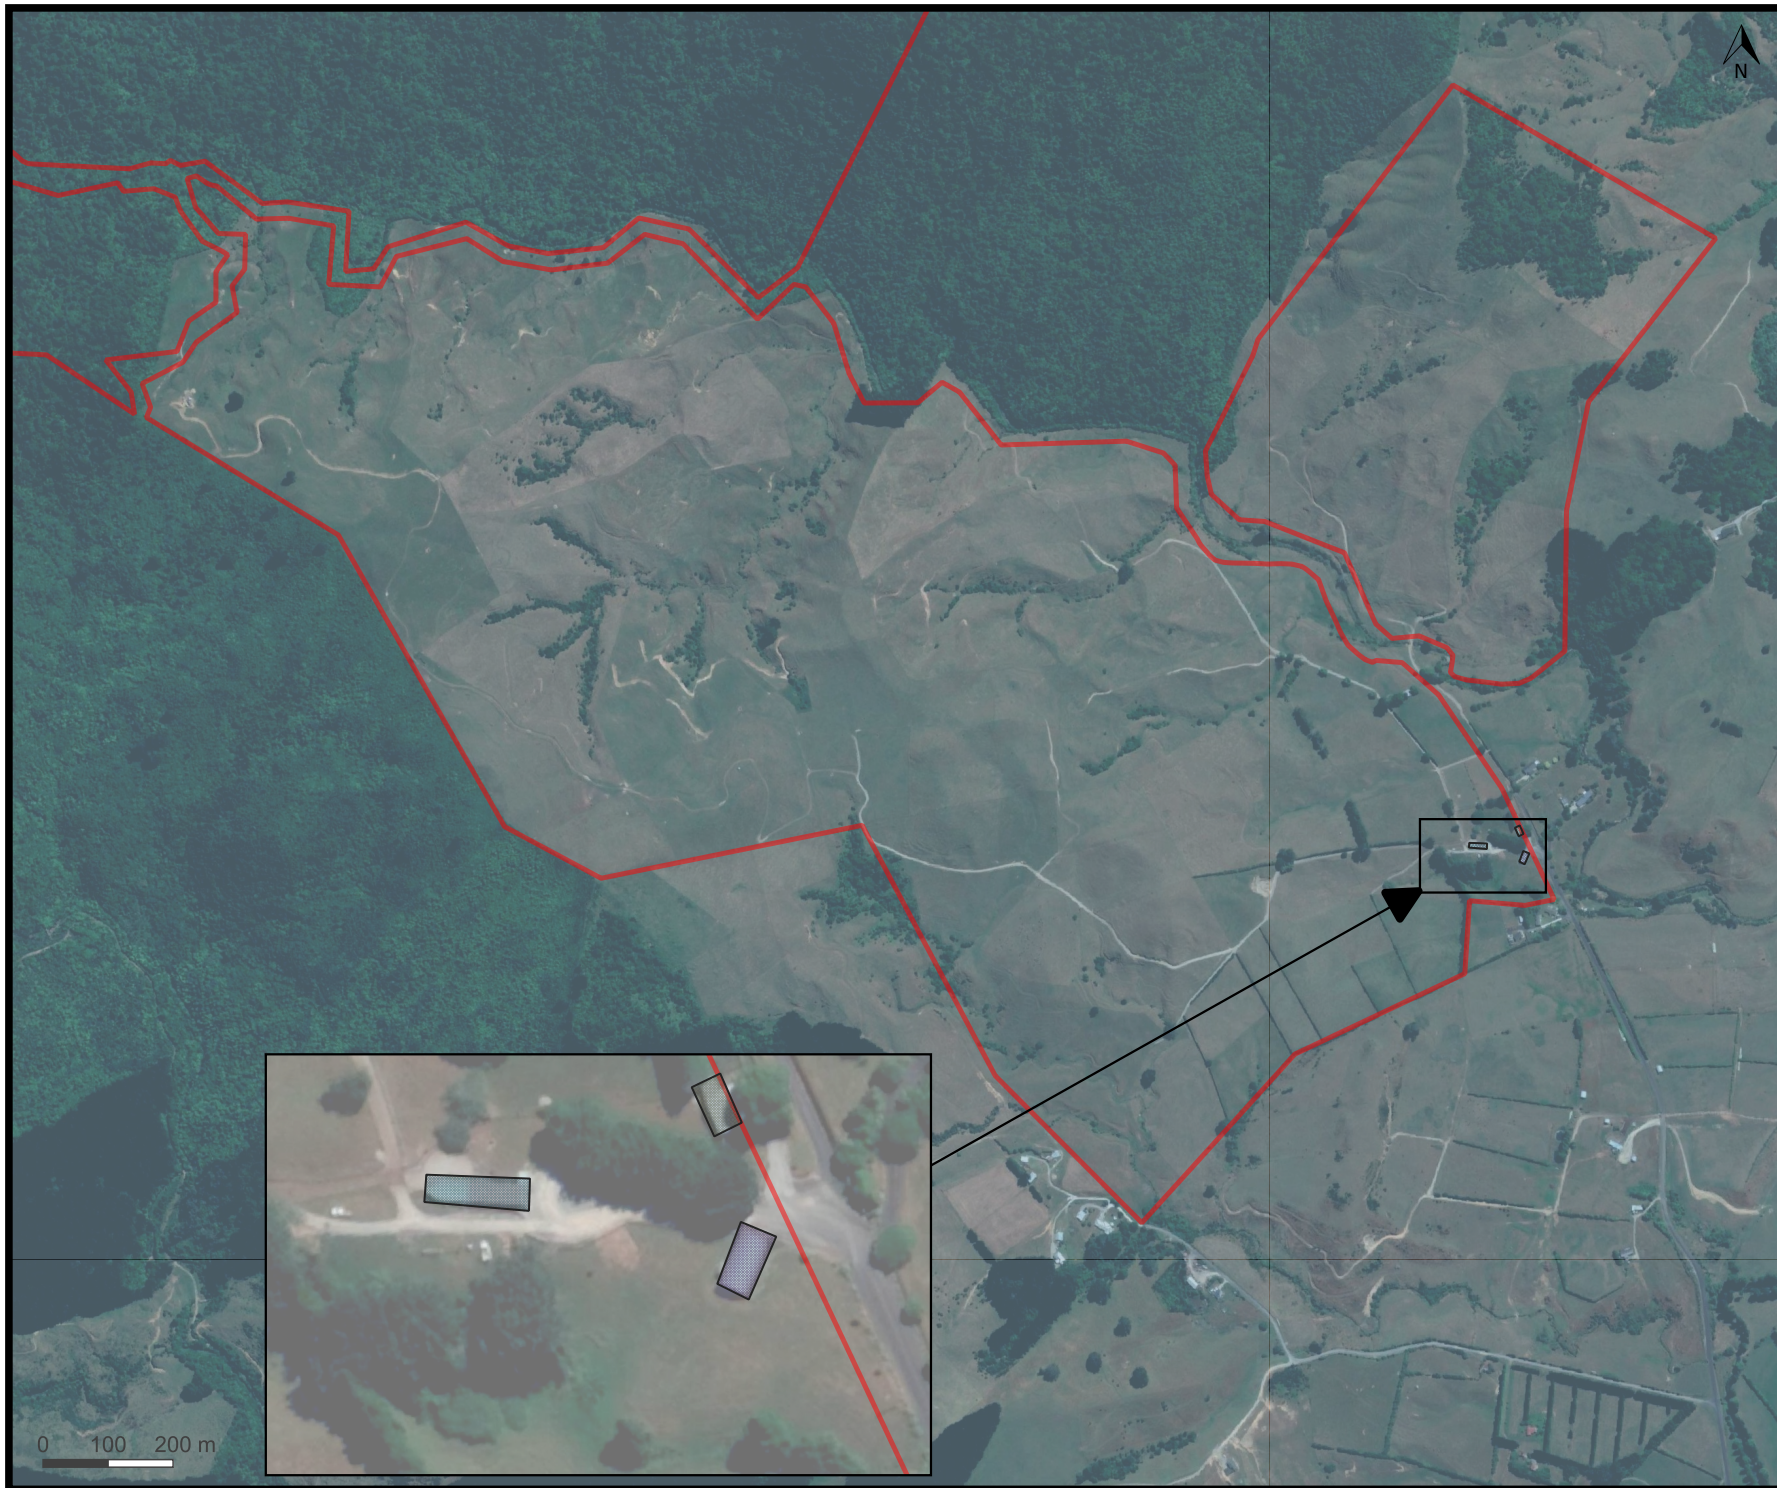
Map Title:
HAIL Activities: Willows Road Property

Land use	Potential contaminants	Possible extent of contamination	HAIL Assessment	Areas potentially impacted
Drench use in yards and storage in sheds <i>HAIL Activity A8: Livestock dip or sprayrace operations</i>	Arsenic, organochlorines	Livestock dips are not evident but use of sprays on animals is likely. Any contamination is likely confined to surface soils in the immediate vicinity of the yards.	HAIL Activity A8 <u>applies</u> to site.	Cattle yards/ sheds
Asbestos use in buildings <i>HAIL Activity E1: Asbestos in a degraded condition</i>	Asbestos	There is potential for ACM to be present in the fascia boards on the dairy shed. If contamination is confirmed, it is likely confined to surface soils immediately surrounding the buildings.	HAIL Activity E1 <u>applies</u> to the site.	Immediately surrounding the buildings.
Effluent application to land <i>HAIL Activity G5: Waste disposal to land</i>	Biological contaminants	Dairy effluent is collected in a pond and irrigated over approximately 10ha. While biological contaminants are likely present in the effluent, in our experience they are short lived and unlikely to present a risk to human health or the environment, so long as good irrigation practices are followed.	HAIL Activity G5 <u>applies</u> to the site.	Paddocks where irrigation occurs, the irrigation pond itself.
