Preliminary Site Investigation

120 Tongue Farm Road, Matakana

Sanderson Partners Ltd

17 October 2025

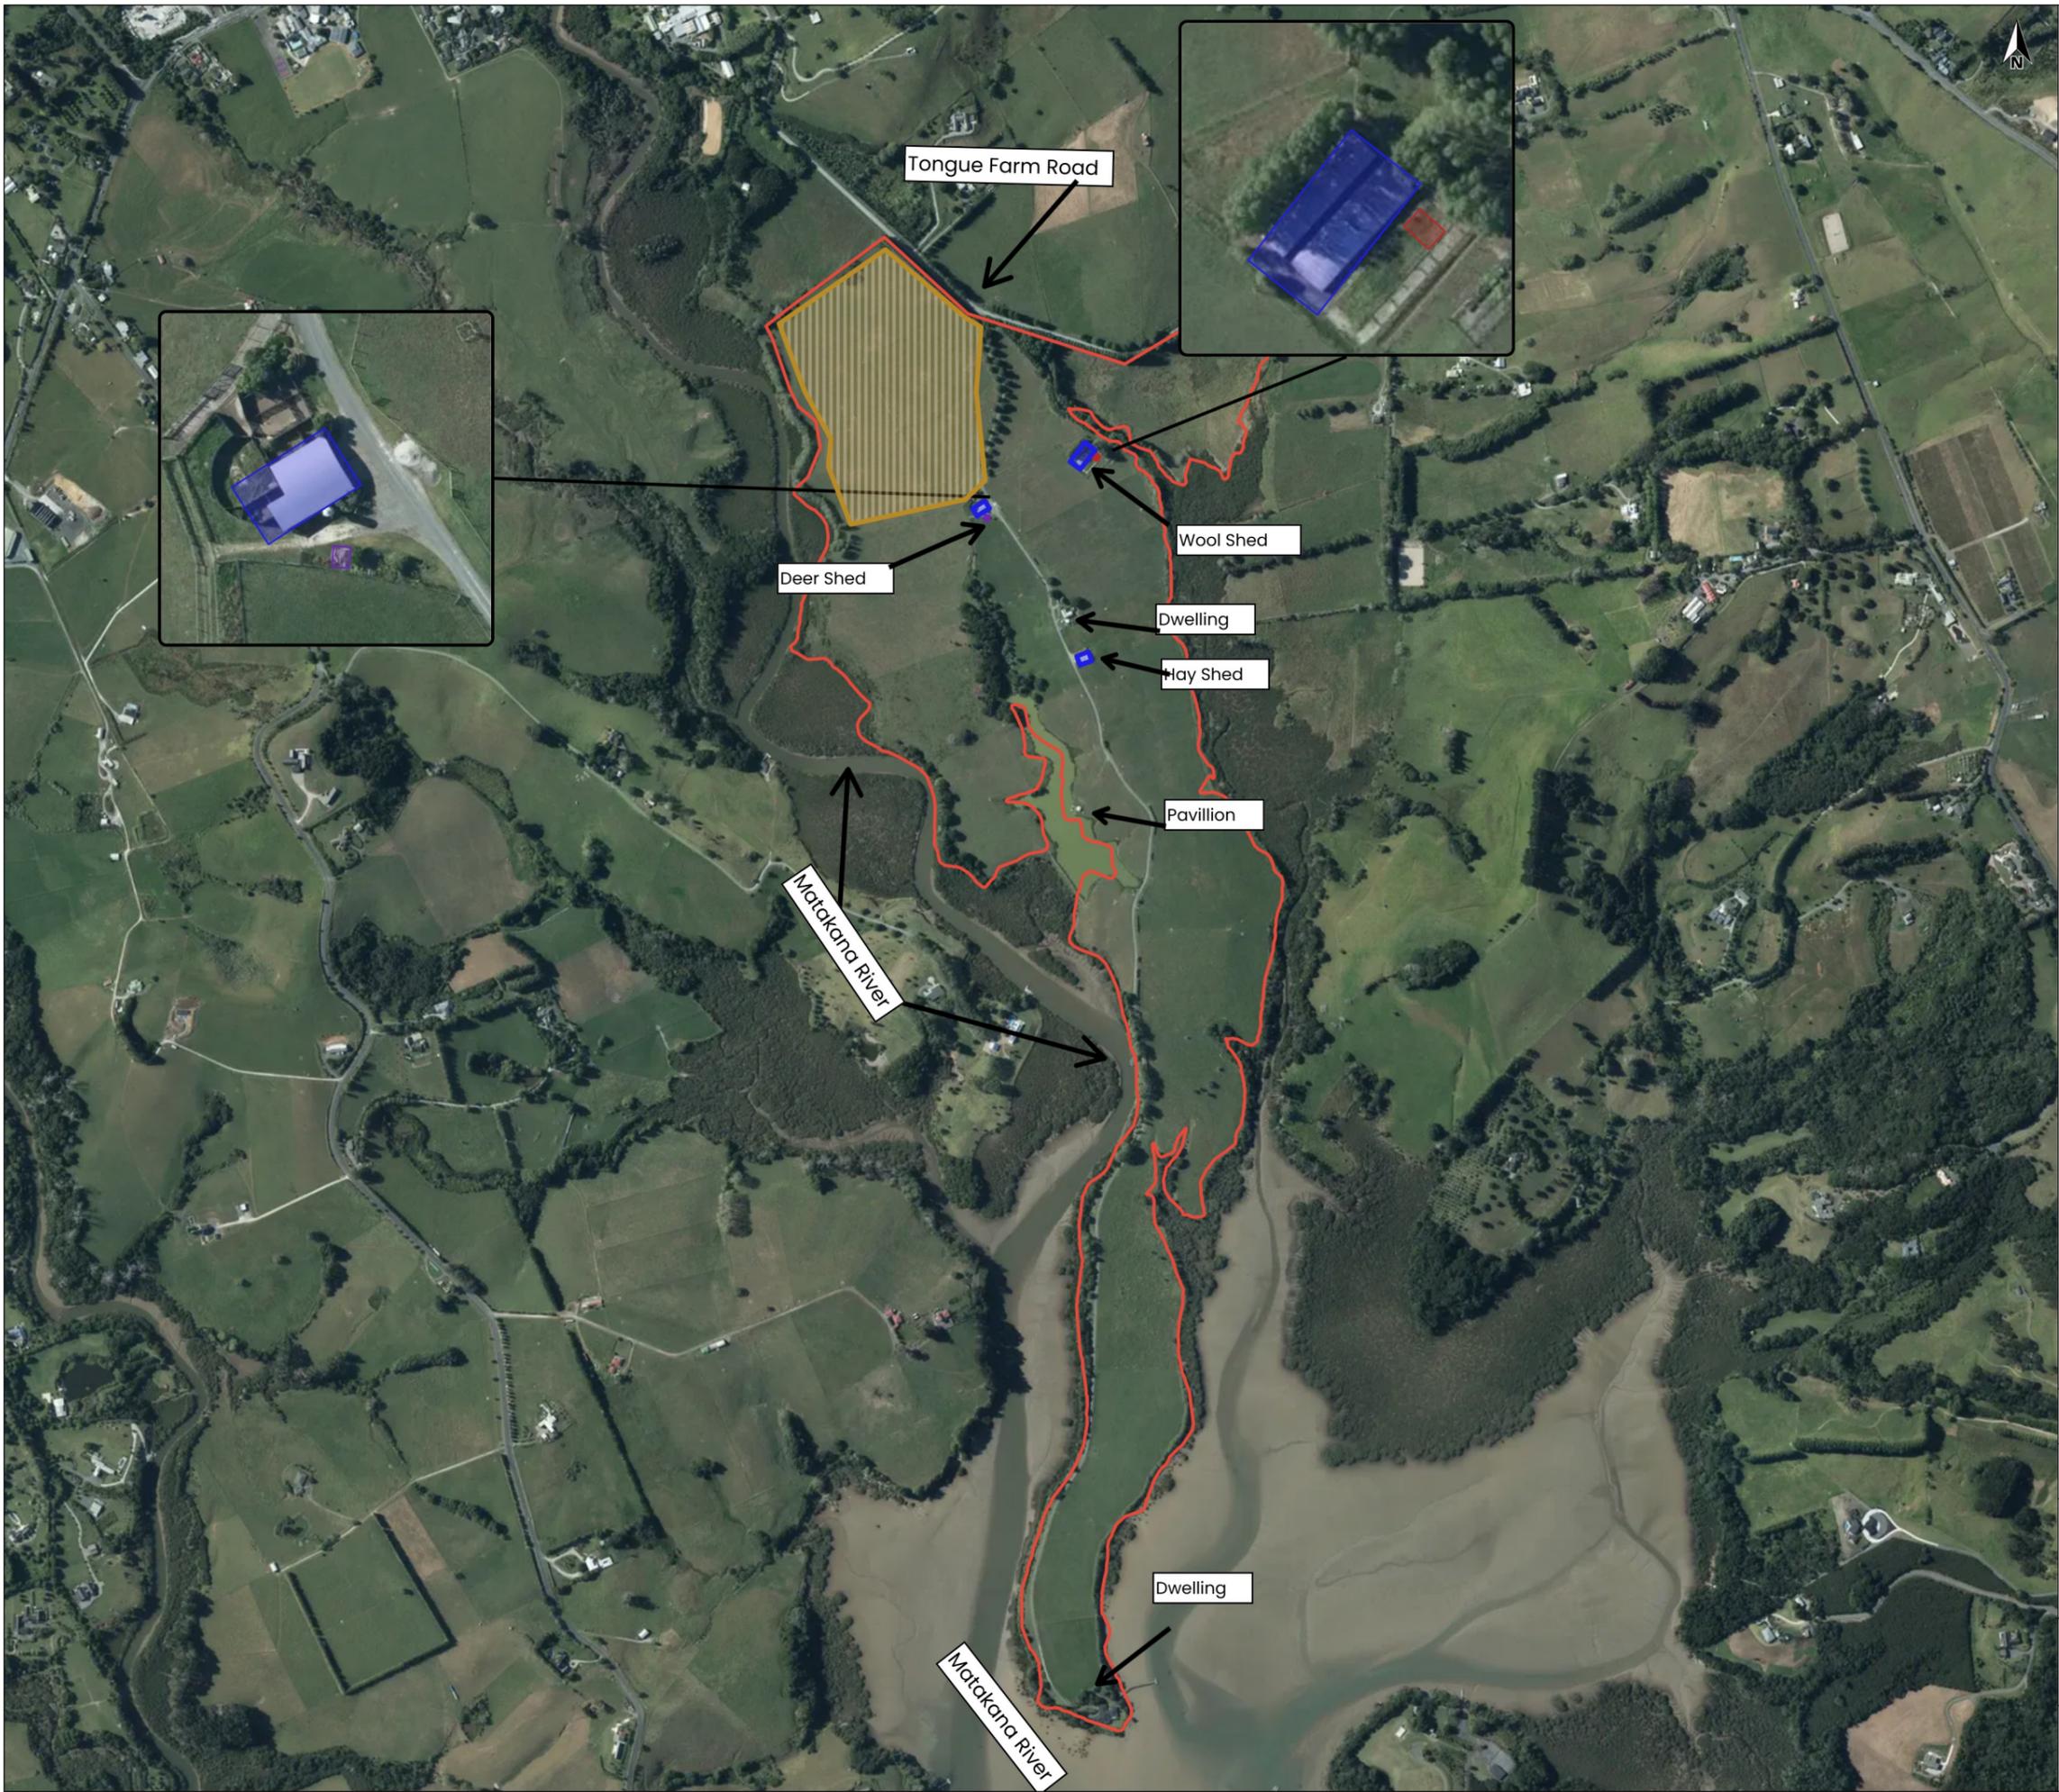
- *E1: Asbestos products manufacture or disposal including sites with buildings containing asbestos products known to be in deteriorated condition.* This category is specifically related to building product observed on the ground at location of former wool shed, during the site walkover. The condition of old structures which were demolished in the mid to late 1990s is unknown, and may have also been constructed with ACM.

- *I: Any other land that has been subject to the intentional or accidental release of a hazardous substance in sufficient quantity that it could be a risk to human health or the environment – associated with:*

- The fence post storage, and the potential for discharge of timber treatment chemicals to shallow soils.
 - Deteriorated buildings, specifically potential for discharge of lead from lead-based paint to soil.

- Potential spill of a fuel product on the ground, observed in the hay shed during the walkover.
 - Potential historical application of cadmium containing fertilisers including superphosphate.

- Based on the findings of this investigation, the NESCS will apply to the proposed future residential land development.
- A targeted DSI is required to be completed in support of the resource consent application for the proposed future land development to understand soil contaminant conditions and guide NESCS and AUP:OP contaminated land consent requirements.

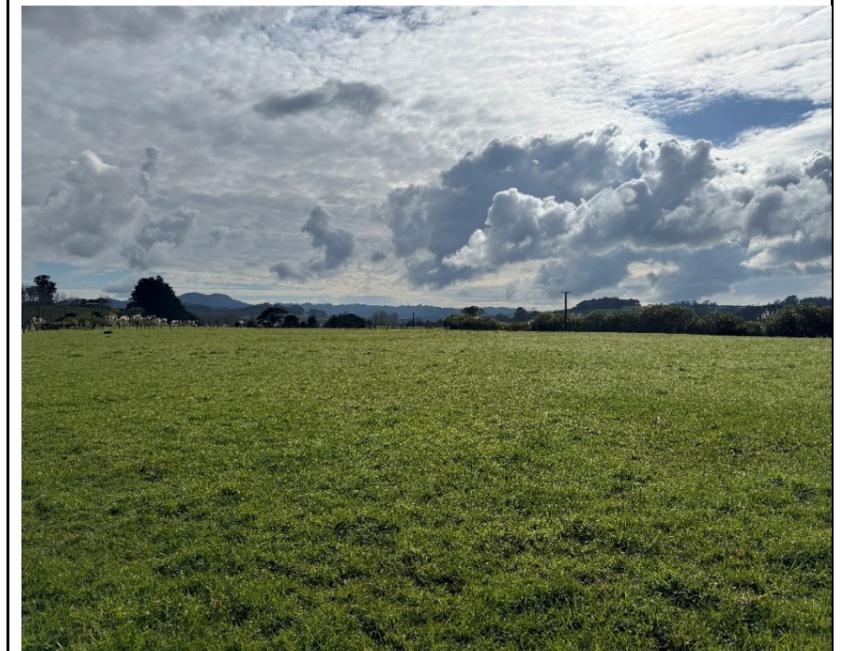
- The walkover confirmed the topography of the Site as generally flat to undulated land. The western boundary of the Site slopes steeply down to the Matakana River (*photos 3 and 6*).

Photo 3: General topography of the Site, facing east (14 August 2025).

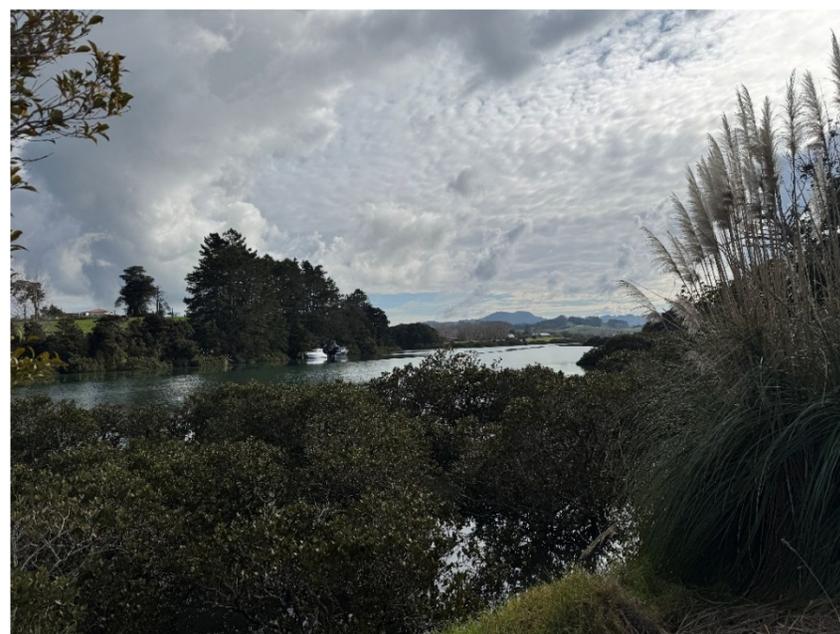
- Native shrubs/trees with mangroves beyond form the western and southern boundary of the Site (*photo 4*).
- The majority of the Site comprises farmland and grazing, and cattle and sheep were observed (*photo 7 and 8*).

Photo 4: Mangroves along western boundary with Matakana River beyond (14 August 2025).

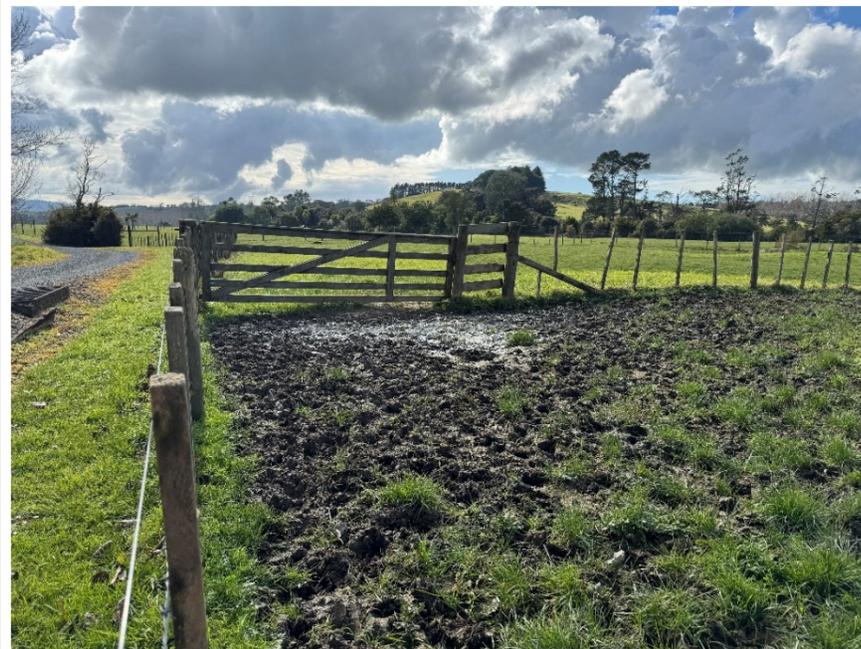
Photo 5: Bare soil around gates (14 August 2025).

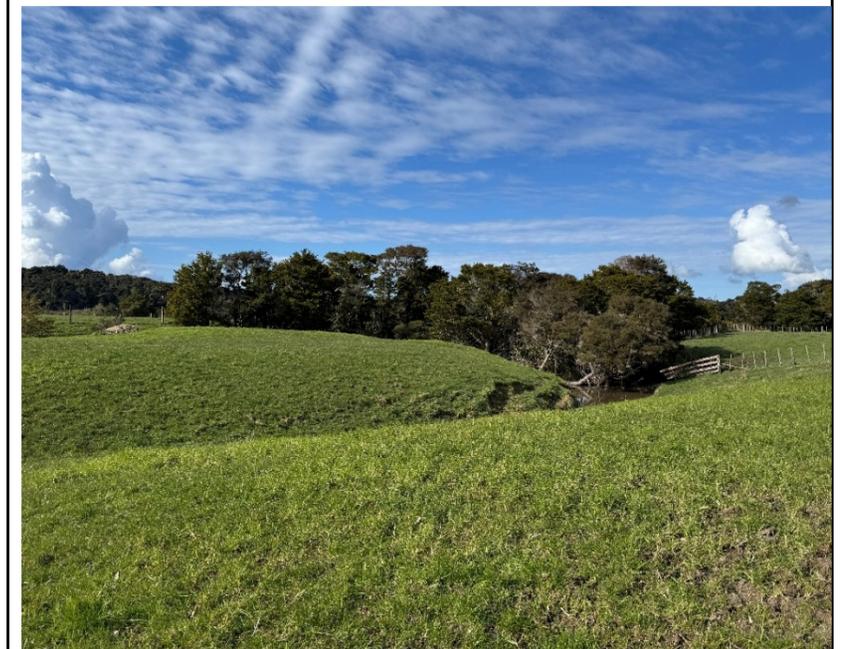
Photo 6: General topography of the Site, facing east (14 August 2025).

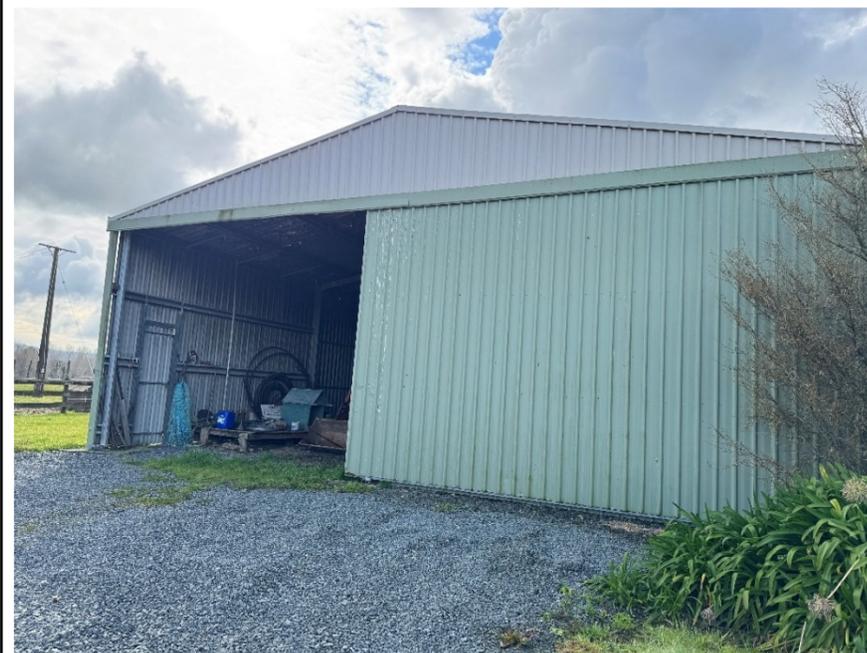
- A hay shed, located centrally along the driveway was observed to be constructed of corrugated metal and was in deteriorated condition. The shed is used for storage of farm equipment, timber, hay. Minor staining was observed on the ground (*photo 11 - 13*).

Photo 11: Hay shed located along the driveway, facing northeast (14 August 2025).

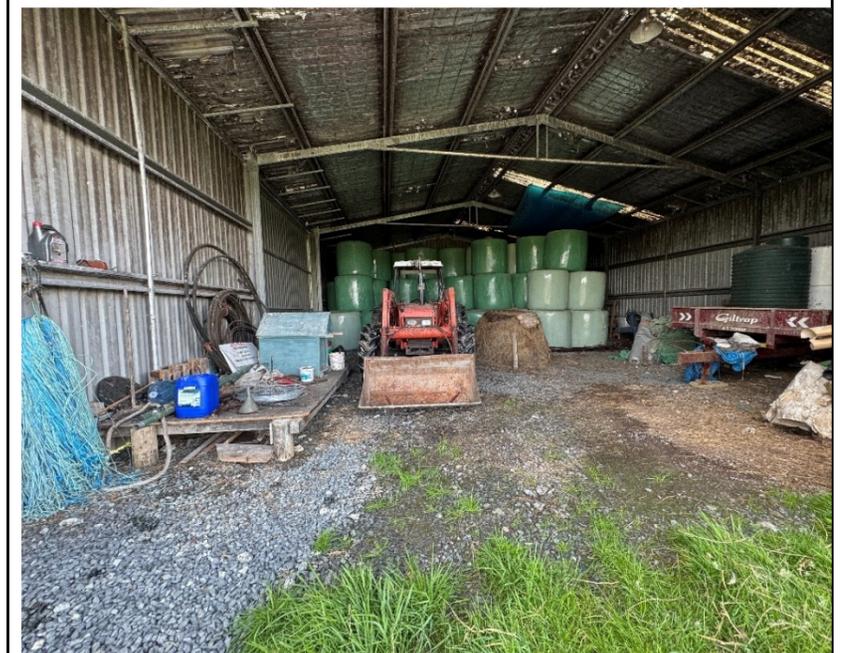
Photo 12: Equipment, tools and hay located inside of hay shed (14 August 2025).

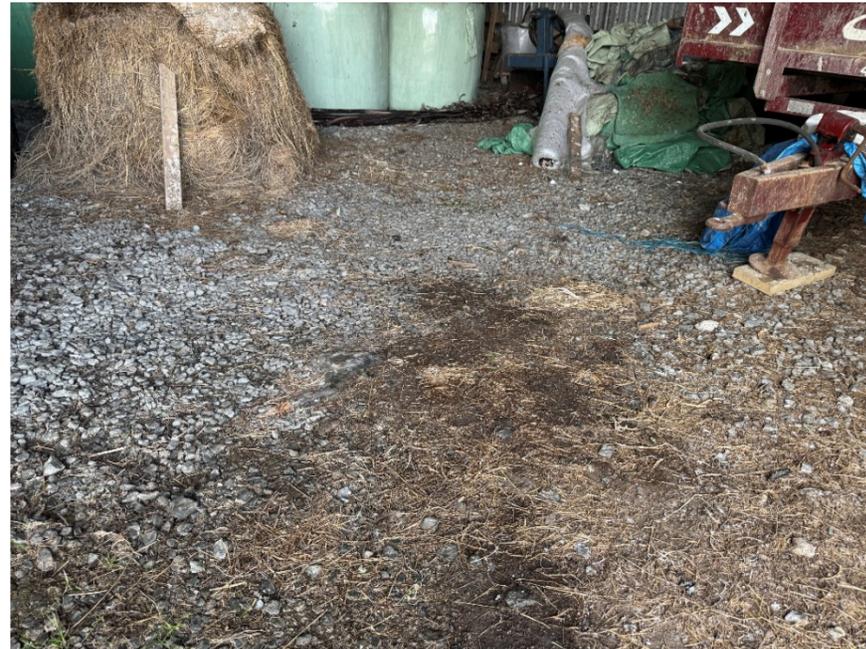
Photo 13: Staining on the ground inside Hay shed (14 August 2025).

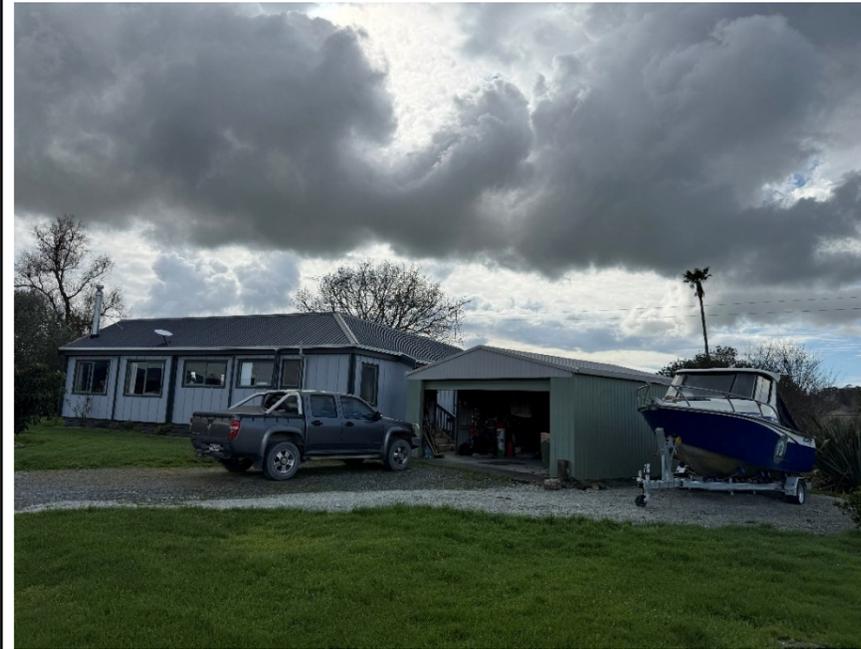
- The dwelling located centrally within the Site was observed to be in good condition. The dwelling is constructed of timber. Adjacent to dwelling is a garage, constructed from timber and use for storage of equipment, tools, engine oils etc. The garage was observed to be tidy with a concrete floor (*photo 14 and 15*).

Photo 14: Dwelling located centrally within the site, facing northeast (14 August 2025).

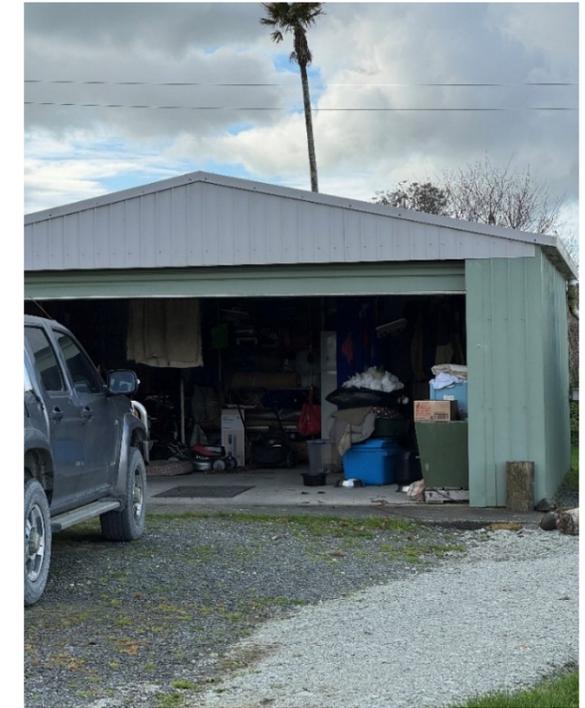
Photo 15: Garage adjacent to a dwelling, facing east (14 August 2025).

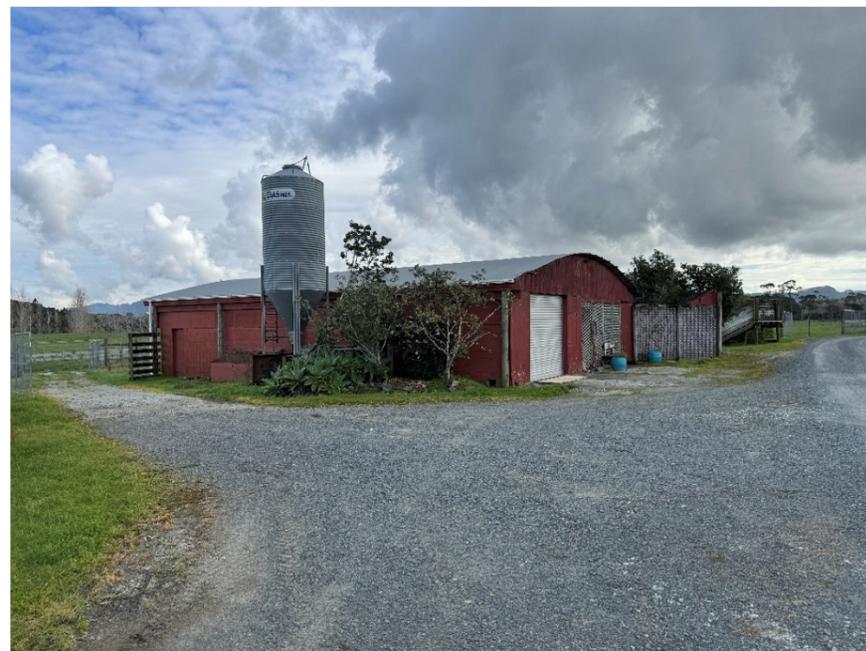
- The deer shed, located along the northern section of the driveway was observed to be in good condition. The shed was closed at the time of a walkover but was told to be used for storage of farm equipment (*photo 16*).

Photo 16: Deer shed located along the driveway, facing northwest (14 August 2025).

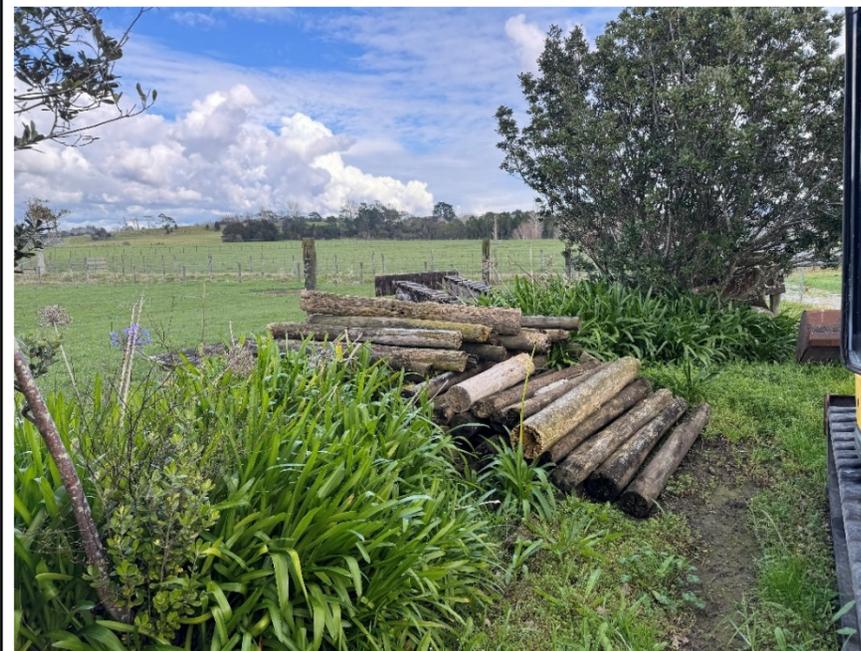
- Fence posts storage was observed adjacent to deer shed (*photo 17*).
- Two remaining wool sheds, located to northeast of the Site were observed to be vacant and in deteriorated condition. A vegetable garden was observed adjacent to sheds to the southeast, with numerous raised garden beds (*photos 18 - 20*).

Photo 17: Fence post storage adjacent to a deer shed, facing northwest (14 August 2025).

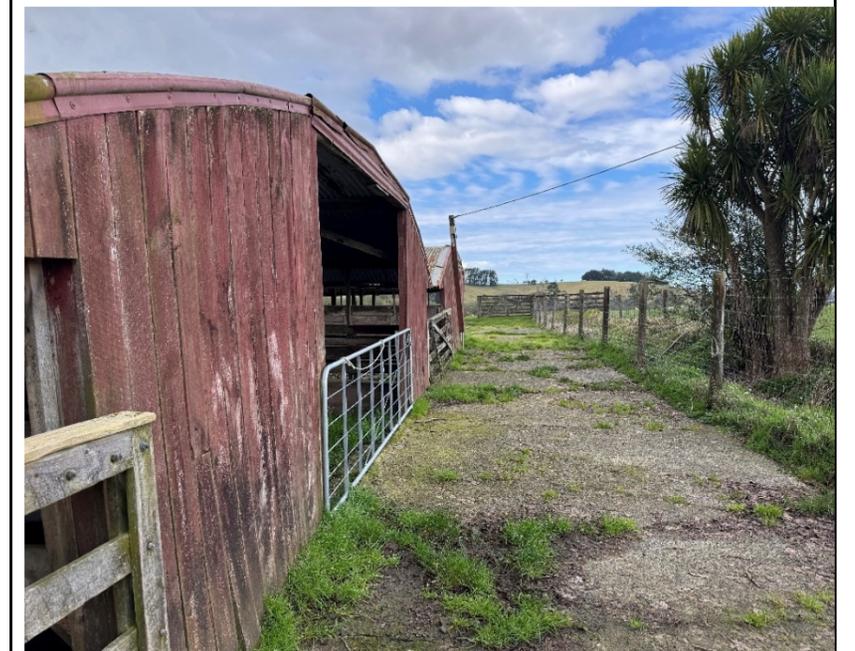
Photo 18: Wool sheds located to north-eastern portion of the Site, facing southeast (14 August 2025).

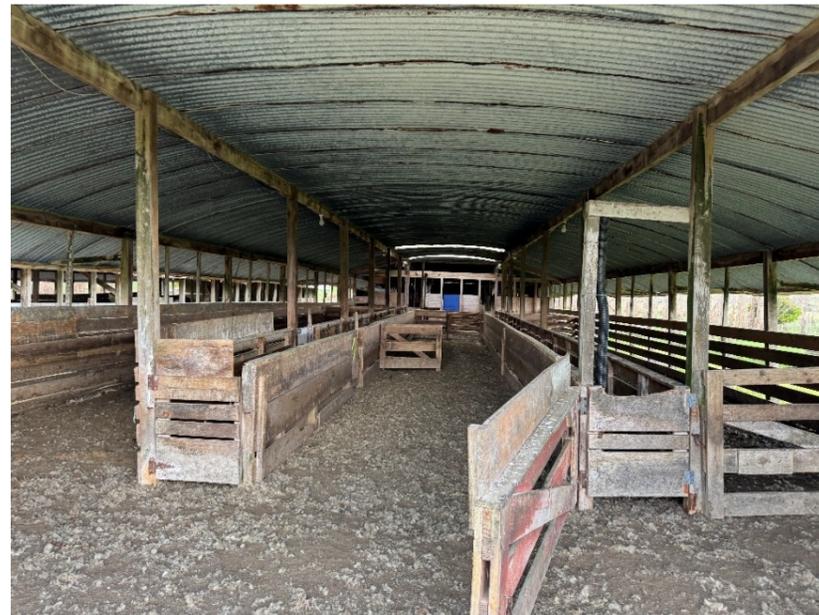
Photo 19: Inside wool sheds (14 August 2025).

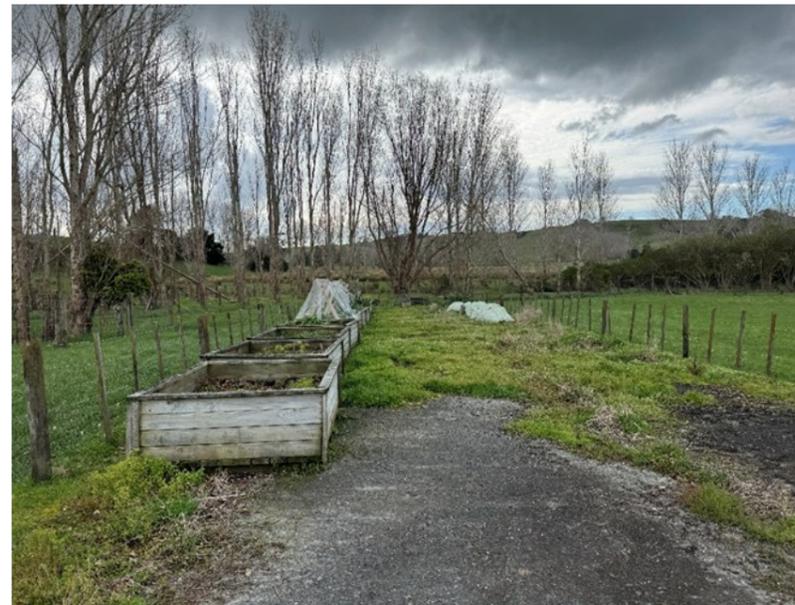
Photo 20: Vegetable garden adjacent to the wool shed, facing east (14 August 2025),

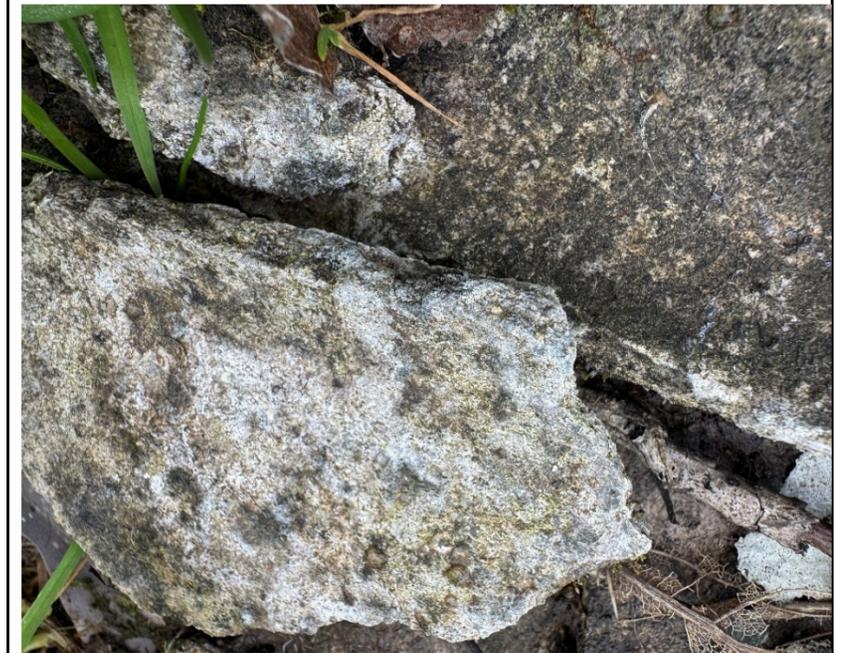
- Potential asbestos containing material (ACM) was observed on the ground at location of demolished shed in the form of corrugated fibre cement fragment (*photo 21 and 22*).

Photo 21: Potential ACM observed on the ground at location of the former wool shed (14 August 2025).

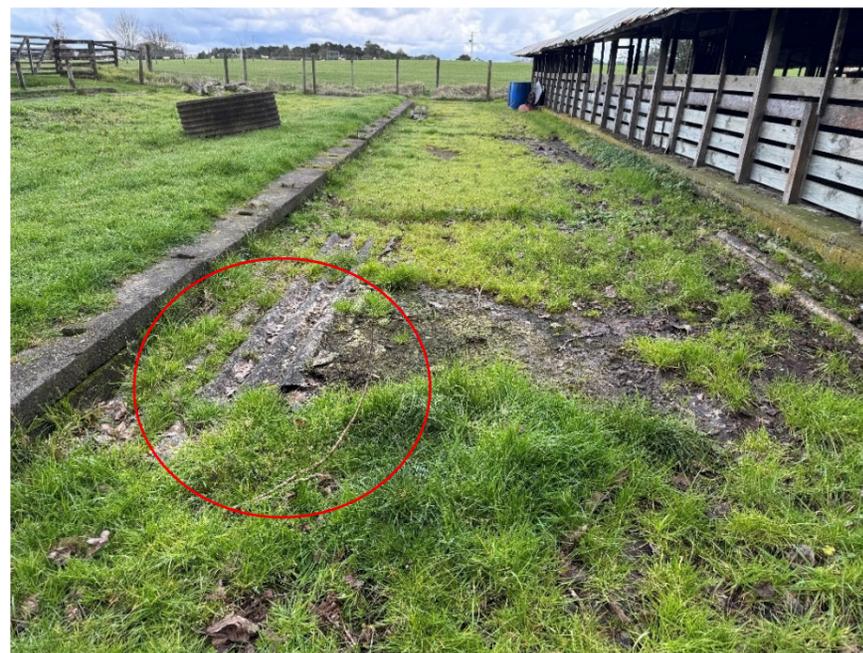
Photo 22: Potential ACM observed on the ground at location of the former wool shed (14 August 2025).

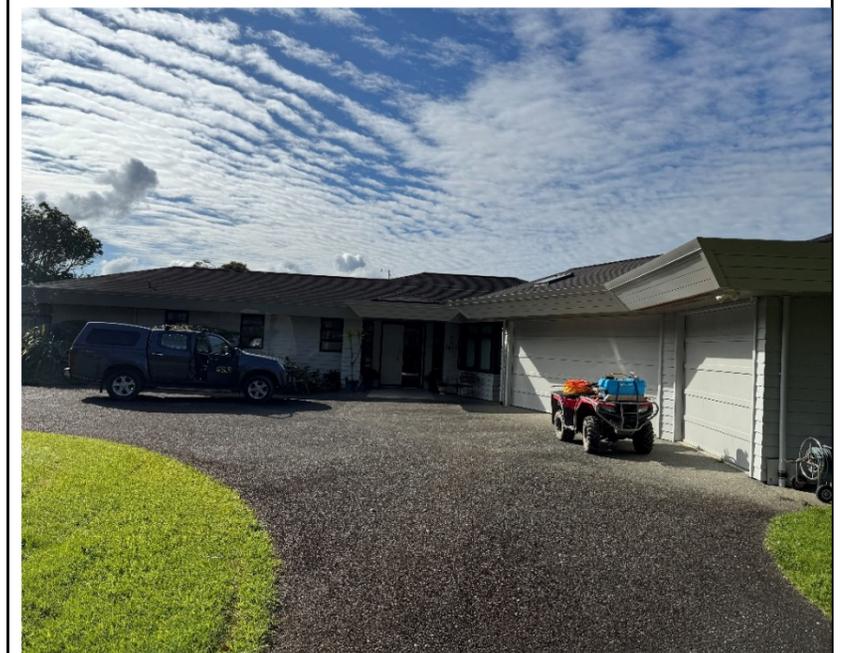
- The dwelling located at the southern tip of the Site was observed to be in good condition. Dwelling is constructed of timber (*photo 24*).

Photo 24: Dwelling located at the southern tip, facing north (14 August 2025).
