**Project Number 16998.000.002**

**Cannon Point Stage 3 Geotechnical  
Investigation for Resource Consent**

10 Cannon Point Road, Craigs Flat, Upper  
Hutt, Wellington 5018

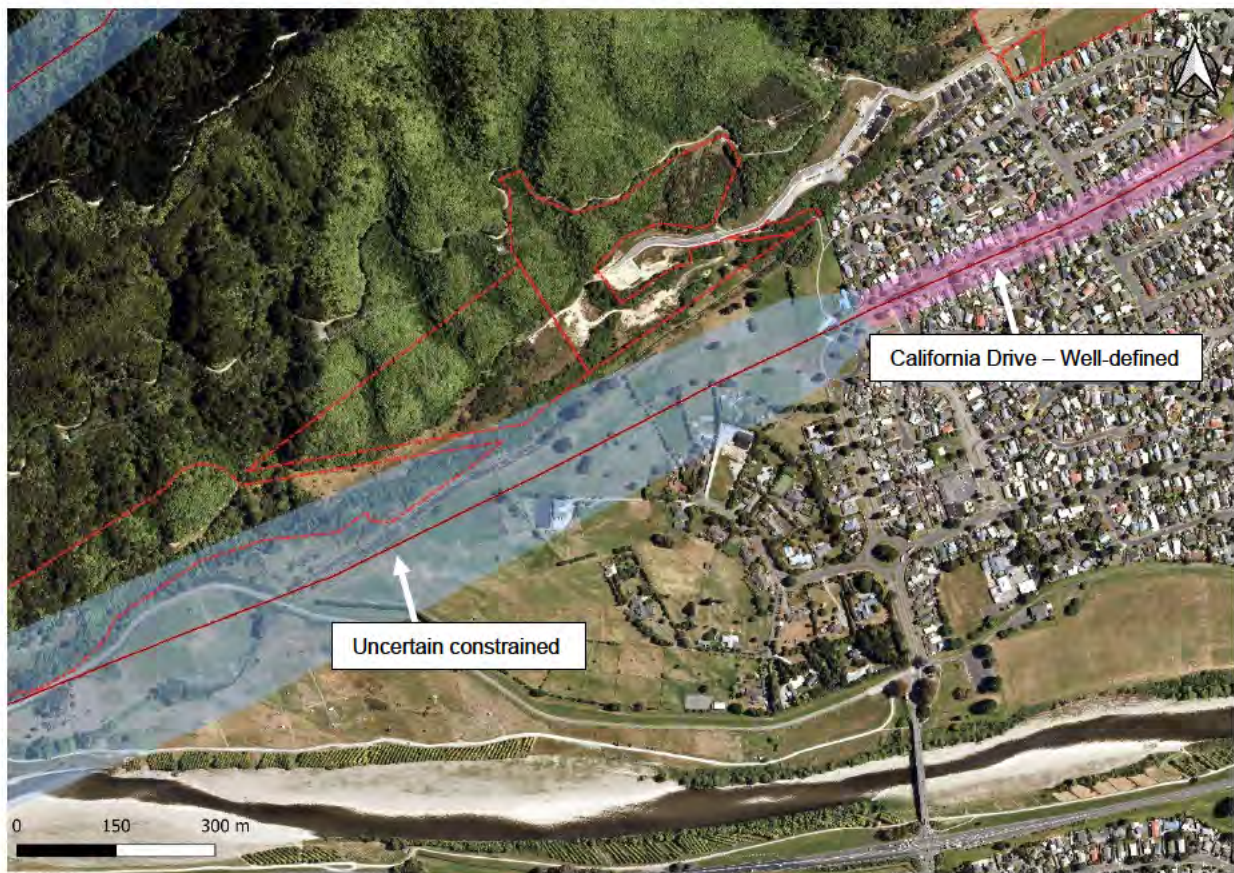
Figure 3: Wellington Fault Location and Confidence of Fault Location

As cited in Section 4.3, the site is located approximately 250 m from the Wellington Fault. At this distance, the likelihood of co-seismic ground rupture and ground lurching are low; however, the southernmost section site lies within the uncertain constrained mapped extent, and therefore we cannot exclude ground rupture as a possibility.

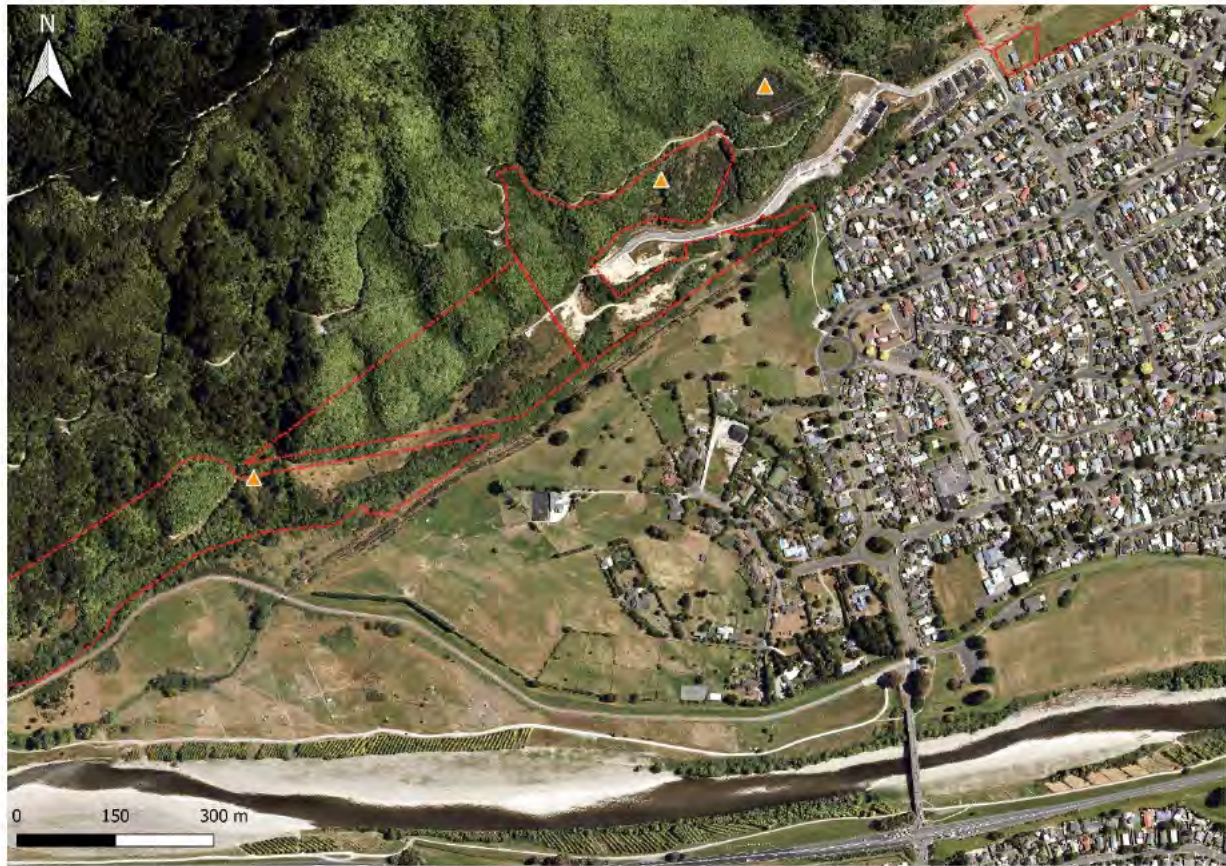
**Figure 4: Recorded Landslides in the New Zealand Landslide Database.**

The New Zealand Landslide Database (Morgenstern et al., 2025) shows three recorded landslides occurred above the site that occurred in 2006 (Figure 4). The database, indicates that the previous events were rainfall induced.

Landslide locations illustrated by orange triangles. Data sourced from GNS Landslide Database and reproduced in QGIS.

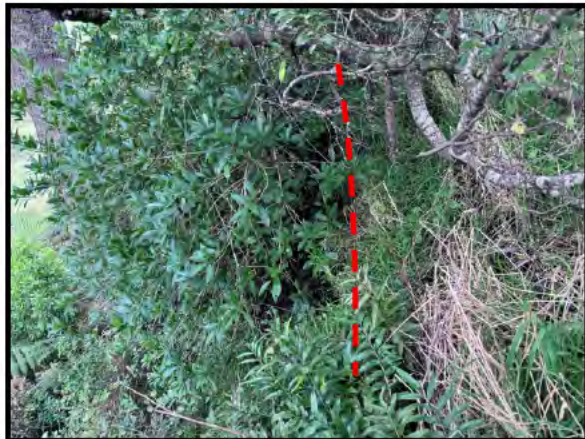
Photo 7: Terrace tread debris flow indicated by red dashed line.

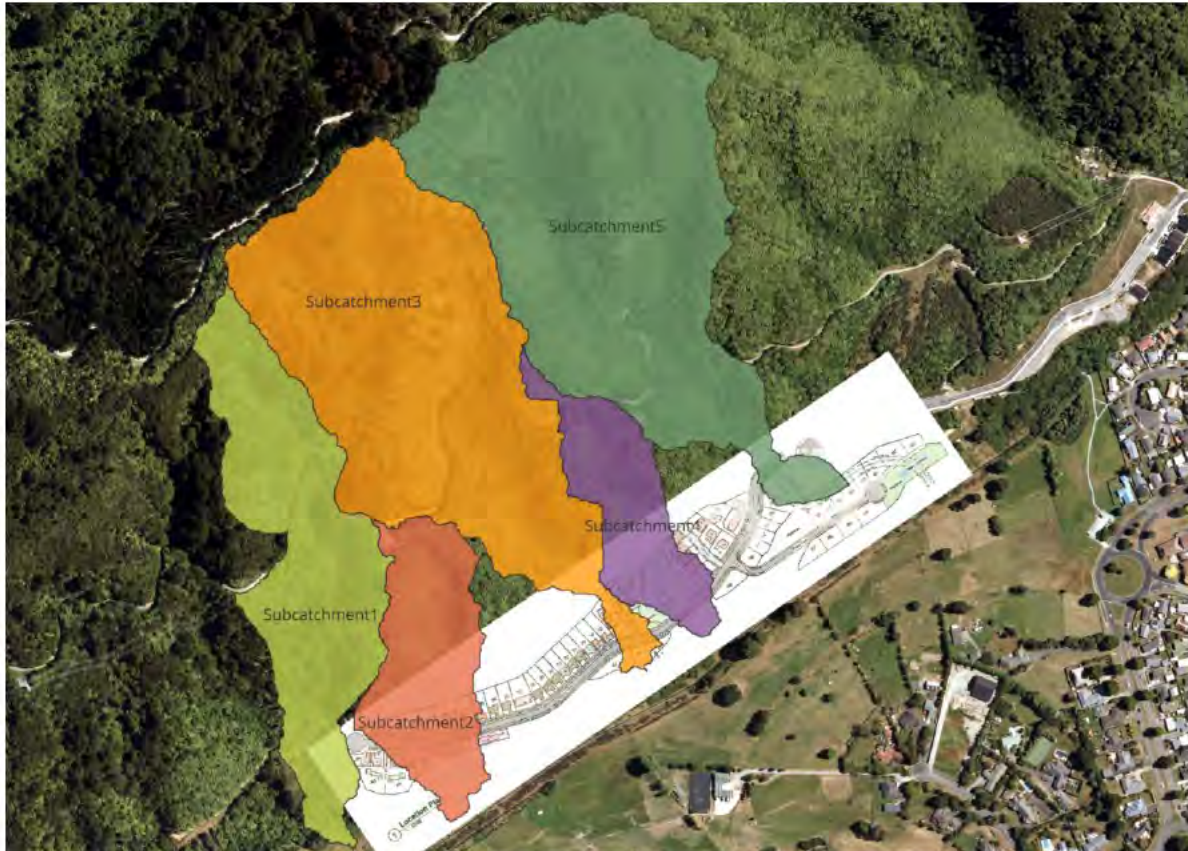
**Figure 6: Catchment Areas Located Above Stage 3**

Large fanlike structures are distributed from the terminations of five main catchments located to the north-western above the site (in text Figure 6). These catchments are of variable size and slope angle, with variable amounts of debris and incision within their primary channels. We infer that the structures at the base of the catchments represent debris fans, most likely derived from repeated, small scale (0.4 – 0.7 m thick) debris flows which have originated within the upper parts of the catchments. Evidence of previous debris flows were observed within the incised channels 10 – 15 m inside the apex of the gullies, furthermore, a test-pit undertaken within one of the debris fans (STG3-TP04), revealed angular to sub-rounded gravely fine to coarse sand.
