Geotechnical Dam Assessment

# Redvale Ponds 5 and 6 Geotechnical and Dam Assessment Report

Waste Management New Zealand

✦ November 2025

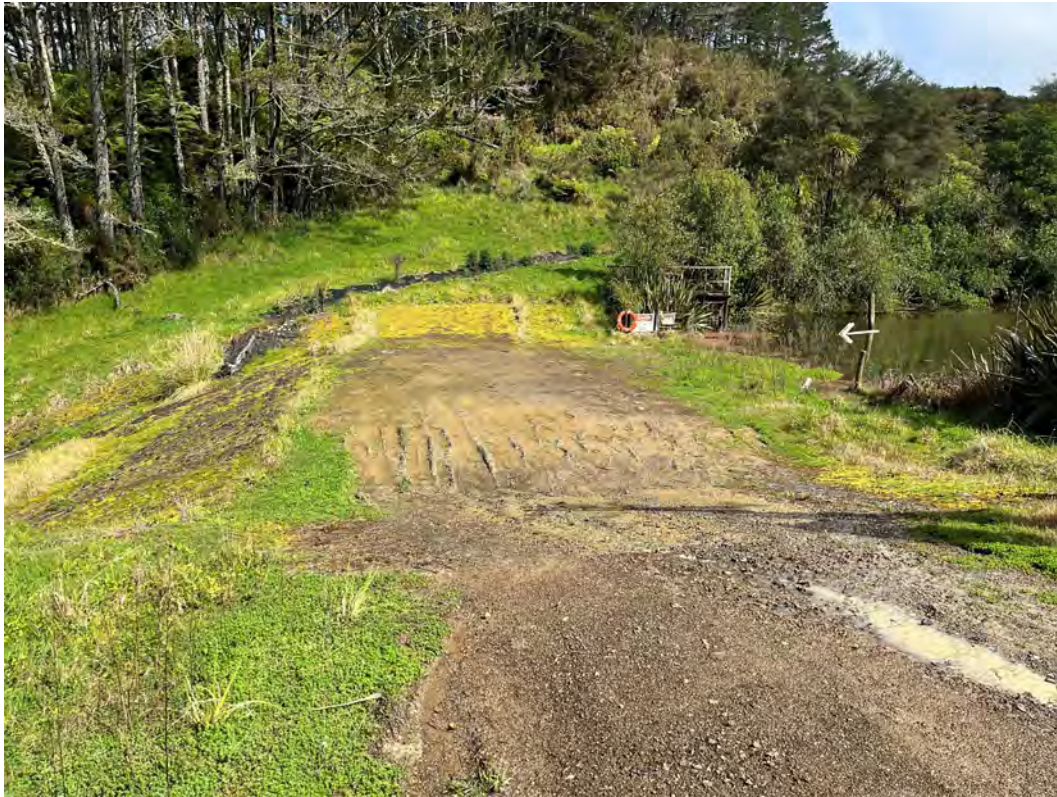
Photo 6 – Pond 5 dam crest spillway with silting and ponded water, looking west.

- ∴ As-built records and geotechnical design information provided by WMNZ, including T&T geotechnical report and earthwork specification, are adopted for the dam stability assessment.
- ∴ The PDP's site visit inspection showed that both Ponds 5 and 6 and associated dams were generally in good condition with no clear evidence of movement, cracking or instability of the dam structure. Maintenance is recommended to clear vegetation from the spillways of both ponds and silt from the top of the spillway of Dam 5.

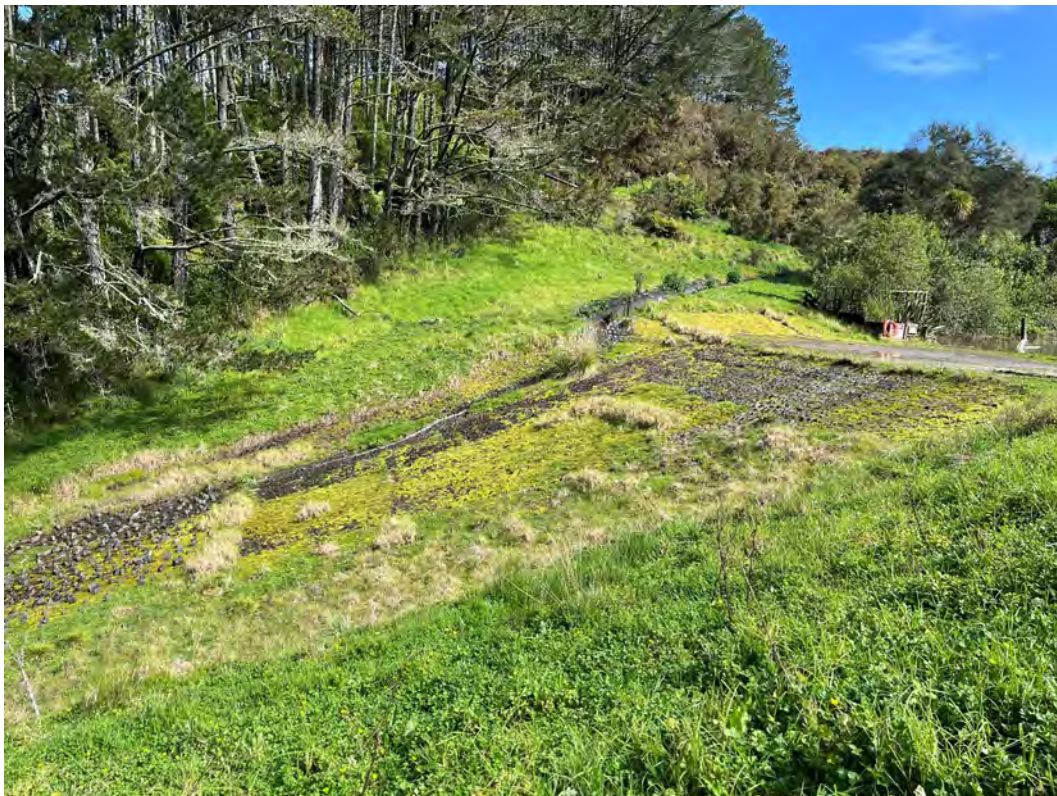
Photo 7 – Pond 5 spillway vegetated with moss and some grasses, looking west.

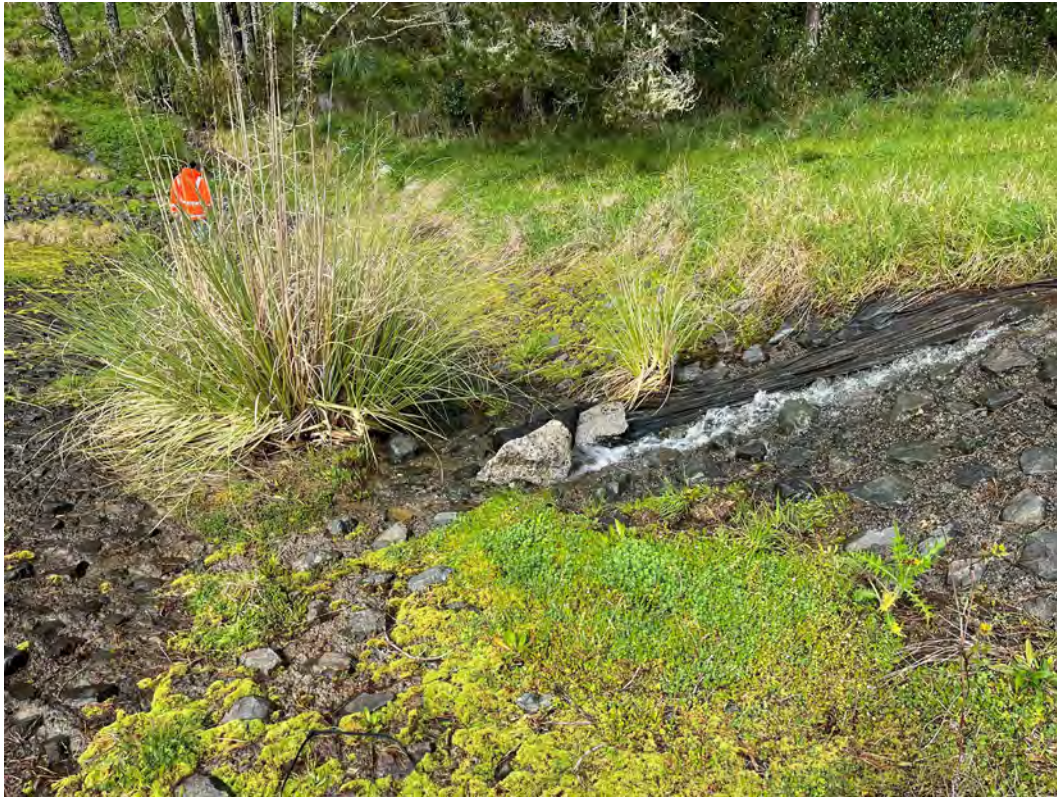
Photo 8 – Outlet of clean water diversion onto the Pond 5 spillway.

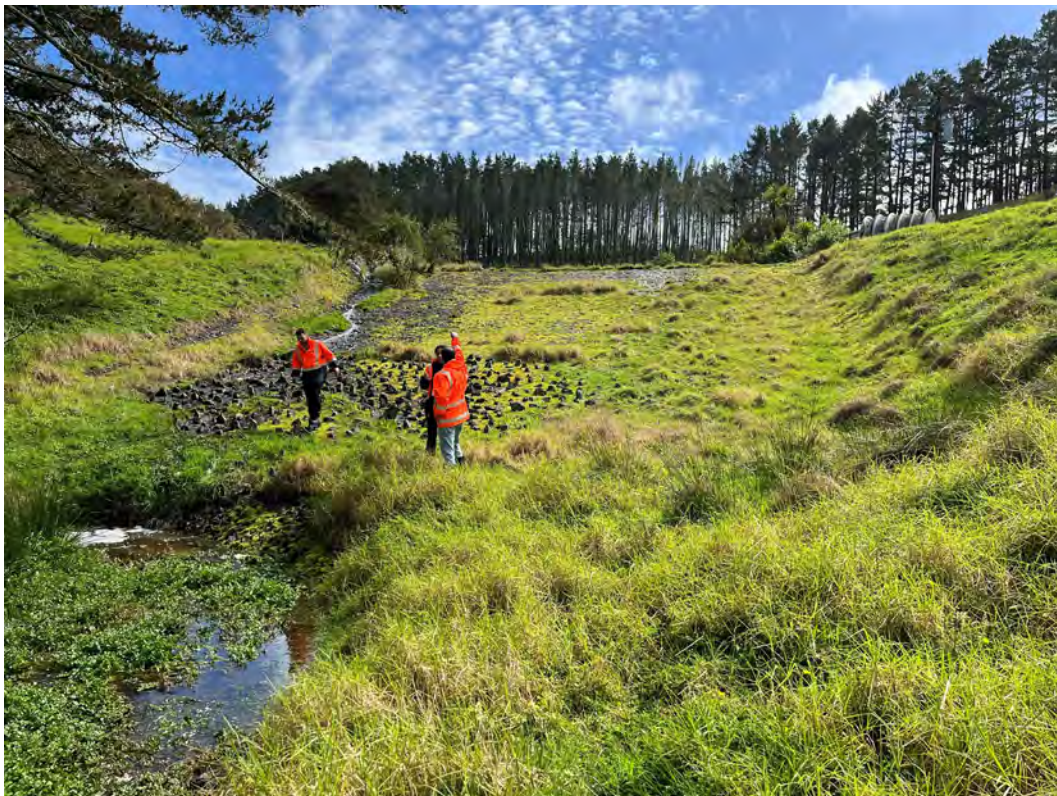
Photo 9 – Pond 5 spillway looking north, ponded water at base of spillway.

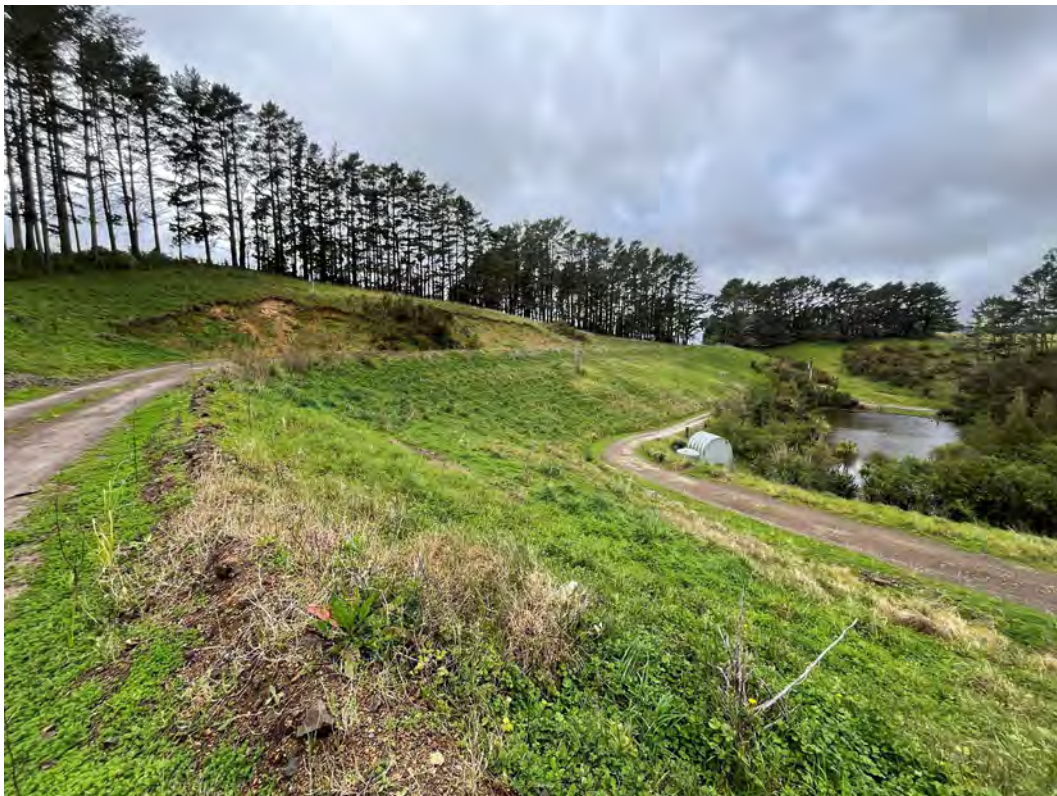
| ⌘ Some instabilities observed upslope of the road in the cut slope. A small slump previously recorded at the northwest end of the pond is now fully grassed over. | |

Photo 11 – Pond 5, looking southeast, cut slope instabilities visible in background.

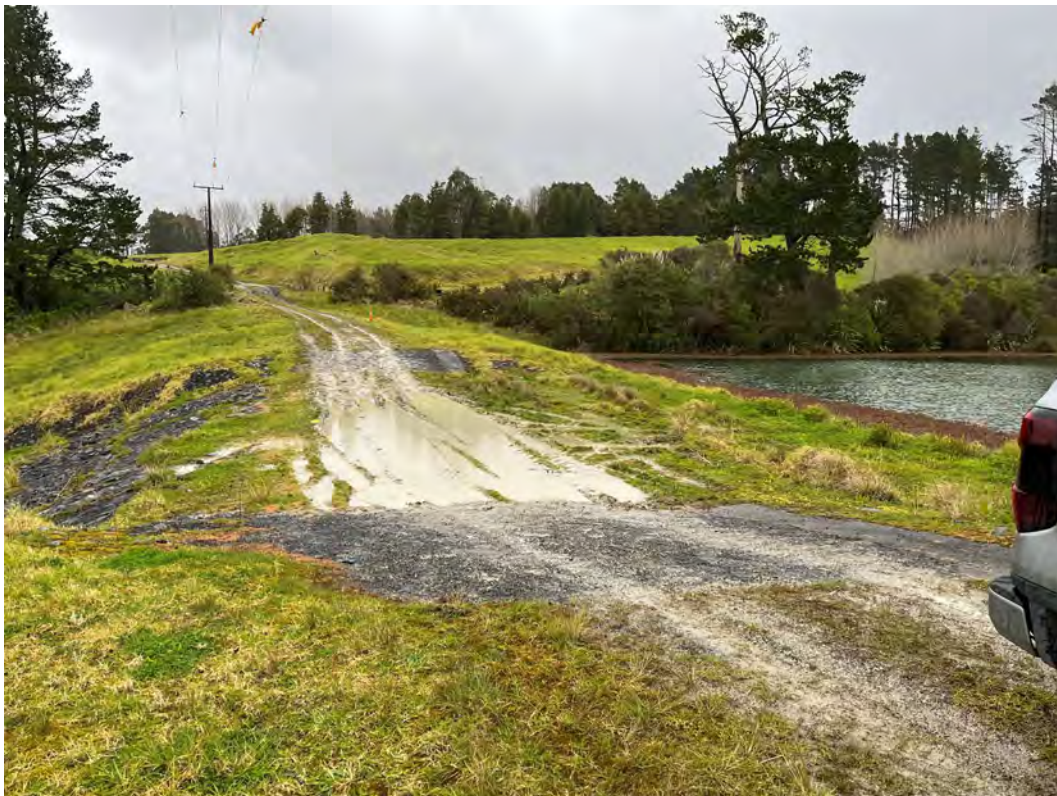
Photo 13 – Pond 6 spillway looking south, with silting and ponded water on crest.

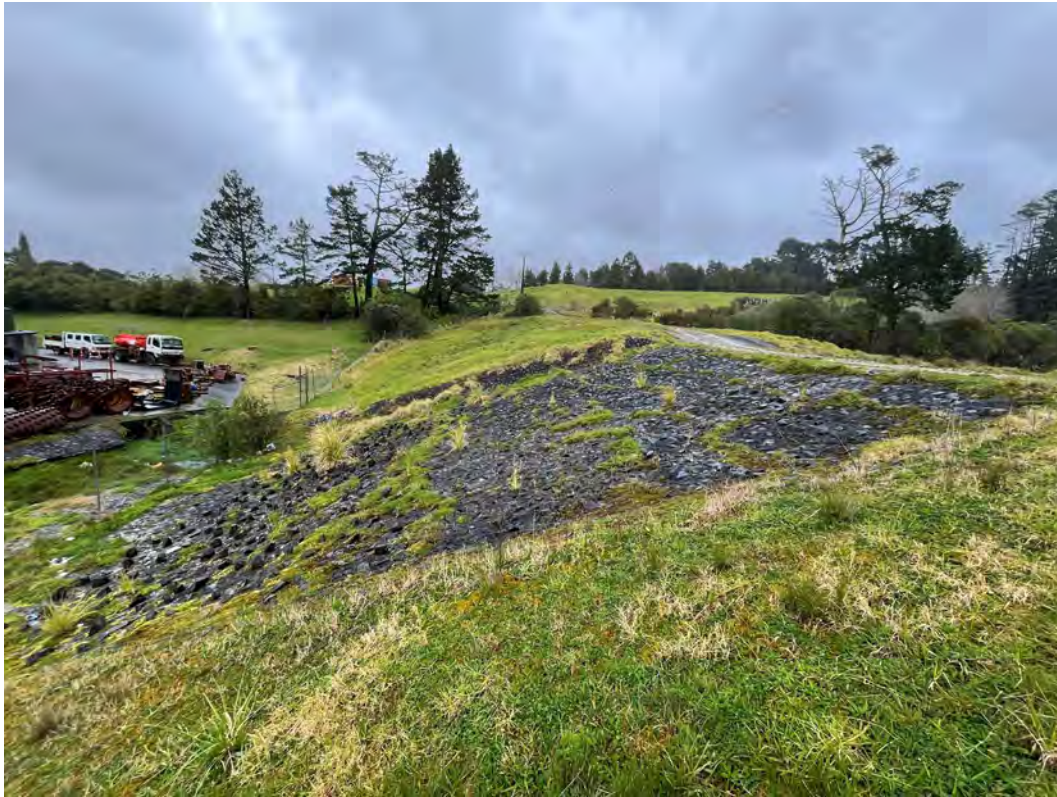
Photo 14 – Pond 6 spillway with some minor vegetation, looking south.

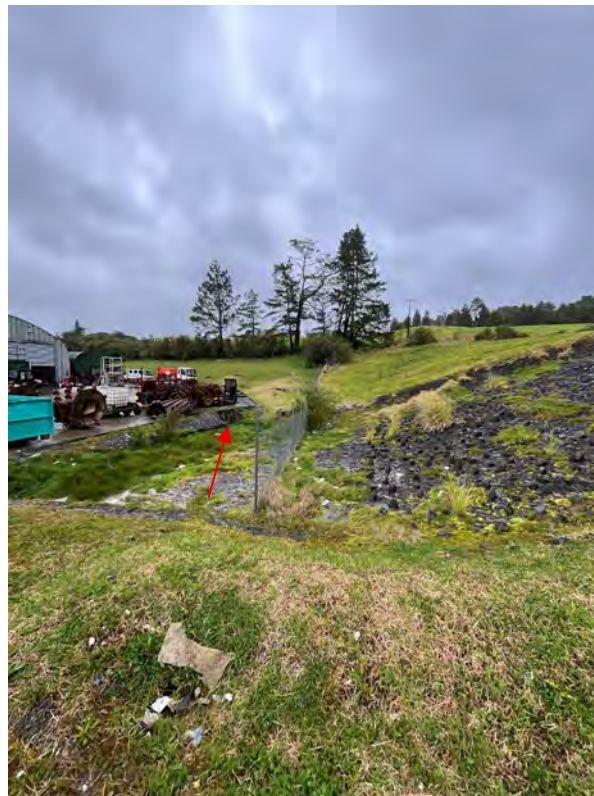
Photo 15 – Pond 6 spillway, looking south, ponded water at base (LHS of fence) draining out the culvert (marked with arrow).

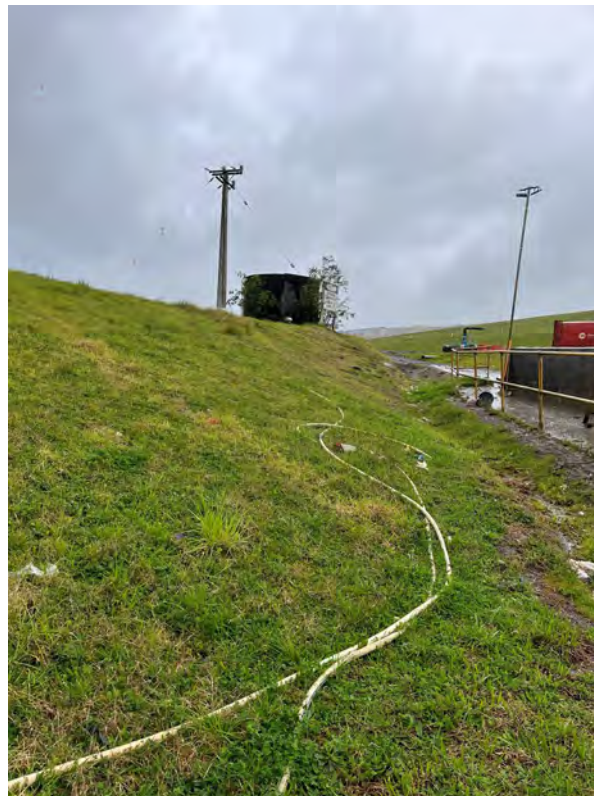
Photo 17 – Pond 6 dam with steepened slopes and concrete drainage on north side of spillway.

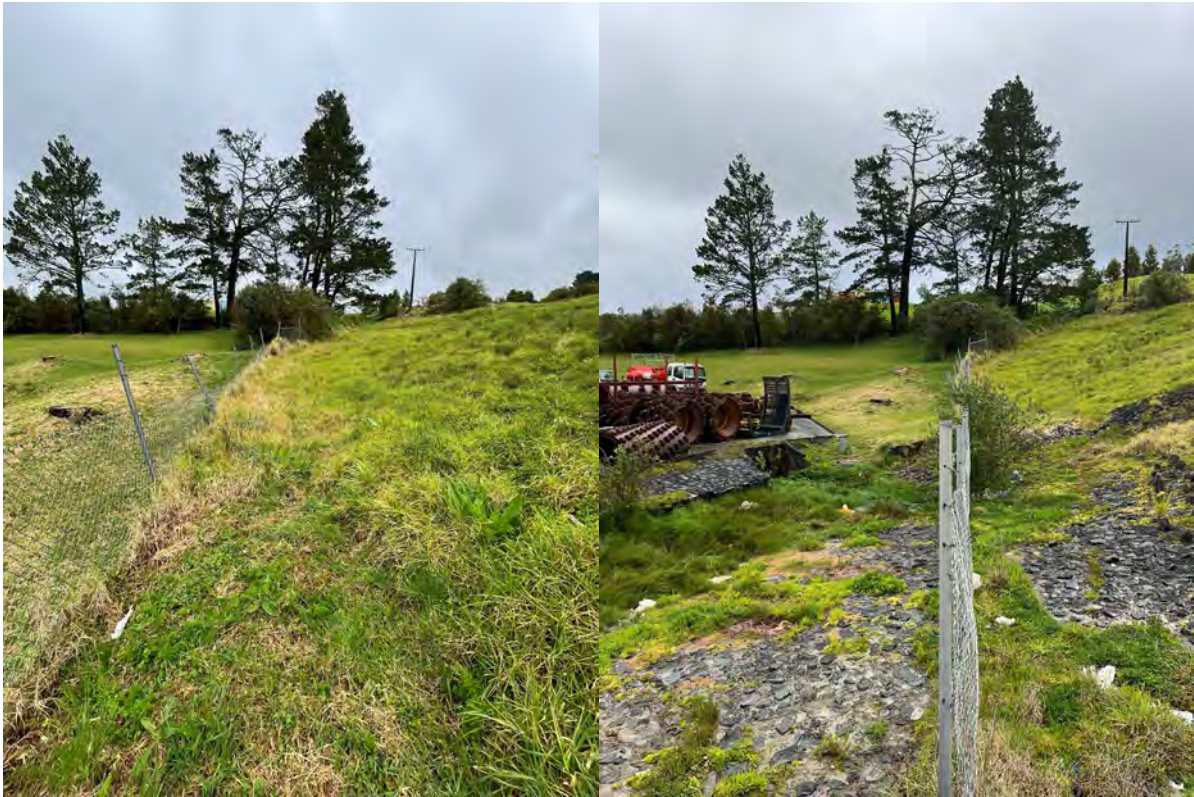
| ⌘ Fence along base of dam partially failing on the southern side of spillway – based on discussions with Najam it is inferred this is related to age or damage from machinery rather than related to ground movement. | |

Photo 18 and 19 – Damaged fence at base of Pond 6 dam on southern side of spillway.
