# SH 67 Kerrs Road Granity LCSIA

Bathurst Resources Limited

Project Number 310206316

August 2026

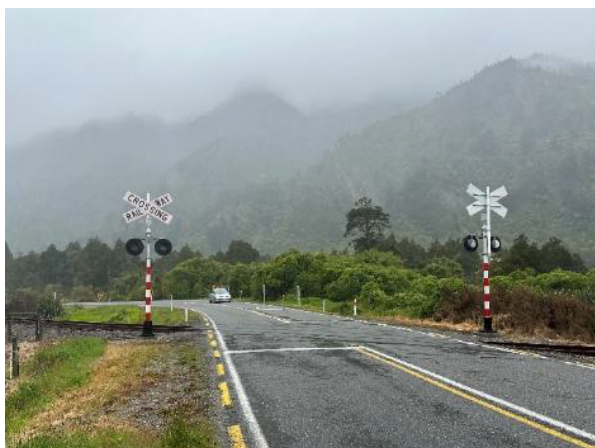
The level crossing is controlled by single FLBs on both approaches to the level crossing as shown in Figure 3-3 and Figure 3-4. There are 'no parking' lines painted in all four quadrants of the level crossing. The carriageway through the level crossing is quite narrow with no sealed shoulders on either side. Additionally, there is no lighting at, or near, the level crossing. Road markings on both approaches to the level crossing were in a fair condition. The FLBs have crossbucks on top and are in good condition facing the oncoming traffic.

Figure 3-3: Southern approach to level crossing from Birchfield Road

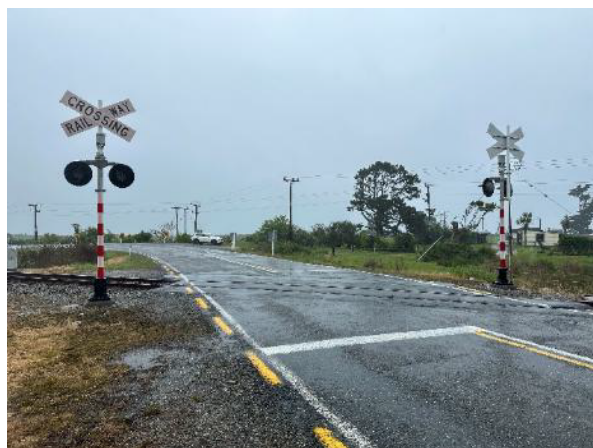
Figure 3-4: Northern approach to the level crossing from Birchfield Road

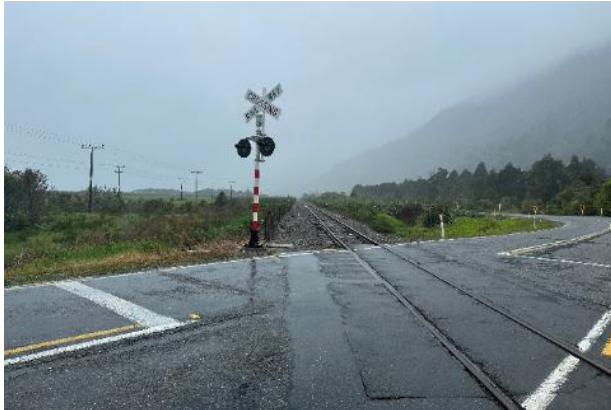
The sightlines from the southern approach both up and down track have good visibility as shown in Figure 3-4 and Figure 3-5. The vegetation along the sides do not obstruct view of sightlines at the level crossing.

Figure 3-5: UP track sightline on southern approach

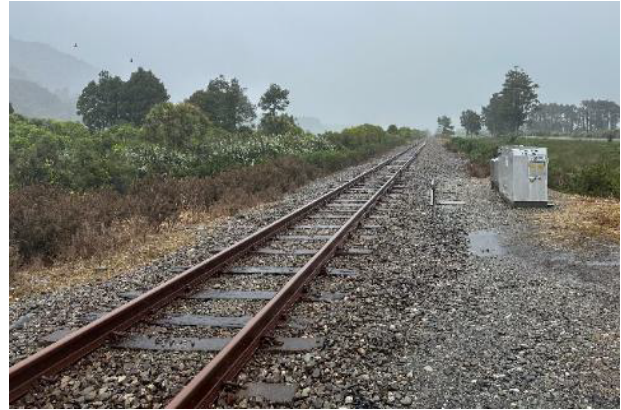
Figure 3-6: DOWN track sightline on southern approach

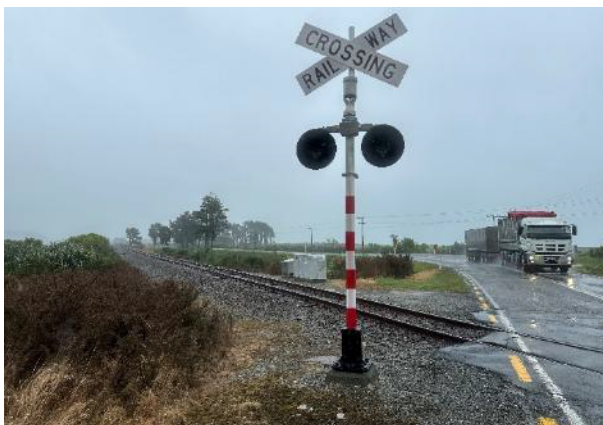
The sightlines from the northern approach both up and down track have good visibility with no vegetation obstruction as shown in Figure 3-7 and Figure 3-8. However, it is possible to envisage the vegetation in the down track view could grow higher and become a sight distance restriction in the future.

Figure 3-7: DOWN track sightline on northern approach

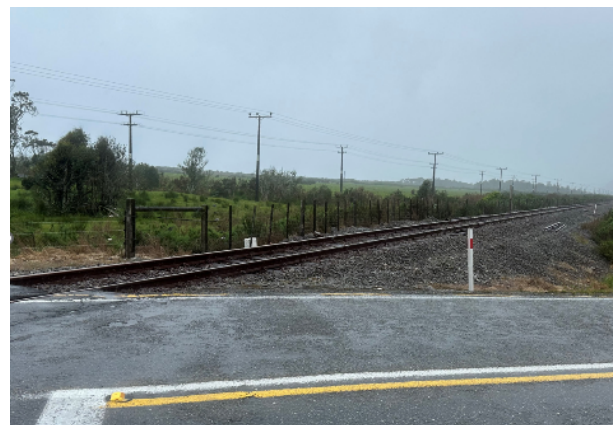
Figure 3-8: UP track sightline on northern approach

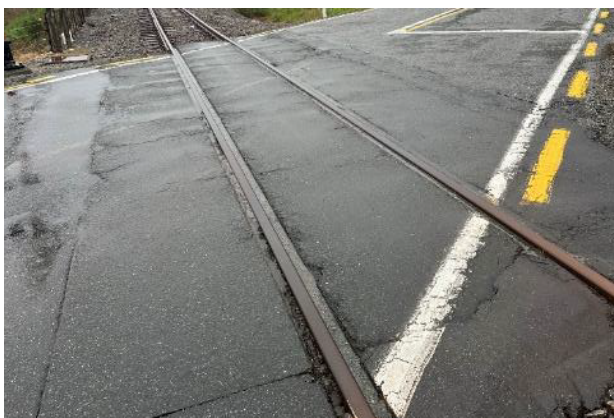
Figure 3-9 shows the condition of the crossing panel to be in an average condition and may require maintenance interventions in the coming years.

Figure 3-9: Crossing panel in moderate condition

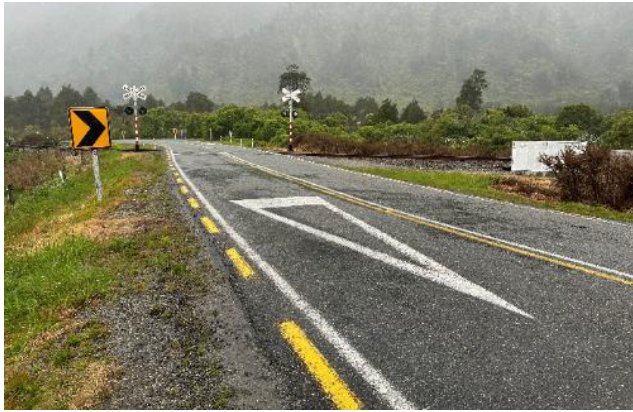
There are old 'GIVE WAY triangle" road markings on both approaches to the level crossing as shown in Figure 3-10 and Figure 3-11. The presence of these road markings may mislead motorists of the type of control this level crossing is operating with. These have not been removed since the controls were upgraded to FLBs in 2014/15.

Figure 3-10: Southern approach with old give way sign still marked

7. **Misleading road markings.** The old 'GIVE WAY triangle road' markings are still present even after upgrading the level crossing from 'GIVE WAY control to FLBs in 2014/15.
8. **Narrow width of road over the level crossing.** The road width is narrow on the approaches and over the level crossing. There are no sealed shoulders on either side of road.
9. **Average condition of crossing panel.** The crossing panel is starting to show signs of wear / deterioration. This needs to be monitored so that a renewal can be timely programmed when required.
10. **No lighting of level crossing.** There is no lighting provision at or near the level crossing as it is in a rural area.

| Safety Recommendation | Necessity |
|---|---|
| <b>5. Remove old GIVE WAY triangle road marking on both approaches</b> | Maintenance |
| Remove the old give-way road markings on both approaches which no longer comply with FLBs | |

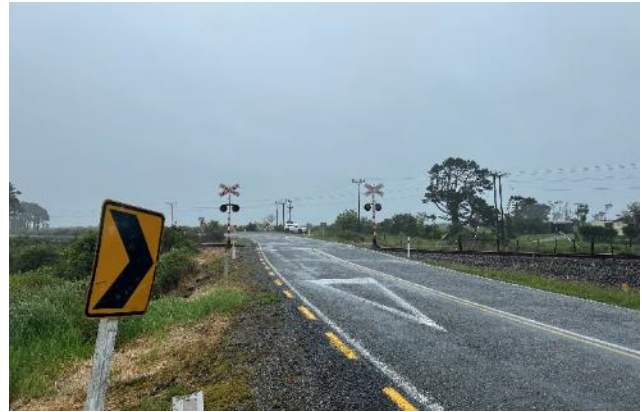
Figure 3-11: Northern approach with old give way sign still marked

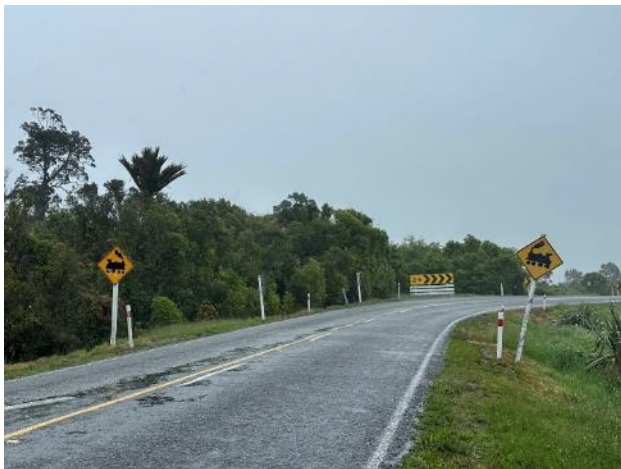
Advanced warning signs on the northern approach are seen in Figure 3-12 and Figure 3-13. The advanced warning signs on the southern approach were not able to be closely examined at the time of the site visit due to safety concerns accessing the signs. However, the gated WX1L and WX1R steam train signs and level crossing reverse curves alignment advanced warning signs were present on the southern approach, along with the 'Rail X' road marking.

Figure 3-12: Steam train signs on northern approach

| Safety Recommendation | Necessity |
|---|---|
| <b>1. Replace existing advanced warning signs, steam engine, level crossing alignment signs. Assess whether these need to be larger sized signs to better delineate the level crossing and reverse curves in road alignment.</b> | Maintenance |

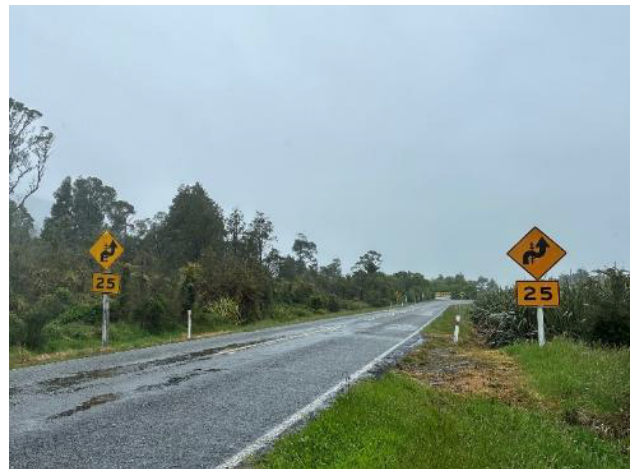
Figure 3-13: Advanced warning signs on northern approach

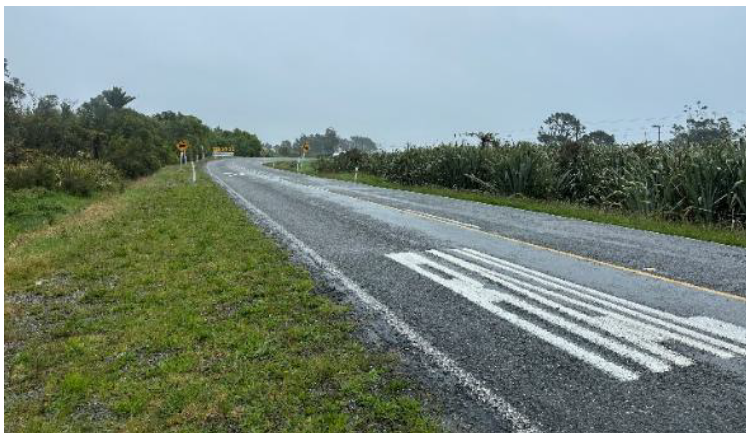
The 'Rail X' road marking on the northern approach is in good condition as seen in Figure 3-14. The WX1R sign on the northern approach was in poor condition, as shown in Figure 3-15. It was installed in October 1999. Because of the age of the sign, it was damaged, likely had no night-time retro-reflectivity, was growing lichen on the sign and pole, and finally was leaning to one side.

Figure 3-14: Rail X markings on northern approach

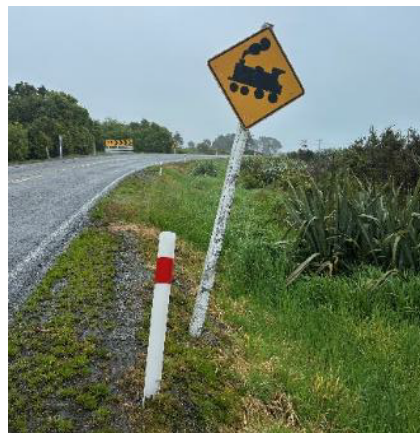
Figure 3-15: WX1R sign on northern approach is damaged.

6. **Damaged, non-reflective and old signage.** Majority of the signage installation for the level crossing dates to 1999, has lichen growing on both the sign and pole, have most likely lost their retro-reflectivity, as well as being damaged.

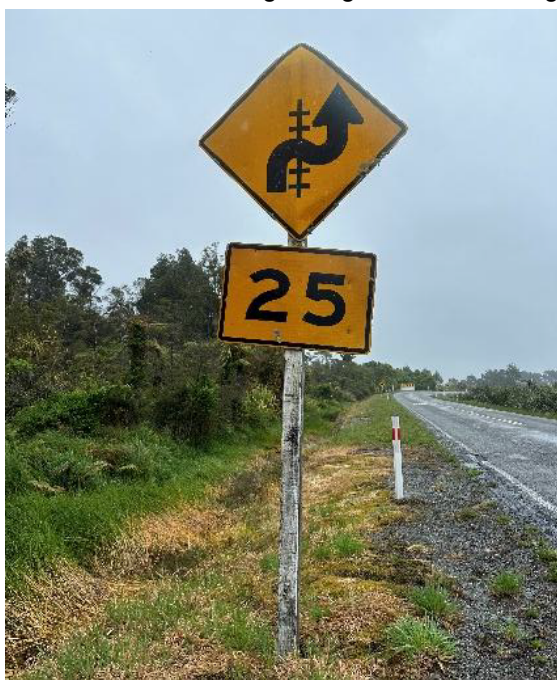
Figure 3-16 shows the level crossing reverse curves alignment advanced warning sign on the left-hand side is in a poor condition with damage, likely no retro-reflectivity, and lichen growing on the sign and pole. This sign was installed in July 2010. The same sign on the right-hand side is in a good condition with no damage and a small amount of lichen growing on it, seen in Figure 3-17. The sign was installed in November 2014.

Figure 3-16: Advanced warning sign on left side of northern approach

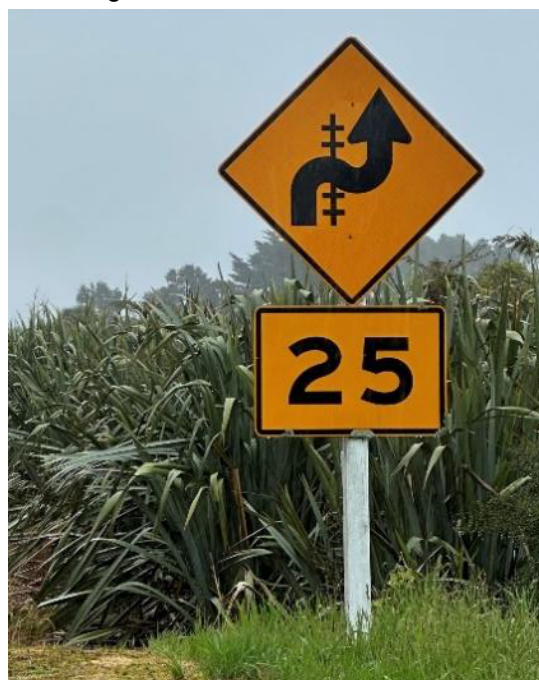
Figure 3-17: Advanced warning sign on right side of northern approach

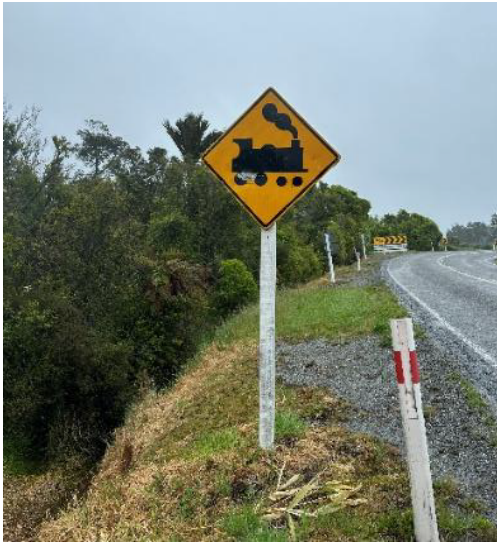
The WX1L sign on the northern approach, as seen in Figure 3-18, was damaged with likely no retro-reflectivity. The single chevron advisory sign closest to the WX1L sign on the northern approach was damaged as seen in Figure 3-19.

Figure 3-18: Damaged WX1L sign on northern approach

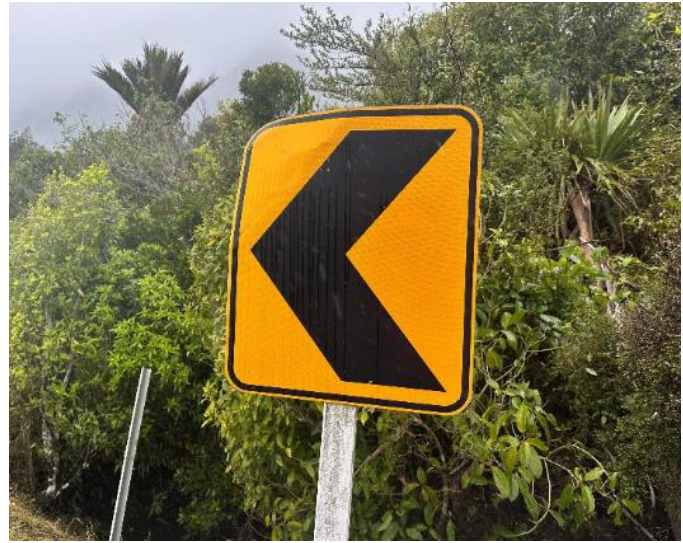
Figure 3-19: Damaged single chevron sign

| Safety Recommendation | Necessity |
|---|---|
| Replace the damaged chevron arrow closest to the advanced warning signs on the right side after crossing the level crossing. | |
