## 8.4 Archaeological Values

## 9 Golden Bar Haul Road

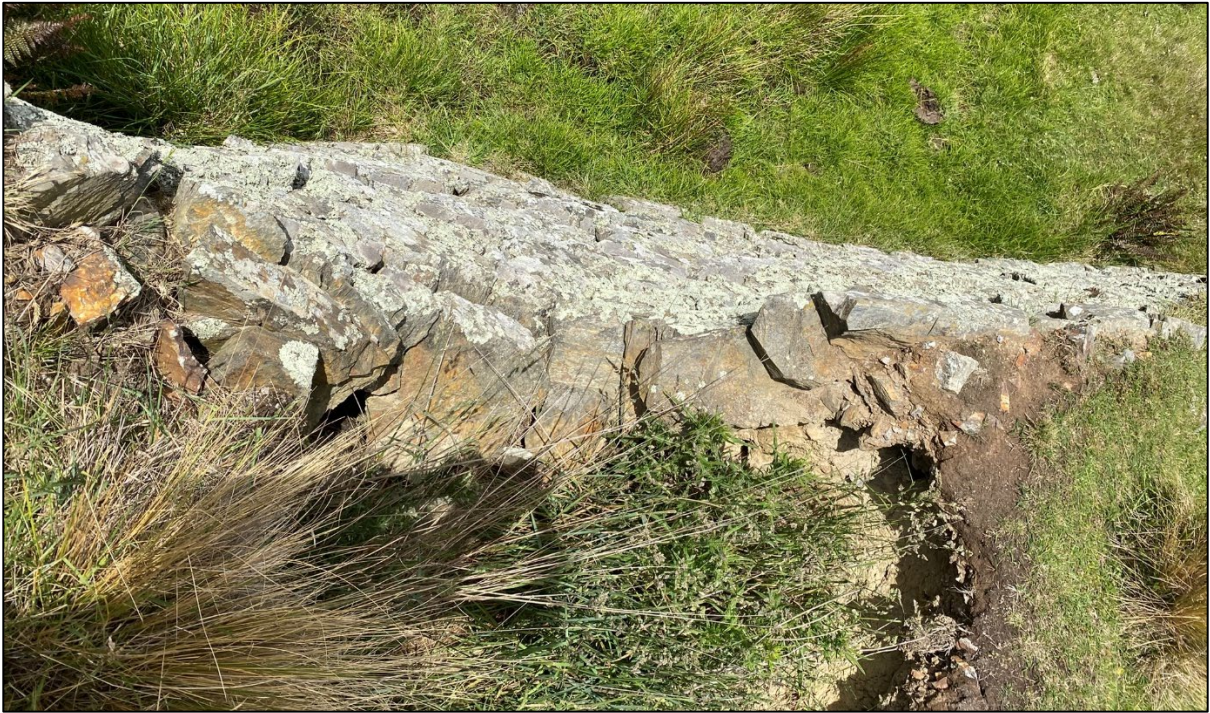
Figure 113. Major revetment along track, looking south-west.

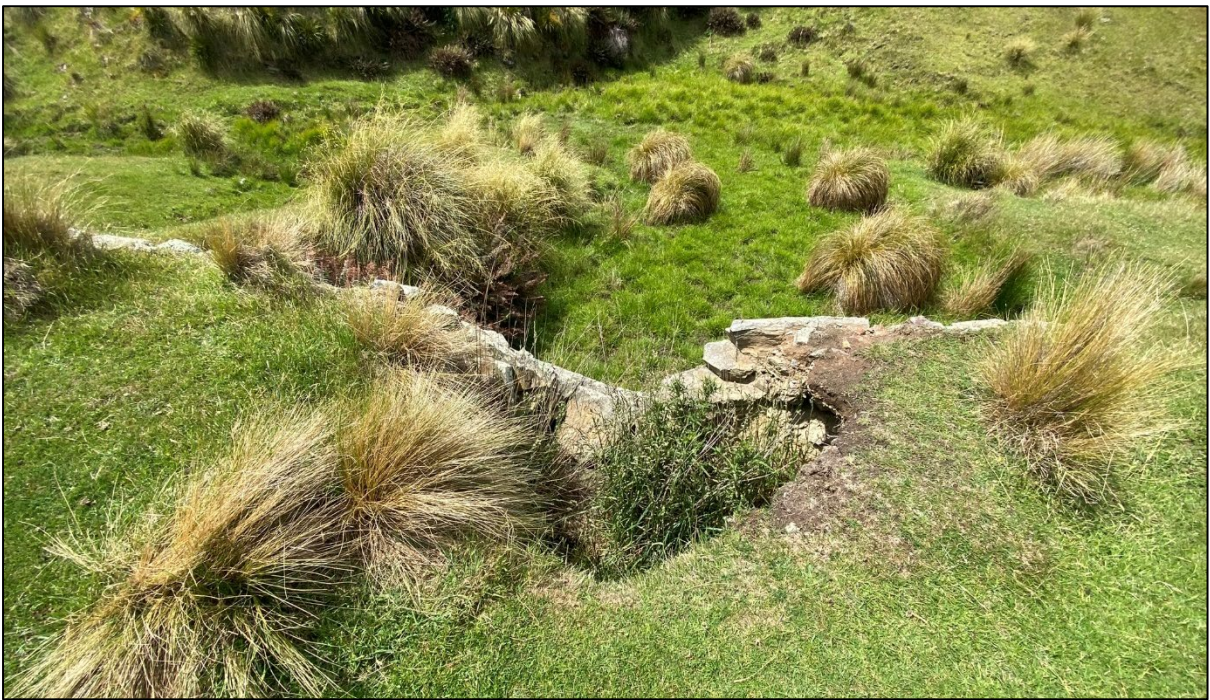
Figure 114. Condition of major revetment as shown in previous photo, looking north-east.

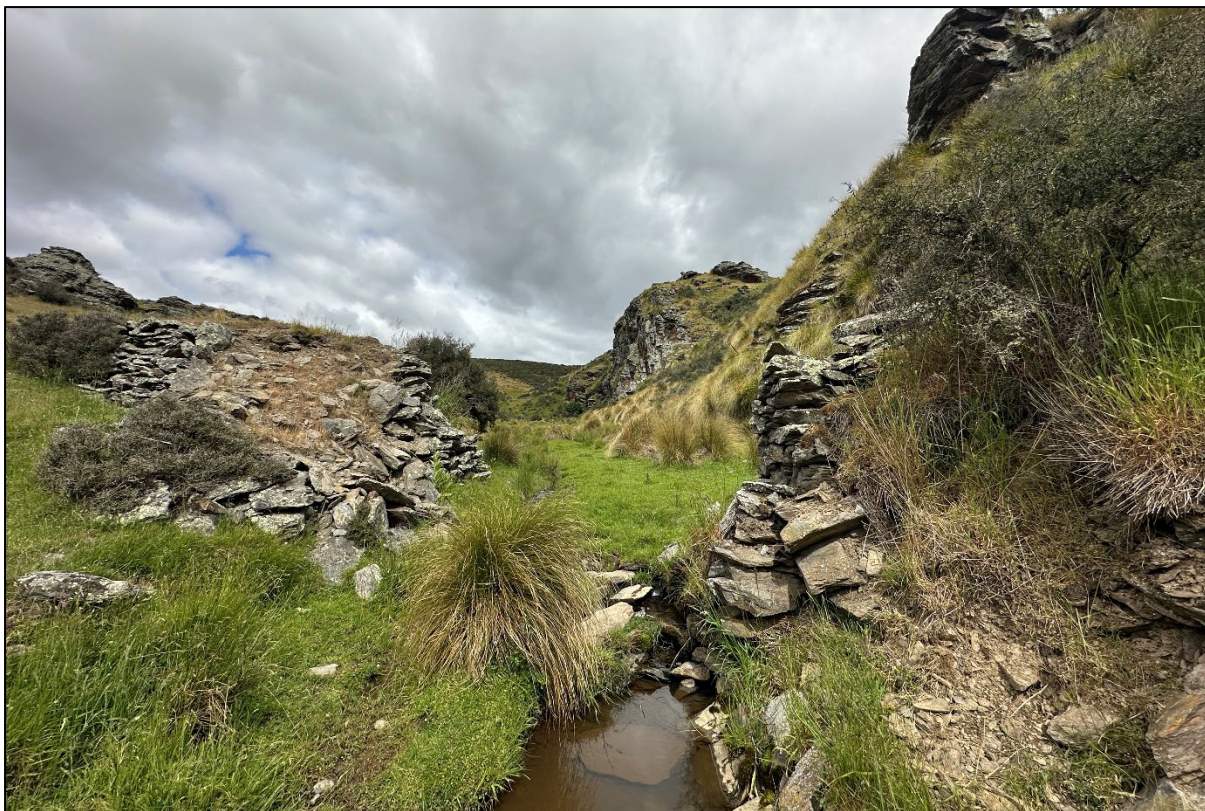
Figure 160. Breached revetment (CC09), looking west.

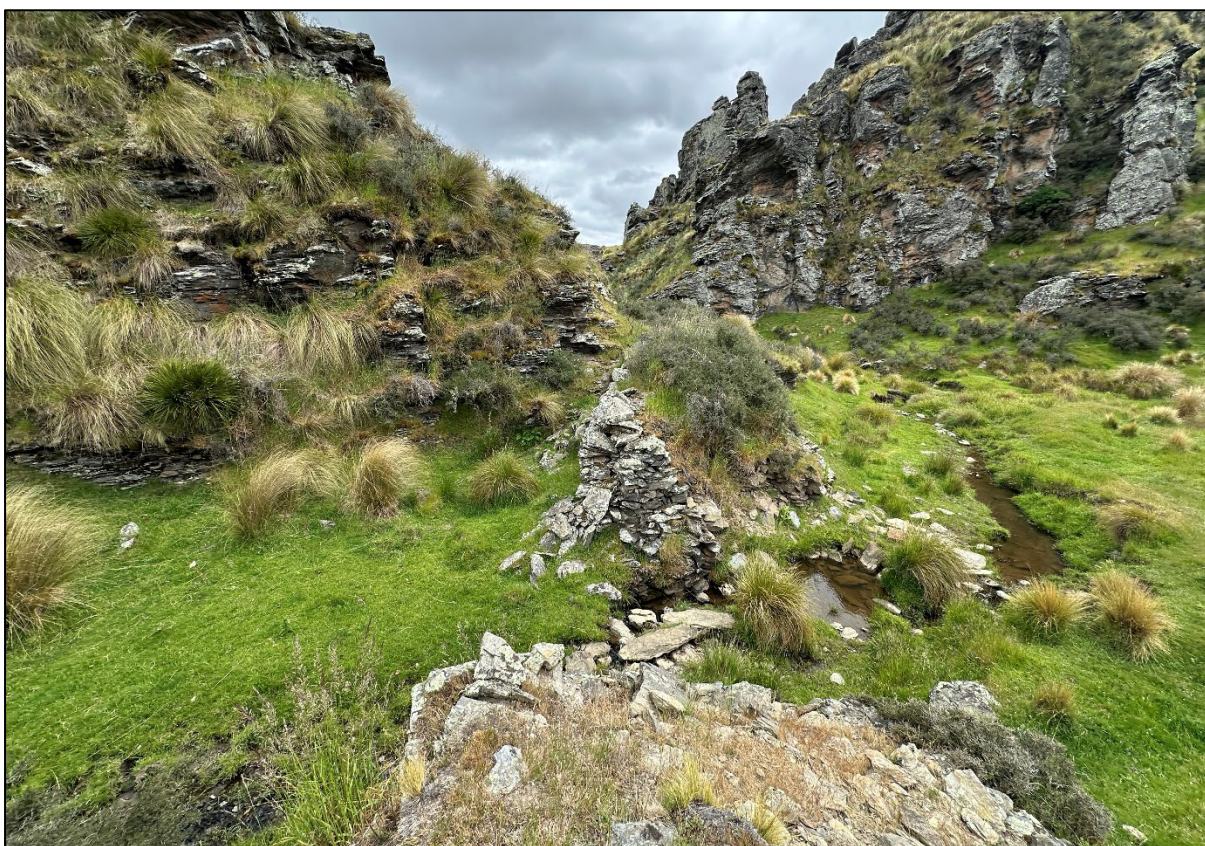
Figure 161. Breached revetment, looking north (CC09).

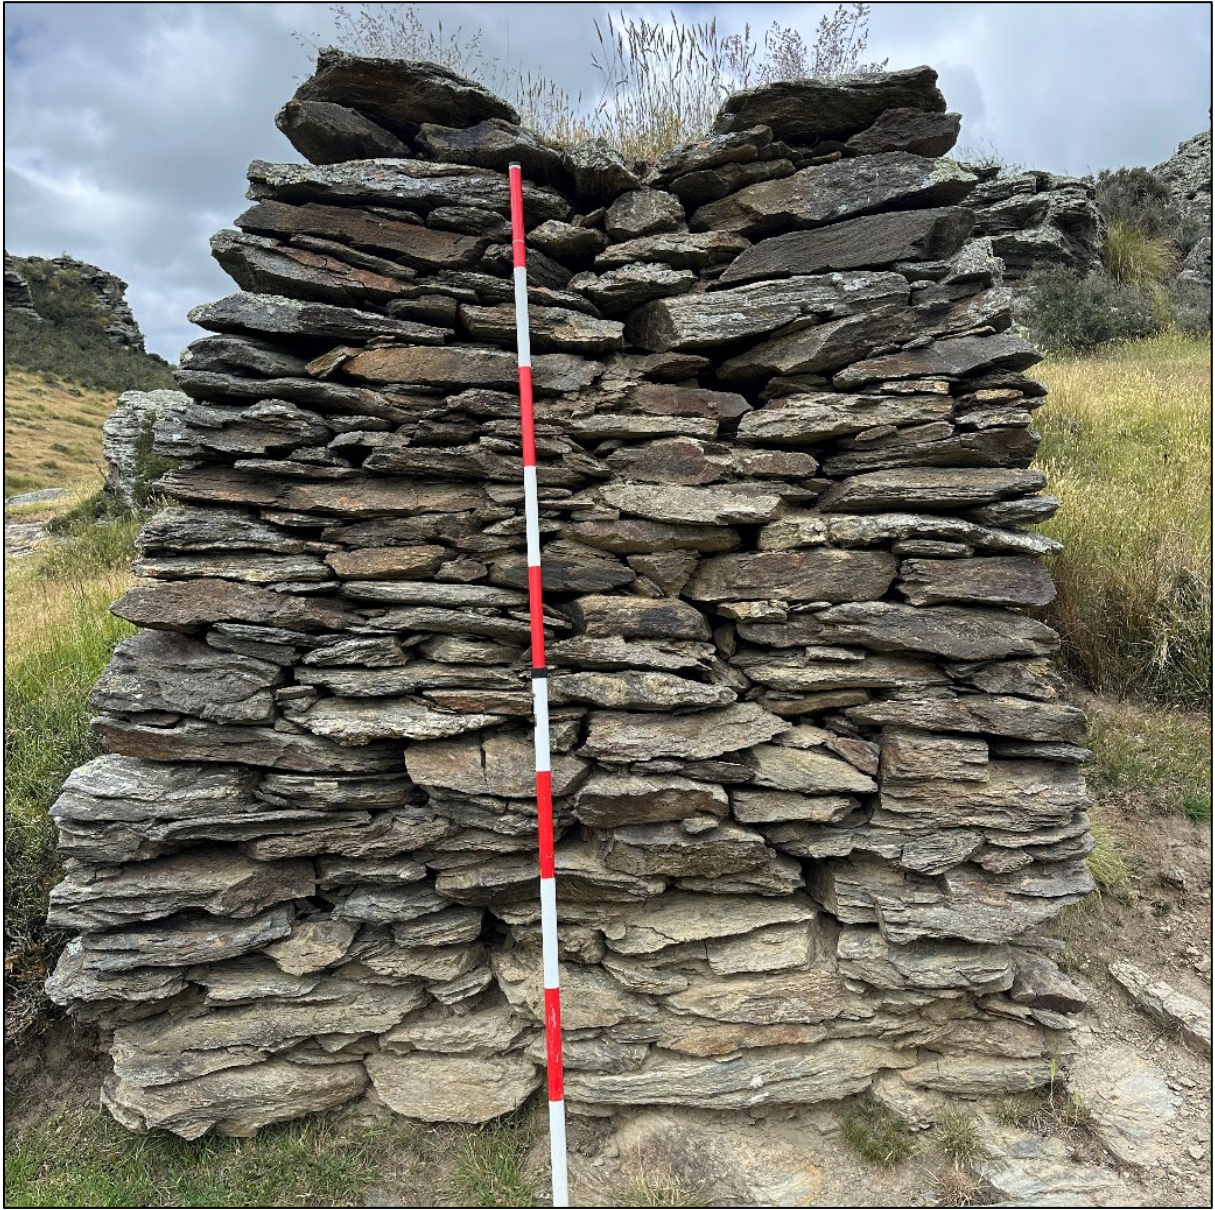
Figure 162. Large revetment with notable curve in the top centre, possibly to accommodate a flume, looking south (CC10).

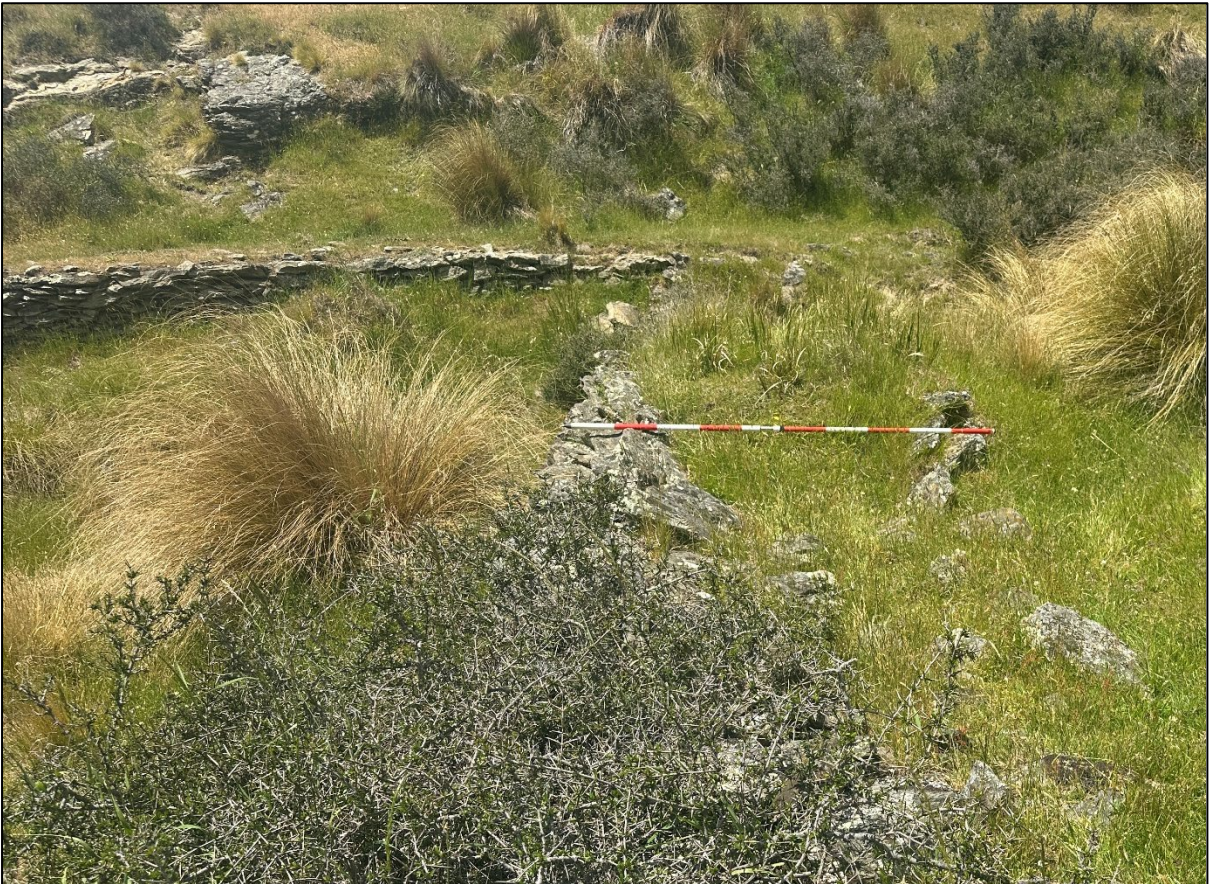
Figure 174. Concave topped revetment (CC24) heading perpendicular to revetment on opposite side of Coal Creek (CC25), looks east.

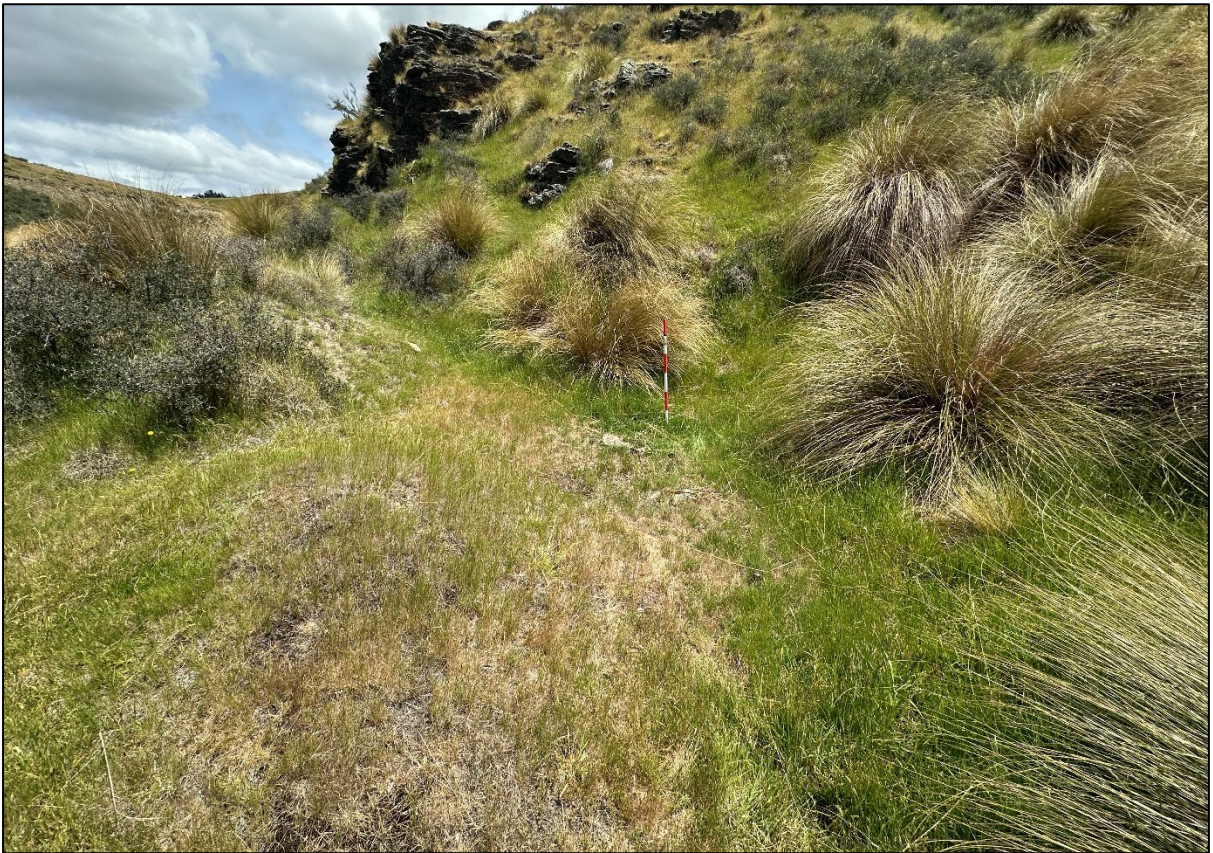
Figure 176. Pits and mounds (CC26) immediately north of CC24 and CC25.

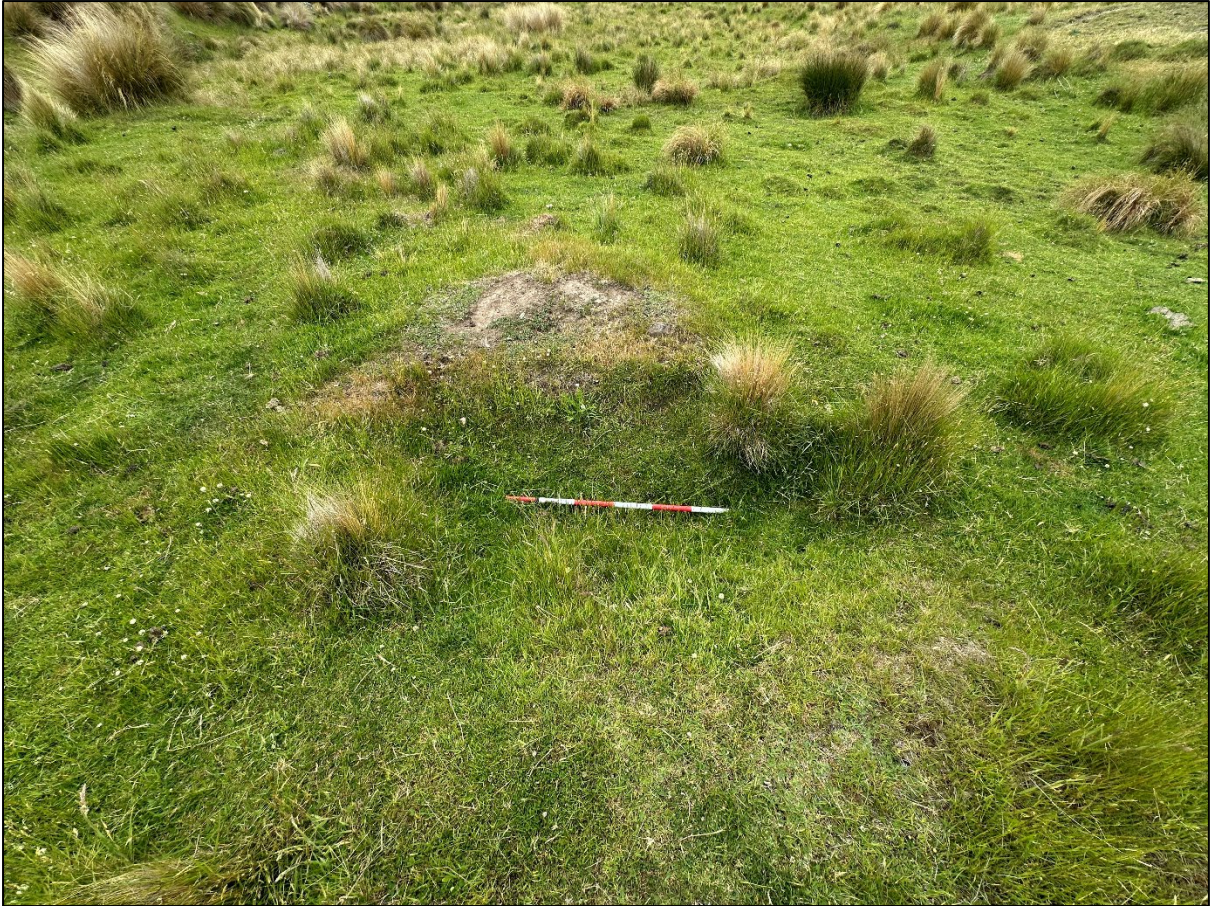
Figure 183. Potential prospecting pit with adjacent spoil pile, looking south (CC13).

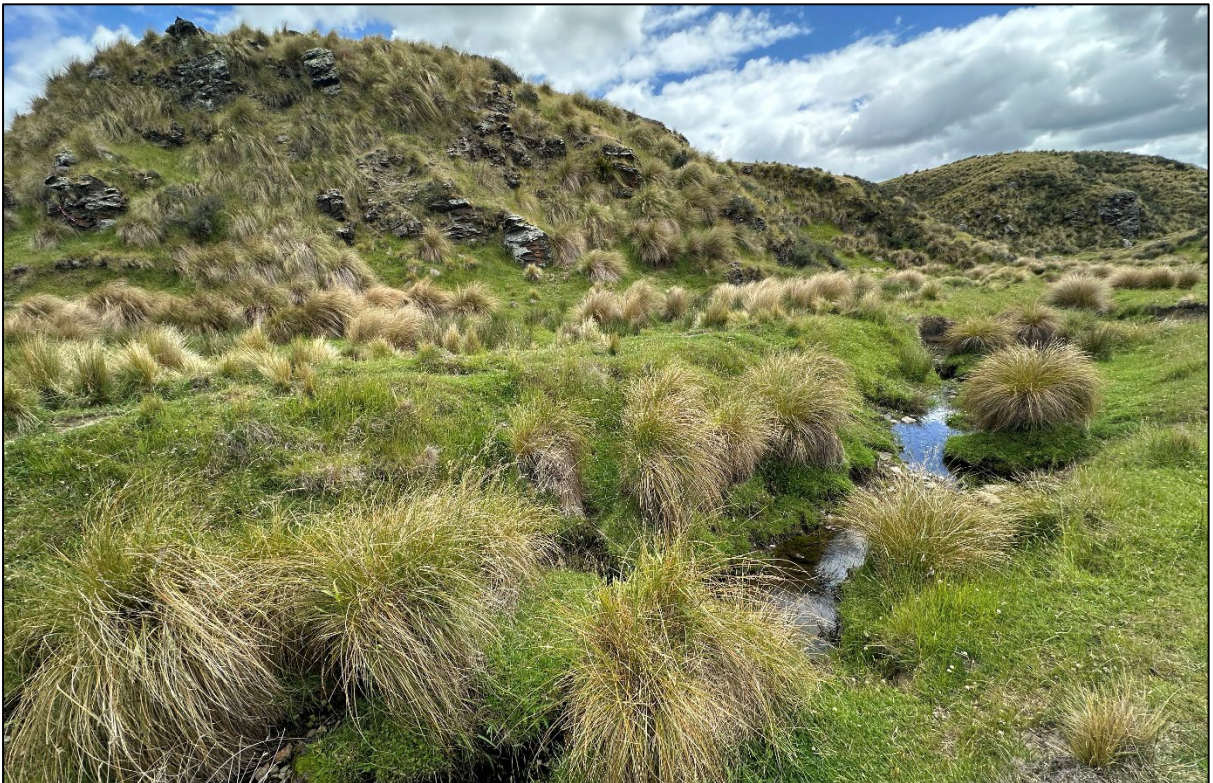
| Ref | Details |
|---|---|
| <b>CC14</b> | Earthen mound causeway of tramline (Figure 184) |

Figure 184. Earthen mound of the tram causeway running north to south (CC14), looking east.

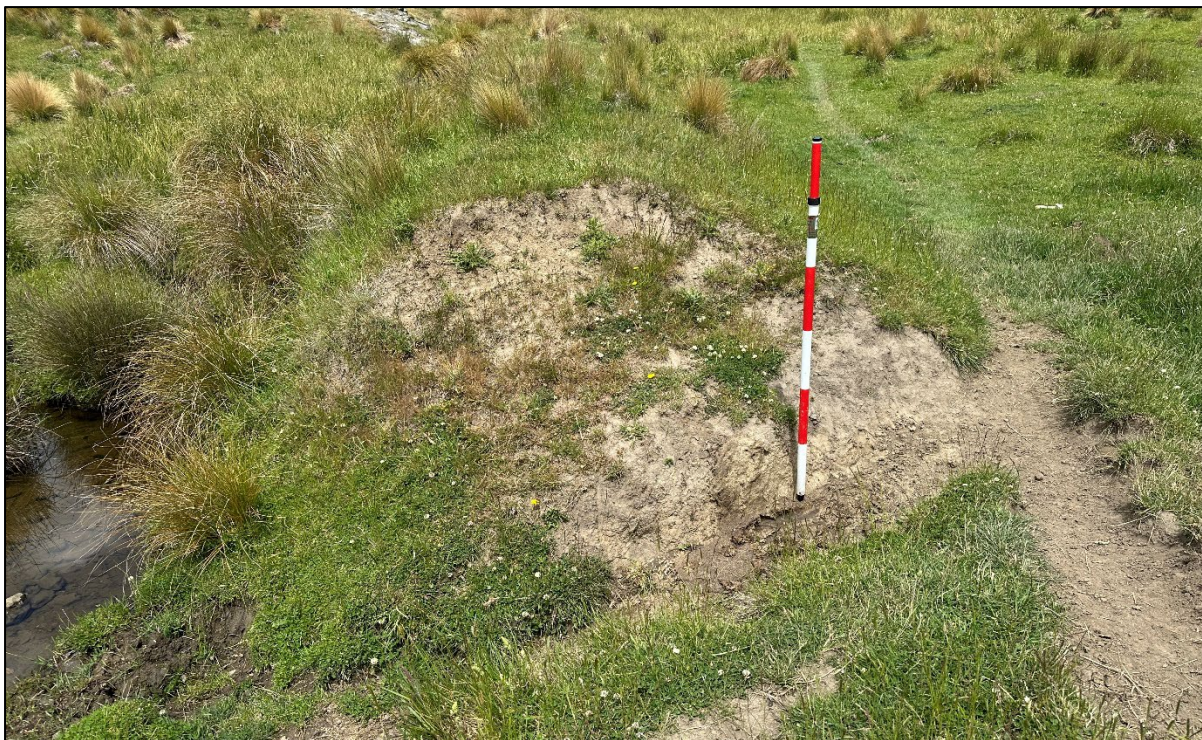
| Ref | Details |
|---|---|
| <b>CC15</b> | Visible cross section of causeway (Figure 185) |

Figure 185. Cross section of tram causeway (CC15), looking south.

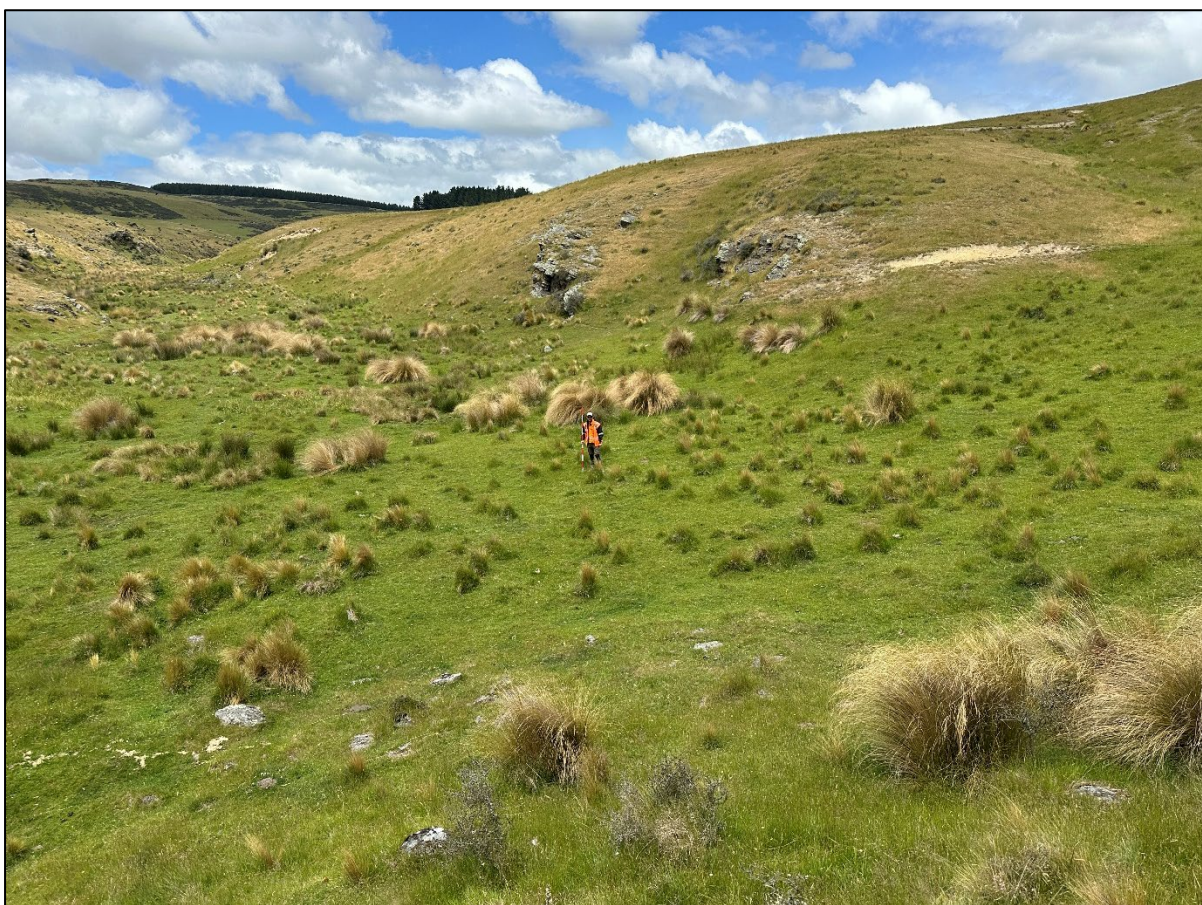
Figure 186. Area recorded as containing workings by Teele (CC16), looking south.

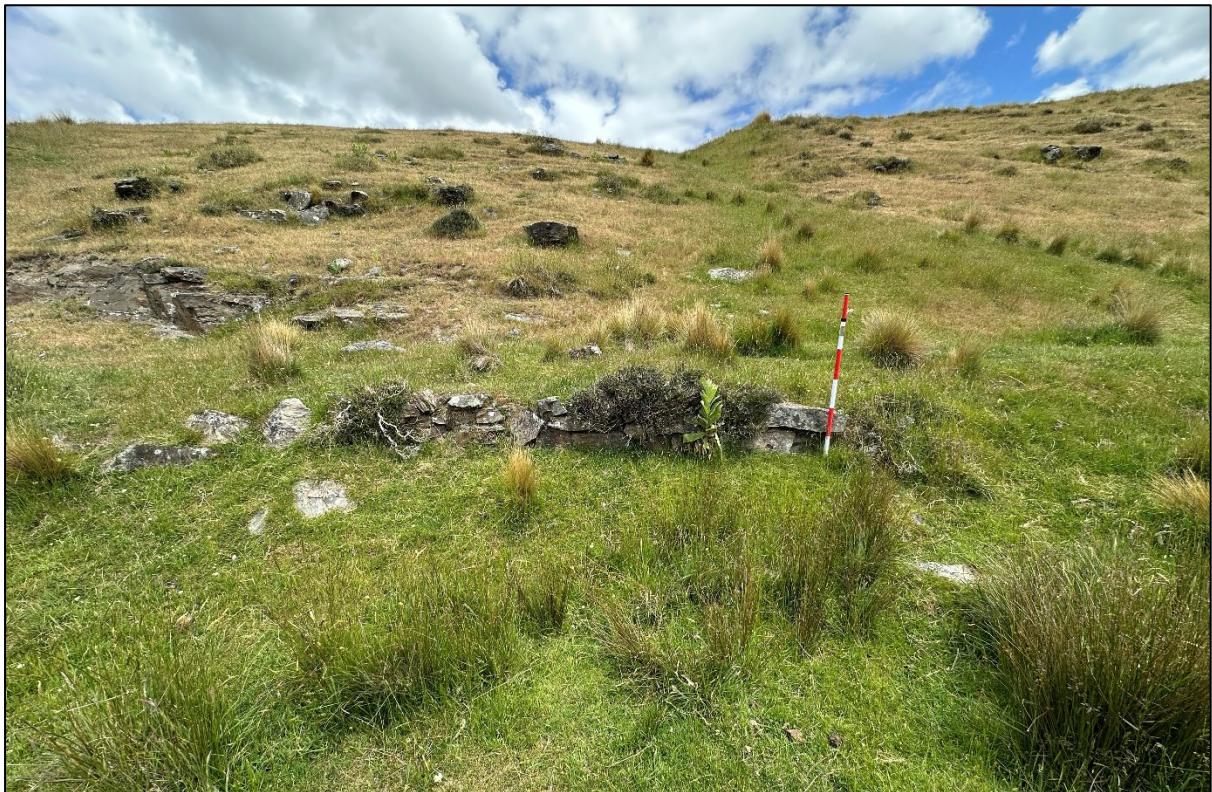
Figure 188. Revetment on slope of the hill associated with tramway (CC17), looks west.

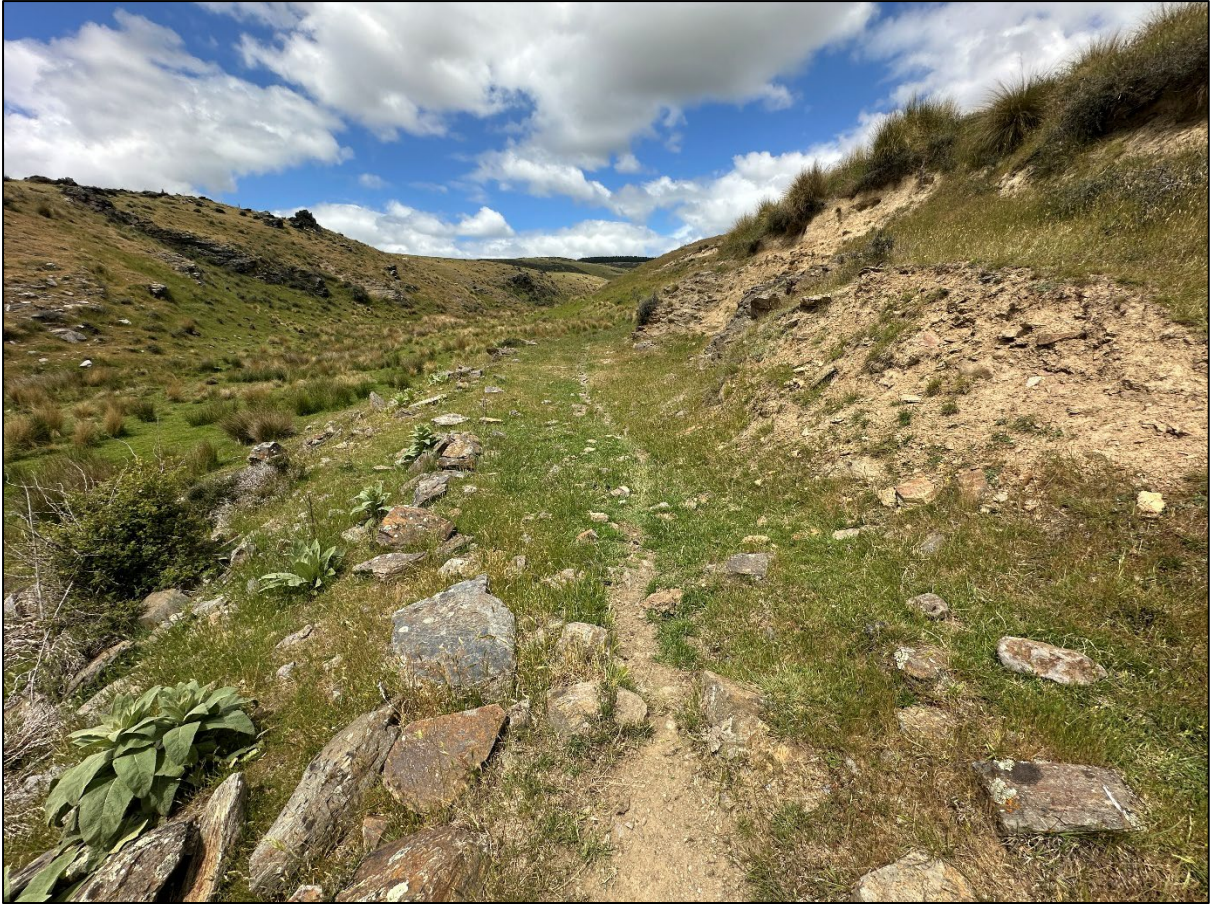
| Ref | Details |
|---|---|
| <b>CC18</b> | Cut for tramline in slope (Figure 189). |

Figure 189. Cutting from hillside for the tramway (CC18), looking south.
