# **Macraes Operation**

## **Preliminary Site Investigation (Ground Contamination)**

OCEANA GOLD (NEW ZEALAND) LTD

WWLA1659 | Rev. 0

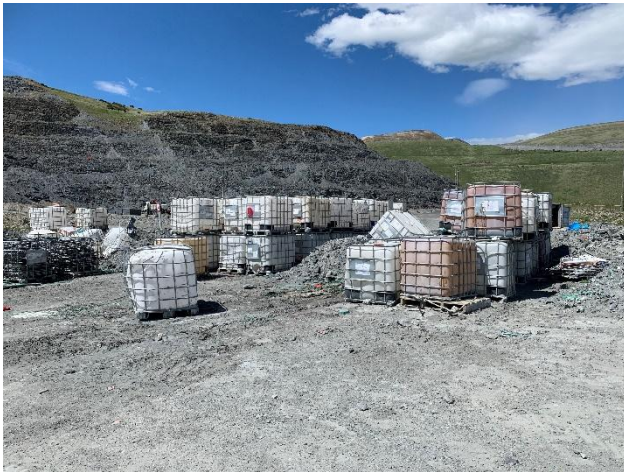
- A laydown area includes storage of numerous used polymer International Bulk Containers (IBCs), used for products including CF Foam and Strata Bond (**Photograph 2**).
- Other storage is general/miscellaneous equipment such as machinery parts and consumables.
- Compressed air is required to be supplied into the underground mine which involves the use of a transformer. No staining is evident at the Golden Point transformer or compressed air facility (**Photograph 3 and 4**).
- Concrete is transferred from above-ground to under-ground trucks at the portal. Washings are discharged to ground with runoff collected into a sediment trap (**Photograph 5**).

Photograph 2. IBC storage at Golden Point portal

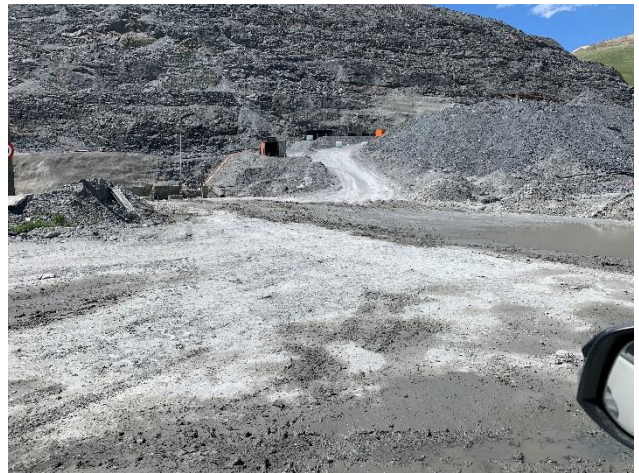
Photograph 5. Concrete washings at the Golden Point portal

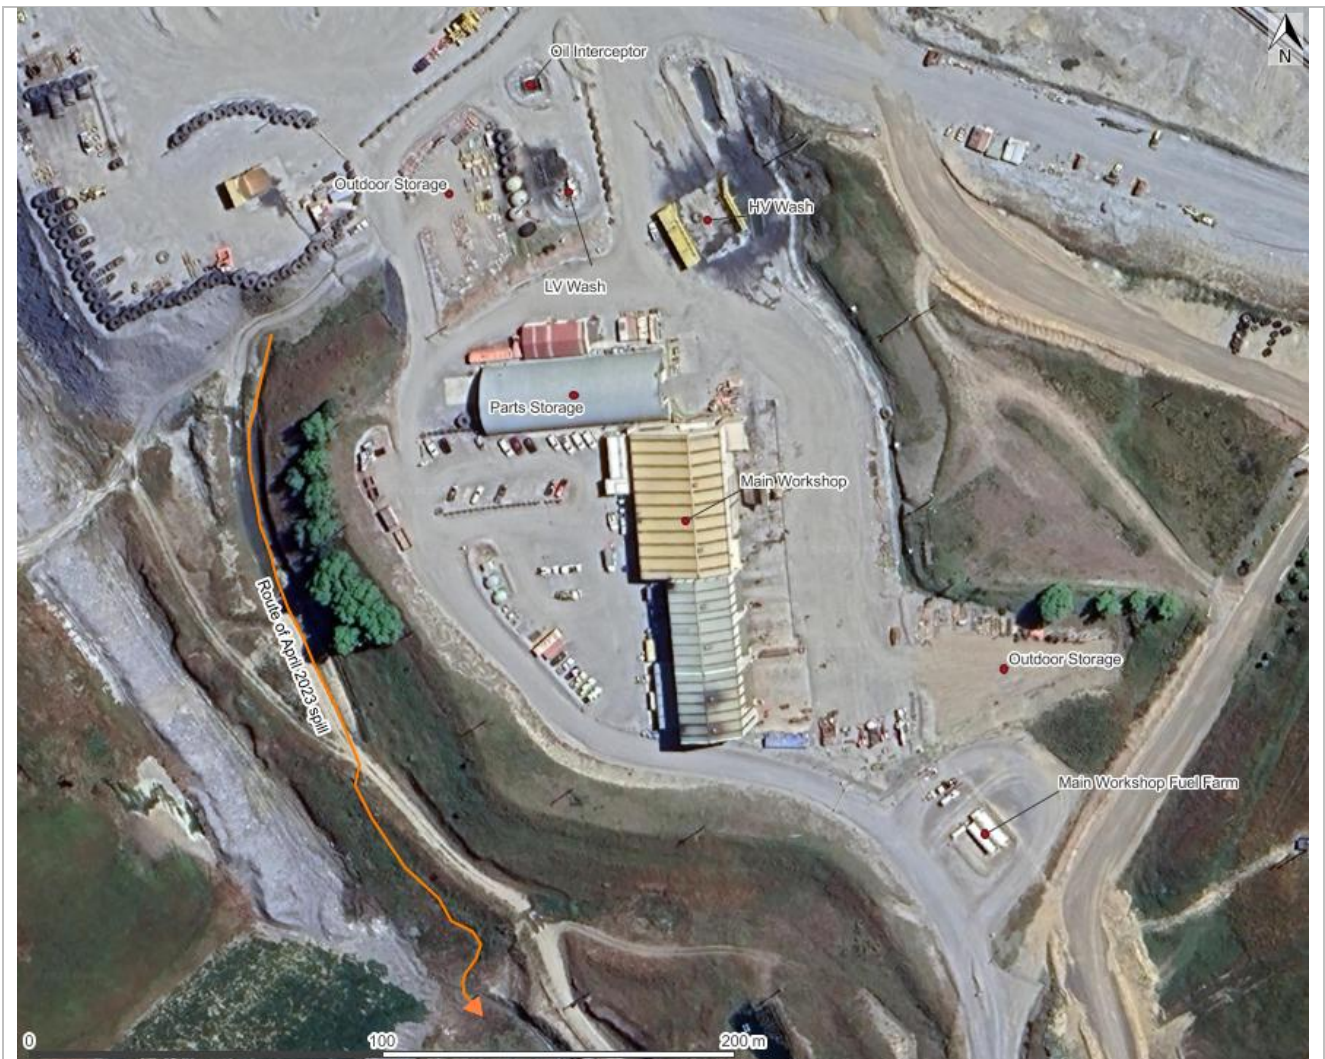
- As discussed in **Section 2.2.4**, it was noted that a large historical spill occurred, resulting from damage to a fuel holding tank on a mobile service truck during a tyre change near the main workshop. Approximately 17,500 L of fuel ran down the drain along the roadside from the tyre changing area and entered the tailings dam (**Figure 11**). Wind blew the oil to one end of the tailings dam where it was able to be removed via vacuum truck and disposed offsite.

Figure 11. Main open pit workshop and surrounds (image source: Google Earth). Spill route shown as orange line

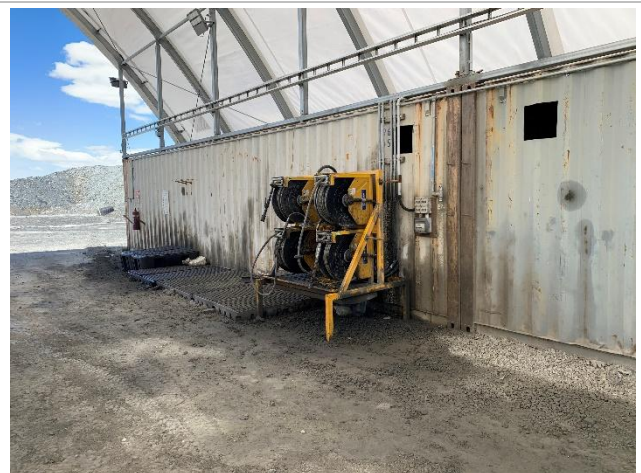
- An oil catchment system, minor staining was visible around the system and the transfer lines (**Photograph 8**).
  - A parts washer was still on site along with miscellaneous parts and machinery.

Photograph 8. Oil transfer system within former Coronation workshop

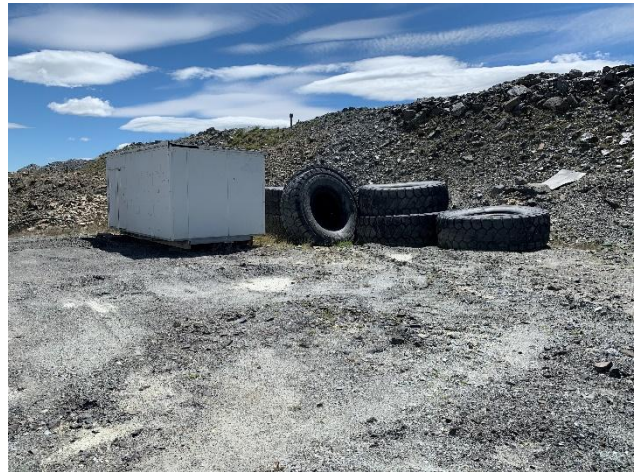
Photograph 10. Miscellaneous storage including tyres at Coronation workshop (tyres in the process of being relocated)

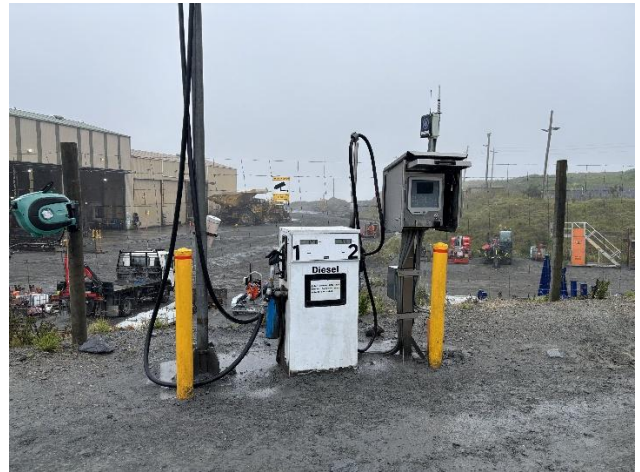
- Tanks are double-lined but generally do not have an external bund. Minor staining is typically visible around the bowsers from spills during refuelling (**Photograph 19**).

Photograph 19. Evidence of minor spills at the Vehicle Workshop Fuel Farm

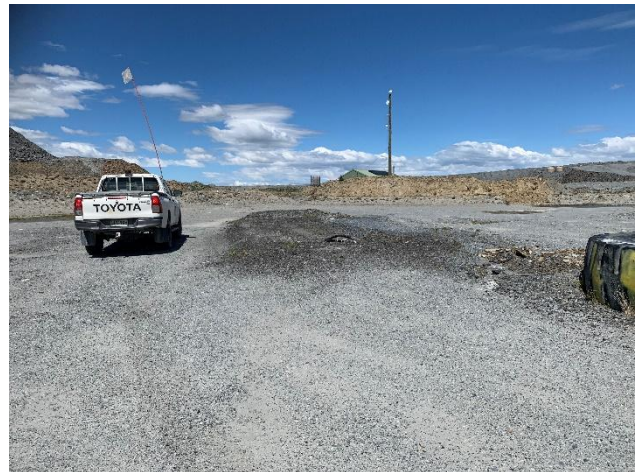
- Some fuel farms also have AdBlue and other fuel additives available for filling, such as at Golden Point Underground Fuel Farm (**Photograph 20**).
- An example of a typical former fuel farm is that which was observed during the site visit at Coronation Crib (**Figure 9**; noting this is now back in use) where only the gravel tank pad, electrical wiring and protective tyres remain. There was no evidence of residual staining at this former fuel farm (**Photograph 21**). Minor building waste, such as residual pipes, was also present at the former Coronation Crib.

Photograph 21. Former Coronation Fuel Farm.

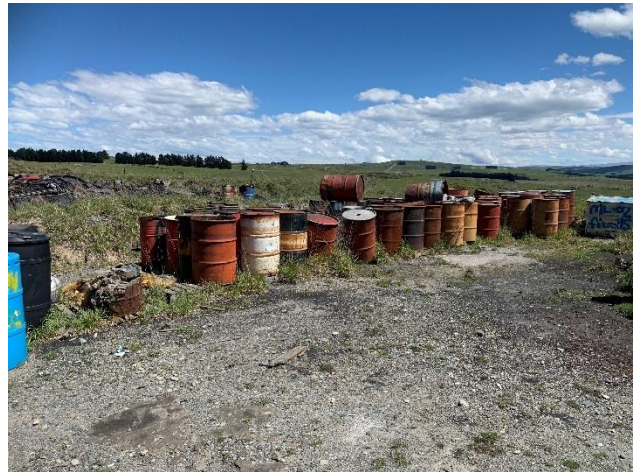
- General wastes are stored in these areas, including spent drums, IBCs, wire, plant/equipment, etc (**Photograph 26**). Many of the drums and IBCs at Finger 13 were noted to be full of used Granular Activated Carbon (“GAC”) from the processing plant; it was expected that this would be re-processed through the plant. Some of the IBCs contained liquid, assumed to be water mixed with the original contents of the IBC. WWLA understands that as of March 2026, remediation of Finger 13 is underway.

Photograph 26. Waste drums at Finger 13

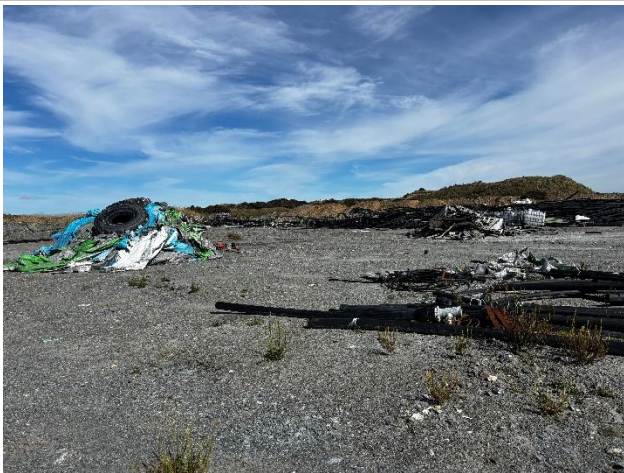
- Finger 33 was previously used for waste storage area for the underground operations. Material stored included vent (duct) bags, tyres, core and proof drilling samples, steel rock anchors/bolts and mesh. It was observed during the site visit that some of the materials had been buried under the western portion of the platform. This has now been largely remediated, with removal of waste and disposal to a licensed landfill ongoing. Updated photos provided by OGNZL as of March 2026 are provided as **Photographs 27 and 28**.

Photograph 27. Refuse removal largely complete at Finger 33

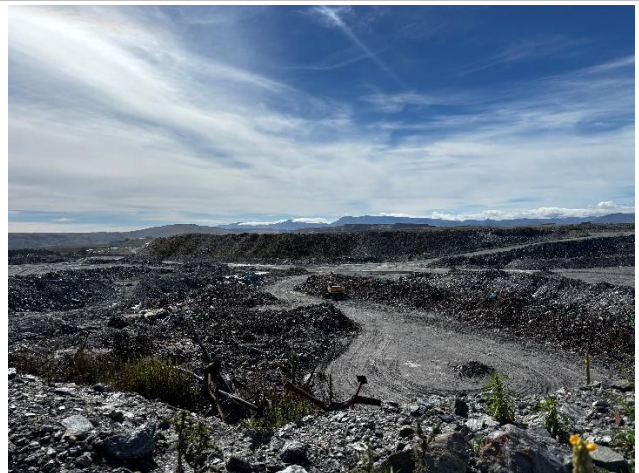
Photograph 28. Current (March 2026) status of Finger 33.

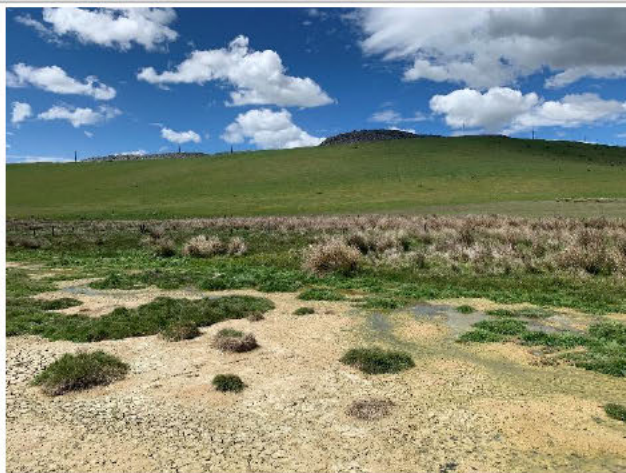
An area of suspected mineralisation /seepage near the northern toe of the Frasers West rock stack was visited during the walkover (Photograph 36). We understand that this is the only known area of uncontrolled seepage associated with the mine operations and a collection system is proposed as part of the MP4 Project. Some impact on grass cover was evident (Photograph 37).

Photograph 36. Overview of area of suspected mineralisation /seepage, Fraser East rock stack in background

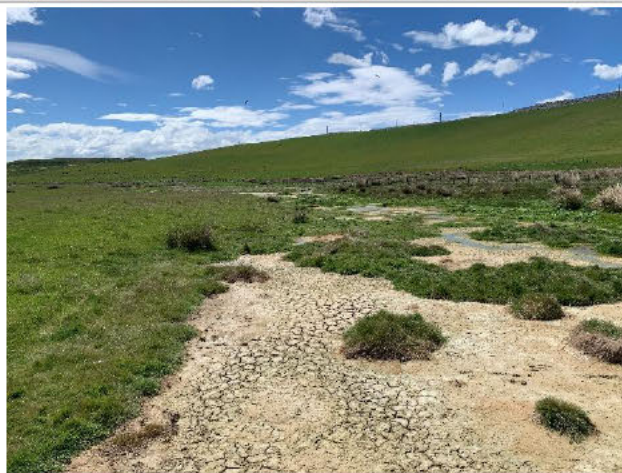
Photograph 37. Closeup of area of suspected mineralisation /seepage
