Geotechnical Appraisal Report

Land Exchange Belmont Quarry
Development Project

Job Reference: BGL000252 v1.0

Report prepared for: Winstone Aggregates

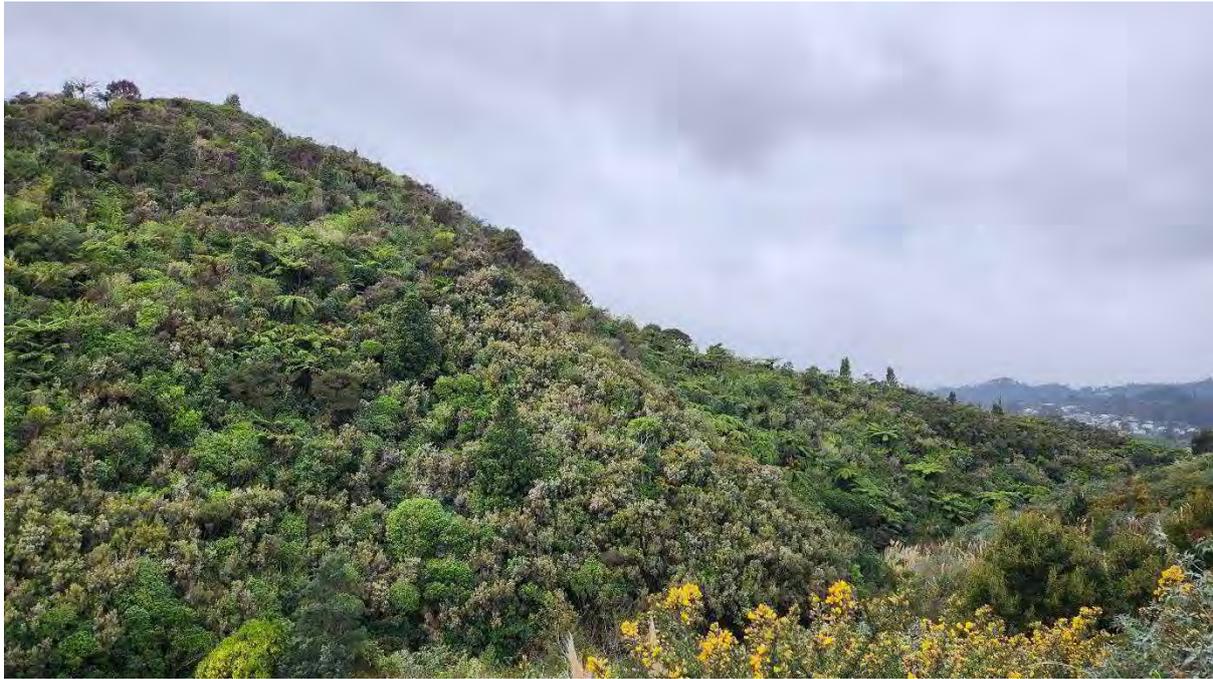
Figure 4-4: Example of natural vegetated northeastern slopes at Dry Creek.

Our review of historical aerial photographs (refer Appendix B – Figures 3 to 5) and our observations made during our site walkover on 20 August 2025 suggest no historical evidence of slope instability in this area of the site (Figure 4-4).

The steepness of the slopes suggests a thin, very stiff to hard soil layer underlain by weathered greywacke rock consistent with adjacent areas of the Belmont Regional Park.

Slope instability in future cannot be categorically ruled out, mainly due to the potential for a seismic event (rupture of the Wellington Fault). In a significant seismic event on the Wellington Fault many of the steep natural slopes in the adjacent Belmont Regional Park are expected to experience shallow instability of the soil regolith. The natural slopes within the proposed land exchange area is expected to demonstrate a similar level of performance.

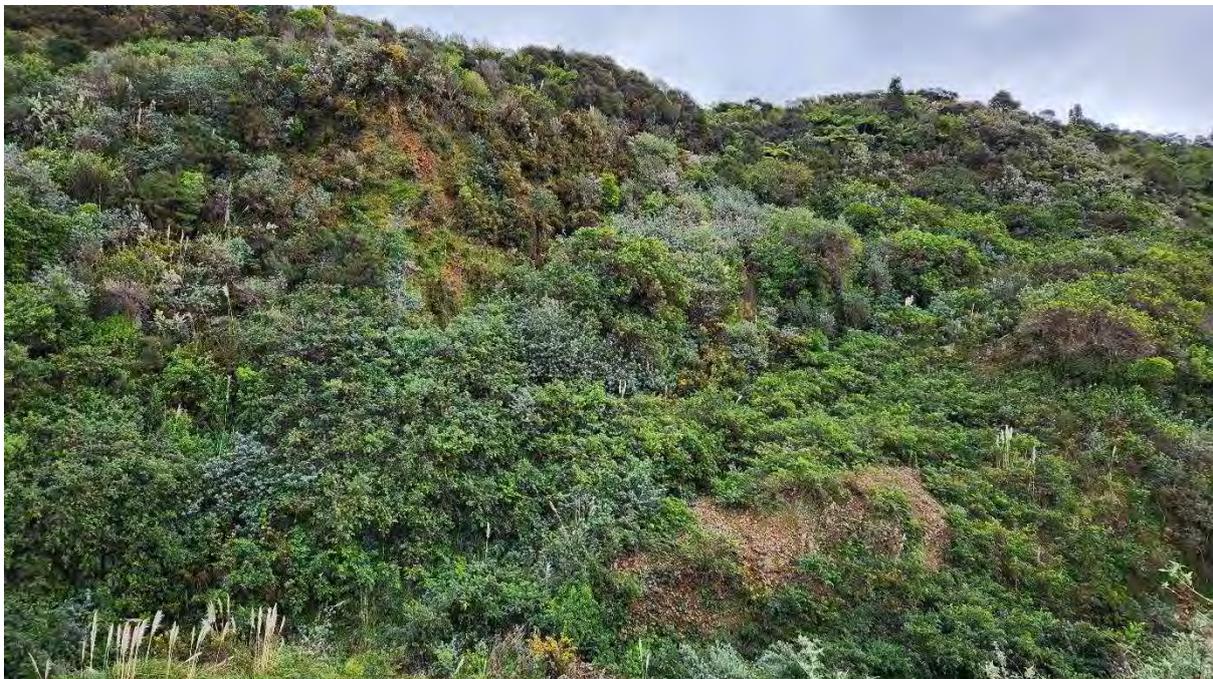
Figure 4-5: Examples of localised rock fall in former quarry batters

The overall slope geometry defined by the unsupported old quarry batters is typically 40-50 m high with an average slope angle of between 30° and 42°. This is comparable to the natural slope angles for the greywacke hills in the area which have slopes of up 100 m high at slope angles of 42°.

Batter performance is typical of old quarry faces with localised areas of spalling of rock from the jointed rock faces and localised instability evident in the upper 1-2 m of soil exposed in the uppermost quarry batter [Figure 4-5].

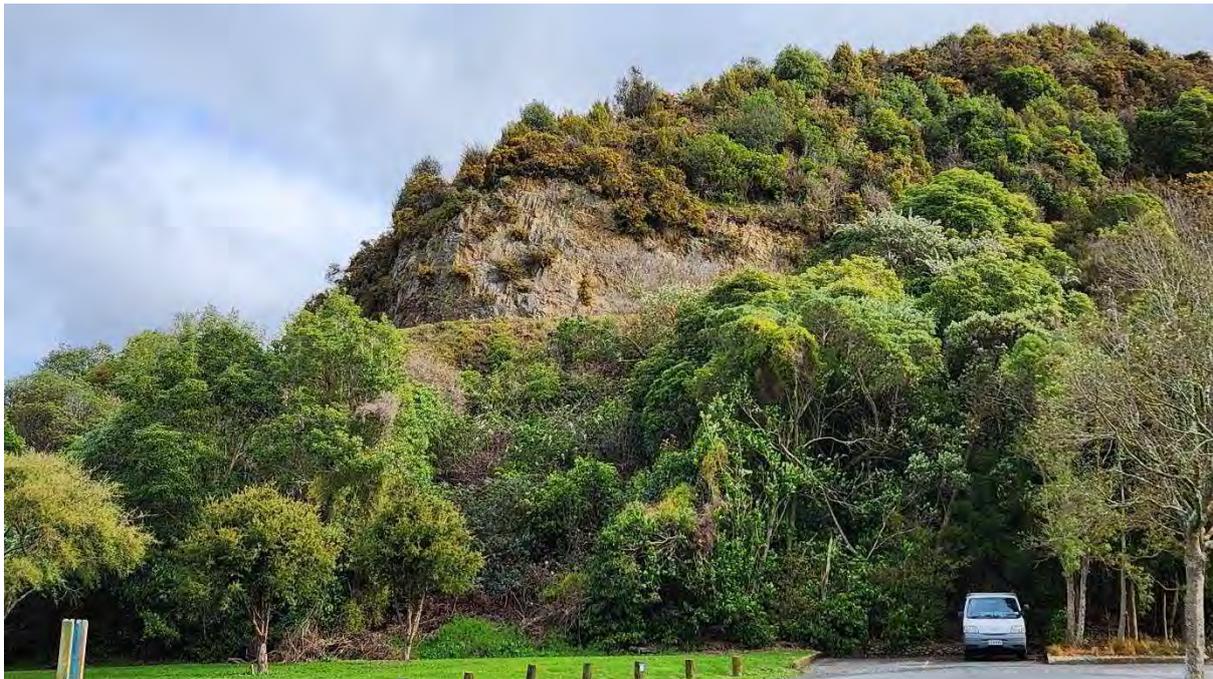
Figure 4-6: Unsupported cut slopes within Belmont Regional Park

Localised small scale instability may still be possible in cut batters above the former quarry access road, but that scale of instability is considered to present little risk to persons and negligible risk to the conservation values of the proposed exchange parcel. We note that similar, or more significant hazard/risk exists for access roads that are already present in Belmont Regional Park (Figure 4-6).

Overall, it is our opinion that slope stability hazard in this proposed land exchange parcel is limited to very localised areas of old access roads and the risk to persons and conservation values is negligible.

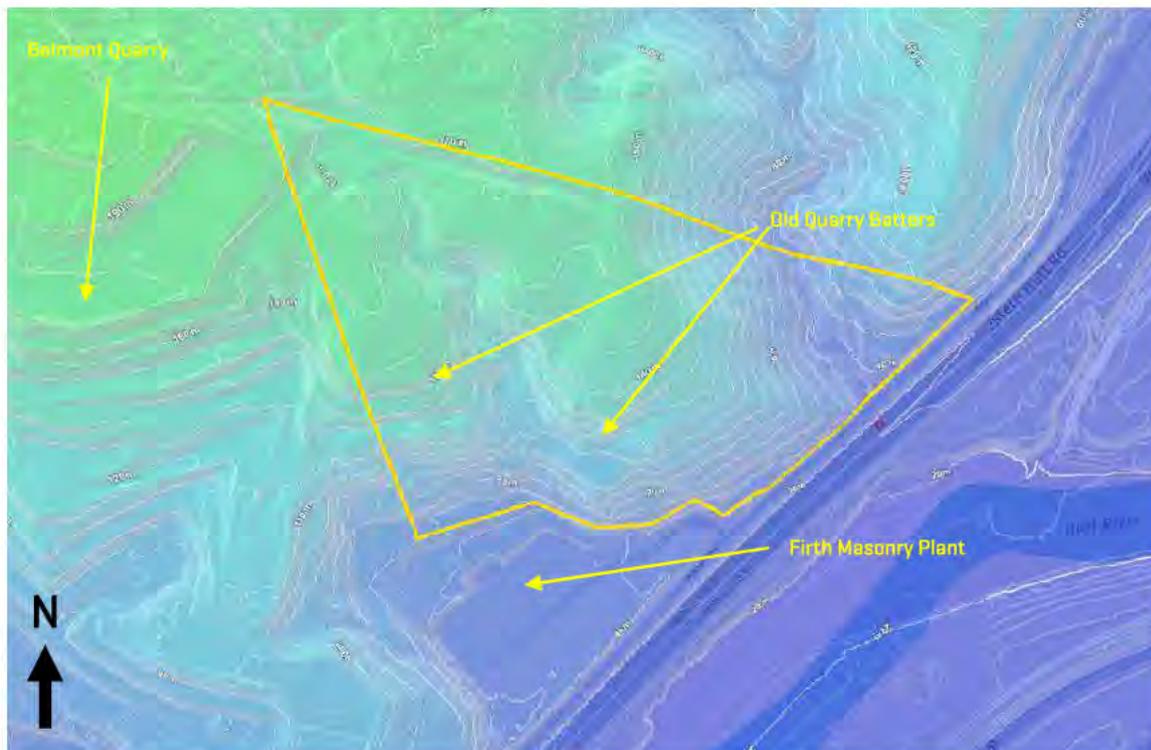
Figure 5-1: Lidar data for Firth Block, proposed exchange land illustrated indicatively [source Winstone Propeller site].

Lidar data for the site indicates that the remnant quarry slopes include 50-60° slopes between 15 and 45 m in height. Overall slope angles from the northernmost Firth site access road to the crest of the uppermost batter are 41-45° for slopes between 85-90 m in height [Figure 5-1].

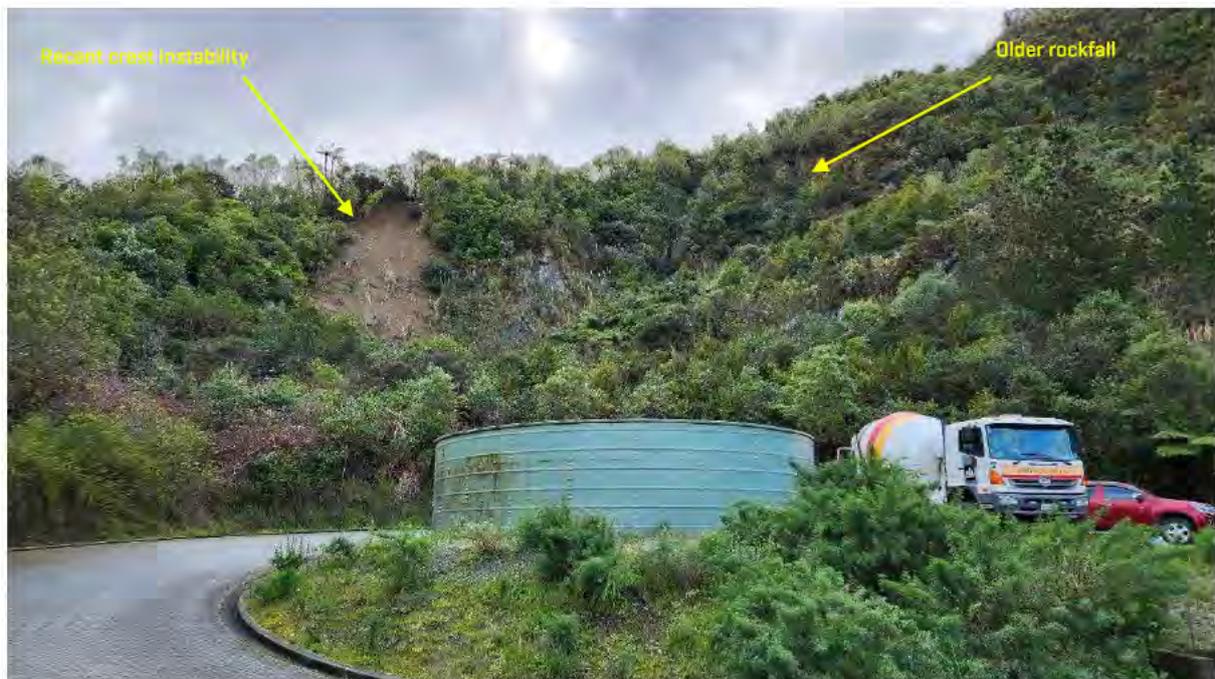
Figure 5-2: Remnant quarry batters Firth Block

Upper quarry batters could be observed from the northernmost Firth accessway. These have generally revegetated, but it was apparent that some rockfall has occurred in localised areas over time [Figure 5-2].

A recent [2025] localised area of instability was observed in the northwest corner of the site, where failure of the upper soils above a remnant quarry batter has occurred over a width of slope of approximately 12 m. The soil material has evacuated down the quarry batter, clearing the batter downslope of vegetation with debris coming to rest on a lower remnant bench [Figure 5-2]. Some localised sections of the remnant quarry batters were observed to be sub-vertical.

In terms of the remnant quarry batters, the recent localised instability observed at the Firth Block [Figure 5-2] lies within land that abuts Belmont Quarry and lies outside of the proposed land exchange parcel [refer Appendix B – Figure 6].

Other quarry batters are generally revegetated, and any remaining loose blocks of rock can be expected to have already fallen from the quarry batters since closure. However, over time continued intermittent spalling and localised areas of rock fall can be anticipated due to ongoing cycles of wetting and drying, root action from vegetation opening fractures in the rock mass or due to seismic events.

While there remains a localised slope instability hazard associated with these remnant batters, the area between the uppermost batter and the Firth Masonry plant site is heavily vegetated and largely inaccessible. Localised batter scale instability therefore is not expected to present a significant risk to persons.

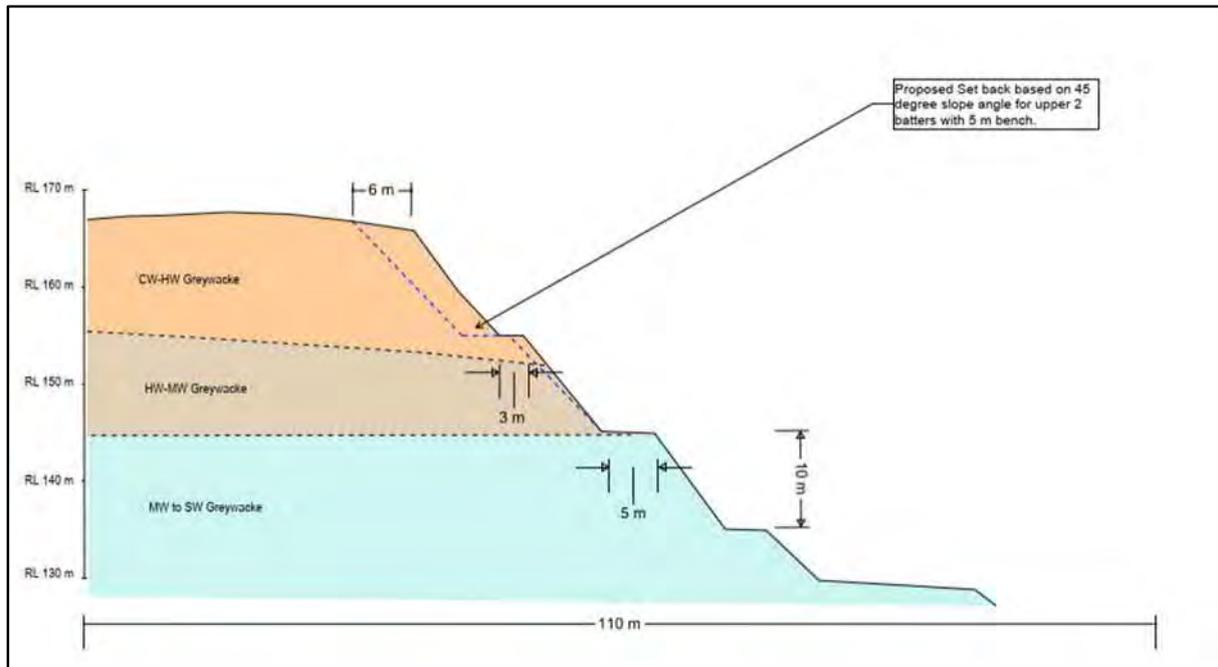
Figure 5-4: Cross Section through Area C

The uppermost batter (above RL 155 m) is formed within completely to highly weathered greywacke, the second batter (between RL 145 m and RL 155 m) is formed within highly to moderately weathered greywacke, while the lower batters are formed within slightly to moderately weathered greywacke.

The key defects in the face are west to east striking bedding, which dips very steeply towards both the north and south. Bedding is defined by thin seams of dark grey argillite.

Below RL 155 m, the batter slopes are generally consistent with the advice provided in T+T 2010 and these batters appear to be performing acceptably. The exception to this is:

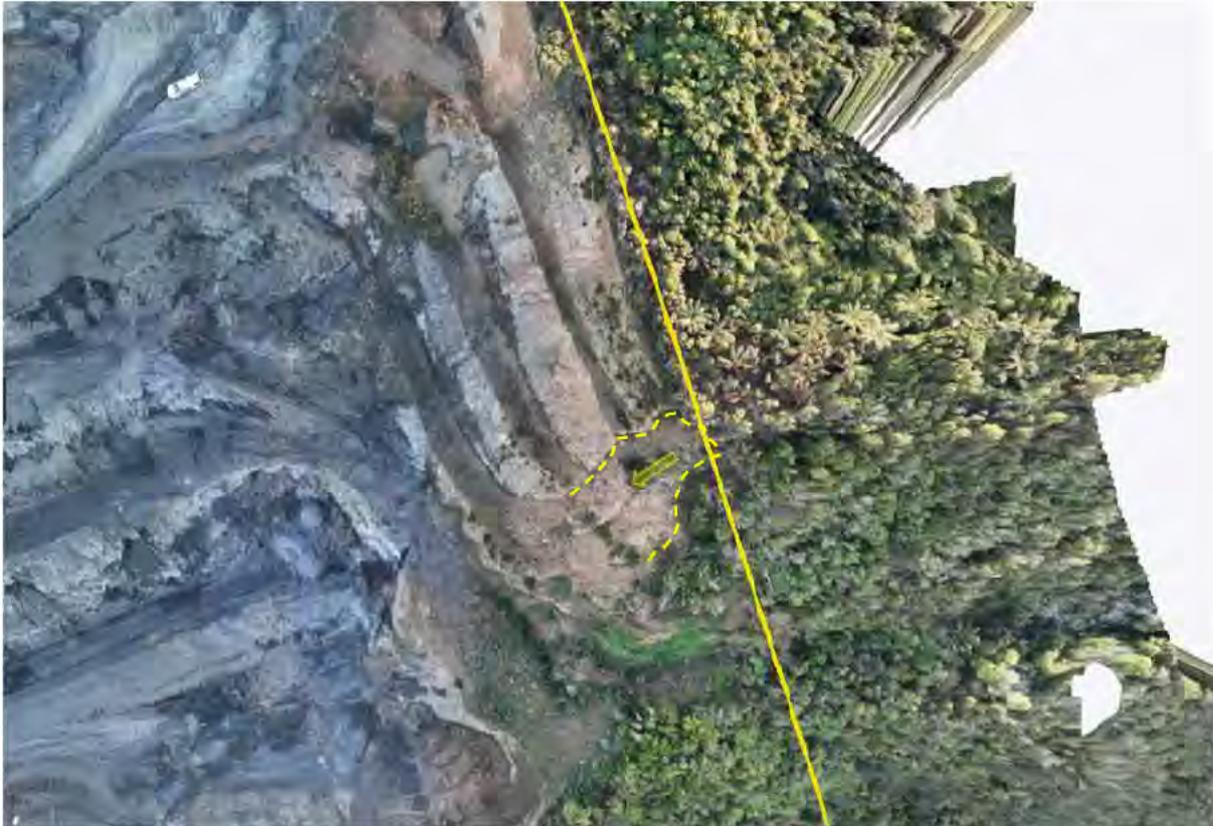
Figure 5-5: Existing instability in Area C. Belmont East wall abutting the Firth Block.

A localised area of slope failure has occurred at the far southern end of the cut batters in this area. This appears to have occurred in an area of deeper weathering of the greywacke, but also where the batters were rotated around to become more northwest-southeast trending as a tie-in to the ground surface. This change in geometry has allowed failure to occur on steep bedding, orientated oblique to the slope with breakout through the highly weathered rock mass. The instability extends through the upper two batters, with debris spilling onto the benches below. It is not clear whether this instability extends into the proposed land exchange area.

Based on our observations in this area, we consider that a 6 m zone measured from the crest of the slope back into the proposed land exchange area presents a higher risk of instability than would normally be accepted for a final cut batter adjacent to a property boundary. The basis for this zone is a hypothetical bench batter geometry of 10 m high batter slopes at 45° separated by a 5 m wide bench, which could be expected to perform acceptably in the materials observed.

While instability could be expected to develop slowly in this area due to residual strengths on defects in the weathered zone, if this zone is included in the land exchange, it would be prudent to exclude people from this area. This could be achieved by erecting fencing positioned a minimum of 6 m from the crest of the quarry batters in this area.

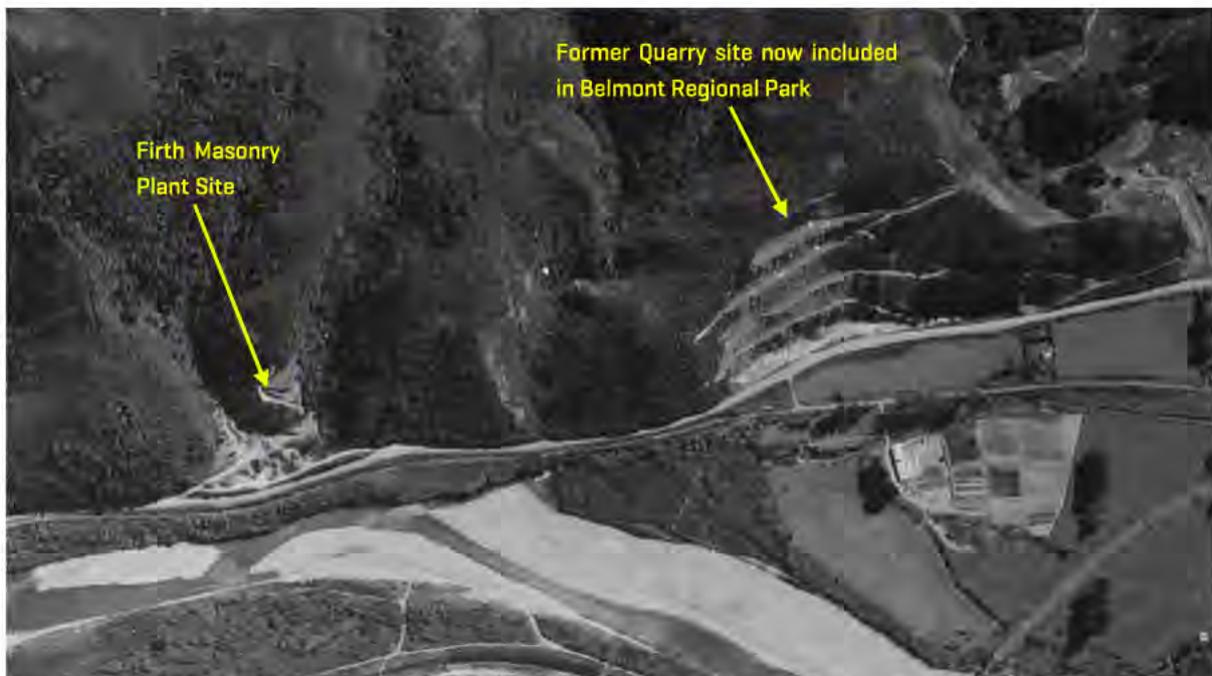
Figure 5-6: 1957 aerial photograph illustrating historic quarry faces incorporated in Belmont Regional Park.

We note that the conservation estate in this area already incorporates an old quarry site on Hebden Crescent, located between the Firth Block and Dry Creek Sites, which was later incorporated into Belmont Regional Park. Excavation at that site appears to have been undertaken in the 1950's and 1960's [Figure 5-6], with the site closed and beginning to revegetate in the 1974 aerial photographs. The remnant quarry batters at the Firth site are consistent with size and scale of those remnant batters that already exist within the Regional Park.

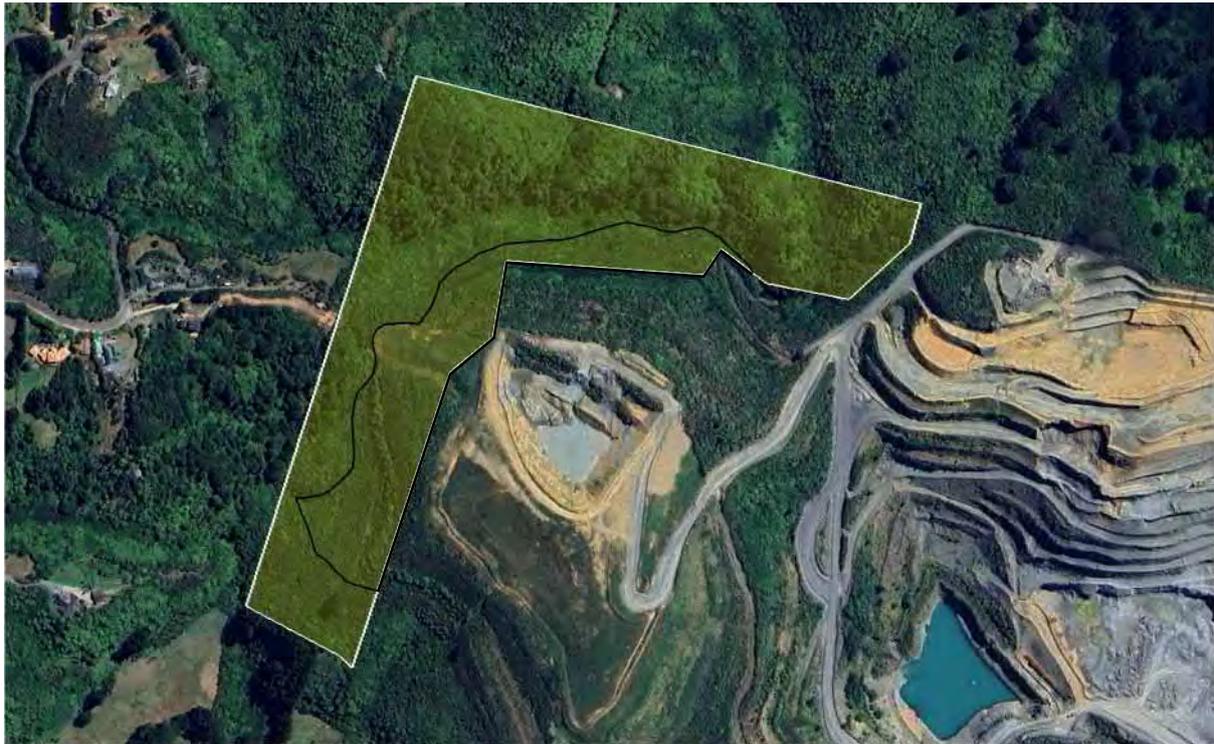
Figure 6-1: Northern Gully exchange parcel [white outline] illustrating former Cottle OBDA placement [black outline].

Part of the proposed exchange parcel incorporates the lower portions of the Cottle OBDA which we have previously observed over a decade or more of involvement with the site [Figure 6-1].

There has been no instability observed in final slopes within the Cottle OBDA since construction commenced in the mid 2000's. Rehabilitation has been progressive since construction commenced and the larger part of the Cottle OBDA that is included in the proposed exchange area has been rehabilitated and revegetating since 2015.

The Cottle OBDA is a designed landform, with the final stage of design completed by Tonkin & Taylor Limited (T+T) in 2019⁷. That document sets out that the final design for the OBDA was expected to have achieved acceptable levels of static and seismic stability [Damage Control Limit State], with calculated displacements in the Maximum Considered Earthquake of less than 170 mm.

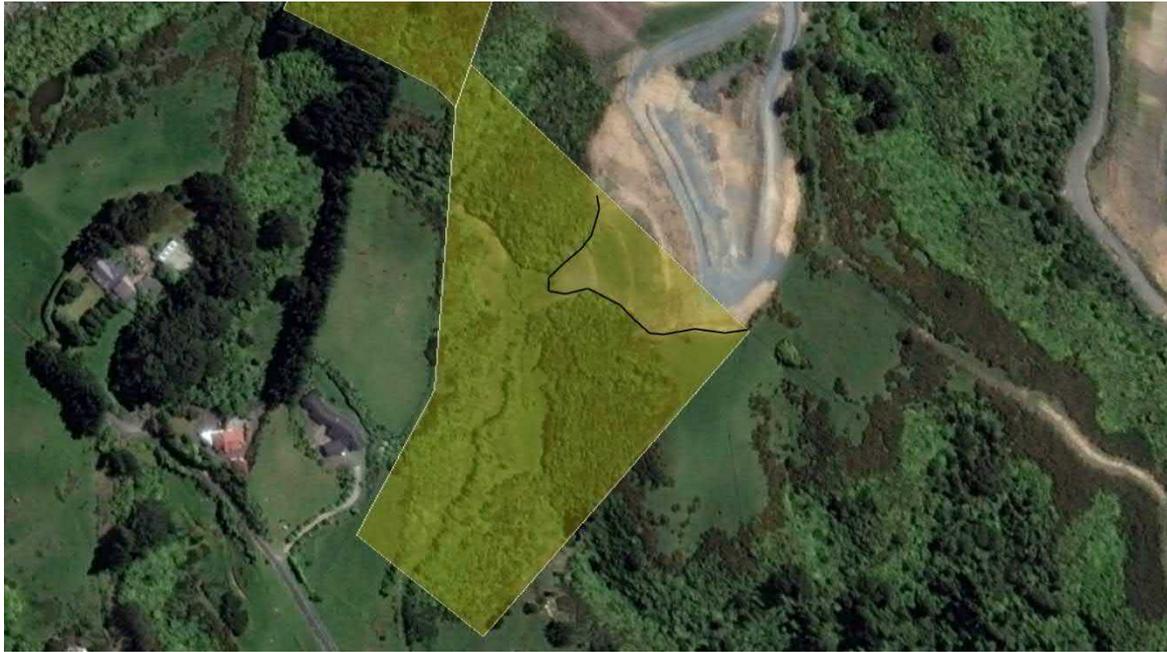
Figure 7-1: Southern Gully Parcel [yellow] illustrating extent of Cottle OBDA fill placement [black line]

The first evidence on the Cottle OBDA extending into this parcel is apparent in aerial photographs from 2015 where the toe of the OBDA is under construction (Figure 7-1). This part of the Cottle OBDA was substantially rehabilitated by 2017.

As noted in Section 6.3, the Cottle OBDA is designed to achieve acceptable levels of static and seismic stability. Since construction of this section of the Cottle OBDA was completed in 2015, the site has been rehabilitated and revegetated. There has been no instability observed in final slopes within the Cottle OBDA since construction commenced in the mid 2000's.
