Technical Advice – Structural Engineering by Jan Stanway

Genesis Energy **Tekapo Submerged Weir**

Structural Condition Assessment

Tekapo Submerged Weir
Structural Condition Assessment

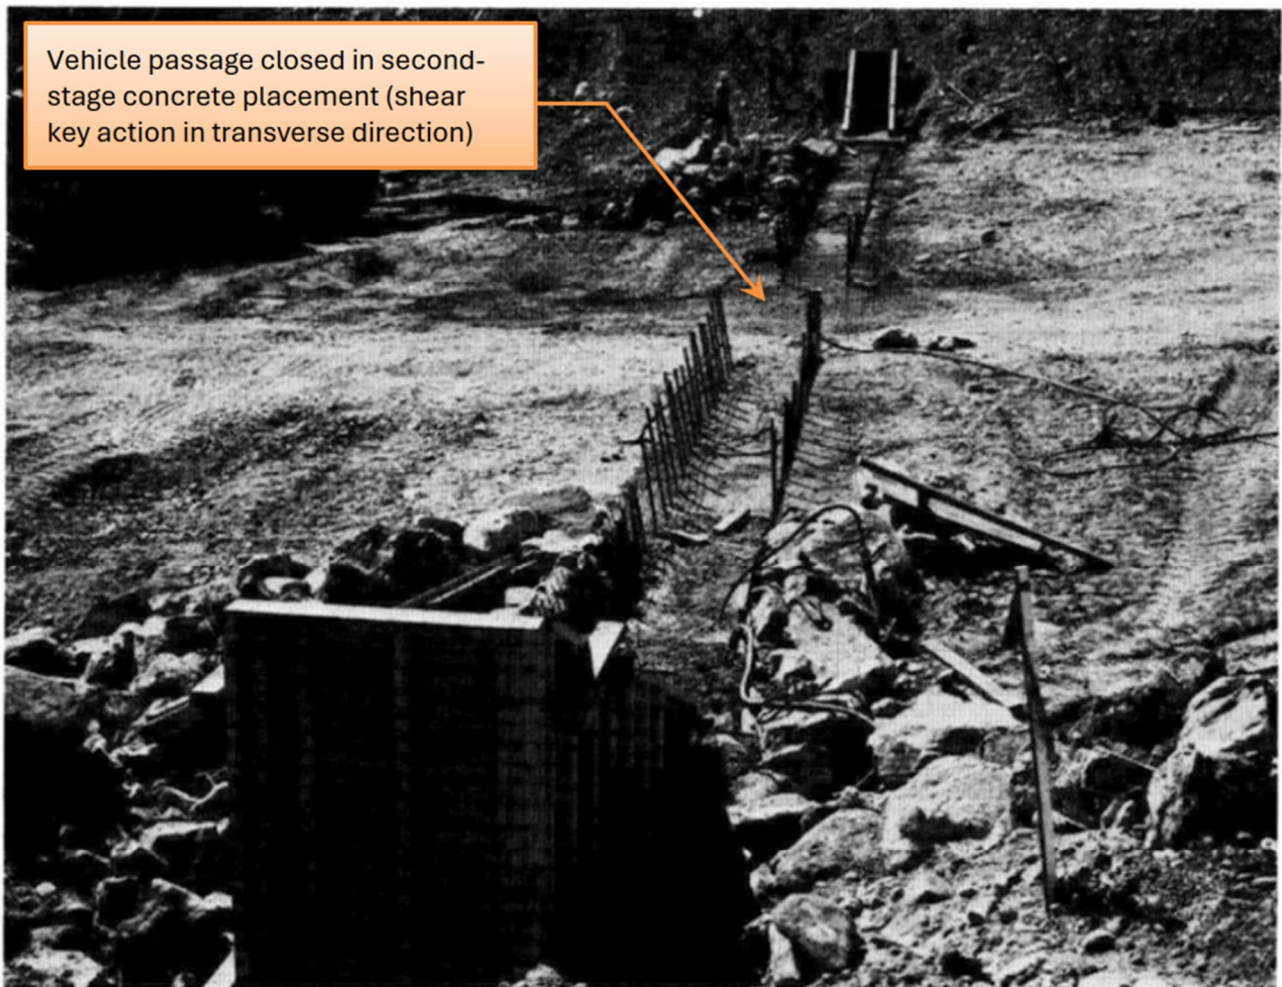
Figure 2-1. Photograph of construction sequence of ribs (source Damwatch Memo dated 27/02/2026).

Review of the drawings and a historical photograph (see Figure 2-1) confirms that the reinforcement that was cast into the unreinforced concrete base section of the weir and sills was provided to create a basic formwork to support the riprap. Following riprap placement, the cap section of the weir and sills was poured between the riprap. The reinforcement provided was not intended to create a reinforced concrete section; the weir and sills act as unreinforced concrete sections. Where the rebars were not surrounded by concrete the vertical 'dowel' bars do not act as normal reinforced concrete dowels to provide a shear and overturning connection between the cap and base sections of the sills. Instead, the reinforcement may have held the unreinforced concrete in place where there was no gap between the reinforcement and the concrete, and resist shear and overturning demands by bearing on the downstream reinforcement.

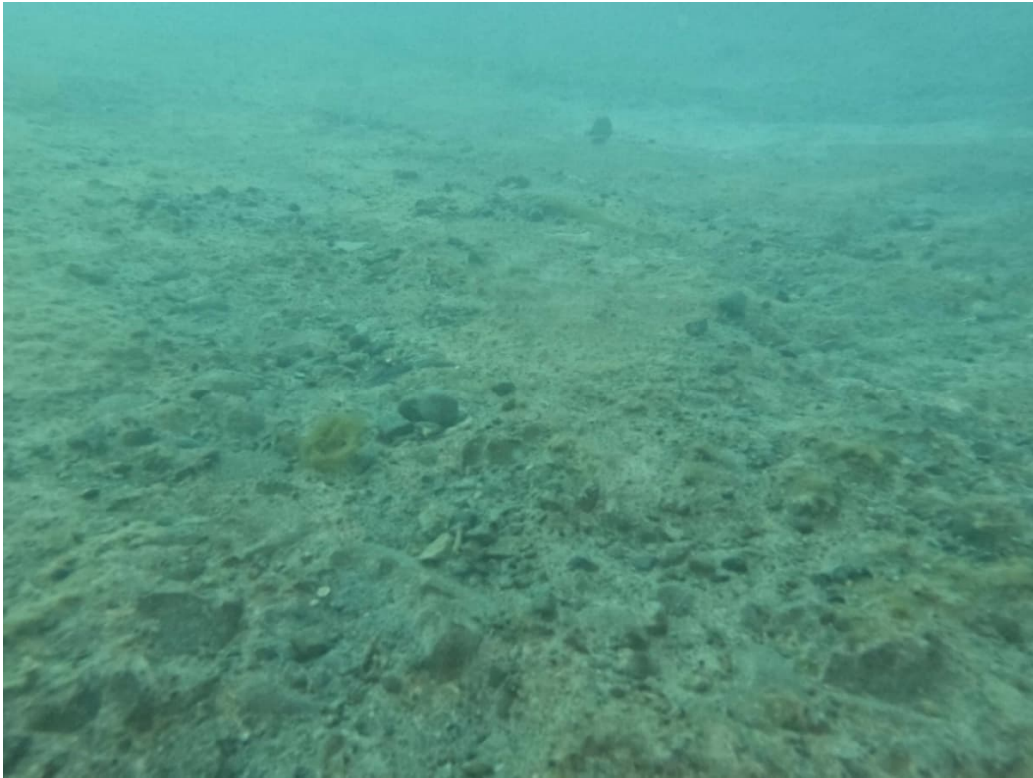
The structure was covered with sediment approximately 40 mm thick. Overall, the structure was in adequate condition. There were multiple areas of exposed aggregate on the surface of the concrete and there was exposed reinforcement on most of the length of the upstream edge of the weir. The riprap that the weir was poured against has rolled away in several areas, exposing reinforcement that appeared to have not been encased in concrete when the structure was originally poured.

Figure 2-2. Picture of typical surface condition of control weir.

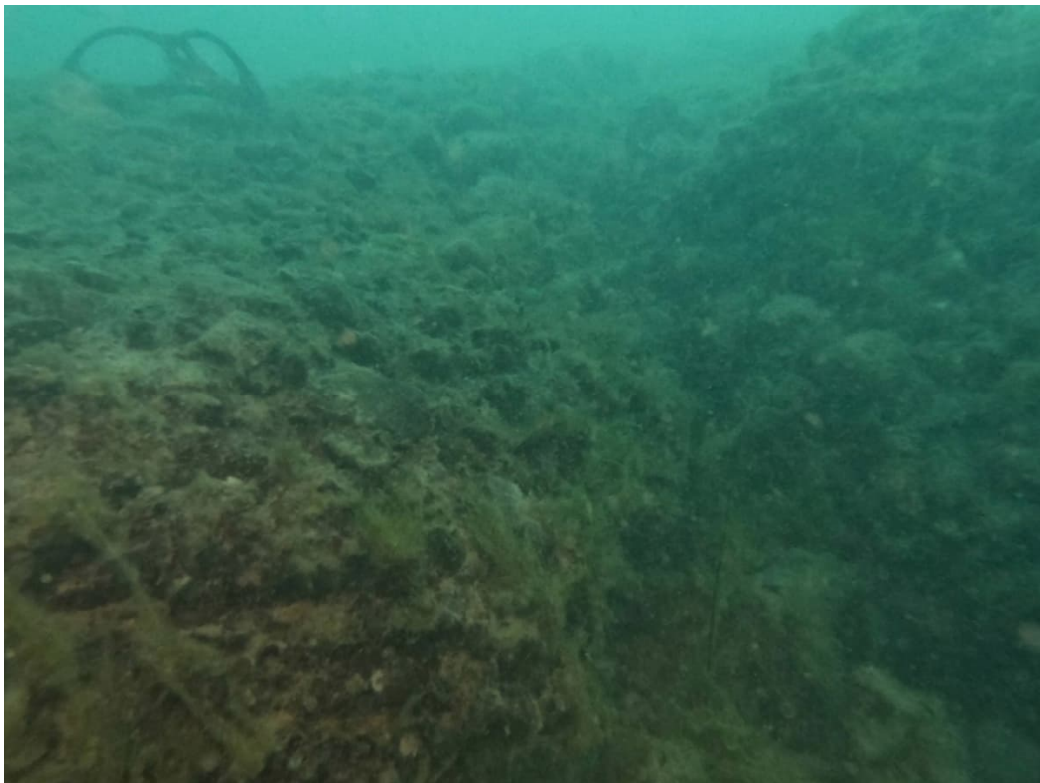
There were several instances of spalling on the top of the weir, forming shaped indentations. The largest being approximately 400x400x100 mm (LxWxD). An example is shown in Figure 2-3, this should be checked to confirm if this has been caused by the passage of water or a crack.

Figure 2-3. Example of channel formed in top surface of control weir.

Areas of concrete subject to section loss or where indentations have formed should be repaired using Sika MonoTop 412N or an approved alternative. It is important to confirm the reason for the indentation in the top surface prior to confirming the repair methodology, if due to channelling due to the passage of water repair with Sika MonoTop 412N is appropriate, however if it is due to a crack, the underlying cause of the crack needs to be addressed as part of the repair works.

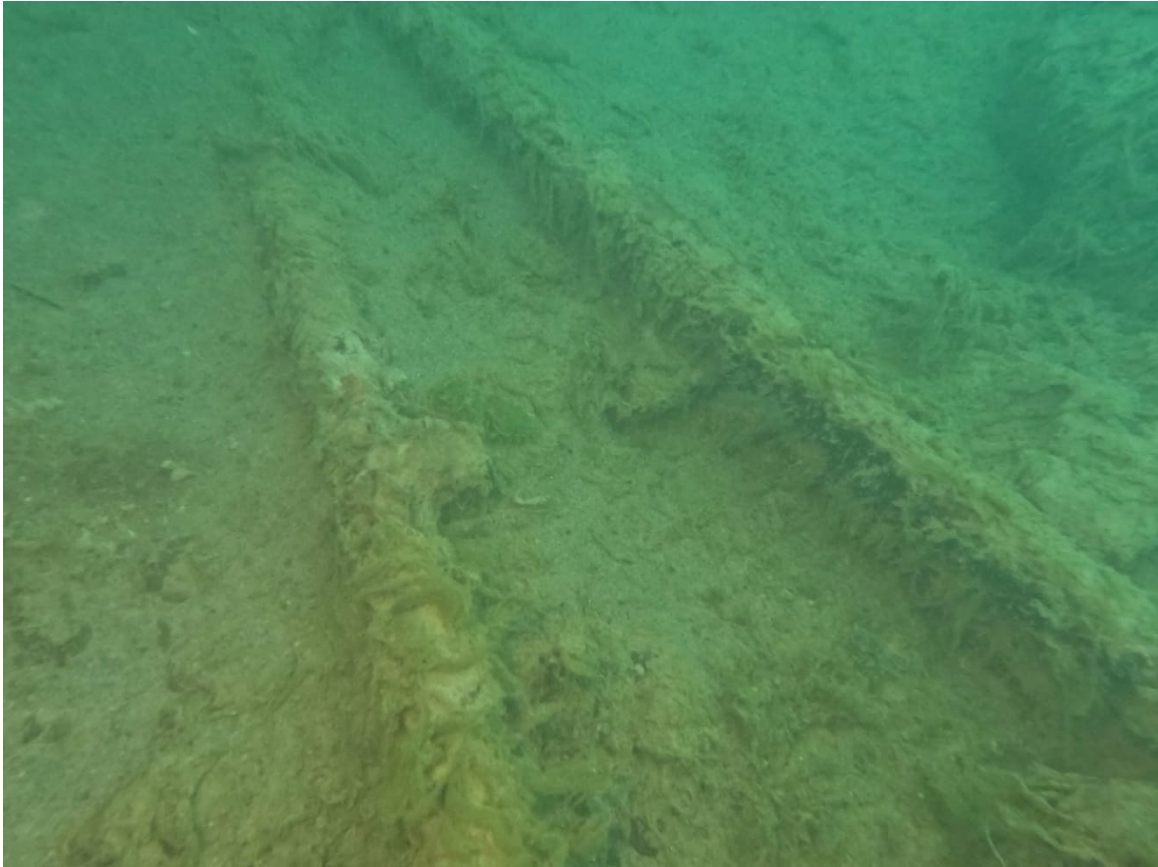
There were several instances of exposed reinforcement on the upstream side of the control weir. Nearly the entire length of the top longitudinal bar on the upstream side of the weir is exposed and appears to be corroded, with a 40 mm maximum gap between the reinforcement and the concrete. This aligns with the construction methodology as discussed in Section 2-2 where the reinforcement was provided as simple formwork to hold the riprap prior to the concrete being poured between the riprap.

In some instances the longitudinal reinforcement bar appears to be 20-30 mm above the level of the concrete and flush with the surface of the concrete in other areas, which shows that the bar has been exposed for the entirety of the structure's life and the concrete was poured and set with the bar exposed. Examples of exposed longitudinal bars are shown in Figure 2-4 and Figure 2-5.

Figure 2-4. Example of exposed reinforcement on top of weir structure.

Areas of reinforcement corrosion shall be broken out to undamaged concrete. The steel reinforcement is to be cleaned with a mechanical wire brush down to the bare steel and treated with Sika FerroGard 903 Plus or approved alternative. New dowels should be installed along the length of the weir and ribs, then the concrete shall then be reinstated using Sika MonoTop-412N repair mortar or an approved alternative to fill the remainder of the repair area.

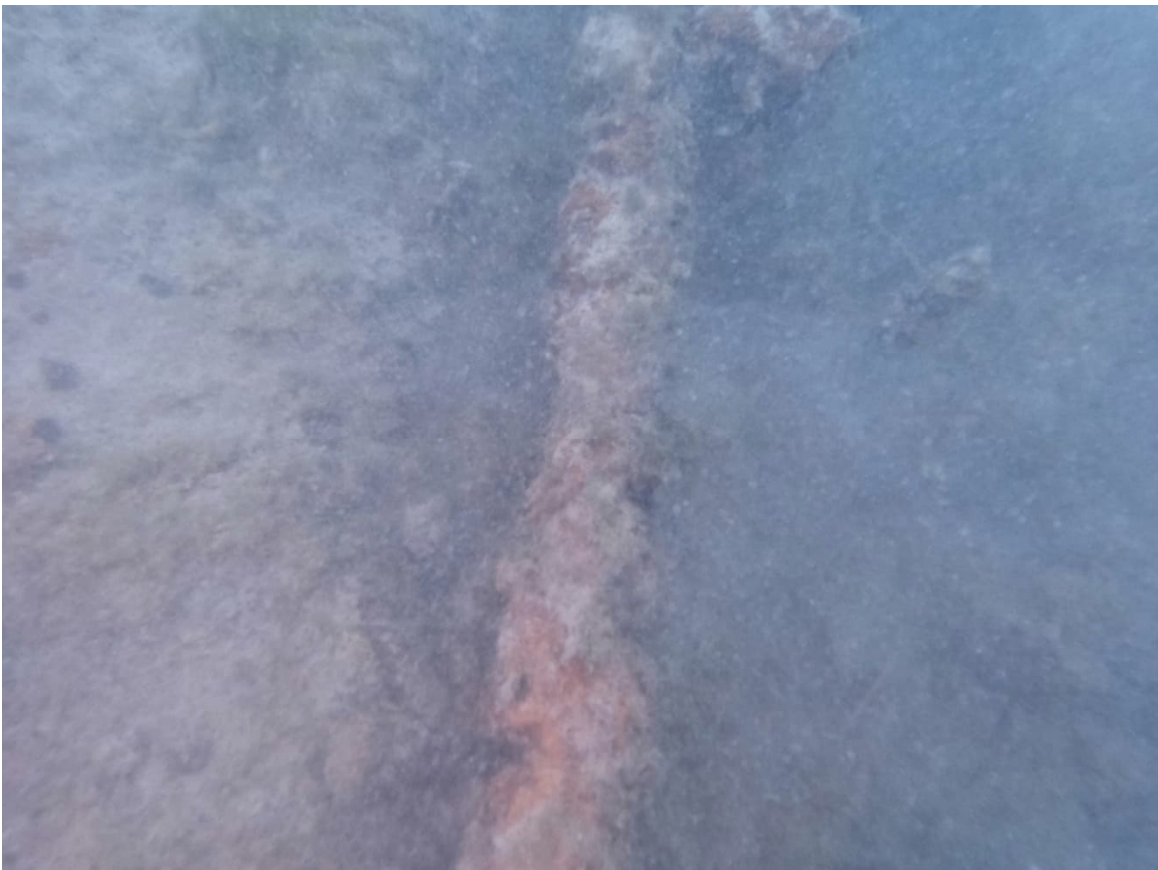
Figure 2-5. Example of exposed longitudinal reinforcement on upstream corner of weir structure.

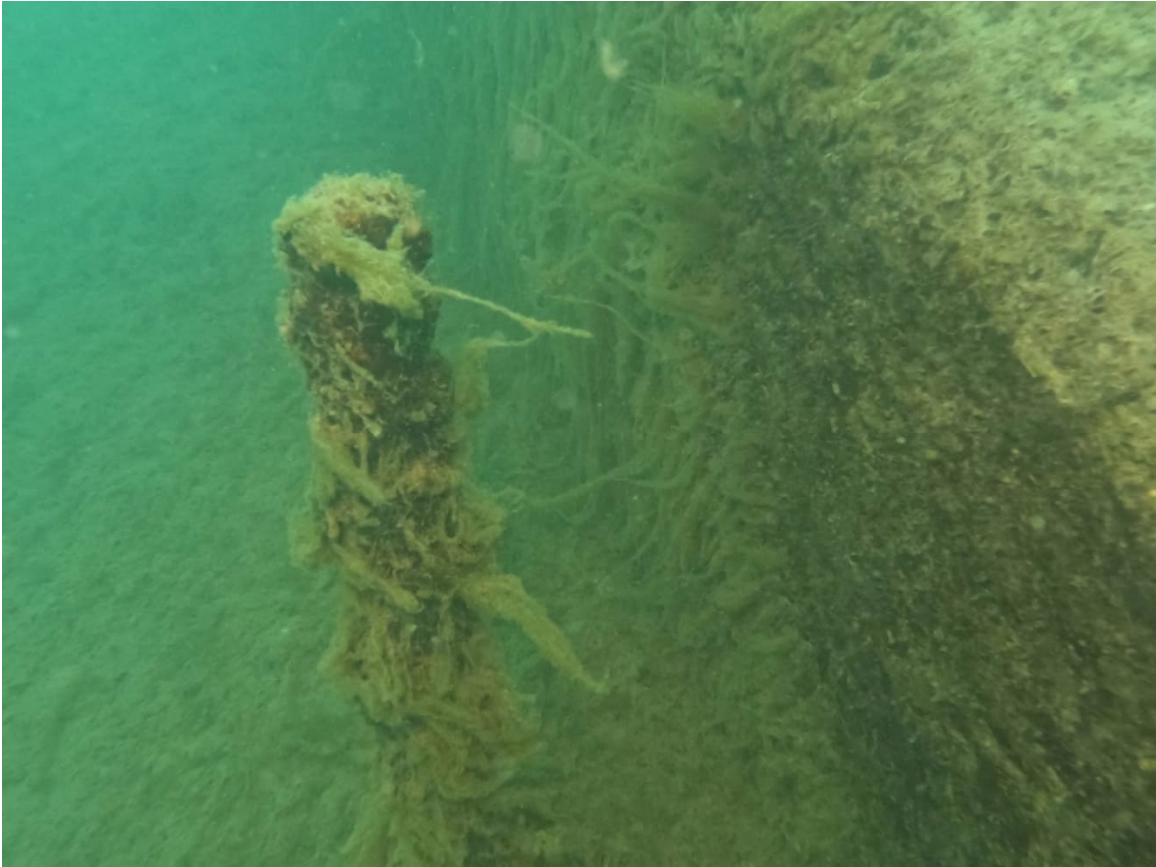
Vertical reinforcement around the weir was observed where the weir has been cast against the rip-rap which has subsequently been displaced. The vertical reinforcement appears to have never been encased in the concrete based on the distance between the bar and weir structure (approximately 60 mm). An example is shown in Figure 2-6.

Figure 2-6. Example of exposed vertical reinforcement on control weir.

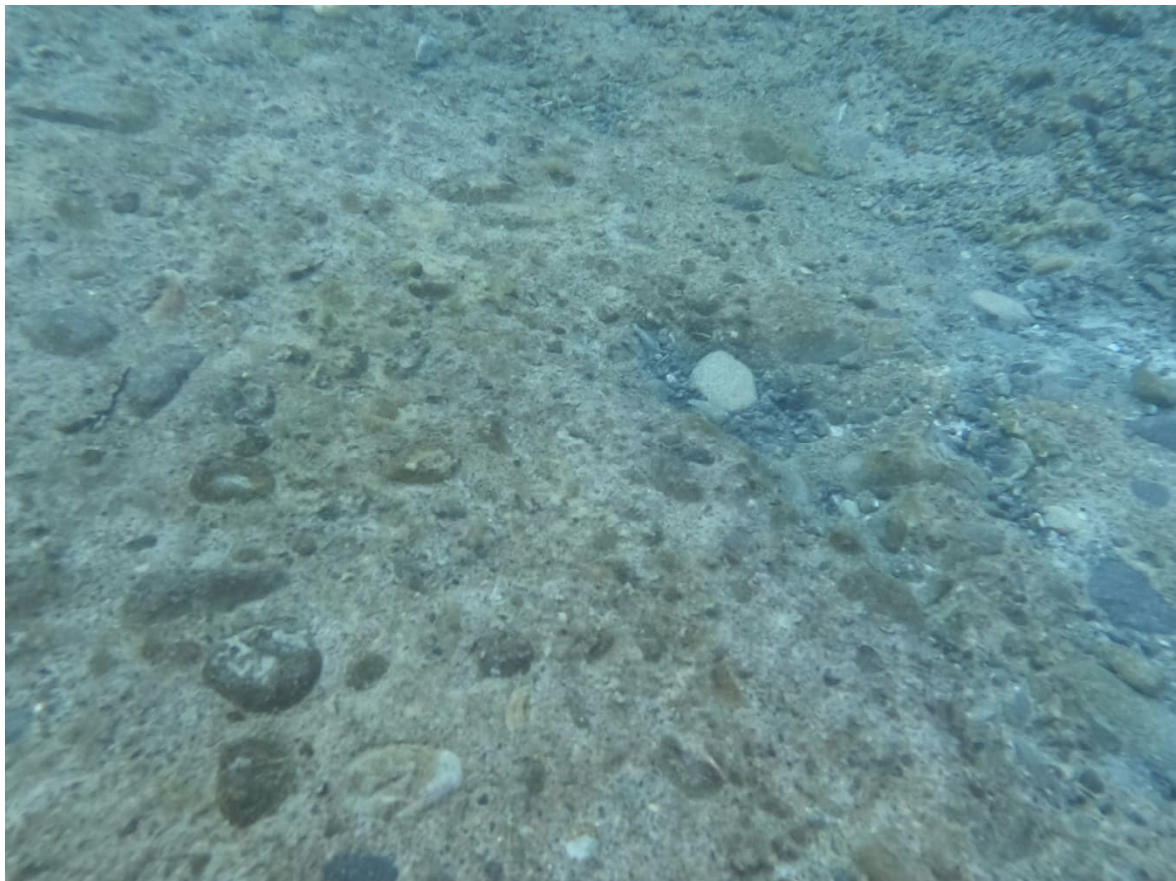
The surface concrete of the weir was generally in reasonable condition. There were multiple cases of exposed aggregate on the surface of the weir, with a maximum loss of section of 20 mm. An example is shown in Figure 2-7.

Figure 2-7. Example of exposed aggregate on the surface of the control weir.

Areas of concrete subject to section loss should be treated with Sika MonoTop 412N, or similar approved, to minimise further damage to the concrete.

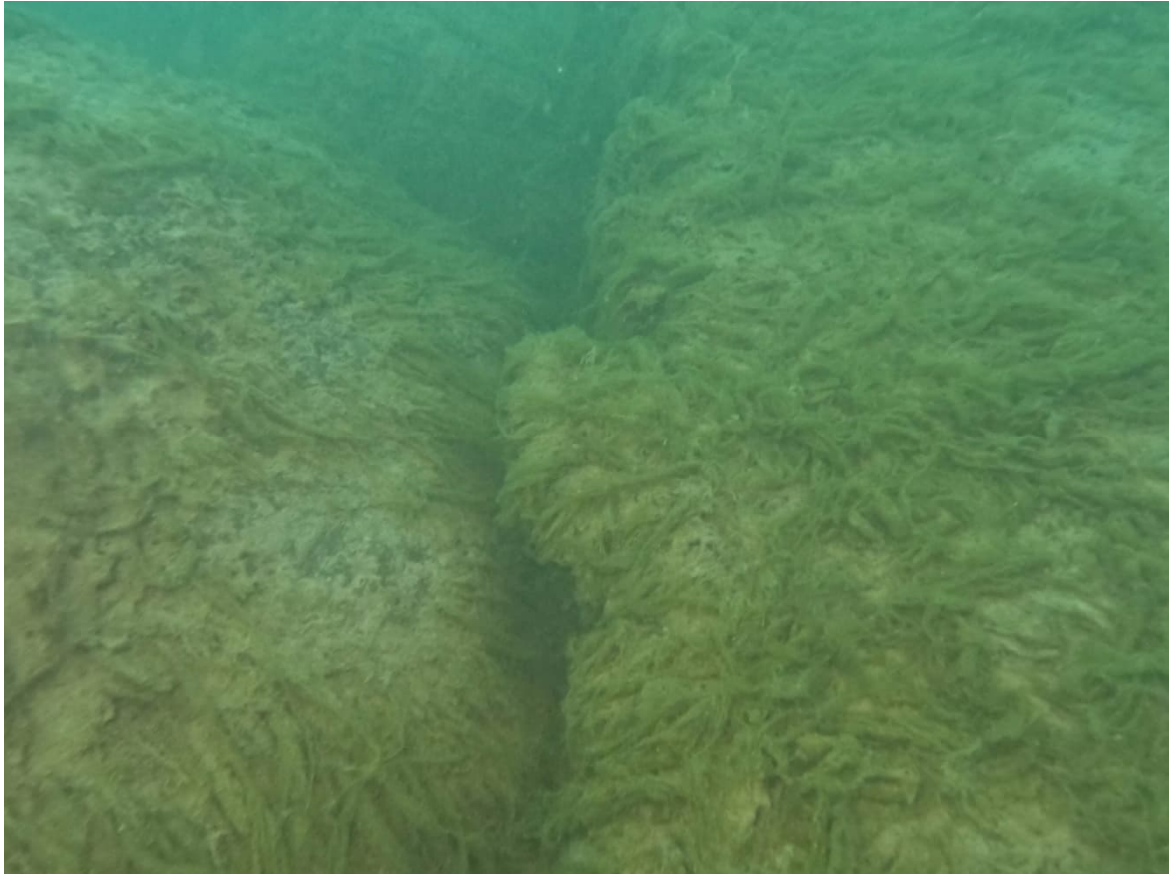
There were no noticeable instances of displacement of the control weir. There are areas along the length of the weir that had an overhang of concrete where it was poured against rip-rap which has subsequently been displaced. An example is shown in Figure 2-8.

Figure 2-8. Example of rip-rap (left) rolled away from concrete (right).

Areas around the upper four ribs and weir that have missing rip-rap should have the rip-rap reinstated to match the original design profile.

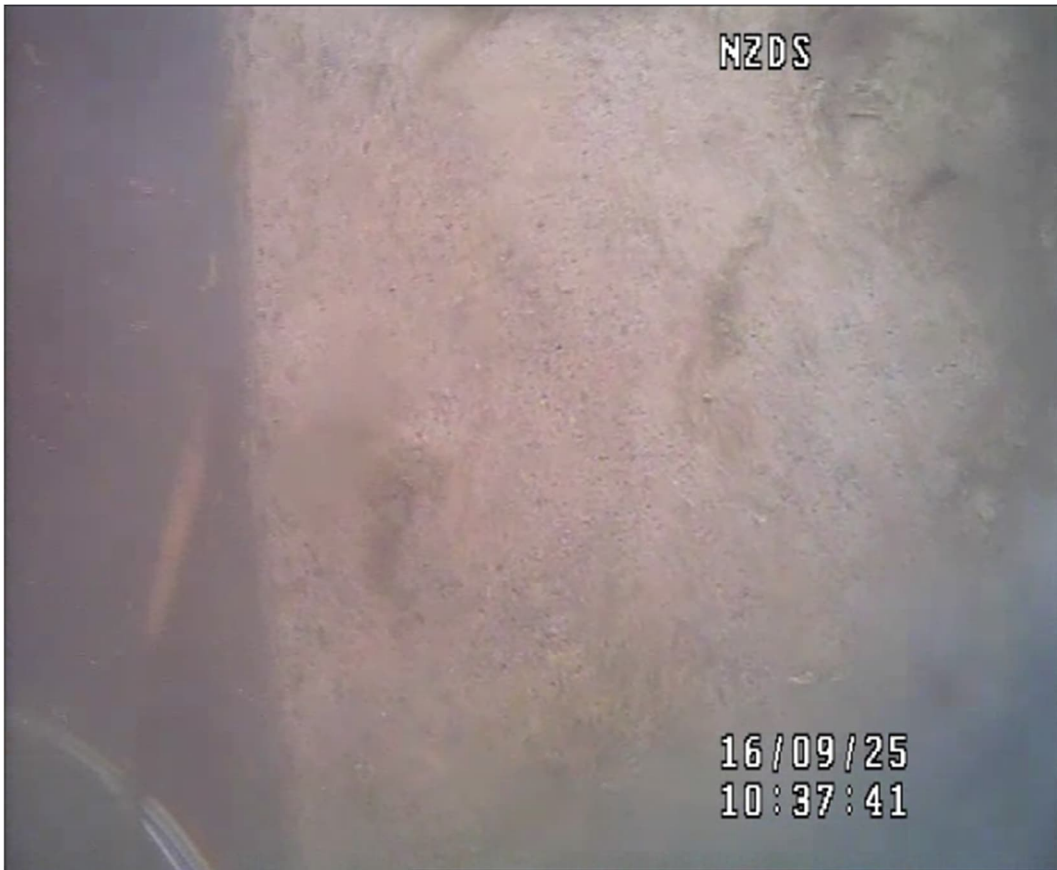
A typical image of the condition of the four concrete ribs that were able to be inspected is shown below in Figure 2-9. Overall, the concrete was in reasonable condition. There were multiple instances of exposed reinforcement and exposed aggregate, which again aligns with the construction methodology discussed in Section 2.2. The ribs further downstream in the channel were covered in layers of sediment up to 200 mm deep and greater as shown in Figure 2-10. This prevented full inspection of the concrete condition. It was decided that the condition of the first four ribs would be based on the condition of Rib 1, as there was no significant discrepancy observed between each structure.

Figure 2-9. Typical condition of rib concrete (Rib 1).

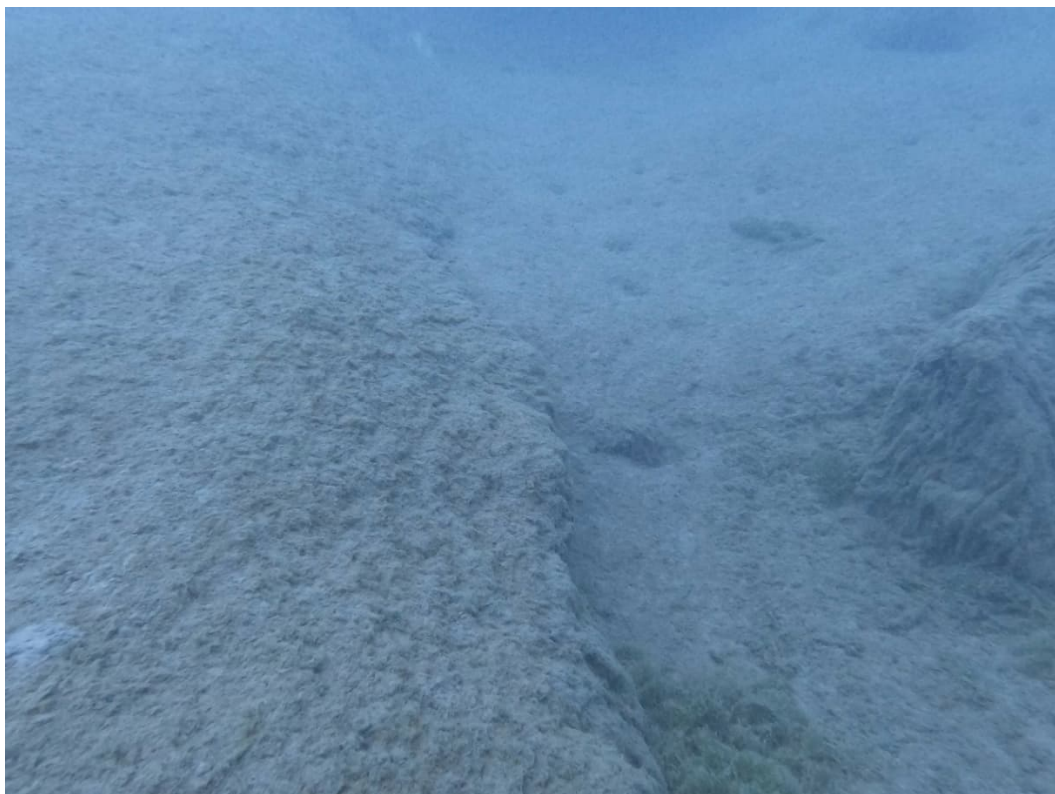
Figure 2-10. Example of extent of sediment coverage on rib structures making inspection impossible (Rib 4).

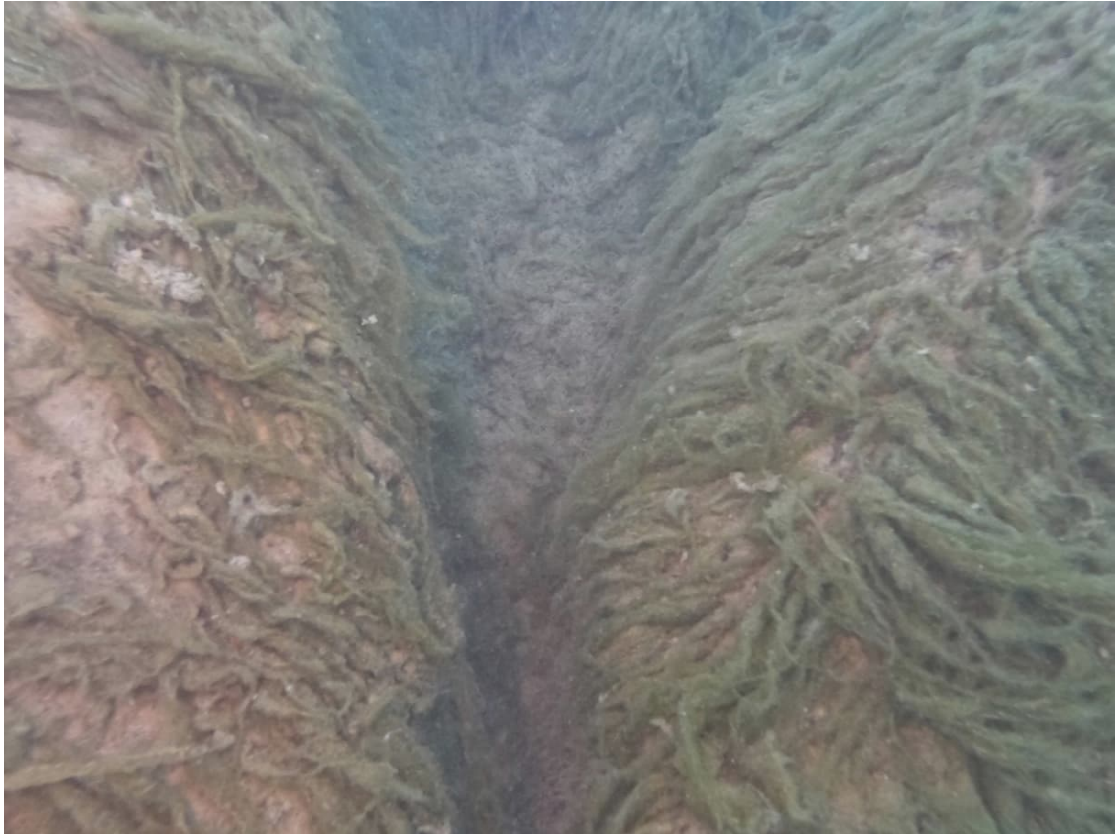
There were several instances of 'channels' forming from the downstream edge to the upstream edge on the top surface of the ribs with a maximum depth of approximately 50 mm. This should be investigated further to confirm the cause of the indentation/'channel'; was it due to the passage of water or it as a result of a crack due to settlement of the rib and initiating the formation of the channel? An example is shown in Figure 2-11.

Figure 2-11. Example of V-shaped channel in concrete on top of rib surface (Rib 1).

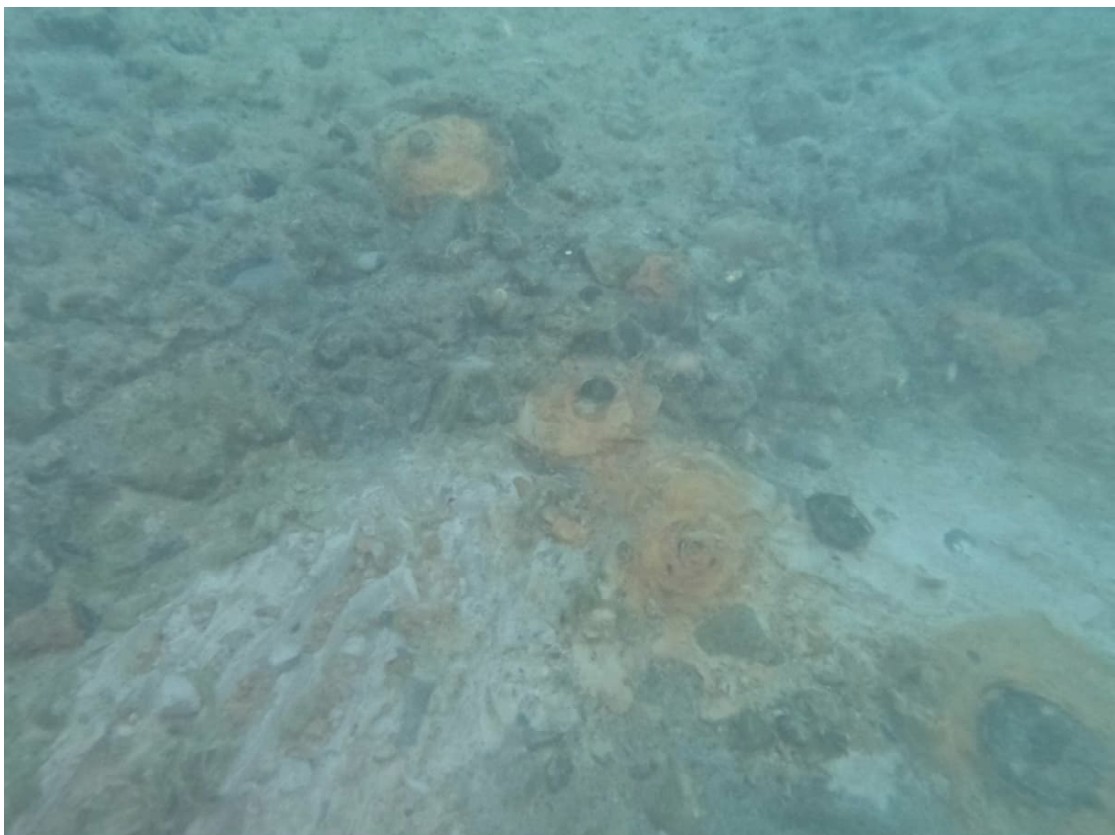
There were multiple cases of exposed vertical and horizontal reinforcement on the ribs. The exposed vertical reinforcement was located on the downstream side of Rib 1, protruding approximately 5mm out of the

concrete surface. This appeared to have been exposed since original construction based on the condition of the concrete surface and the number of bars exposed. An example is shown in Figure 2-12.

Figure 2-12. Example of exposed reinforcement on top surface of rib (Rib 1).

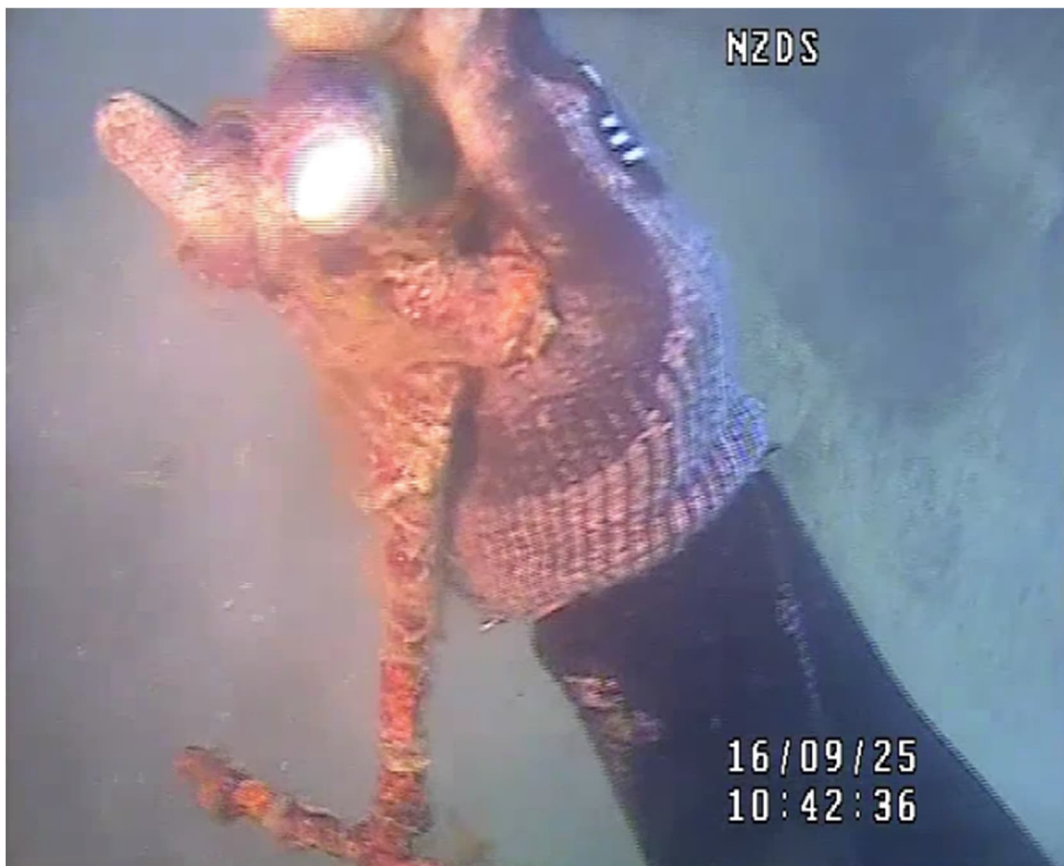
The exposed horizontal reinforcement was on the edge of the upstream face of the ribs and was a maximum distance of 20 mm from the surface of the concrete. An example is shown in Figure 2-13. Loose mesh reinforcing was observed sitting on Rib 1 as shown in Figure 2-14.

Figure 2-14. Loose mesh reinforcing on Rib 1.

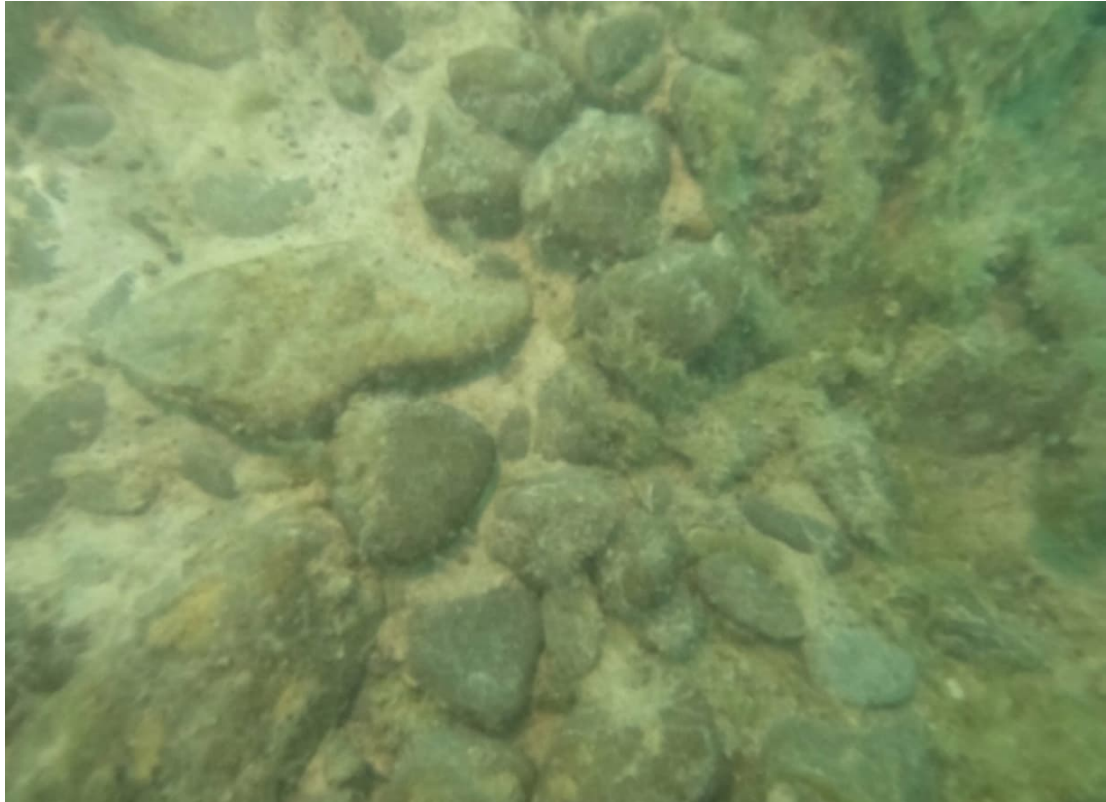
Figure 2-15. Example of exposed aggregate on rib surface (Rib 1).

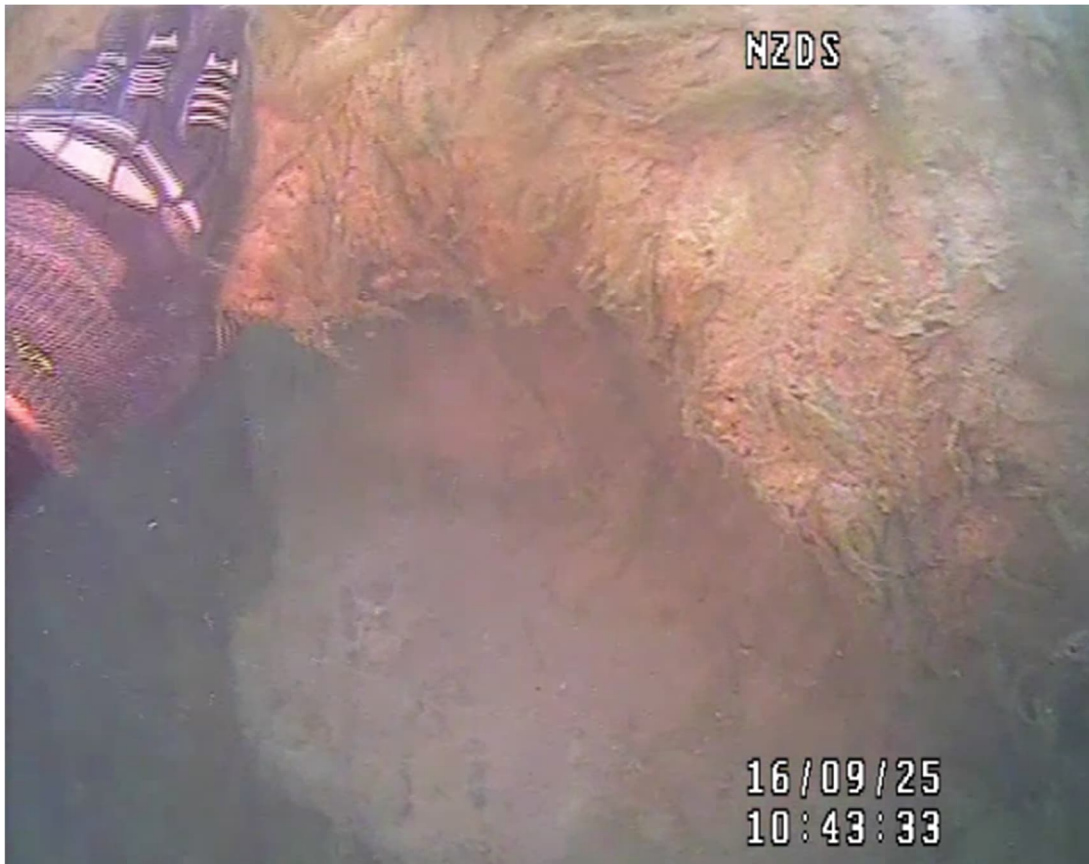
A significant number of the large boulders making up the rip-rap on the downstream side have been displaced, leaving an overhang on the downstream face of several ribs. Rib 1 was approximately 1200 mm above ground level with no surrounding rip-rap. An example of the concrete overhang is shown in Figure 2-16. The exposed concrete appeared to be in reasonable condition.

Figure 2-16. Example of downstream side of rib where rip-rap has rolled away (Rib 1).
