# SH 67 Granity Ngakawau LCSIA

Bathurst Resources Limited

August 2026

**SH67 Granity Ngakawau (1395) LCSIA**

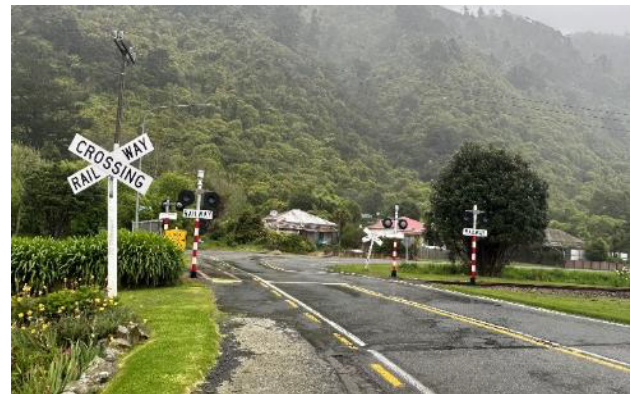
Figure 3-4: Northern approach to the level crossing from Torea Street

The WX6 crossbuck signs are installed on separate poles approximately 10-15m in front of the FLBs on both approaches (as seen in Figure 3-4). The crossbuck sign for the southern approach is in a poor condition. The sign is damaged, lacks reflectivity, is leaning over, and the pole is no longer a white colour, with lichen growing on it. The crossbuck on the northern approach is in much better condition.

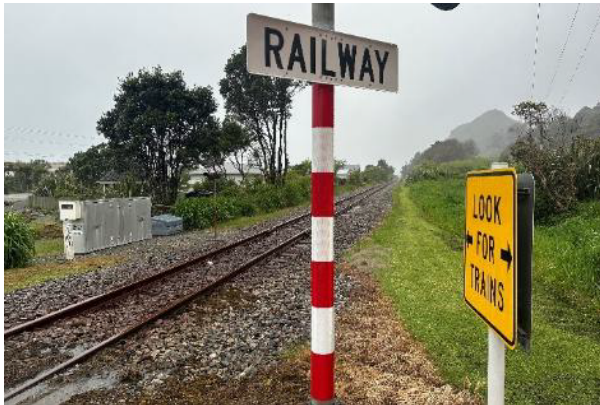
Figure 3-5: UP track sightline on southern approach

Sightlines up and down the track from the southern limit line area are shown in Figure 3-5 and Figure 3-6. There is good visibility in both directions with no obstruction to sightlines.

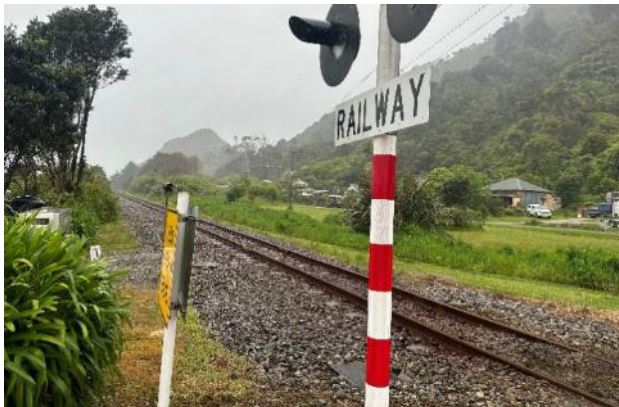
Figure 3-7: UP track sightline on northern approach

Sightlines up and down track from the northern limit line area are shown in Figure 3-7 and Figure 3-8. There is good visibility in both directions with no obstruction to sightlines.

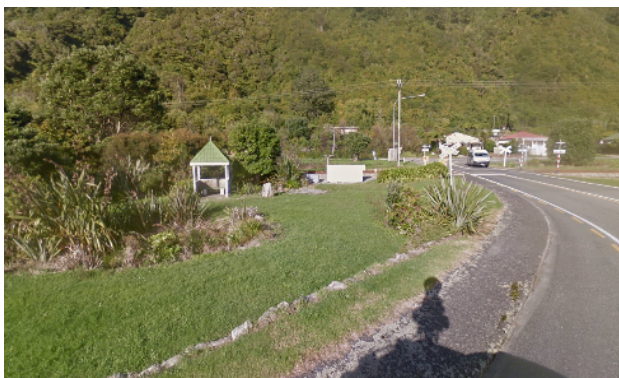
The reverse curve bend obscures the level crossing controls until after the bend is navigated, thereby reducing user awareness of the proximity of the controls as shown in Figure 3-10

Figure 3-9: Poor visibility of crossing controls from the north (Google Street View)

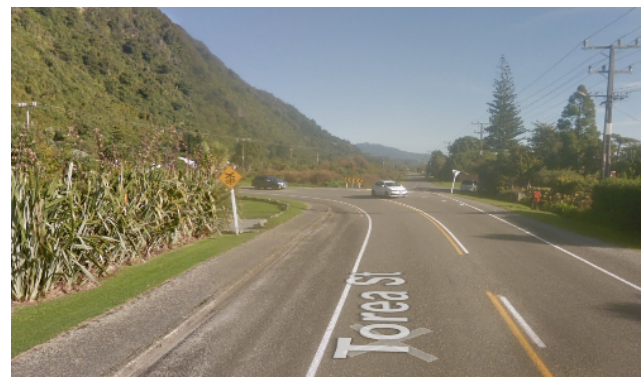
While visibility of the level crossing is good at the limit line, the northern approach is obstructed by vegetation, hindering the view of southbound trains as shown in Figure 3-9.

Figure 3-10: Vegetation masking the approach of southbound trains (Google Street View)

| No. | Recommendation | Level of Necessity |
|---|---|---|
| 2. | Trim or remove vegetation in the northeast quadrant to improve sightlines | Maintenance |

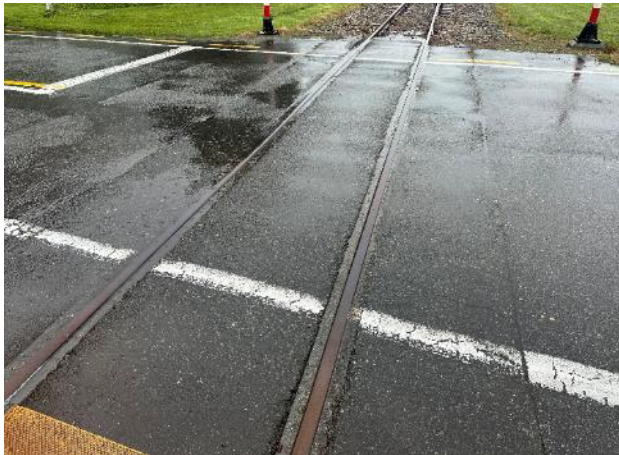
The track panel is in a good condition as seen in Figure 3-11. However, the line marking is starting to fade on both approaches. The average condition of the line marking on the northern approach is shown in Figure 3-12.

Figure 3-11: Track panel in good condition

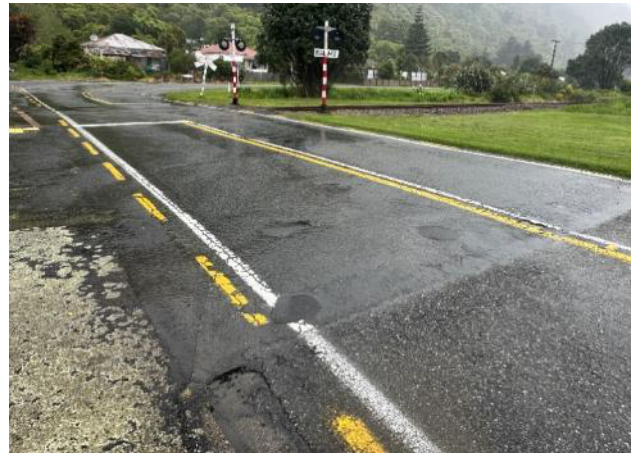
Figure 3-12: Faded line markings on the northern approach

5. **Aging and tired line marking.** Some of the line marking near the level crossing is fading / cracking and requires re-marking.
6. **Crossbuck signs should not be on separate poles.** These should be located on top of the FLBs as per TCD Pt9.

| No. | Recommendation | Level of Necessity |
|---|---|---|
| 6. | Renew line marking on the approaches to the level crossing | Maintenance |

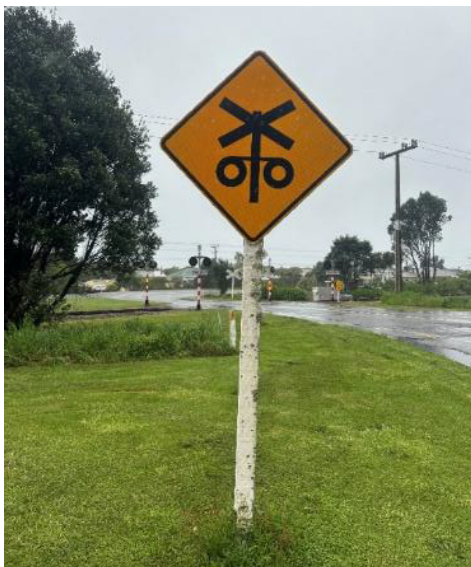
Figure 3-13: WX3 on left side on the southern approach

The WX3 sign from the southern approach is in an average condition (Figure 3-13), while the sign itself is in a relatively good shape, the pole has lichen growing on it. It is assumed that the sign may no longer have adequate night-time retro-reflectivity, as it was installed sometime between 2013 and 2018.

| Safety Recommendation | Necessity |
|---|---|
| Install new advanced warning signs on approaches as these are over 25 years old, being installed in October 1999 and well past their use by date effectively. These signs must meet current reflectivity standards. The signs will be the main form of warning for motorists prior to the corner bend, hence, need to be in good condition. | |

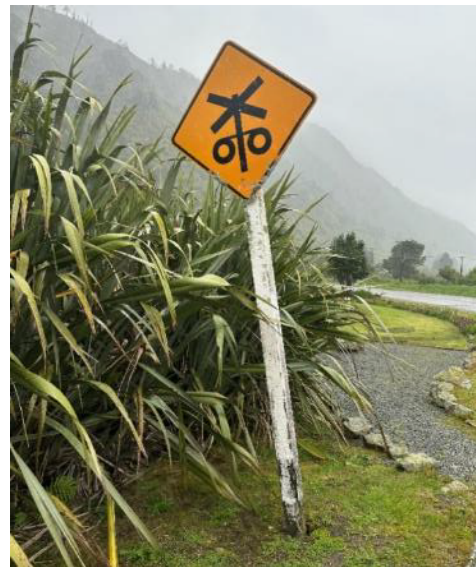
Figure 3-14: WX3 on left side on the northern approach

The WX3 sign from the northern approach has lichen growing on the sign and pole as shown in Figure 3-14. The pole is also loose in the ground and on a slight lean. This sign was installed in October 1999, which means its night-time retro-reflectivity is probably non-existent.

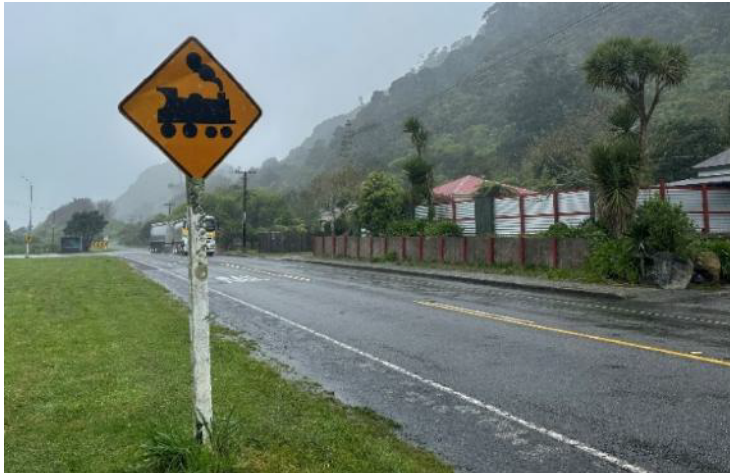
Figure 3-15: WX1L sign on southern approach

There is a WX1L and WX1R sign on the southern approach to the level crossing. The WX1L sign, as shown in Figure 3-15, is damaged and the pole has lost its white colour with lichen growing on it. The installation of the sign dated back to October 1999. The WX1R sign (not pictured), was in a similar condition.

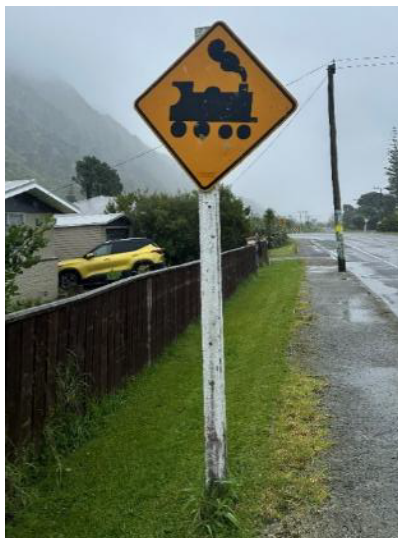
Figure 3-16: WX1L sign on northern approach

The WX1L sign on the northern approach to the level crossing was in a moderate condition with little lichen growing on the sign and pole as shown in Figure 3-16. This sign was installed in October 1999 hence the night-time retro-reflectivity of the sign may not be effective now.

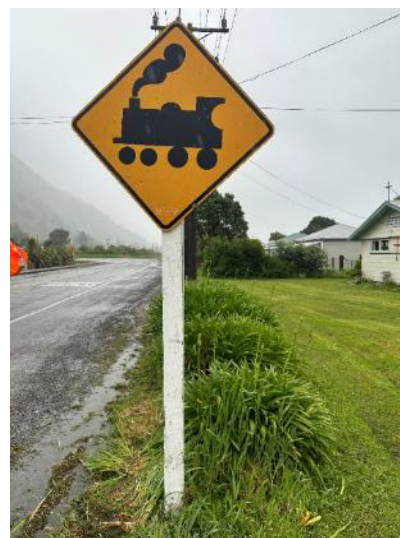
Figure 3-17: WX1R sign on northern approach

The WX1R sign on the northern approach was in a good condition as shown in Figure 3-17. It too is assumed that this sign may have lost its night-time retro-reflectivity.

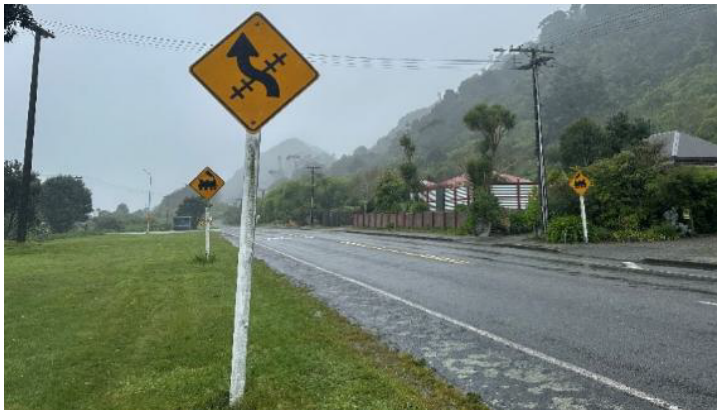
Figure 3-18: Level crossing alignment sign from southern approach

A level crossing curve alignment sign was located on the left side of Torea Street (SH67) from the southern approach, as shown in Figure 3-18. This sign was in a moderate condition, with no damage, but it may have lost its night-time retro-reflectivity as well. The pole has some lichen growing on it. It is very closely spaced from the WX1L sign seen in the background of the same figure.

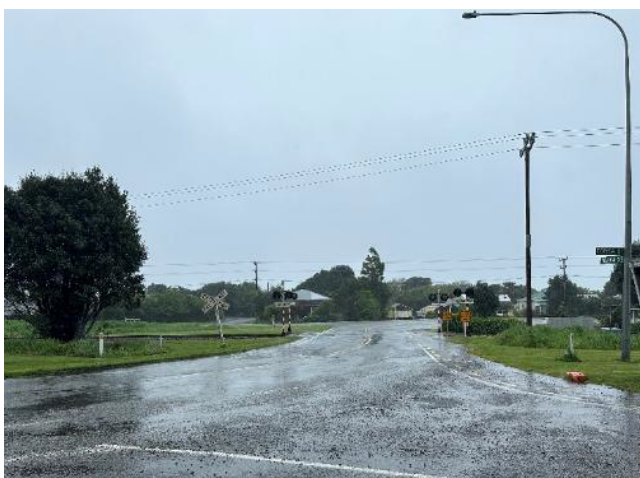
Figure 3-21: Sightlines from Back Road towards the level crossing

Back Road is a nearby side road to the level crossing from the southern approach. There are good sightlines to the north of SH67 towards the level crossing as shown in Figure 3-21. This allows good visibility of the level crossing controls from the intersection. The one street light pole near the level crossing can also be seen in Figure 3-21.

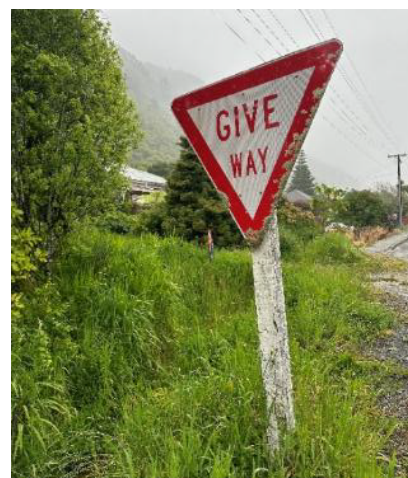
The GIVE WAY sign at the intersection has lichen growing on it and the height of the sign is mounted too low, as shown in Figure 3-22.

Figure 3-22: Condition of GIVE WAY sign at Back Road / SH67 intersection

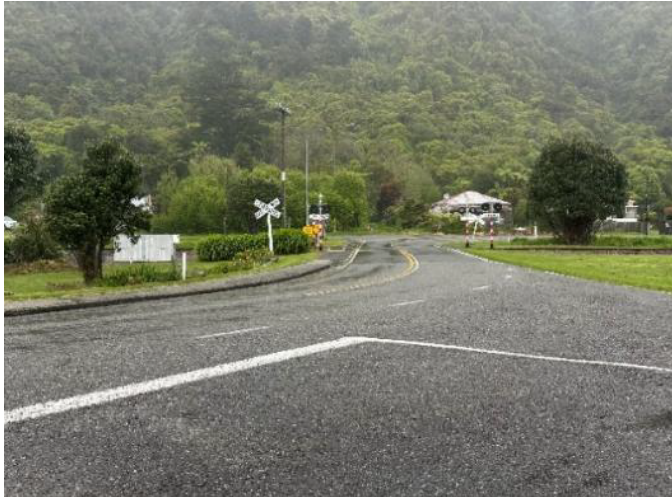
Figure 3-23: Sightlines from Domain Road towards the level crossing

Domain Road is a nearby side road to the level crossing from the northern approach. There are clear sightlines to the south of SH67 towards the level crossing as shown in Figure 3-23. This allows good visibility of the level crossing controls from the intersection.

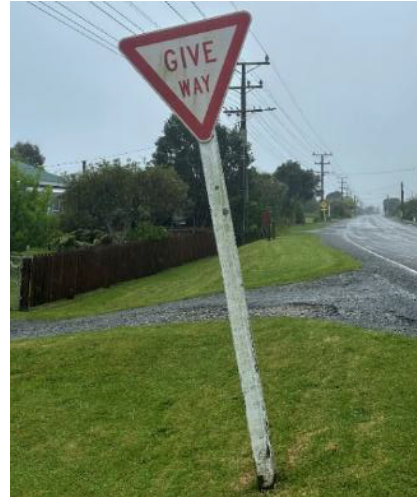
The GIVE WAY sign at the intersection is unclear, leaning, and has some lichen growing on it as shown in Figure 3-24.

Figure 3-24: Condition of Give Way sign at Domain Road / SH67 intersection

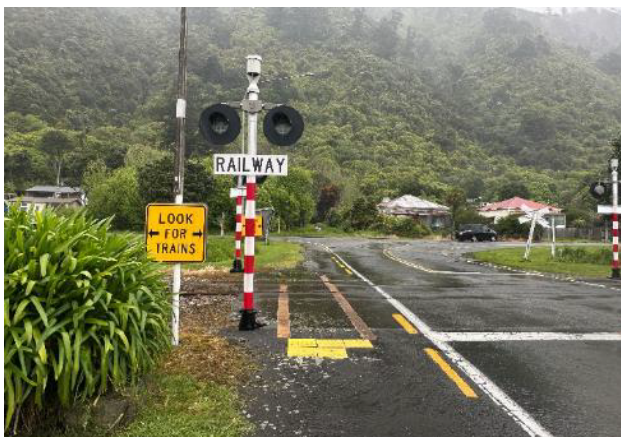
Figure 3-25: Pedestrian crossing northern approach

The tactile pavers on the northern approach are in a poor condition with one tile missing and others being misaligned, as shown in Figure 3-25. While the southern approach (Figure 3-26), does not have any tactile pavers and the yellow delineation tape across the tracks is faded.

1. **Lack of maintenance occurring at the pedestrian level crossing facility.** There are missing tactile pavers on both approaches and the delineation tape over the pedestrian crossing is very damaged and needs to be replaced. Again, this follows the same narrative as the road level crossing, defects are being ignored.

| Safety Recommendation | Necessity |
|---|---|
| The pedestrian level crossing is in a bad state of repair and needs tactile pavers and delineation tape to be renewed. | |
