# PRELIMINARY GEOTECHNICAL REPORT

## TE KOWHAI DEVELOPMENTS

PROJECT NO: HD1996  
LYSAGHT CONSULTANTS  
REFERENCE: PGR  
25 MAY 2021

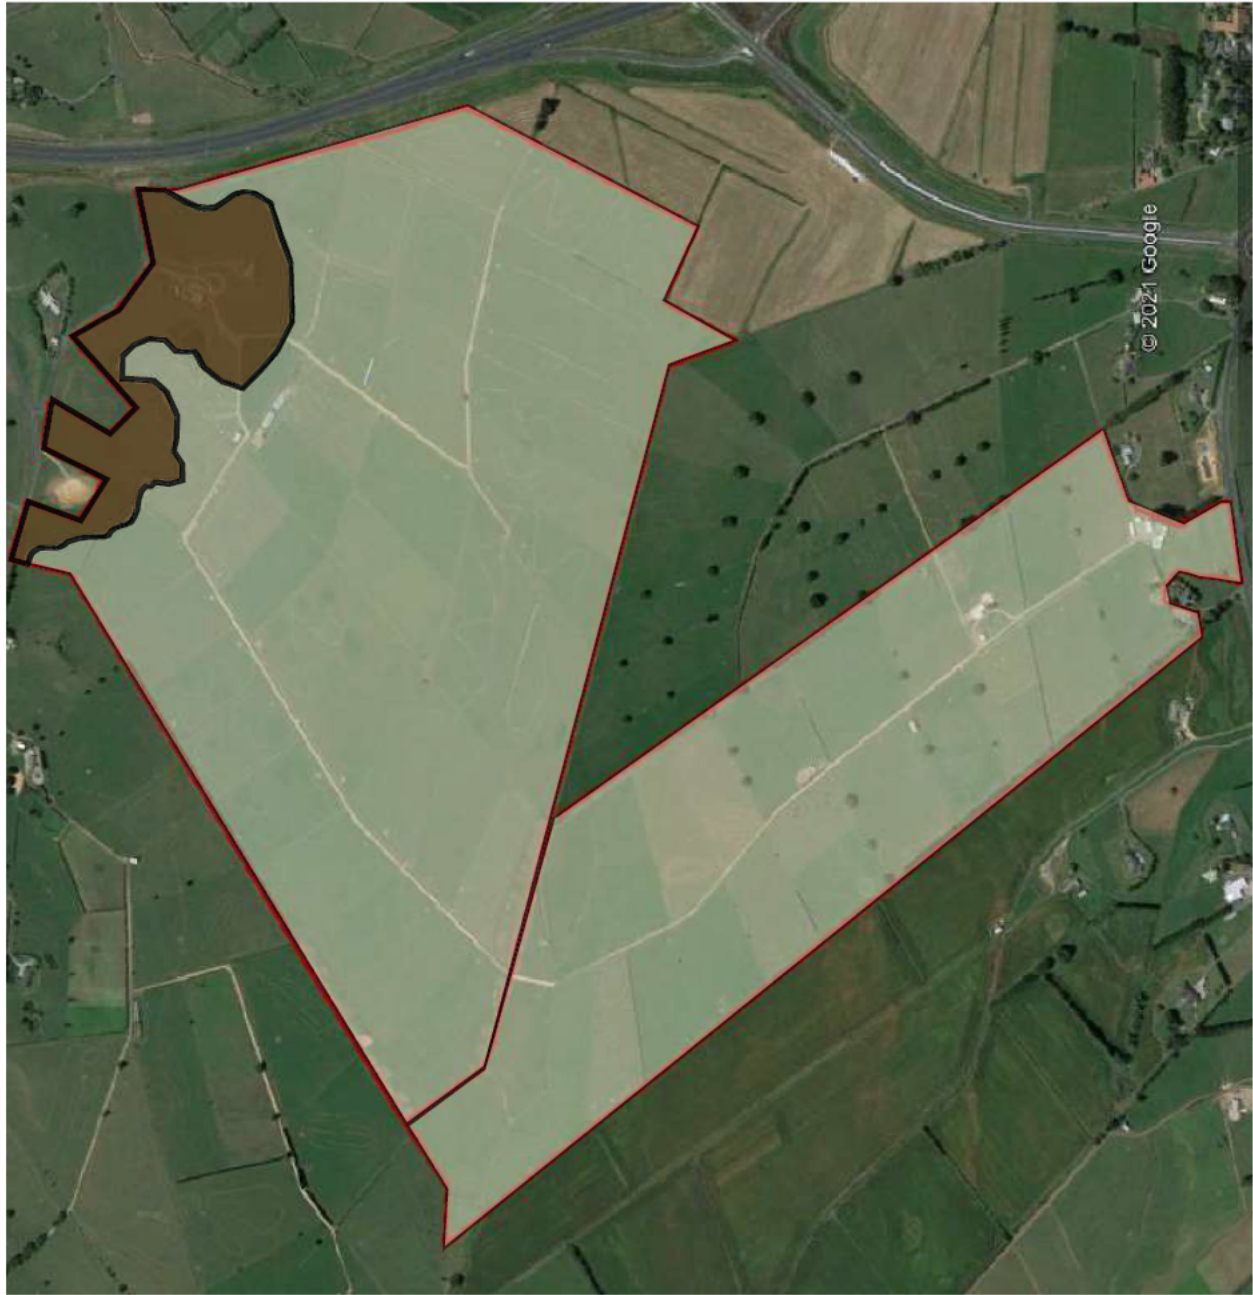
# APPENDIX A – GEOLOGIC TRANSITION PLAN

While not encountered during this investigation, our experience in the area is that organic and soft soils are commonly (but not exclusively) found in Paleochannel features and close to the Hill Terrain in 'embayments'. As the risk of consolidation settlements is often greatest in these areas, they should be a target area for future investigations.

Further investigation and analysis should be undertaken to define the static settlement hazard and whether mitigation measures such as excavation or preloading are required. Further engineering design is recommended for development of this part of the site.

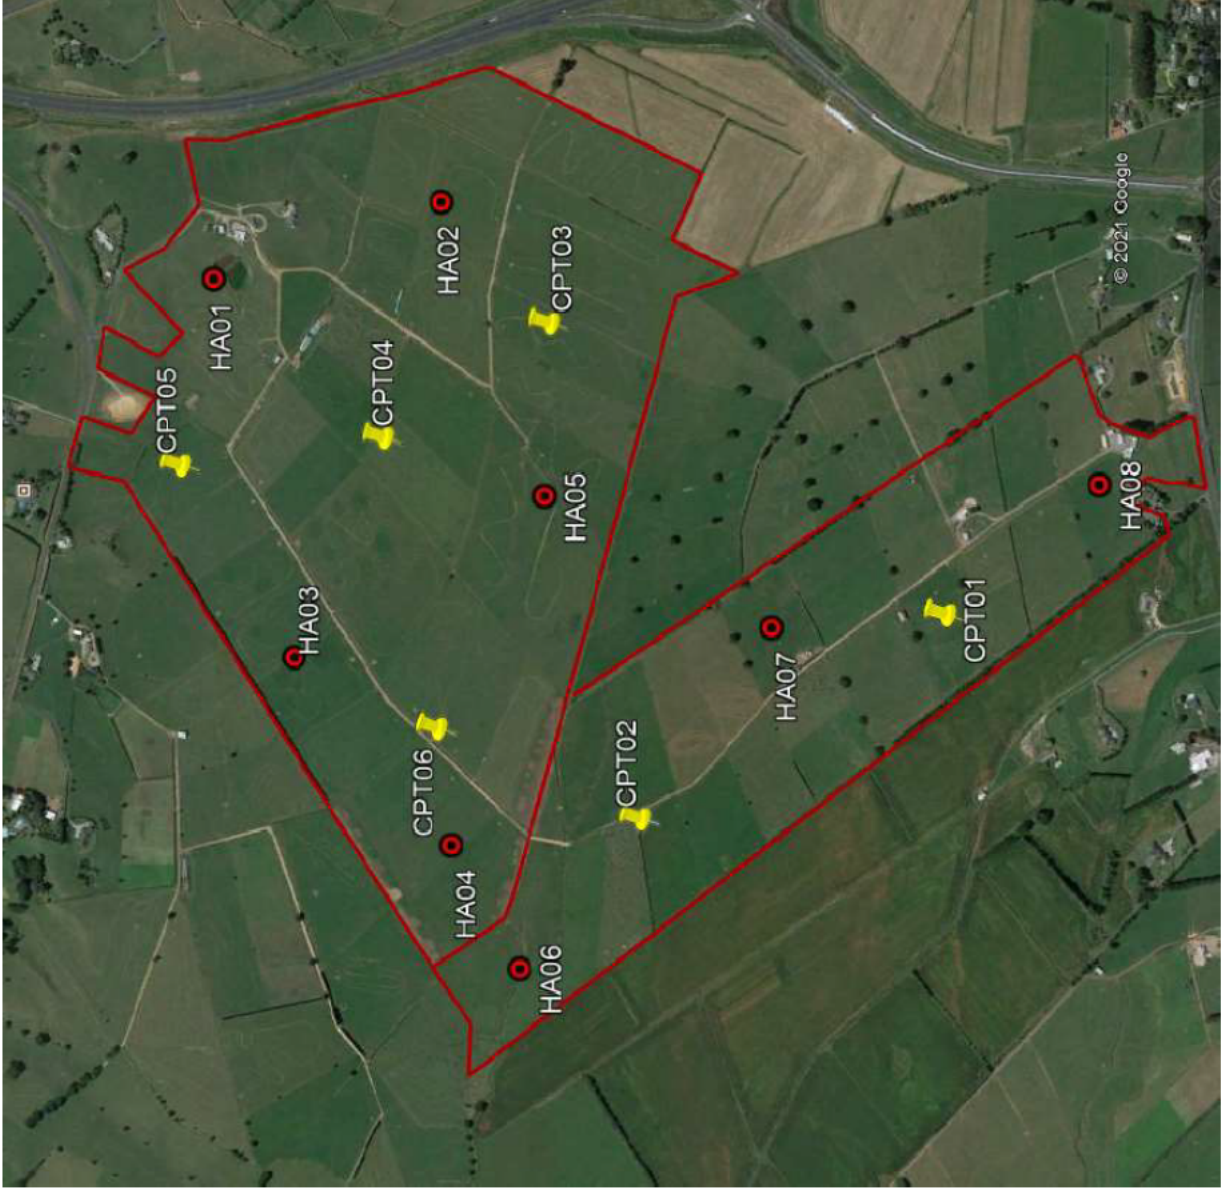
# APPENDIX B – SITE PLAN AND INVESTIGATION DATA

We completed our onsite investigation on 19 and 20 May 2021. We assessed ground conditions by conducting 8 hand augers (HA) and 6 cone penetration tests (CPT). In-situ strength testing was undertaken using a dynamic cone penetrometer (DCP) and shear vane. The hand augers had a target depth of 3.0 m, which was not achieved for HA04 and HA06 to HA08 due to hole collapse. Test locations are shown on Drawing No.2 in Appendix B.

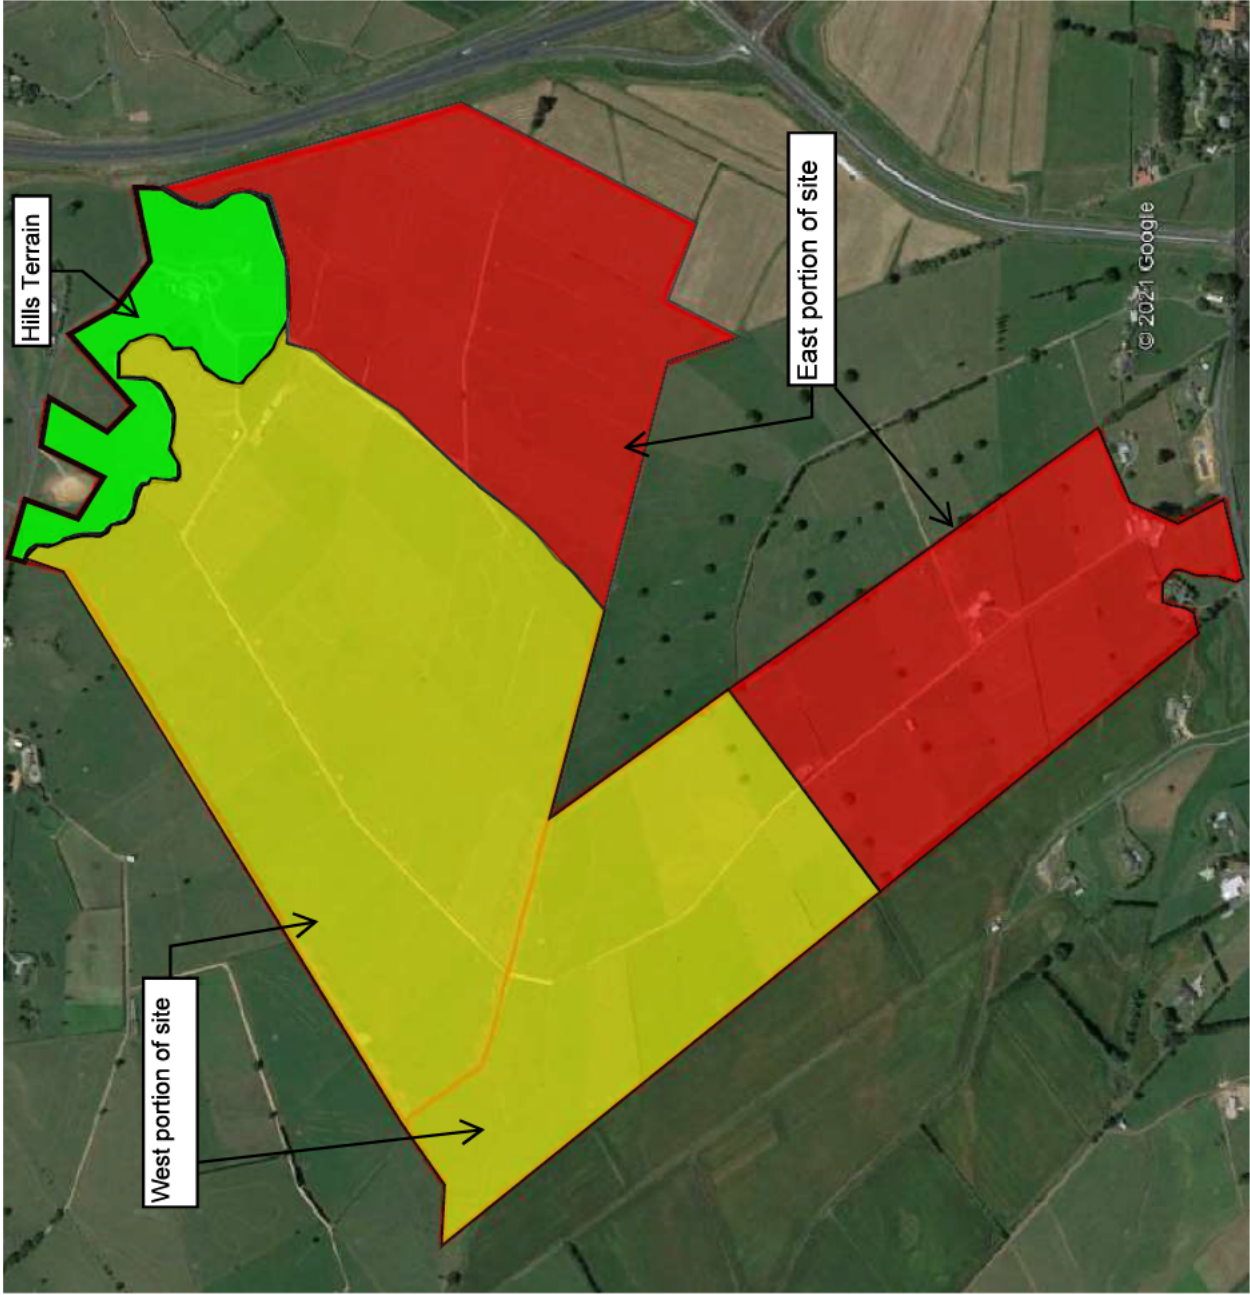
# APPENDIX C – LIQUEFACTION ASSESSMENT

Our assessment indicates that the site lies within performance level L1 (west) to L3 (east), mild to high anticipated liquefaction effects in accordance with Table 5.1 of the latest MBIE and NZGS guidelines<sup>7</sup>. Liquefaction hazards area is shown on Drawing No.3 in Appendix C.

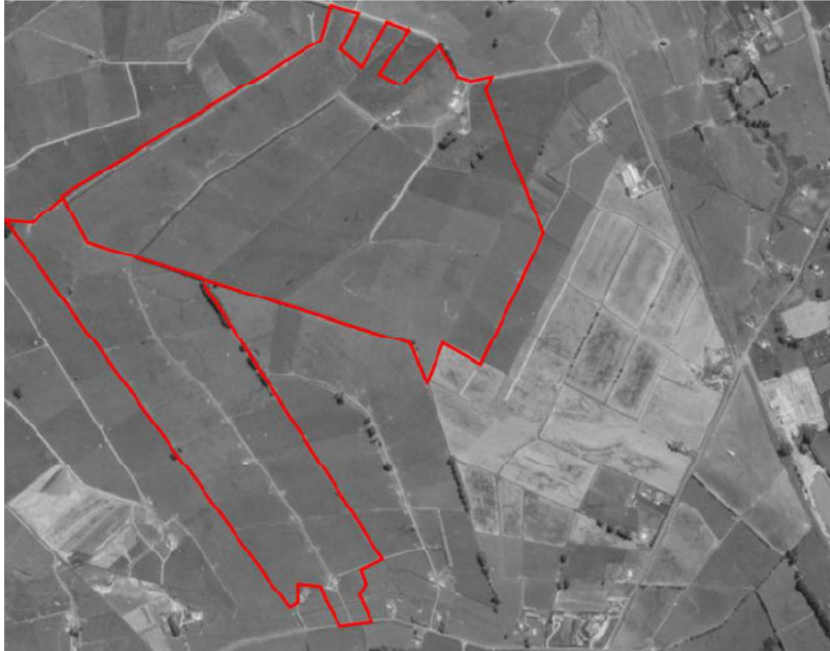
We reviewed historic<sup>1</sup> and recent<sup>2</sup> aerial photos, dating back to 1979, to identify features of interest at the site and within the surrounding area. In the photo of 1979, Paleochannel could be observed across the site. The Paleochannel were not visible in image of 1995, which may indicate that the channels been filled by that time. The effluent pond in the north of the site was built by 1995.

*Figure 1. Aerial imagery from 1979. Site location in red.*

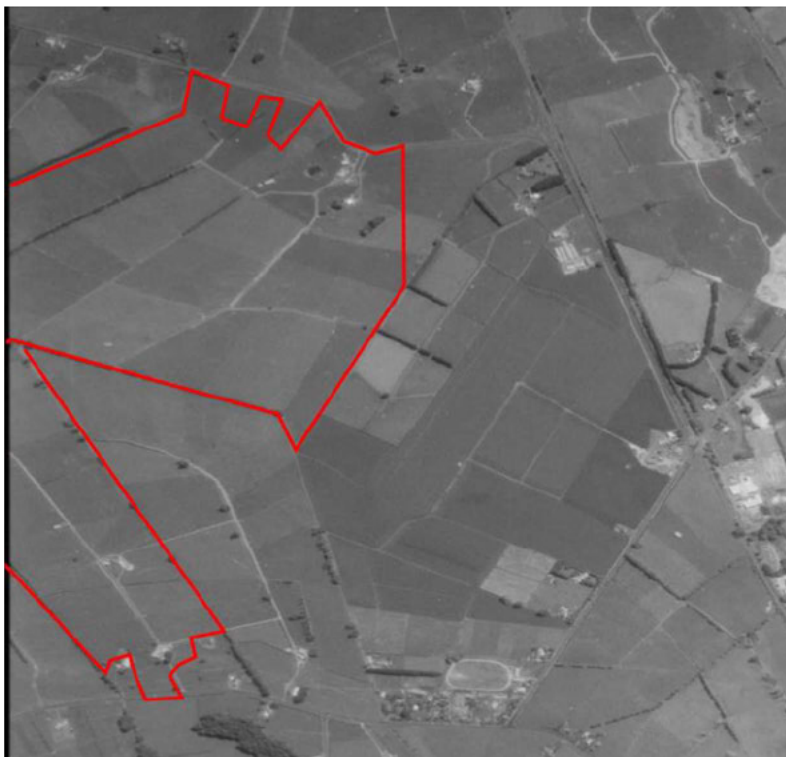
*Figure 2. Aerial imagery from 1995. Site location in red.*
