Project Number 19796.000.002

**Geotechnical Investigation – Mt Welcome
Development**

422 State Highway 59, Pukerua Bay, Porirua

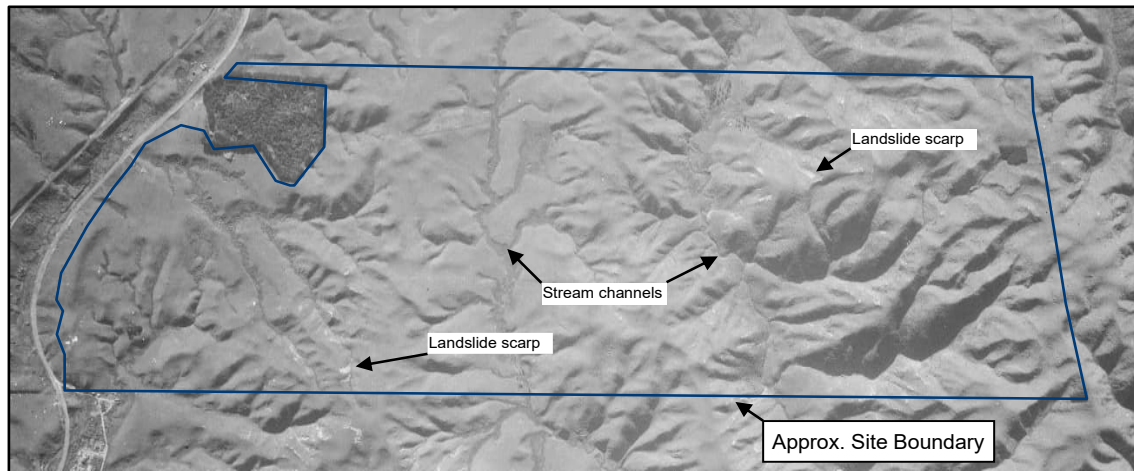
Photo 1: 1942 Imagery: This imagery is the oldest available on Retrolens that covers the site. The imagery shows the site with very little vegetation cover. A number of stream channels are visible through the valleys with smaller tributaries feeding into the streams. Landslide scarps can be identified on slopes to the east as well as on slopes that fall toward gullies and water courses.

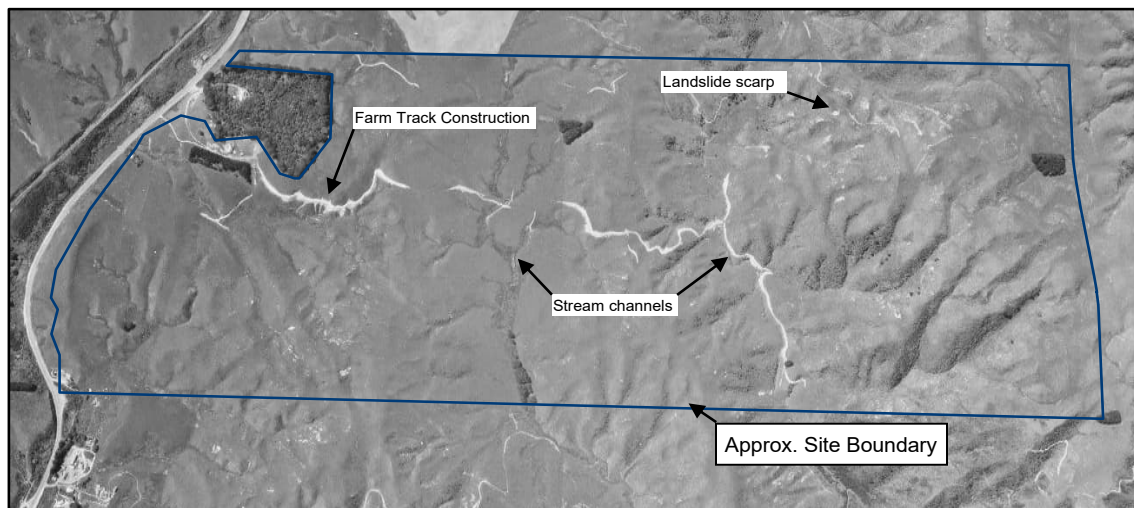
Photo 2: 1966 Imagery: This imagery shows minor growth of vegetation in some areas and the construction of a farm track is visible. New landslide scarps that weren't visible in the 1942 imagery can be identified. The scarps appear to be similar size to the garage buildings present in the western area of the site.

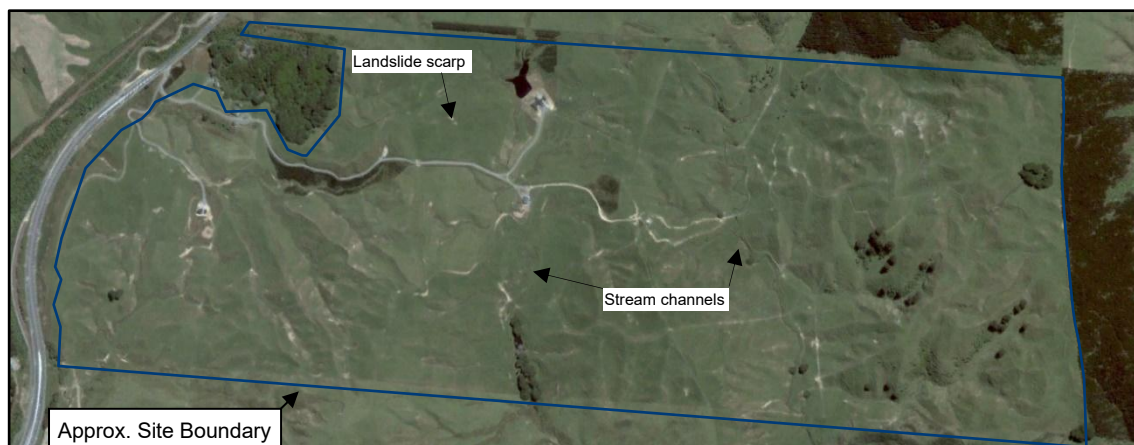
Photo 3: 2002 Imagery: The above imagery from Google Earth shows the continued growth of vegetation in some areas and the plantation of new vegetation. A new building along with a water reservoir has been constructed near the northern site boundary. New landslide scarps can be identified across the site.

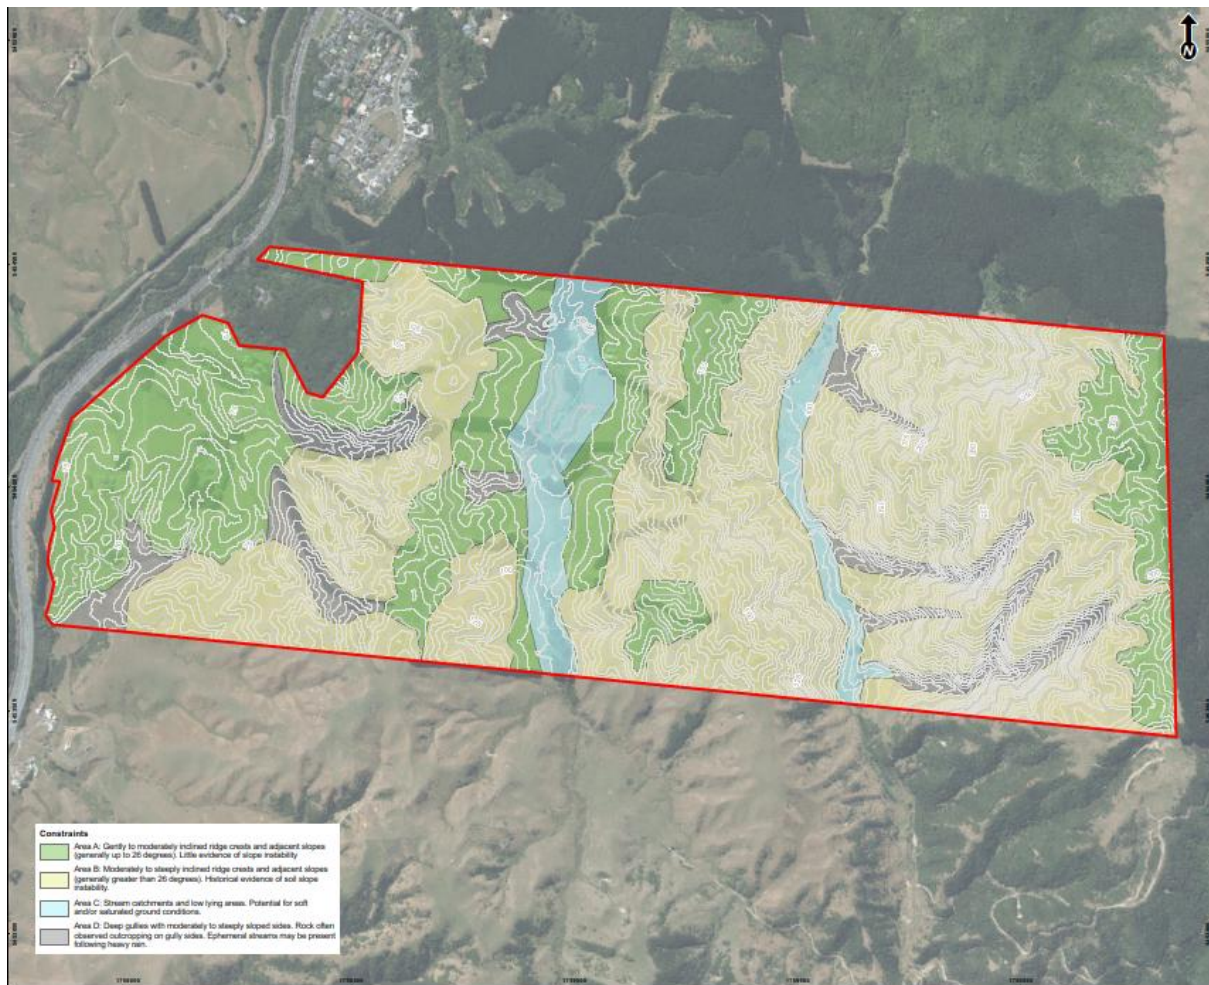
Figure 3: Geotechnical Constraints Map

The areas of the site that have been proposed for development for house lots generally do not sit in these potentially liquefiable areas and will be significantly altered from their current state, either through excavation or placement of engineered fill. Therefore, we do not consider liquefaction to be a significant risk to the development of the site, as is currently planned. If development were to extend into these low-lying areas in future, then detailed liquefaction and lateral spread investigation and analysis should be undertaken. The areas are shown highlighted blue on the map in Figure 3.
