Memo

Date: 19 March 2026

Subject: **Tekapo B Power Station tailrace weir and chute – condition assessment and review of bathymetric survey data**

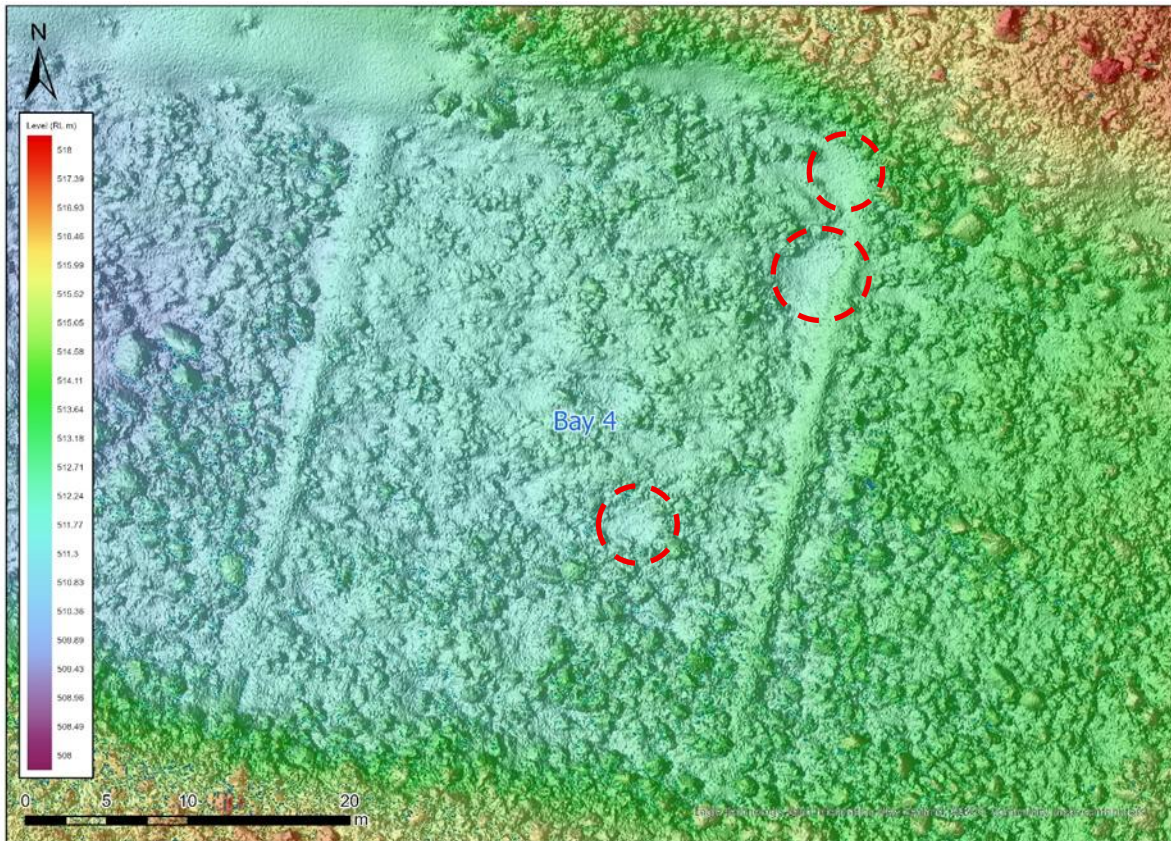
Figure 2: Image of bay 4 between sills 4 and 5 on from bathymetric survey of Tekapo B Power Station tailrace weir and chute

There is no evidence from the recent bathymetric survey that there has been any marked deterioration in the paved lining of the rock chute since Thompson and Campbell (1979) made these observations.

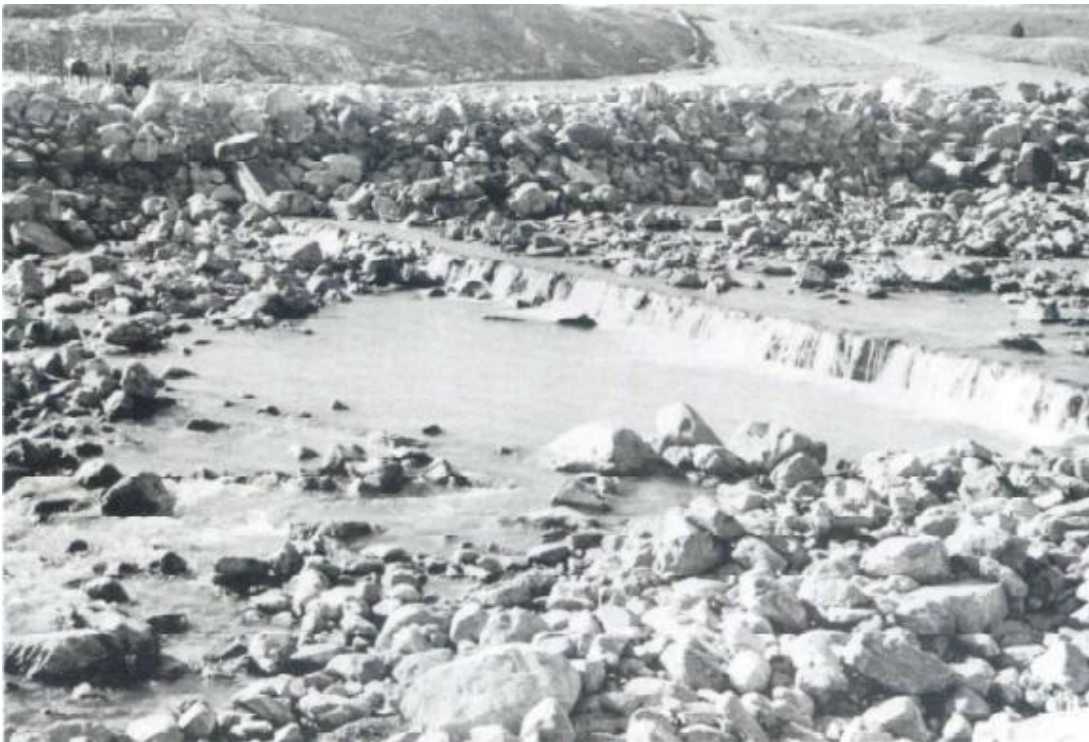
Figure 6: Scour hole downstream of sill 5 which developed after 72 hours of tailrace weir and rock chute operation in early August 1977

After 72 hours at full load, a semi-circular scour hole measuring about 14 m diameter and 3 m deep developed downstream of sill 5 (Malan & Hancock, 1979). This hole is shown in the photo in Figure 6. The hole remained stable in size for the next two months of the winter generation season (generation ceased in mid-September 1977 and did not resume until early January 1978). The scour hole was repaired after the winter generation period (MWD, undated-c).

The two scour holes which formed during early operation of the temporary tailrace weir and rock chute structure were similar to the local failures on model block ramps described by Pagliara and Chiavaccini (2007). The first scour hole at sill 5 did not develop beyond the initial size while the second larger one at sill 9 was fixed before it progressed to a more global failure in bay 9 (between sills 9 and 10).

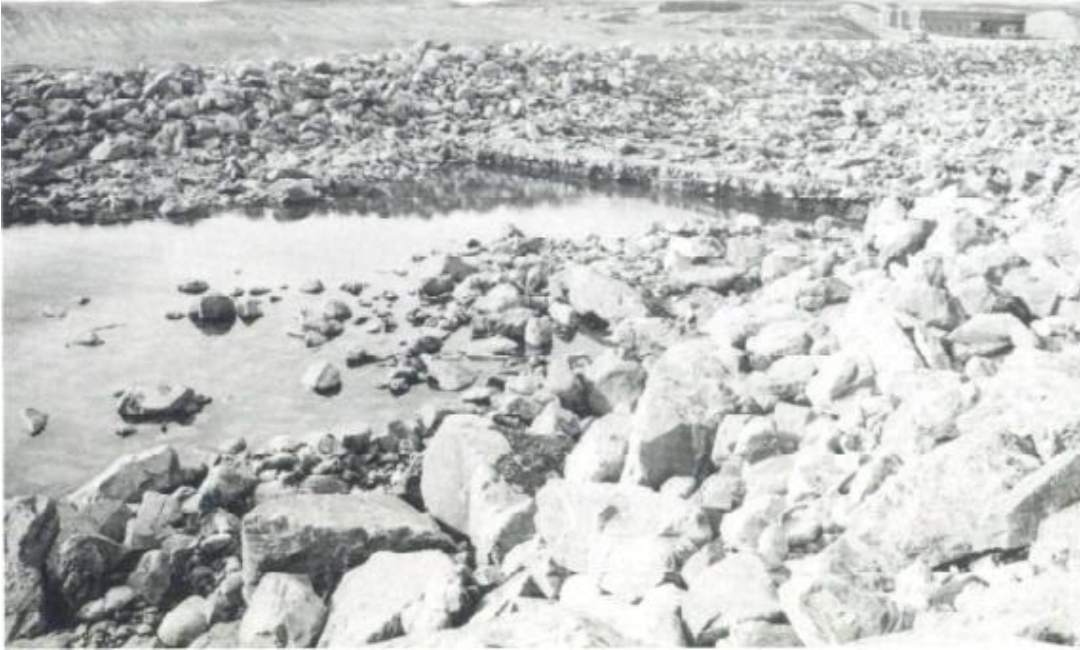
Figure 7: Scour hole downstream of sill 9 which developed after 12 days of tailrace weir and rock chute operation in mid-August 1977

After 12 days at full load with peak flows up to 140 m³/s, another major scour hole measuring 24 m in diameter and nearly 5 m deep was detected immediately downstream of and underneath sill 9 during a routine inspection (Malan & Hancock, 1979). This is shown in the photo in Figure 7. A flow through Tekapo B Power Station of 60.9 m³/s (corresponding to 50% maximum station load) was allowed overnight after the scour hole was discovered. The scour hole was repaired the next day with 1650 m³ of gravel fill material and 665 m³ of riprap material. Care was exercised to achieve good penetration of the gravel fill material underneath the concrete sill. The repair performed very satisfactorily afterwards.

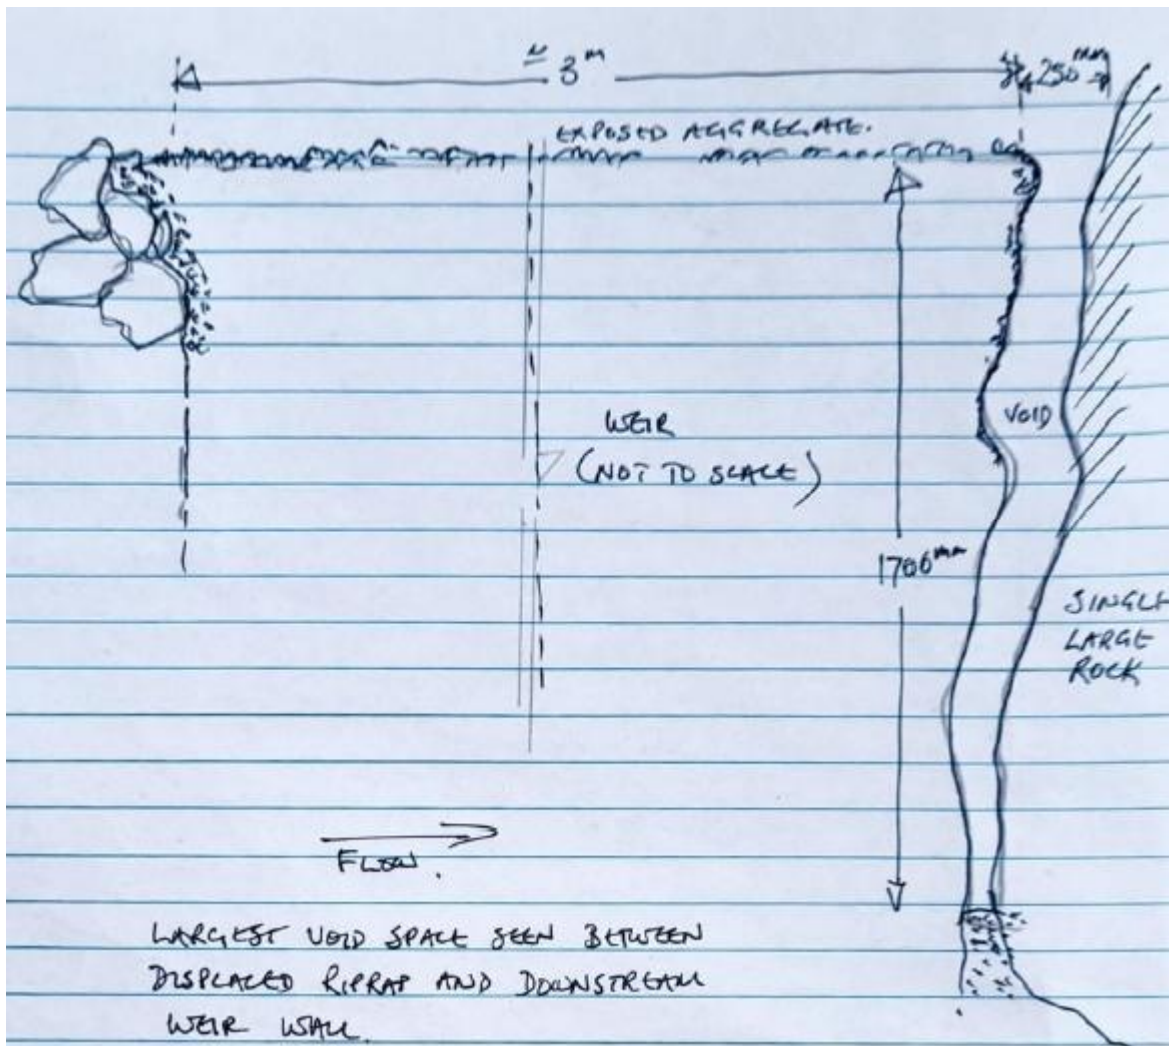
Figure 12: Diver's sketch of void (gap) noted between concrete control weir and riprap

Note: Lift joint is approx. 1,435 mm deep, compared to diver's observed depth of rib face approx. 1,700 mm deep

The deepest exposure of the sill was in a 250-millimetre slot between a very large rock and the downstream side of the sill where the rock had settled and separated. The slot was approximately 1700 millimetres deep.

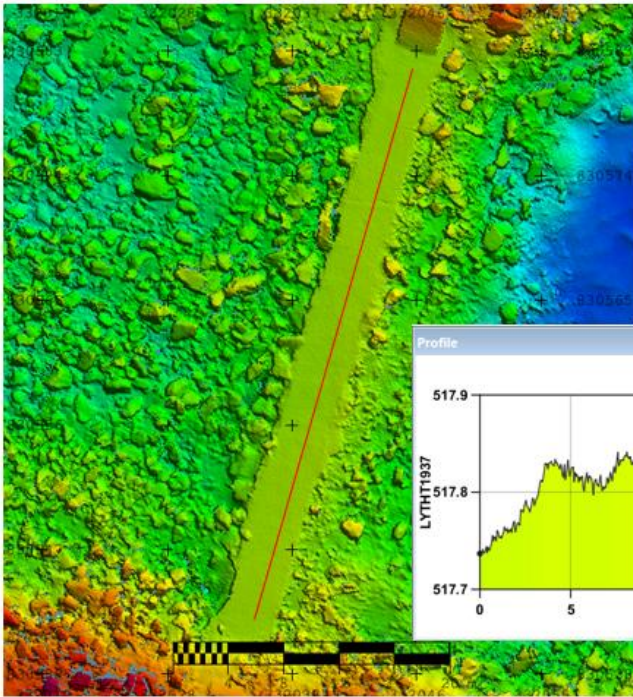
Tekapo B Weir – MBES Survey 03/02/26

The MBES survey revealed the top surface of the No1 Sill is not completely flat/uniform along its centreline, ranging in height between 517.45 to 517.86m – see below. Notwithstanding this, the results confirm the vertical height solution is valid (within +/-2.5cm of “as built” height).

- From MBES Survey = 517.75 – 517.86
- From As Built Plan = 517.85

Note: Sill is not completely flat – see profile

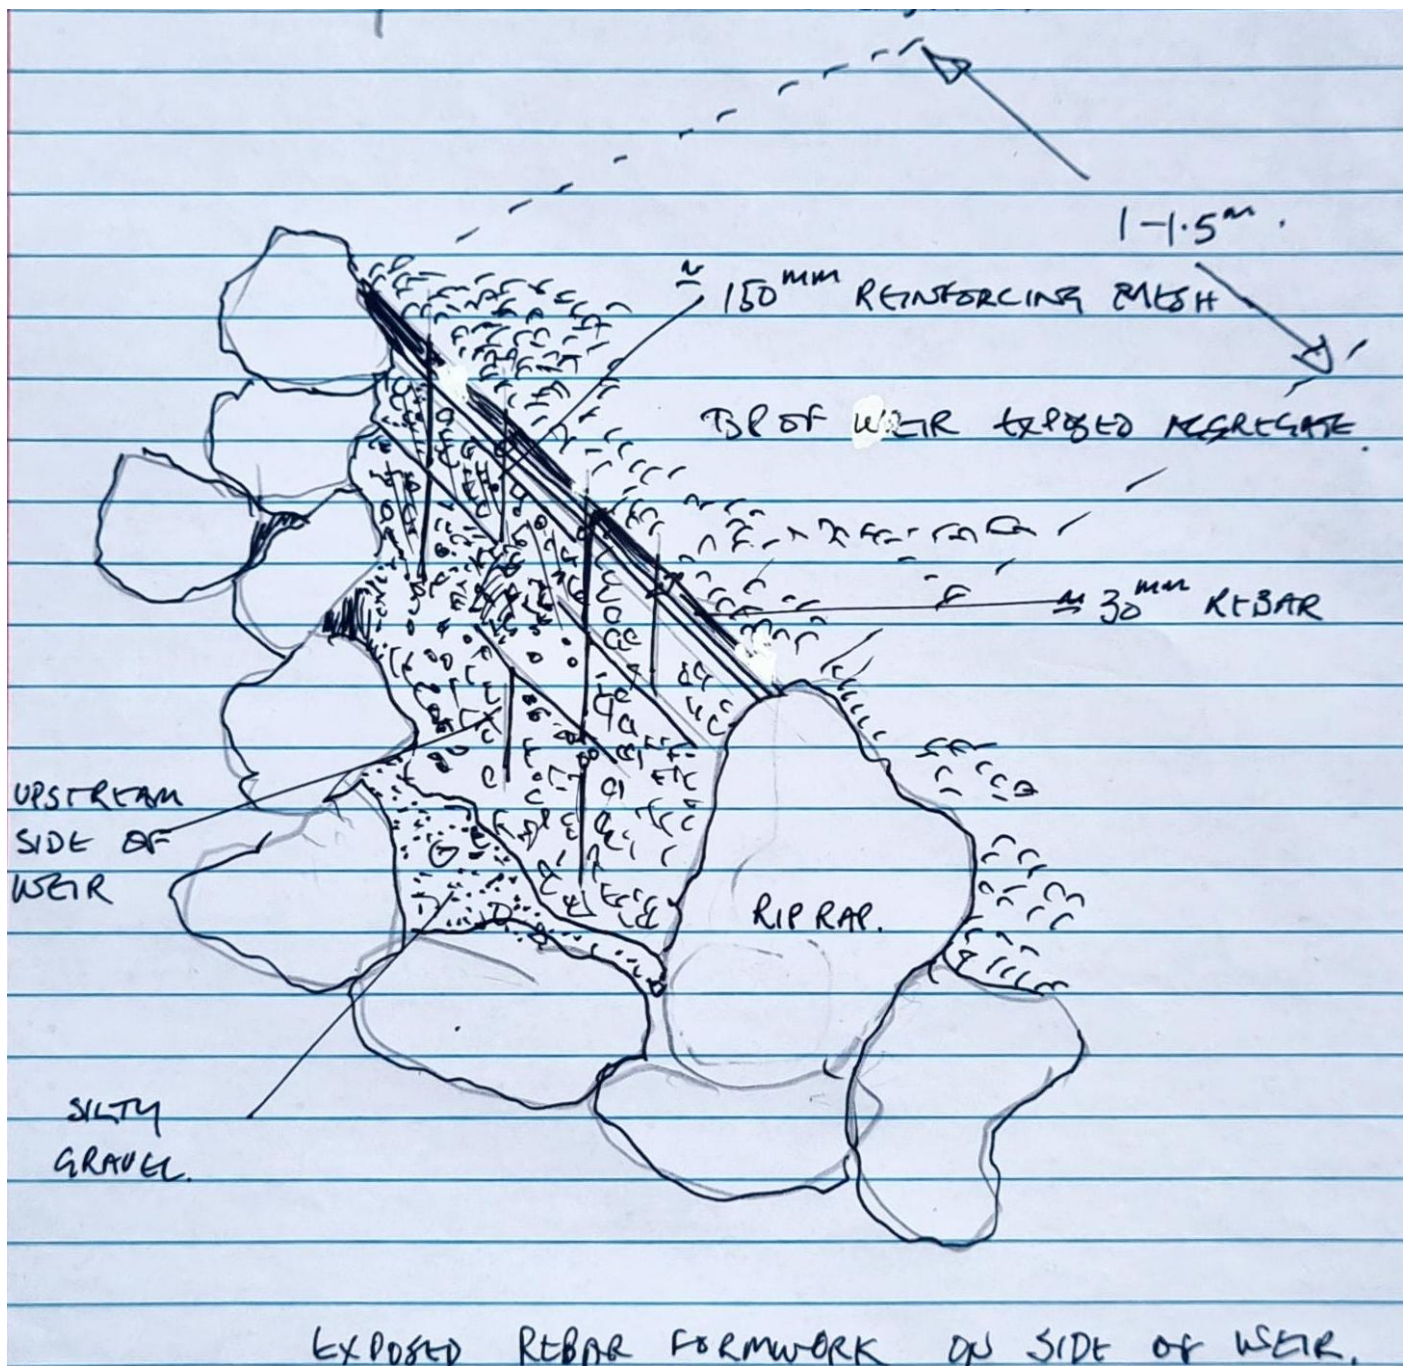
The line of the weir's upstream edge was intermittently a vertical concrete face with exposed aggregate and exposed steel mesh (approximately 150 x 150) tied into 32mm steel re-bar on the top corner by way of a form rather than reinforcing.

The steel was partially exposed due to it being the outside of the pour (not erosion).

These sections were not more than one to 1.5 metres long and approximately 0.5 metre high.

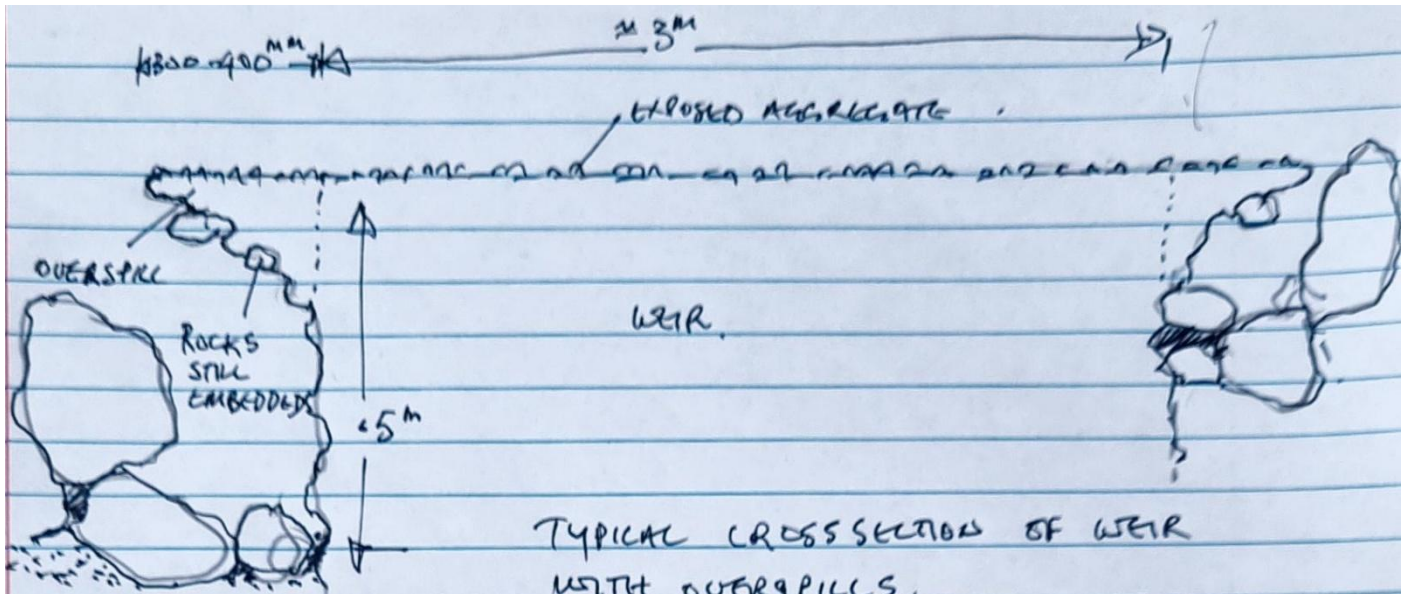
In other places the material trapped by the concrete overspill remained as a cantilevered tongue overhang, and any loose material had been washed away from underneath it, but no further than the line of the weir.

This pattern continues across the upstream face.
