## Technical Advice – Water Engineering - by Mark Groves

Date	30.03.2026
To	Trinity White, Environmental Manager – South Island Renewables, Genesis Energy
From	WSP New Zealand Limited
Project advice provided for	Fast-track Application for Lake Pukaki Hydro Storage and Dam Resilience Works
Documents referred to	WSP, 2025 “ <i>Tekapo B Weir Assessment Summary Memo</i> ” WSP, 2026 “ <i>Tekapo B Weir Assessment Memo Addendum</i> ”
Qualifications and experience	ONC, HNC Civil Engineering. Chartered Engineer (CPEngNZ). 28 years of experience.
Code of Conduct	As an expert witness I have read, and I am familiar with, the Code of Conduct for expert witnesses contained in the Environment Court Practice Note 2023. This memorandum has been prepared in compliance with that Code. In particular, unless I state otherwise, this response is within my area of expertise and I have not omitted to consider material facts known to me that might alter or detract from the opinions I express.

**To:** Andrew Balme  
**From:** Jeremy Robertson  
**Office:** Taupō  
**Date:** 19 December 2025  
**File/Ref:** 2-38161.00  
**Subject:** Tekapo B Weir Assessment - Summary of Findings

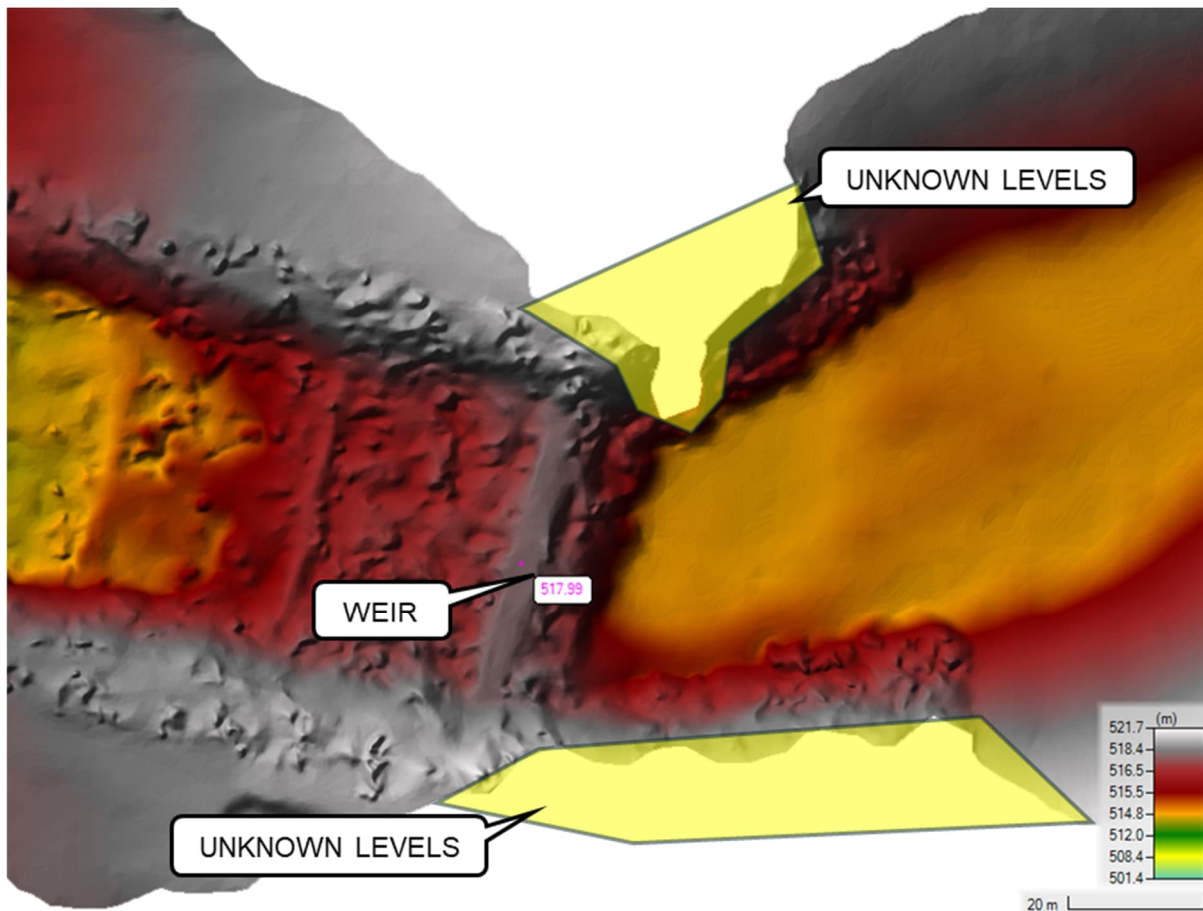
The ground model was based on the recent bathymetric survey (WSP, Sept 2025). There were missing ground levels in surfaces upstream of the weir (refer to yellow regions in Figure 3-1). For the purposes of the assessment, surveyed levels surrounding these areas with missing levels have been interpolated to generate

Figure 3-1 Missing ground levels upstream of the weir site from the recent bathymetric survey (WSP, 2025)

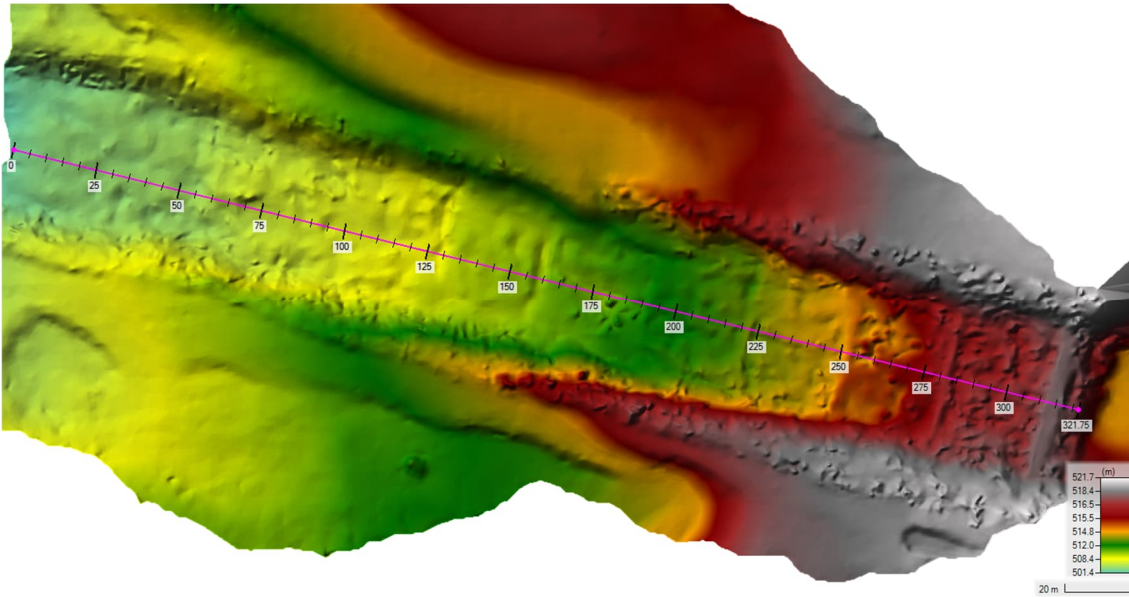
Figure 3-4 Bathymetric survey of the chute

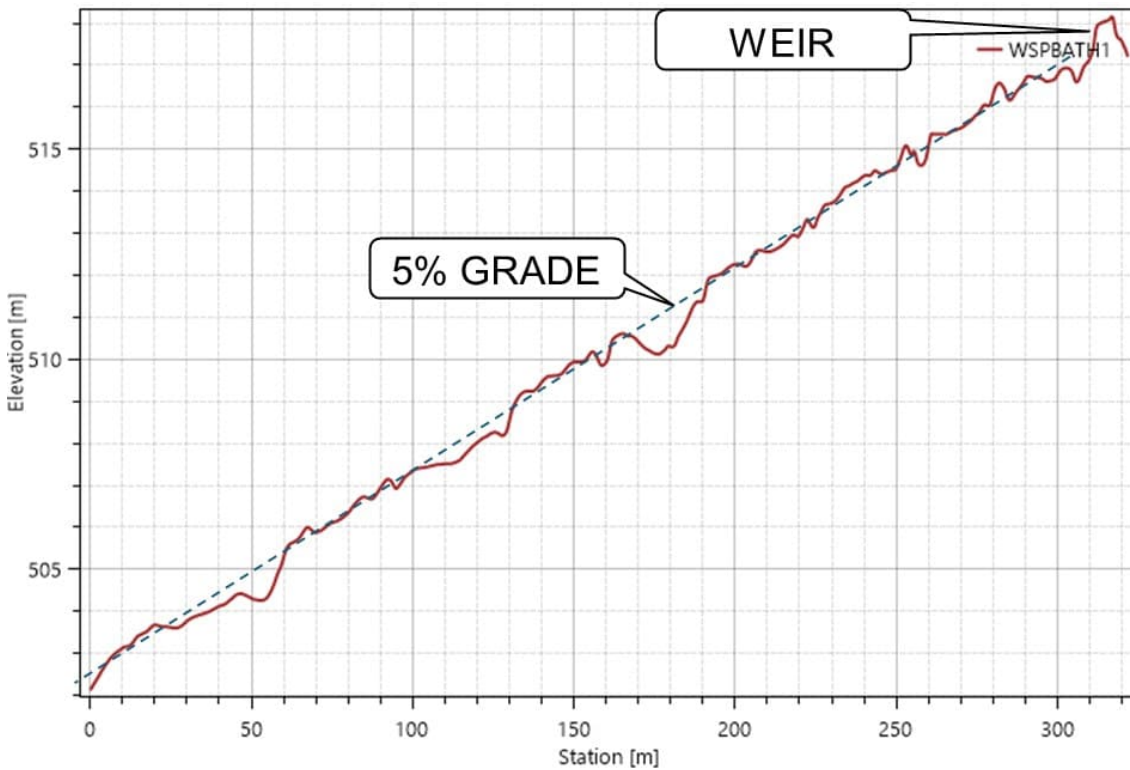
Figure 3-5 plots the longitudinal profile of the chute centreline from the weir to the downstream survey extent. The figure includes a 5% grade line that represents the original design longitudinal grade for comparison. Ground level drops of up to 1 m deep are found at around Station 50 m and 175 m.

Despite indication of change in profile compared to when the chute was designed and constructed, silt deposition may still be masking actual ground movement (e.g. scour holes, rock riprap displacement) that may have occurred after the lake level has risen above the weir.

Figure 3-5 Longitudinal section of the chute centreline ground level

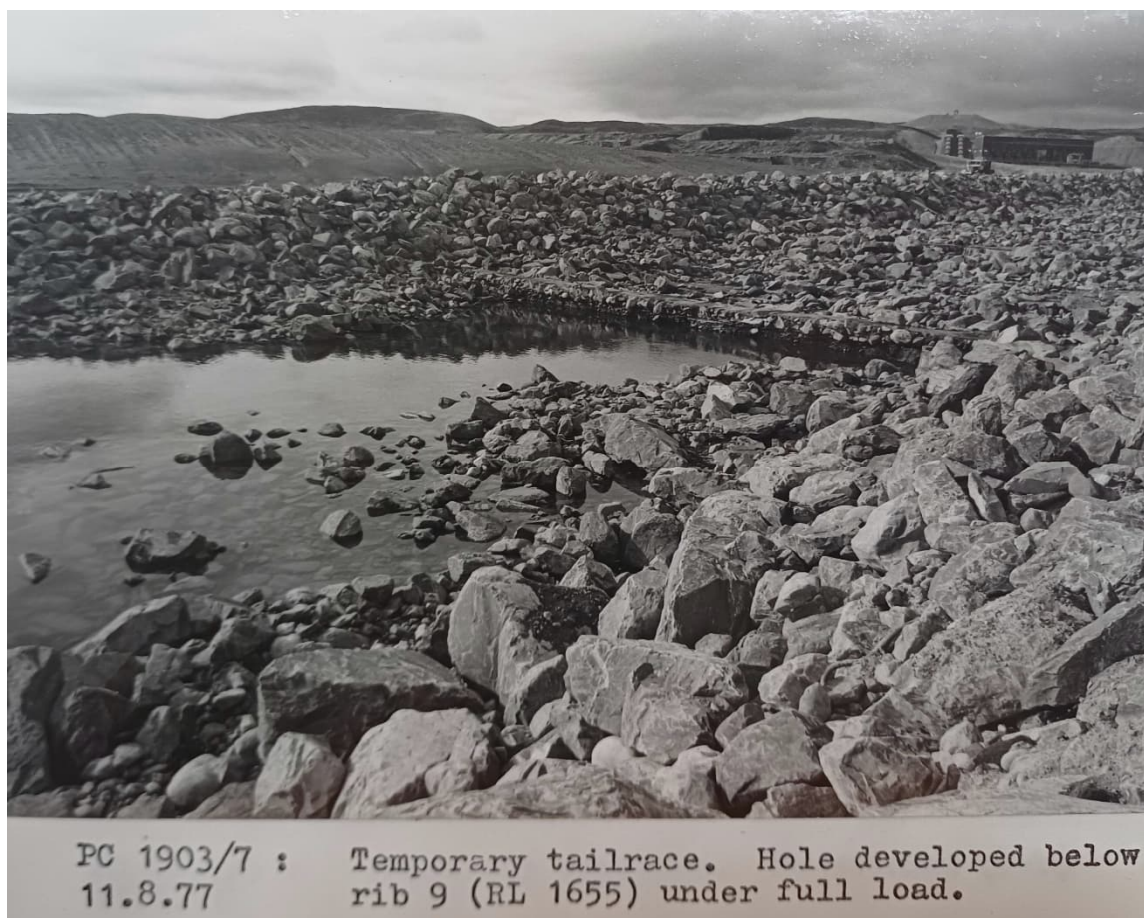
rock chute were experienced and repaired during operations of the temporary tailrace including a large hole located downstream of sill 9 (Figure 3-7 and Appendix A). Correspondence from the Ministry of Works and Development also states “it should be stressed that the chute is a risk structure and minimal use only can be recommended” (Ministry of Works and Development , 1977).

Figure 3-7 Tailrace with scour failure 1977 experience 12 days after operation (source Genesis Energy)

Historical reports have confirmed there has been previous failures experienced in the chute including the formation of a scour hole underneath sill 9 near the downstream end of the chute during the early months of commissioning. Our survey indicates significant silt deposition and structural deterioration at the weir and chute, creating uncertainty about their ability to safely convey design flows once lake levels are reduced.

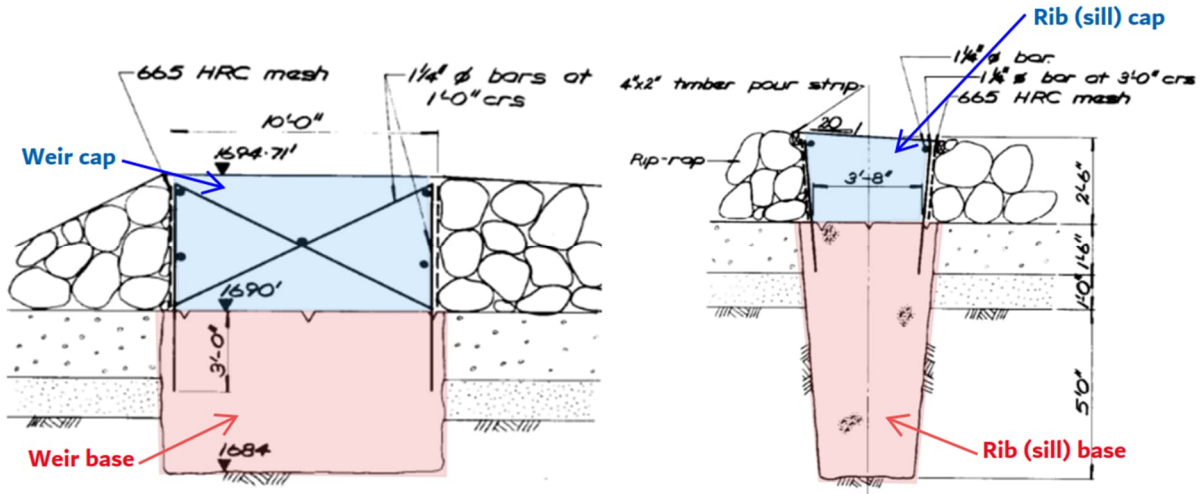
- Loss of structural connection of the weir or sill ‘cap’ (also referred to as ‘upper weir’ by Damwatch) from the lower concrete base. Refer to Figure 1 below for clarification the cap and base sections of the weir and sills.
- Existing damage to the concrete weir and sills has the potential to reduce the capacity of the concrete to sustain the lateral loads on the concrete to support the riprap and the hydraulic forces from water.
- Damage to the concrete weir and sills due to concrete condition when they are exposed due to draw down and reused as a weir and chute in the future.

Figure 1: Weir and rib (sill) concrete structure showing the cap and base sections

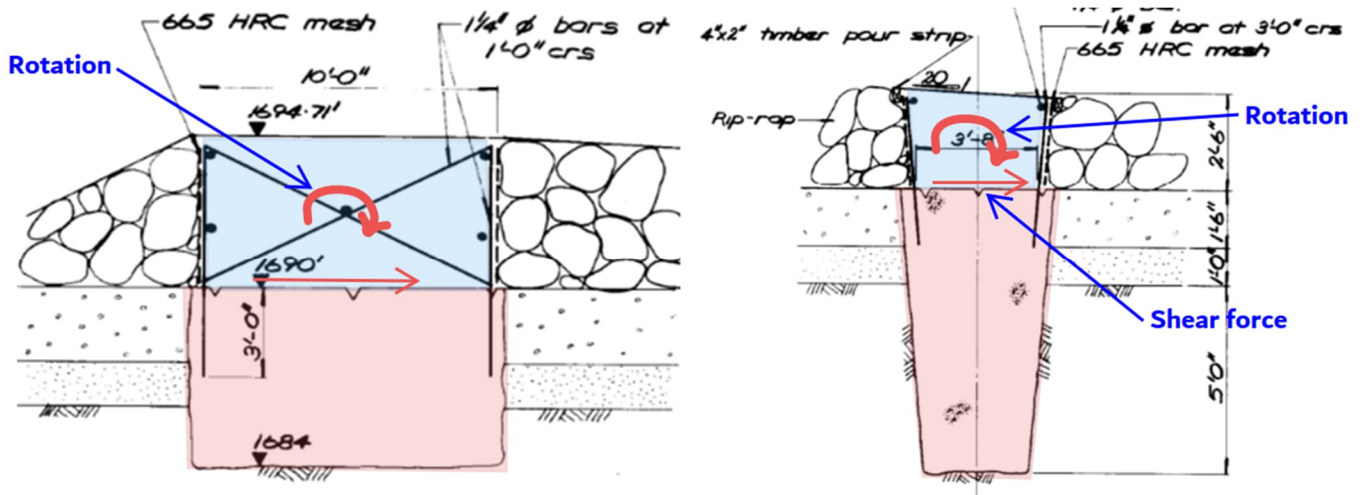
To bring the chute back into operation today the connection of the concrete cap to the weir is essential to enable the weir and sills to achieve their intended design purpose to hold back the riprap during design water flow. The connection of the concrete cap would need to resist the lateral loads due to the gravity load of the upstream riprap bearing on the cap as well as the lateral force on the cap as a result of the hydraulic flow of water down the chute. The lateral loads will create a shear force at the interface of the cap and the base concrete (i.e. at the construction joint) and an overturning force on the cap. Note given the dimensions of the weir cap the weight of the cap is expected to be sufficient to resist any overturning force on the cap. It is possible that the weight of the sill cap may be insufficient to resist the overturning and assuming there is sufficient section of reinforcement remaining in the vertical rebars these could provide the necessary overturning resistance if required. The forces to be resisted are shown in Figure 2 below:

Figure 2: Weir and rib (sill) concrete structure showing loads to be resisted by concrete caps

The current condition of the vertical 1.25 inch (approx. 32mm reinforcement) is unknown. Photographs show corrosion.

WSP recommendation: Given that the importance of keeping the concrete caps connected to the concrete base to achieve the structural performance of the concrete weir and sills, and given that the vertical reinforcement has an unknown extent of corrosion, and is known to have varying gaps between the reinforcement and the concrete it is recommended drilling and grouting new steel dowels along the length of the weir and sill beams, to ensure the connection between the concrete cap and base remains during use of the structure.
