8 June 2026

Ben Murray  
Corporate Affairs and HSE Manager  
Graymont New Zealand Limited  
214 Collingwood Street  
**HAMILTON 3204**

## **OPARURE QUARRY SOUTH-WESTERN PIT – CONTAMINATED LAND PRELIMINARY SITE INVESTIGATION**

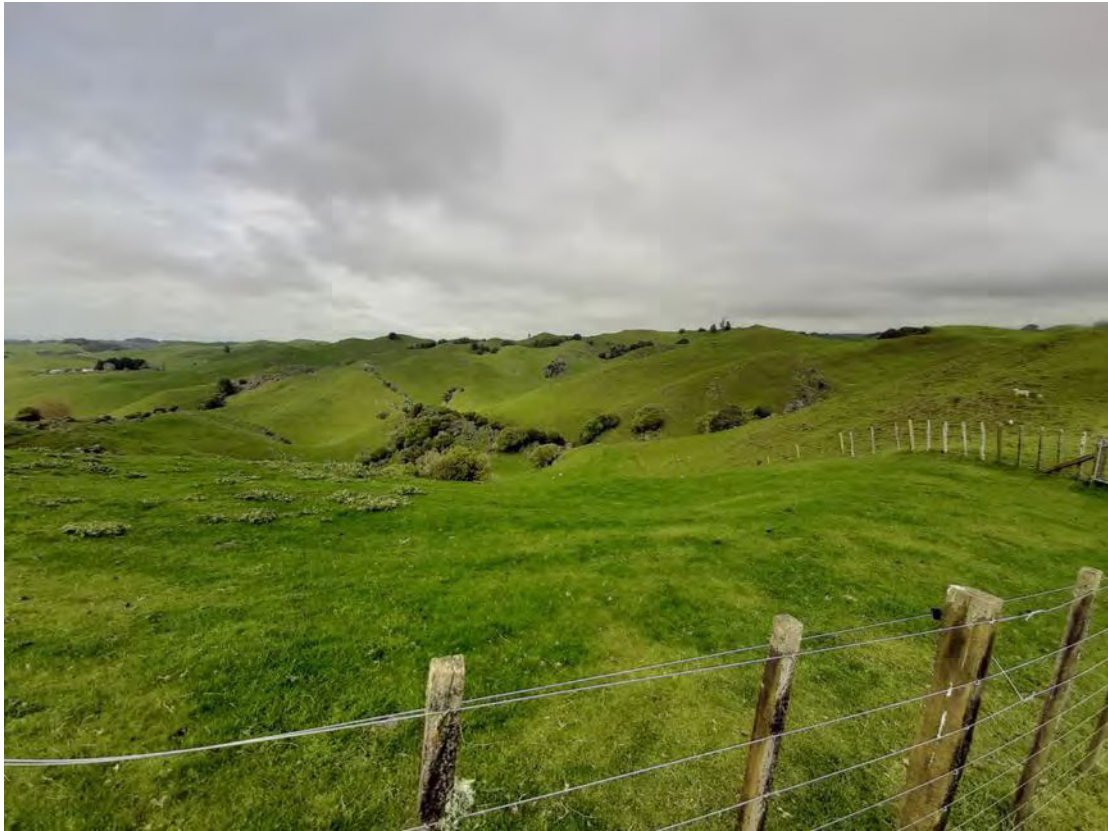
**Photograph 1: General landscape of the site.**

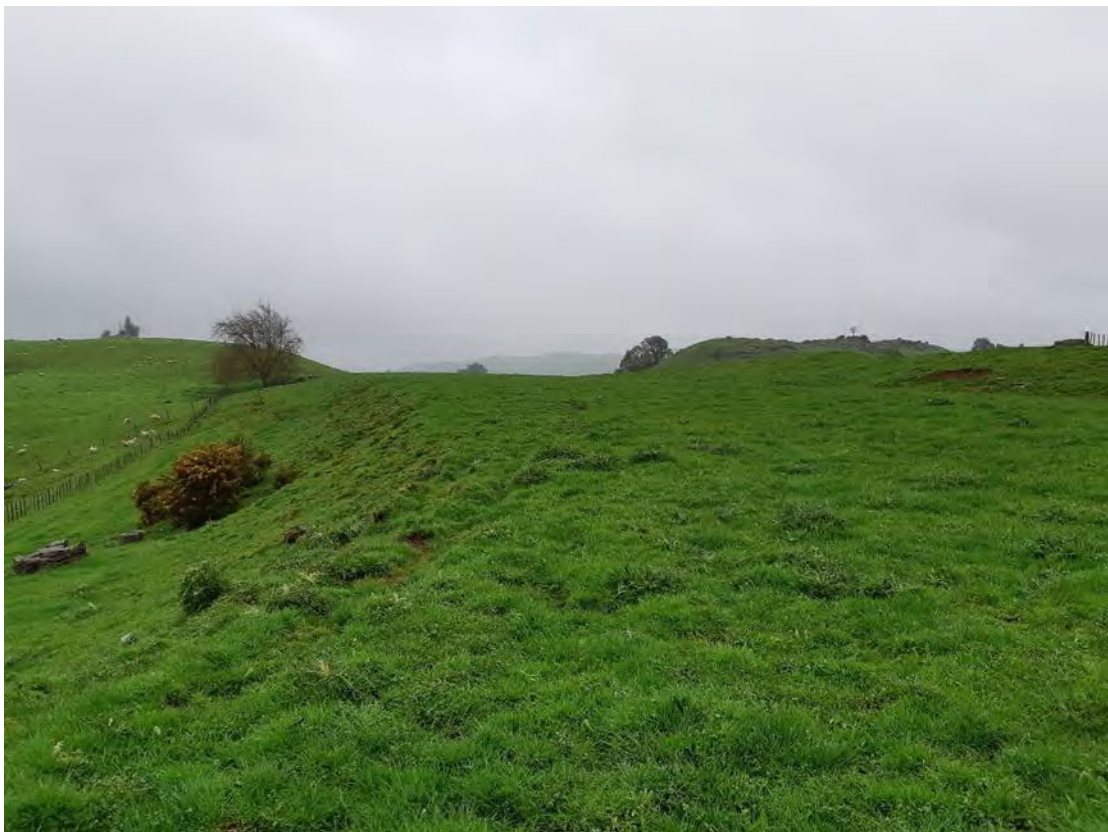
The WRC LUIR identified two airstrips on the site. The former Grainger Farm Airstrip was visited as part of the PSI site walkover and no infrastructure (e.g. fuel storage or dispensing facilities) or signs of contamination were observed. Anecdotal evidence from talking with farmers on site suggests that this airstrip was formerly used to load aircraft with fertiliser products, however no evidence of this was observed during the site walkover, and no other evidence of this activity has been found from any of the other information sources reviewed as part of this PSI. Therefore, the potential HAIL activity listed on the LUIR (Category A6: fertiliser manufacture or bulk storage) is not considered further for the airstrip location in this investigation.

**Photograph 2: View facing south west of a former airstrip (Grainger Farm airstrip) which is located in the north-western portion of the site.**

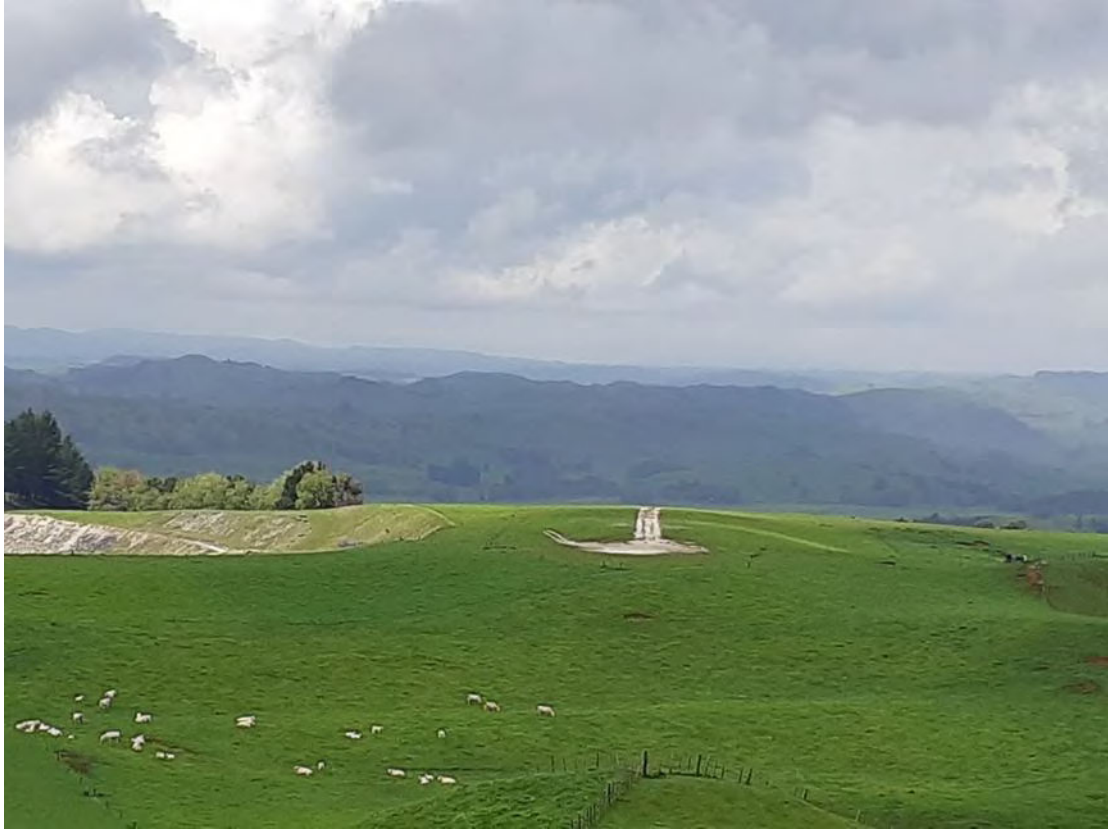
**Photograph 3: View facing south east of the Oparure Lime Quarry (McDonalds Lime Ltd Quarry) airstrip located to the south-east of the site.**

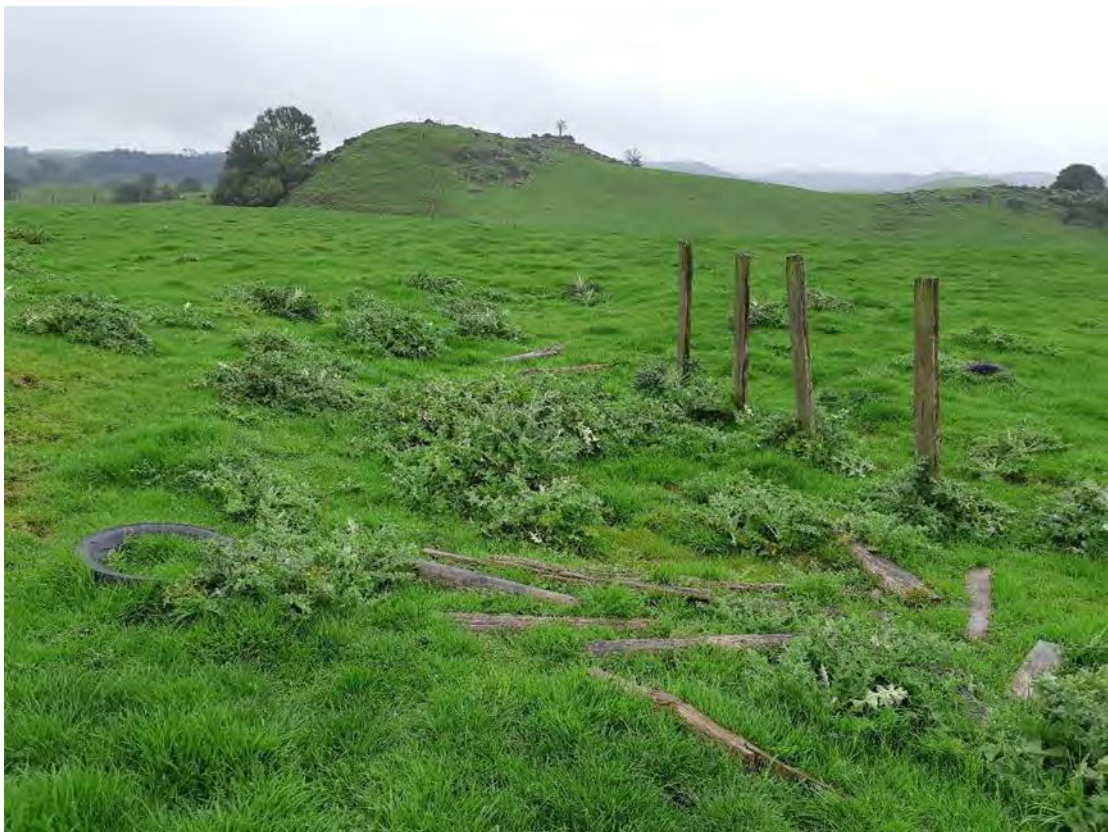
**Photograph 4: Fencing timber on ground in the west portion of the site adjacent to the former airstrip.**

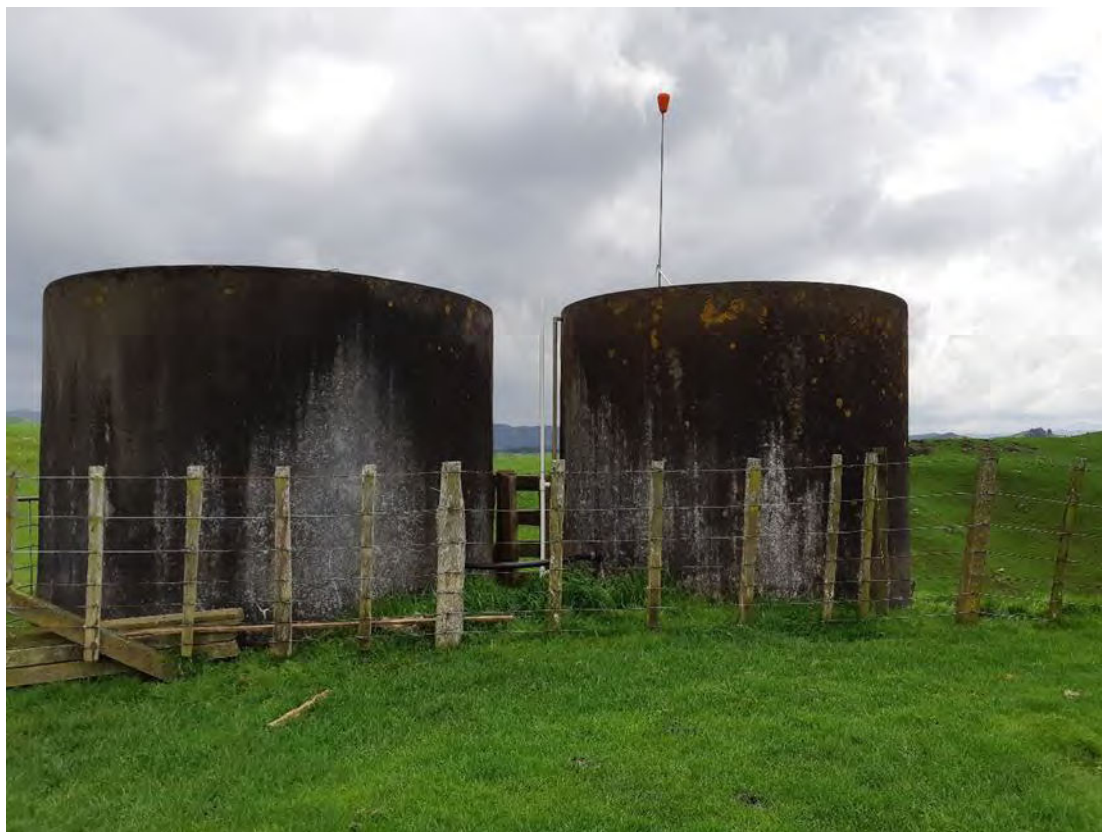
**Photograph 5: View facing north of water tanks in the north-eastern portion of the site.**

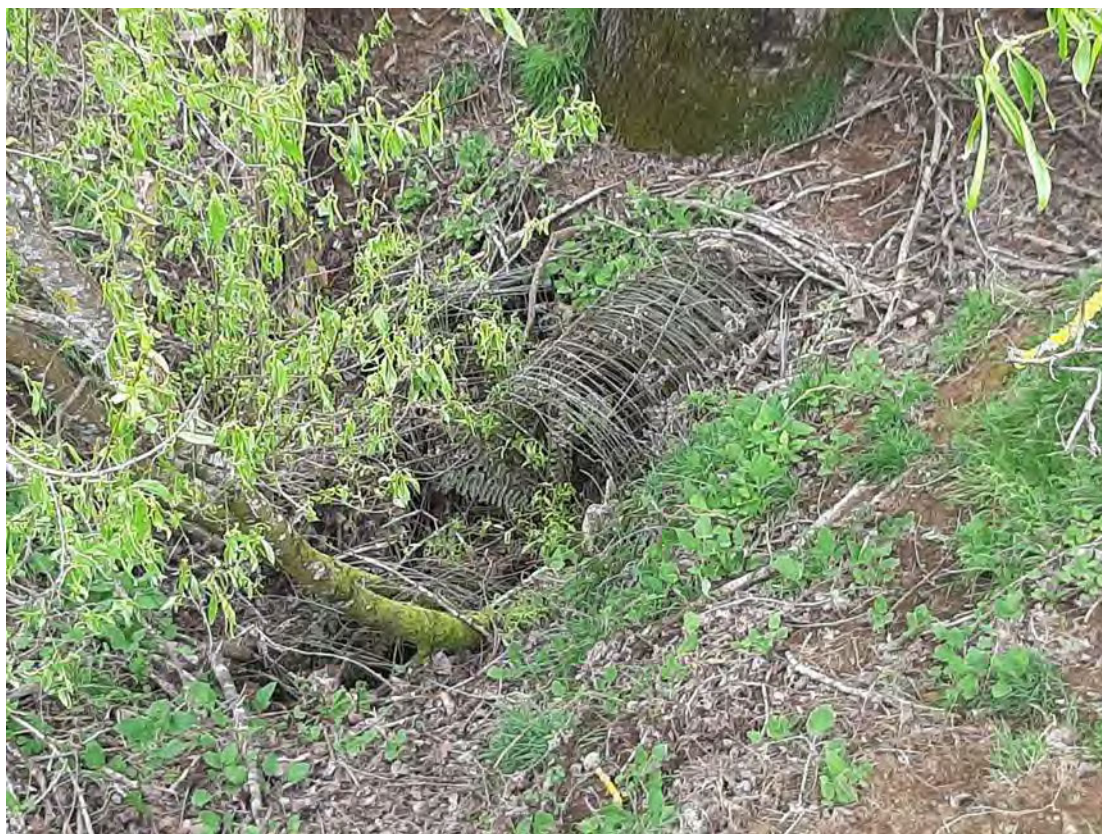
The fly tipping of farm waste was observed in some tomos throughout the site including areas within the proposed quarry area. Waste observed comprised mostly of fence posts, fencing wire and tyres, however the tomo nearest the farm buildings (Buildings 1, 2 and 3) had evidence of offal waste and an empty unidentified chemical container. Given the quantity and type of waste observed across the site, the fly tipping is not considered to fall within the definition as a HAIL activity, as it is unlikely that hazardous substances would be released in sufficient quantity to pose a risk to human health or the environment.

**Photograph 6: View of the typical waste (predominantly fencing materials) observed in some of the tomos at the site.**

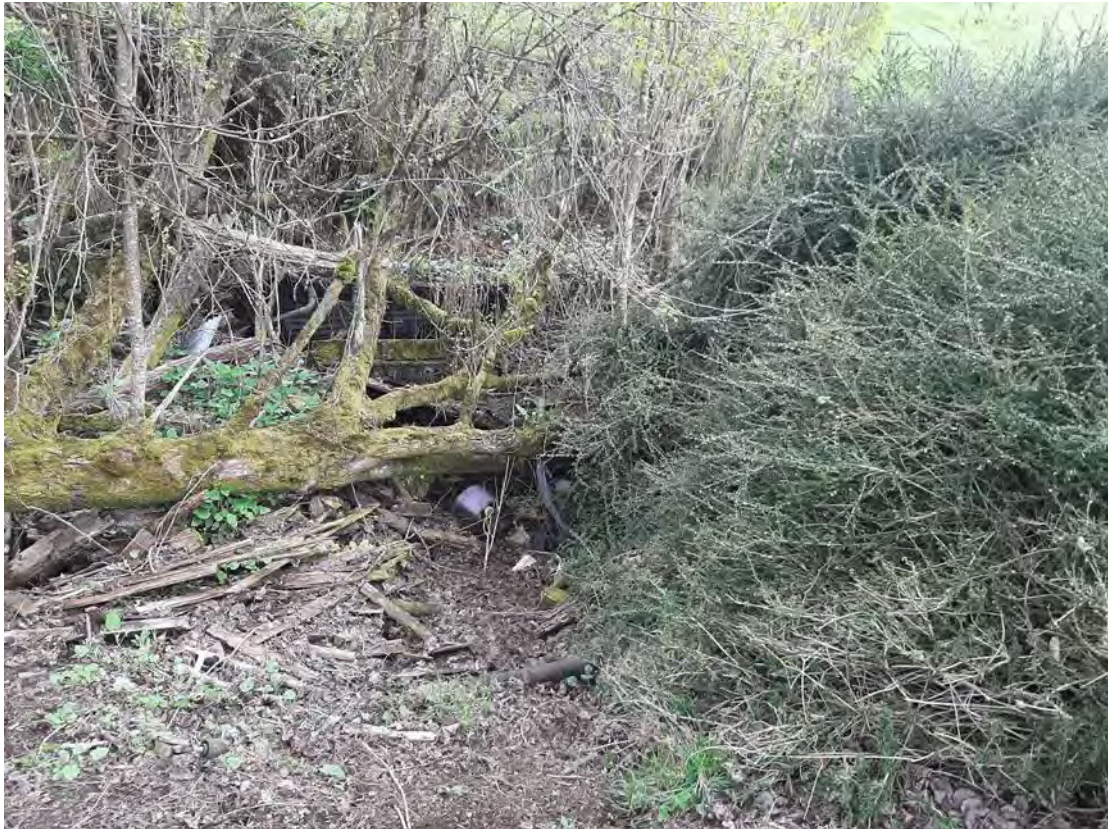
**Photograph 7: View of waste and vegetation within the tomo closest to Building 1 in the southern section of the site.**

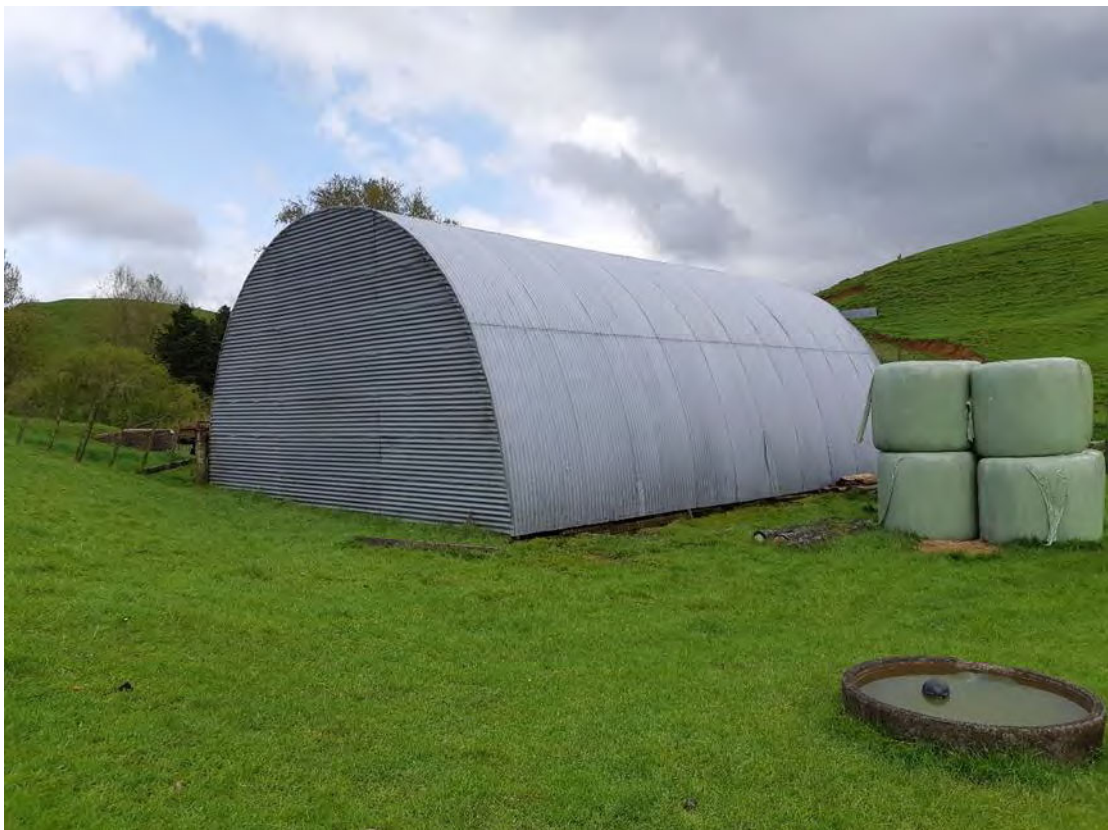
Building 1 is located outside of the proposed quarry area and it is understood that no earthworks are proposed in this vicinity. Building 1 was observed to contain a small above ground storage tank (AST) labelled as containing diesel. Building 1 was locked during the site walkover therefore it was not possible to access inside, however from an observation point through a gap in the door, the AST appeared to be in good condition. Storage of chemicals and fuel is an activity listed on the HAIL (Category A17: storage tanks or drums for fuel, chemicals or liquid waste) and the shallow soil in the vicinity may have been impacted by this activity. If the land use in this area of the site is proposed to be changed or any earthworks are proposed as part of any future site development, a soil investigation is recommended under the NES-CS.

Timber fencing materials are stored outside of this building, and the timber is likely to be treated. However, given the quantity of the potentially treated timber, the timber storage is not considered to represent a HAIL activity as it is considered unlikely that a sufficient quantity of hazardous substances would be released to cause a risk to human health or the environment.

**Photograph 8: View of Building 1 facing south west in the southern section of the site. Building used for storing a tractor and farming equipment.**

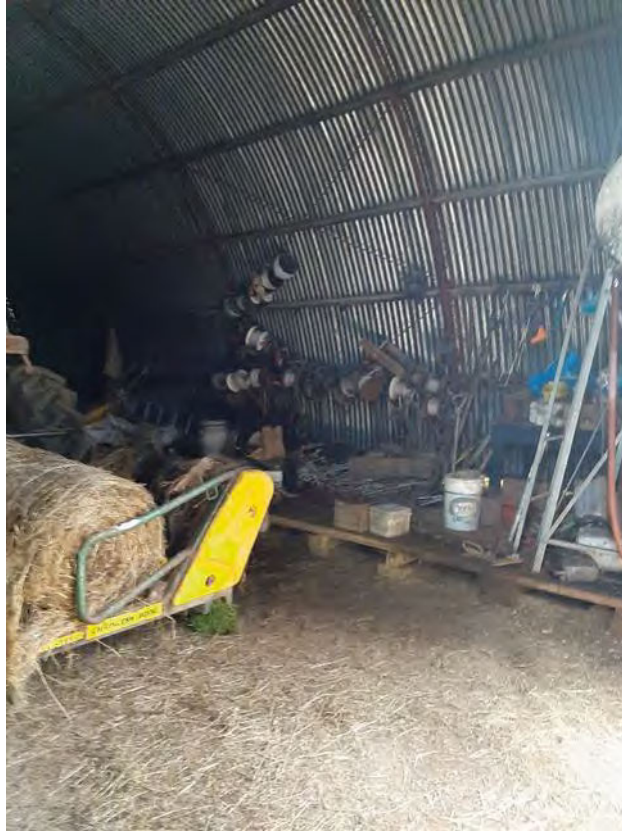
spillage was observed around the diesel tank or chemical storage area, however a full inspection was not completed;

**Photograph 9: View of the farm equipment and small diesel above ground storage tank located in Building 1.**

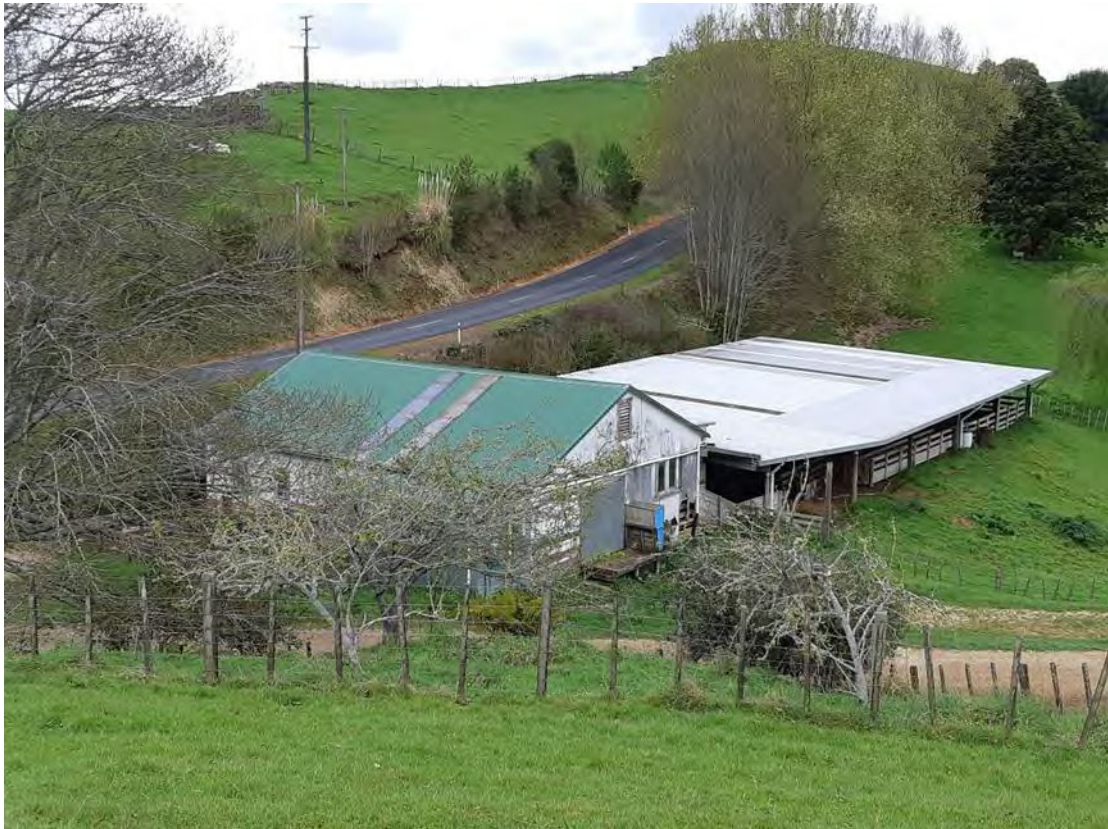
Given the age of Building 2 (approximately 1950s), painted building materials observed may contain lead. The condition of the paint on the building indicates that lead in soil contamination may be present where paint has weathered and been deposited on to the ground. At this time, this contamination source is considered to represent a 'potential HAIL', noting that the use of lead-based paint is not listed on the HAIL and therefore any contamination from this source would be categorised as Category I: any other land that has been subject to the intentional or accidental release of a hazardous substance in sufficient quantity that it could be a risk to human health or the environment. Category I is only considered to apply in cases where soils are found to contain concentrations of contaminants that exceed the MfE *Methodology for Deriving Standards for Contaminants in Soil to Protect Human Health (the 'Methodology')* (MfE, 2011b) Soil Contaminant Standards (SCS) for the applicable land use scenario. This can only be determined via soil sampling, hence the conclusion provided herein that the site is 'potential Category I'.

**Photograph 10: View of Building 2 facing south on the southern site boundary. Building used as wool shed (for shearing), livestock pen and livestock spraying area; Oparure Road is visible beyond the building.**

proposed to be changed or any earthworks are proposed as part of any future site development, a soil investigation is recommended under the NES-CS.

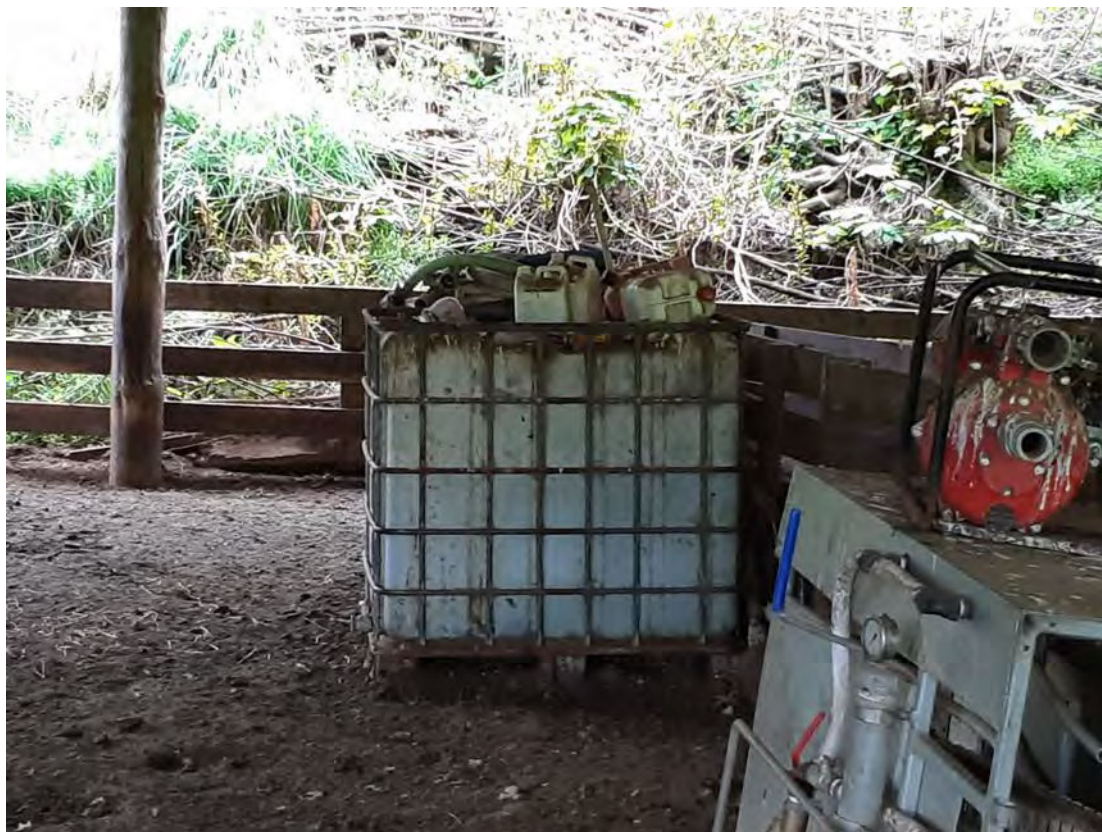
**Photograph 11: View of livestock spraying equipment and chemicals located on unsealed ground within the livestock pen in Building 2.**

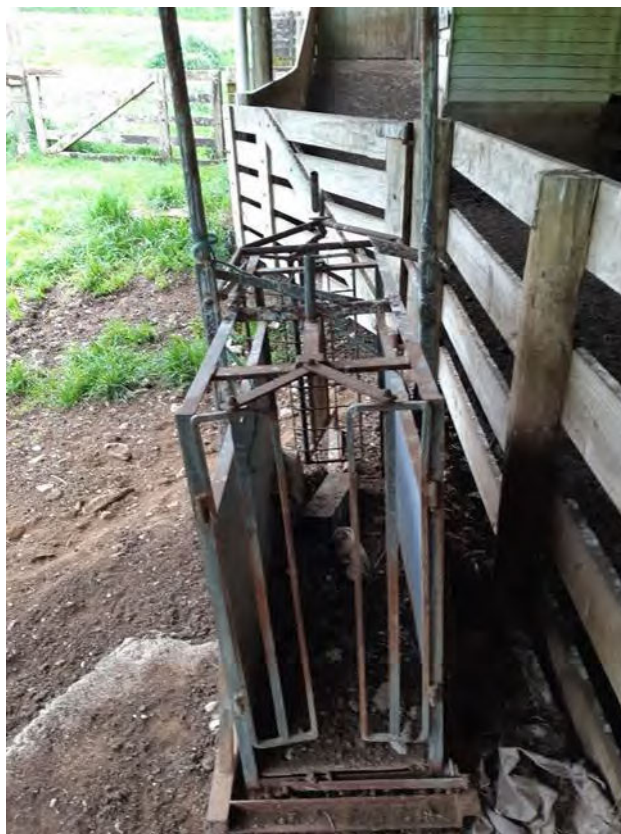
**Photograph 12: View of livestock spraying equipment in Building 2.**

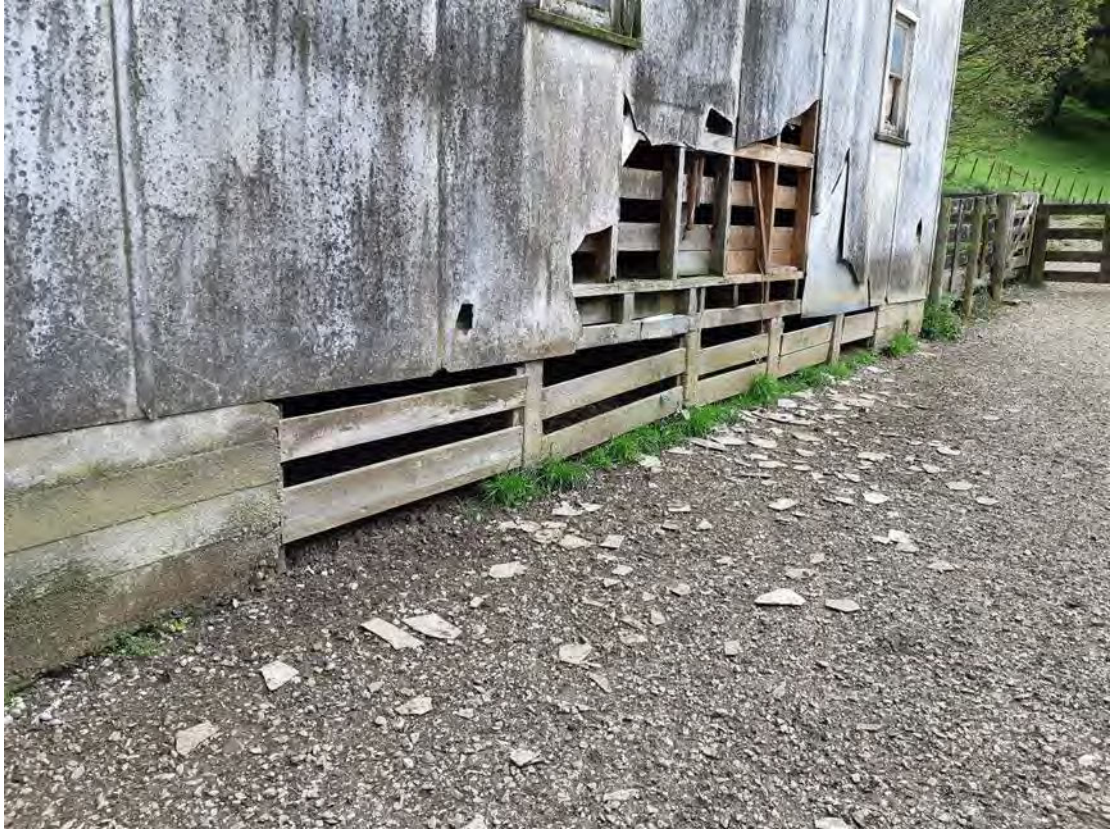
- ✧ A woolshed (Building 2) is located adjacent to the access gate at Oparure Road and exterior building materials were observed to be in a degraded state with broken asbestos containing material (ACM) cladding spread over the ground surrounding the structure (photograph 13);

Building 2 has asbestos cladding located on the southeastern exterior wall which has been broken, and fragments are spread over the gravel race on the southeast side of the building. The fragments were observed to have spread as far as the covered stock yard. Asbestos contamination of soils in this area related to these broken fragments has been assessed as possible given the quantity of fragments present, in accordance with the assessment criteria provided in the BRANZ and ALGA (2024) *'New Zealand Guidelines for Assessing and Managing Asbestos in Soil'*. Given the deteriorated condition of the broken fragments on the ground on the southeast wall of Building 2, this location is considered to meet the definition of HAIL Category E1: sites with buildings containing asbestos products known to be in a deteriorated condition. The building footprint, and area surrounding the other walls of Building 2 are not considered HAIL.

Degraded ACM was identified on unsealed ground surfaces during the PSI site walkover and this source of potential contamination represents a potential risk to human health. Although this potential contamination source was located in an area of the site that is outside of the area to be developed for minerals extraction, the whole site is owned by Graymont who are a Person Conducting a Business or Undertaking (land owner) in accordance with the Health and Safety at Work Act (asbestos) Regulations 2016 (HSWA-AR). As such, Graymont have responsibilities under the HSWA-AR for identifying asbestos or ACM that may give rise to risk at locations which are a workplace.

**Photograph 13: View of broken asbestos containing cement sheet on the southern exterior wall of Building 2.**

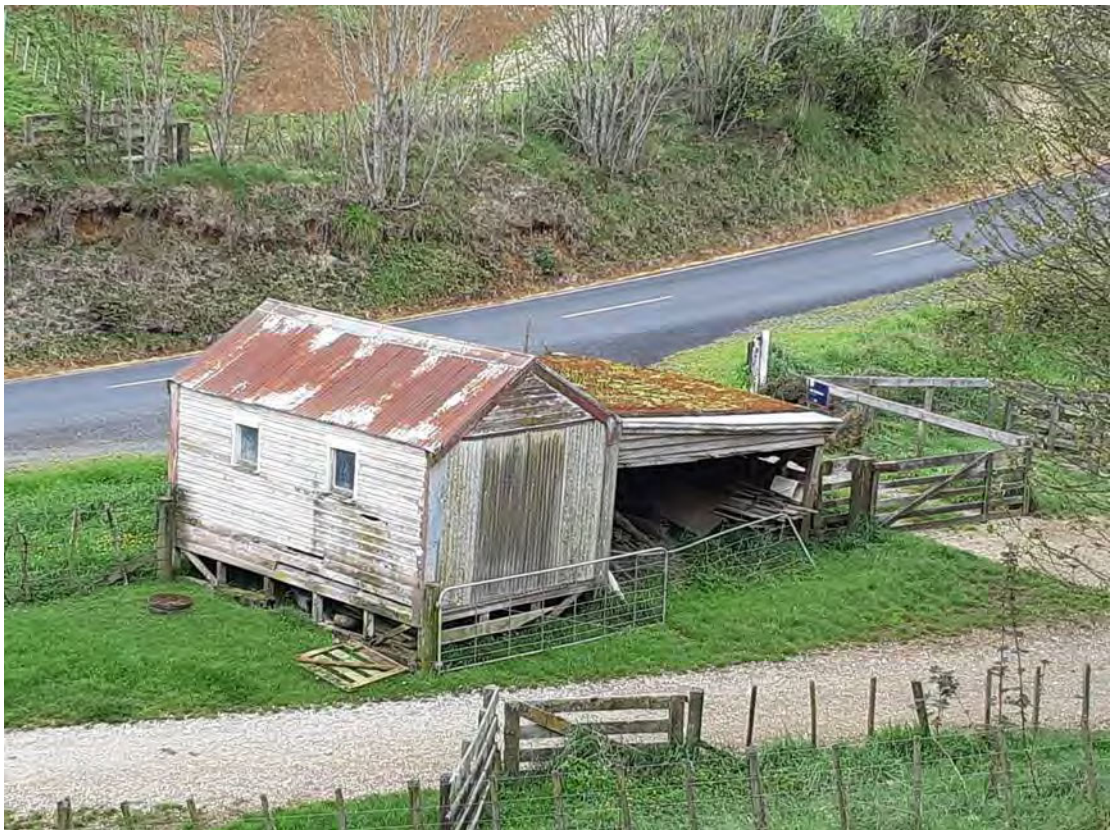
Given the age of the building (estimated to be in the 1950s based on historical aerial photographs), the painted building materials observed may contain lead. The deteriorated condition of the paint on the building indicates that lead in soil contamination may be present where paint has weathered and been deposited on to the ground. At this time, this contamination source is considered to represent a 'potential HAIL', noting that the use of lead-based paint is not listed on the HAIL and therefore any contamination from this source would be categorised as Category I: any other land that has been subject to the intentional or accidental release of a hazardous substance in sufficient quantity that it could be a risk to human health or the environment. Category I is only considered to apply in cases where soils are found to contain concentrations of contaminants that exceed the Methodology SCS (MfE, 2011b) for the applicable land use scenario. This can only be determined via soil sampling, hence the conclusion provided herein that the site is 'potential Category I'.

**Photograph 14: View of Building 3 facing south on the southern site boundary; Oparure Road is visible beyond the building.  
Building used to store wool off cuts.**

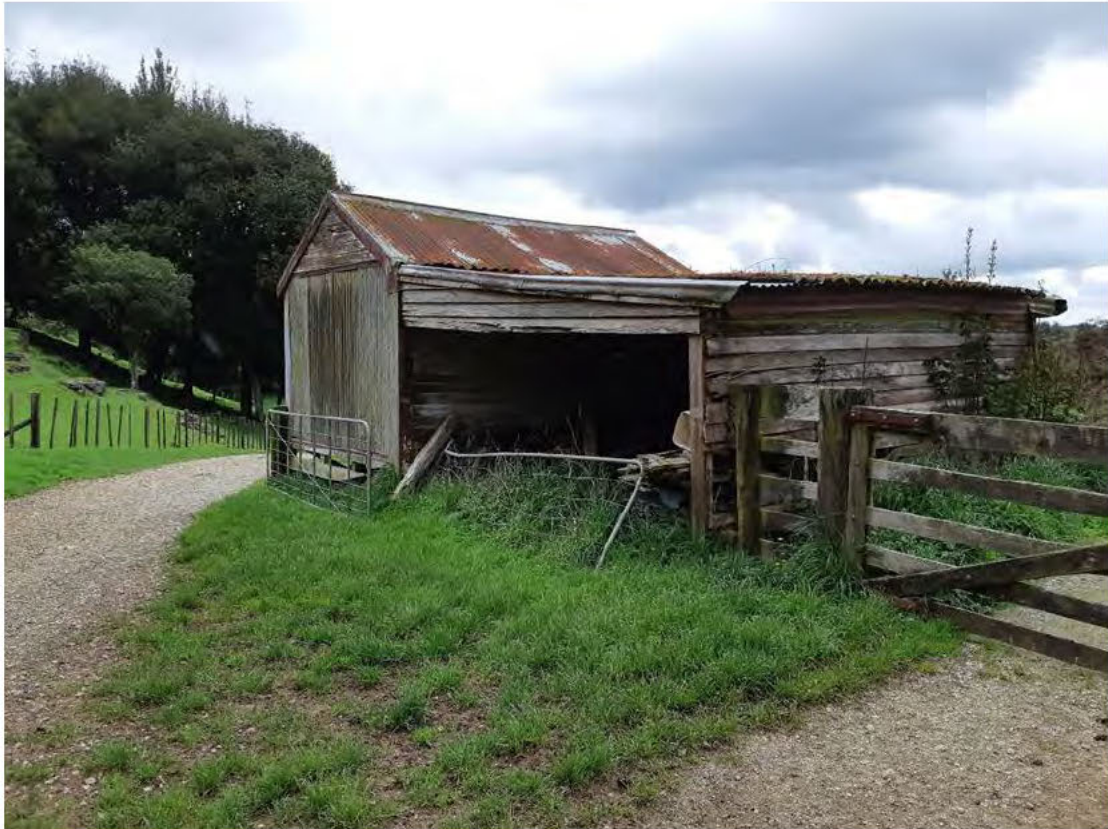
Building 3 has partial asbestos cladding and roofing in a moderately weathered condition, as well as asbestos super 6 sheeting in a good condition stored in an attached lean-to area. This piece of land is not considered as HAIL as the quantity and degree of weathering on the asbestos to land is not considered to be of sufficient quantity that could be a risk to human health or the environment.

**Photograph 15: View facing east of asbestos cladding on the building and roofing in the lean-to at Building 3.**

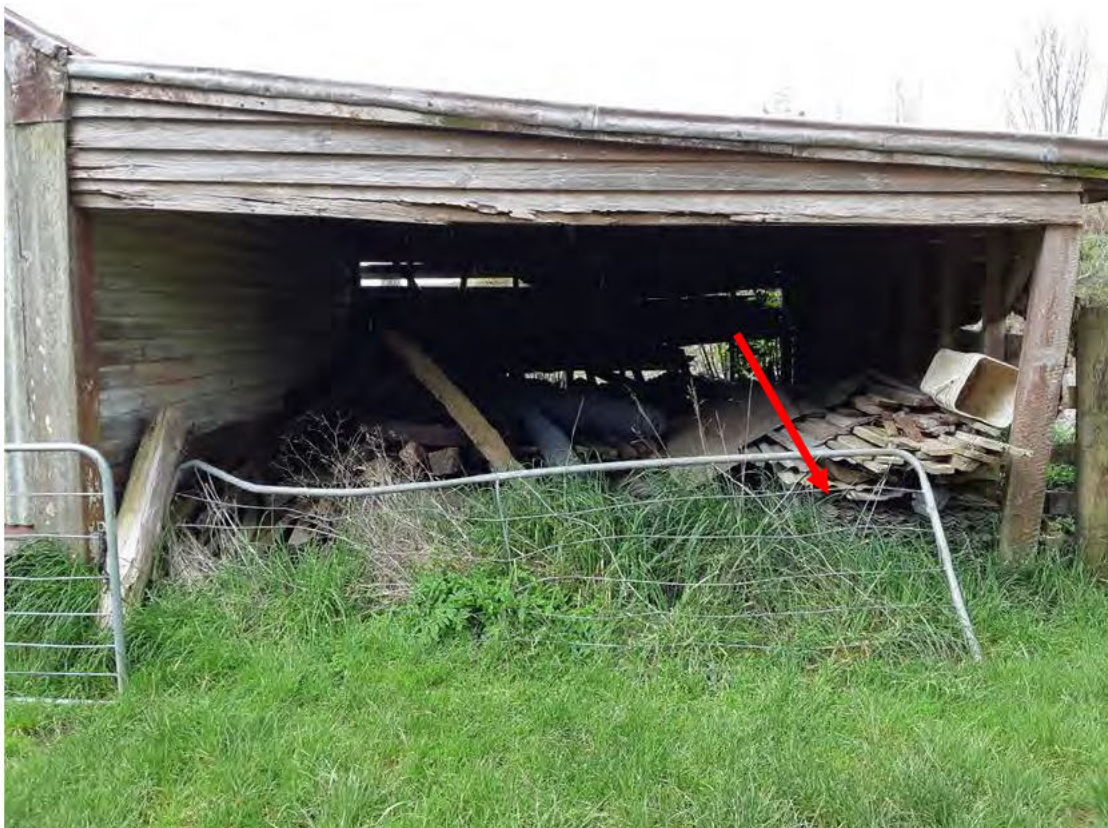
The attached lean-to contains timber fencing materials and the timber is likely to be treated. However, given the shed cover and the small quantity of the fence posts stored there, the timber storage is not considered to represent a HAIL activity as it is considered unlikely that a sufficient quantity of hazardous substances would be released to cause a risk to human health or the environment.

**Photograph 16: View of asbestos cement sheet being stored in the lean-to at Building 3.**

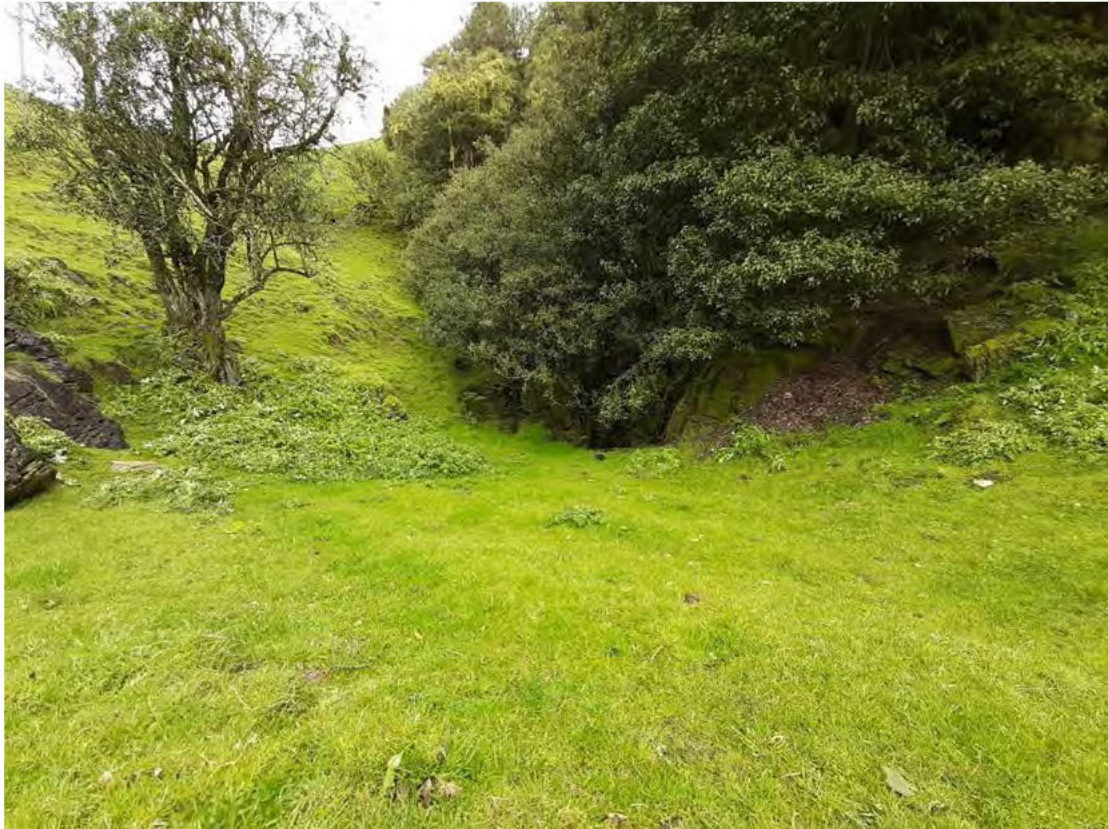
Building 4 is located outside of the proposed quarry area and it is understood that no earthworks are proposed in this vicinity. Building 4 is a pump shed located on the northwestern boundary of the site. The pump within the shed pumps water from a stream to supply water to troughs around the site. Motor oil was observed to be leaking from the pump equipment onto the ground surface however this leak is not considered as HAIL as the amount of hazardous substance potentially released is not considered to be of sufficient quantity that could be a risk to human health or the environment.

**Photograph 17: View facing west of the vicinity of Building 4 located within the heavily vegetated gully in the north-western boundary of the site. The building is used for storing a water pump.**

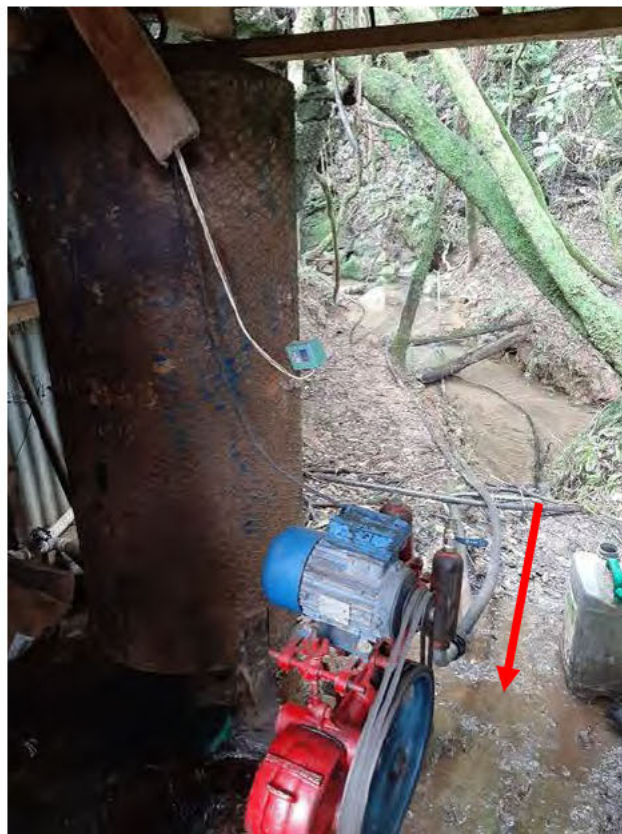
- ✧ A pump shed (Building 4) was observed on the northwestern section of the site (Lot 1, DPS 77130) and a minor spill of motor oil (AEGIS 20w40 motor oil) was observed on the wet concrete floor of the shed; this spill was observed to be running off onto the unsealed ground outside of the building (photographs 18 and 19). The shed also contains a potential asbestos electrical backing board and herbicide containers;

**Photograph 18: View of the pump within Building 4; a small stream is visible beyond the building. Minor motor oil spill identified by the arrow.**

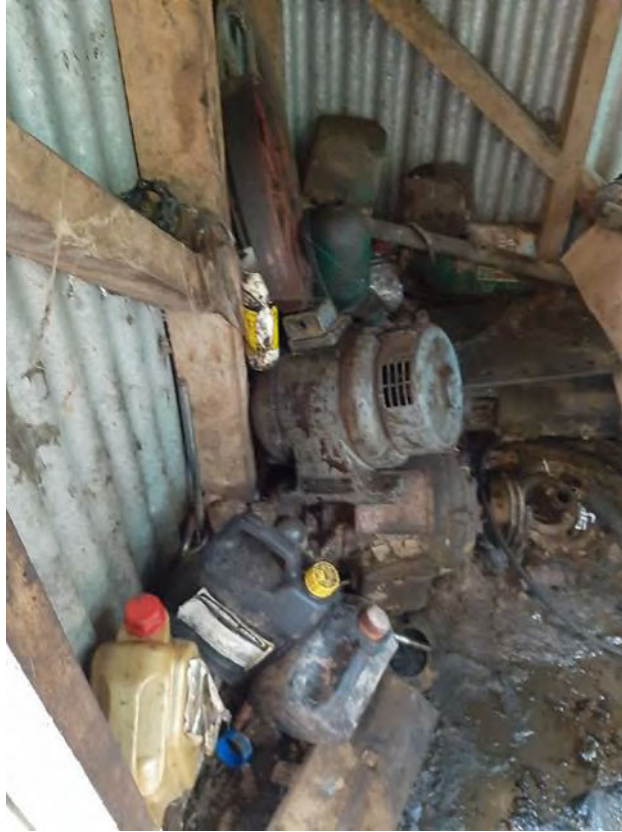
**Photograph 19: View of oil containers and old parts within Building 4.**

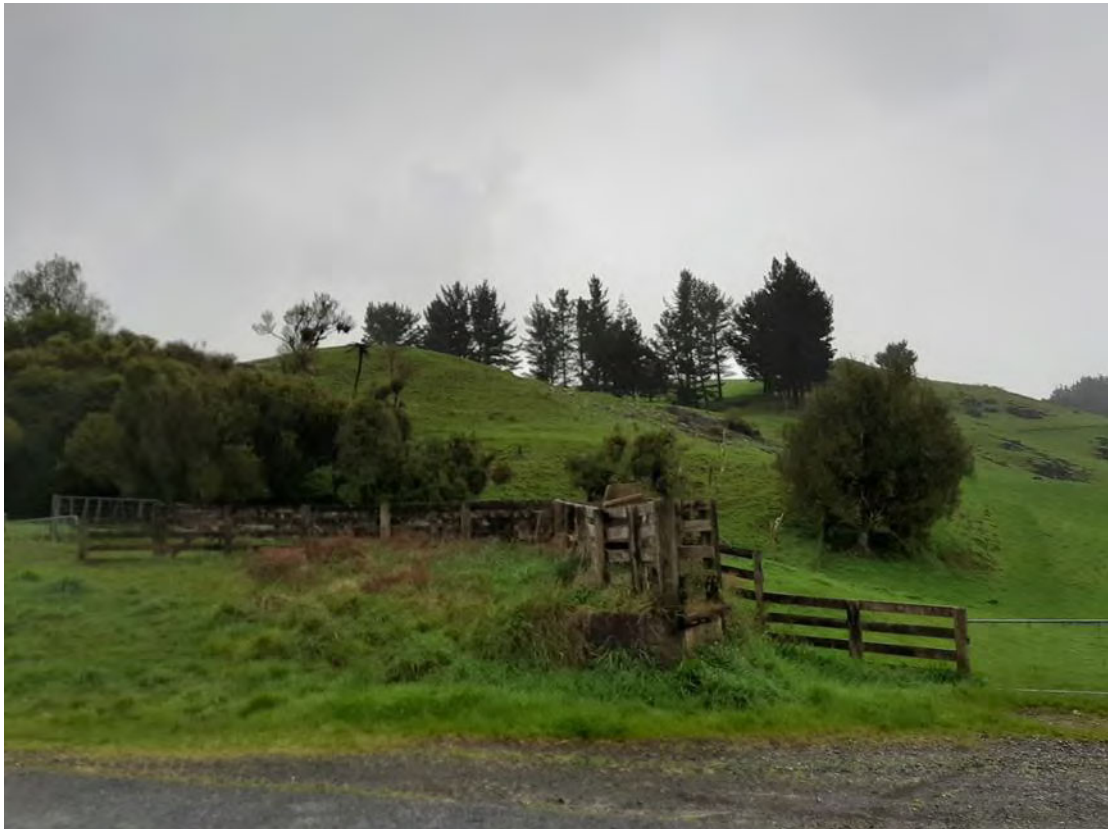
**Photograph 20: View facing north of a stockyard and livestock loading pen (Building 5) located in the south-eastern portion of the site adjacent to Oparure Road.**
