Geotechnical assessment report for

Proposed Maitahi Village Subdivision
Kaka Valley, Nelson

Prepared by
Tonkin & Taylor Ltd

Date
February 2025

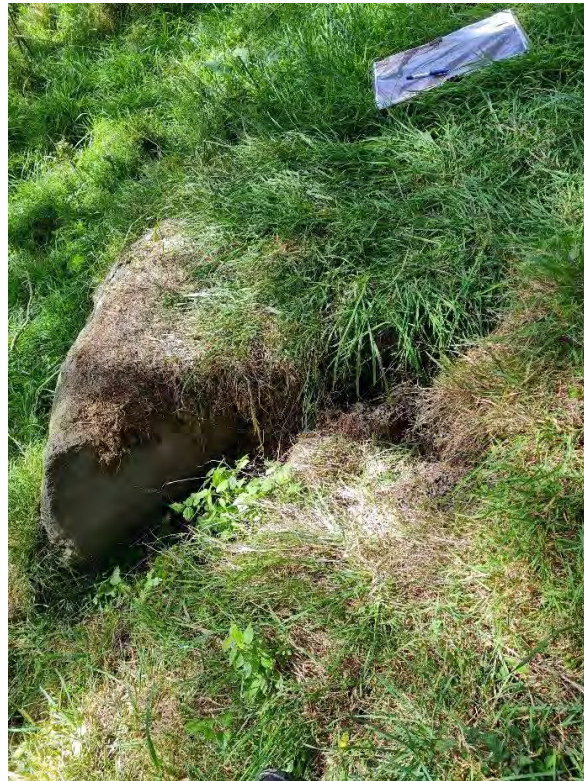
Where Gully 16 steepens (approximately 250 m upstream of the pylon track), fewer boulders were observed to be visible on the slope surface most were partially buried within the hummocky surface topography of the gully floor (*Photograph 4.3*).

Photograph 4.3: Example of boulder encased in hummocky debris

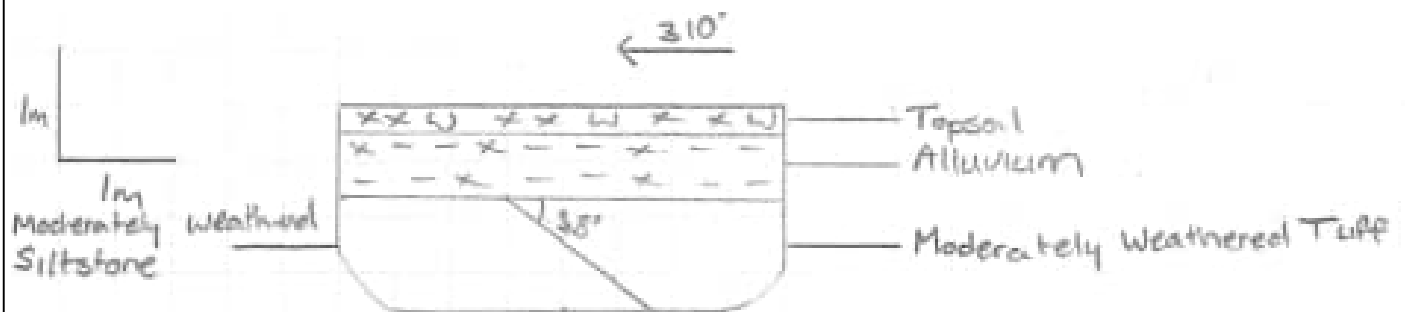
COMMENTS: Water ponded at surface.

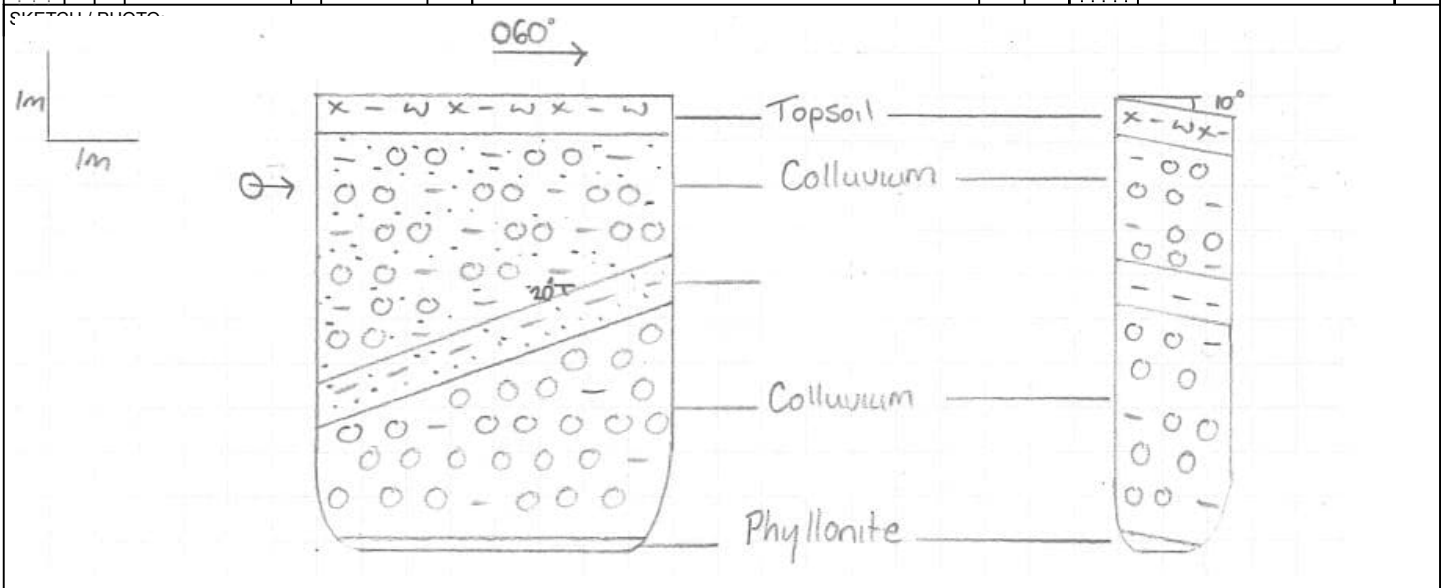
COMMENTS: Water ponded at surface.

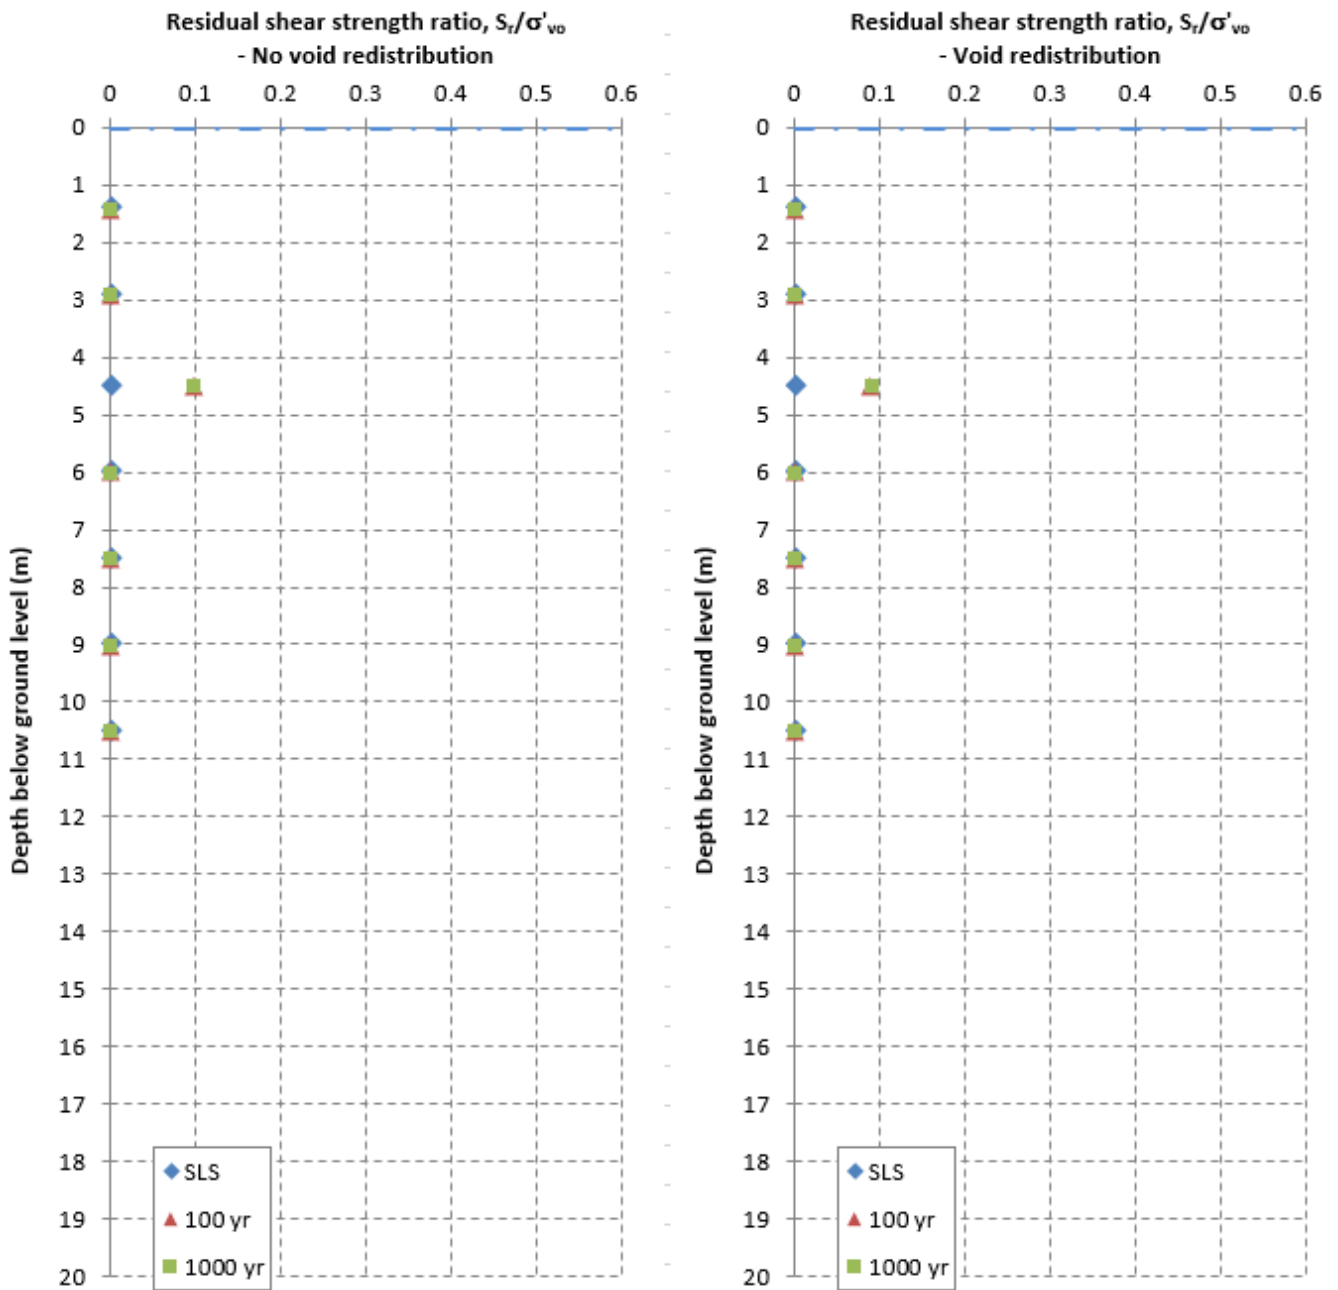
Figure 5, residual strength assessment for the upper layer of liquefiable material

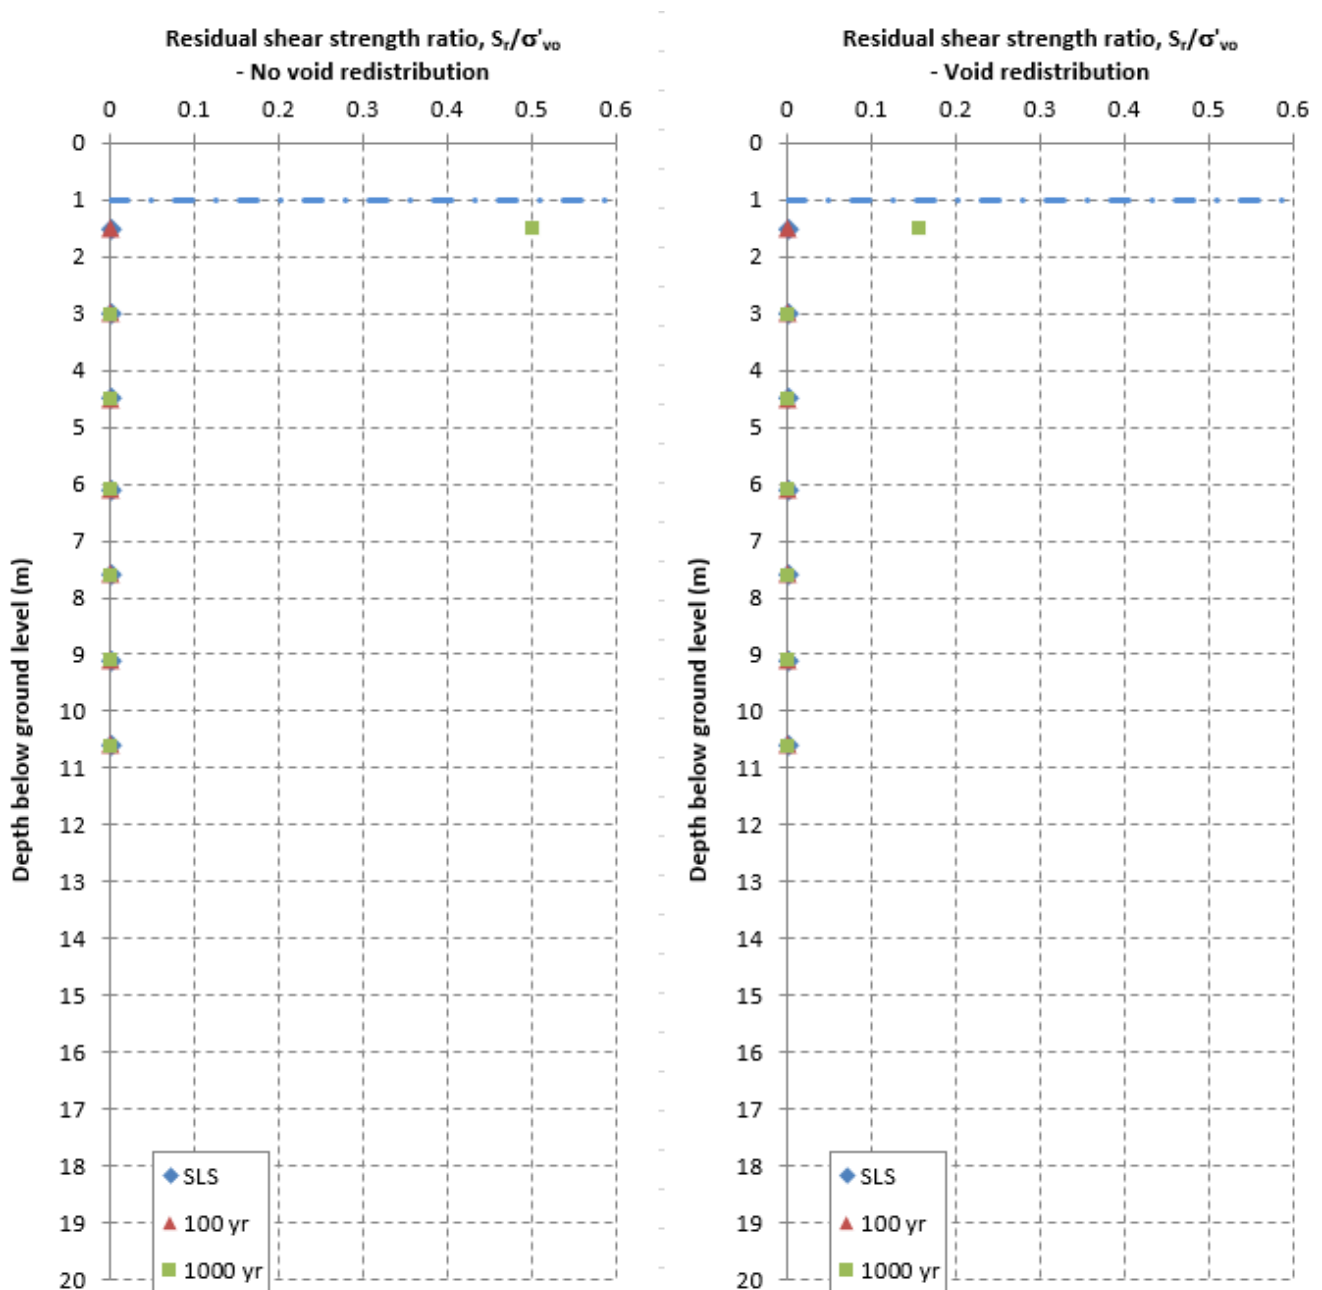
Figure 6, residual strength assessment for the lower layer of liquefiable material

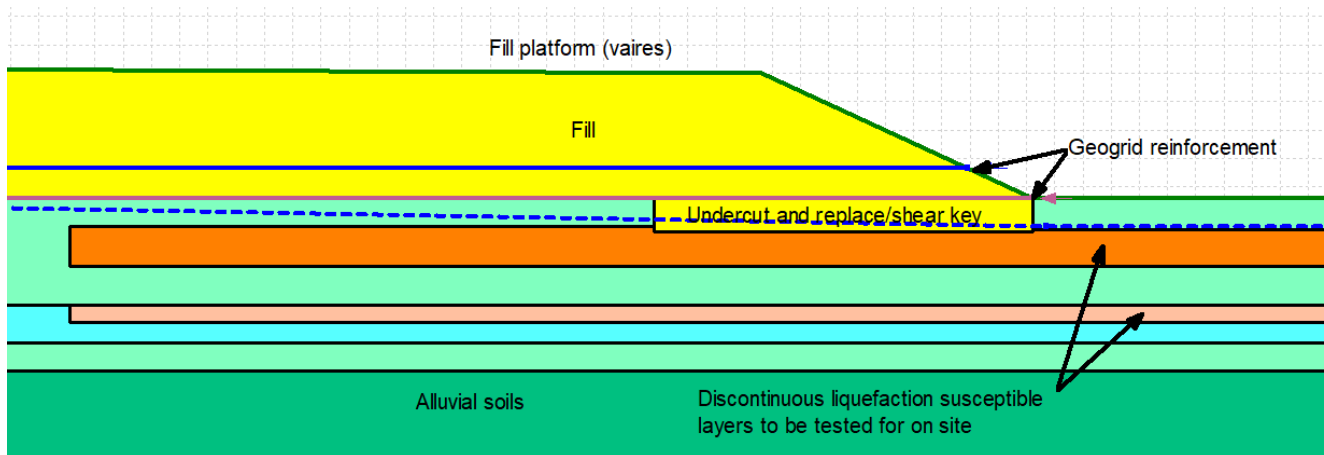
Figure 8, potential strengthening works to reduce liquefaction induced ground damage near the fill face
