**IN THE MATTER:** an application for approvals for the Lake Pūkaki Hydro Storage  
and Dam Resilience Works

**STATEMENT OF EVIDENCE OF MURRAY GRANT WEBBY ON BEHALF OF  
MERIDIAN ENERGY LIMITED**

**TEKAPO B POWER STATION TAILRACE WEIR AND ROCK CHUTE**

Dated: 15 April 2026

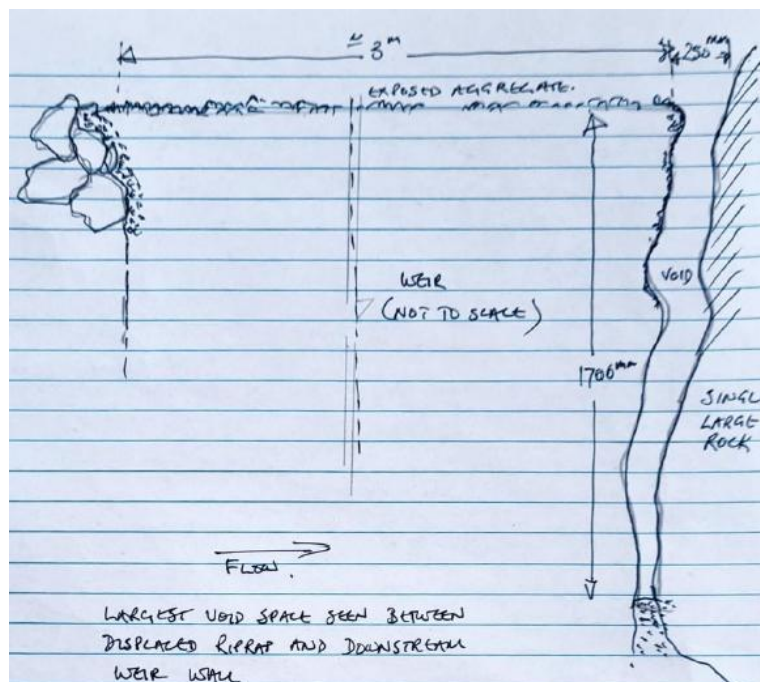
**Figure 1: Diver's sketch of void (gap) noted between concrete control weir and riprap**

- 16 The gap between the control weir and rock lining in bay 1 observed in the recent dive inspection (refer to the sketch in **Figure 1** below - reproduced from **Figure 12 of Damwatch document c** (Paragraph 10 above)) most likely developed during the initial period of structure operation when stabilisation of the chute lining occurred. Similar gaps could exist on the downstream side of other sills due to the “downdrift” behaviour of the chute lining in each bay described by Thompson and Campbell.

Note: Lift joint is approx. 1,435 mm deep, compared to diver's observed depth of rib face approx. 1,700 mm deep

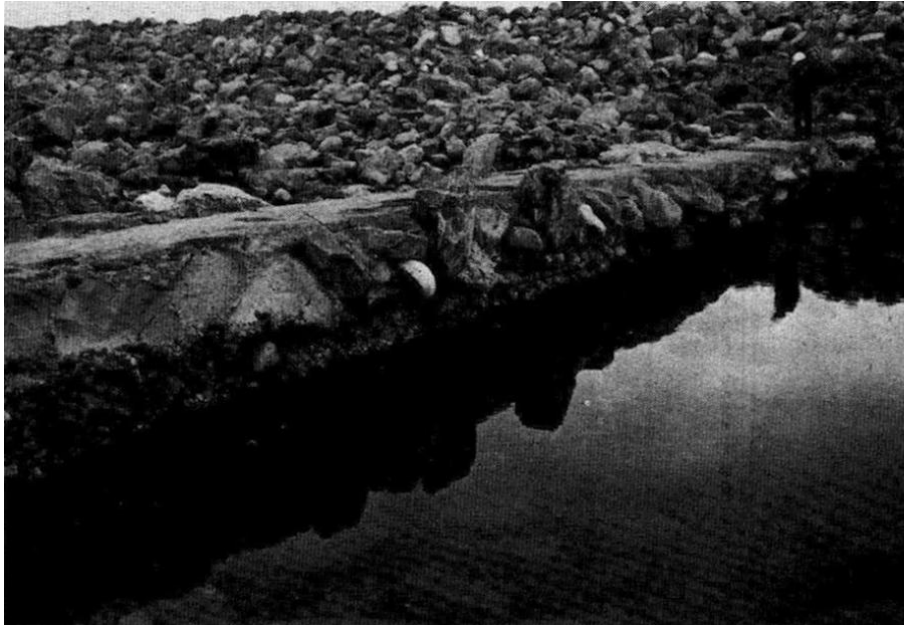
**Figure 2: Scour hole which formed downstream of sill 9 in July 1977 showing rock elements of chute lining partially embeded in concrete of sill**

However, there is also other evidence of rock elements of the chute lining partially embedded within the concrete sill as seen in the in the photograph in Figure 2 below sourced from the 1979 technical note “Construction and Performance of the Rock-Lined Chute at Tekapo B Power Station”: by Ted Malan and Bruce Hancock of the Ministry of Works and published in the Proceedings of the Institution of Civil Engineers UK (referenced in Damwatch documents a and c – Paragraph 10 above),

- 62 In the unlikely event that a repair to the weir and chute structure needs to be implemented during any future operation, the 1977 experience with the repair of the second more serious scour hole which developed in bay 9 and under sill 9 provides a useful reference for the magnitude and time scale of repair effort. As described in Section 5.3 of Damwatch document c (Paragraph 10 above), when the scour hole measuring 24 m in diameter and 5 m deep was first detected during a routine inspection when Tekapo B Power Station was offline for minor machine repairs, The power station was allowed to resume operation at half-load overnight, discharging about 61 m<sup>3</sup>/s. The scour hole was repaired in 8 hours the next day with 1650 m<sup>3</sup> of gravel fill material and 665 m<sup>3</sup> of riprap material before Tekapo B Power Station was allowed to return to full service again.

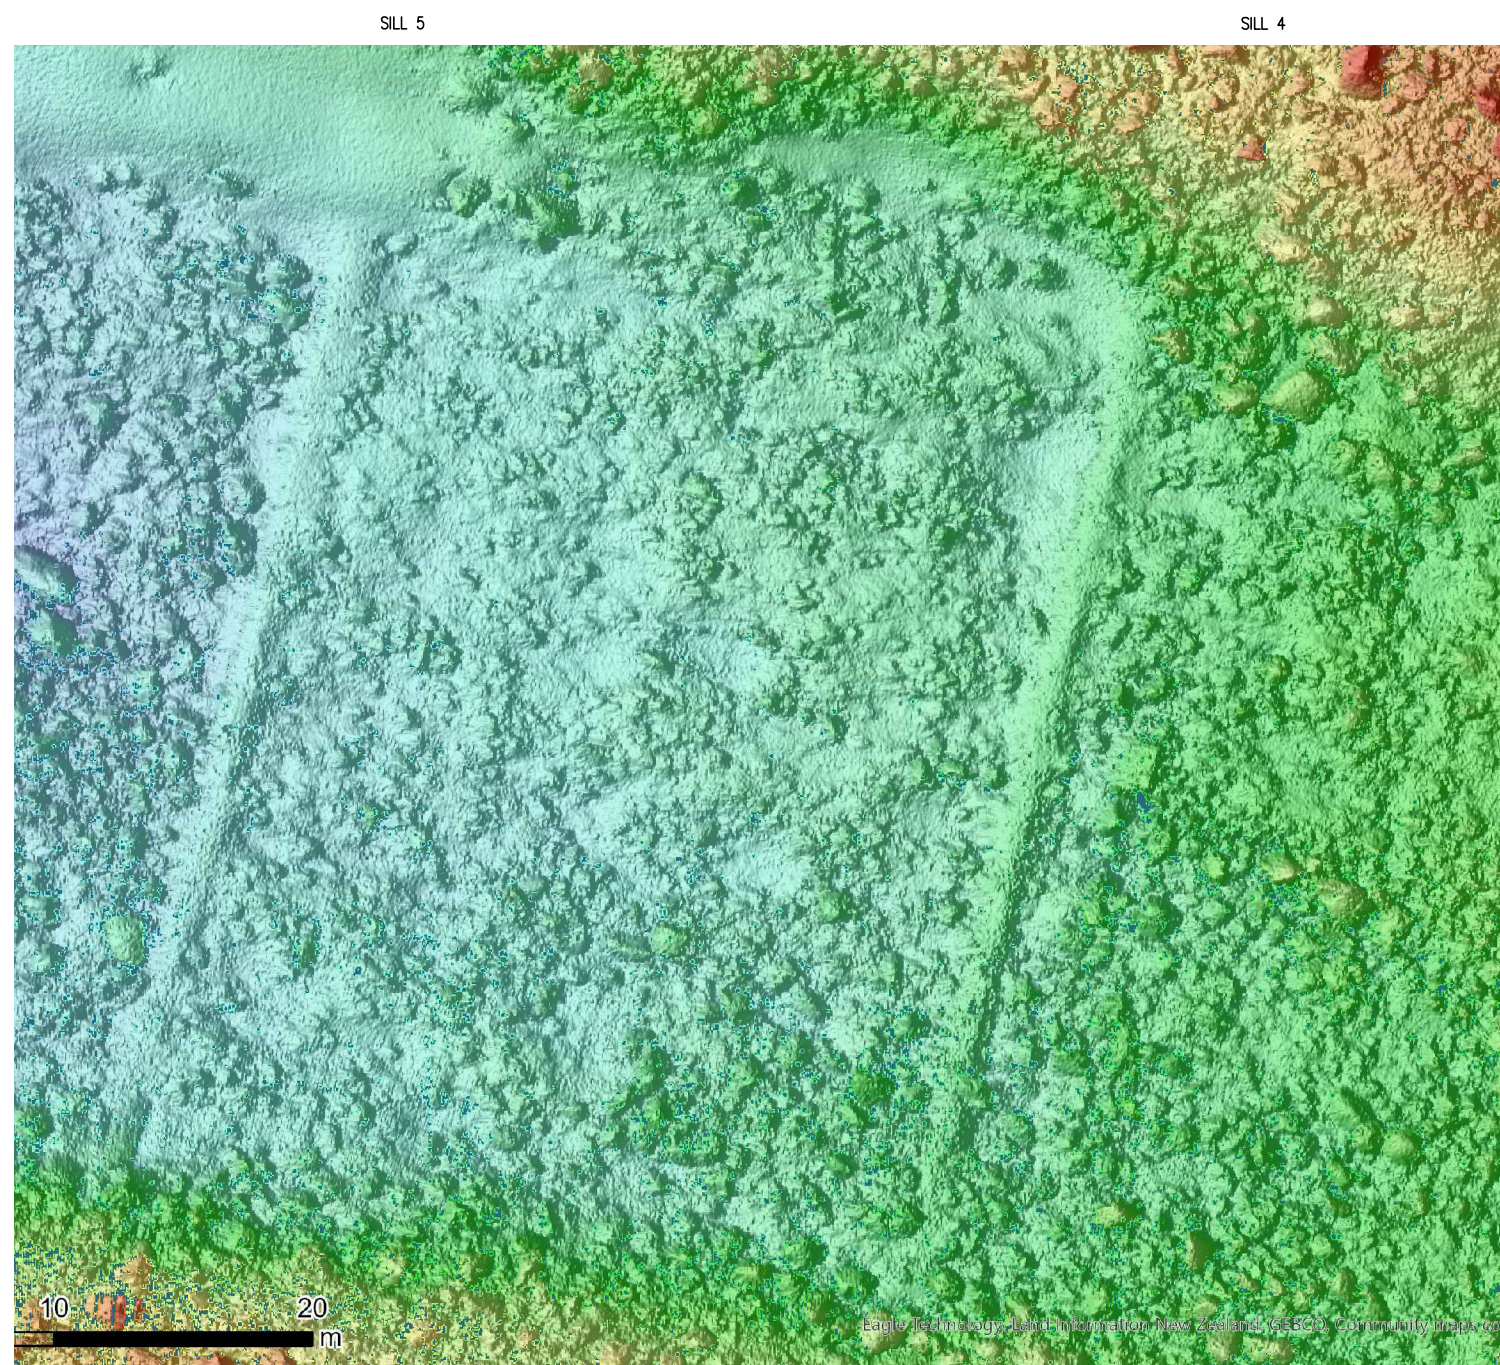
PLAN - BAY 4  
SCALE 1:300

- 20 The depression apparent from the WSP bathymetric survey does not show up in the longitudinal centreline profile of the chute on the Damwatch Drawing TEK-B\TW\CHT\PROFILE SECTION in Appendix C of Damwatch document c (Paragraph 10). However, a dip in the longitudinal right side profile in the same drawing does show up immediately downstream of sill 4. A clear patch also shows up in the same location in the bathymetric survey image of bay 4 between sills 4 and 5 on **Drawing TEK-B\TW\CHT\BAY-4** in **Appendix A**.

- 21 Meridian plan to shortly undertake another dive inspection of the weir and chute structure when conditions allow to investigate these and other anomalies identified from the bathymetric survey imagery. Note that there are some lighter patches on the survey images of bay 3 and bay 4 on paper copies of **Drawings TEK-B\TW\CHT\BAY-3 and BAY-4** in **Appendix A** which appear to indicate an absence of boulders in the tightly packed mosaic of the rock lining. However, when viewed on a digital version of these drawings, it is possible to distinguish boulders within these patches. It may be that the boulders in these patches are masked to some extent by deposited sediment.

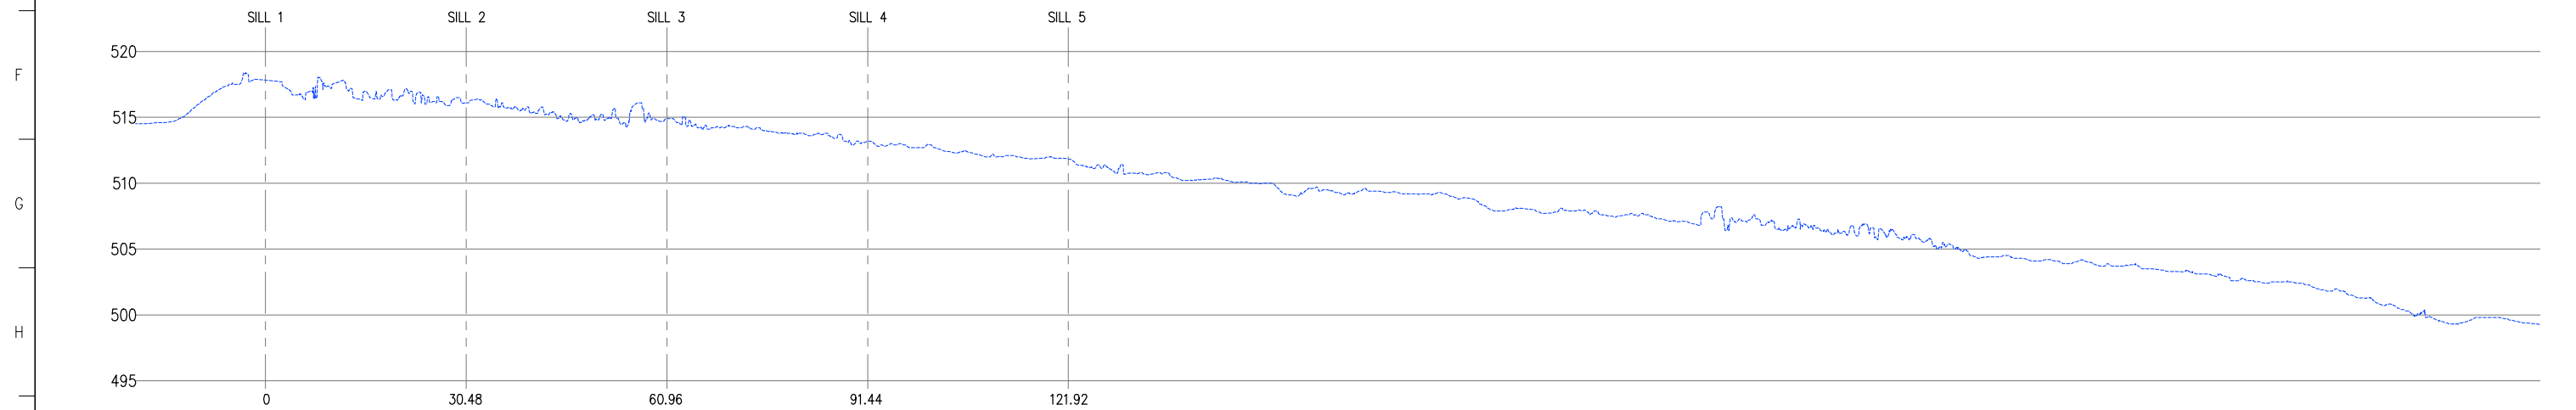
**(B)** LONG SECTION ALONG CENTRELINE OF STRUCTURE  
SCALE 1:1000 H  
1:500 V

- 19 WSP in their document a (Paragraph 9) note that the longitudinal bed profile of the chute shown in Figure 3-5 (and sourced from their bathymetric survey) exhibits a 1 m drop below the mean bed slope at about distance 140 m from control weir sill 1. This would place this apparent depression in the rock lining between sills 4 and 5 (refer to the long-sections sourced from the separate bathymetric survey carried out for Meridian Energy on **Drawing TEK-B\TW\CHT\PROFILE SECTION** in **Appendix A**.
