**Project Number 16998.000.002**

**Cannon Point Stage 4 - Geotechnical  
Investigation for Resource Consent**

10 Cannon Point Road, Craigs Flat, Upper  
Hutt, Wellington 5018

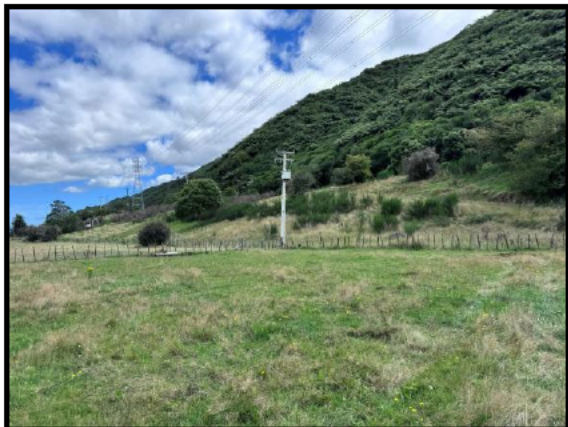
Photo 1: North-eastern extent of terrace riser.

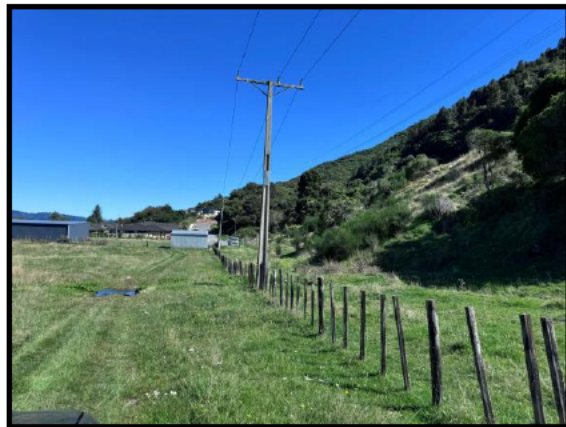
- At the south-western extent of the terrace riser a couple of shallow head scarps were noted along the crest of the terrace riser.
- In the centre of the site the steep terrace riser geometry is replaced by an undulating shallow slope, which continues to a greater height on the slopes above the site than the surrounding terrace riser. This terrane generally contains a lower level of semi-mature vegetation compared to the surrounding terrane. The toe of the undulating slope is lobate extending away from the slope suggestive of the toe of a historic landslide.

Photo 2: Steeper south-western extent of terrace riser

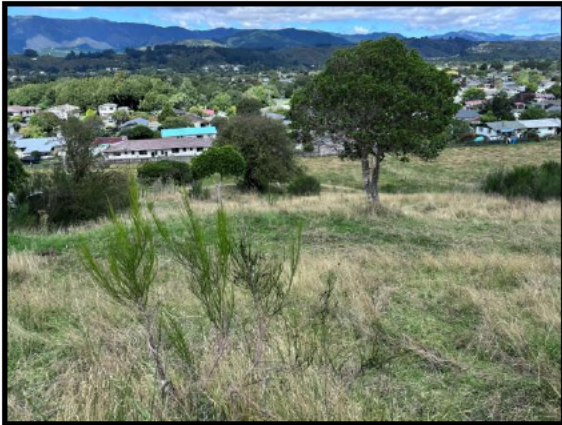
Photo 3: Photo looking down across undulating ground of historical landslide.

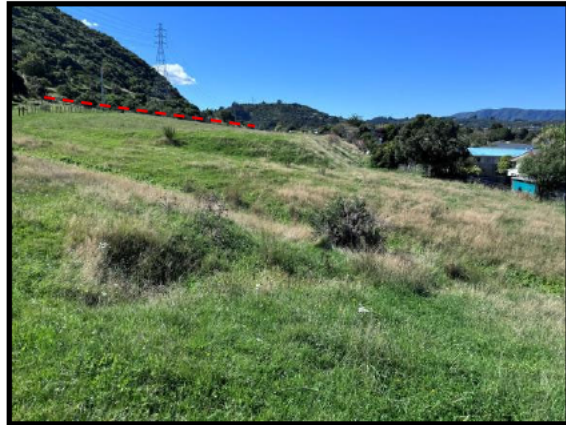
Photo 4: Gentle lobe-like structure from apex of Subcatchment 1.

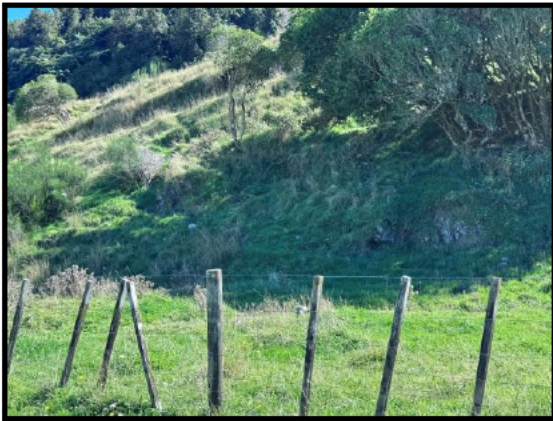
- Groundwater was observed to be seeping out of the terrace riser immediately south of the stream apparently along the soil to rock boundary. The ground was saturated in the area immediately surrounding the seepage area; however, this was also near the stream channel.

Photo 5: Rock observations where groundwater seepage was observed.

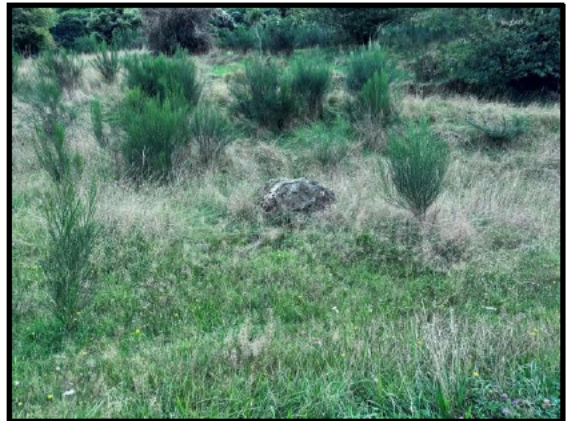
- Across the site, Greywacke boulders were observed at the toe of and across the face of the terrace riser, along the top of the terrace tread, and along the toe of the slopes above the site, which were covered by the tree canopy. Boulders across the grassland and terrace tread were sparse and isolated, while those at the toe of the slopes above the site were abundant and clustered.

Photo 6: Example of boulder on terrace riser.

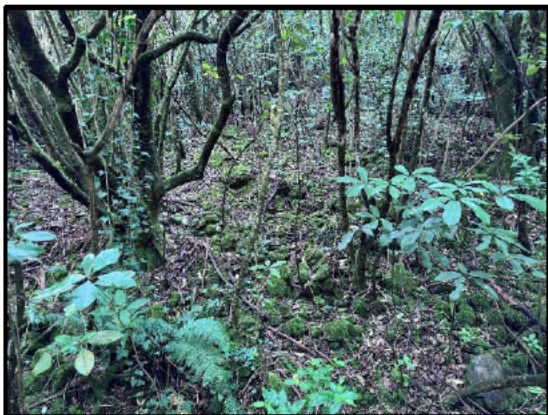
- Much of the rockfall debris was no more than 10 m away from the track at the toe of the slope. The largest boulder observed outside of the bush line was 2.6 m in length and may have originated from an exposed rock face in the slope above. However, it is unclear however if the boulder had been moved to its current position or if it naturally fell to this point.

Photo 7: Rockfall debris observed at the base of slopes. Largely moss and lichen covered.

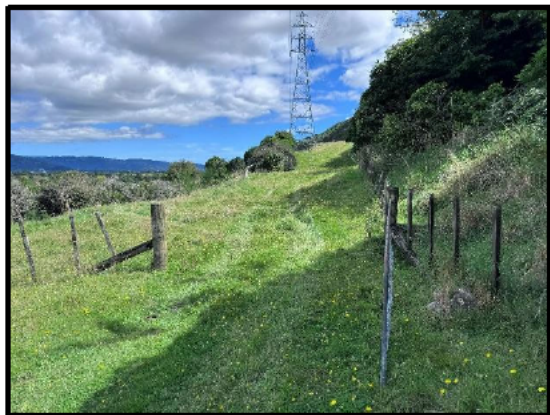
Photo 8: Transmission line on top of land slide debris above the site

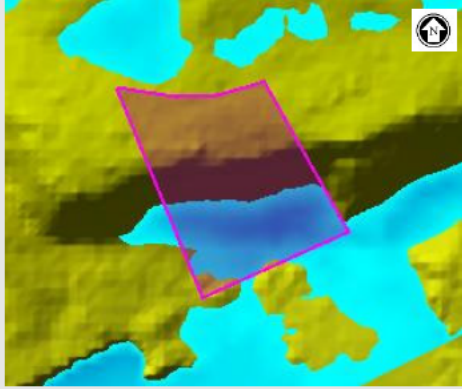
| Lot | IDF | Location | Discussion |
|---|---|---|---|
| 2 | 0.59 | | <p>Lot 2 contains a steep drop off from an upper terrace to a lower terrace. Following earthworks, we understand the lot will not contain a steep gradient.</p> <p>The existing civil plans show stormwater intakes in the road north of the site.</p> <p><b>The final civil cut / fill plan and stormwater infrastructure design will need to be reviewed to determine if additional debris flow mitigation measures are required.</b></p> |

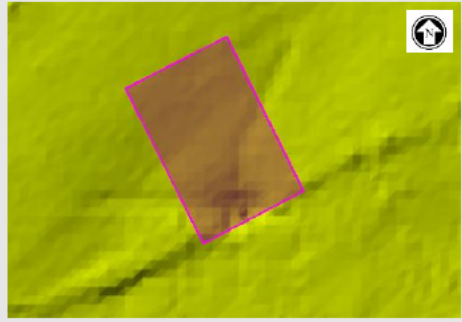
| Lot | IDF | Location | Discussion |
|---|---|---|---|
| 28 | 0.56 | | <p>Ponding at Lot 28 was significant because of the terrain variation and low point. Following earthworks, the lot is likely to be relatively flat</p> |

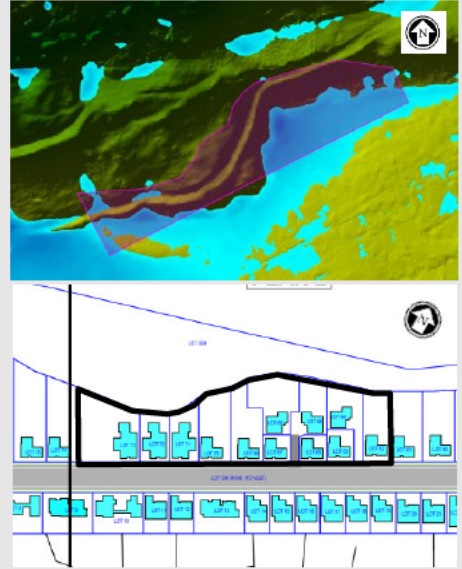
| Lot | IDF | Location | Discussion |
|---|---|---|---|
| 62 | 0.90 | | <p>Lots 62, 68, 72, and 73 back up to the toe of the existing mountain slope. The terrain indicates that a natural channel may be present within the site running parallel to the northern boundary.</p> <p>Following earthworks, we understand the lot will not contain a steep gradient.</p> <p><b>The final civil cut / fill plan and stormwater infrastructure design will need to be reviewed to determine if additional debris flow mitigation measures are required.</b></p> |

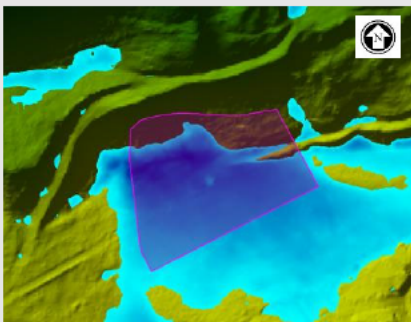
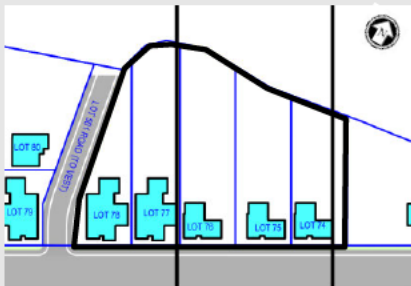
| 74 | 0.47 | | <p>The source of the inundation to the building platforms is runoff from the terrace north of the lots. Once the stormwater reaches the proposed housing platforms, it becomes largely stationary and occupies a low region in the existing terrain. Extensive cut / fill works are planned for this area and will impact the flow of stormwater.</p> <p><b>The final civil cut / fill plan and stormwater infrastructure design will need to be reviewed to determine if additional debris flow mitigation measures are required.</b></p> |

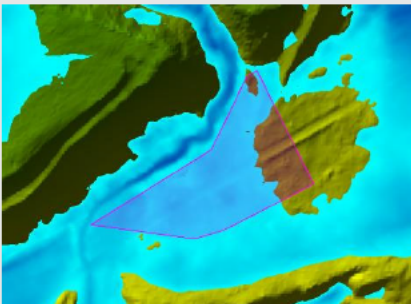
| 86 | 1.20 | | <p>Review of the time series data in the debris flow model indicates that inundation occurs at Lots 86, 88, 89, and Lot 90 when the creek north of the sites breaches its banks. Construction of a culvert (blue arrow) is proposed to carry stormwater from the creek, which will significantly reduce inundation risk.</p> |

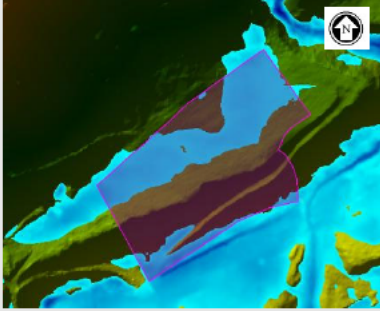
| 91 | 1.25 | | <p>The majority of Lot 91 is green space. Inundation to the building platform is limited and the majority of inundation is a result of ponding on the existing access road.</p> <p><b>The final civil cut / fill plan and stormwater infrastructure design will need to be reviewed to determine if additional debris flow mitigation measures are required.</b></p> |
