# ASBESTOS MANAGEMENT PLAN

## Downtown Carpark

Prepared for Auckland Transport | 07-Feb-2020

## Asbestos Management Survey

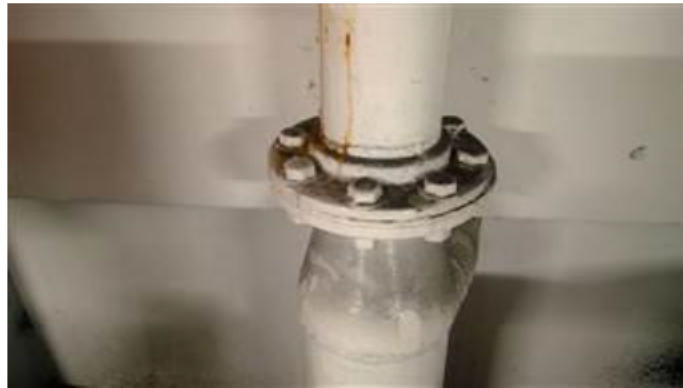
**Photo No: S-002**

**Asbestos Type: No Asbestos  
Detected**

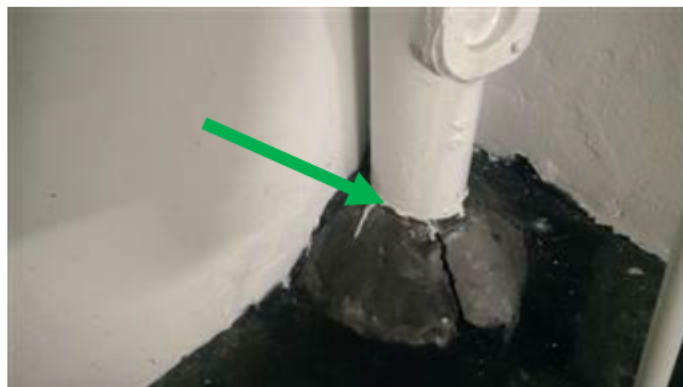
**Photo No: S-003**

**Asbestos Type: No Asbestos  
Detected**

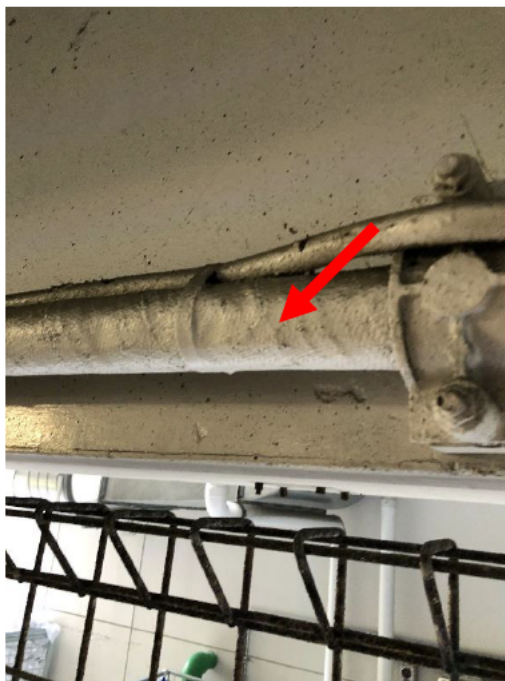
**Photo No: S-004**

**Asbestos Type: Chrysotile**

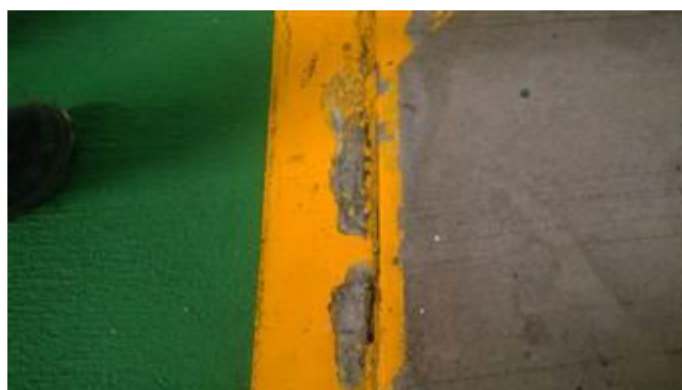
**Photo No: S-005**

**Asbestos Type: No Asbestos  
Detected**

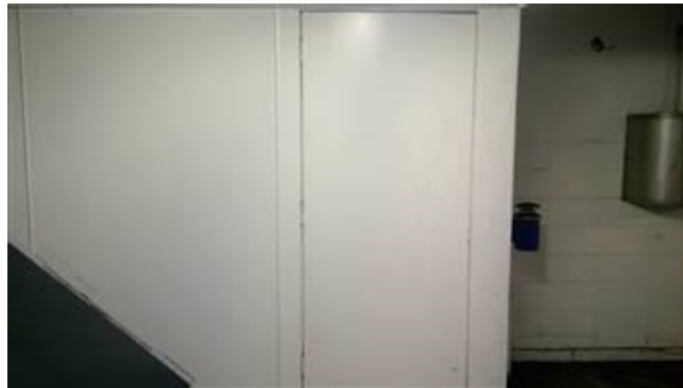
**Photo No: S-006**

**Asbestos Type: No Asbestos  
Detected**

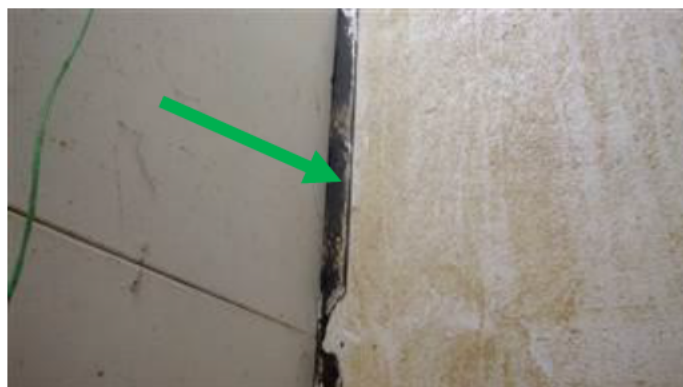
**Photo No: S-010**

**Asbestos Type: No Asbestos  
Detected**

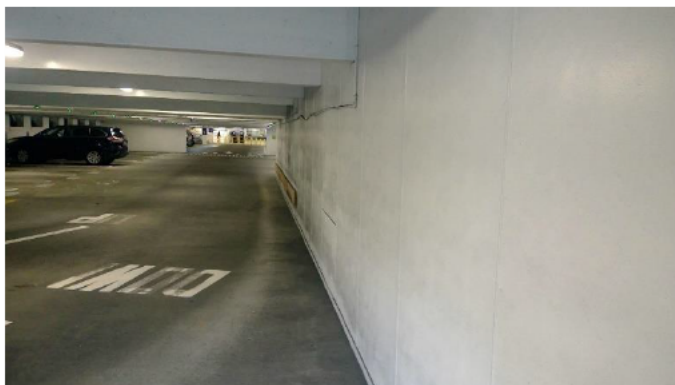
**Photo No: S-011**

**Asbestos Type: No Asbestos  
Detected**

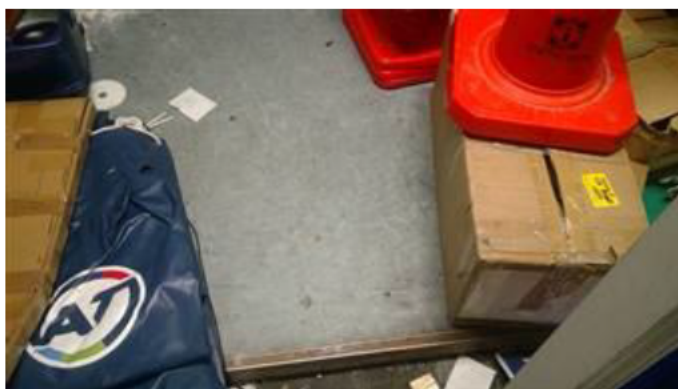
**Photo No: S-012**

**Asbestos Type: No Asbestos  
Detected**

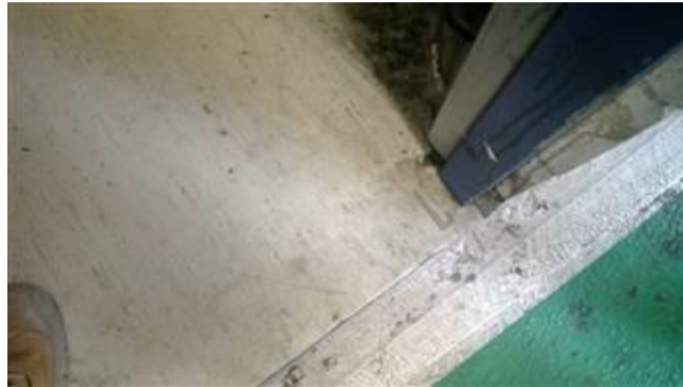
**Photo No: S-013**

**Asbestos Type: No Asbestos  
Detected**

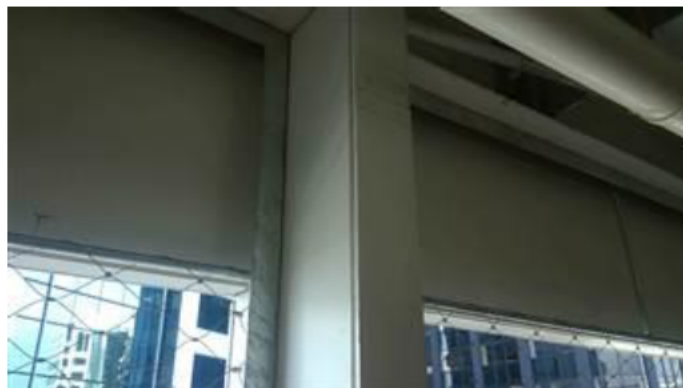
**Photo No: S-014**

**Asbestos Type: No Asbestos  
Detected**

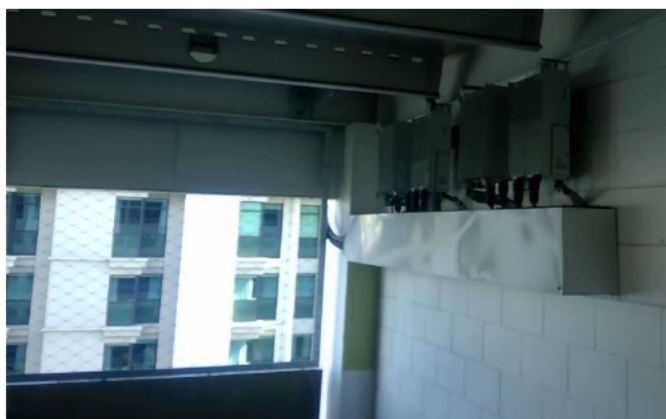
**Photo No: S-016**

**Asbestos Type: No Asbestos Detected**

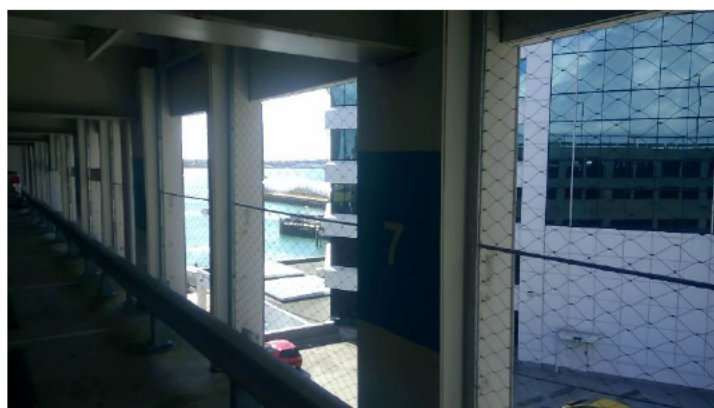
**Photo No: S-017**

**Asbestos Type: No Asbestos Detected**

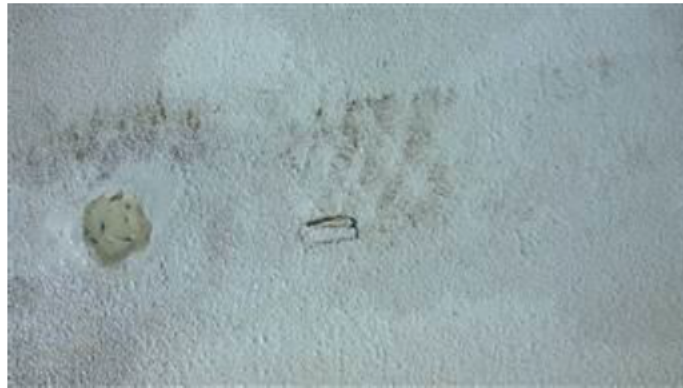
**Photo No: S-018**

**Asbestos Type: No Asbestos  
Detected**

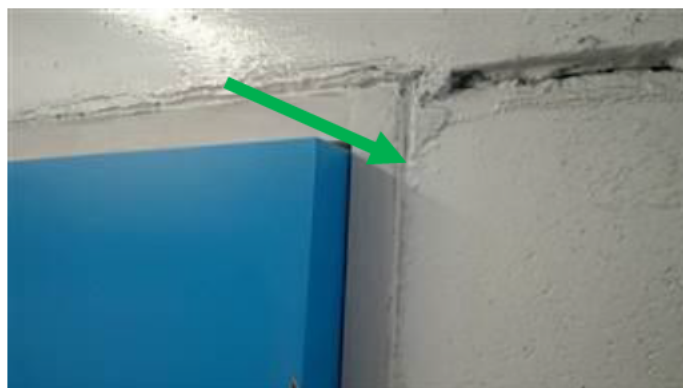
**Asbestos Type: No Asbestos  
Detected**
