# Belmont Quarry Development – Part F

Substantive Application  
Appendix F.1.B.12 – Land Exchange Application  
- Geotechnical Report  
Winstone Aggregates

# Geotechnical Appraisal Report

Land Exchange Belmont Quarry  
Development Project  
Wellington

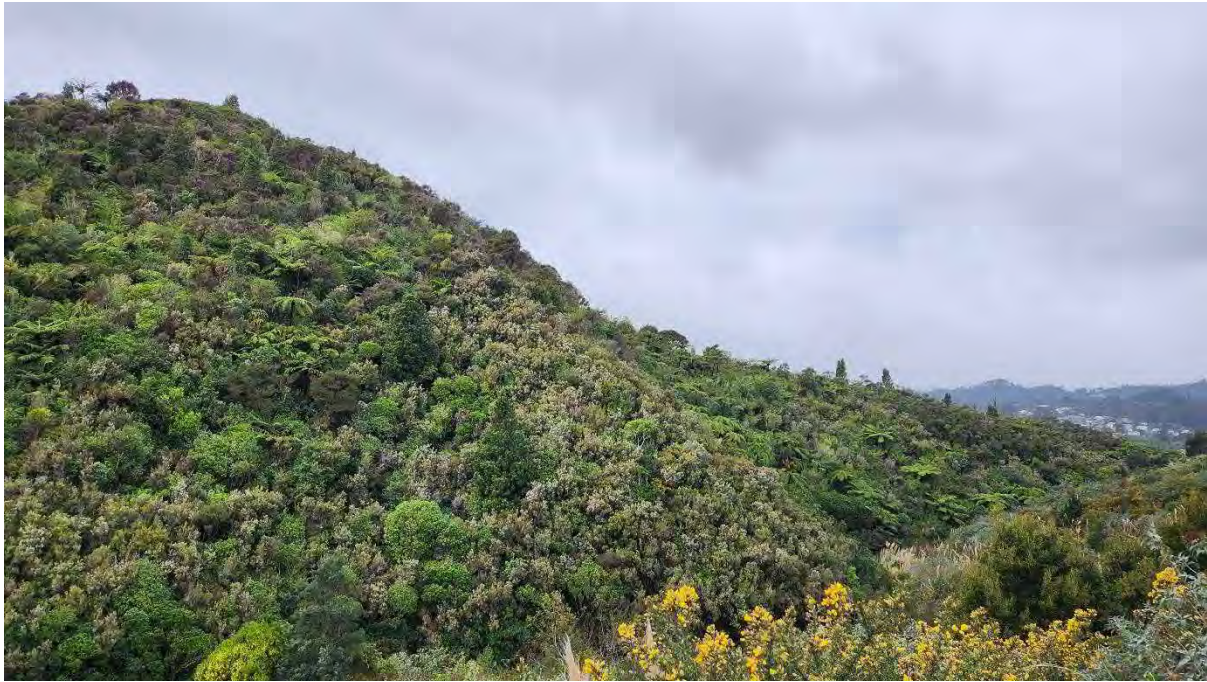
Figure 4-4: Example of natural vegetated northeastern slopes at Dry Creek.

Our review of historical aerial photographs [refer Appendix B – Figures 3 to 5] and our observations made during our site walkover on 20 August 2025 suggest no historical evidence of slope instability in this area of the site [Figure 4-4].

The steepness of the slopes suggests a thin, very stiff to hard soil layer underlain by weathered greywacke rock consistent with adjacent areas of the Belmont Regional Park.

Slope instability in future cannot be categorically ruled out, mainly due to the potential for a seismic event [rupture of the Wellington Fault]. In a significant seismic event on the Wellington Fault many of the steep natural slopes in the adjacent Belmont Regional Park are expected to experience shallow instability of the soil regolith. The natural slopes within the proposed land exchange area is expected to demonstrate a similar level of performance.

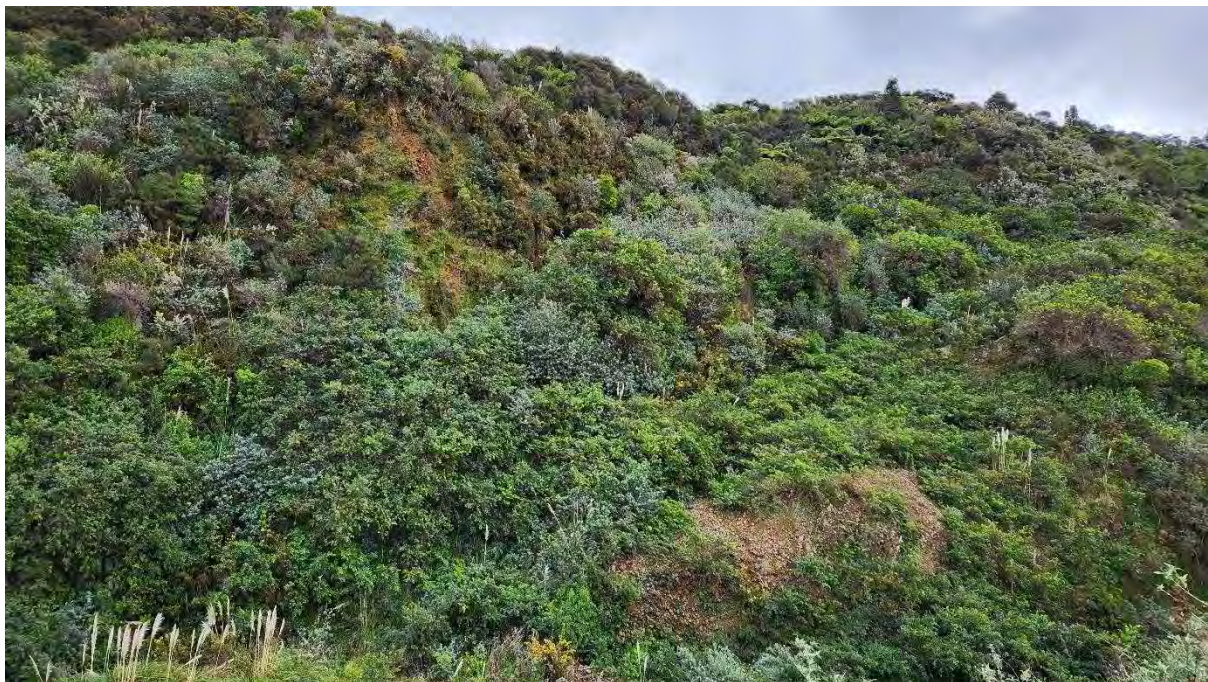
**Figure 4-5: Examples of localised rock fall in former quarry batters**

The overall slope geometry defined by the unsupported old quarry batters is typically 40-50 m high with an average slope angle of between 30° and 42°. This is comparable to the natural slope angles for the greywacke hills in the area which have slopes of up 100 m high at slope angles of 42°.

Batter performance is typical of old quarry faces with localised areas of spalling of rock from the jointed rock faces and localised instability evident in the upper 1-2 m of soil exposed in the uppermost quarry batter [Figure 4-5].

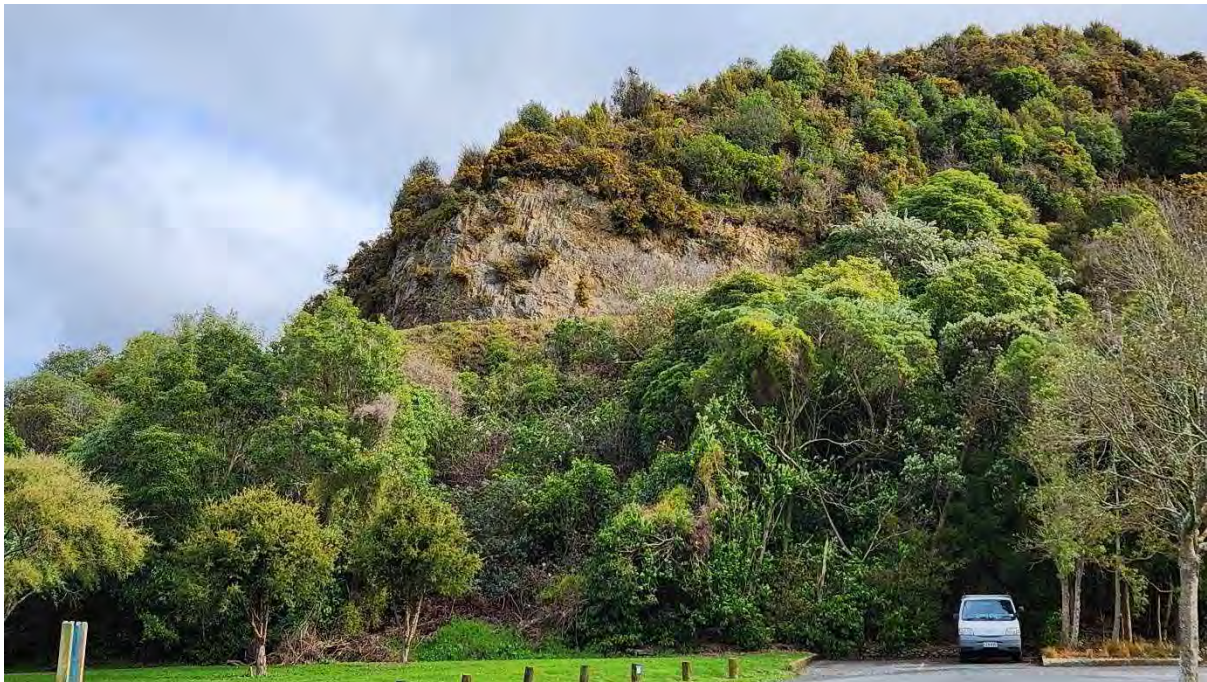
Figure 4-6: Unsupported cut slopes within Belmont Regional Park

Localised small scale instability may still be possible in cut batters above the former quarry access road, but that scale of instability is considered to present little risk to persons and negligible risk to the conservation values of the proposed exchange parcel. We note that similar, or more significant hazard/risk exists for access roads that are already present in Belmont Regional Park (Figure 4-6).

Overall, it is our opinion that slope stability hazard in this proposed land exchange parcel is limited to very localised areas of old access roads and the risk to persons and conservation values is negligible.

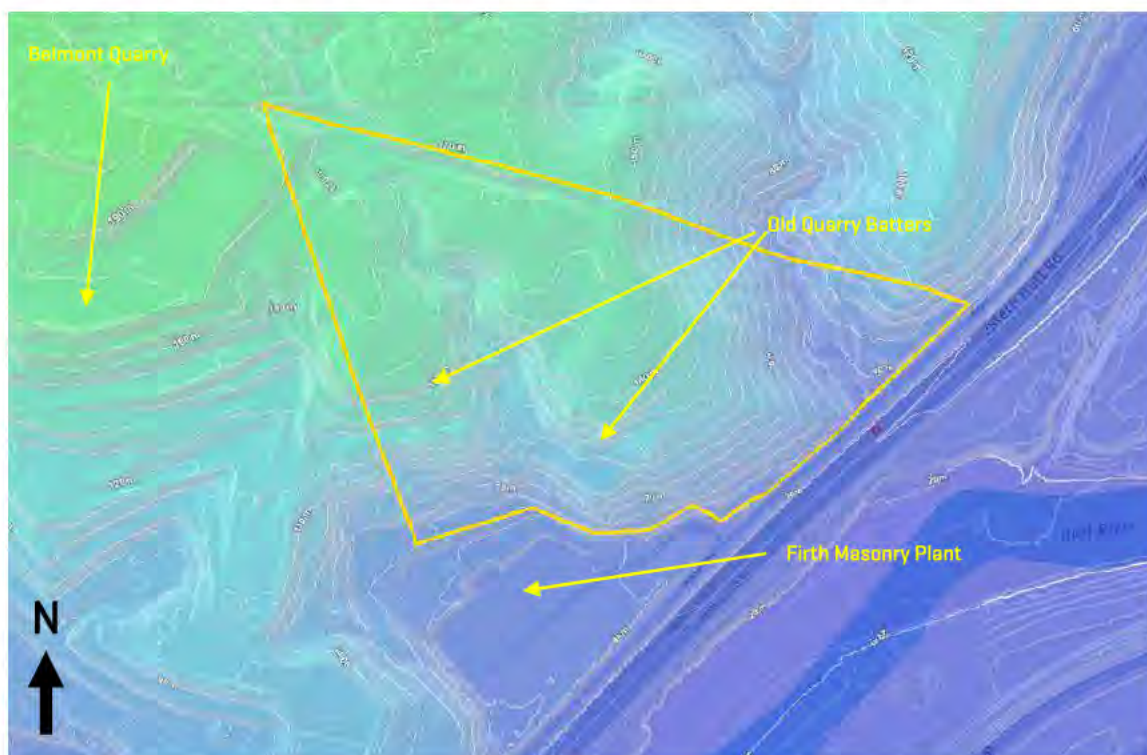
Figure 5-1: Lidar data for Firth Block, proposed exchange land illustrated indicatively [source Winstone Propeller site].

Lidar data for the site indicates that the remnant quarry slopes include 50-60° slopes between 15 and 45 m in height. Overall slope angles from the northernmost Firth site access road to the crest of the uppermost batter are 41-45° for slopes between 85-90 m in height [Figure 5-1].

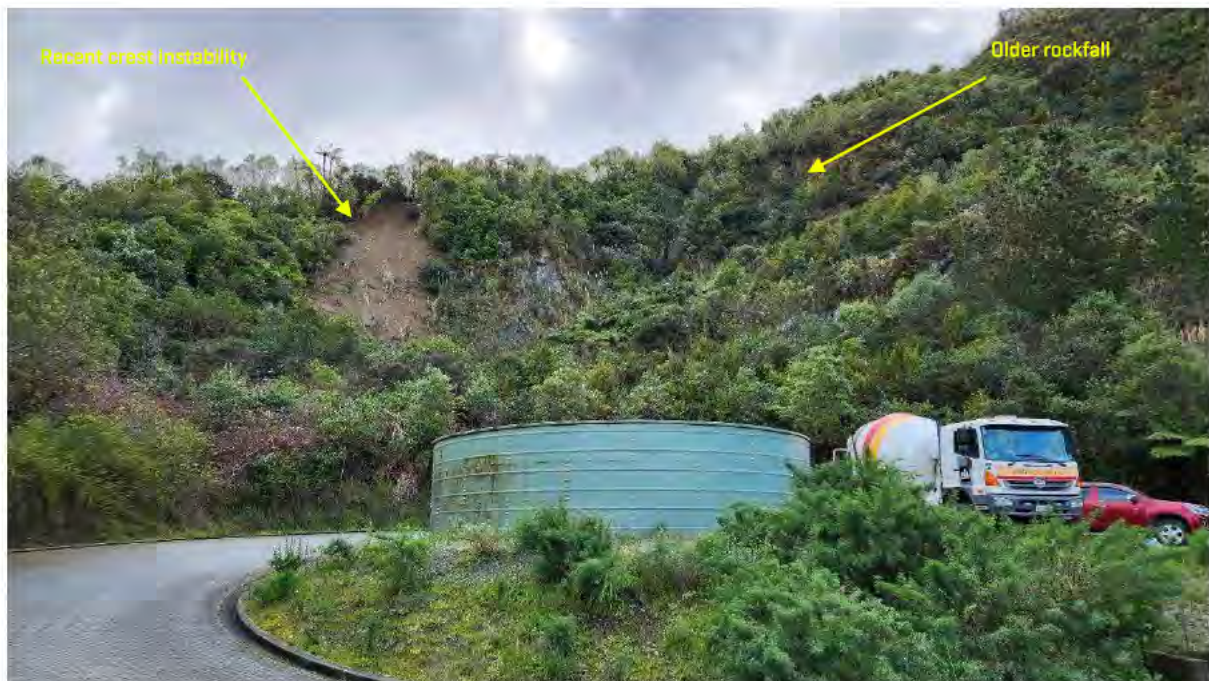
Figure 5-2: Remnant quarry batters Firth Block

Upper quarry batters could be observed from the northernmost Firth accessway. These have generally revegetated, but it was apparent that some rockfall has occurred in localised areas over time [Figure 5-2].

A recent [2025] localised area of instability was observed in the northwest corner of the site, where failure of the upper soils above a remnant quarry batter has occurred over a width of slope of approximately 12 m. The soil material has evacuated down the quarry batter, clearing the batter downslope of vegetation with debris coming to rest on a lower remnant bench [Figure 5-2]. Some localised sections of the remnant quarry batters were observed to be sub-vertical.

In terms of the remnant quarry batters, the recent localised instability observed at the Firth Block [Figure 5-2] lies within land that abuts Belmont Quarry and lies outside of the proposed land exchange parcel [refer Appendix B – Figure 6].

Other quarry batters are generally revegetated, and any remaining loose blocks of rock can be expected to have already fallen from the quarry batters since closure. However, over time continued intermittent spalling and localised areas of rock fall can be anticipated due to ongoing cycles of wetting and drying, root action from vegetation opening fractures in the rock mass or due to seismic events.

While there remains a localised slope instability hazard associated with these remnant batters, the area between the uppermost batter and the Firth Masonry plant site is heavily vegetated and largely inaccessible. Localised batter scale instability therefore is not expected to present a significant risk to persons.

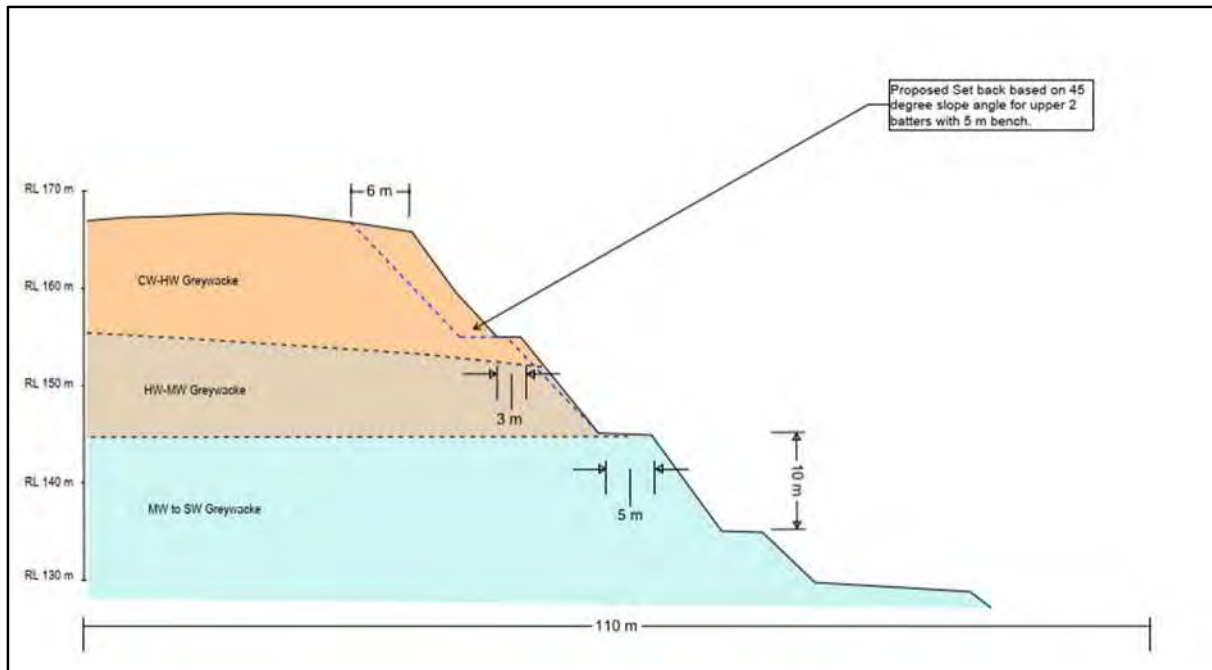
**Figure 5-4: Cross Section through Area C**

The uppermost batter (above RL 155 m) is formed within completely to highly weathered greywacke, the second batter (between RL 145 m and RL 155 m) is formed within highly to moderately weathered greywacke, while the lower batters are formed within slightly to moderately weathered greywacke.

The key defects in the face are west to east striking bedding, which dips very steeply towards both the north and south. Bedding is defined by thin seams of dark grey argillite.

Below RL 155 m, the batter slopes are generally consistent with the advice provided in T+T 2010 and these batters appear to be performing acceptably. The exception to this is:

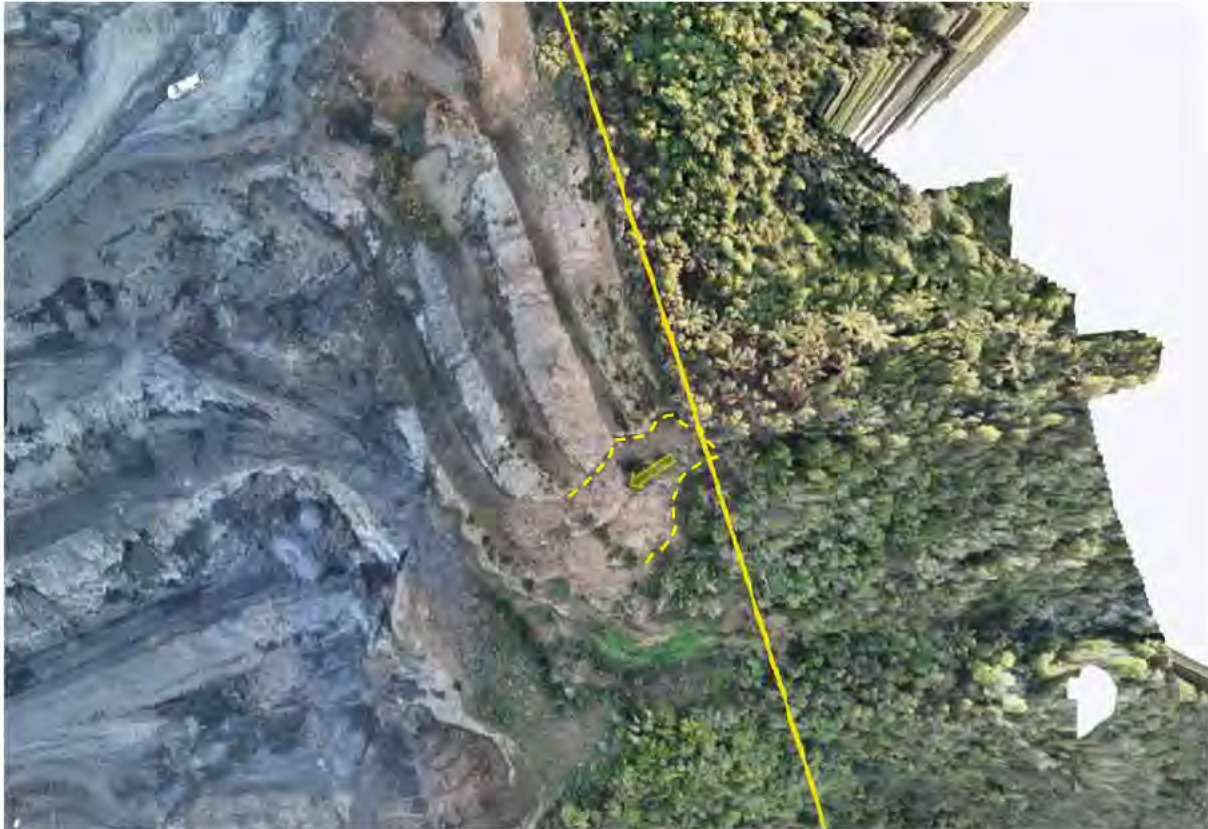
**Figure 5-5: Existing instability in Area C. Belmont East wall abutting the Firth Block.**

A localised area of slope failure has occurred at the far southern end of the cut batters in this area. This appears to have occurred in an area of deeper weathering of the greywacke, but also where the batters were rotated around to become more northwest-southeast trending as a tie-in to the ground surface. This change in geometry has allowed failure to occur on steep bedding, orientated oblique to the slope with breakout through the highly weathered rock mass. The instability extends through the upper two batters, with debris spilling onto the benches below. It is not clear whether this instability extends into the proposed land exchange area.

Based on our observations in this area, we consider that a 6 m zone measured from the crest of the slope back into the proposed land exchange area presents a higher risk of instability than would normally be accepted for a final cut batter adjacent to a property boundary. The basis for this zone is a hypothetical bench batter geometry of 10 m high batter slopes at 45° separated by a 5 m wide bench, which could be expected to perform acceptably in the materials observed.

While instability could be expected to develop slowly in this area due to residual strengths on defects in the weathered zone, if this zone is included in the land exchange, it would be prudent to exclude people from this area. This could be achieved by erecting fencing positioned a minimum of 6 m from the crest of the quarry batters in this area.

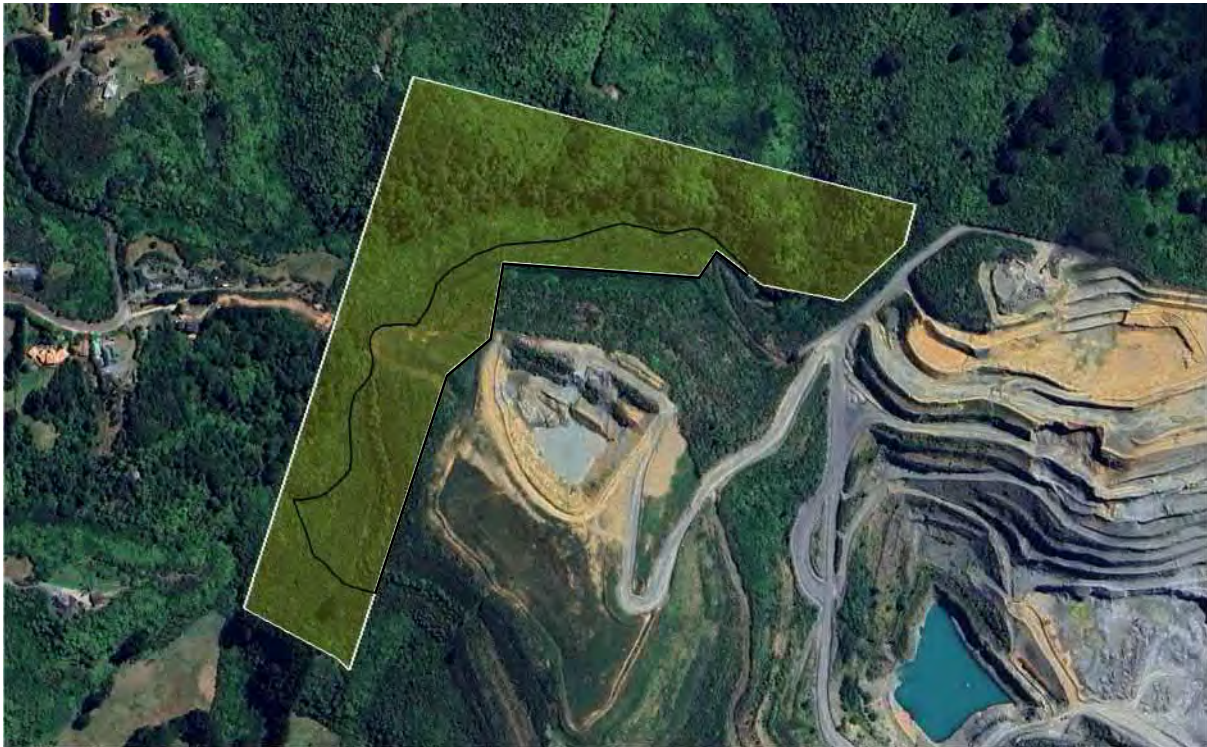
Figure 6-1: Northern Gully exchange parcel [white outline] illustrating former Cottle OBDA placement [black outline].

Part of the proposed exchange parcel incorporates the lower portions of the Cottle OBDA which we have previously observed over a decade or more of involvement with the site [Figure 6-1].

There has been no instability observed in final slopes within the Cottle OBDA since construction commenced in the mid 2000's. Rehabilitation has been progressive since construction commenced and the larger part of the Cottle OBDA that is included in the proposed exchange area has been rehabilitated and revegetating since 2015.

The Cottle OBDA is a designed landform, with the final stage of design completed by Tonkin & Taylor Limited (T+T) in 2019<sup>7</sup>. That document sets out that the final design for the OBDA was expected to have achieved acceptable levels of static and seismic stability [Damage Control Limit State], with calculated displacements in the Maximum Considered Earthquake of less than 170 mm.

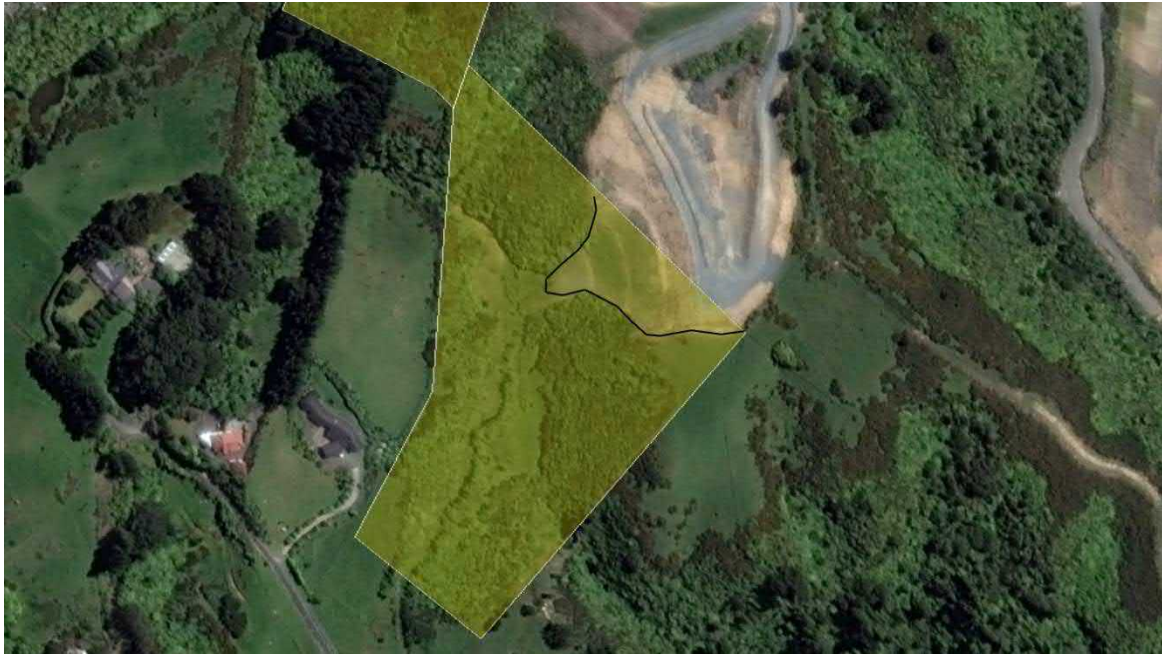
Figure 7-1: Southern Gully Parcel [yellow] illustrating extent of Cottle OBDA fill placement [black line]

The first evidence on the Cottle OBDA extending into this parcel is apparent in aerial photographs from 2015 where the toe of the OBDA is under construction [Figure 7-1]. This part of the Cottle OBDA was substantially rehabilitated by 2017.

As noted in Section 6.3, the Cottle OBDA is designed to achieve acceptable levels of static and seismic stability. Since construction of this section of the Cottle OBDA was completed in 2015, the site has been rehabilitated and revegetated. There has been no instability observed in final slopes within the Cottle OBDA since construction commenced in the mid 2000's.
