# Appendix AA Tree Risk Assessment

Hinuera Solar Farm

Harmony Energy NZ #6 Limited

## **Tree risk assessment**

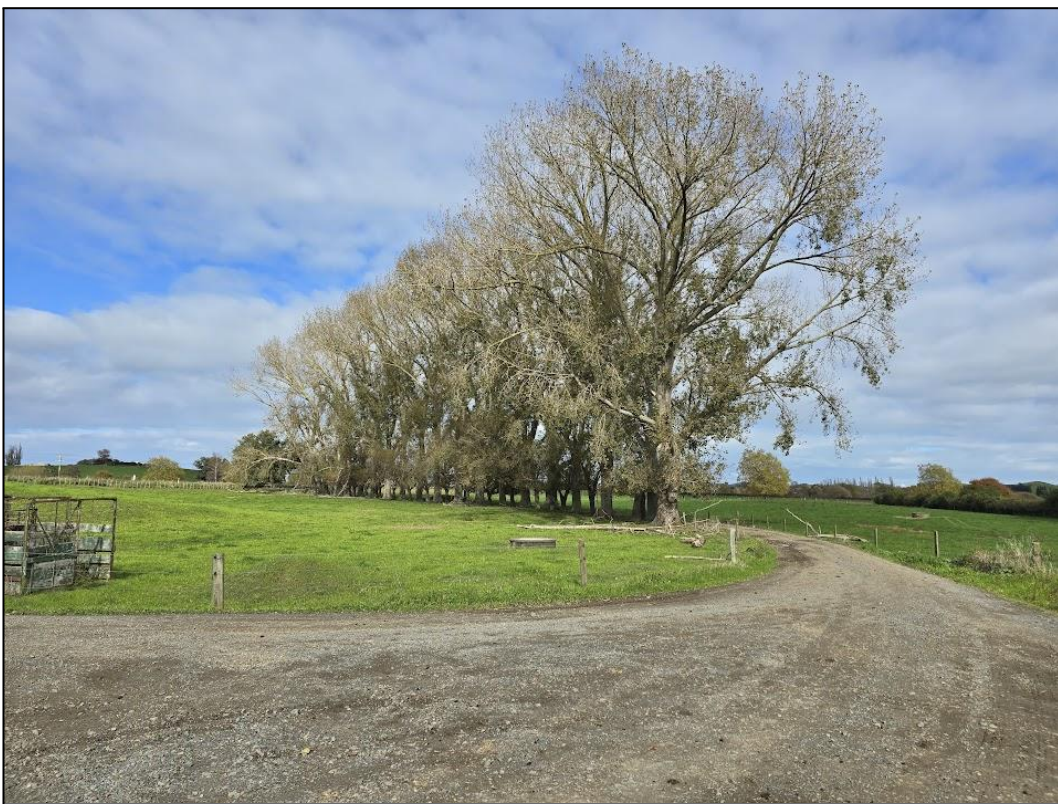
Photo 1

- 4.1. Property description: Dairy farm.
- 4.2. The subject trees form a line of trees beside the tanker race. The trees overhang the tanker race.
- 4.3. The tanker race serves as the main entry into the farm and is accessed by people and vehicles on a daily basis.
- 4.4. Targets:<sup>2</sup>: People, vehicles, and fences.
- 4.5. Photos showing the subject trees are below.

After assessing the risk presented by the subject trees and the proposed occupancy of the area beneath and nearby the trees I recommend that the subject trees should be removed.

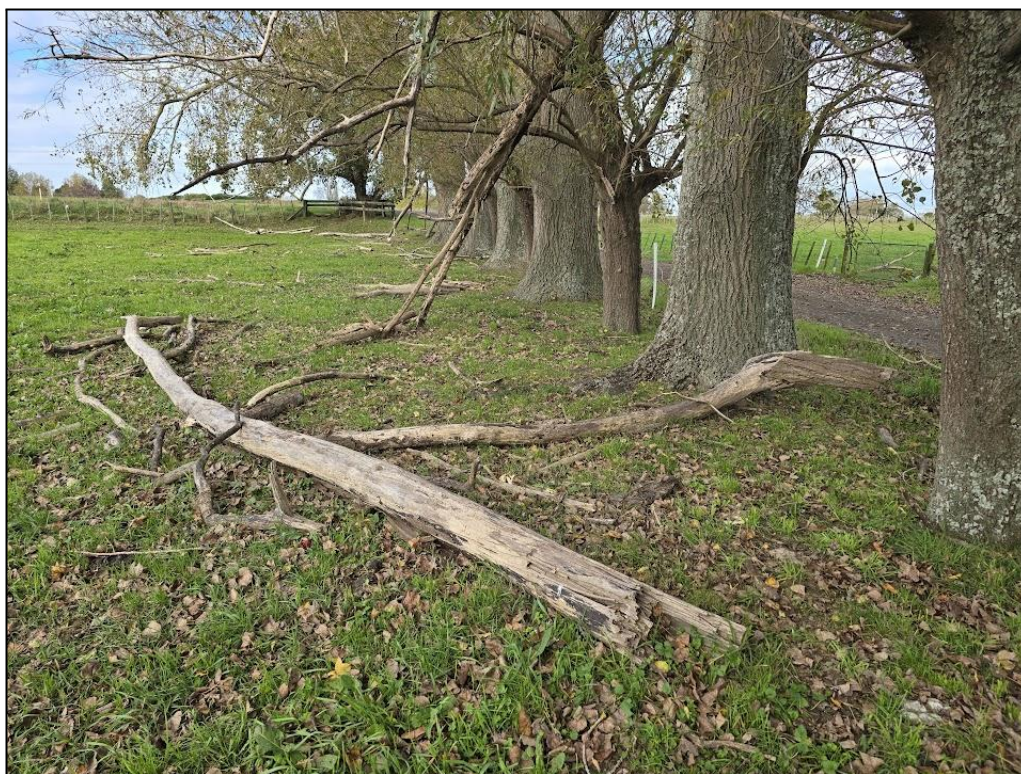
Photo 5

7.1. There was evidence of a large number of trunk and limb failures over a long period of time. The photos below are some examples of the failures.
