# Belmont Quarry Development – Part B

Substantive Application  
Appendix B.3.B – PSI – Overburden Source Area  
Winstone Aggregates

## **PRELIMINARY SITE INVESTIGATION - BELMONT QUARRY - OVERBURDEN SOURCE AREA**

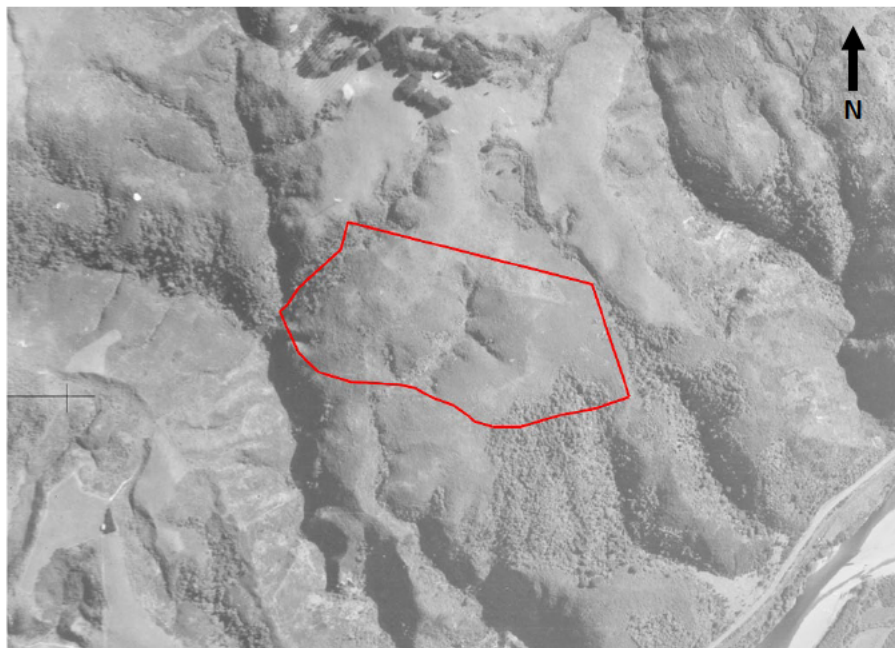
**Photograph 1: 1942 sourced from Retrolens**

| Date | Reference | Description |
|---|---|---|
| 1942 | Photograph 1 | The site and surrounding area appear to be predominately grassed and in pastoral use. Dense bush cover is observed along the site boundary in the western and southeastern areas of the site. A gully is present running south through the centre of the site. |

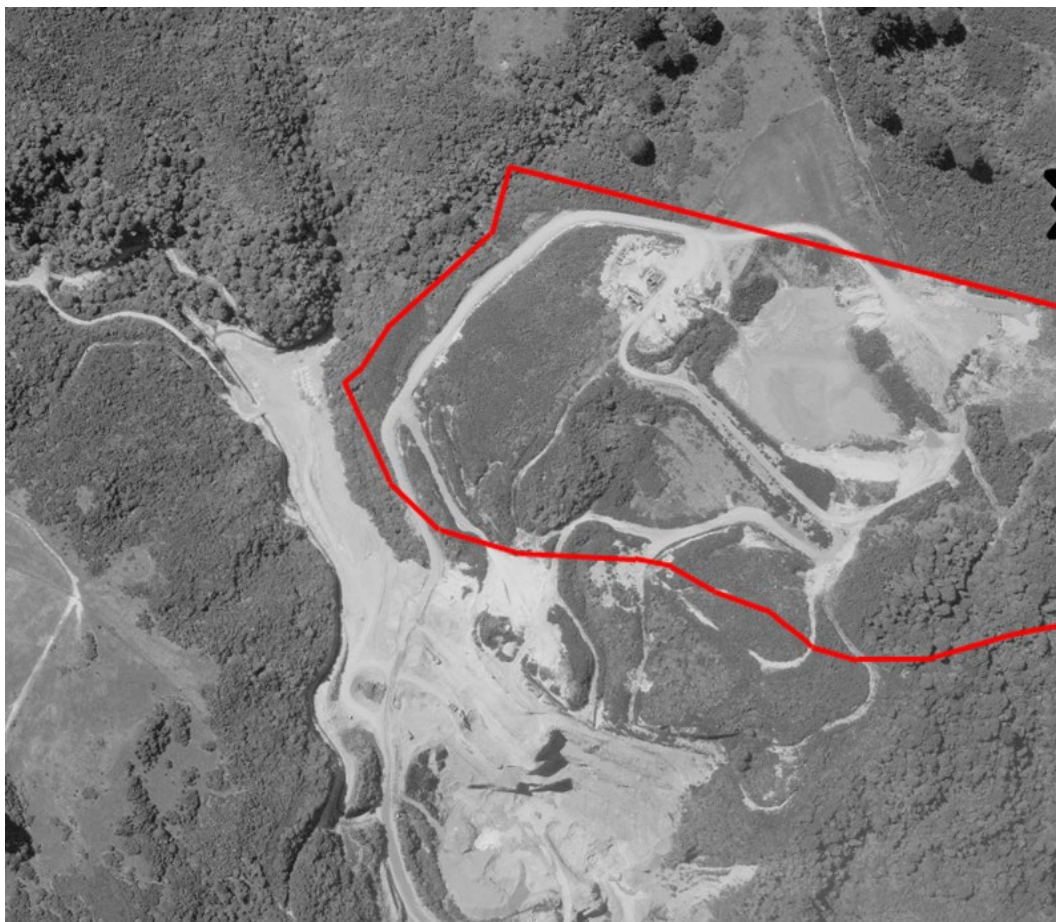
**Photograph 5: 1995 sourced from Retrolens**

| Date | Reference | Description |
|---|---|---|
| 1995 | Photograph 5 | Belmont Quarry has now expanded into the site, and a terraced quarry area can be observed across the site. Part of a road extends from the site into the wider property to the north of the site. Miscellaneous items and equipment, and a small structure appear to be located in the northern area of the site. |

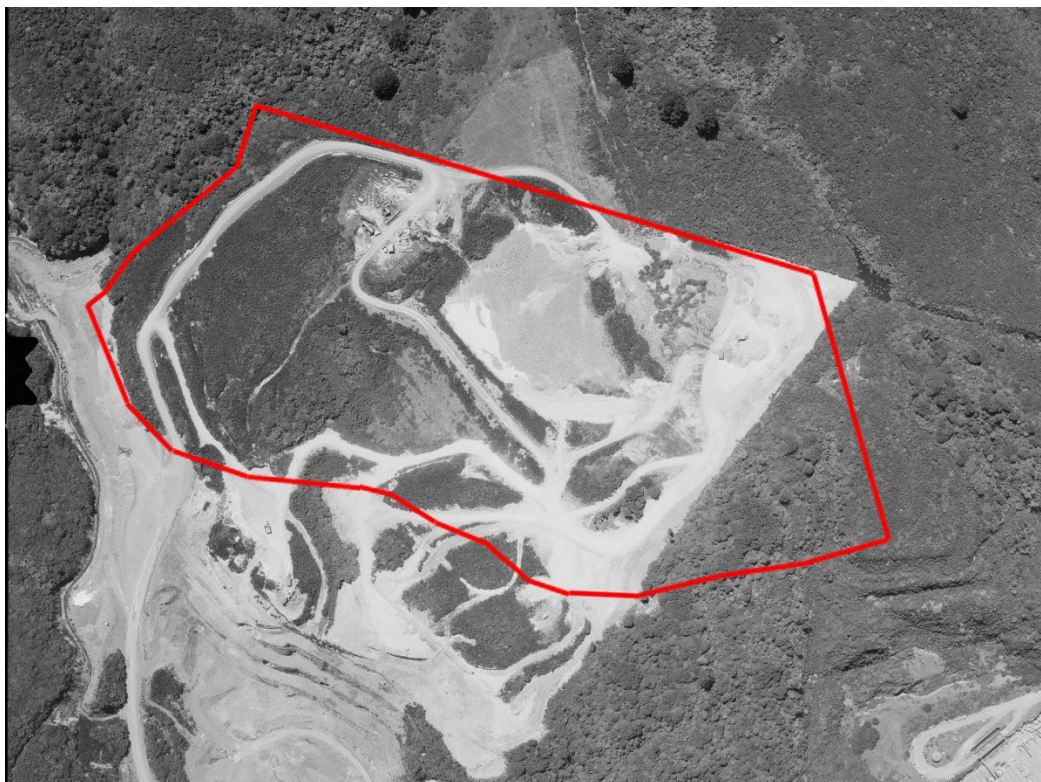
**Photograph 6: 1996 sourced from Retrolens**

| Date | Reference | Description |
|---|---|---|
| 1996 | Photograph 6 | The quarry area has been further developed to the east of the site. Further miscellaneous items, equipment and tyres are observed in the northern area of the site. A small cleared area is present offsite to the northeast. |

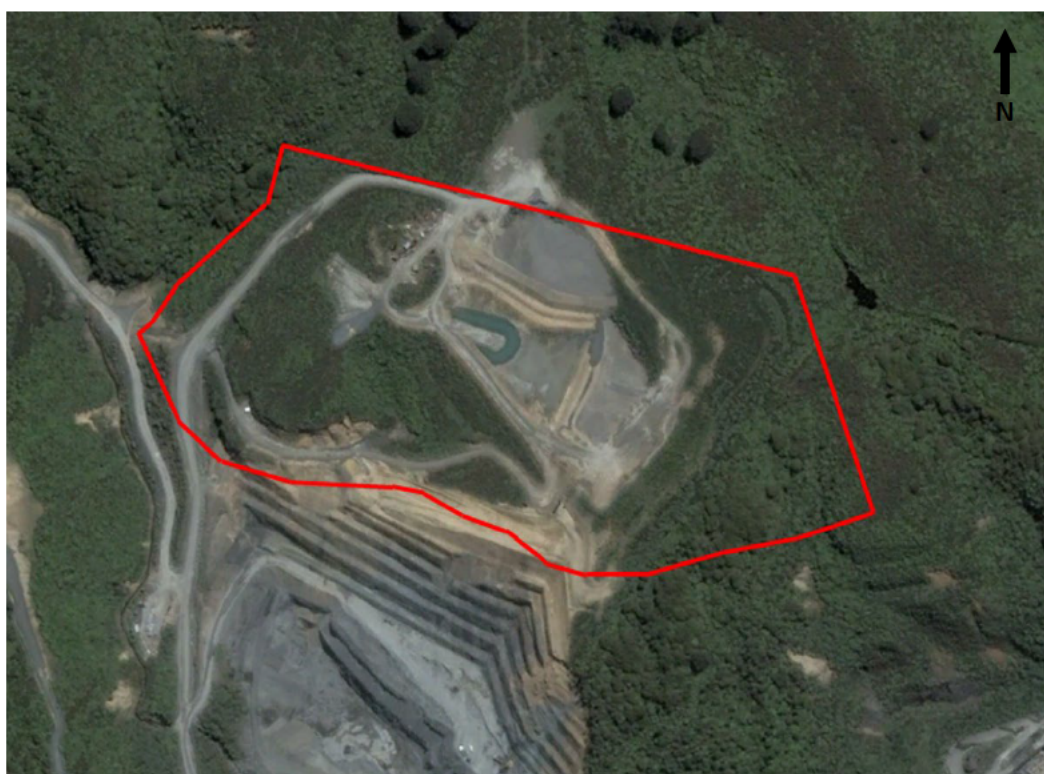
**Photograph 8: 2004 sourced from Google Earth Pro**

| Date | Reference | Description |
|---|---|---|
| 2004 | Photograph 8 | The quarry area has been further developed across the site. Miscellaneous items are observed across the northern area of the site. |

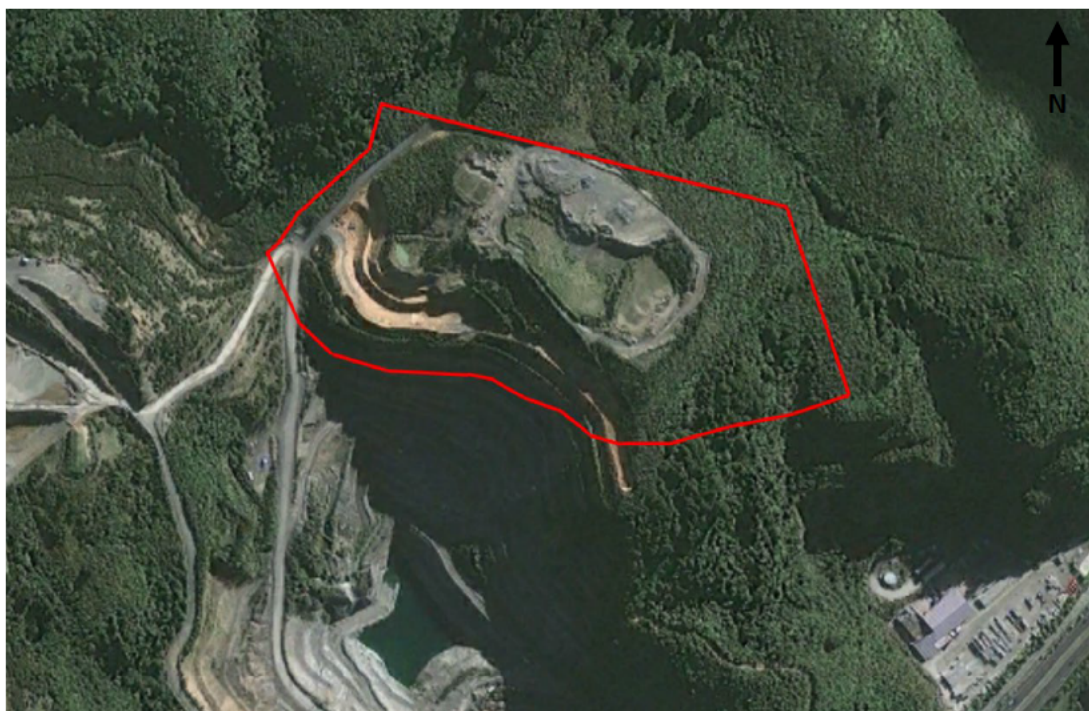
**Photograph 13: 2013 sourced from Google Earth Pro**

| Date | Reference | Description |
|---|---|---|
| 2013 | Photograph 13 | The quarried terrace to the southeast of the site has been further developed and extends offsite. Miscellaneous items including spare pieces of culvert pipe are visible in the central area of the site. |

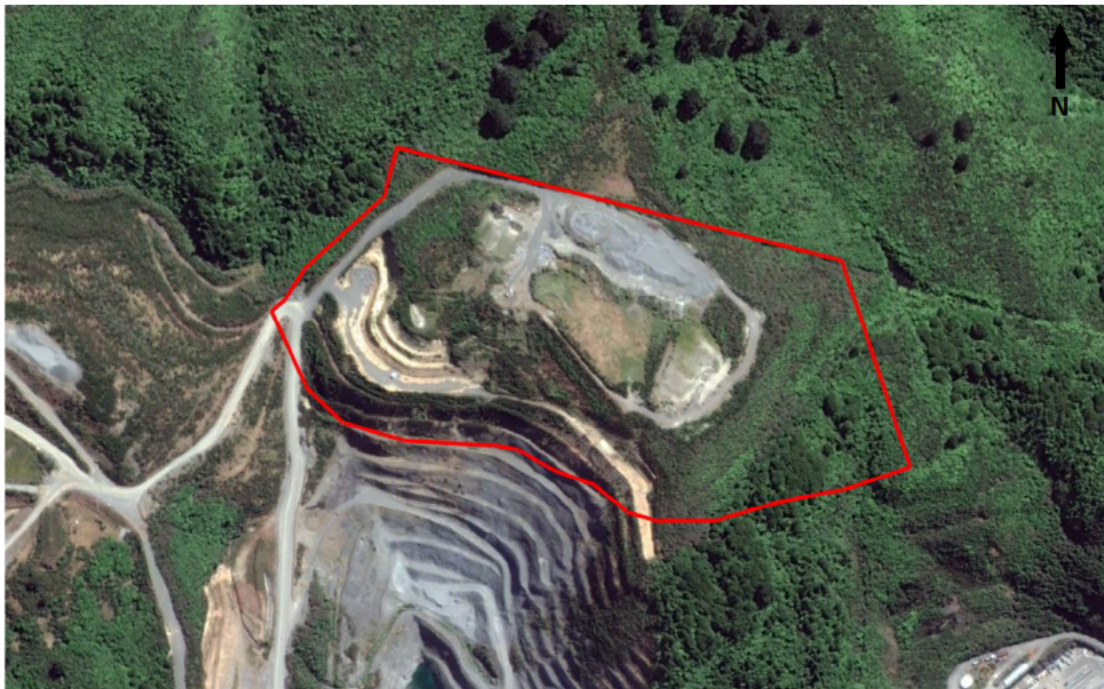
Photograph 15: January 2015 sourced from Google Earth Pro

| Date | Reference | Description |
|---|---|---|
| January 2015 | Photograph 15 | The stockpiled aggregate material is more clearly visible. Tyres are visible in the northern area of the site. |

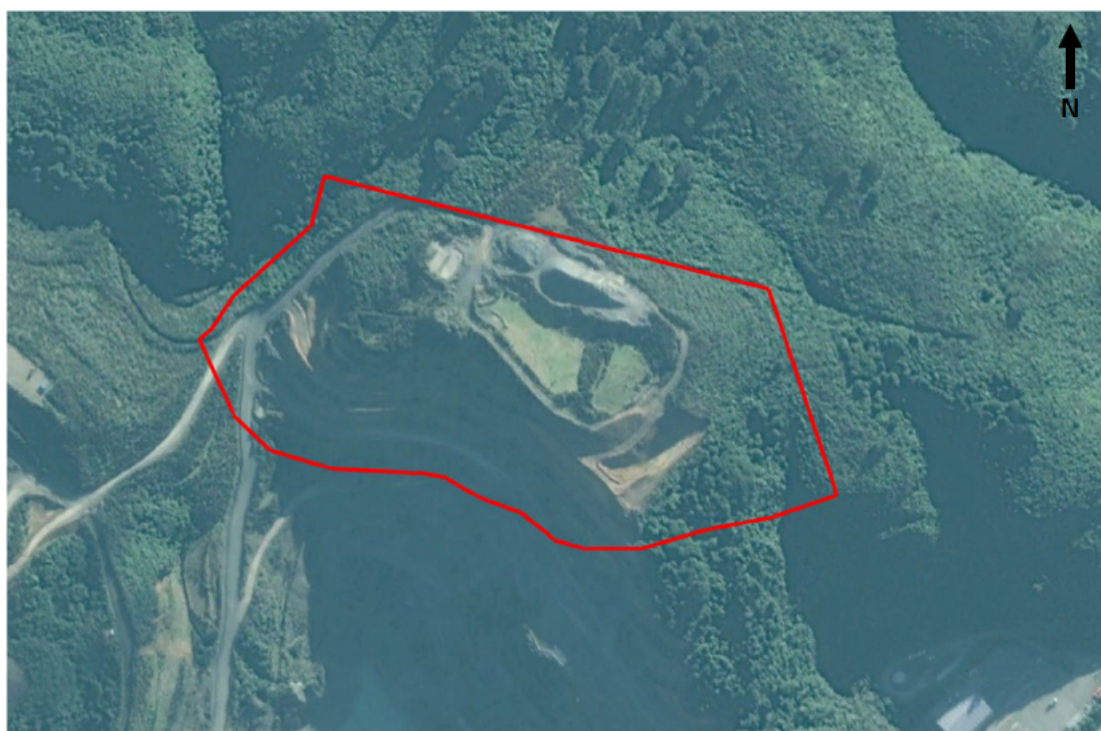
Photograph 18: 2017 sourced from Google Earth Pro

| Date | Reference | Description |
|---|---|---|
| 2017 | Photograph 18 | The quarry area has expanded to the southeast of the site, and a large stockpile of what appears to be quarried material is visible in the north of the site. |

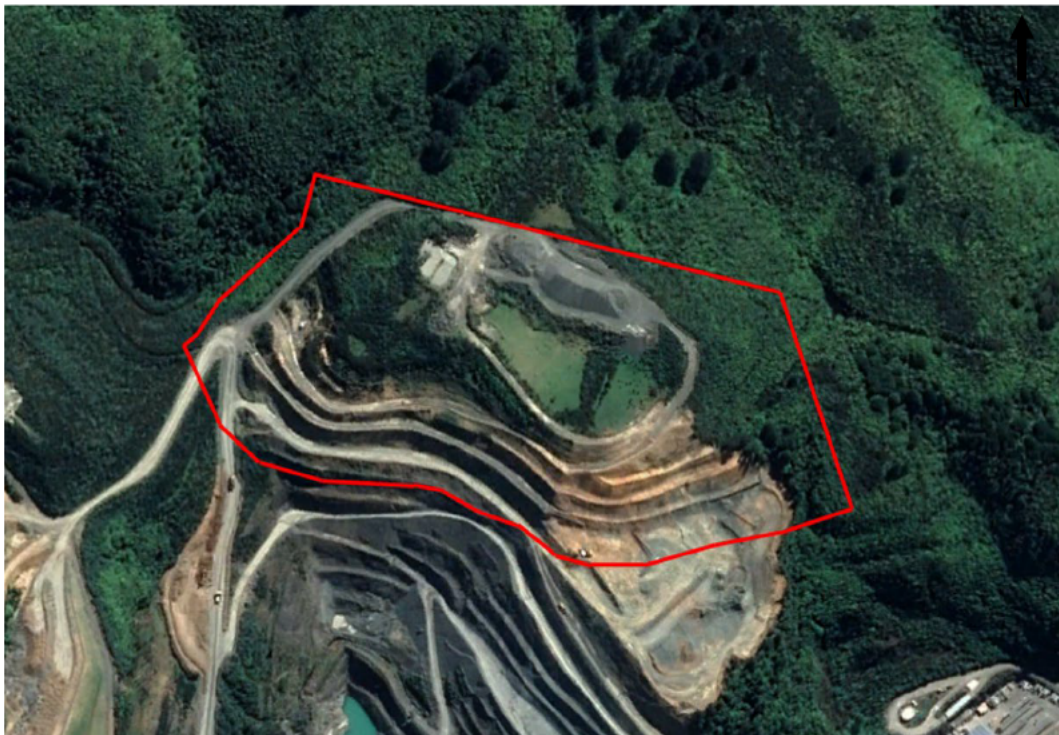
Photograph 22: October 2018 sourced from Google Earth Pro

| Date | Reference | Description |
|---|---|---|
| October 2018 | Photograph 22 | The quarry area to the southeast of the site has been further developed, as more terraces are observed. Stockpiled material comprising pipes and potentially aggregate, is visible in the central area of the site and the existing stockpiled aggregate to the northeast of this appears to have slightly increased in size. |

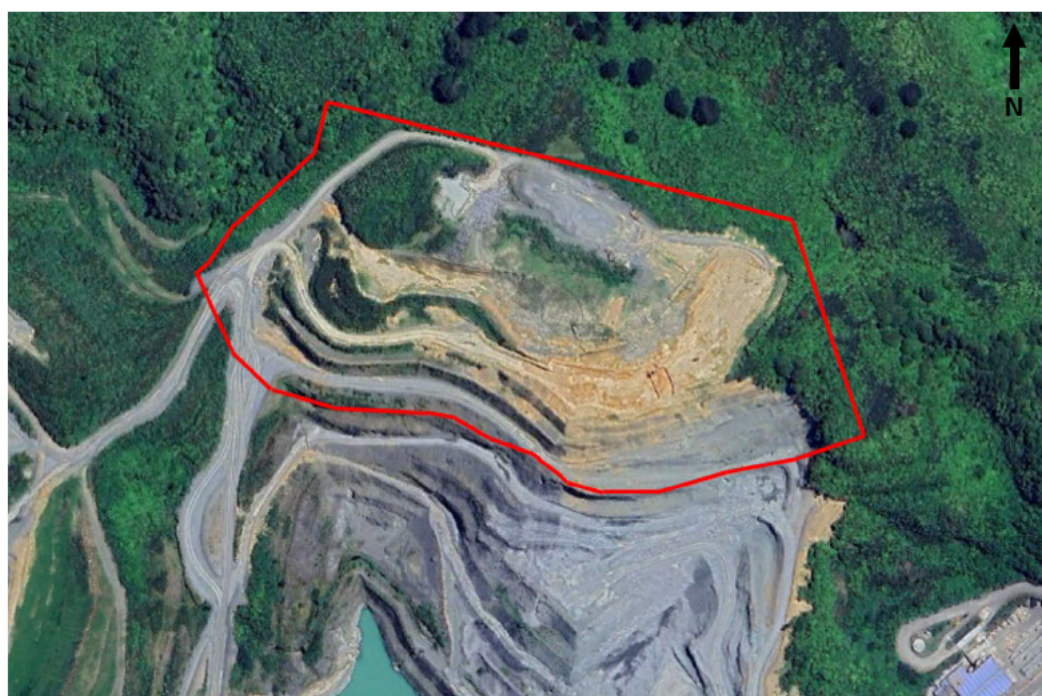
Photograph 24: 2021 sourced from Google Earth Pro

| Date | Reference | Description |
|---|---|---|
| 2021 | Photograph 24 | Further development of the quarry has occurred across the site. Tyres and miscellaneous items are stored in the central area of the site, and a pile of tyres are visible to the north. |

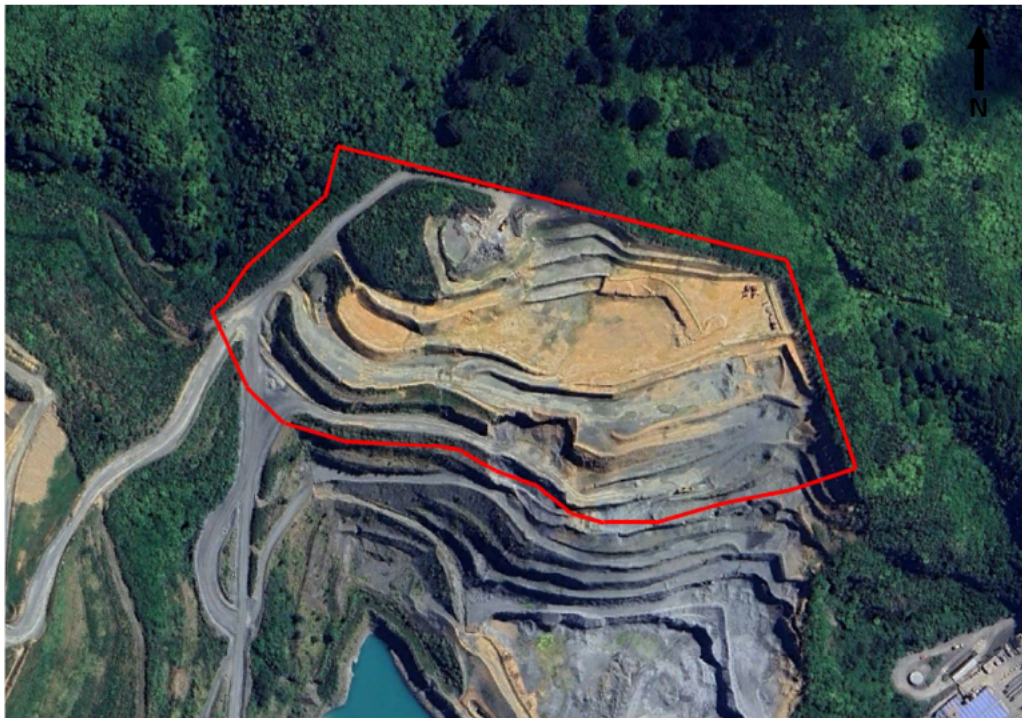
Photograph 27: 2025 sourced from Google Earth Pro

| Date | Reference | Description |
|---|---|---|
| 2025 | Photograph 27 | Further development of the quarry has occurred across the northern area of the site. |

Communications with the Belmont Quarry Manager identified the miscellaneous items observed through the historical aerial images onsite as being spare culvert pipe, boulders, spare parts comprised of steel and tyres. It was also communicated that no storage of chemicals or petroleum related products had occurred on the site. Belmont Quarry also provided current aerial photographs (Photographs 28 and 29) of the site which show no significant changes since the 2025 historical aerial photograph (Photograph 27).
