**Mill Road:  
2025 archaeological assessment**

**report to  
Waka Kotahi NZ Transport Agency**

## **Appendix A: Alfriston Meeting House Built Heritage Assessment**

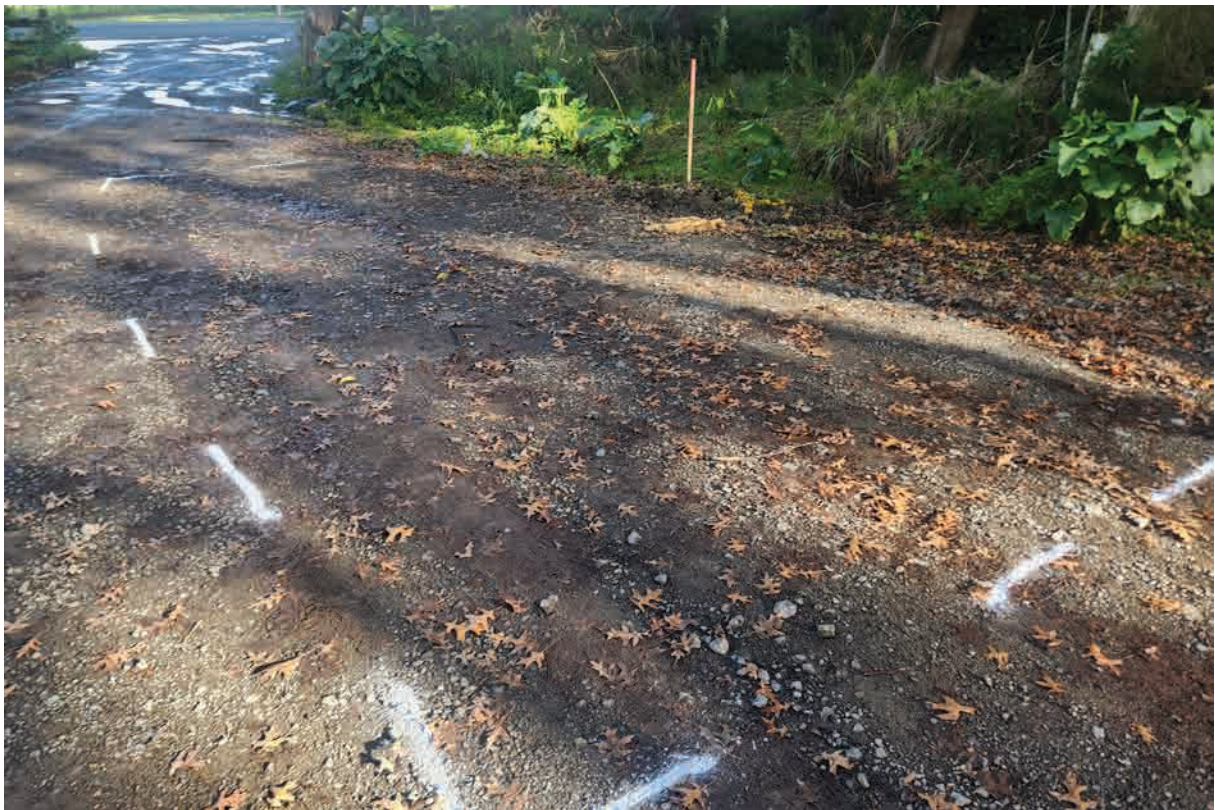
*Figure 12. View south across driveway of 242 Redoubt Road showing built up surface.*

This property was surveyed on 19 May 2025. It was inspected to see if evidence of the Puhinui Creek tributary was visible. The property appears to have been built up and any evidence of the original ground surface has been obscured beneath the current front yard of the house.

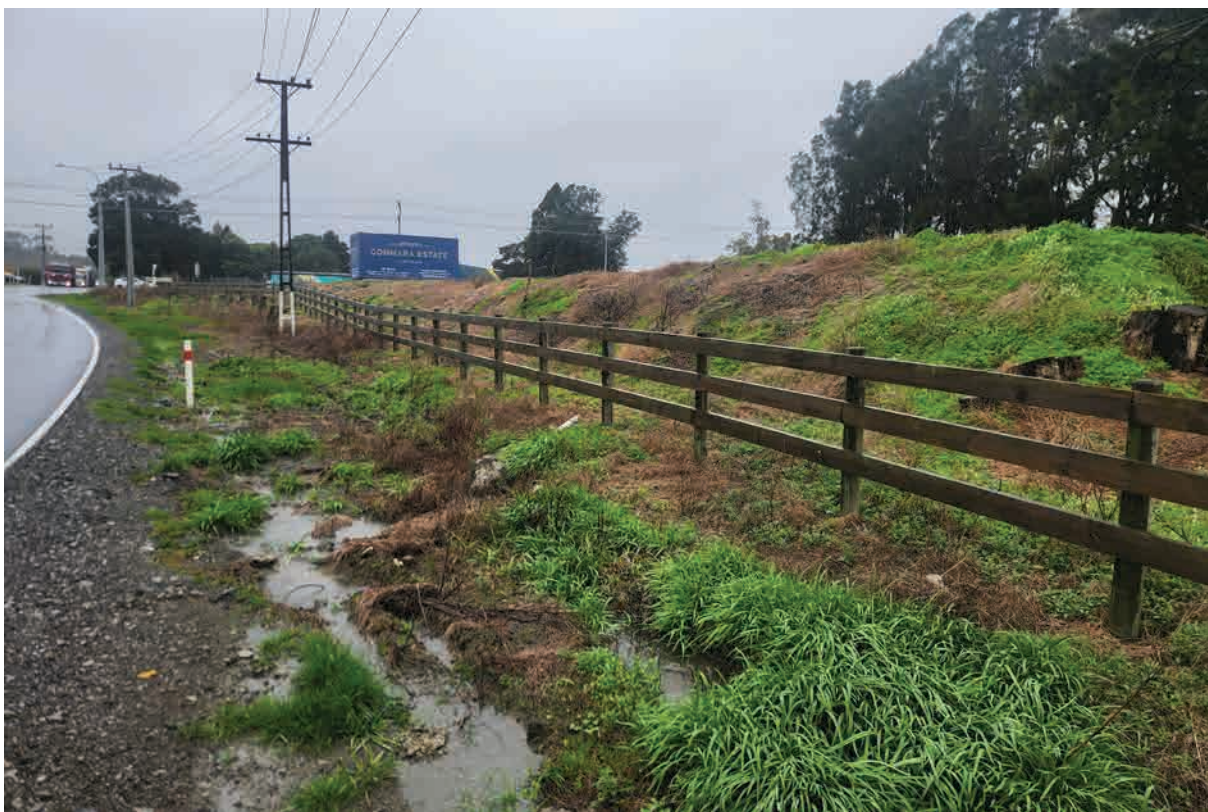
*Figure 17. View east along Alfriston Road showing built up fill on 1345 Alfriston Road.*

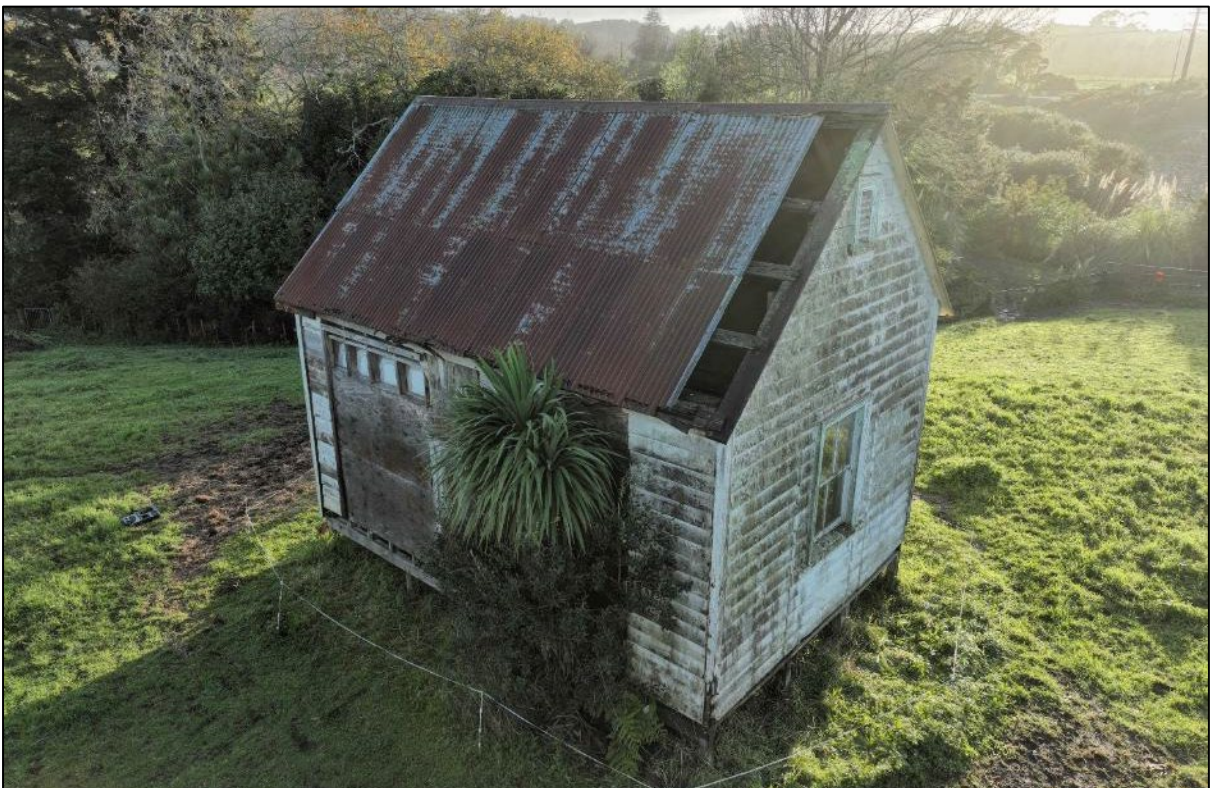
The biggest defect to the roof, aside from the holes on the lower west side, is the missing roof sheet on the south end of the west elevation which leaves a large hole for weather to come in (Figure 4). This has been missing for quite some time evidenced by the considerable decay of the timber beneath (purlins, top plate, rafter, wall framing, floorboards).

Figure 4. West and south elevations of the meeting house showing the corroded roofing and missing sheet.

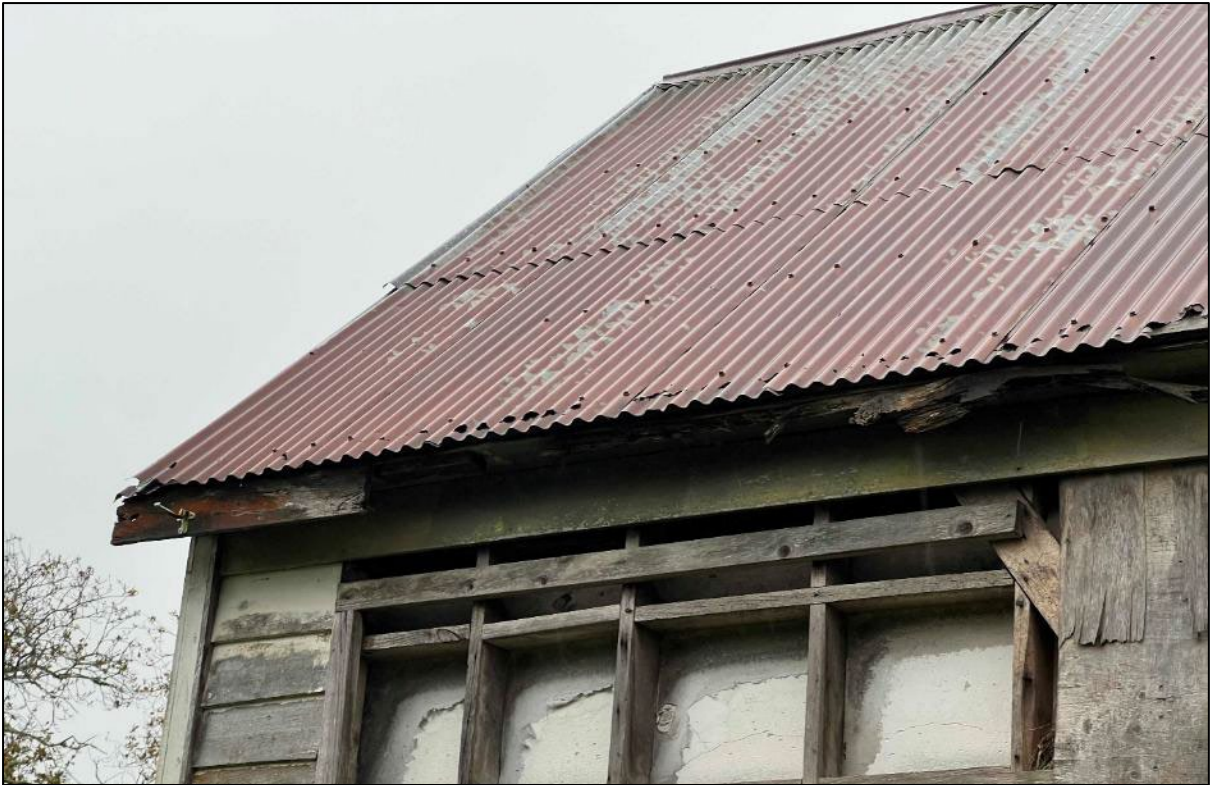
There are no fascia boards, except for a very short section on the west elevation (Figure 5). Soffit boards remain intact on the east elevation but are decayed on the west. The historic photograph also indicates that it had bargeboards and coverboards at each gable end; these are now all missing.

Figure 5. Eaves at the north-west corner. The holes in the roof sheet, decayed remnant of fascia, and single remaining gutter bracket are all evident.

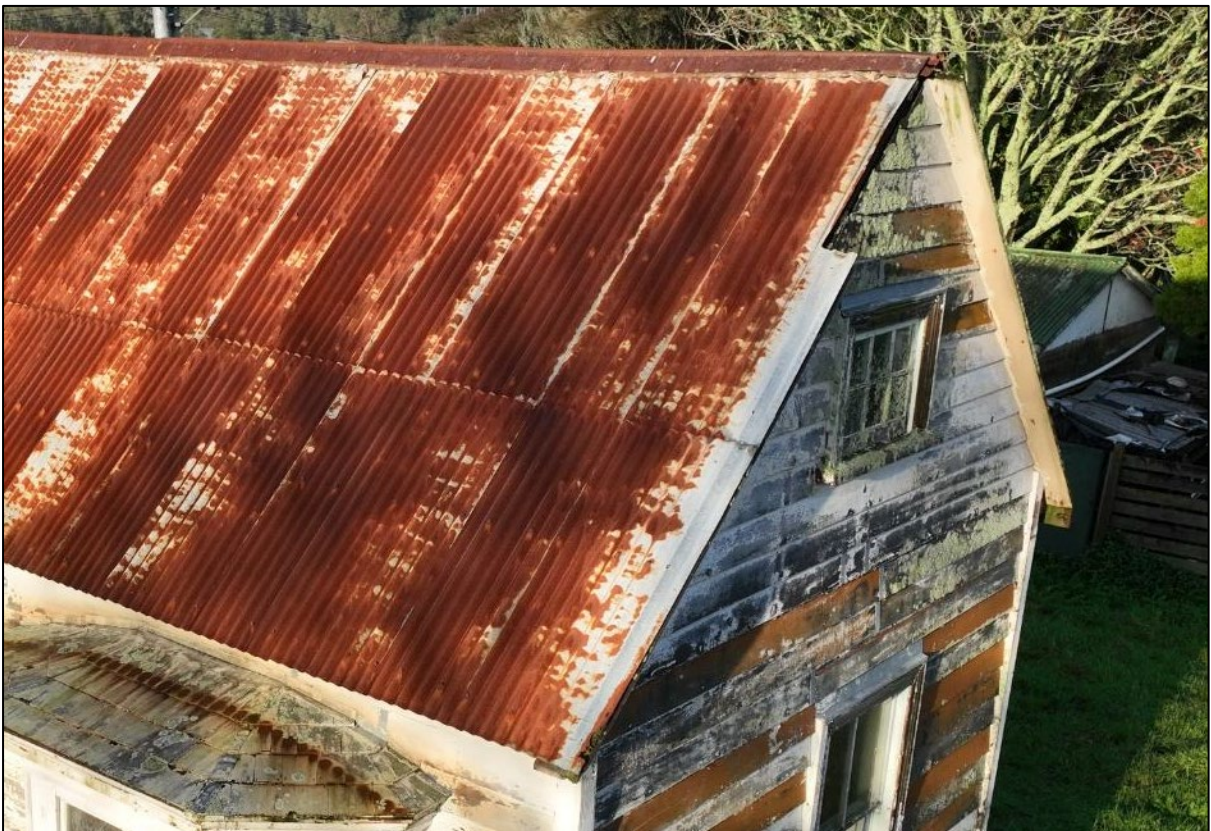
The roof sheet above the main door (north end of the east elevation) has been cut, leaving a section missing (Figure 6). An examination of an earlier photograph<sup>1</sup> shows that there was a chimney on this elevation – and so the roof sheet was cut to accommodate it.

Figure 6. North elevation gable with notch cut out of roofing for former chimney.

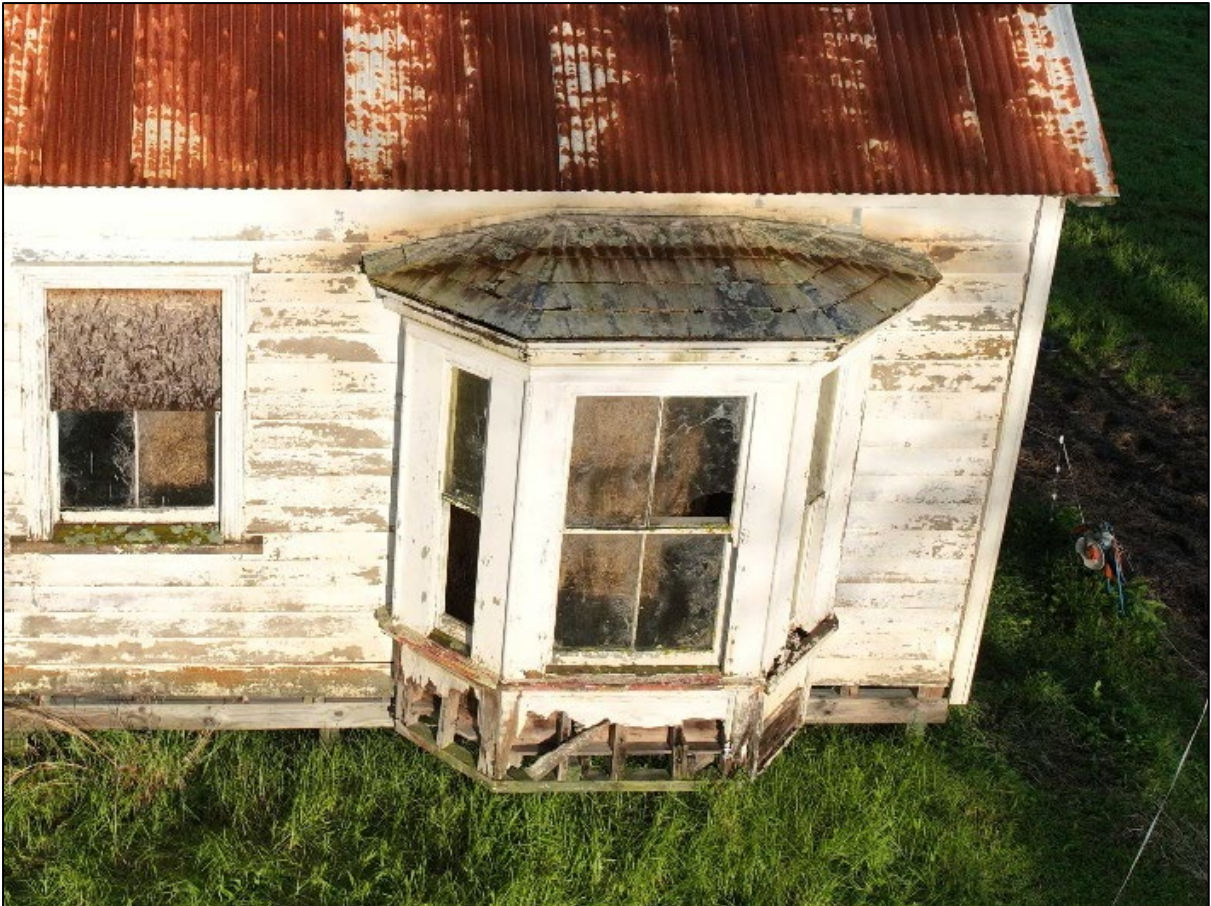
The bay window on the east elevation has what appears to be shingles on the roof (Figure 7). These appear to be in poor condition.

Figure 7. Bay window with shingle roof.

- Replace decayed timber shingles with tray roofing, if pitch is sufficient, or membrane roofing if not.

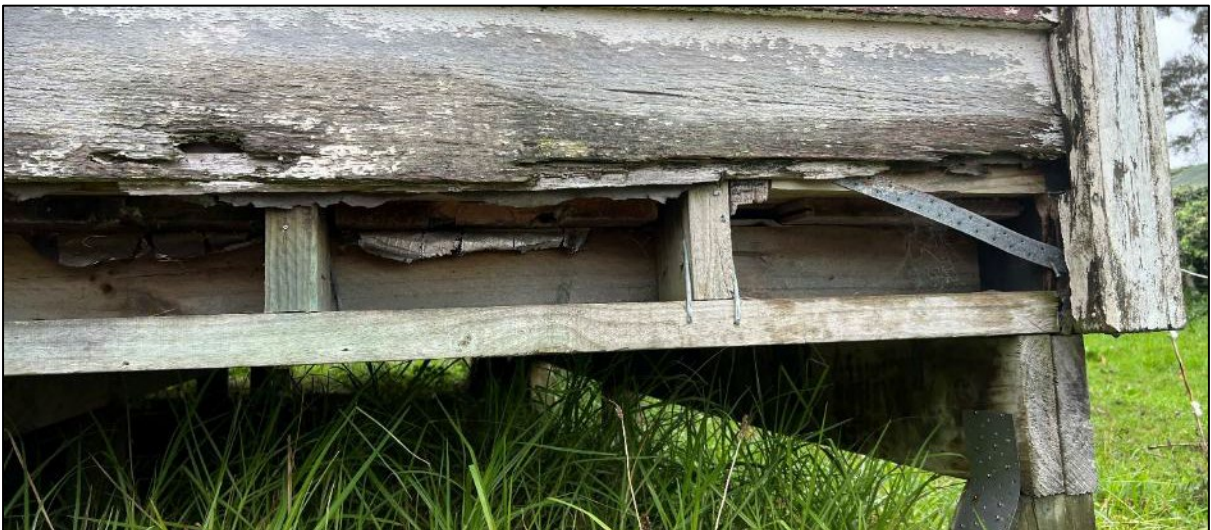
All elevations are missing the bottom row of weather boards – exposing the bottom of the studs, base plates and the ends of the joists (Figure 8). On the east elevation the lower sections of the studs are black due to bio growth and excessive moisture and are badly decayed (Figure 12). A short distance vertically further up the studs the timber appears to be sound. Repairs will need to be undertaken to remove the decayed timber from the lower studs and add new timber. The base plate on the south elevation is bowed (Figure 9 and Figure 13). It appears that the two central piles have dropped, and it was also noted that a nail through the end joist had missed picking up the base plate.

Figure 8. Decayed weatherboards on the north elevation.

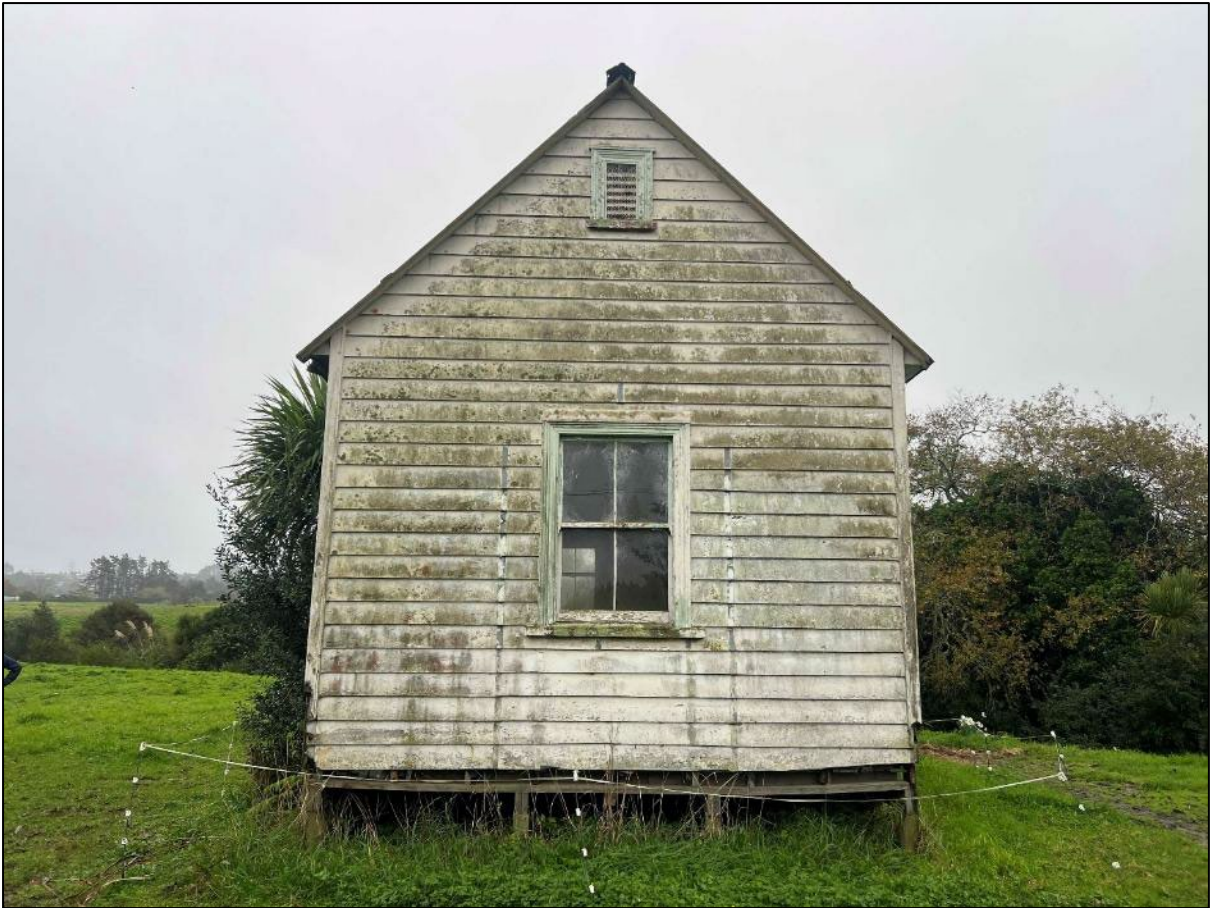
The external walls are clad in painted shiplap weather boards measuring approximately 220mm X 20mm. Following probing with a screwdriver, it appears that the weather boards are generally sound – a little soft in some cases and in need of painting but otherwise can be retained. An exception is the north elevation where the front door is. Here some of the lower weather boards are decayed (Figure 8). It should be noted that the upper weather boards were not able to be reached, as the inspection was from ground level only. Several galvanised steel strips have been fixed over the vertical joins in the weather boards to prevent water ingress (Figure 9). These are largely intact and are not corroded.

Figure 9. South elevation. Note the steel strips visible over joins in weatherboards and the bowed baseplate.

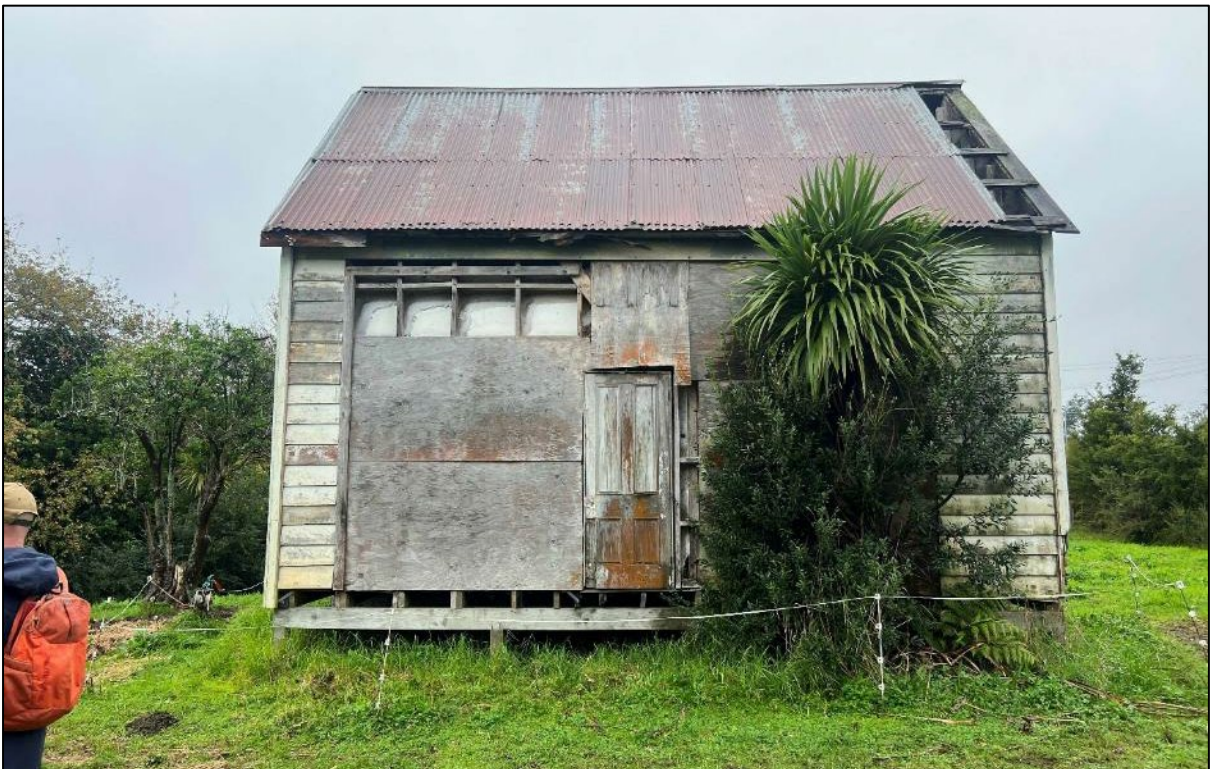
The west elevation is much altered (Figure 10). Approximately half of the façade is covered in plywood, with vertical cuts in the weather boards at both ends. One piece of plywood is loose, and it appears that another piece has detached showing the exposed wall studs (145mm x 45mm). Wall studs are also exposed beside the door. These appear to be sound and are not decayed. The boxed corner detail at the south-west corner is decayed (Figure 11). A cabbage tree is growing through this elevation.

Figure 10. West elevation.

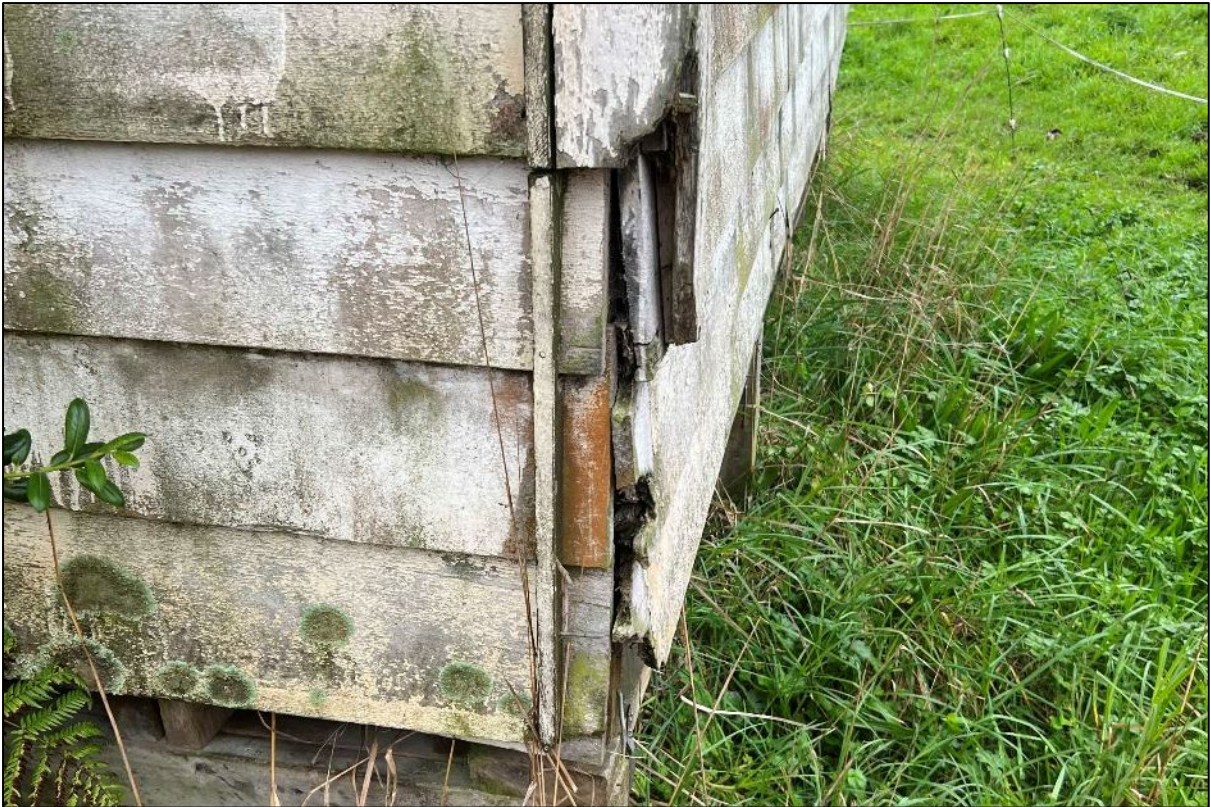
Figure 11. Decayed boxing at south-west corner.

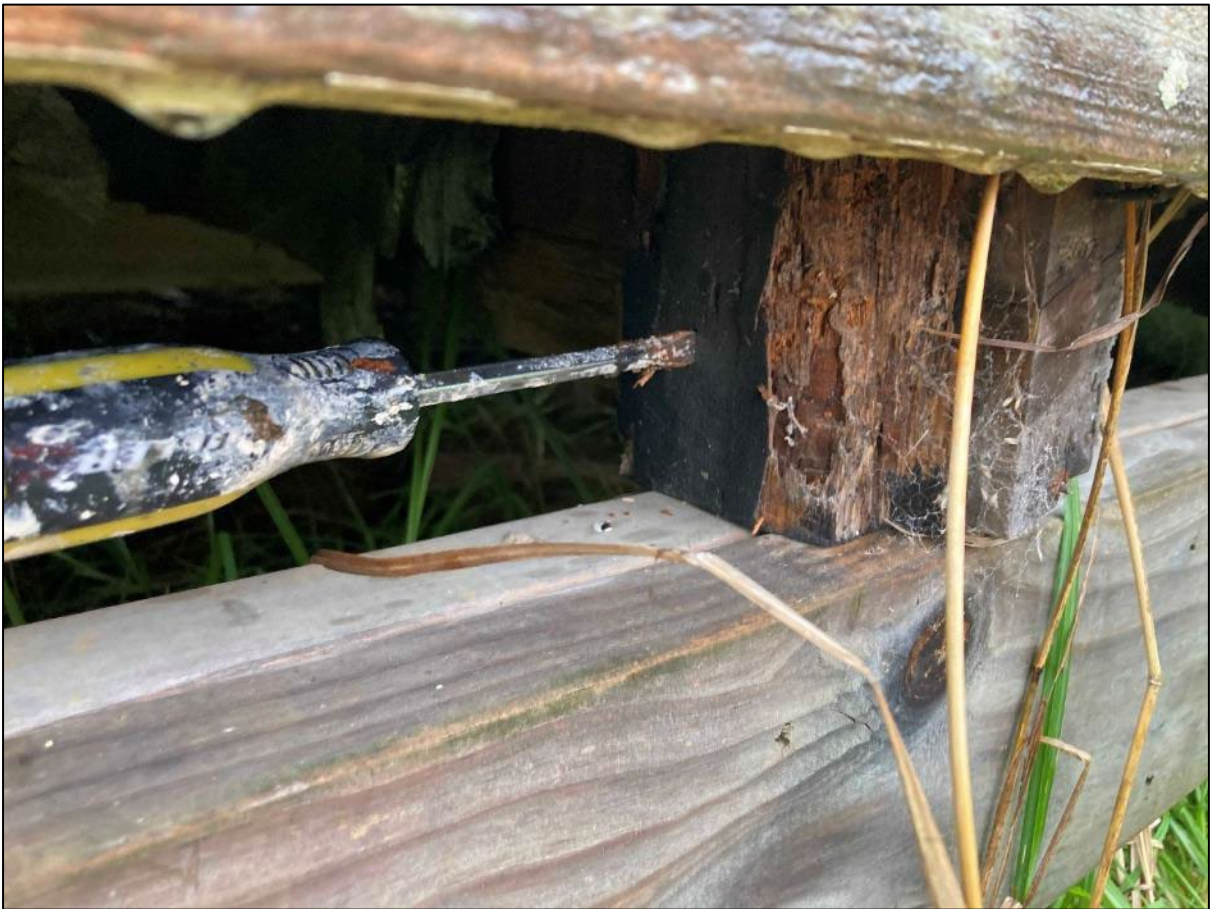
Figure 12. Blackened and decayed stud at the base of the east elevation.

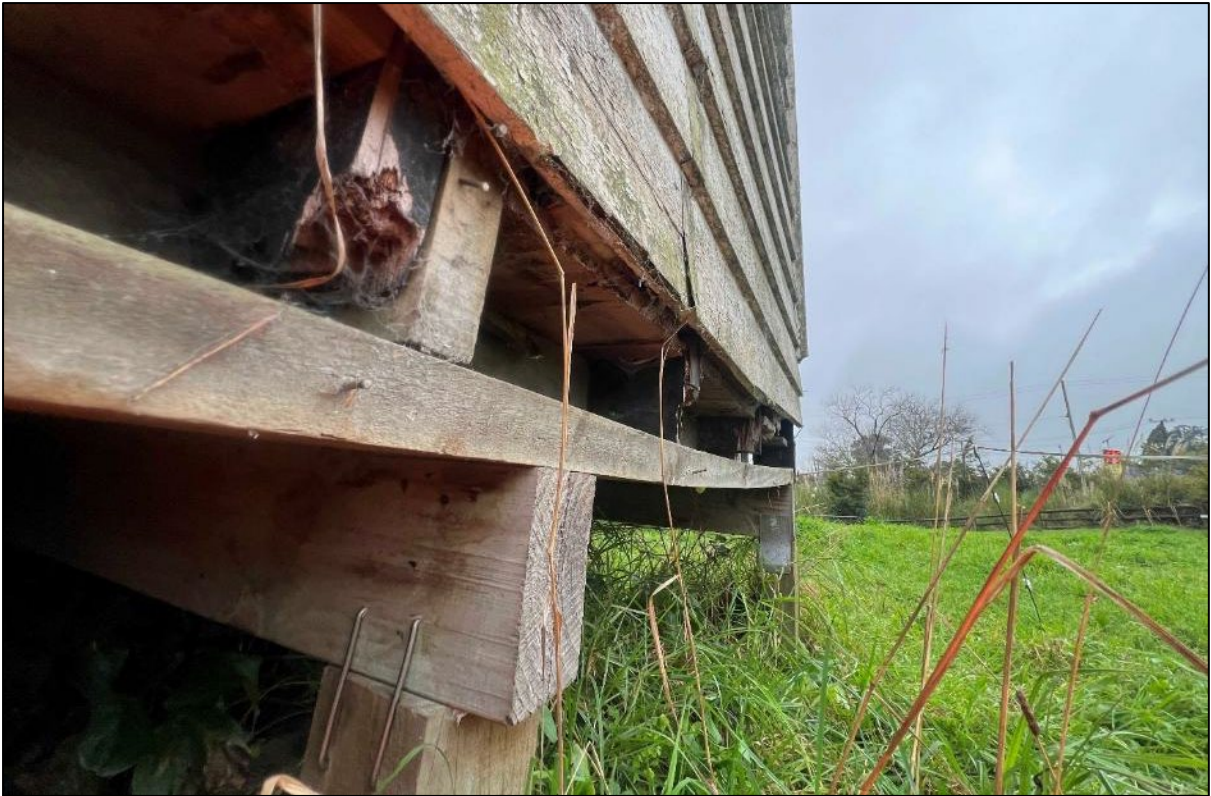
Figure 13. Bowed bottom plate on south elevation, looking east.

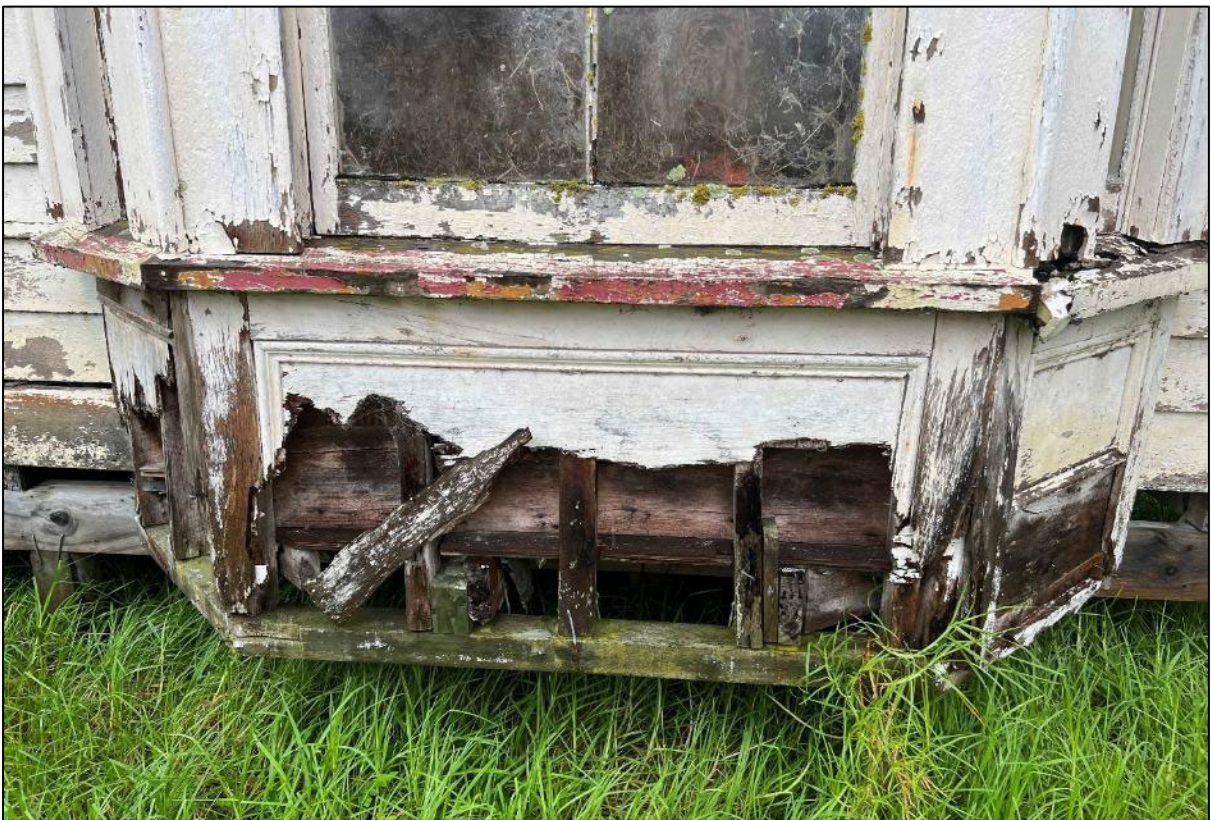
The cladding to the base of the bay window is very badly decayed and has mostly disappeared (Figure 14). This is plywood which suggests previous intervention. The base plate and framing are also decayed. There is evidence of previous repairs including the fixing of galvanised Z nails.

Figure 14. Decayed cladding at the base of the east elevation bay window.

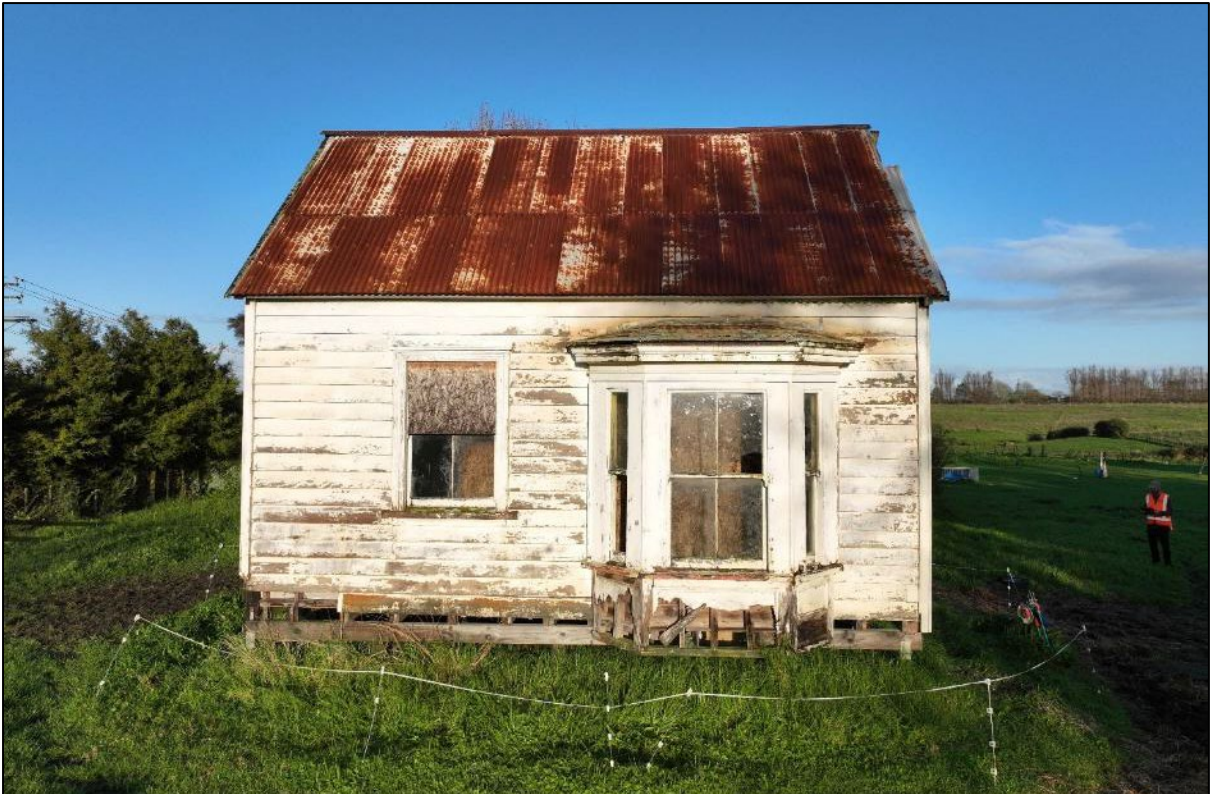
The single timber sash window with vertical glazing bars has a broken pane to the upper sash window which is boarded over (Figure 15). The two panes to the lower sash window are intact, however, the bottom rail is decayed. The remainder of the frame and glazing bar are sound. The external architraves and sill are intact. As with all the joinery, the paint is peeling exposing bare timber. Bio growth is also evident – especially to the bottom rails and the sills. Urgent painting is needed for protection against the weather. A galvanised steel flashing is fixed to the top of the window. This appears to be intact and functioning as weather protection.

The bay window consisting of two narrow single-paned sash windows to the sides and one large sash window to the centre, with vertical glazing bars (Figure 15). The whole pane of glass is missing to the lower sash window on the left side. A pane is broken on the upper sash window in the centre of the bay (Figure 16). The timber frames, including the slender glazing bars are intact and sound, but need painting. Putty is also missing from the glazing. There is extensive timber decay to the sill on the right side of the bay window. This needs to be replaced. The hardware (sash rings and closing latches) to the bay window is intact.

Figure 15. East elevation.

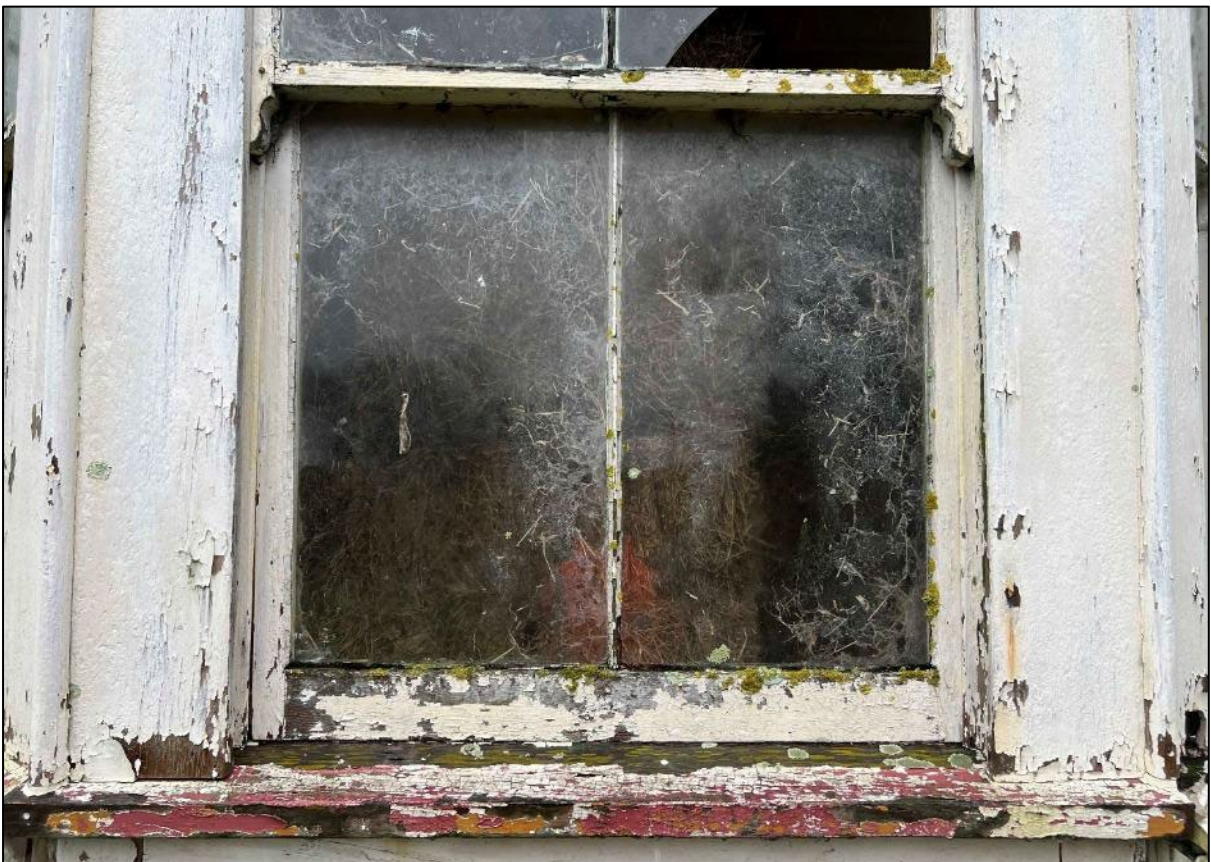
Figure 16. Detail of lower sash of the central part of the bay. Note the broken pane in the upper sash and missing putty.

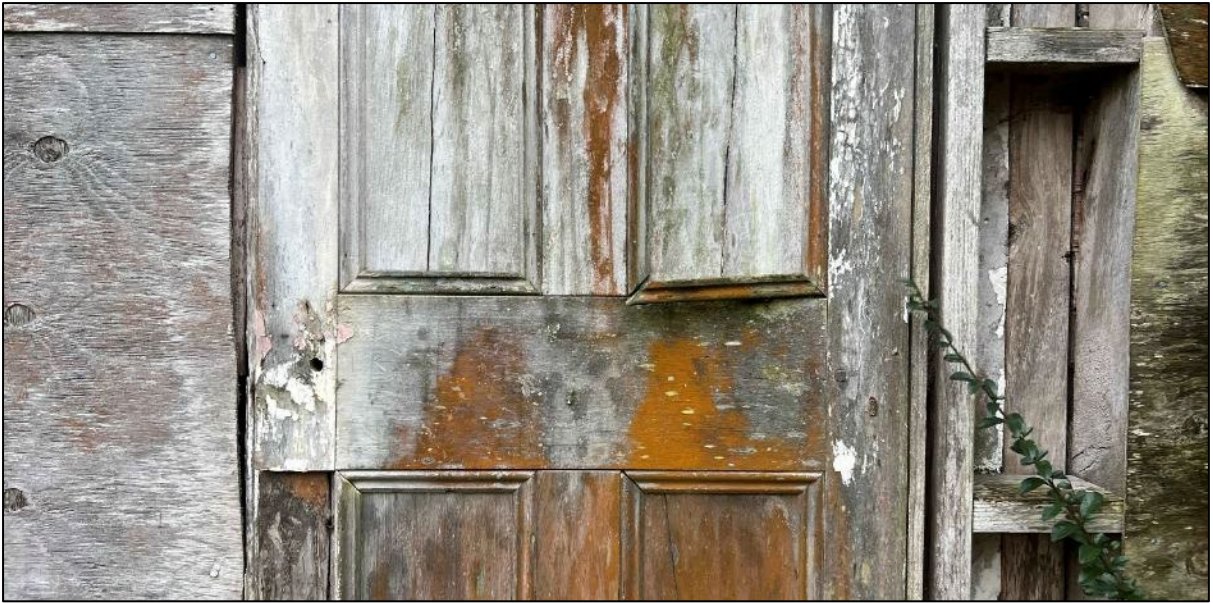
The door on the west elevation is in very poor condition. Some of the detailing is loose; the door is bowed and very weathered; panels are split; bio growth; corroded hinges (Figure 21). The door is relatively thin and appears to be an internal door. There is also no threshold which also suggests that it is not an external door.

Figure 21. Detail showing biogrowth, splitting, and loose bolection moulding.

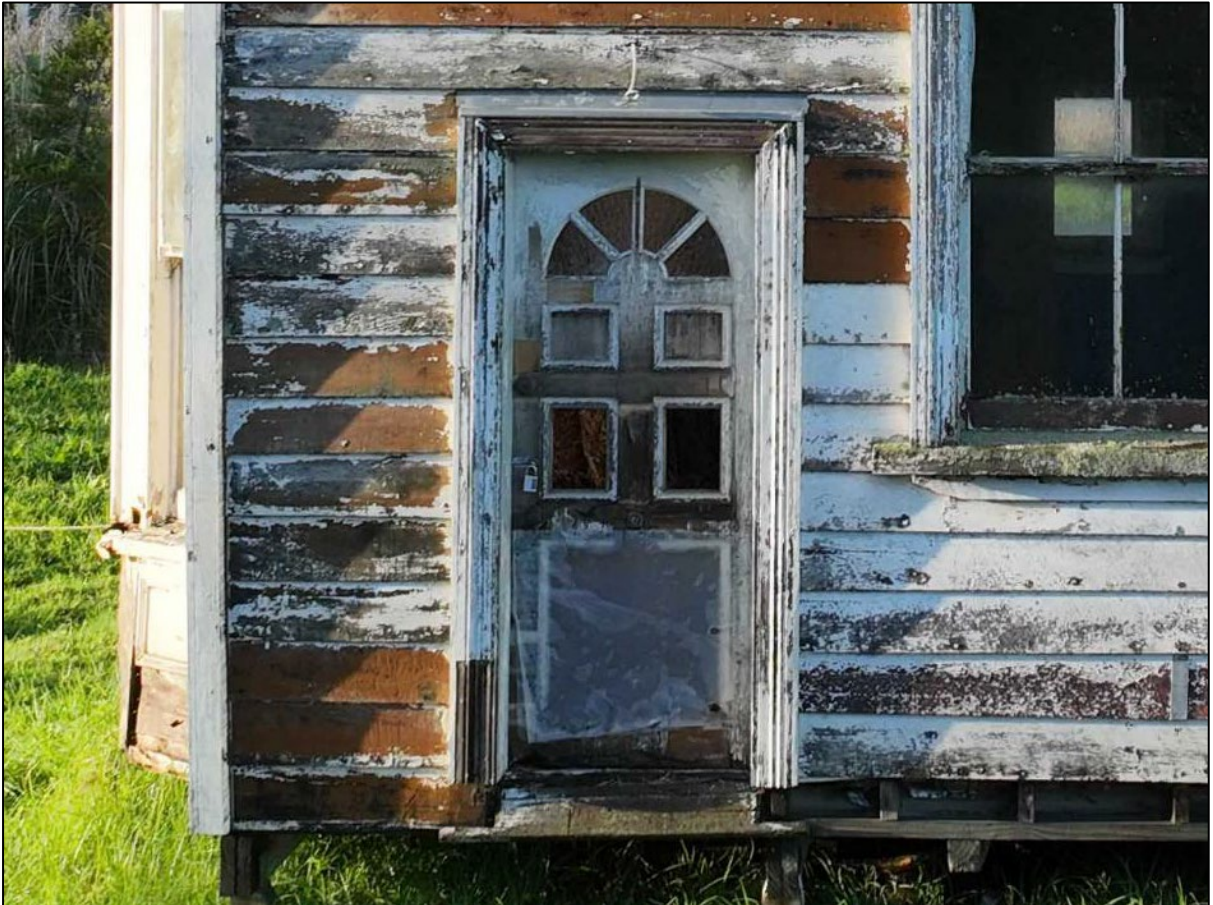
This door is not original (Figure 22). In fact, it is not obvious where the front door was located as the north elevation originally had a fireplace and chimney where the existing door now is. The current door is timber with a veneer facing. It has five inset panels and a textured glass top light in the array of a fan. It is in poor condition. The lower panel is missing and is covered by a plastic sheet; the two smaller panels above are also missing; paint has either weathered off or is peeling; the veneer is also peeling in many locations. There is a peep hole, a Bakelite door handle, a modern lock and bolt with padlock. The threshold is decayed.

Figure 22. Door on north elevation.

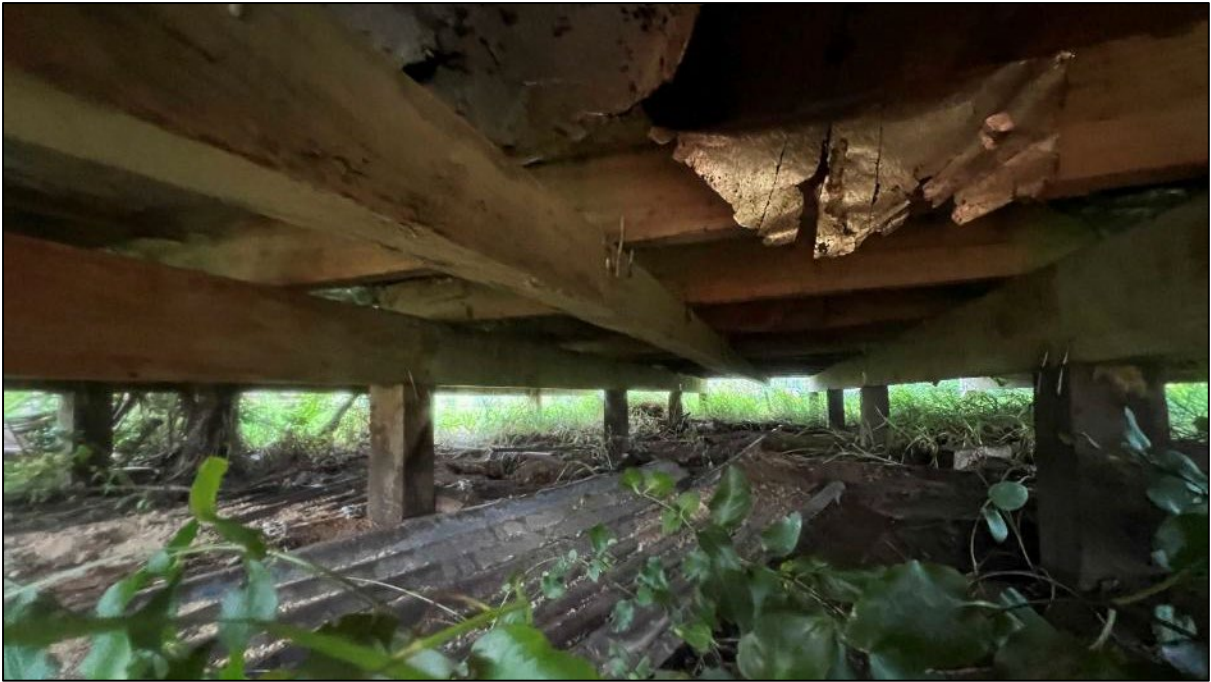
It appears that interventions earlier than 2010 were carried out to the sub-floor using galvanised Z nails and nail plates as opposed to the stainless versions used *circa* 2010 (Figure 23). These have been cut through during the re-piling process.

Figure 23. Subfloor: the c. 2010 bearers and piles fixed with stainless steel Z nails are visible on either side of the image. The member at the centre of the image is interpreted as relating to earlier renovations and is fixed with galvanised Z nails.

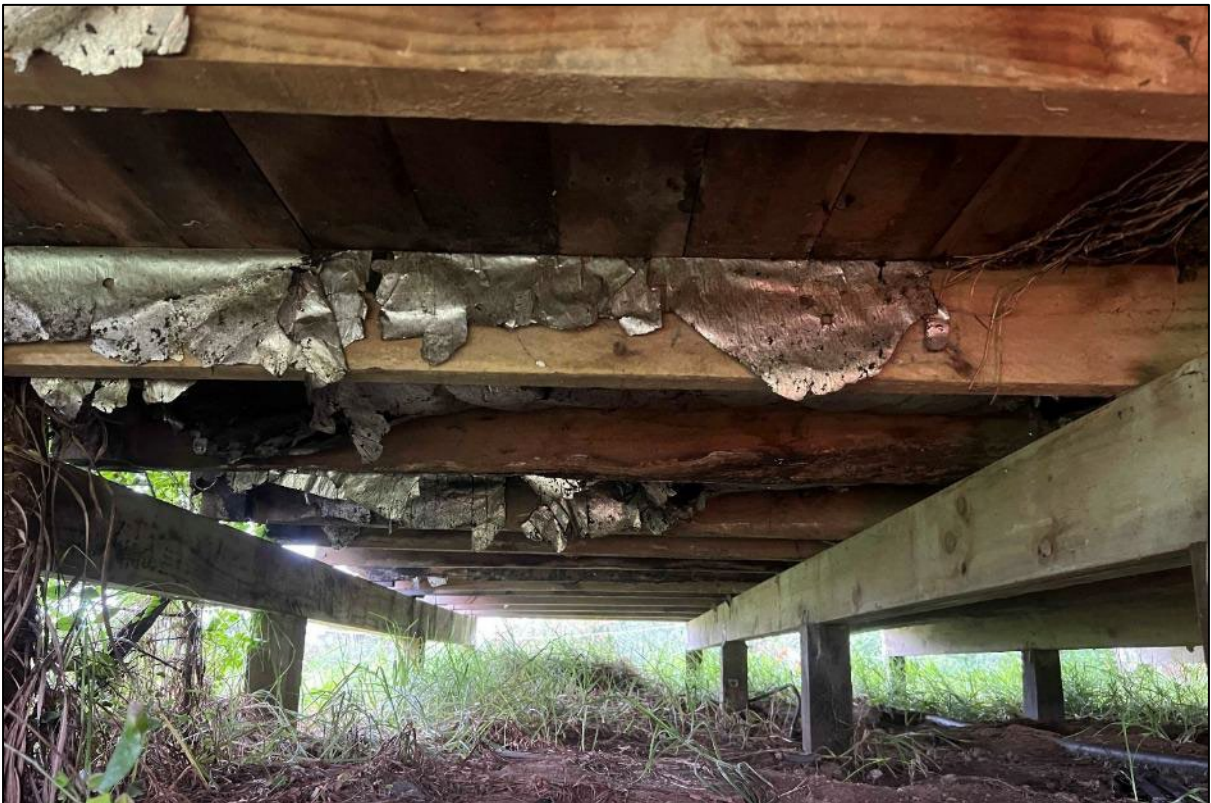
CFG have indicated that the building was reportedly re-piled in 2010 – possibly to a higher level as the building now sits well above ground level. The new treated timber piles (125mm x 125mm) and bearers (two 190mm x 45mm, side-by-side) are easily visible and are connected with stainless steel Z nails (Figure 23). The bearers run in the north-south direction. New floor joists (145mm 40mm) can also be seen, although several older joists are also visible. Some of these appear to be decayed. It is likely that at the time of reinstating the floor these joists were in good enough condition to retain (Figure 24).

Figure 24. Subfloor image showing a mixture of new and old joists and floorboards above.
