Enviser Ref: 1480

# Preliminary Site Investigation

**Taharoa Ironsand Mine, Taharoa**

**Taharoa Ironsands Limited**

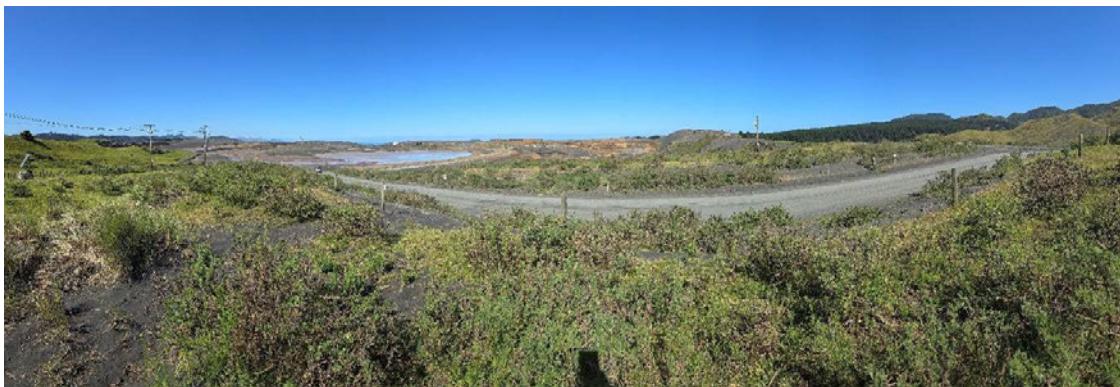
- There are large portions of disturbed sands and manmade waterbodies that form part of the mining operations across the Site (refer Photograph 1 below). Spread around these features are laydown areas and car parks, and above ground pipelines to transport slurry and water across the Site (refer Photograph 2). It is assumed that the locations are temporary and move throughout the Site depending on mining operations.

***Photograph 1: General site view from Taharoa Road. Site entrance is to the right of the photograph***

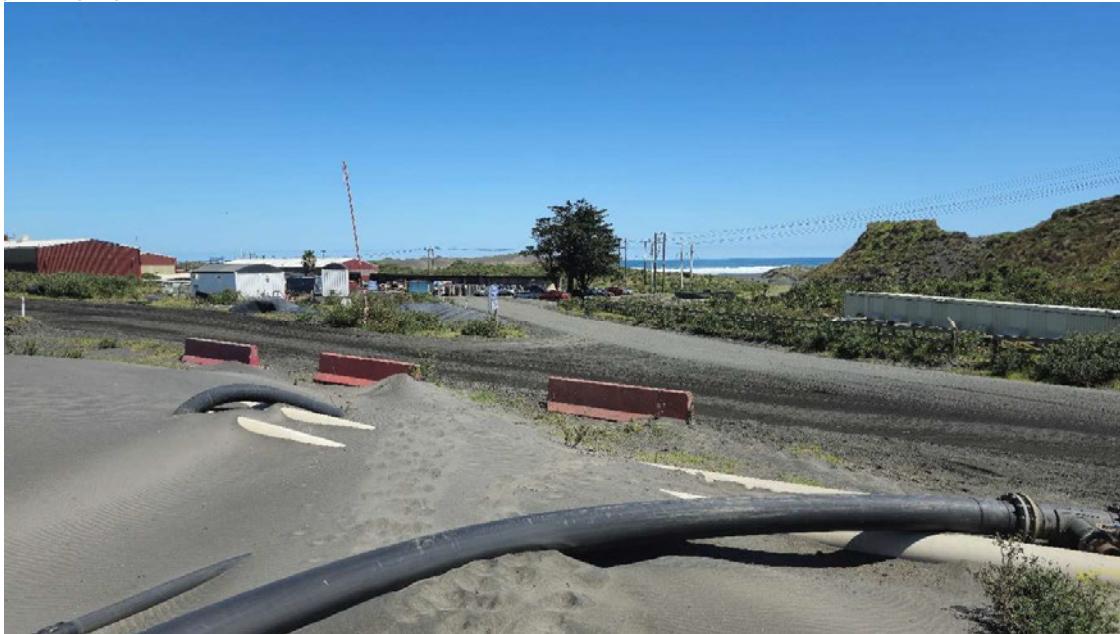
***Photograph 2: Entrance to administration block and example of above ground pipelines in the foreground***

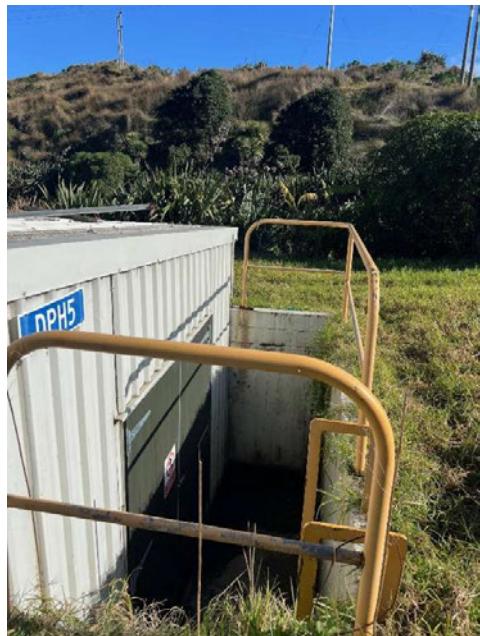
- A pump house and fuel storage are located to the west of Taharoa Road (Photograph 3).
- The main administration block is located in the north-west corner of the Southern Block and includes offices, staff facilities, a laboratory, mechanical and electrical workshops, dangerous goods store, above ground storage tanks (ASTs) for fuel, the Pump Hall and electrical substation. Upgrade works are currently underway for the substation (refer Photograph 4). A fuel spill occurred in the area into an interceptor prior to TIL operating the Site.

**Photograph 3: Wainui pump house and fuel storage**

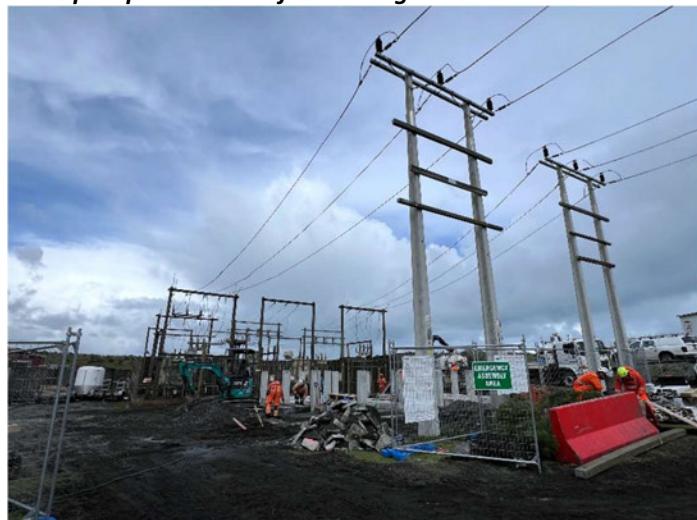
**Photograph 4: Substation upgrade works underway**

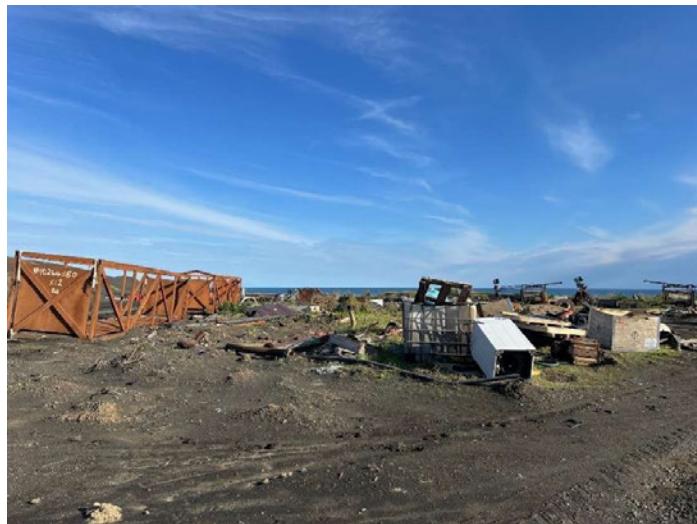
- An area for stockpiling and storing old materials is located south of the administration block. This includes steel, pipes, treated timber pallets and poles, empty IBCs (intermediate bulk containers), appliances including washing machines and fridges, vehicle engines (refer Photographs 5 and 6 below). No materials have been intentionally buried, however some windblown sand now partially covers some waste materials.

**Photograph 5: Stockpile – steel, appliances, engine, treated timber product, empty IBC are visible**

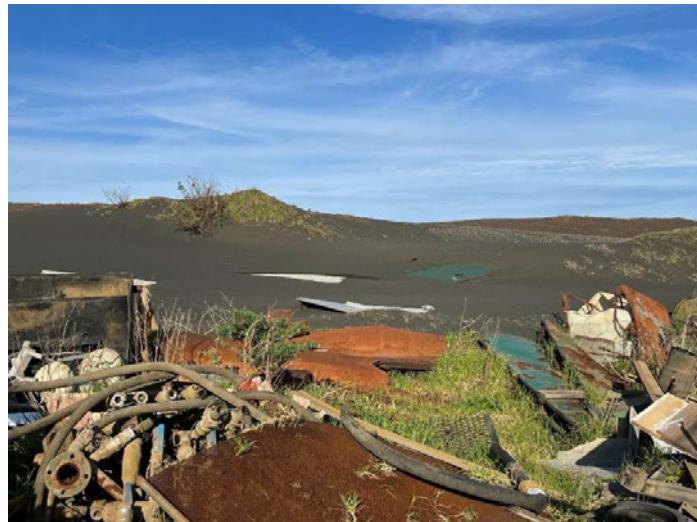
**Photograph 6: Stockpile – steel and pipes, some waste partially covered by windblown sands**

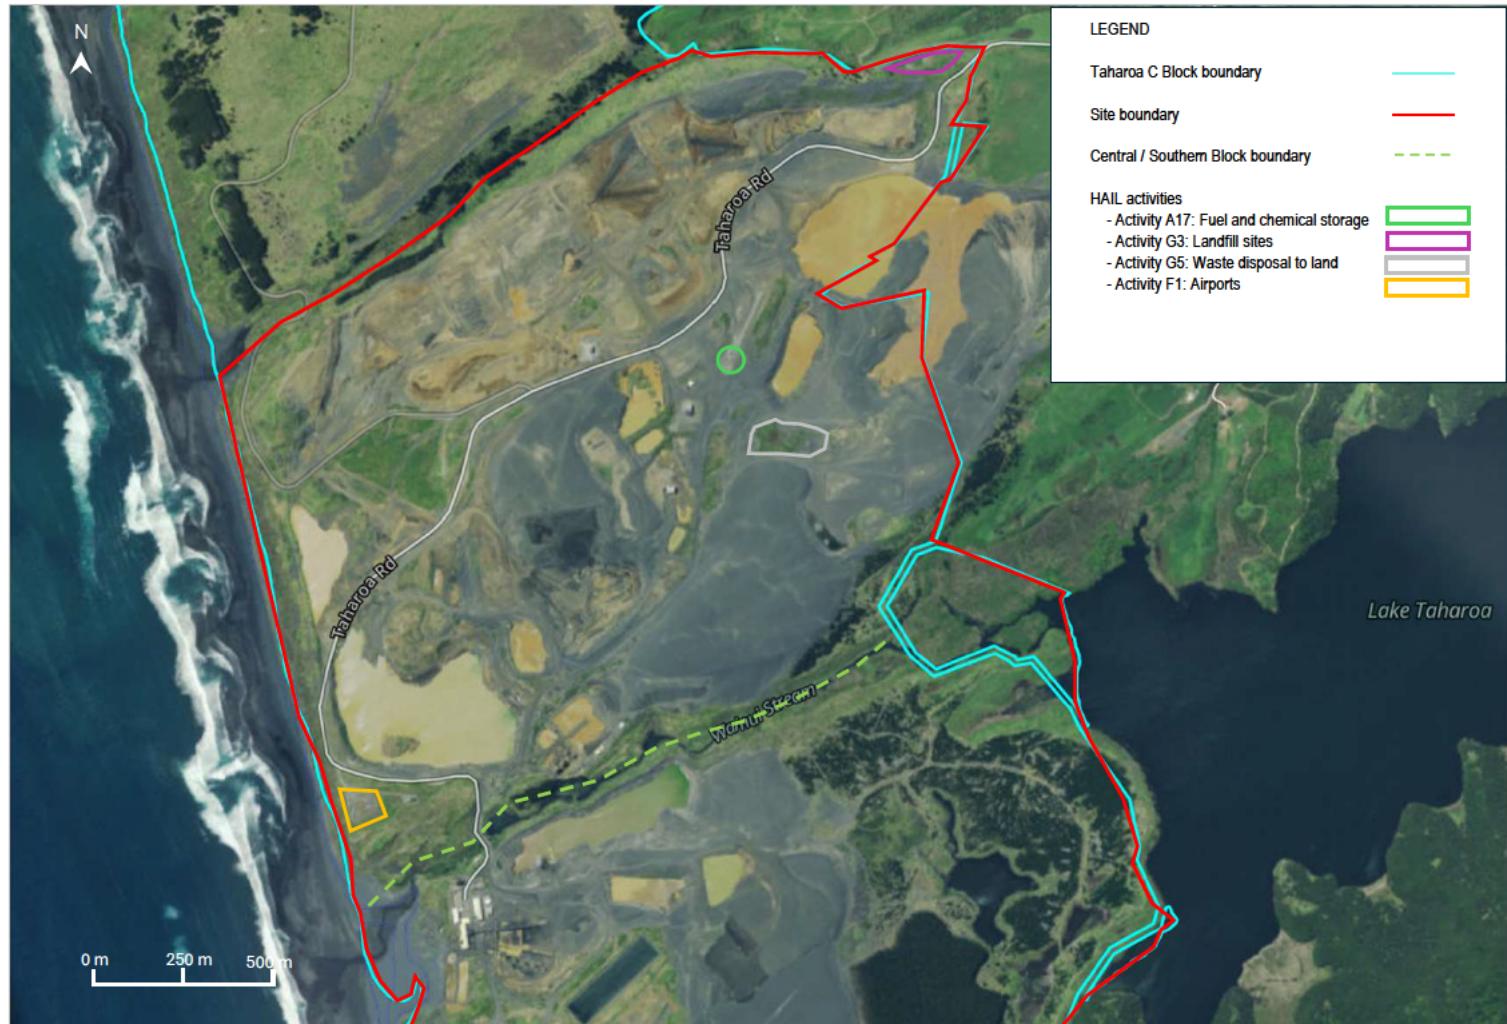
Taharoa Ironsands Mine Preliminary Site Investigation  
Figure 2a: HAIL Locations – Central Block

HAIL activity ID	Description
A17: Storage tanks or drums for fuel, chemicals or liquid waste	<ul style="list-style-type: none"> <li>There are four current locations for fuel storage across the Site – one in the Central Block, and three in the vicinity of the administration block in the Southern Block.</li> <li>There is one former UST (removed in 2015) that resulted in ground contamination, but below the MfE<sup>10</sup> human health criteria for commercial / industrial land use. This location is included in Figure 2b, Appendix A. Other fuel USTs removed in 2015 did not result in ground contamination and have not been shown on Figure 2b, Appendix A.</li> <li>A dangerous goods and laboratory are present in the Southern Block.</li> </ul>
B4: Power stations, substations or switchyards	<ul style="list-style-type: none"> <li>A power station is located in the Southern Block.</li> </ul>
D5: Engineering workshops with metal fabrication	<ul style="list-style-type: none"> <li>A mechanical workshop to support site activities is located in the Southern Block.</li> </ul>

F1: Airports including fuel storage, workshops, washdown areas or fire practice areas	<ul style="list-style-type: none"> <li>A helicopter pad, and likely refuelling facilities are located in the south west corner of the Central Block. It is understood from TIL that fire training activities are not carried out on Site.</li> </ul>
E1: Asbestos products manufacture or disposal including sites with buildings containing asbestos products known to be in a deteriorated condition	<ul style="list-style-type: none"> <li>Buildings that were constructed pre-2000s may include asbestos containing materials. Surface soils surrounding the buildings have the potential to be asbestos contaminated, particularly buildings in poor condition.</li> </ul>

HAIL activity ID	Description
G3: Landfill sites	<ul style="list-style-type: none"> <li>An area with former landfilling activities is in the north-east corner of the Site.</li> </ul>
G5: Waste disposal to land	<ul style="list-style-type: none"> <li>Two disposal fields are located in the Central Block where treated effluent from the community (and Site septic tanks) wastewater treatment plant discharge.</li> <li>A waste materials storage area is located south of the administration block. Some materials may be buried by windblown sands.</li> </ul>
I: Any other land that has been subject to the intentional or accidental release of a hazardous substance in sufficient quantity that it could be a risk to human health or the environment	<ul style="list-style-type: none"> <li>Buildings that were constructed pre-1970s are likely to have lead-based paints. Surface soils surrounding the buildings have the potential to be contaminated by the paint, particularly buildings in poor condition.</li> <li>A fuel spill was reported to discharge to an interceptor, prior to TIL operating the Site. It is understood that no work has been undertaken in this area to assess if the spill resulted in ground contamination.</li> </ul>

If soil disturbance activities are proposed within the HAIL areas, an assessment against Regulation 8 of the NESCS which covers the permitted activity criteria (including soil volume limits, duration of works) is required. Site investigations comprising targeted soil sampling may need to be undertaken to inform health and safety and soil management procedures. The results of the investigations will be used to develop a Contaminated Site Management Plan for the proposed works that will need to be implemented onsite.

It is understood that soil disturbance activities are not currently proposed within the HAIL areas and therefore the NESCS would not apply. For potential future developments onsite, the NESCS will be applicable to any soil disturbance activities undertaken within these areas. Site investigations and appropriate management may need to be undertaken where soil disturbance is proposed at the locations identified on Figure 2a and Figure 2b, Appendix A and the specific works exceed the permitted activity criteria outlined in Regulation 8 of the NESCS.
