Preliminary Site Investigation  
Stagecoach Rd, Tasman  
Tahimana Ltd  
June 2026

**Title:** Preliminary Site Investigation  
Stagecoach Road, Tasman  
Tahimana Ltd

**Reference:** J00087-RPT-001-A- PSI\_TahimanaLtd\_v7

**Date:** 5 June 2026

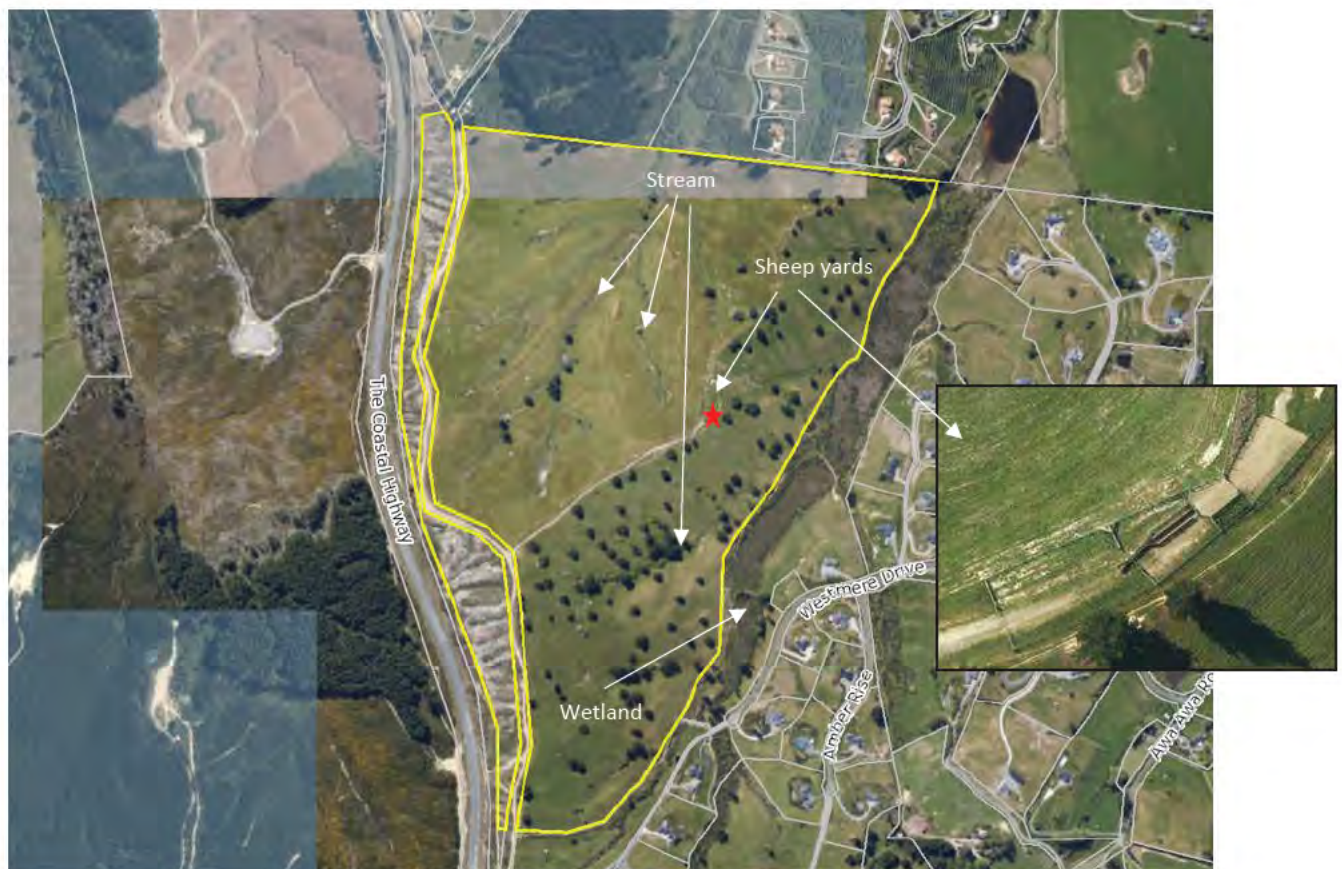
Figure 3 – Notable property features, with sheep yards shown in inset.

The only notable feature observed whilst onsite was the presence of sheep yards. These appeared to be of a modern construction, with no obvious signs of a historic sheep dip. These were not visible in the historic aerial images until 2012 and were absent in 2011, so presumably were constructed sometime between 2011 and 2012.

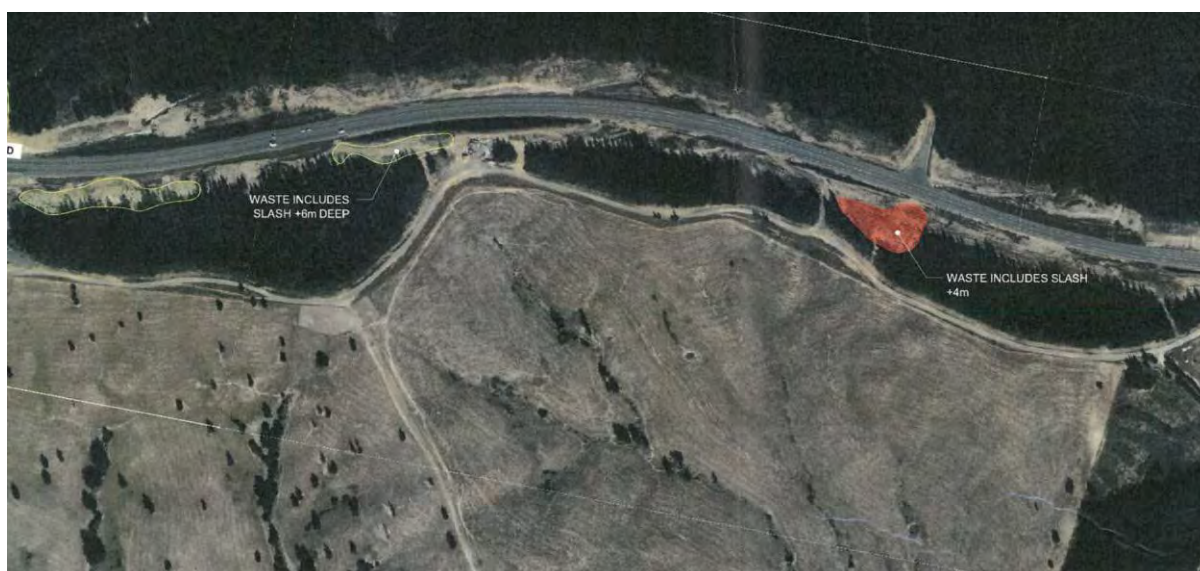
Figure 4 – Excerpt from letter to TDC “Waste Spoil Dump Sites from the construction of The Ruby Bay Bypass (February 2013)”

The property file obtained from TDC in 2022 for the site was reviewed. The only notable entry was records of the locations used by New Zealand Transport Agency (NZTA), for the disposal of surplus fill and spoil during the construction of the Ruby Bay Bypass which was opened in 2010. The letter<sup>4</sup> to TDC (dated 26<sup>th</sup> February 2013) from agents acting on behalf of NZTA details three locations on this property used as fill sites which are shown in Figure 4 below.

The letter indicates that some disposal sites were used for the disposal of marine sediment and these site covered by resource consents, however the balance of sites are not. The letter details no formal process was in place for recording the exact nature of the fill disposed of at each site, but indicative notes are provided on the specific drawings. It specifies the bulk of the material was in the form of topsoil, Moutere gravels, tree slash, and small amounts of chip seal. Notes on the three disposal locations on this property indicates forestry slash has been buried at depths of 4 m and 6 m.

Based on this advice, and the annotations on the photographs, it has been assumed in the absence of further detail, that there is nothing of contamination significance present in these locations. It should also be noted that these areas are beyond the proposed development footprint (refer to Appendix A).

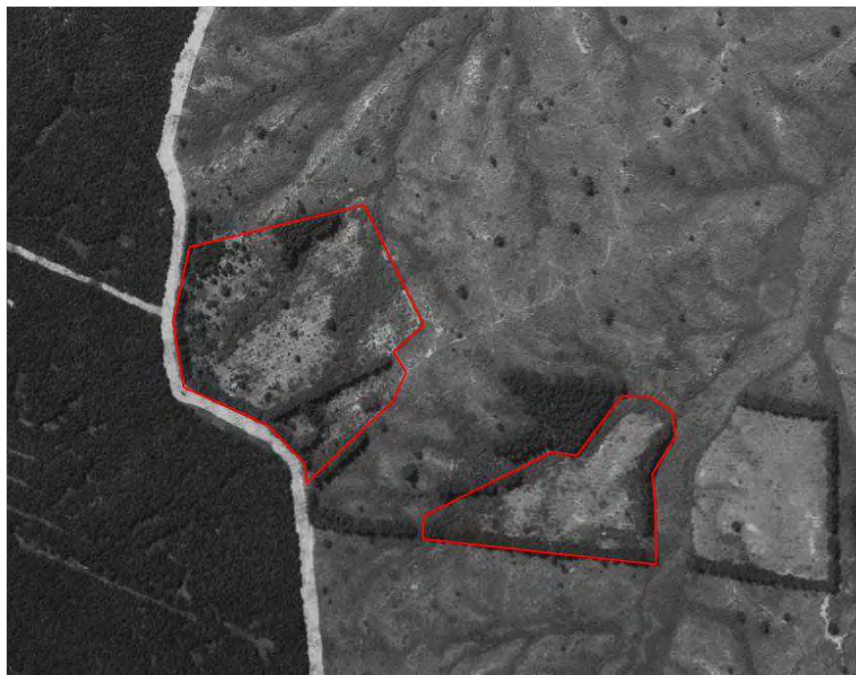
*Figure 5 – Areas of interest from the 1940 aerial image*

One area within the site showed possible remnant orchard trees or horticultural activity in the earliest possible image from 1940 and this was still indicated in 1946. There was no evidence of such activity in the 1958 image. Figure 5 shows the areas observed in 1940.

The earliest historic aerial imagery (1940) identified two areas that may have been planted in orchard trees; however, they may alternatively represent plantation forestry or vegetation unrelated to agricultural activities. The planting pattern was not typical of an apple orchard of that era and, therefore, the evidence supporting historic orchard use is not considered strong.

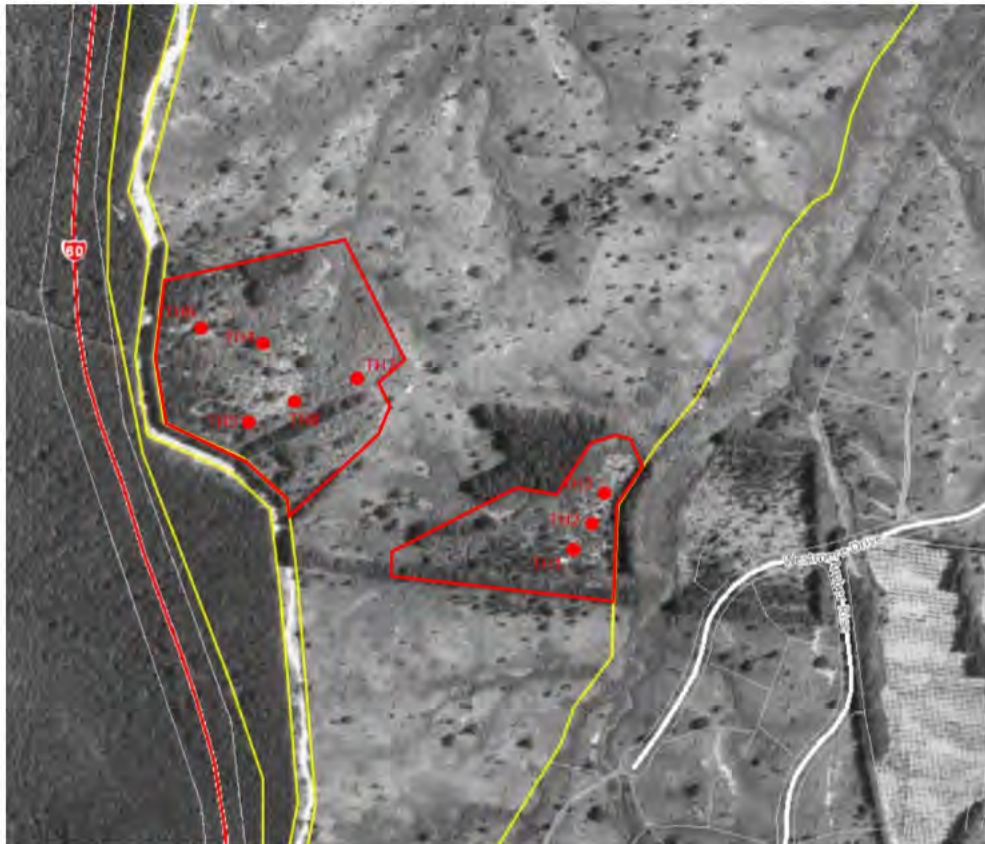
Figure 6 – Soil sample locations (approximate) on 1946 aerial overlay

Preliminary soil samples were collected from the two areas that may have contained orchard trees as seen in the 1940 and 1946 aerial images (shown in Figure 5). Samples were located in the footprint that had been strategically planted in the historic aerial images and collected from the areas that appeared the most modified. All samples collected were surficial soil samples (0 – 75 mm below current ground levels). The soil sample locations are shown in Figure 6.

The sample results report that contaminants of concern (specifically arsenic, copper and lead) are not present at concentrations greater than the NESCS standards for a rural residential land use from the areas identified that may have contained orchard trees as early as 1940.

Sample results are also reported at concentrations less than the regional background concentrations for the Tasman region.

Soils from within the area of interest (that may have contained orchard trees as early as 1940) are considered to be low risk in the context of the proposed rural residential development.

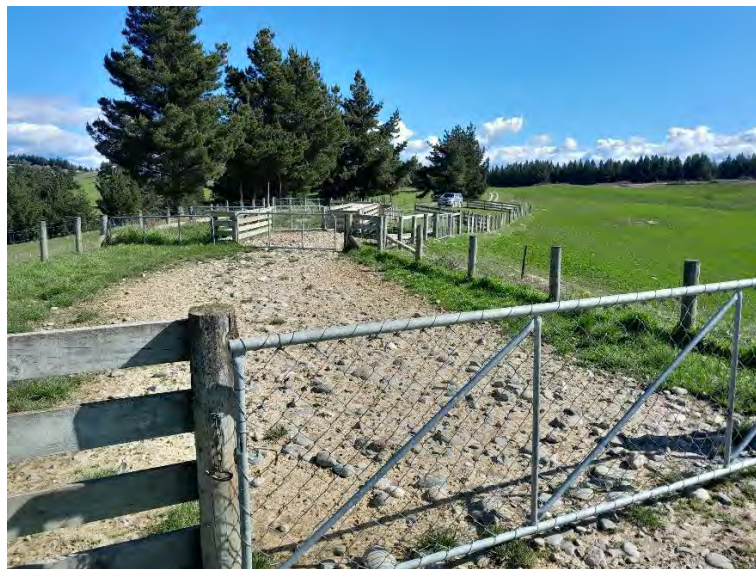
**Photo 1: Sheepyards**

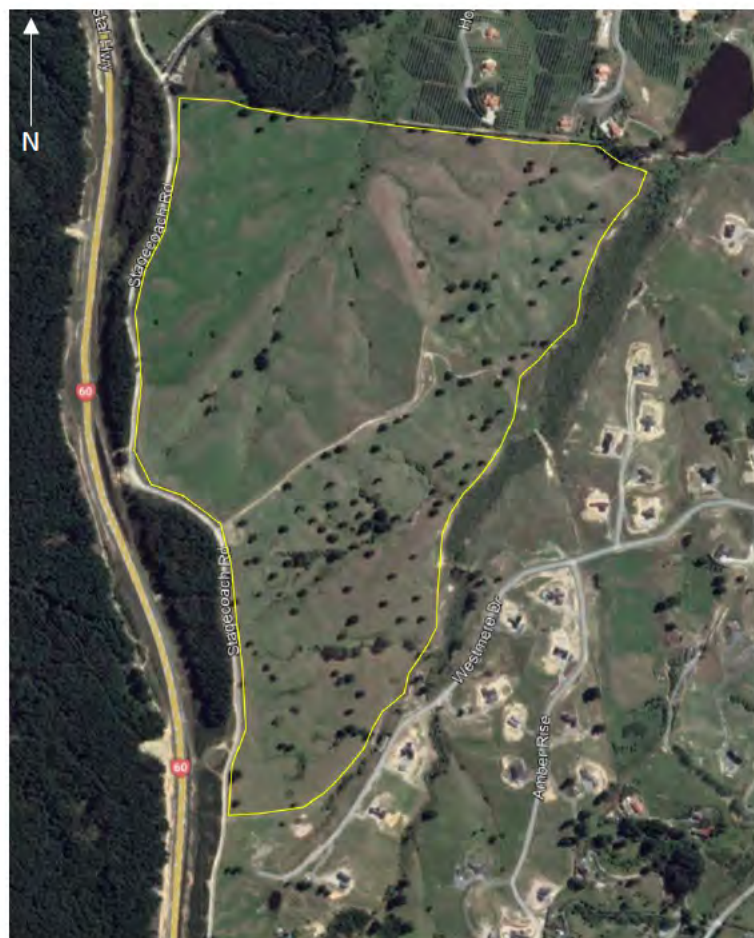
Photo 19: 2018 (Google Earth) sheepyards present
