15 July 2022

Caland Holdings Limited  
66 McFetridge Drive  
RD 6  
Rotorua 3096

## Active fault investigation for 66 McFetridge Drive, Rotorua

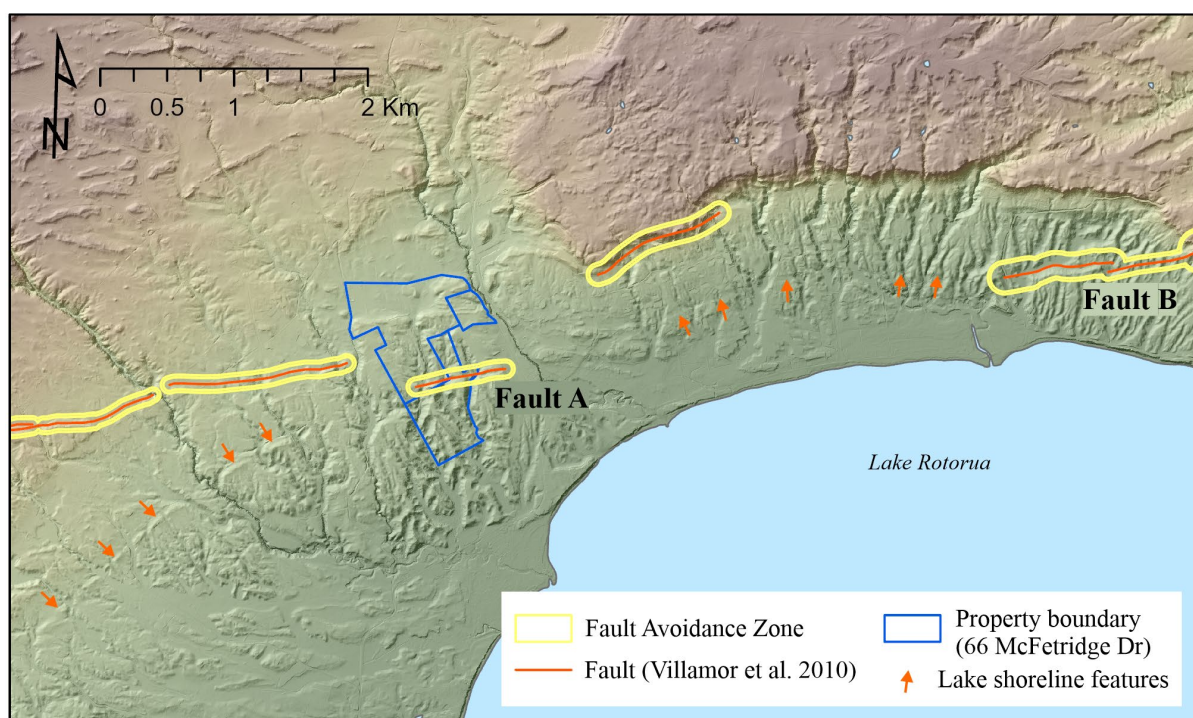
Fault A was mapped along a distinct lineation (i.e. a straight to semi-straight step) in the landscape identified in high-resolution LiDAR topographic maps (Villamor et al. 2010; Figure 2.1). Similar steps also lie to the southwest around the lake (orange arrows, Figure 2.1), but they have a more arcuate shape and are clearly formed by lake-shore erosion. However, Fault A is more linear and lies directly along strike (along a straight line projection) from another prominent active fault 3.8 km to the east (here called **Fault B**, Figure 2.1). Fault B has a strong topographic expression in the landscape and is almost certainly an active fault. Despite some similarities with the arcuate features to the southwest, the lineation at Fault A was mapped as an active fault because of its along-strike relationship to Fault B. It therefore follows that we should treat Fault A and Fault B as the same fault, and this means that we can use the landforms in between Fault A and Fault B to constrain the fault recurrence interval.

Figure 2.1 Topography of the northern Lake Rotorua area in the vicinity of 66 McFetridge Drive (blue property boundary). The topographic data is a 2 m resolution LiDAR digital elevation model from the Bay of Plenty Regional Council. The faults and FAZ are from Villamor et al. (2010), and the names 'Fault A' and 'Fault B' are specific to this report. Arcuate lake shoreline features discussed in text are pointed out by the orange arrows.

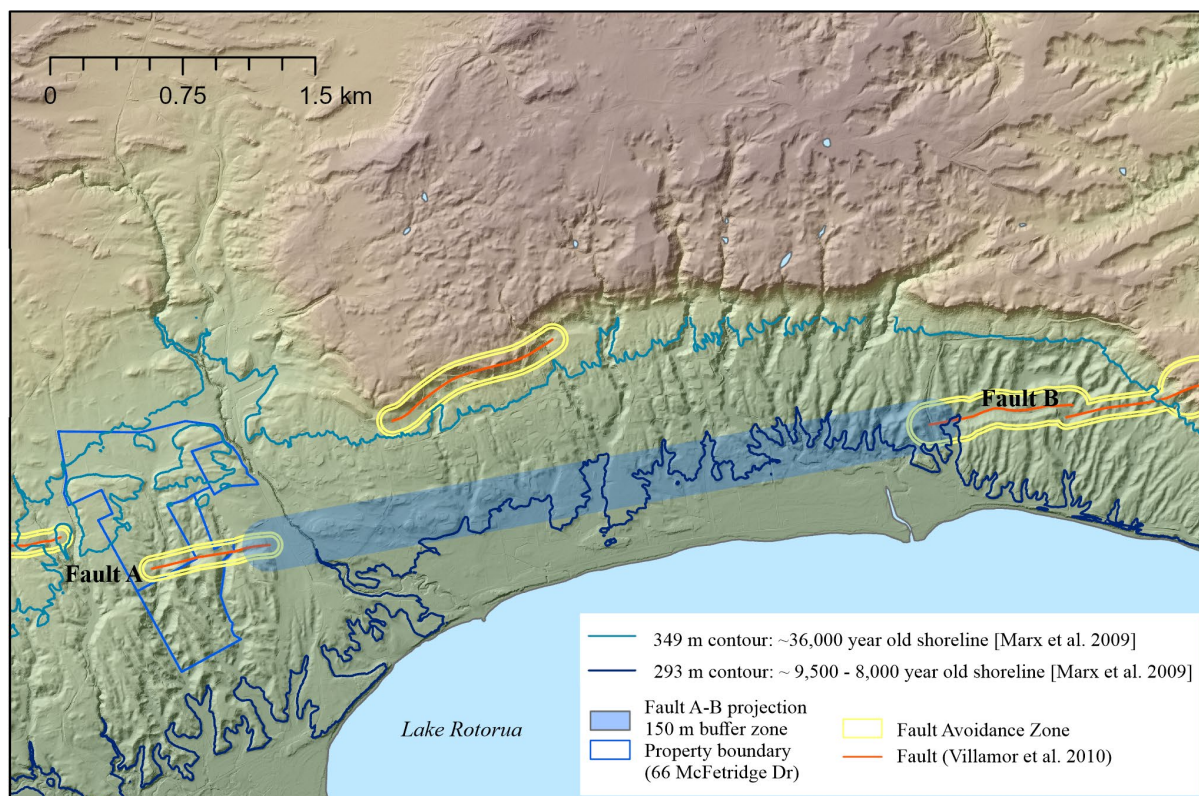
The former lake shorelines present between Fault A and Fault B have been mapped in several publications (Kennedy et al. 1978; Marx et al. 2009), and the progression over time in understanding the age of past volcanic eruptions has resulted in some different information about the precise age of the shorelines. Here we defer to the most recent age information in Marx et al. (2009). In the northern area of Lake Rotorua, the most topographically prominent shorelines are at ~349 m asl and ~293 m asl (blue lines in Figure 2.2). The projection of the fault between Fault A and Fault B crosses the land between the 349 m and 293 m shorelines. The 349 m shoreline is associated with a highstand (highest topographic level reached by the lake at certain time) at around 36,000 years ago (Marx et al. 2009). The most recent age estimate of the 293 m shoreline associates the shoreline with the Rotoma and Mamaku volcanic eruptions at 9500–8000 years ago (Marx et al. 2009). This means that the shoreline formed at approximately 9500 to 8000 years before present and the lake level has fallen progressively since ~8000 years to its current elevation. If we take the youngest possible age for the 293 m shoreline at ~8000 years ago, and we can see that this has not been displaced by a fault, then we can reason that Fault A and Fault B have not had a surface rupture in the last ~8000 years. **The recurrence interval of Fault A and Fault B must therefore be >8000 years.** It is possible that the recurrence interval of Fault A and Fault B is significantly longer than 8000 years because the land surface between the 349 m and 293 m shorelines is not displaced, and this land ranges in age between 36,000 and 8000 years.

Figure 2.2 Topography of the northern Lake Rotorua area in the vicinity of 66 McFetridge Drive with the 349 m and 293 m contours highlighted. These elevations correspond with the approximate positions of former lake shorelines at 36,000 years and 9500–8000 years, respectively. The zone of the fault projection between Fault A and Fault B is shaded blue, and no offset of the 293 m shoreline can be seen along this fault projection zone or anywhere in the area between Fault A and Fault B.

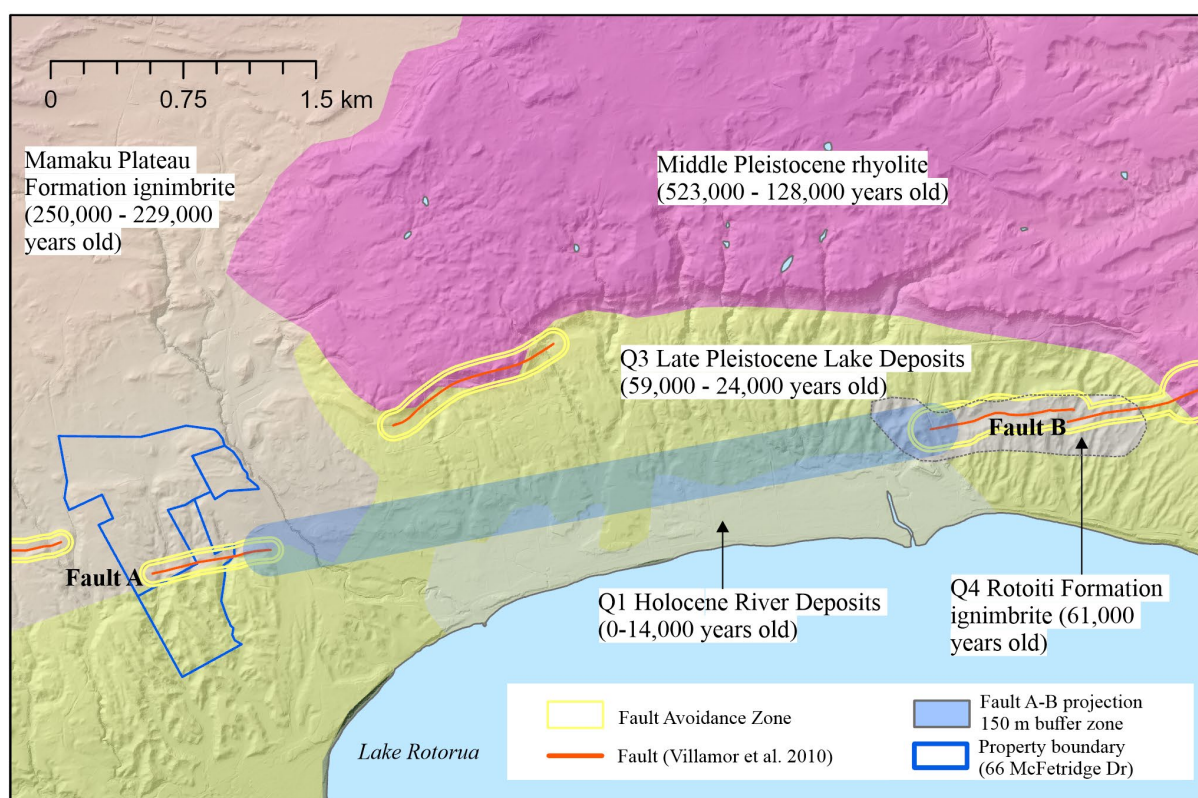
Geological maps can also be used to confirm the long (>8000 years) recurrence interval of Fault A and Fault B. The 1:250,000 geological map (QMap, Leonard et al. 2010) shows that the geological units in between Fault A and Fault B are Late Pleistocene lake deposits (59,000–24,000 years old) and Holocene alluvial deposits (14,000–0 years old) (Figure 2.3). The projection of the fault (and a 150 m buffer around the fault projection) crosses both of these units, and we do not see any surface expression of a fault. The Holocene alluvial deposits could be very recent, so the absence of offset on this unit is not useful for constraining the recurrence interval. The Late Pleistocene (yellow) lake deposits are not offset, so if we take the youngest age of these deposits as 24,000 years, this suggests that the fault has not had a surface rupture in the last 24,000 years. However, we believe that the lake shorelines offer a more precise method of landform dating than the more generalised geological map, so we prioritise the 8000-year-old shoreline age when constraining the recurrence interval of Fault A and Fault B. Note that, in Figure 2.2, Fault B appears to have surface expression across the land surface between the ~349 m elevation and ~293 m elevation, but the geological map shows that this land is 61,000-year-old Rotoiti Formation ignimbrite (Figure 2.3) not the Late Pleistocene lake deposits.

Figure 2.3 Geological units of the northern Lake Rotorua area, overlain on a digital elevation model. Geological units and labels are from Leonard et al. (2010). The fault projection between Fault A and Fault B shows no offset of Quaternary 3 Late Pleistocene lake deposits or of the Quaternary 1 Holocene river deposits.
