CONTAMINATED LAND DESK STUDY REVIEW – ROGERSONS BLOCK

179 - 183 Tuhikaramea Road, Dinsdale, Hamilton

Prepared for G A Rogerson

9 June 2025

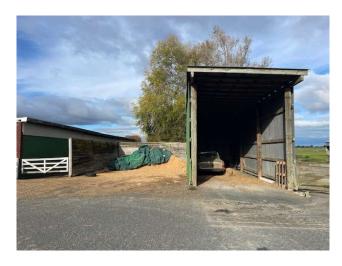
Photo 6: Hay barn adjacent to stables

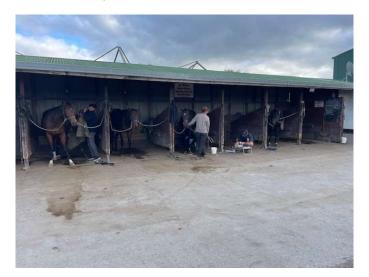
Photo 9: Horse yards

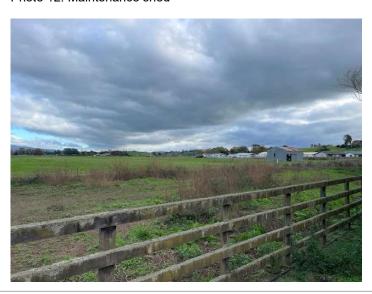
Photo 13: Surrounding farmland and out building
