Geotechnical Assessment

Queenstown Cable Car

October 2025
GeoSolve Ref: 250134

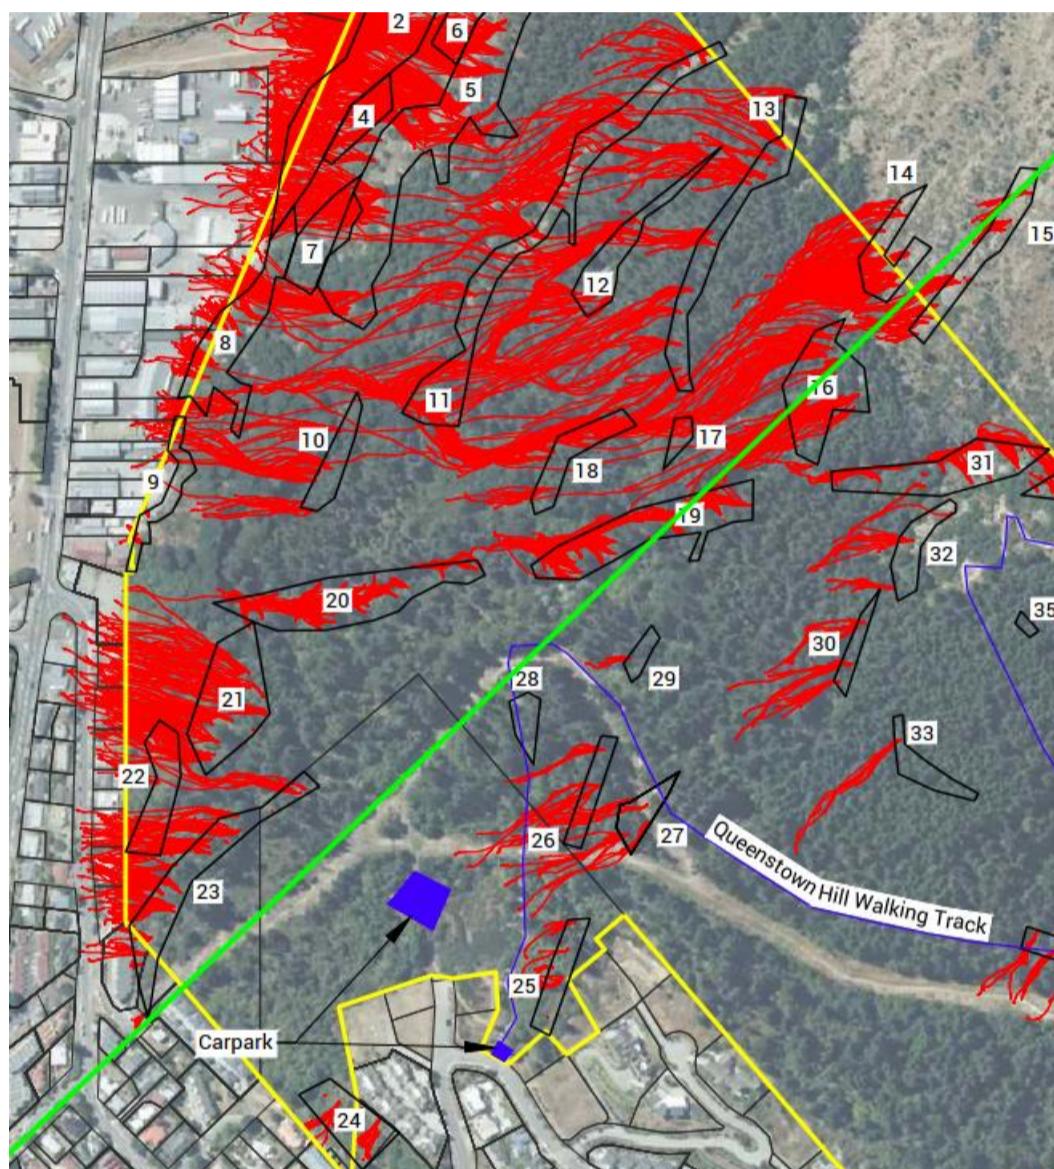
Figure 4.1. Mapped bluffs on Queenstown Hill and the proposed Cable car Route (green line).

The principle bluffs (15, 16 and 19) were reviewed for the purposes of this assessment. Block formation was identified for each bluff and failure was considered possible. Scaling

(removal of potentially unstable blocks) was considered a practical remediation solution if required.

Gaps between the bluffs and the modelled rockfall run-out trajectories are readily apparent on the ground and on Figure 4.1 below. Locating towers in locations with a very low likelihood of rock fall impact on the structure is therefore expected to be achievable and will be a suitable method to address the risk of rock fall. See also Section 4.14 below.

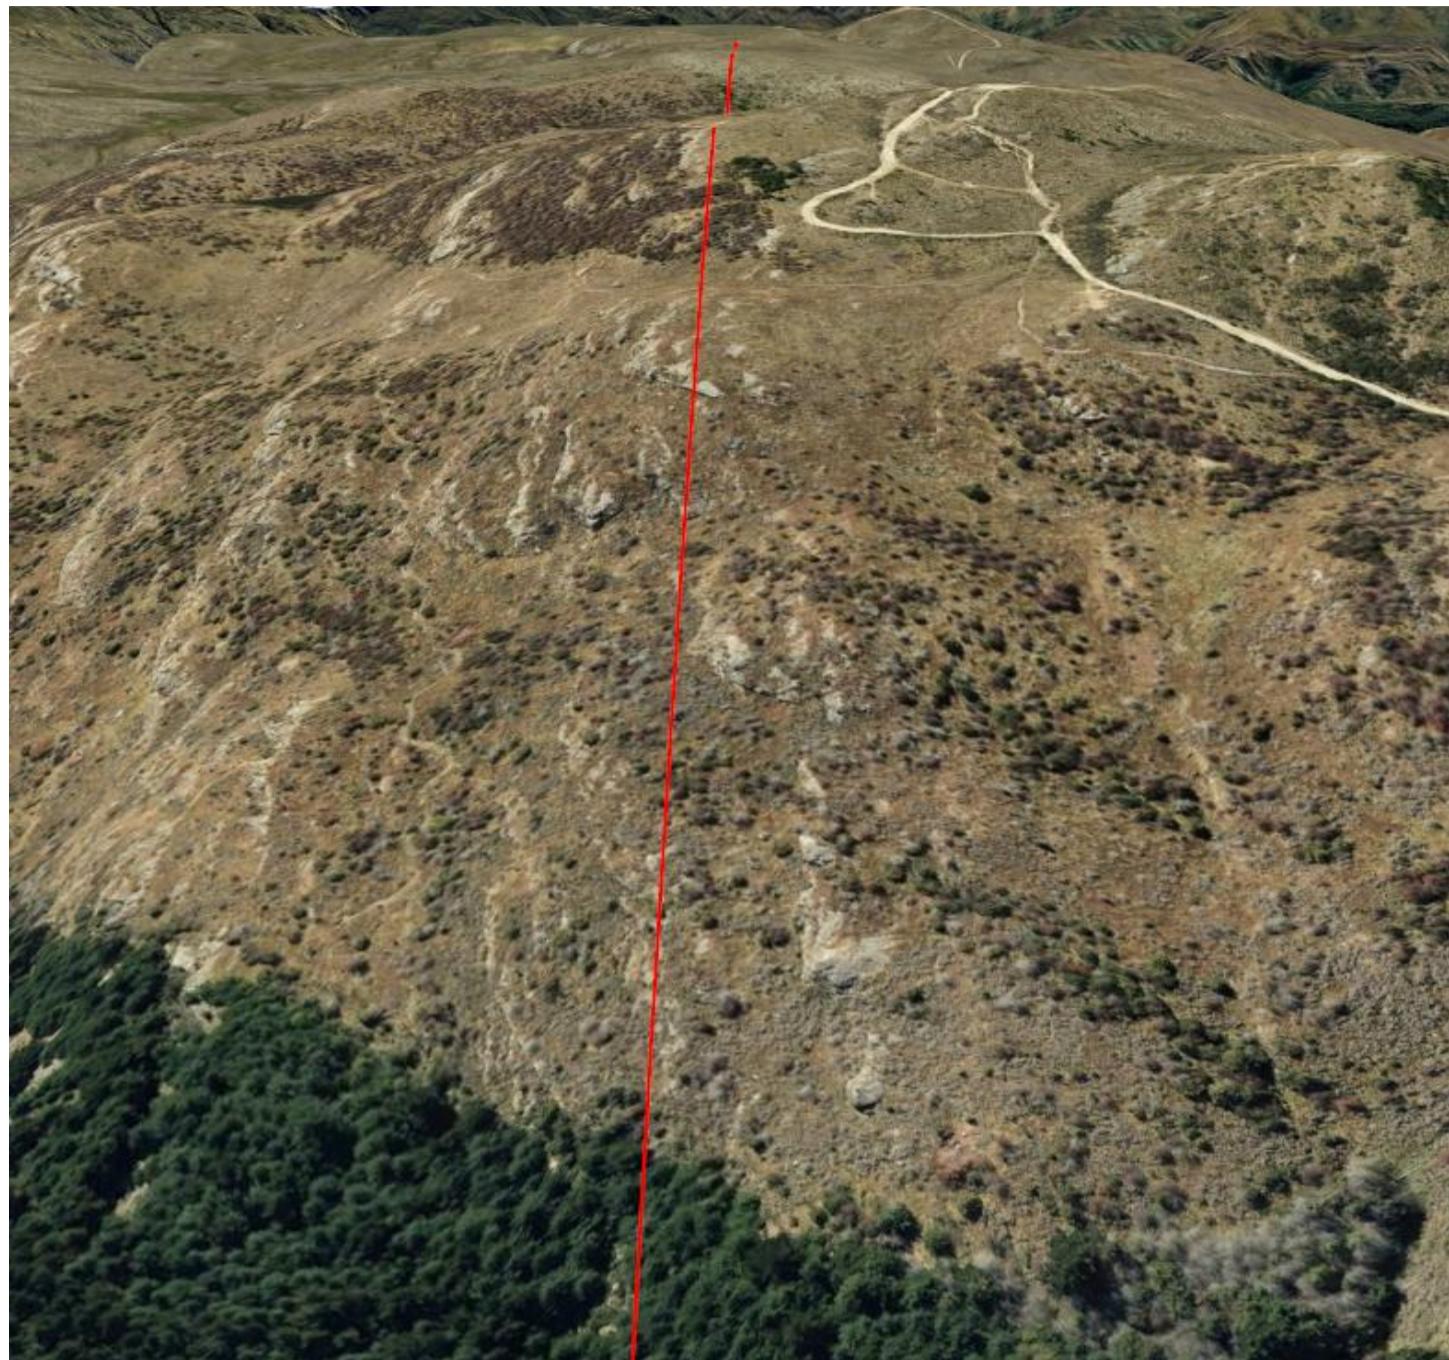
Figure 4.2 Proposed Cable Car Route and bluffs in the middle and upper area of Queenstown Hill (Google Earth).

The lower slopes of Queenstown Hill pass through a forested area. To control the risk of tree fall and fire effecting the cable car cable, removal of trees along the cable car corridor may be required. Rock fall run-out distances can increase where tree removal has occurred, and, where tree removal is undertaken directly on bluffs, rock destabilisation can result. Geosolve have reviewed the bluffs present along the cable car corridor and, once tree removal extents are known, review of bluff impact can be completed. Generally, the risk from bluffs along the Cable car route is expected to be manageable with standard construction methods and assessment procedures.

As with recent similar projects, assessment and implementation of measures to control the risks associated with tree removal will be required. Such measures may include bluff treatment and engineering review of temporary works, e.g. access tracks and slope drainage. See also Section 5.2.6 below.

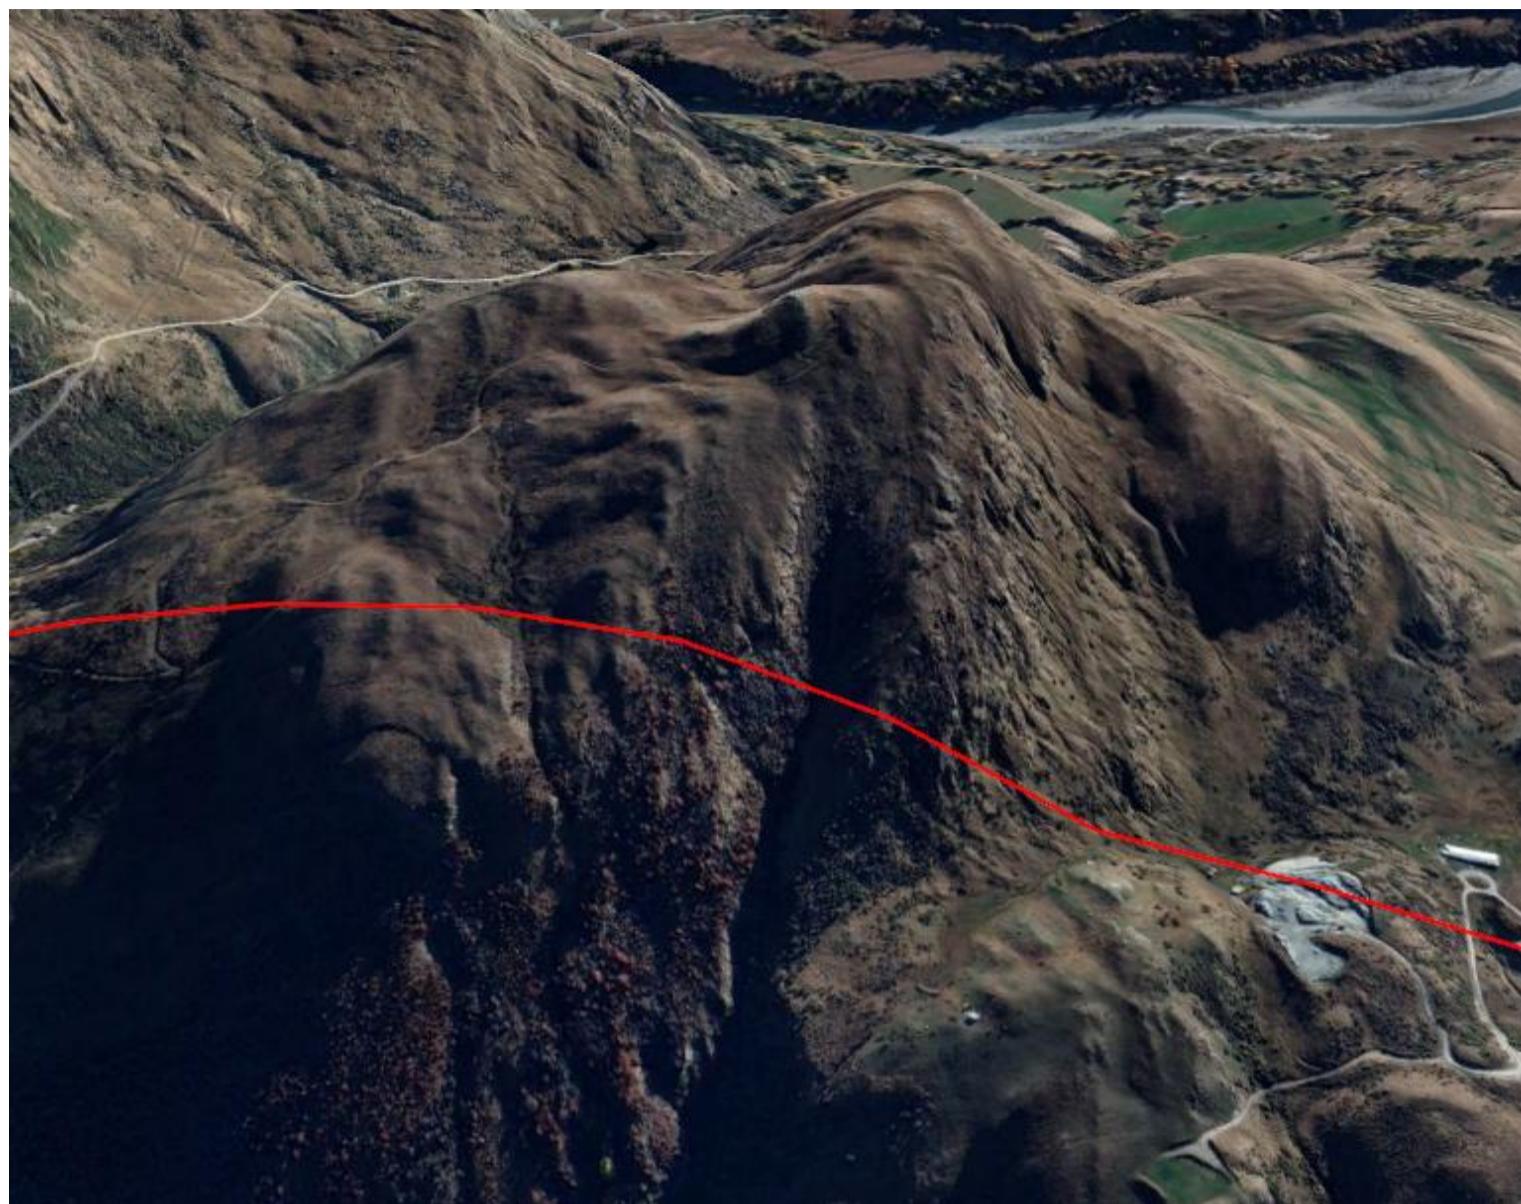
Figure 4.3. Proposed Cable car Route on the southern flank of Hill 781.

The route crosses a series of shallow gullies and bluffs, see Figure 4.3 below. Rock fall, and shallow surface erosion and instability, should be expected in this area. Tower locations that target the elevated ridge like features are recommended to address the risk from localised shallow instability.

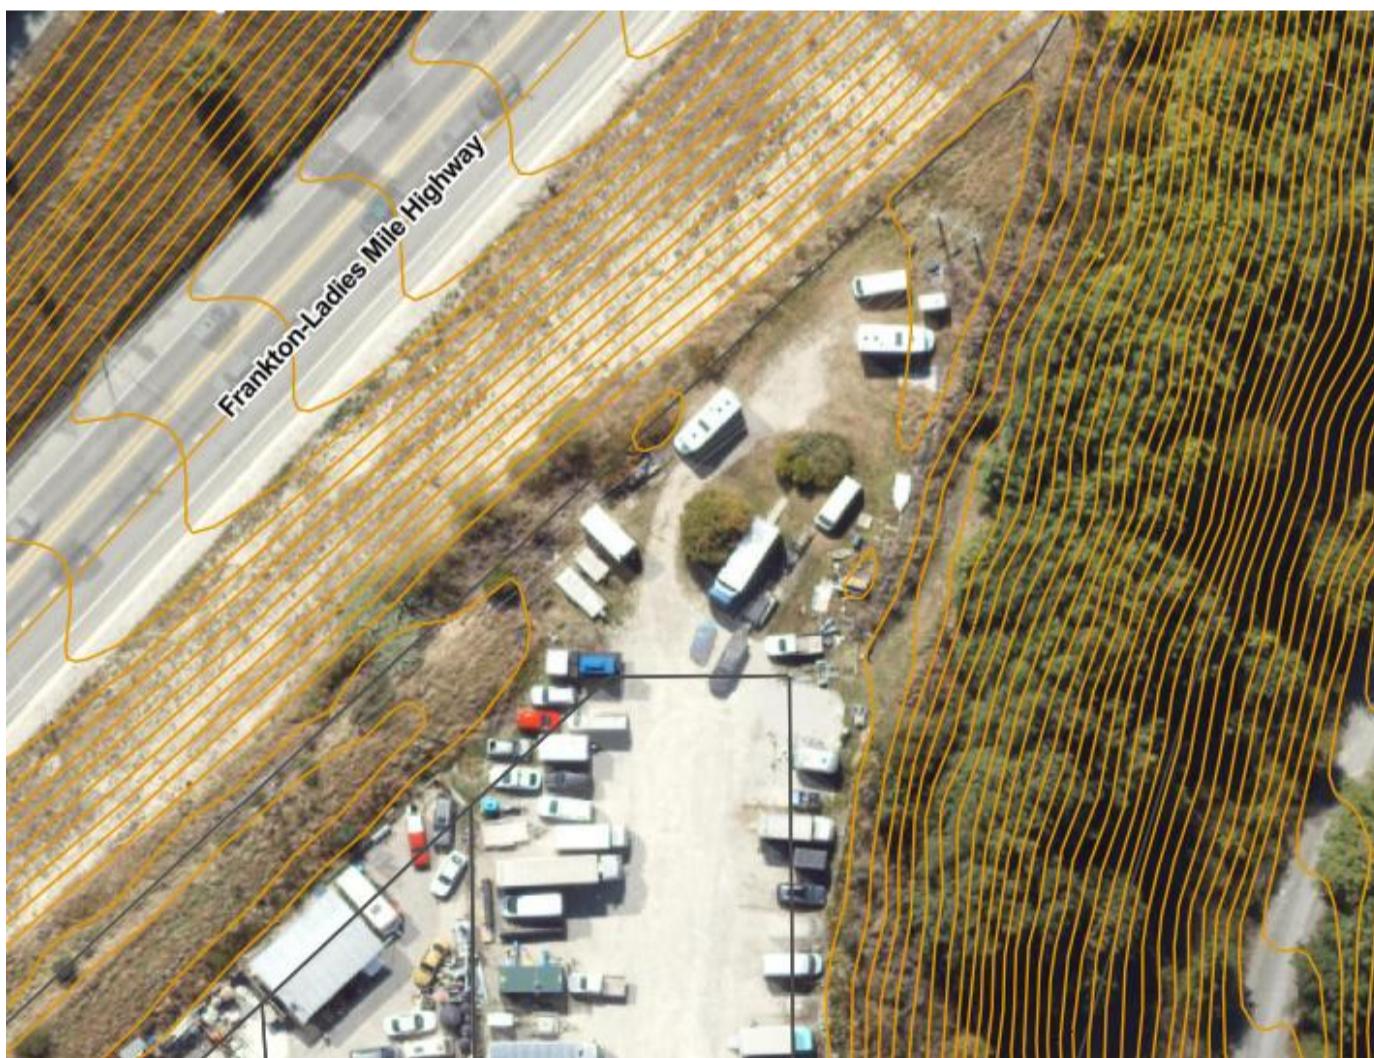
Figure 5.1. Frankton North Station location showing the surrounding slopes.

Frankton North Station is located on a 'ridge' like feature with a slope to the north west, the SH6 Road cut, and to the south west, the Shotover River terrace. The width of the ridge varies, as can be seen on Figure 5.1 below.

As can be seen in Table 5.1 the proximity of the structure to the existing slope crests and specific foundation design will need consideration. If the structure is close to either slope crest shallow footings are not expected to be appropriate. Specific Engineering design such as enhanced foundation systems, piles, and/or ground improvement, may be required to achieve the required long term performance for the structures design life.

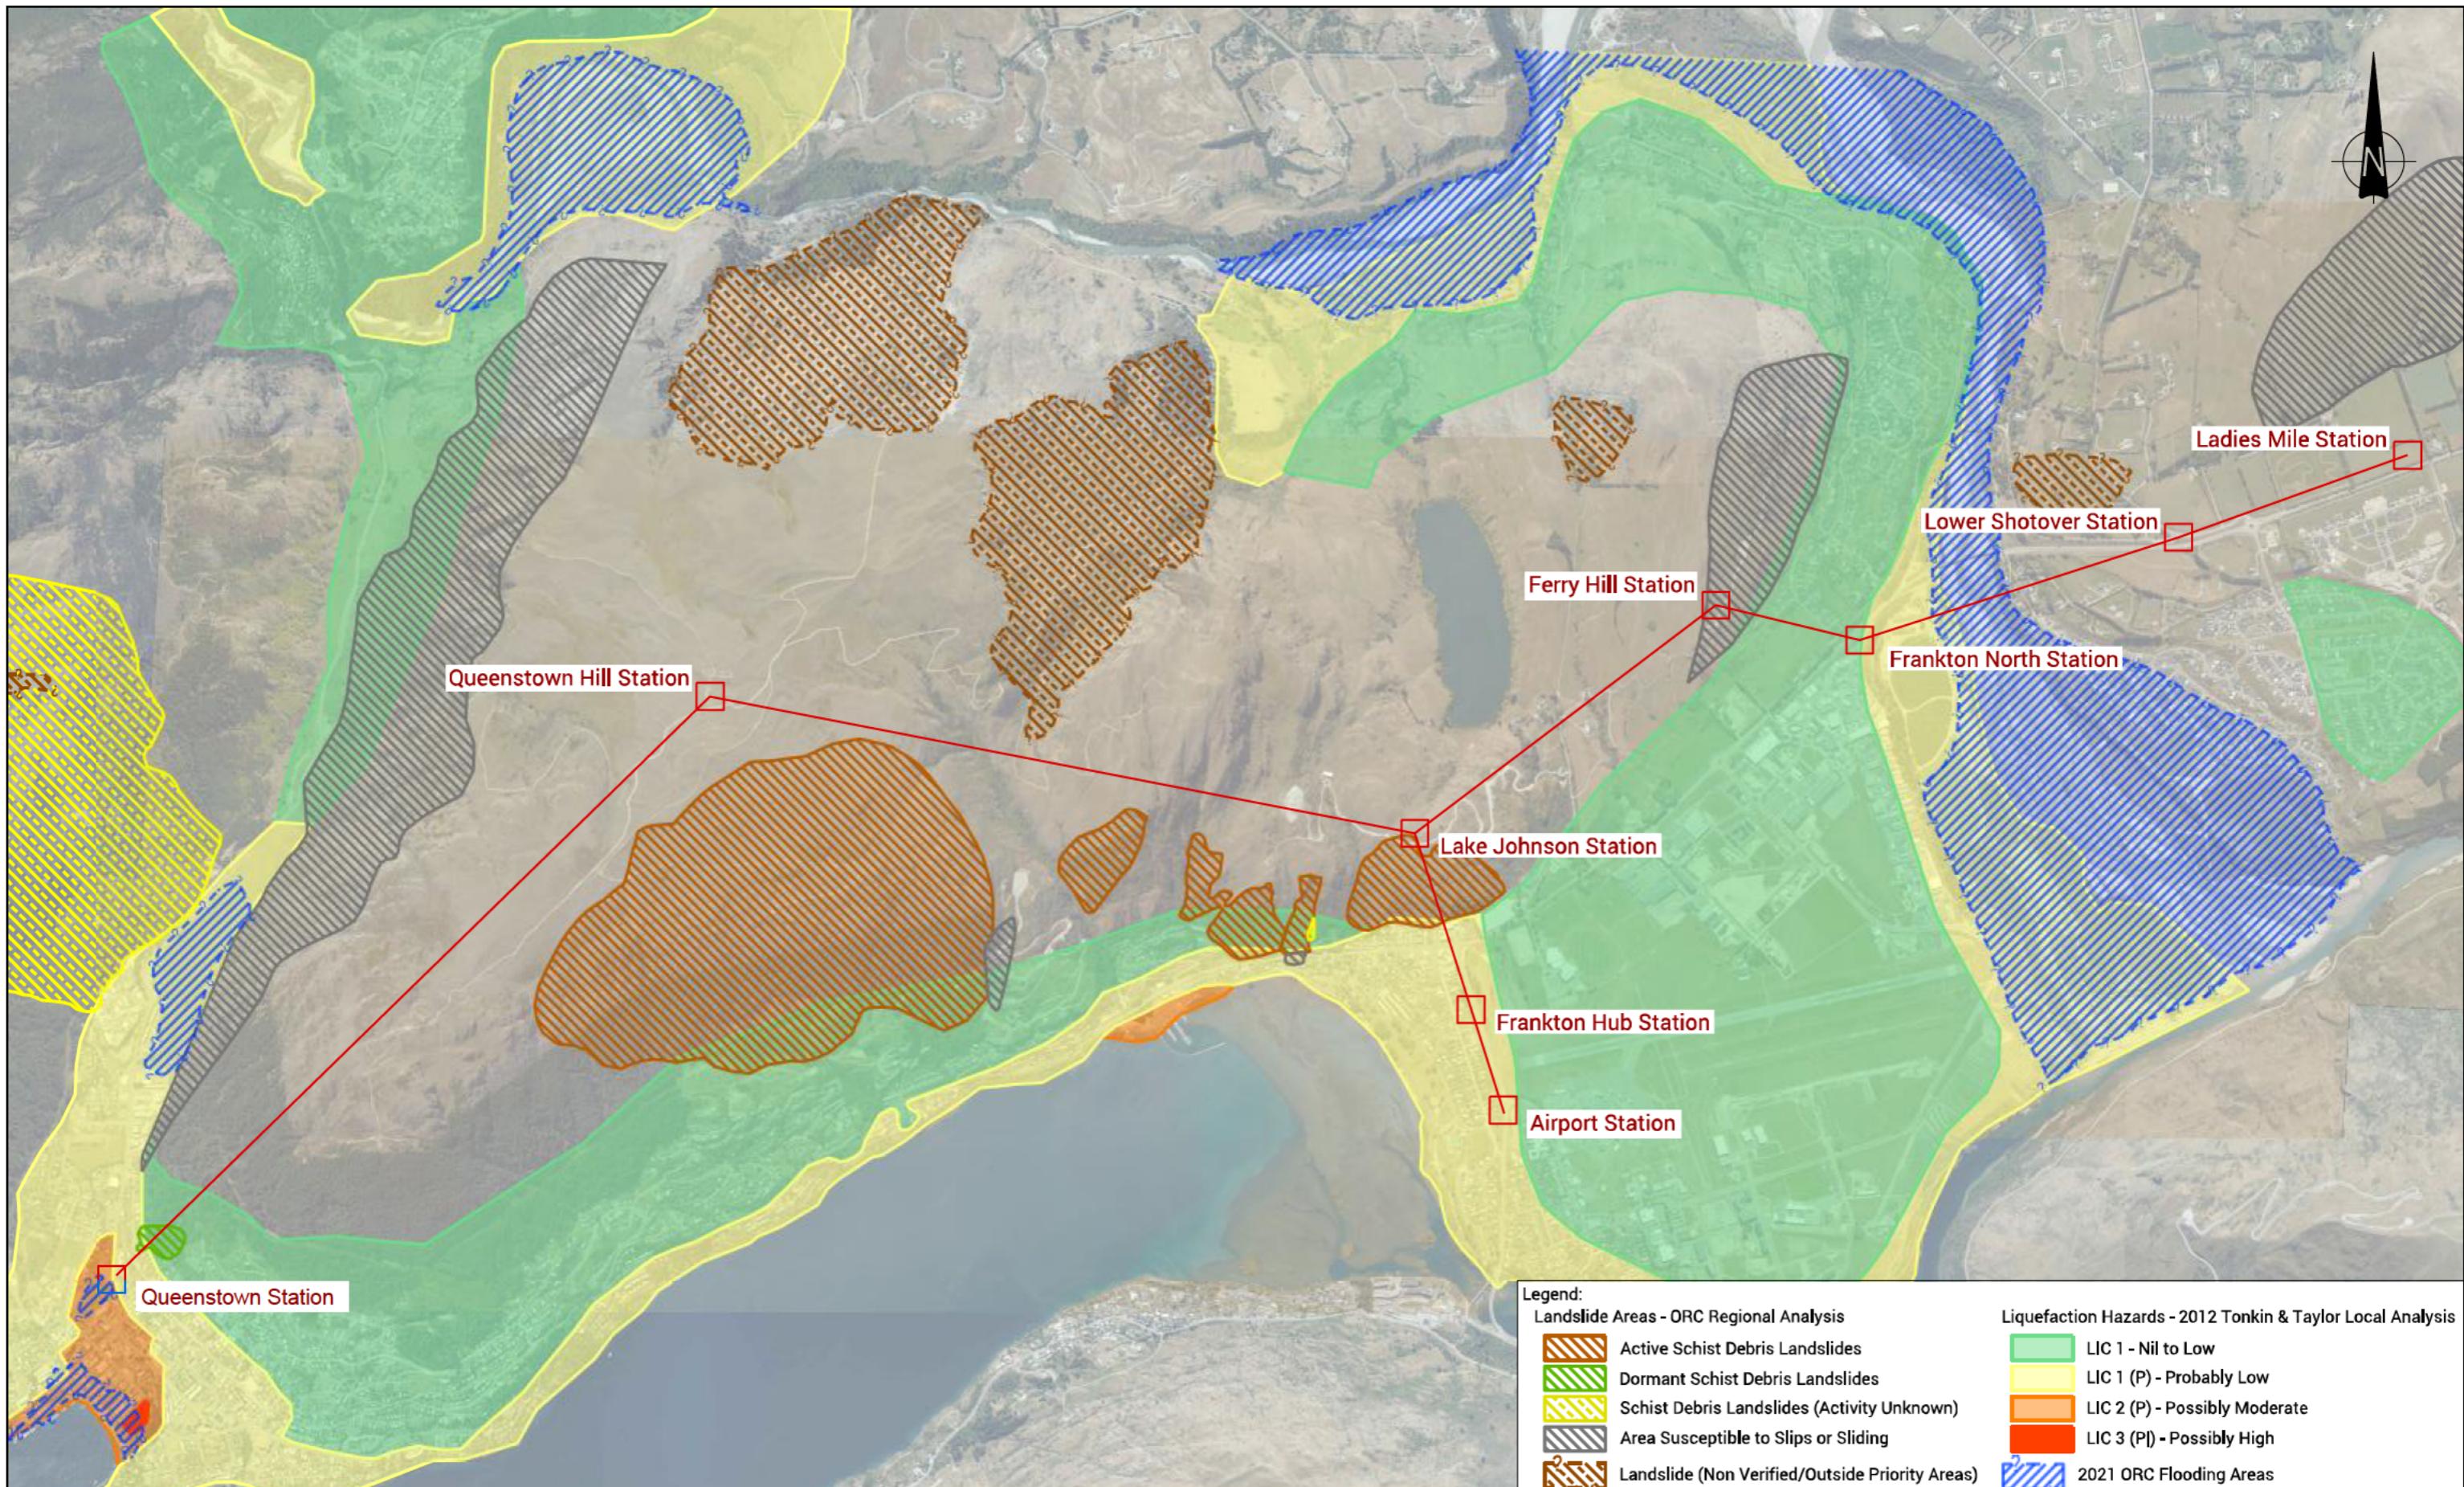
Southern Infrastructure Limited
Queenstown Cable Car
Geotechnical Review
Natural Hazards Plan - Route A
Figure No.
Appendix A, Figure 1c

A regional seismic risk, which is not specific to the Cable car, is present, as discussed in Section 3.2 above. Localised natural hazards along the Cable car route are summarised below, and are shown on Figure 1c and 1f, Appendix A.

No mapped natural hazards are shown in the location of Lake Johnson Station. Hazard mapping shows the upper extent of a schist debris landslide is present approximately 60 m to the south, see Figure 1c, Appendix A.
