Water Ways Consulting

Homestead Bay Aquatic Ecology Assessment

Date: November 2023

Report Number:127-23

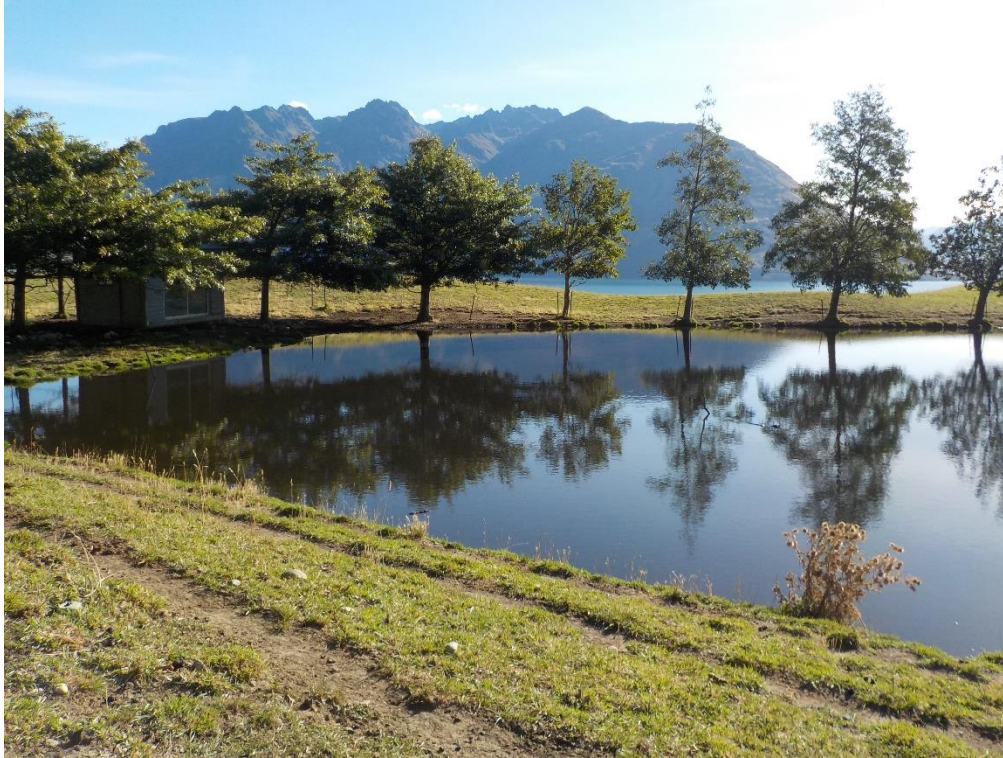
The unfenced pond (site HOME1, Figure 1) is situated on a hilltop (altitude 380 m) and has no inflowing tributaries. There is a small hut and oak trees¹ beside the pond (Figure 2), and duck decoys in the pond indicating the pond is used for recreation duck shooting. The pond margin is grazed pasture grass or bare ground.

Figure 2: The pond with small hut and oak trees.

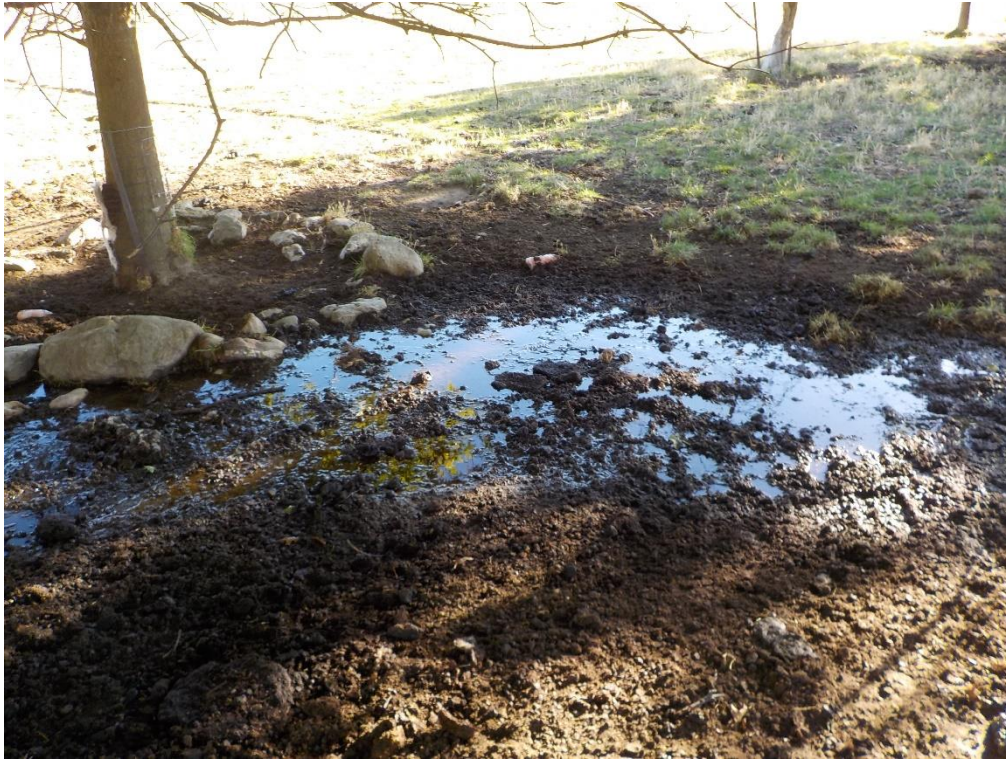
An outflow was present with water flowing out of the pond at a low point along its banks. The outflow does not have permanent flow as the outflow water course was across pasture grass and bare ground (Figure 3). There was also a substantial accumulation of sheep pellets on the bare ground indicating that sheep had been resting in this area when it was dry. The outflow was likely to have commenced flowing after rainfall in the previous two days. A pipe was observed in the pond that was discharging water into the pond and this artificial input was the only water supply for the pond.

Figure 3: The pond outflow on bare ground that is a sheep resting area.

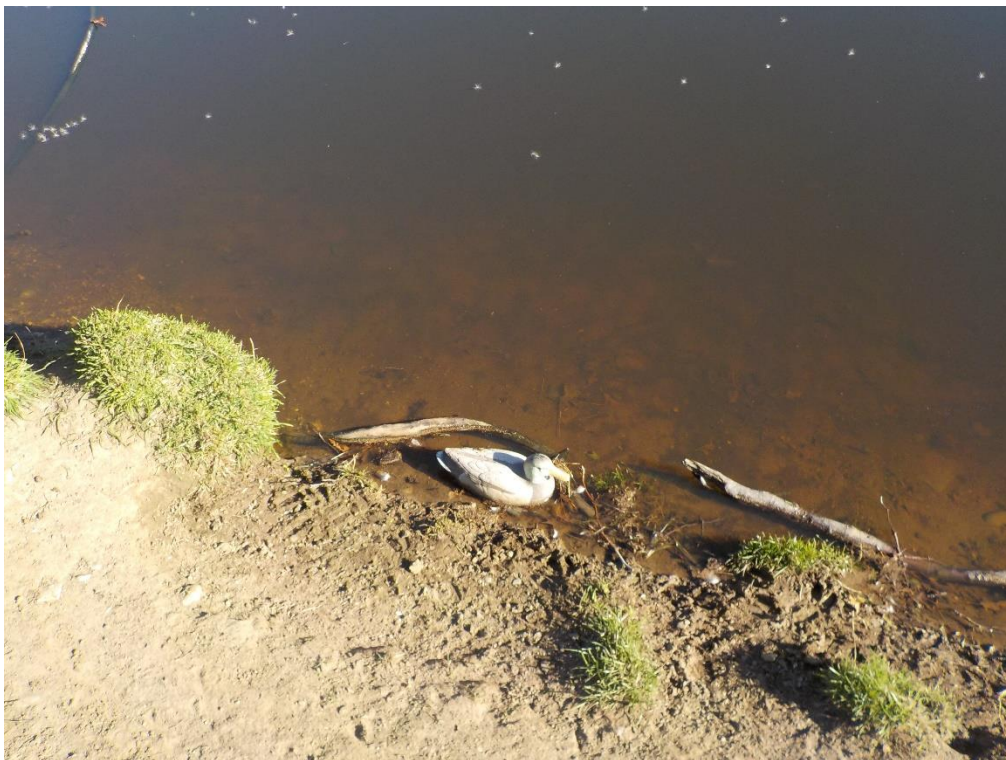
With no tributaries and no outflow connection to other water bodies the pond cannot be colonised by fish. Diving beetles, backswimmers and water boatmen were the only macroinvertebrates seen in the pond. For the most part the pond bottom is mud with the occasional stick and rock on the bottom (Figure 4).

Figure 4: Pond edge and muddy bottom.

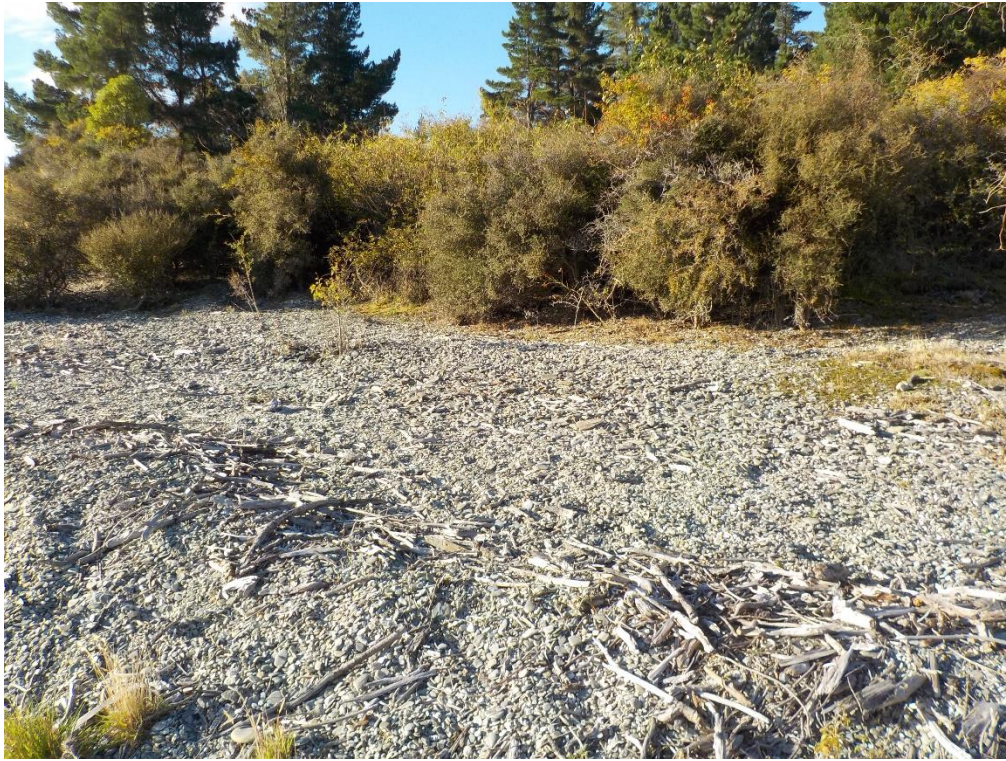
across the lake shore and above the gravel lake shore the stream channel is well vegetated with terrestrial shrubbery (Figure 5).

Figure 5: The lakeshore where Water Course 1 discharges into Lake Wakatipu.

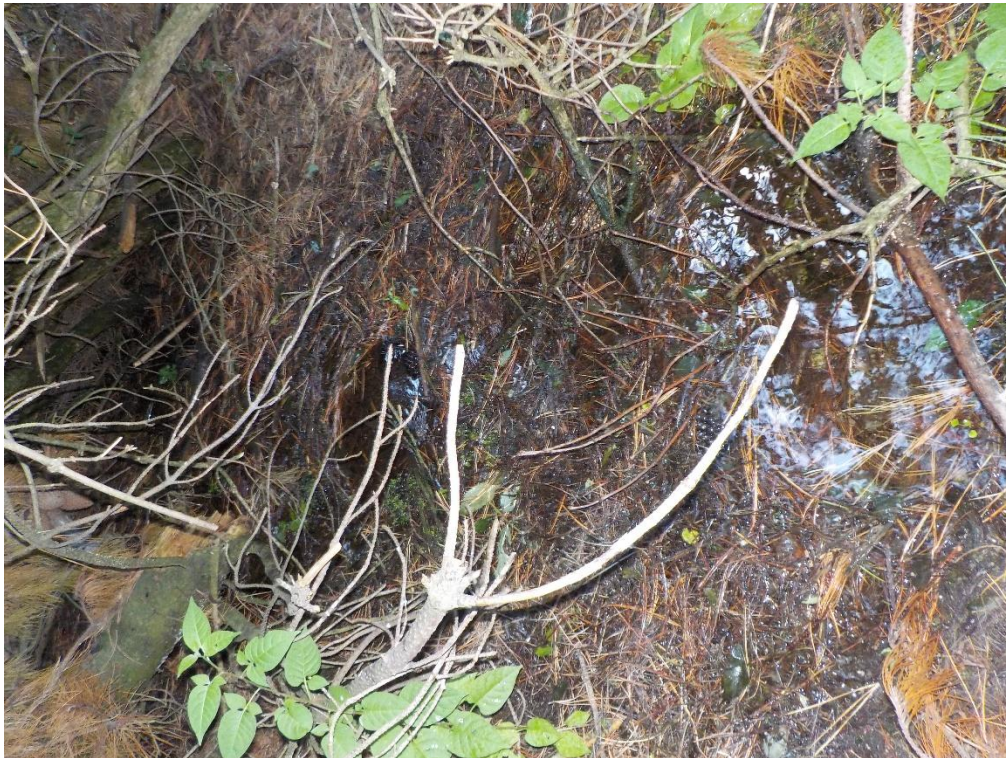
Fifty metres upstream from the lake shore the stream emerges from a steep sided valley and pine plantation. At Site Home 2 windfall pines, valley floor vegetation and leaf litter have created a dam and upstream of this a small wet area with well-established weedy terrestrial species (Figure 6).

Figure 6: windfall pine and leaf litter creating a dam and ponded water.

This is an ephemeral water course with little wetted habitat in the stream course. The short wetted section is insufficient to support fish and there is no fish passage between this wet section and Lake Wakatipu to allow fish to migrate upstream. It is likely that the stream only flows during and after heavy rainfall and the majority of the water course dries very quickly. The presence of terrestrial grasses in the mid and upper reaches of the water course shows that when wet there is not enough water-power to scour a channel nor is the duration of any wet period sufficient to eliminate the terrestrial plants. The small section of wetted channel appears to have been created by a channel blockage where windfall pines have fallen in the stream channel. This habitat is unlikely to be permanent as the blockage will fail as the trees decay and flow events flush the accumulated leaf litter downstream.

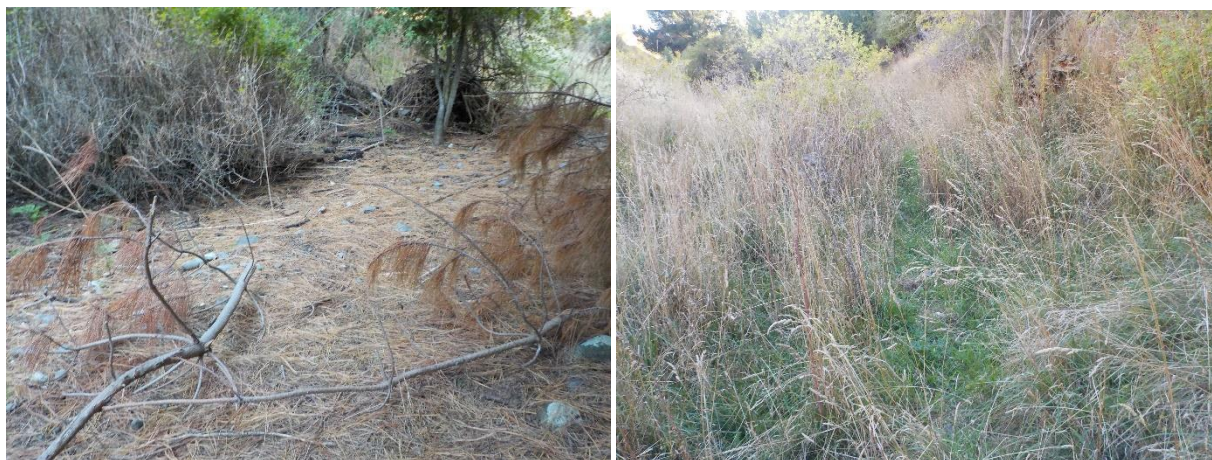
This wetted area of the valley floor extends for less than 75 m between sites HOME2 and HOME3 and the water is very shallow. At Site HOME3 and upstream to site HOME4 and further the water course is dry and vegetated with terrestrial plants, often grazed grasses (Figure 7).

Figure 7: Water Course 1 at (left) top of pine plantation and (right) near site HOME4 with a terrestrial vegetation valley floor.

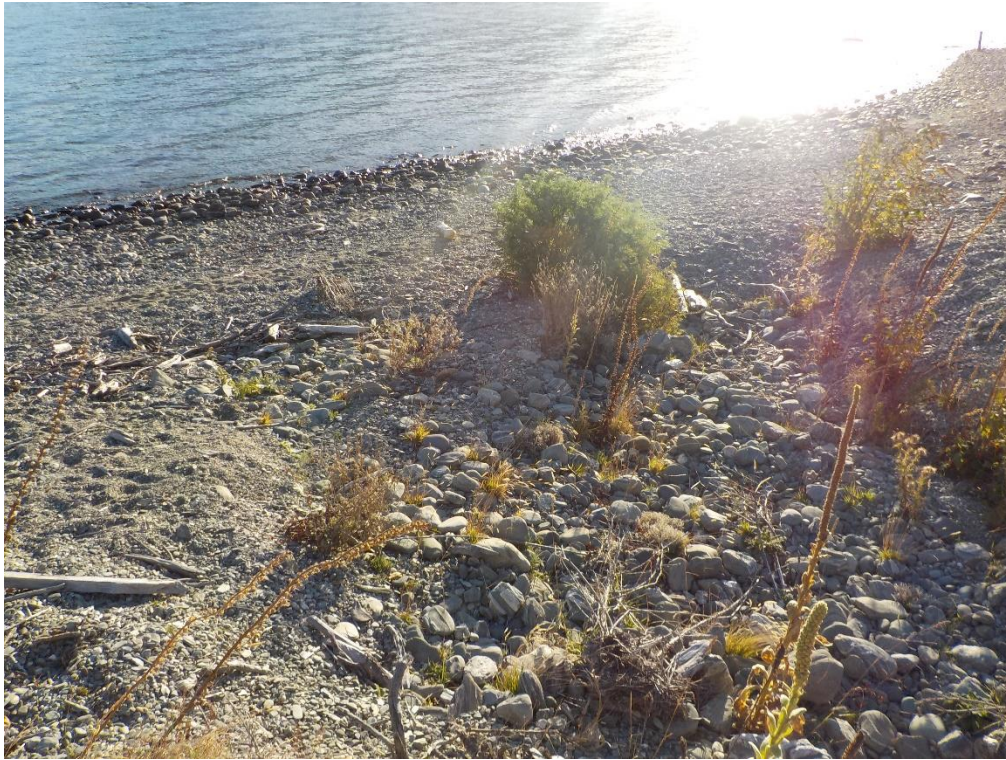
Water Course 2 rises on the flank of the Remarkables Range, flows under State Highway 6 and down slope to Lake Wakatipu. The outflow to Lake Wakatipu across the lake front has a dry stream channel upstream of the lake shore where wave action creates the lake shore gravel/cobble beach zone (Figure 8). The stream flows out of a canyon like valley with a wide valley floor and steep, often vertical sides (Figure 9).

Figure 8: The Lake shore and dry channel of Stream Course 2.

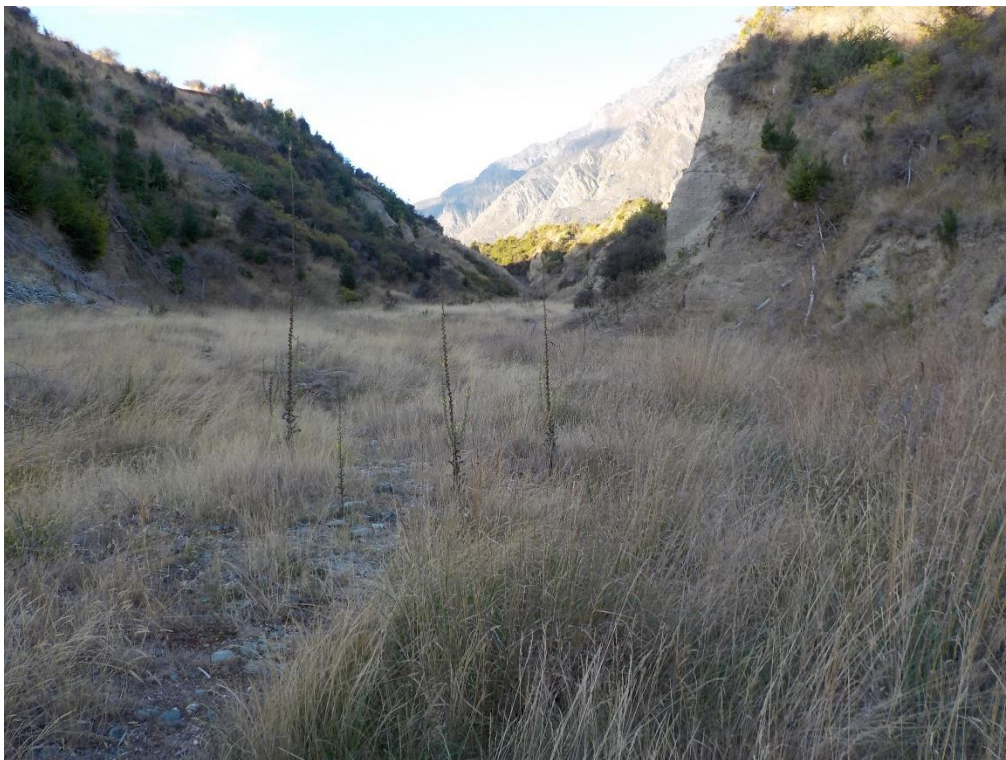
Figure 9: Looking upstream in Stream Course 2.

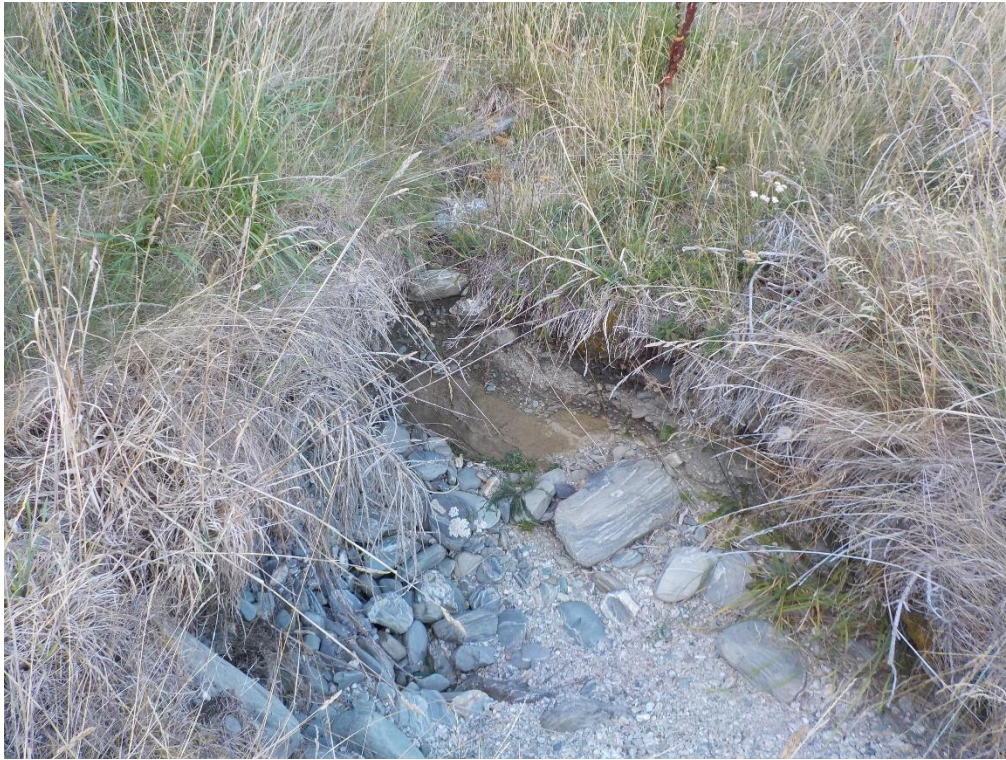
Upstream of the shoreline the stream has a well-established, 1 m wide incised channel with a dry gravel/cobble/boulder bed. This channel extends upstream for nearly 400 m before terrestrial grasses began to establish in the channel. Within this reach there are small boulder waterfall structures with downstream scour pools. While the channel is deep none of the scour pool retained water (Figure 10). The scour pools do indicate that when the stream flows it has the power to move cobble and gravel material downstream. Between 400 m and 500 m upstream from the lake there are a number of tributary inflows, and the channel become progressively smaller and terrestrial grasses and shrubs begin to grow in the channel. The tributaries include scour channel flowing over the canyon walls (Figure 11). Beyond site HOME8 the channel has intermittently exposed rock but is predominately overgrown with terrestrial vegetation.

Figure 10: Scour pool in Stream Course 2.

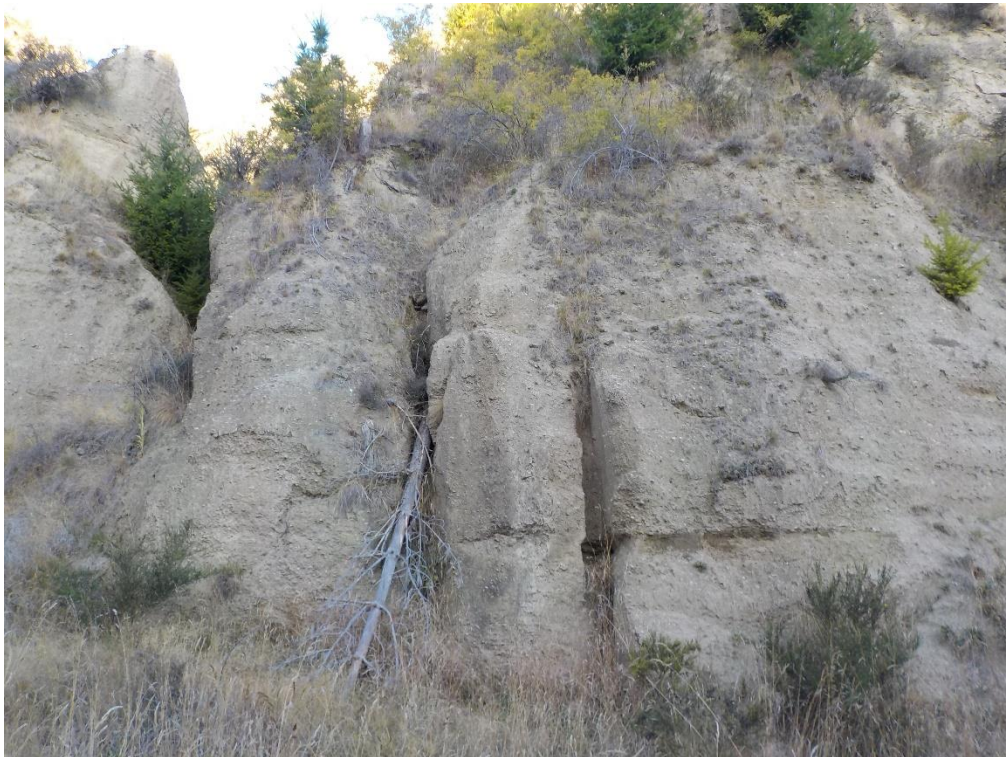
Figure 11: Erosion channel in canyon walls.
