# Southern Link Inland Port

## Geotechnical Desktop Study and Appraisal

Prepared for:  
Southern Link Property Limited

Date:  
20 February 2026

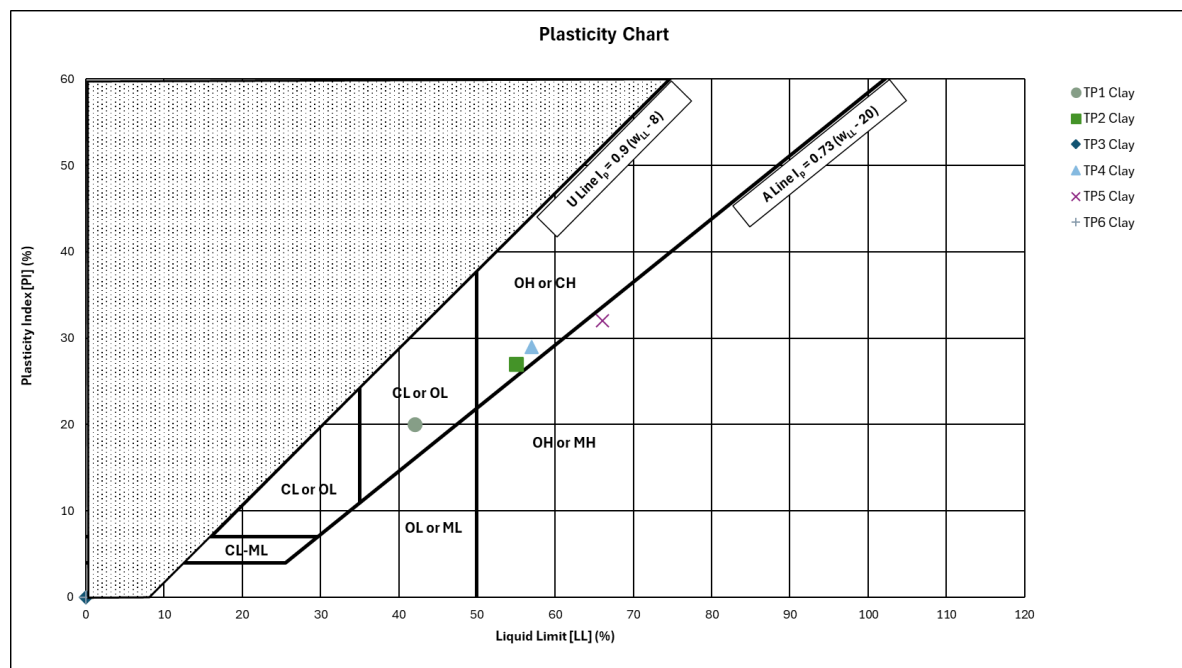
Figure 8. Plasticity chart for Site test pit samples

Based on these test results, the fine-grained soils appear to consist of low- and high-plasticity clays (CL and CH, respectively) and high-plasticity silt (MH), with likely non-plastic silts encountered in TP3, TP6 and TP7, though no additional test data (such as particle-size analysis) is available to confirm the differentiation between fine-grained and coarse-grained materials (e.g., silt versus silty sand) for these three samples.

Higher values of LL and PI (such as those for the CH and MH soils) generally correspond to greater plasticity, compressibility, and moisture sensitivity. CL soils typically exhibit moderate cohesion and plasticity, remaining relatively firm when dry and showing limited volume change with water content variation, whereas CH soils are highly cohesive and exhibit pronounced plasticity, potentially becoming very soft when wet and undergoing shrink-swell cycles, which can lead to substantial changes in consistency and strength. MH soils display lower cohesion than clays but are highly sensitive to moisture, often losing structure and strength rapidly when saturated, and are prone to erosion. In contrast, non-plastic silts lack measurable plasticity and exhibit little cohesion, behaving more like granular soils. These soils can become unstable when saturated and may be highly susceptible to erosion.

Such risks can be managed by undertaking detailed site ground investigations, followed by geotechnical testing and interpretation of soil properties and parameters at the detailed design stage. These interpretations, as well as design calculations, will enable a refined assessment of the expected risks and possible mitigation strategies. Since these potentially challenging fine-grained soils are expected to be present at relatively shallow depths (generally less than 1.6 m bgl), excavation and replacement with suitable fill material may be a feasible option for critical Site facilities where the risk of unstable soils is not within the tolerable limits of a structure. Such limits will be confirmed during detailed design, and design calculations will be undertaken to quantify the expected risk.

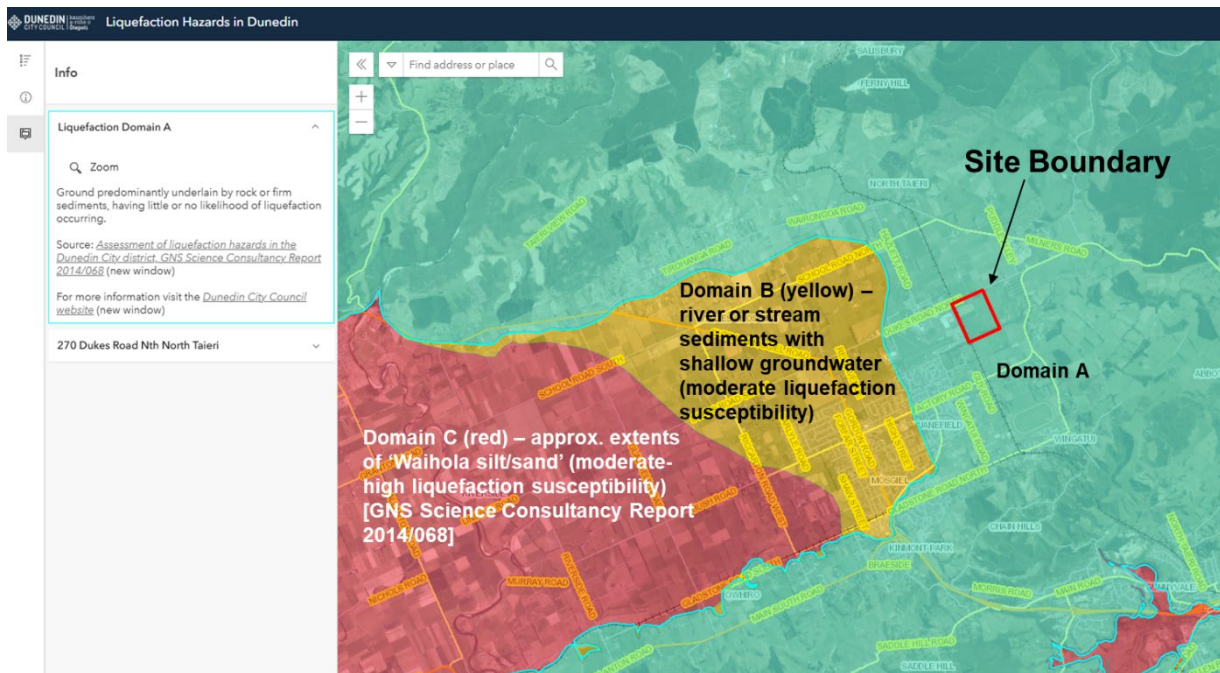
Figure 11. Dunedin City Council liquefaction hazard mapping for the Site area

According to (Barrell, Cox, Glassey, & Lyttle, 2014), the Site is in an area mapped as Liquefaction Domain A, comprising little or no likelihood of liquefaction. Figure 11 shows the associated Dunedin City Council hazard mapping for the site area based on the 2014 GNS study.

The GNS study developed the Domains accounting mainly for geological factors (e.g., limited to coarse silt and fine sand material types) and not necessarily other geotechnical characteristics and behaviours. New studies since that study’s publication in 2014 have shown that other soil types (such as gravels) may also be susceptible to liquefaction when assessed using shear-wave velocity profiles. Therefore, liquefaction cannot be ruled out for the Site based on this map alone.

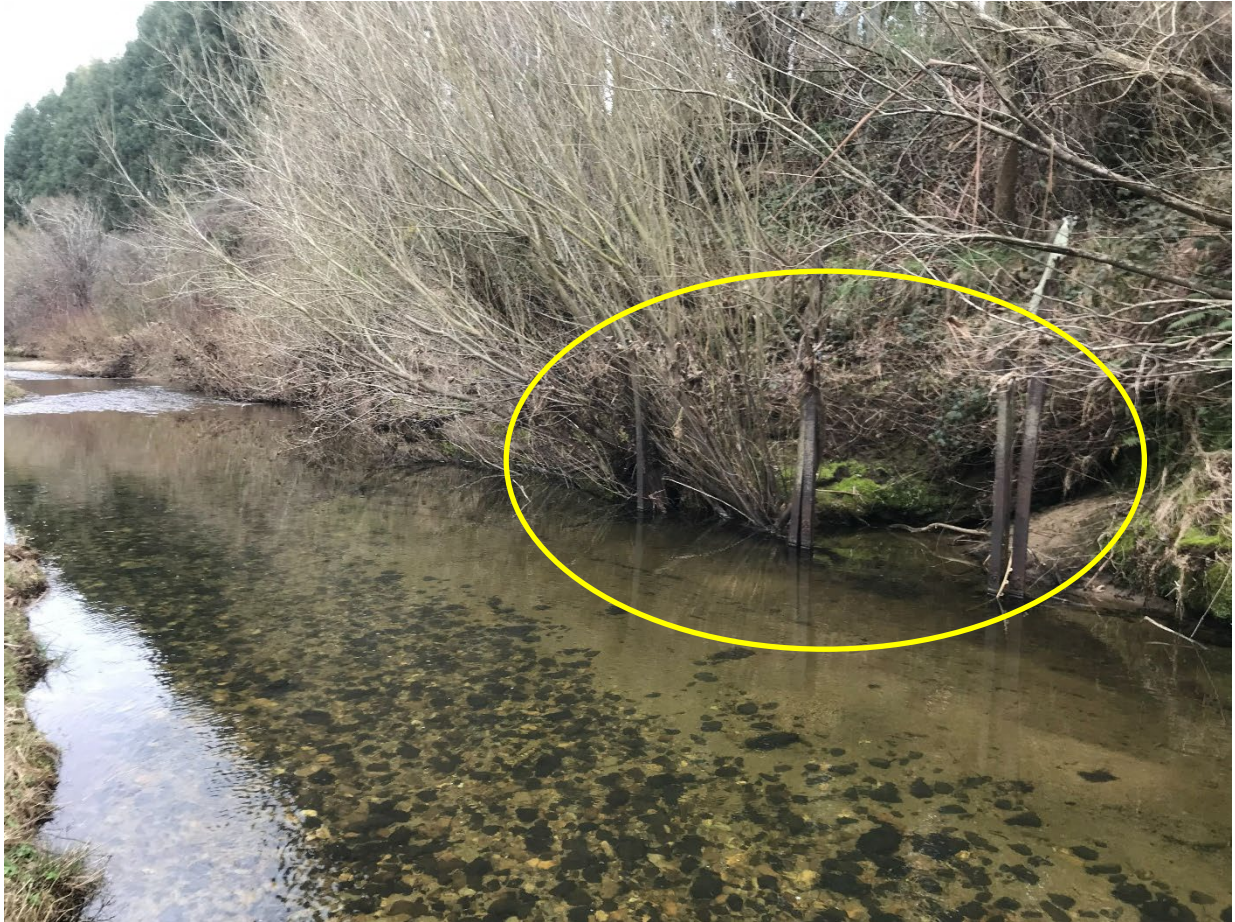
A site visit was undertaken by **e3 Scientific** (e3) as part of a Site freshwater ecological assessment focusing on Silver Stream. During their site visit, e3 observed railway iron installed at the base of the stream banks that appears to have been placed as a form of slope protection, though the original intent is unknown. Figure 14 presents a photograph from the e3 site visit showing the iron inserted vertically into the ground at the base of the slope.

*Figure 14. Railway iron (highlighted by a yellow circle) placed along the Silver Stream bank (photograph provided by e3 Scientific)*

According to e3, the iron rails appeared to have been placed along most of the stream length along the Site boundary, presumably at a similar spacing as shown in the photo above. The timing of installation is unknown since they are not visible in historical aerial imagery. Nonetheless, their presence suggests that bank erosion has been a concern in the past. Whether the measures have been effective at stabilising the bank remains unknown at this stage, though they will be further assessed during and after the upcoming site walkover and geotechnical investigations, as described below.

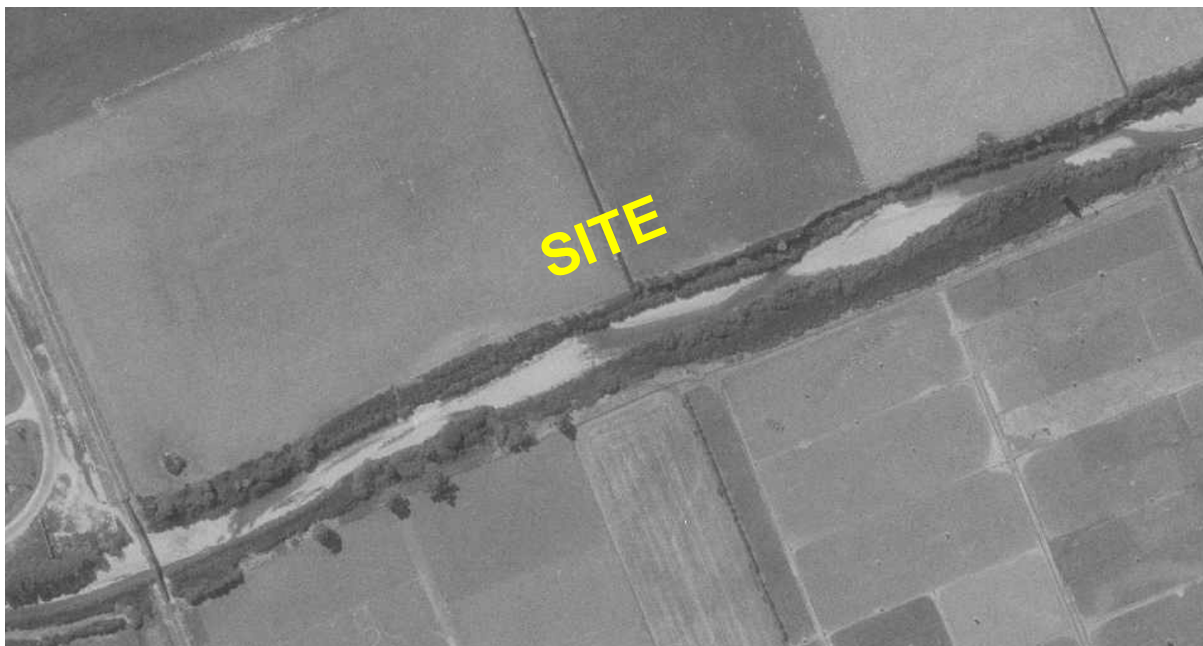
Historical aerial imagery and topographic data reveal areas of potential slope instability along the northern bank of Silver Stream, which forms the southeastern boundary of the Site. Evidence of subsidence or instability is first visible in historical aerial imagery from the late 1960s to the 1980s, with no clear indication of recent failures, though ongoing erosion or shallow instability cannot be ruled out. A site visit by other parties indicated that railway iron had been installed at the base of the stream bank along much of the Site boundary potentially as a form of slope protection. However, the timing, intent, and effectiveness of this installation are unknown. The steep and incised stream margins suggest that instability could extend beyond the bank crest into parts of the site.

*Figure A9. 1985 aerial imagery of Silver Stream (Retrolens), showing first noted occurrence of potential slope instability area (circled in red) near southeastern corner of Site*

parameters. Mitigation measures may involve slope stabilisation works, setback requirements from stream banks, excavation of weak soils, ground improvement, or other engineering controls. However, the appropriate approach will depend on the geotechnical parameters and subsurface conditions confirmed during the design-phase investigations.
