Background and context - Andrew Balme

Original role and function of the Temporary Structure

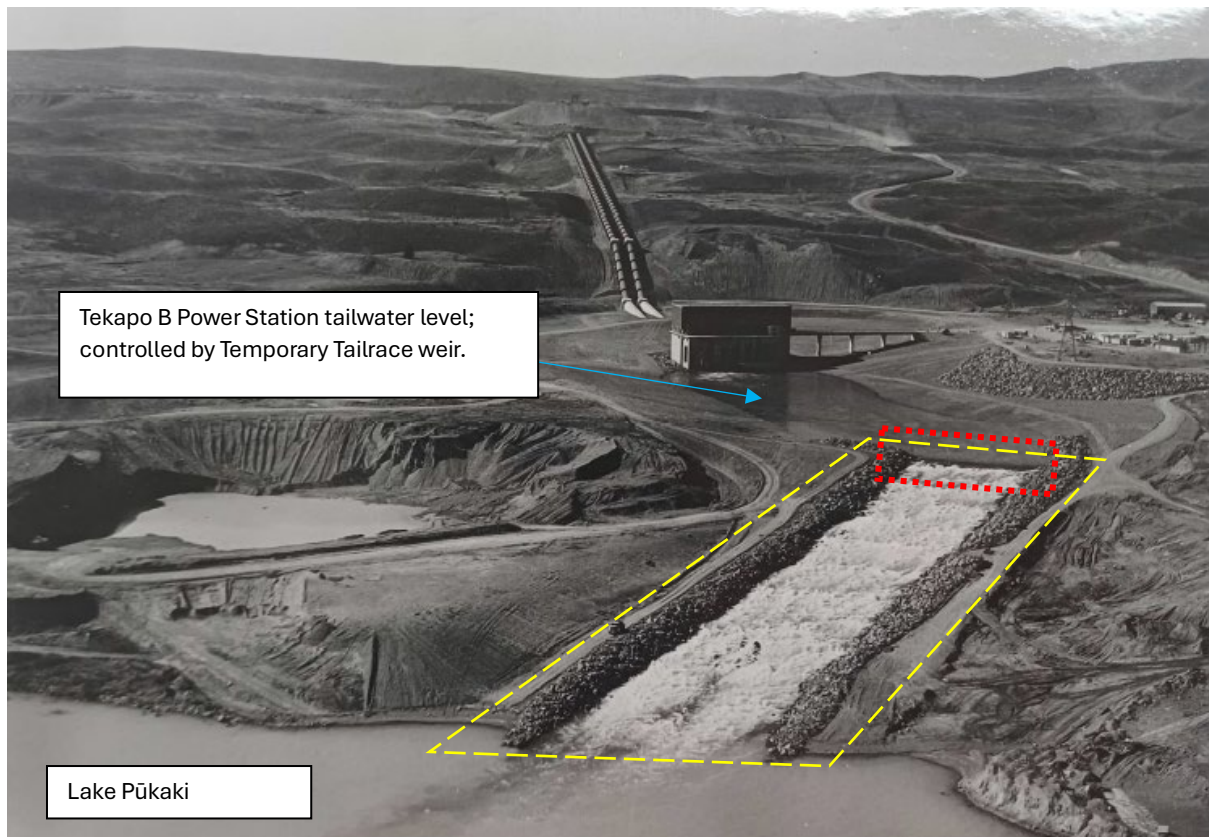
4. The Temporary Structure consisted of a concrete tailrace weir to provide the necessary minimum tailwater level at the station, and a rock lined tailrace chute to carry the station discharge down to the rising Lake Pūkaki; these elements are shown in Figure 1 below.

Figure 1 – Photo taken 1977 showing the Temporary Structure in operation. Weir is shown by red dotted outline and chute is shown by yellow dashed outline. Note - chute extends further below the water level in the photograph.

13. The bathymetric survey and dive inspections confirm there has been movement of the riprap rock armouring along the chute, and in certain areas directly adjacent to the weir and concrete ribs where the rock armouring has separated from the concrete elements. Due to accumulation of silt since the Temporary Structure was last operated (1978) there is potential for masking of other underlying defects which would be exposed when flows operated and the accumulated silt flushed away. Areas of uneven armouring present potential for cascading flow through the chute that could increase shear forces on top of high-flow velocities and increase the risk of local scour and progressive chute failure. There are two documented failures of the chute rock armouring during operation between 1977 and 1978.

16. Damwatch recommends enhanced monitoring and reactive controls to manage operation of the Temporary Structure, and that potential risk remains, even for short term temporary operation. This recognises that there are aspects of performance and stability that cannot be confirmed in advance. I am, and Genesis is, of the view that relying on such measures alone is unacceptable for the discretionary operation being sought by Meridian. WSP have recommended that repairs, which are specified in their works, are completed before such reliance can be considered.
