# Geotechnical Assessment A Drive Borrow Pit, Stockton Mine

Bathurst Resources Limited

✦ March 2026

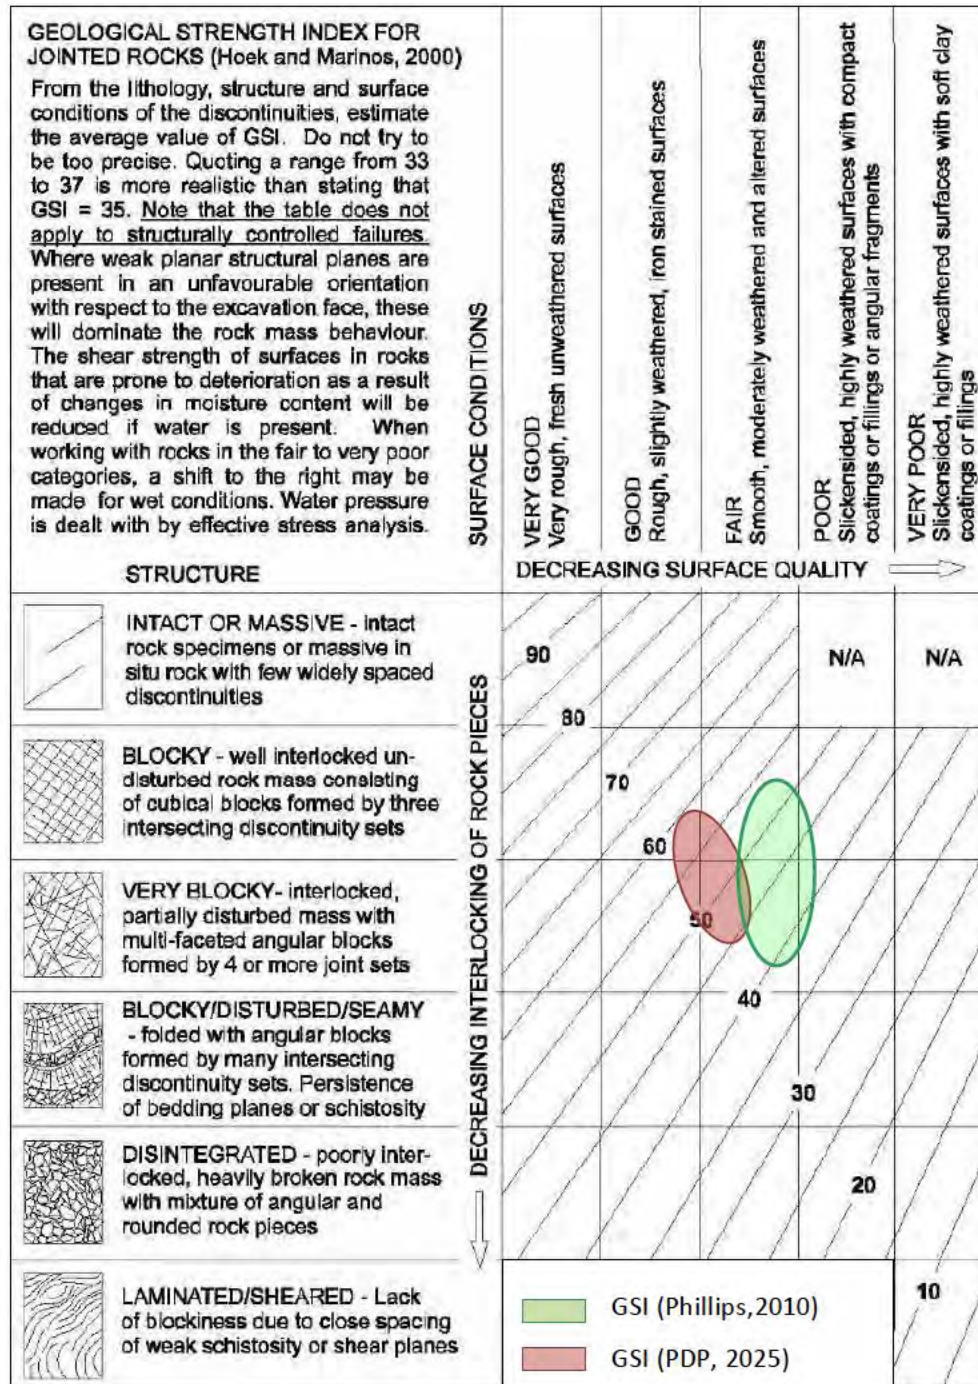
Figure 5: Results of the Geological Strength Index (GSI) determination from Hoek and Marinos (2000) of basement rock in A-Drive Borrow Pit.

AGSI assessment has been carried out to estimate the rock mass strength of the granitic basement. This assessment was informed by site observations of the current highwall conditions and core photographs from the Phillips (2010) investigation presented in Appendix E. The results, along with a comparison to the original Phillips (2010) assessment, are presented in Figure 5.

Based on the GSI assessment a GSI value of 50 indicating a blocky to very blocky rock mass with joints in are fair to good condition has been adopted in the rock strength classification to be used in the slope stability analyses.

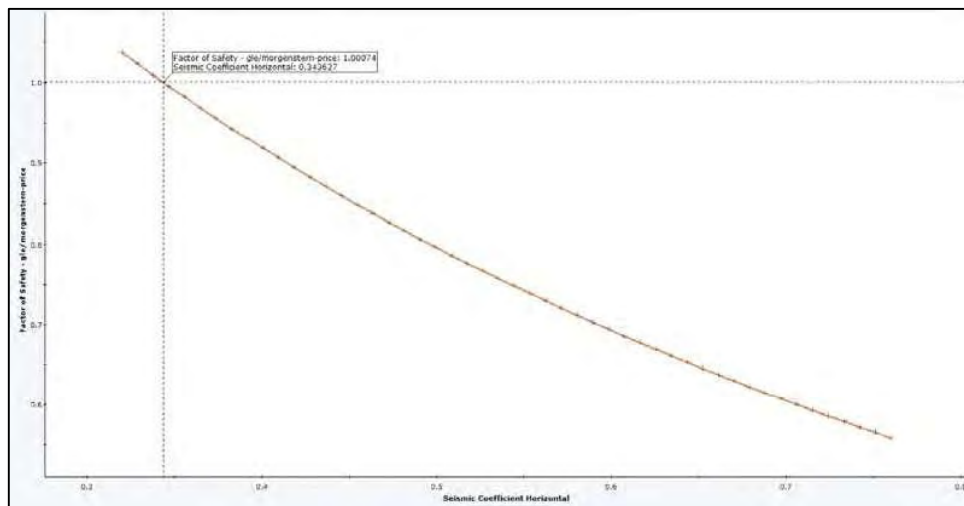
**Figure 7: Estimated yield peak ground acceleration for failures in fill materials - Factor of Safety 1.0, Horizontal Seismic Coefficient 0.34g.**

Sensitivity analysis of the shallow failures in the fill material placed at the top of the highwalls are also likely to occur under seismic loadings exceeding a peak ground acceleration (PGA) of 0.34g (Figure 7), reprofiling or removing the fill slope back from the highwall crests will reduce the risk of rock fall during smaller seismic event.

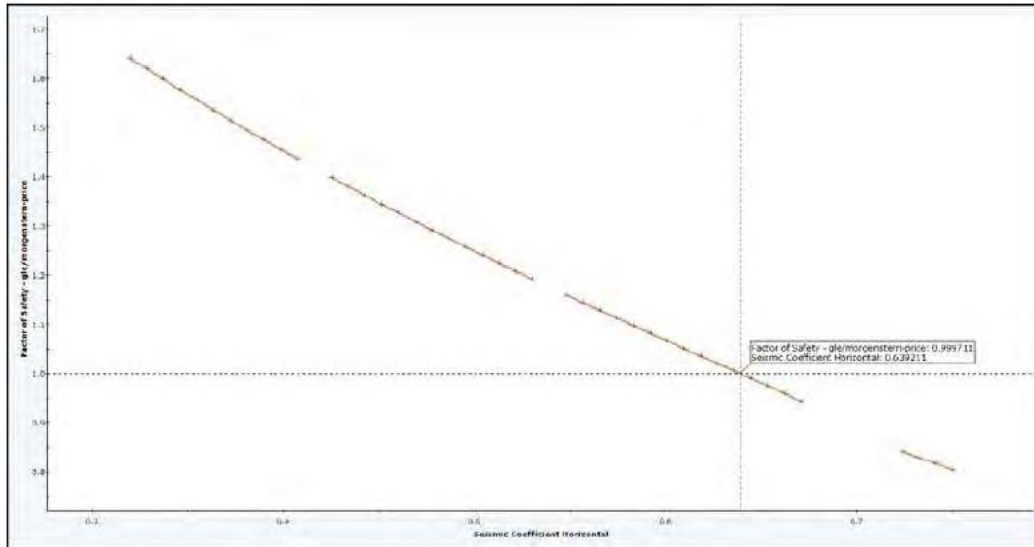
**Figure 8: Sensitivity analysis of seismic coefficient for overall slope failure – Factor of Safety 1.0, Horizontal Seismic Coefficient 0.63g.**

Sensitivity analysis of seismic coefficient for the overall slope of the CFS Stage 3 highwall was undertaken. The results indicate of the analysis indicate a yield threshold of the slope is likely to occur at peak ground accelerations (PGA) exceeding 0.63g. The sensitivity analysis graph is presented in Figure 8.

The yield-threshold PGA determined from the sensitivity analysis was used to estimate potential seismic-induced slope displacements (D) using a sliding block approach following Jibson (2007). The analysis indicates that displacements of less than 0.1 cm may occur during an MCE event. Displacements of this magnitude are considered stable based on the criteria outlined by Bray and Travasarou (2007) in Table 15. Accordingly, only minor bench-scale failures are expected in the highwalls of the A-Drive Borrow Pit and CFS Stages 2 and 3 during an MCE level earthquake.
