RE: Remarkables Ski Area Upgrades and Doolans Expansion - Response to Natural Hazards Feedback

**Re: Natural Hazards Assessment Peer Review, Remarkables Ski Area Expansion**

**Reference: Responses to Questions on Doolans Natural Hazards Assessment**

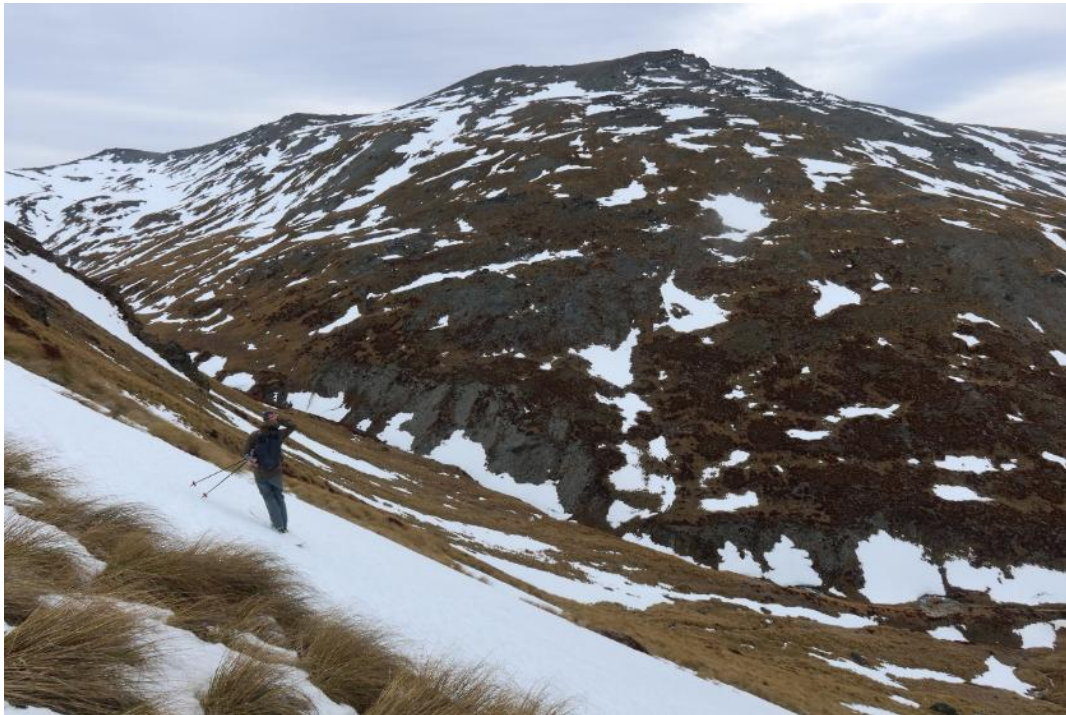
N.B the true left of the Right Branch is identified as a potential landslip but with 'no information'

The risk to proposed infrastructure associated with the development is low as there are no elements of the development proposed to be within this area. The slope is shown below.

*Figure 9 Looking North to the True Left of the Doolans Creek Right Branch showing the nature of the topography on the True Left.*

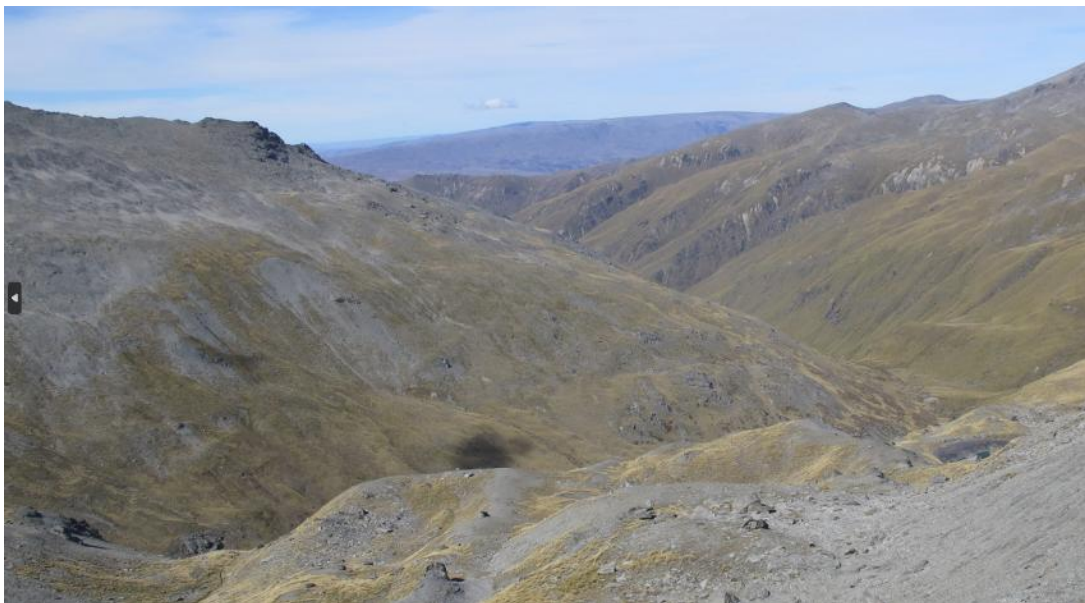
*Figure 10. Looking down on the same slope as identified in Figure 9 above*

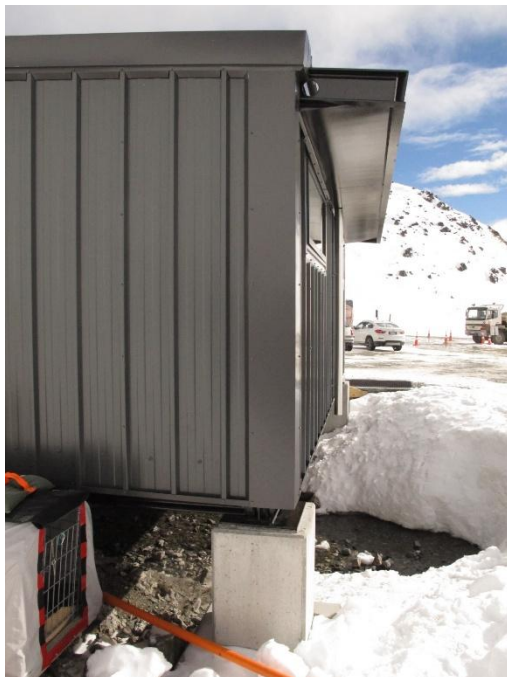
The patrol building itself is also elevated as shown in the photograph below, and is consequently above any potential flood water level within the 'drop off' area:

Figure 14. Patrol Building on Elevated footings above potential flood level

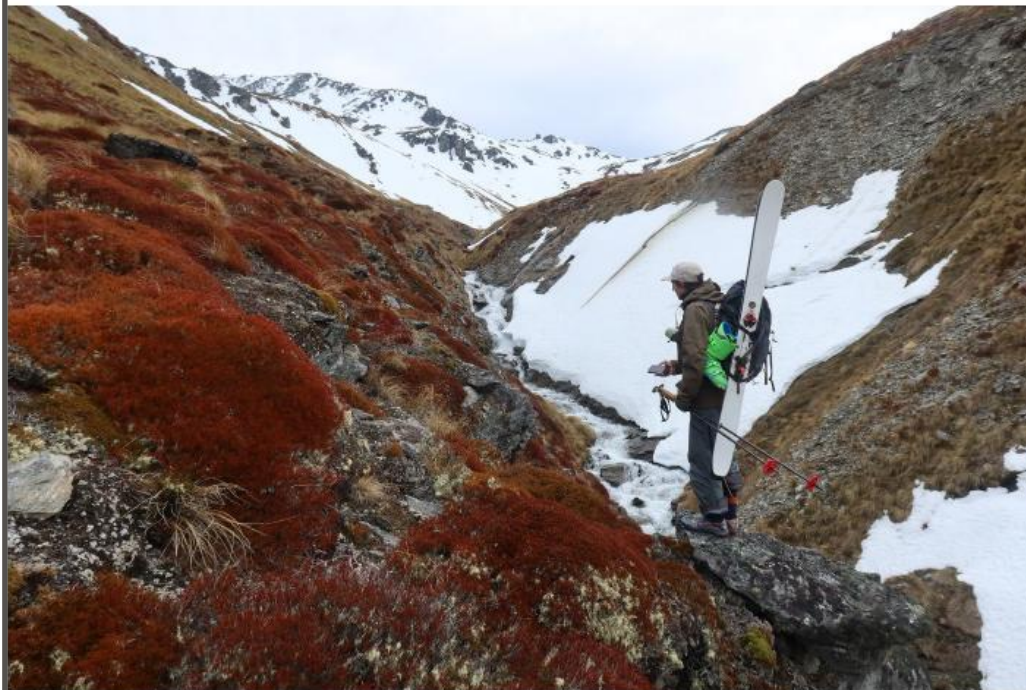
Debris flow as a result of a landslide dam within Doolans Creek Right Branch is considered a possibility. Slipping of the bank, potentially as a result of erosion, saturation, or both may result in localised failures of the bank which could result in a natural dam forming. The dam may fail because of water pressure and cause a debris flow within the creek bed.

The Upper Doolans Creek Right Branch is deeply incised and thus a localised naturally occurring dam is a possibility.

Figure 22. Relevant section of Natural Hazards Assessment which identifies the Risk of Localised Land Instability in Doolans Creek Right Branch

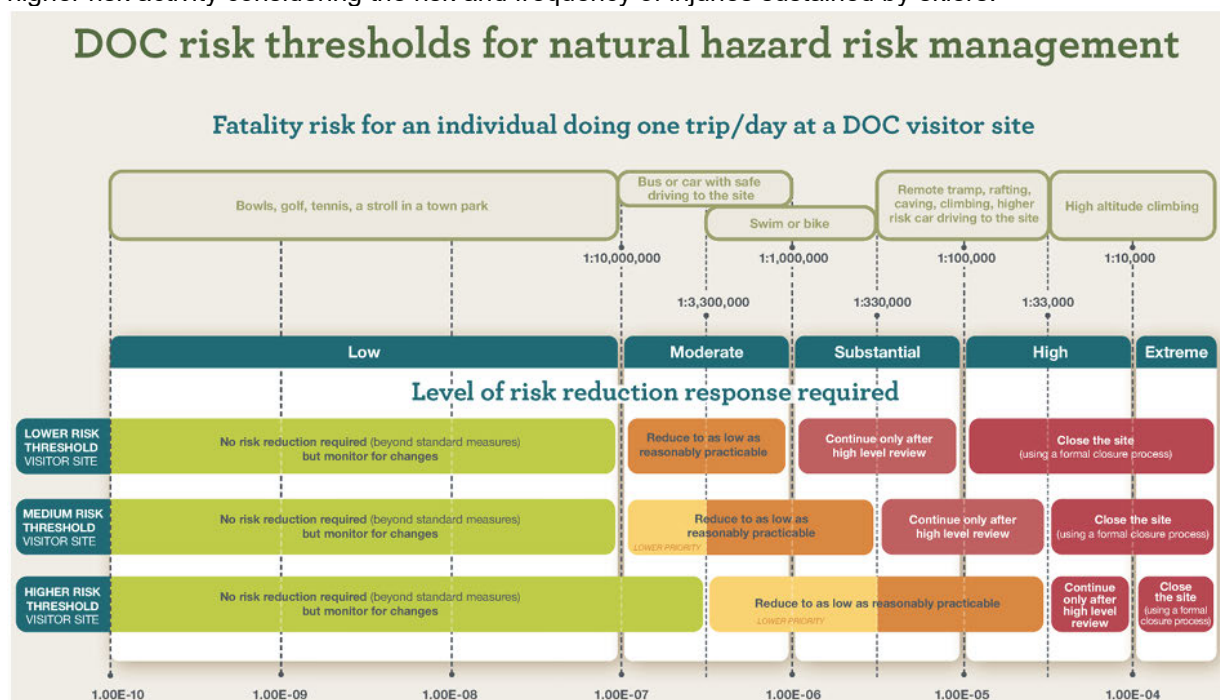
The Department of Conservation risk thresholds for Natural Hazards are shown in the figure below. It is considered that there is a 'Higher risk threshold' for this site and activity and that mitigation measures such as operational rules and the practicalities of winter and spring operation will reduce or eliminate the use of the road at higher risk times. The Departments guidance is that 'higher risk' activities include tramping tracks, routes and grade 5 and 6 cycle trails. Thus, off-piste skiing could be considered a higher risk activity considering the risk and frequency of injuries sustained by skiers.

Figure 27. Department of Conservation Natural Hazard Risk Thresholds for Visitor Sites, likely potential status of the road above Swan Lake marked with circle

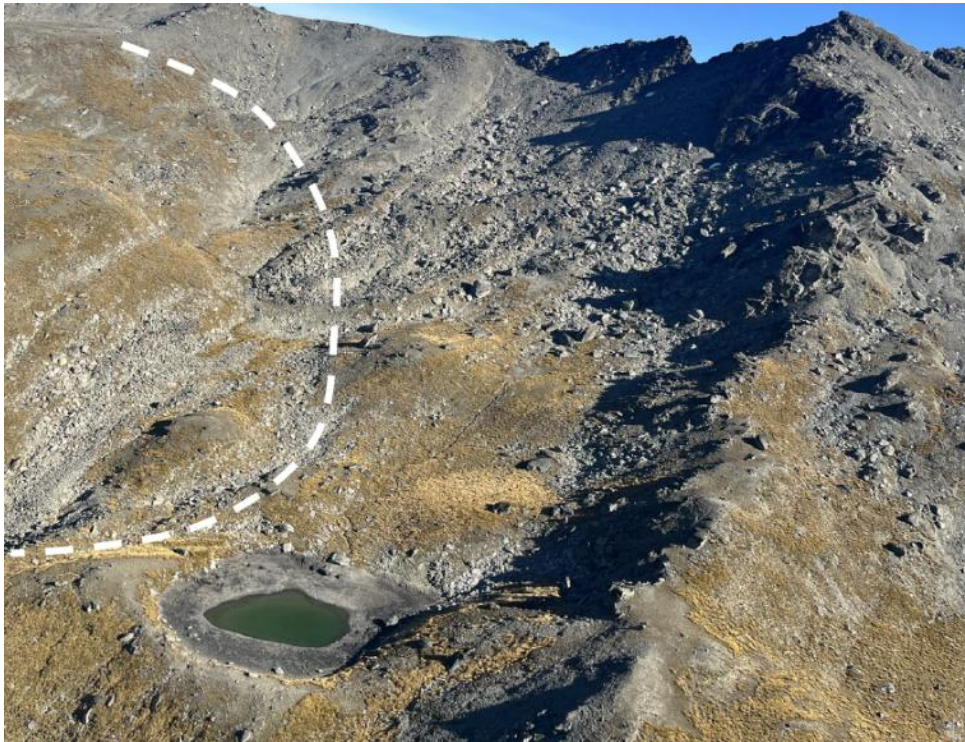
Rockfall from the ridge adjacent to the proposed reservoir, which is oriented north-west to south-east, is less than the rockfall risk from Helicopter Ridge in the area above Swan Lake. This is because the ridge adjacent to the reservoir has fewer potentially unstable rocks and has a more benign slope below. In addition, formed and groomed ski trails are located outside any likely rockfall runout zone. The area between the ski trails and the ridge line, up slope of the Reservoir, will not be groomed but will be opened for off-piste skiing when snow conditions allow. This physical separation between the groomed trails and the ridgeline is indicated in the Natural Hazards Report. The area between the ski trails and the ridge and the area will be skiable, off-piste, terrain. Off Piste skiing is clearly a higher risk threshold visitor activity and is likely only to be undertaken by competent skiers. Skiing in the area above the reservoir is a moderate risk activity, per the Department of Conservation figure above, and the number of skiers in this location is not expected to be high and the presence of skiers within this area is transitory. The road and trail route in relation to the ridge is shown in the figure below from the Natural Hazards Report.

*Figure 28. Diagram of approximate position of ski trails in relation to the ridge above the reservoir site (from Natural Hazards Report)*

If rockfall occurs during the ski season rockfall energy will be attenuated by the presence of snow, although this effect is variable depending on the snow conditions and is thus not able to be accurately quantified. Overall, the natural hazard risk from rockfall above the reservoir is considered to be mitigated for the reasons set out above and is considered to be an acceptable level of risk for an activity occurring within an alpine environment. This level of risk is consistent with the level of risk associated with off piste skiing on commercial ski areas in New Zealand.

Instead, Stantec has recommended that a general rockfall hazard assessment be undertaken that will undertake a walkover inspection to identify potentially unstable rocks and model the potential rockfall to quantify the risk from rockfall to the reservoir site. Stantec anticipates that the existing slope above the reservoir will attenuate most rockfall, but analysis of the rockfall path will allow both the risk zone and path to be better understood. Site investigations to date of the larger rocks adjacent to the existing tarn site have revealed lichen growth on the individual rocks, and thus Stantec infers that the frequency of rockfall reaching the site of the proposed reservoir is low.

The assessment will subsequently identify any mitigations, if necessary, to be included into detailed design in relation to the risk of rockfall above the reservoir.
