# **Appendix K   Preliminary   Site Investigation**

**Hinuera Solar Farm**

**Harmony Energy NZ #6 Limited**

# Preliminary Site Investigation

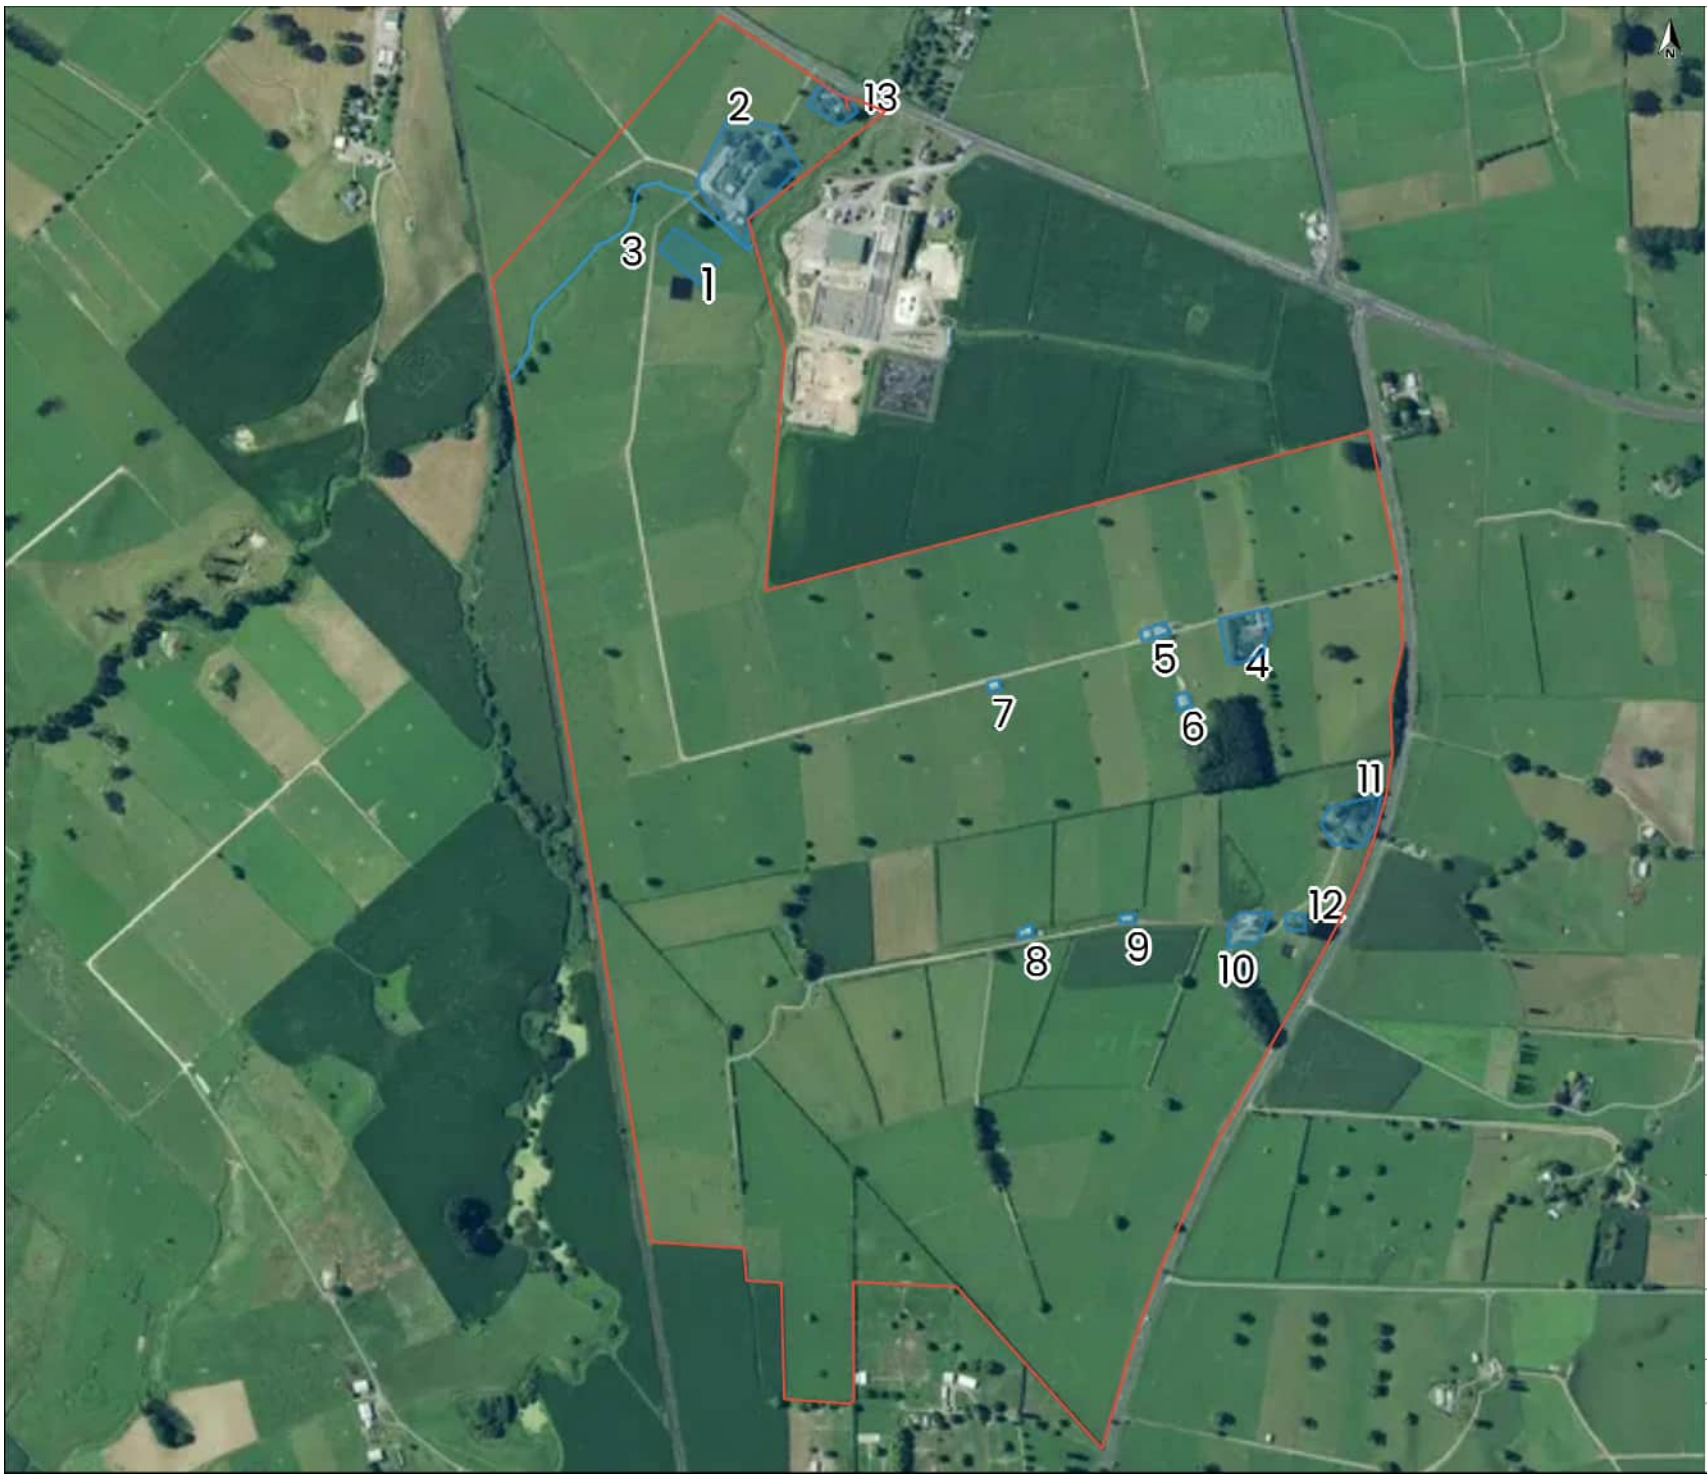
Based on the findings of the PSI, the area around the farm buildings, Oxidation Ponds and the depression adjacent to the cow shed (Features 1, 2 and 4 to 13 on **Figure 1**) have been subject to HAIL activities and are therefore a Piece of Land in accordance with Regulation 5(7) of the NESCS. However, as the Piece of Land is production land, and will remain production land, under regulation 5(8) of the NESCS, the NESCS does not apply.

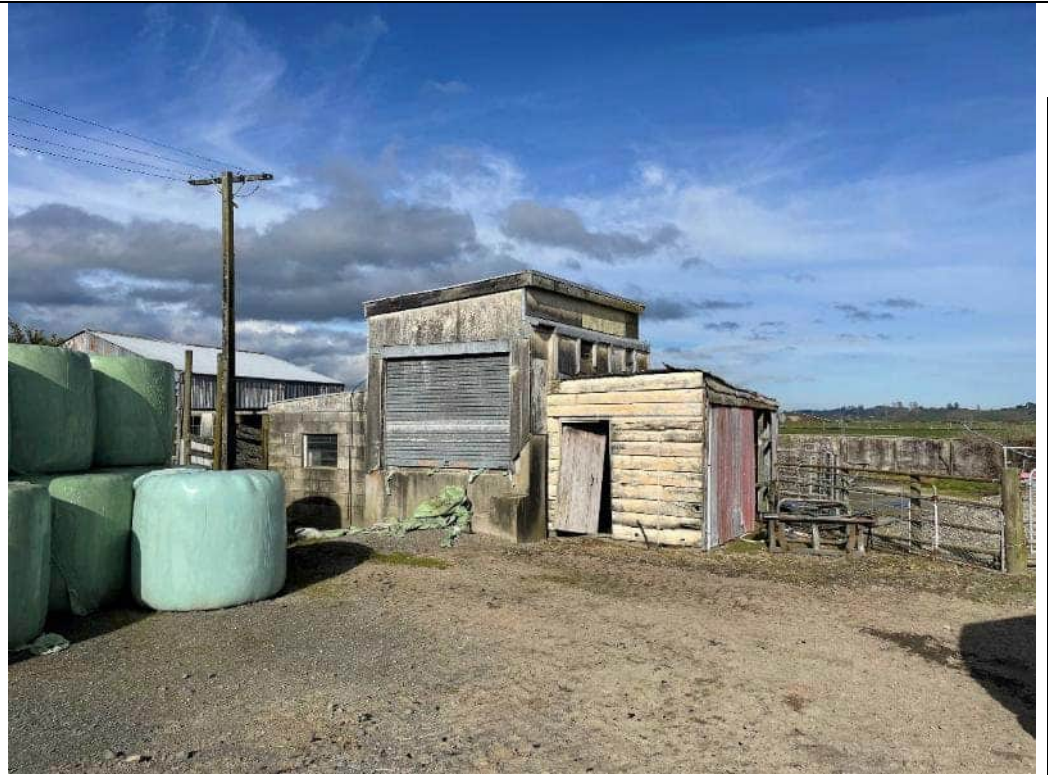
View showing farm buildings with potential ACM.

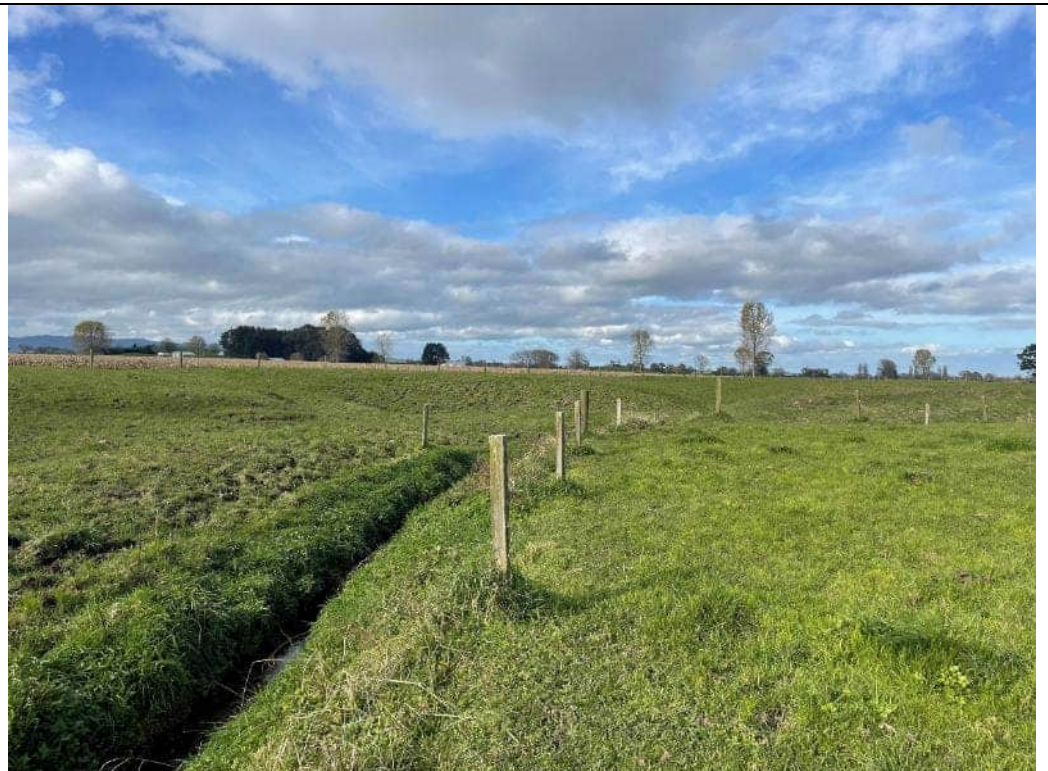
4

View of an unnamed tributary of the Waihu River (feature 3 on Figure 1).

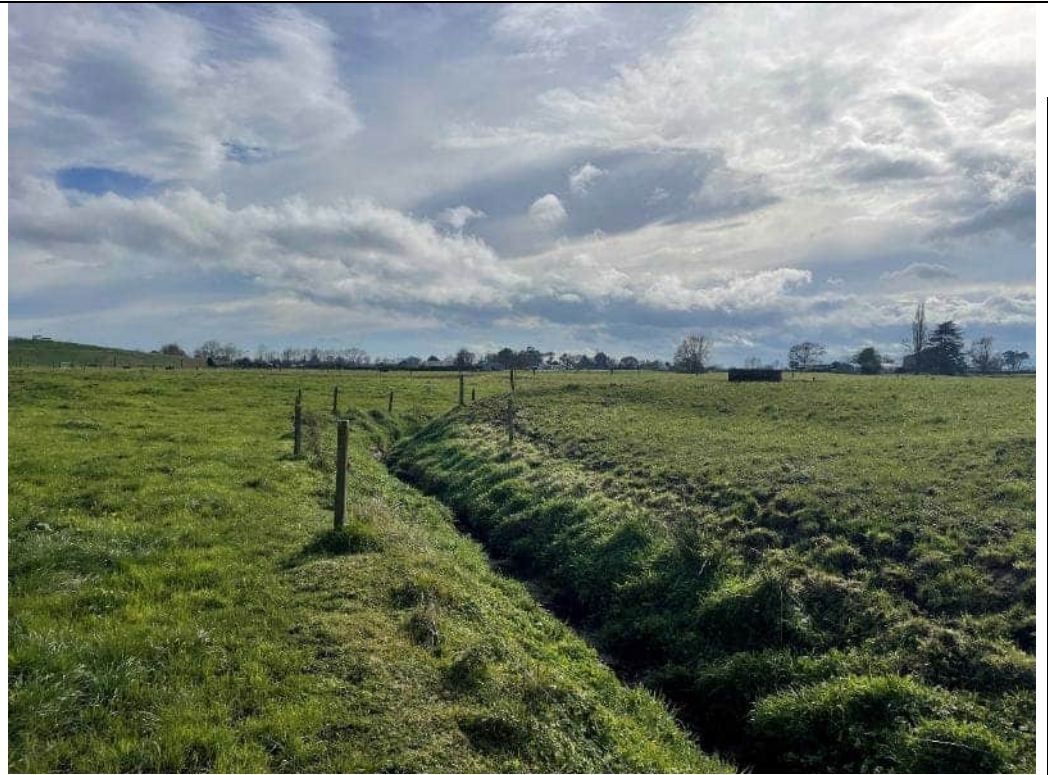
View of an unnamed tributary of the Waihu River (feature 3 on Figure 1).

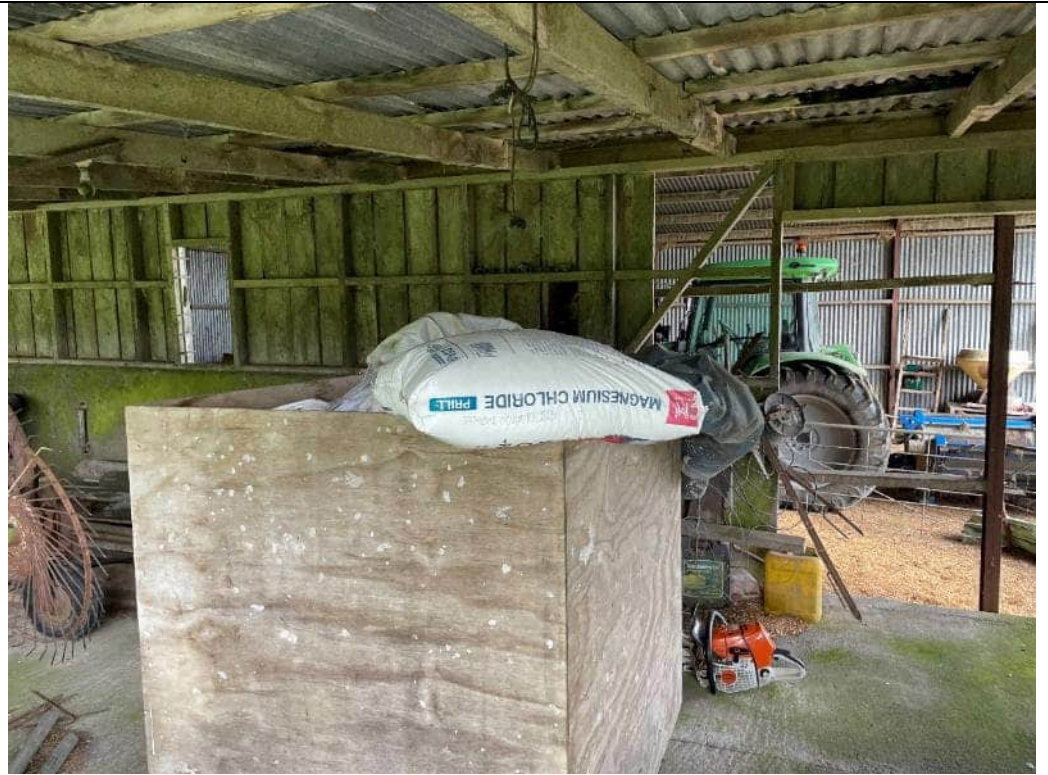
View of stored pesticides within the Hay Barn.

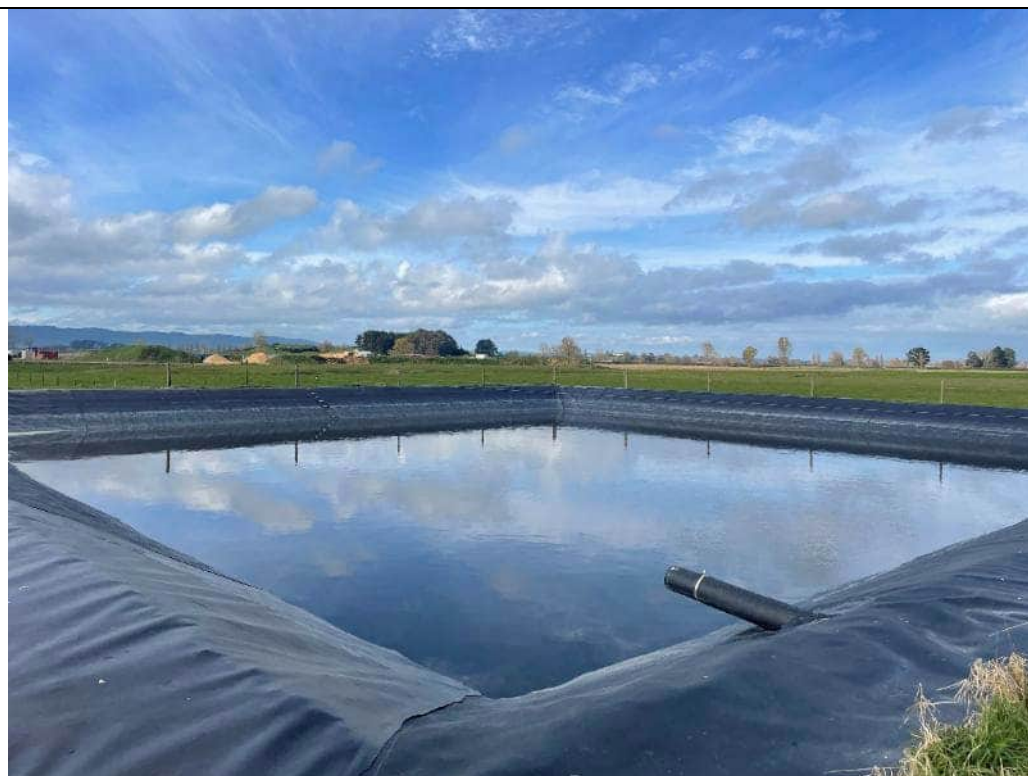
| Photo No. | Date: |
|---|---|
| 11 | 16 June 23 |

| Photo No. | Date: |
|---|---|
| <b>Description:</b><br>General view of Oxidation Ponds in the Northeastern area of the Site (Feature 1 on Figure 1). | |

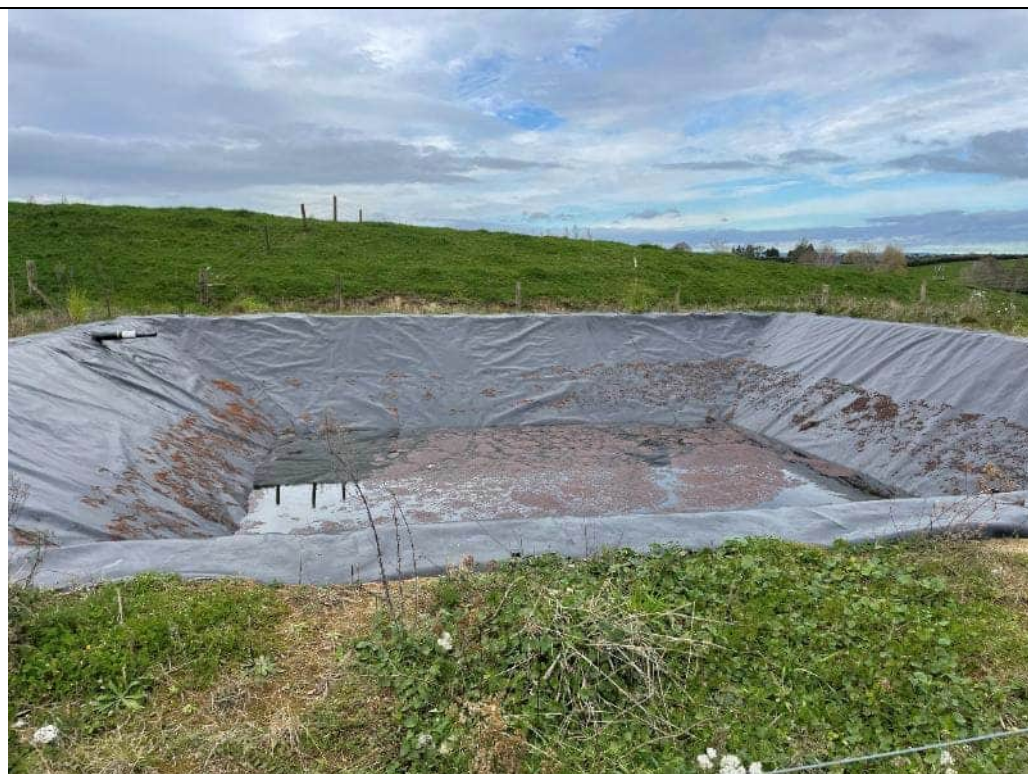
| Photo No. | Date: |
|---|---|
| 12 | 16 June 23 |

| Photo No. | Date: |
|---|---|
| <b>Description:</b><br>General view of Oxidation Ponds in the Northeastern area of the Site (Feature 1 on Figure 1). | |

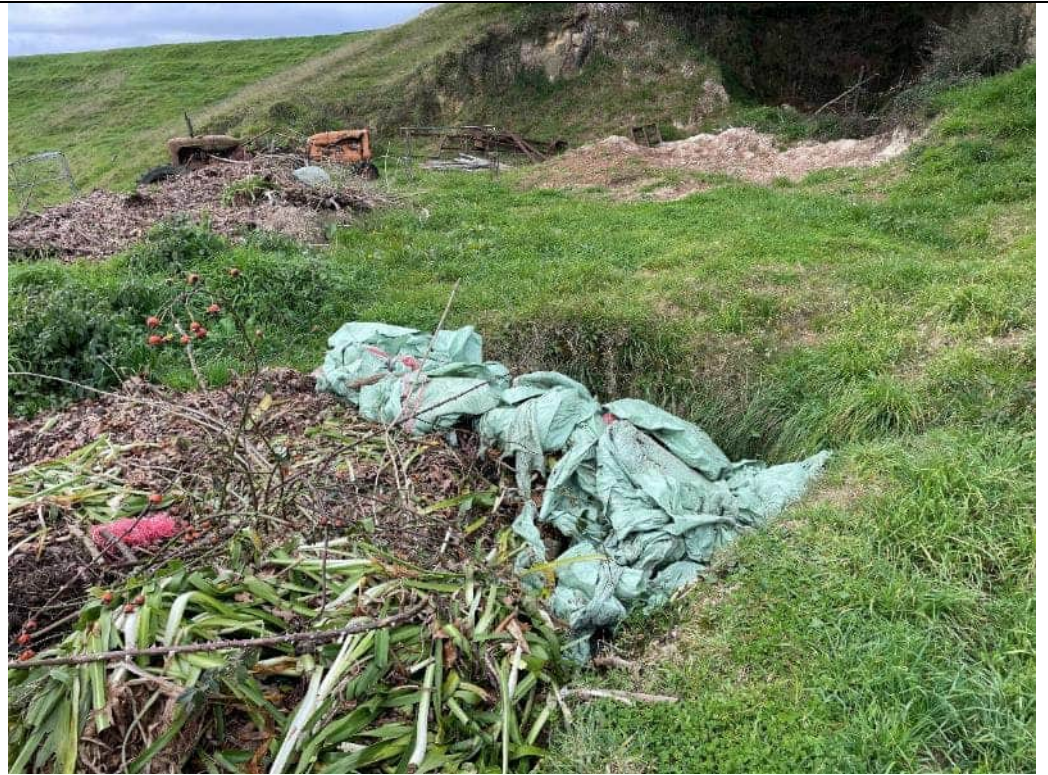
- **G3: Landfill sites** – this HAIL activity was considered likely due to the landowner informing SLR staff about the small hole near the cowshed used to bury plastic bale wraps, which have been historically burnt on Site. Based on this information it is considered that HAIL Category G3 has occurred at the Site as defined in the NESCS as waste that has been disposed of.

View of dump zone east of the cow shed (Feature 12 in Figure 1).

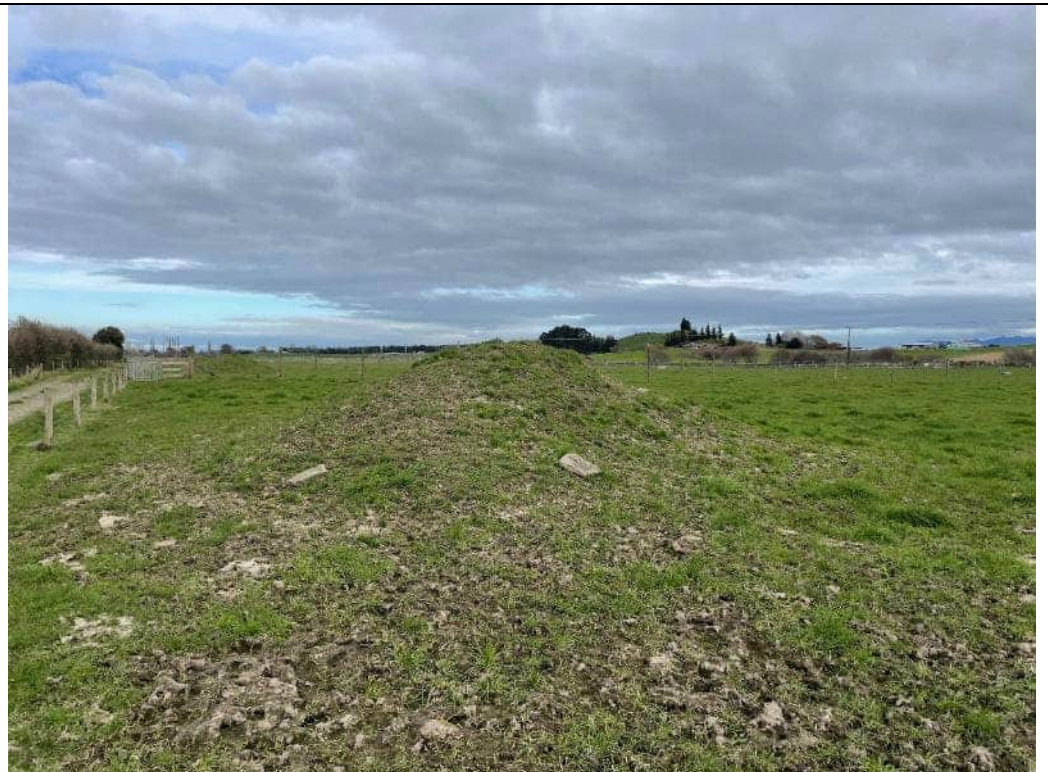
**Photo No.**  
14

Filled depression near races.

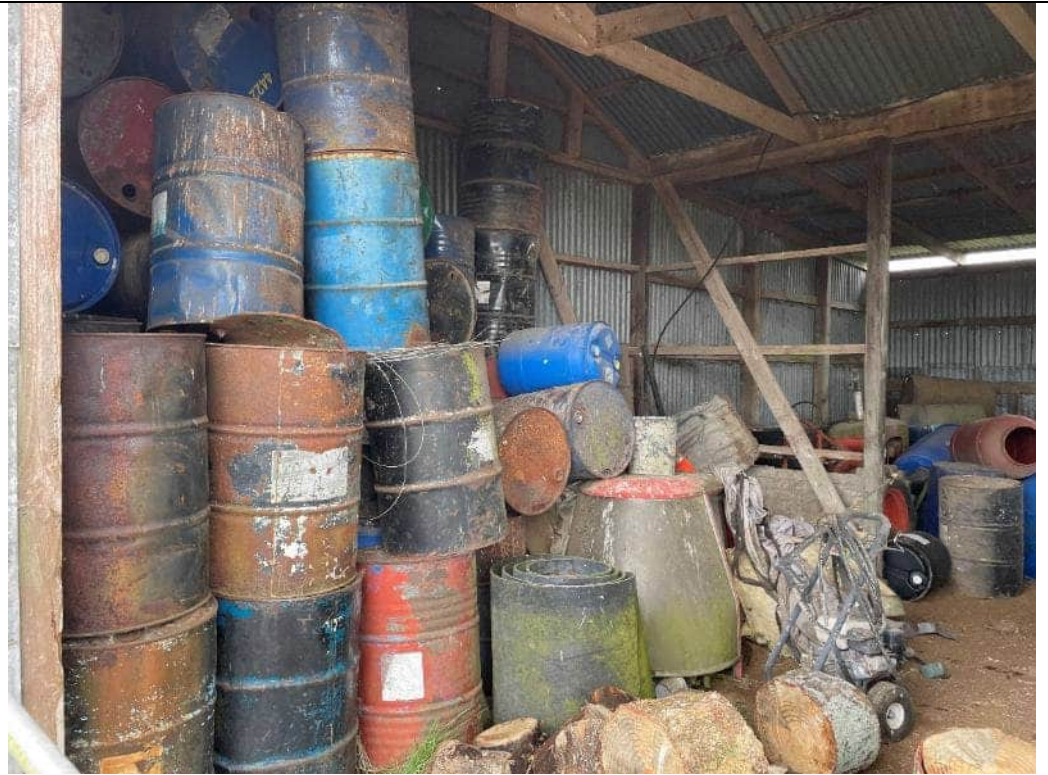
**Description:**  
General view of bulk  
stored chemicals.

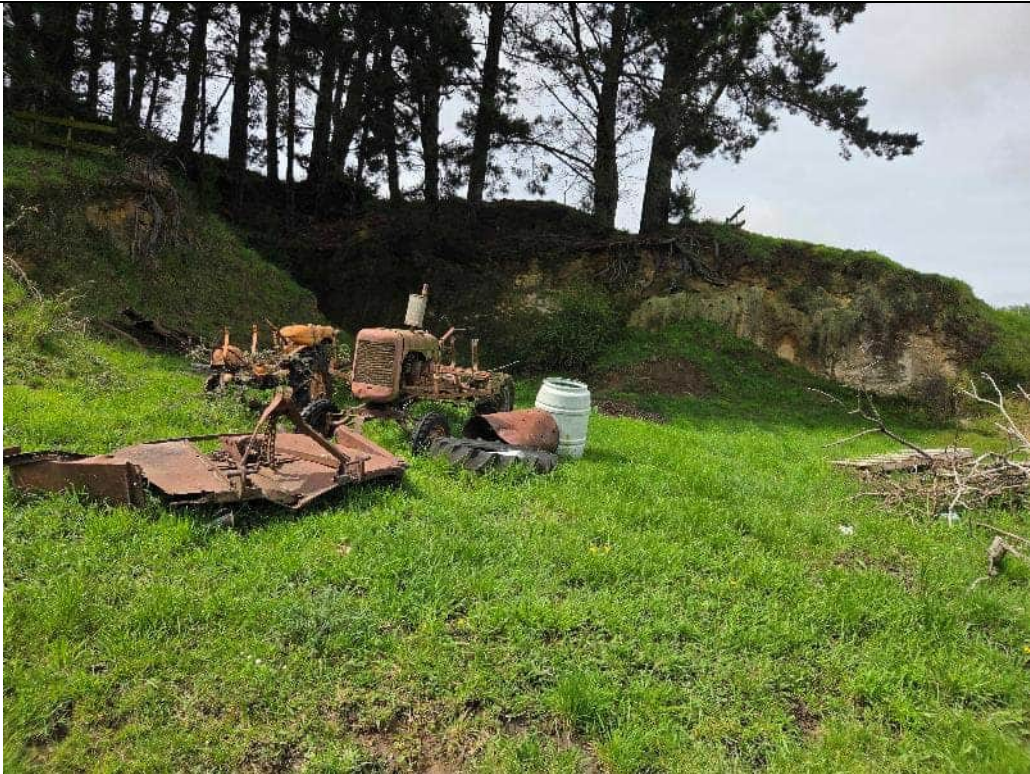
| <b>Description:</b><br>General view of old unused mechanical farming equipment within the southern farm area. | | |
