# Memo

**Subject:** **Pūkaki Fast-Track Application: Tekapo B Power Station Tailrace Weir & Chute Response to Questions from Review Panel**

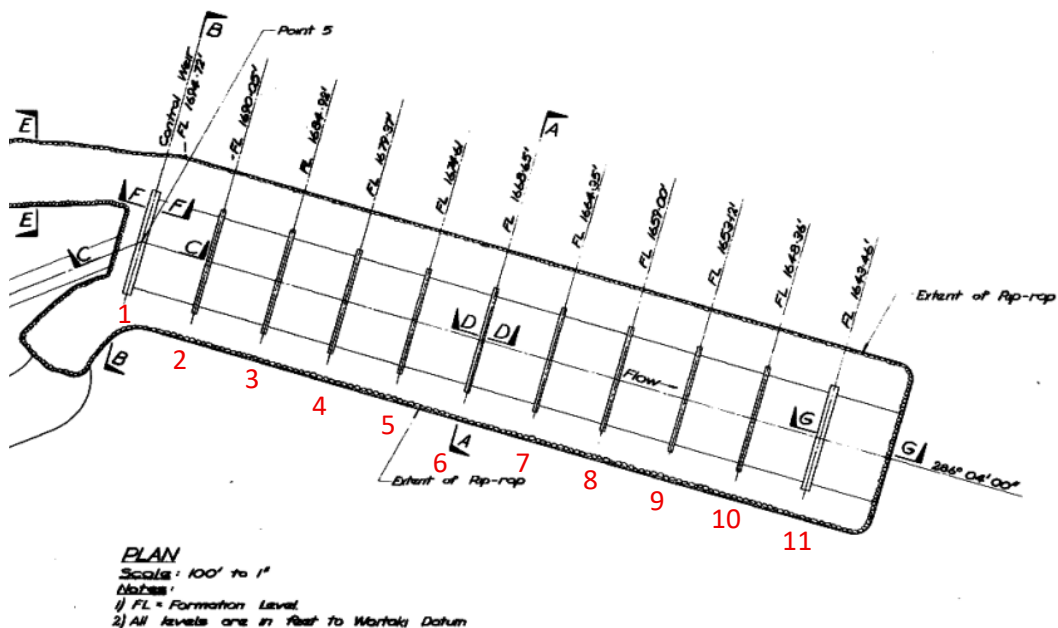
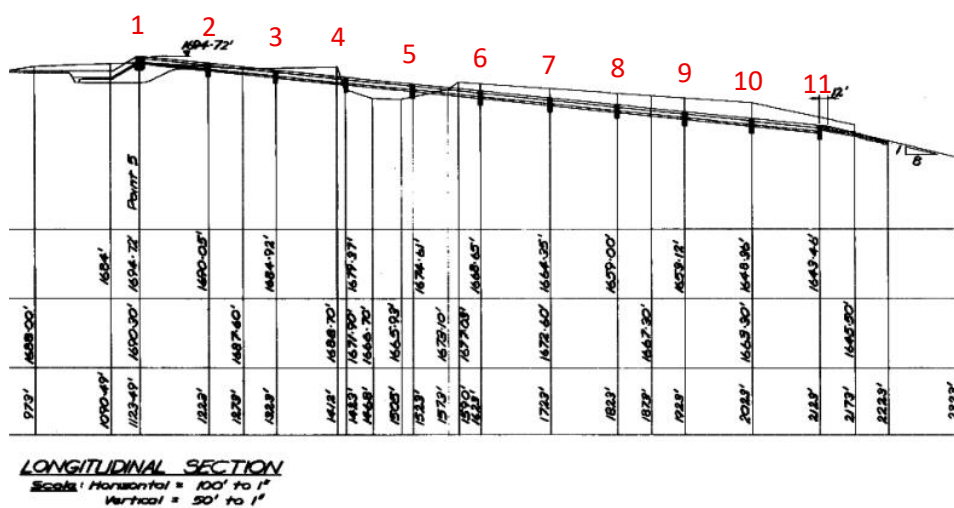
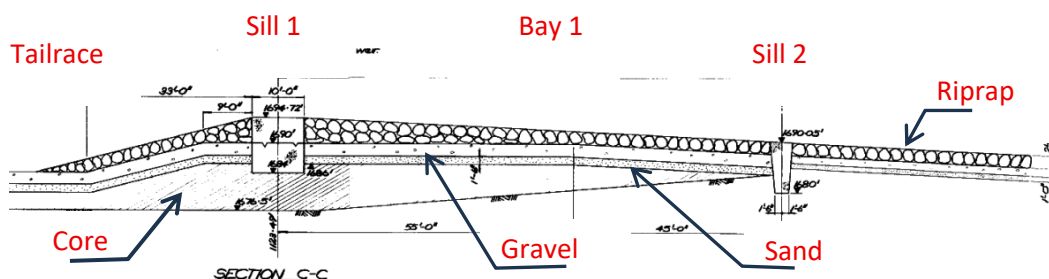
Figure 3.1: Tekapo B Power Station tailrace weir and chute: (a) plan view of whole structure; (b) long-section of whole structure; (c) long-section of control weir and bay 1 of structure

The weir and chute structure is comprised of a control weir at the upstream end and a long chute on a nominal 1V in 20H slope, except for a short steeper 1V in 8H sloping section at the lower end (see Figure 3.1b). The structure is approximately 375 m long and 50 m wide (see Figure 3.1a and b).

The control weir (referred to as Sill 1) has a trapezoidal long-section (see Figure 3.1c). The weir crest is formed by a concrete Sill 3.05 m wide by 3.26 m deep. The upstream sloping nose of the control weir and the compartment downstream of the weir are both rock-lined with riprap. The weir controls water levels in the upstream trapezoidal-shaped earth-lined tailrace channel.

At the control weir, core material was placed below the sand filter to extend the seepage path from the upstream tailrace channel (refer to Figure 3.1c). The remaining sills and bays were founded in native soils

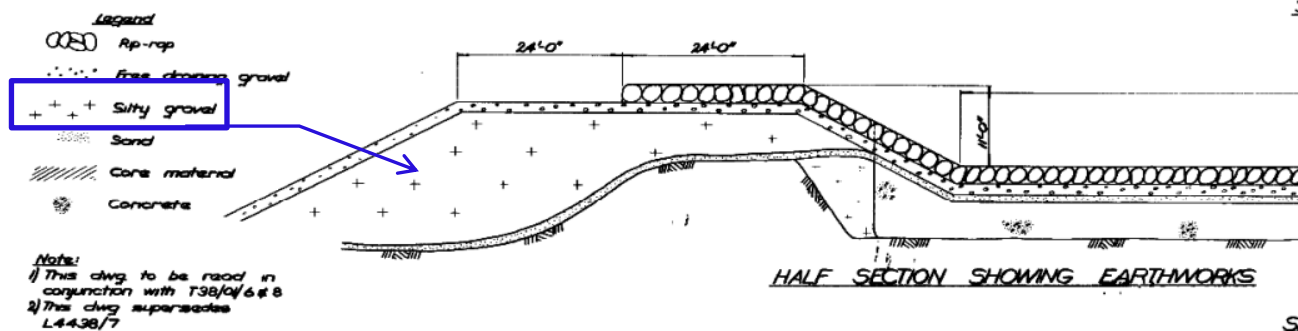
**Figure 3.2: Cross section of berm constructed from silty gravel.**

except for construction of the side berms. Figure 3.2 shows that silty gravel was used to build the side berms and was placed above the sand filter.

No information is available on the core and silty gravel materials other than a specified permeability ( $k$ ) requirement of less than  $1 \times 10^{-5} \text{ cm/sec}$  for the core (MWD, undated-a). The core permeability requirement is the same as that for the Tekapo Canal lining per Specification HD924 (MWD, 1973). The specified grading of the lining material is also shown on Figure 3.3. The lining material is much coarser than expected for a typical clay core but is considered reasonable for the glacial depositional environment. It was considered as a possible representative material for the core material.

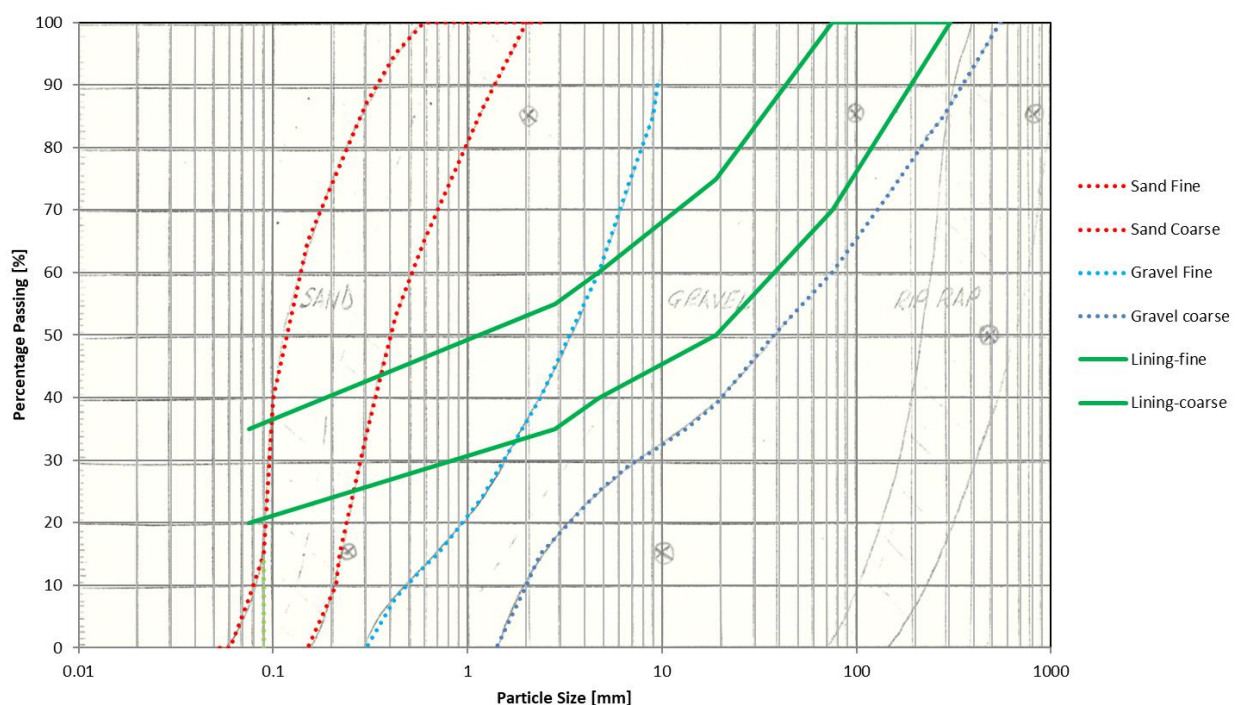
**Figure 3.3: Specified grading envelopes for filter layers, riprap and canal lining.**

Figure 3.1c shows general arrangement of these materials. The sand acts as a filter to the underlying soils. Figure 3.3 shows the corresponding specified grading curves (MWD, undated-a).

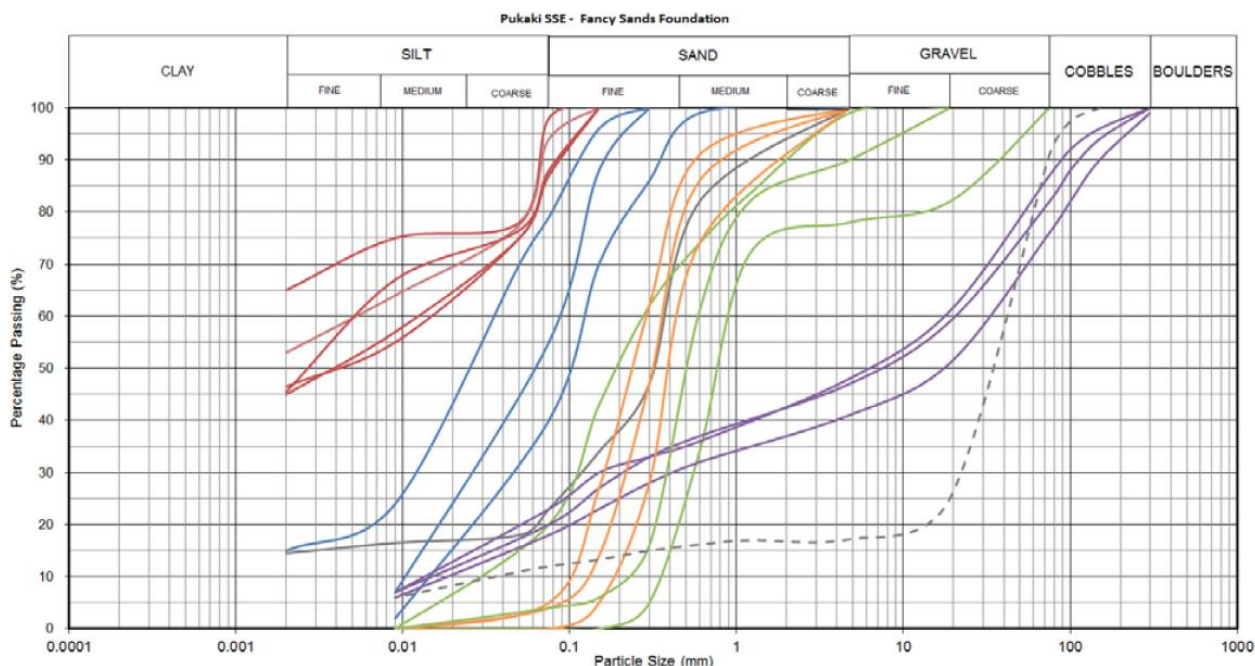
**Figure 3.4: Fancy sand grading curves.**

The Pūkaki 'pug' has similar characteristic to the soils encountered at the tailrace channel. Figure 3.4 shows the available Fancy Sands grading curves where we consider the finer gradings (red and blue curves) to be the 'pug' soils. Atterberg limits tests performed on the 'pug' material indicate a plasticity index (PI) of 8-18, classifying the soil as low plastic clay (CL) and a PI of 22-30 classifying it as high plastic silt (MH). The corresponding liquid limit (LL) is 26-48 and 77-84, respectively. These gradings and plasticity are considered in this assessment given the similarity in description, consistency and composition to that encountered at the tailrace channel.

The coarser Fancy Sands gradings (blue, yellow and green curves) provide an indication of foundation alluvial soils that may exist at the tailrace channel. Composition of alluvial soils may vary significantly spatially due to their depositional environment.
