Remarkables Ski Area Expansion Project Natural Hazards Assessment

Prepared for:
NZSki Limited

29 April 2026

Remarkables Ski Area Expansion Project - Natural Hazards Assessment

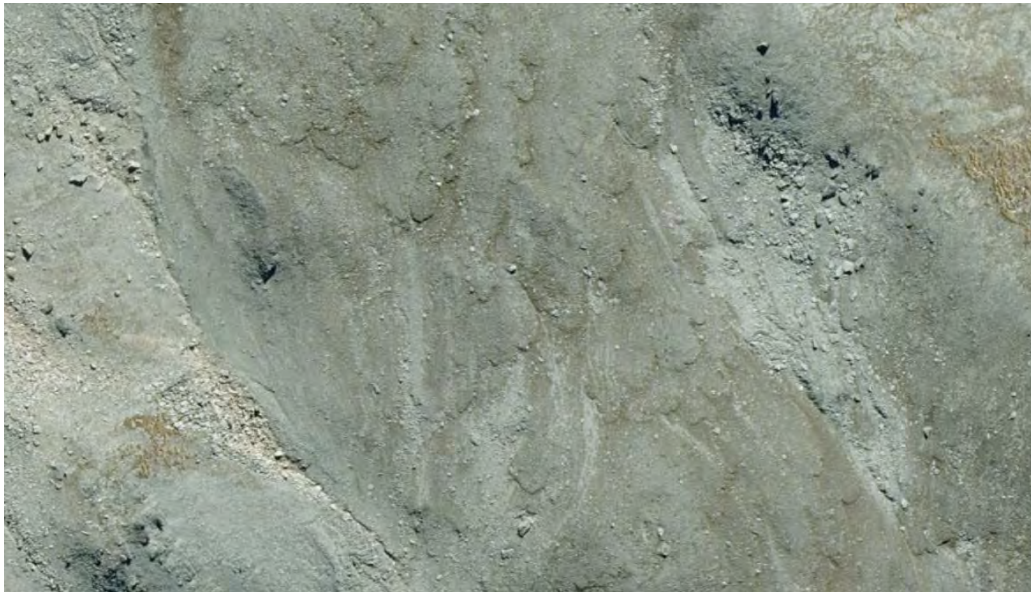
Solifluction is slow, downslope creeping of water-saturated soil and rock debris associated with cyclic freeze thaw conditions which occurs on slopes in cold alpine regions. It is caused by gravity movement of the upper layers of ground thawing and creeping downslope. This often occurs because of the upper layers becoming saturated from snow melt while resting on an impermeable, still frozen, or layers below. The Upper Doolans Creek Right Branch contains notable examples of this phenomenon. These are shown in the figure below.

Figure 6. Aerial view of solifluction lobes in the Upper Doolans Right Branch

The effects of solifluction creep may be managed by locating gondola towers or other structures in locations where existing lobes are either non-existent or small (in the order of a 200mm or less). In addition, any structures within an area potentially prone to such movement should be founded a minimum of 2m below ground level or a level where the surface movement does not affect the founding of the structure. This is standard practice for structures such as gondola or lift towers.

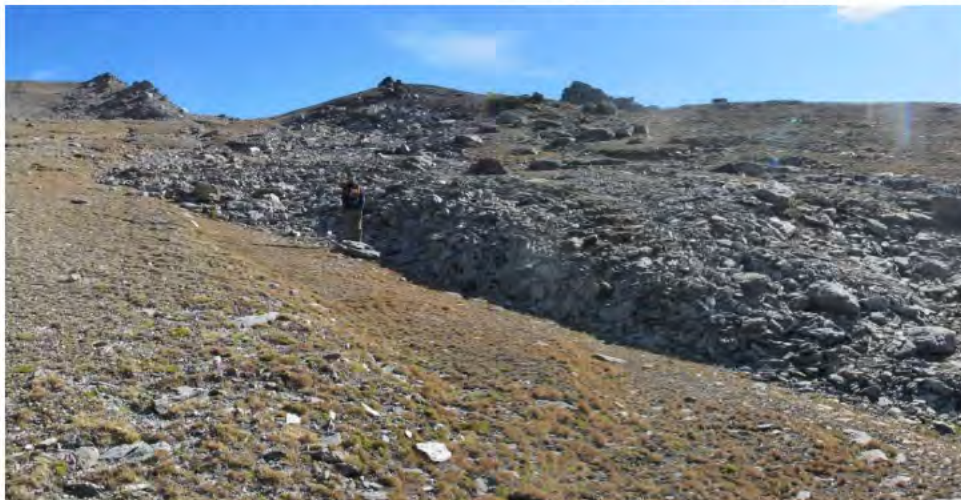
There is a significant solifluction lobe southeast of Helicopter Ridge which is sufficiently deep to be considered a minor debris flow. The flow speed of this feature has been a slow creeping movement, but the quantity of material involved is greater than typical solifluction lobes.

Figure 8. Large solifluction lobe/minor slow debris flow southeast of Helicopter Ridge with person for scale

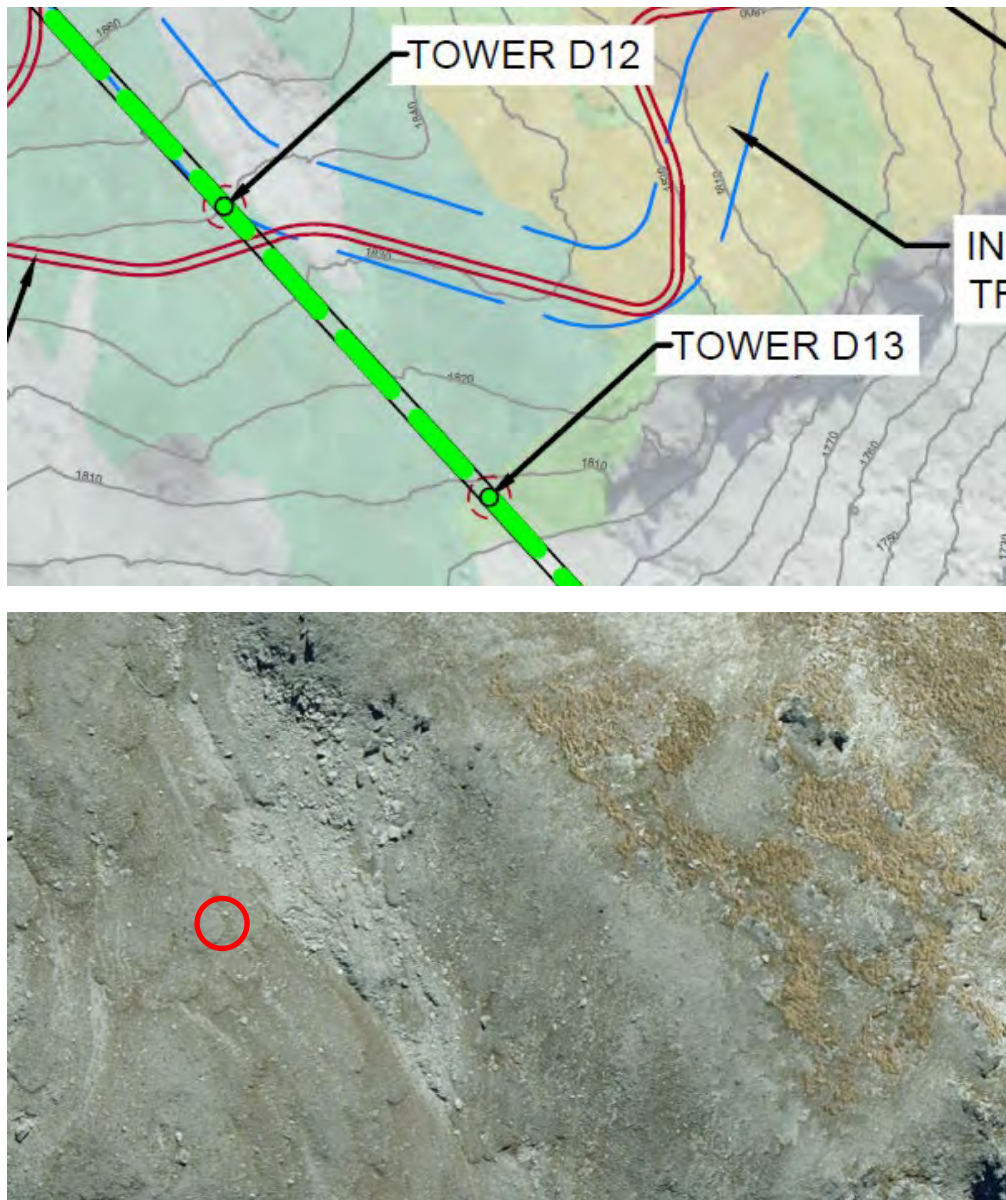
Figure 9. Expanded aerial view of solifluction/debris flow feature and approximate tower 12 location drawing

The solifluction/debris flow feature is up to approximately 2m maximum depth. This feature appears to be recent, as vegetation has not become established on the surface. This feature is likely to have been caused by water build up within the surficial material which has fluidized the debris and caused the flow. It is possible that this feature is caused by a solifluction mechanism where surficial material becomes saturated during snow melt (potentially combined with heavy rain) over top of the subsoil, which is impermeable due to either frozen ground or underlying rock. The resulting fluidized slurry has flowed down the slope.

The preliminary alignment indicates that the proposed tower 12 location is immediately west of the active lobe of the feature. Further setout and site investigation is required to confirm the location of the tower in relation to this feature. It is recommended that the tower is located in a location outside active lobes of this feature.

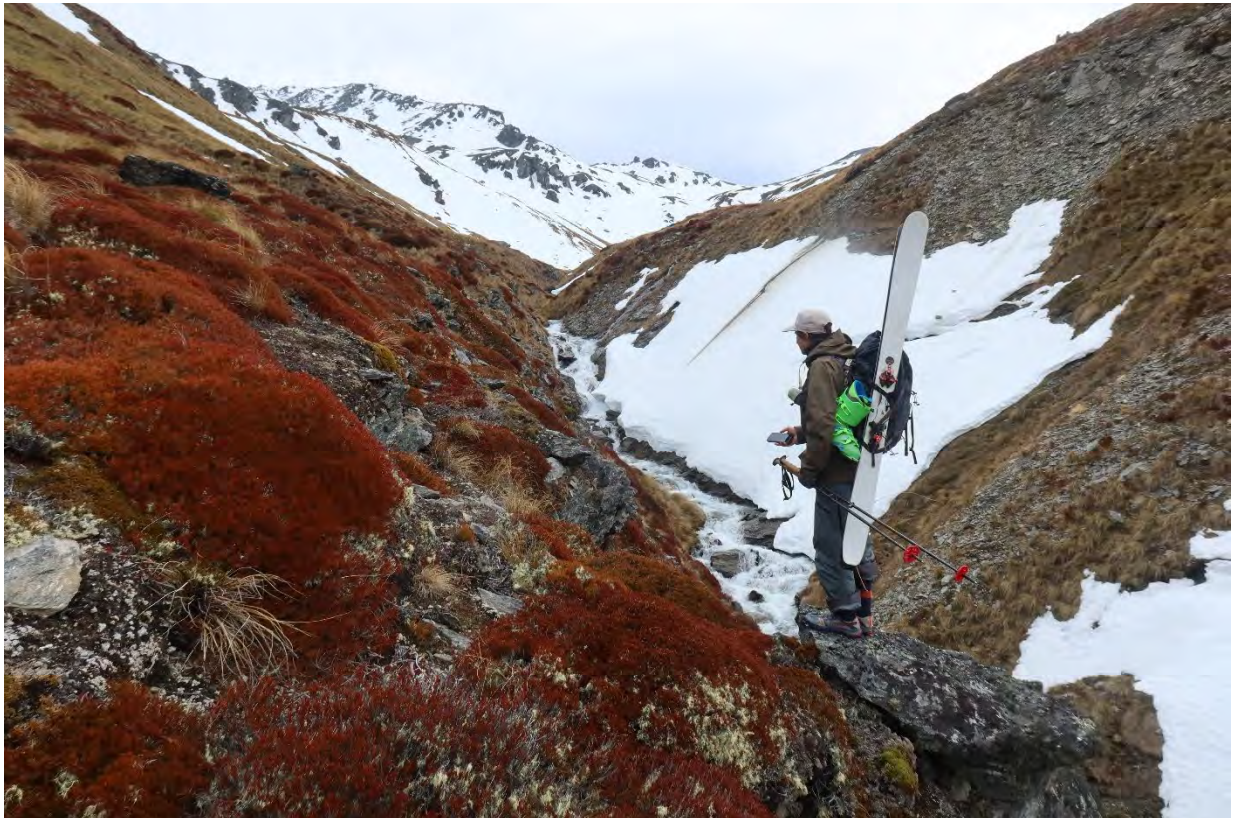
Debris flow as a result of a landslide dam within Doolans Creek Right Branch is considered a possibility. Slipping of the bank, potentially as a result of erosion, saturation, or both may result in localised failures of the bank which could result in a natural dam forming. The dam may fail because of water pressure and cause a debris flow within the creek bed.

Figure 10. Deep Vee shaped creek bed where a natural dam and resulting dam break may occur

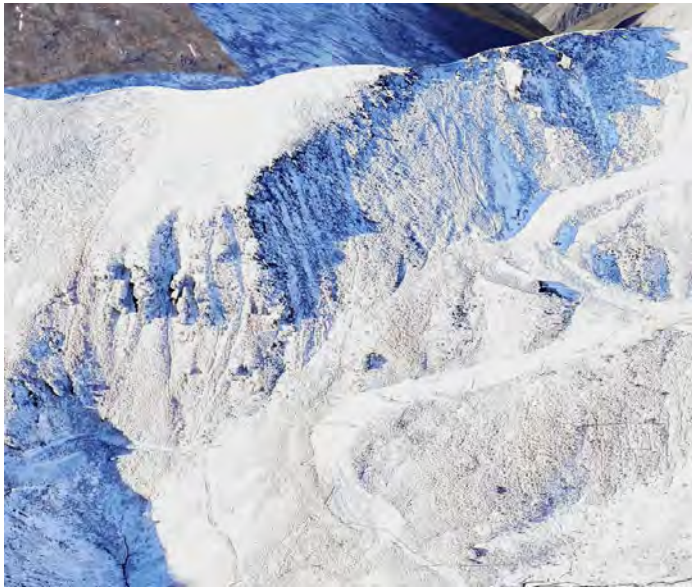
Figure 11. Area of localised rilling erosion where periodic avulsion occurs but there is no identified risk of build-up of sufficient material to result in a debris flow

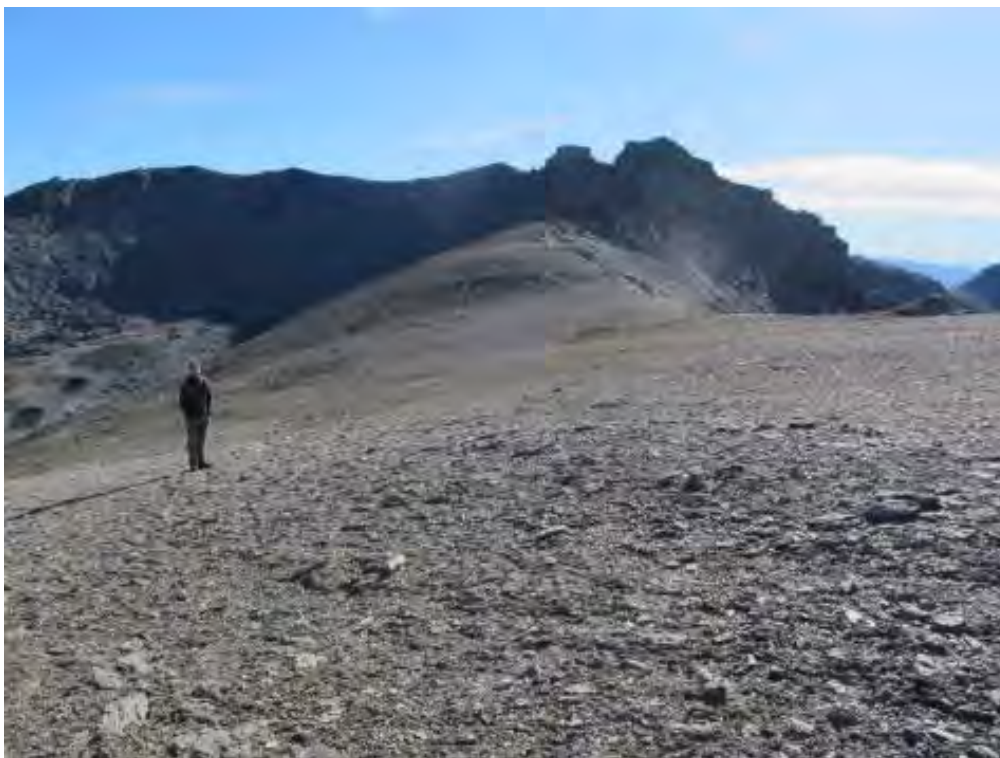
The windswept nature of the site is visible in the figure below. It is conceivable that the wind speed has been a contributing factor to surface erosion at the site.

Figure 23. Windswept location of the mid station terminal

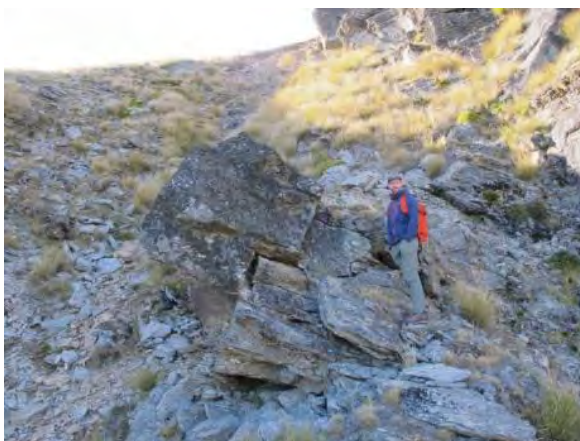
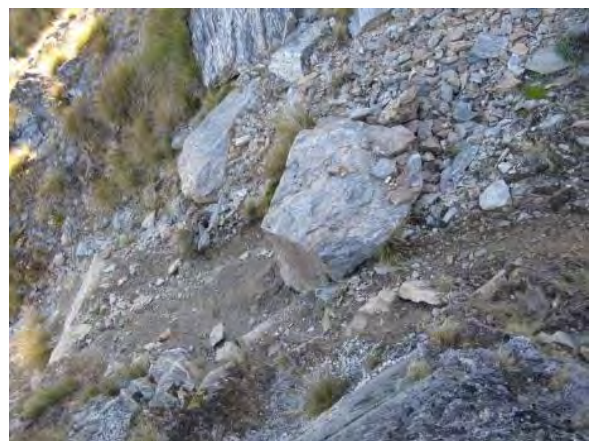
Within the chutes there are a number of perched rocks which are at risk of becoming unstable, particularly in an earthquake. These features are shown in the figures below.

Figure 34. Potentially unstable rocks in the Gallipoli Chutes

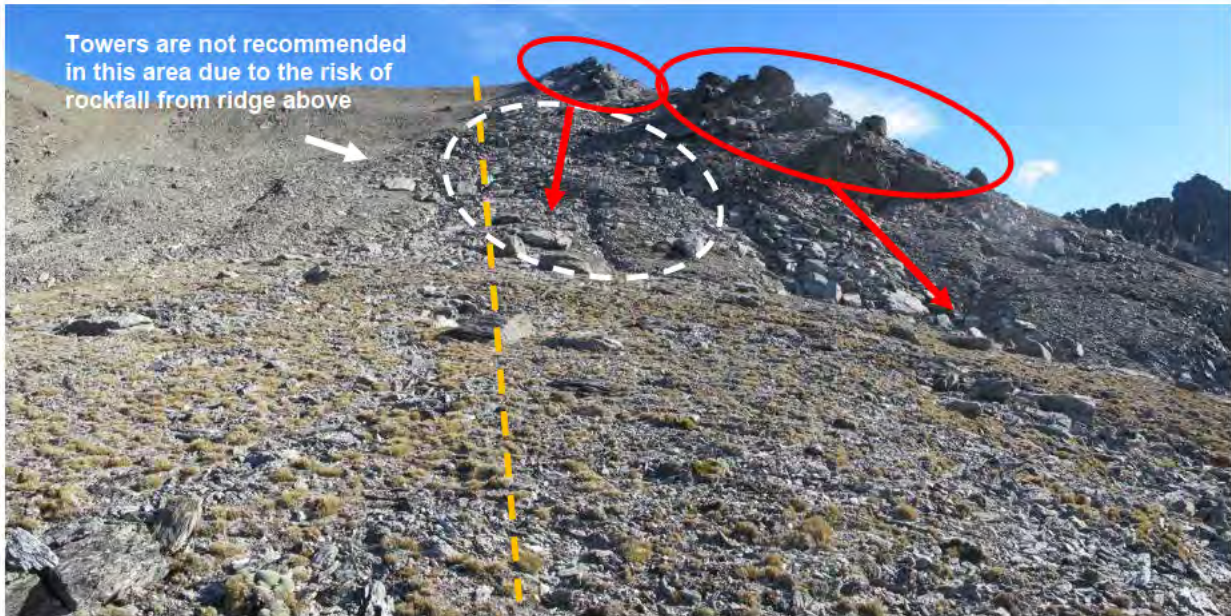
Figure 36. Rock spine with previous rockfall and the approximate alignment of the rope shown

- towers are not located in the area indicated below which is threatened by the higher of the two rock features, or
- remove potentially unstable rocks during construction of the gondola to remove the risk. We anticipate that it will not be a difficult task for a sufficiently large excavator.

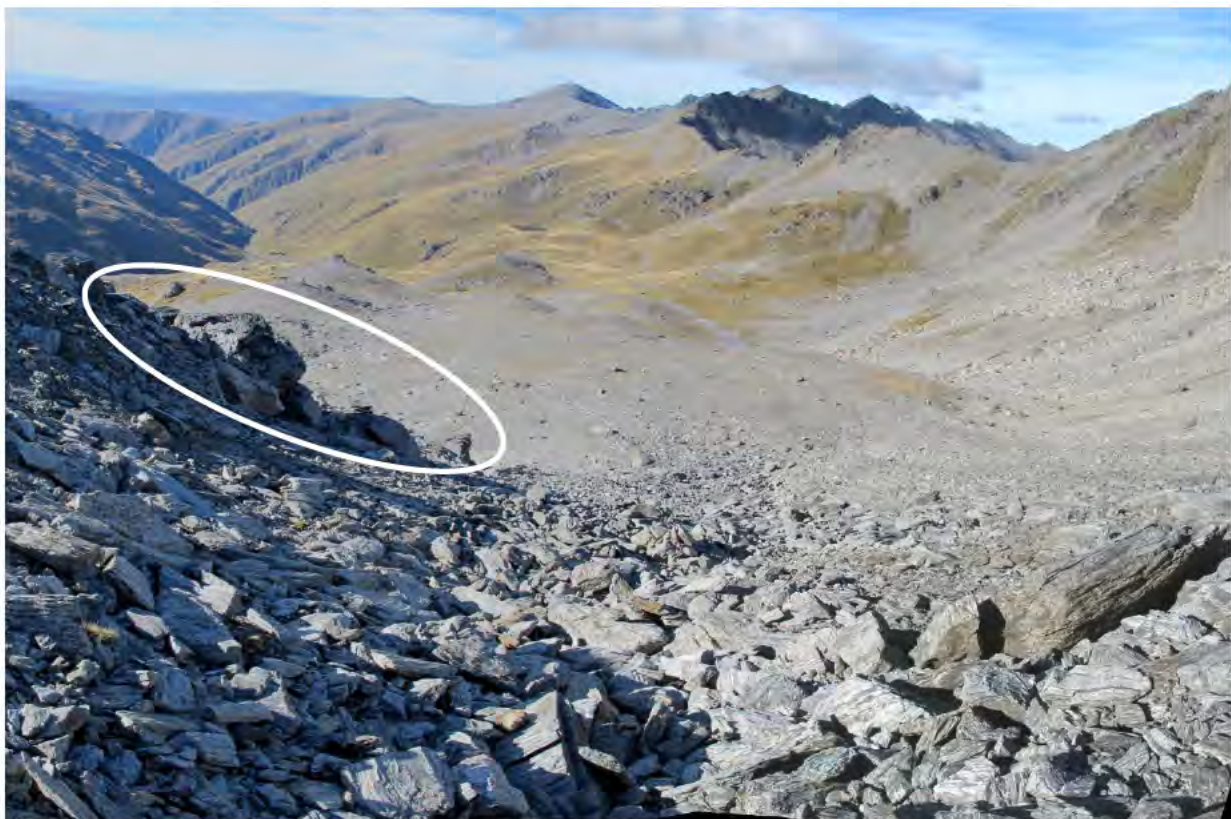
Figure 37. Potentially unstable rocks viewed from immediately below the ridge line

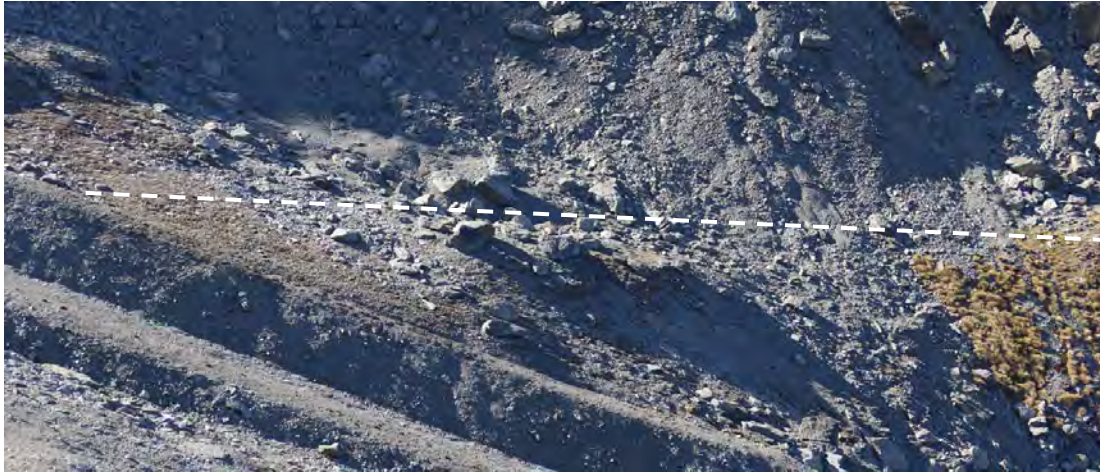
Figure 39. Debris field of large fallen rocks (and part of the unused half pipe) below the ridge line. Nominal route of proposed temporary access shown as broken line.

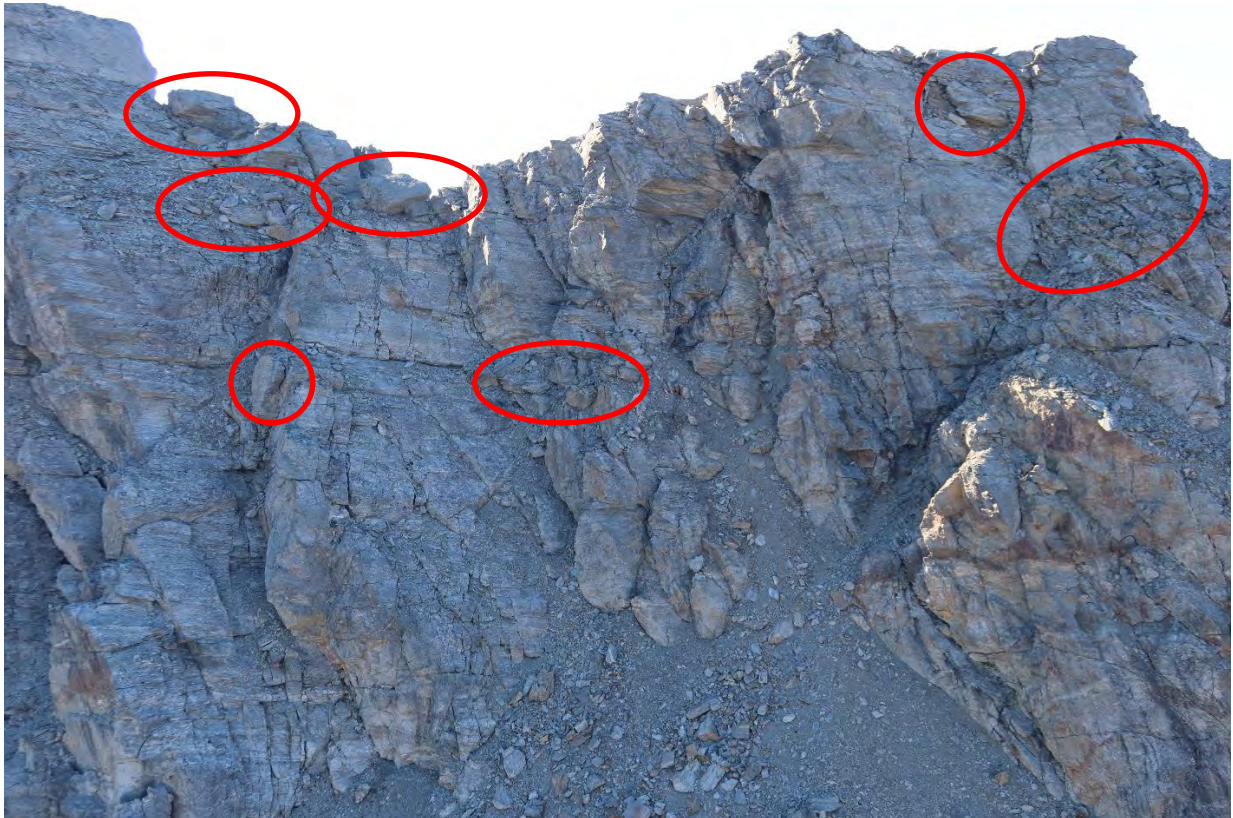
Large and potentially loose boulders along this ridge line are shown in the figure below.

Figure 40. Locations of potentially unstable rock along the ridgeline

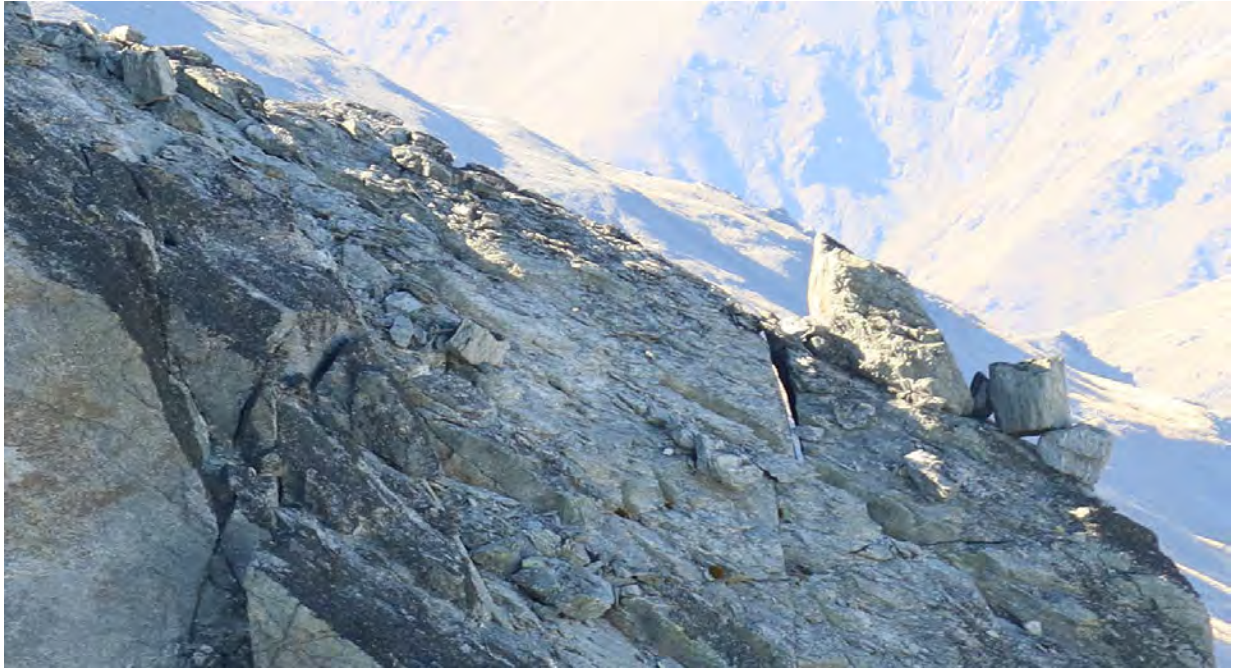
Figure 41. Numerous perched blocks along the ridge line

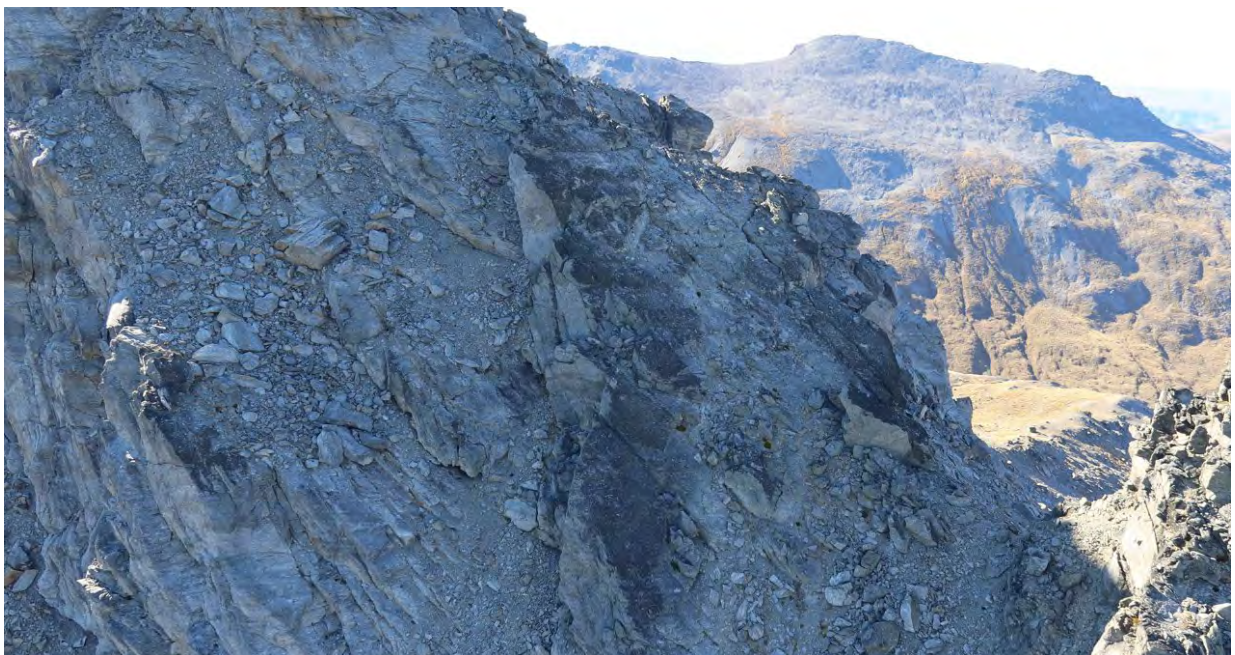
Figure 42. Perched boulders on western side of ridge

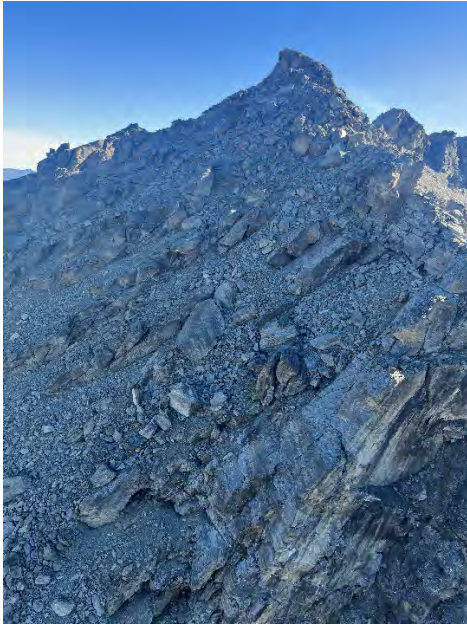
At the upper part of the ridge, there are a variety of large blocks above a blocky talus slope. These blocks may become unstable in either an earthquake or during heavy rainfall, but this risk is less than the blocks in the area above Swan Lake. This is shown in the figure below.

Figure 46. Upper part of the ridge above the snow making reservoir

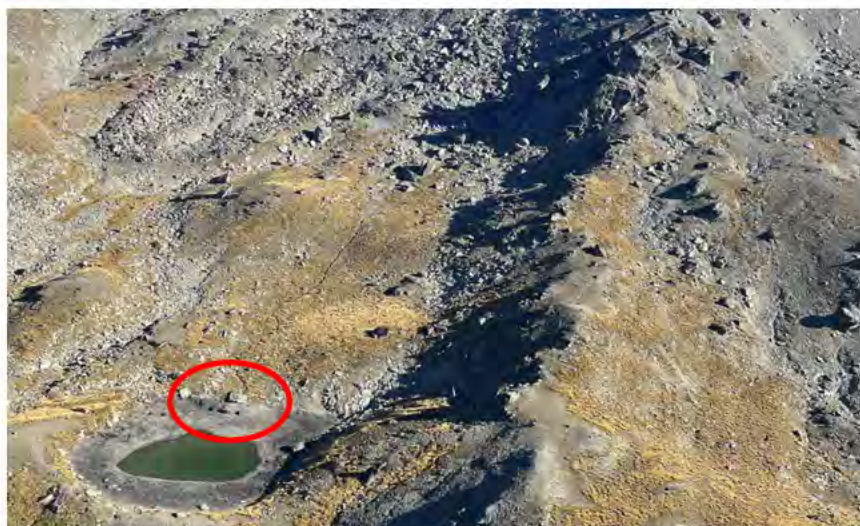
There is a boulder on the west shore of the tarn. It is likely that this fell from the slope above. Most previous rockfall has collected on the talus slope below the ridge line or on the terrace above the tarn. This is shown in the figure below.

Figure 48. Tarn area with Terrace above and rock which may have rolled to the tarn

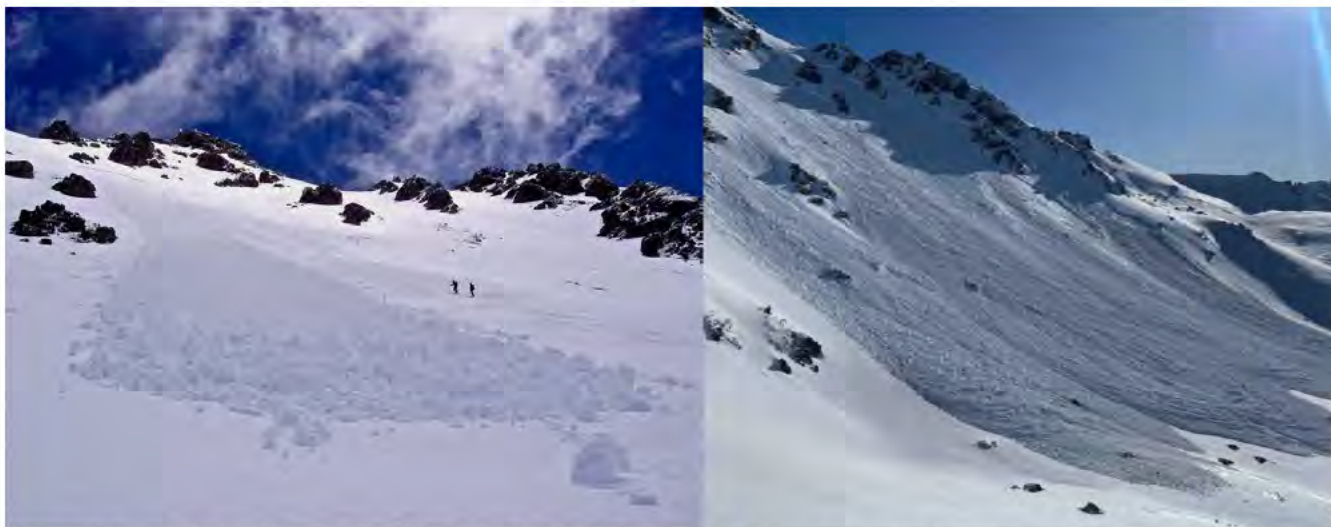
Figure 51. Spring and winter avalanches at 'Site B' into on the western side of the Upper Doolans Creek Right Branch.

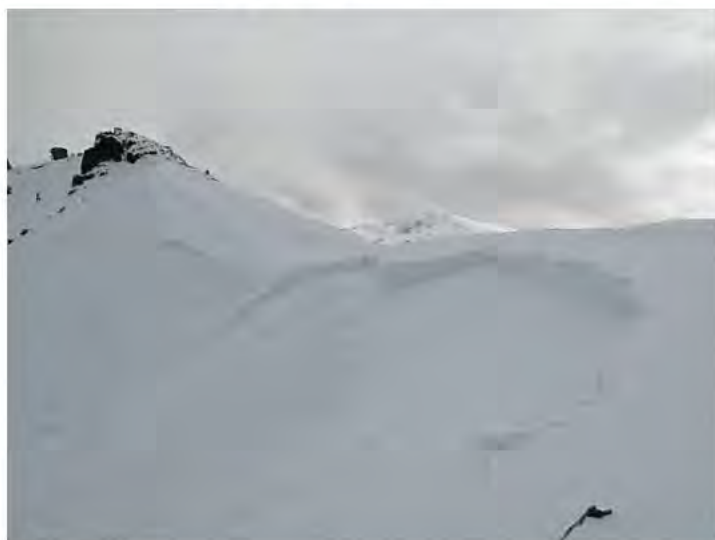
Figure 52. 'Site A' Lee slope slab avalanche from Helicopter Ridge near to the proposed mid station site.
