1 September 2025

Our Ref: 50197 - Rev.1

**RE: 6591 STATE HIGHWAY 8, TWIZEL, MACKENZIE DISTRICT
DUE DILIGENCE GEOTECHNICAL REPORT**

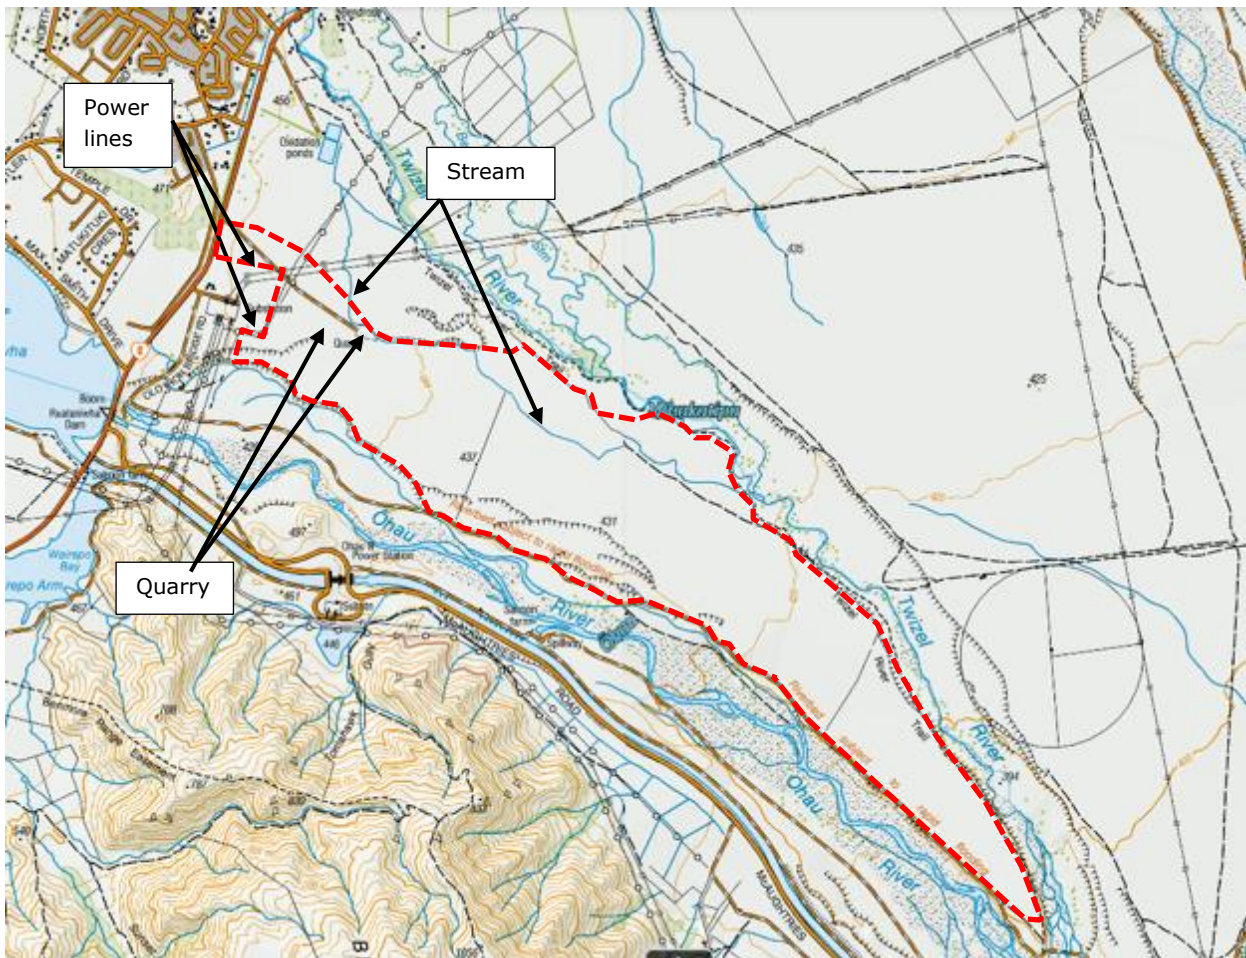
Figure 2: Excerpt from the NZ LINZ Topo Map

- The NZ LINZ Topo map indicates a stream course crosses the site, which appears to be associated with Oxidation ponds to the north.

In addition to the above, a stream is shown to transect the site on Figure 2. It is not known what feeds this stream (it appears to be the oxidation ponds to the north) and if it is prone to flooding or needs to be maintained post purchase of the site.

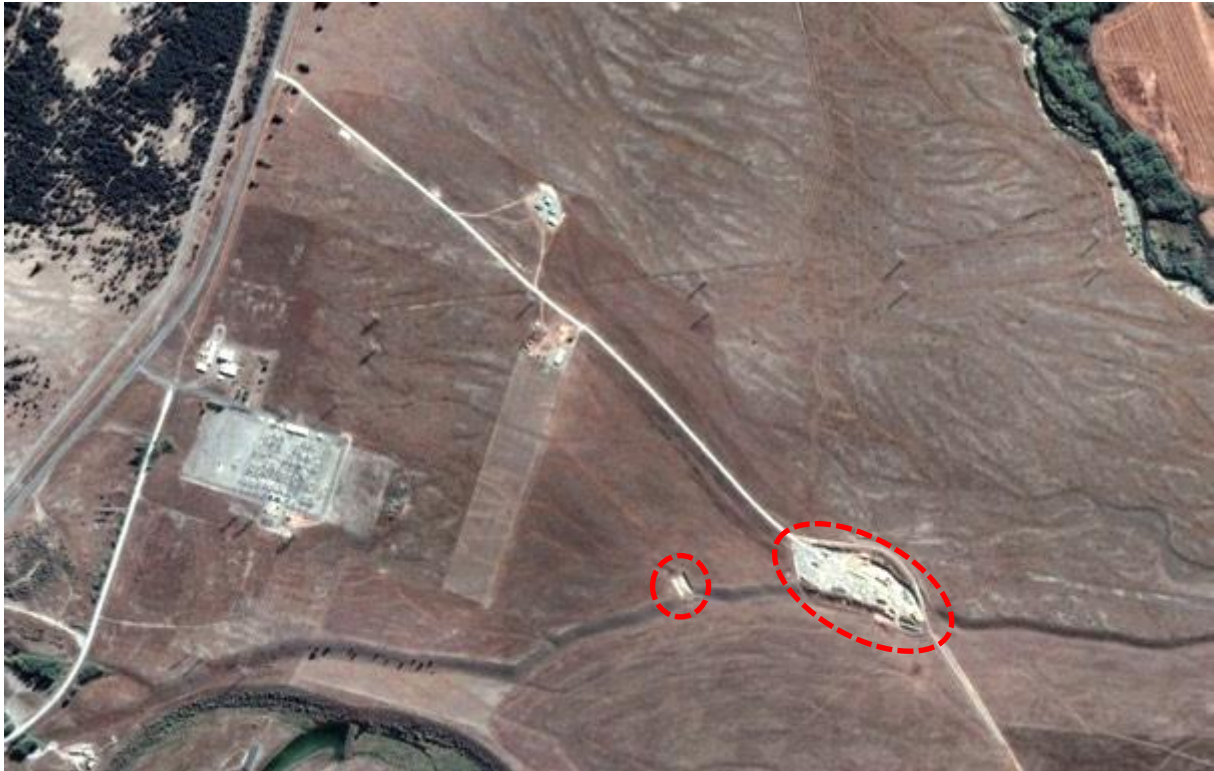
Figure 3: Aerial showing the Quarry Locations

- Two sets of high voltage electricity lines supported on pylons transect the northwest area of the site (Figure 2).
- Two quarries, understood to be operated by the SOL Group, are cut into the edge of one of the higher river terraces. It is understood that gravels are extracted and screened for the production of graded hardfill materials. The quarries are accessed via an unsealed track off State Highway 8 (Figure 2 and Figure 3).

Historical aerial photographs available on the New Zealand Historical Aerial Photo Database 'Retro Lens' and Google Earth have been reviewed by EDC for the years 1959 through to the present. Quarrying activities are not visible until 2016 and do not appear to include additional areas to the two identified on Figure 3.

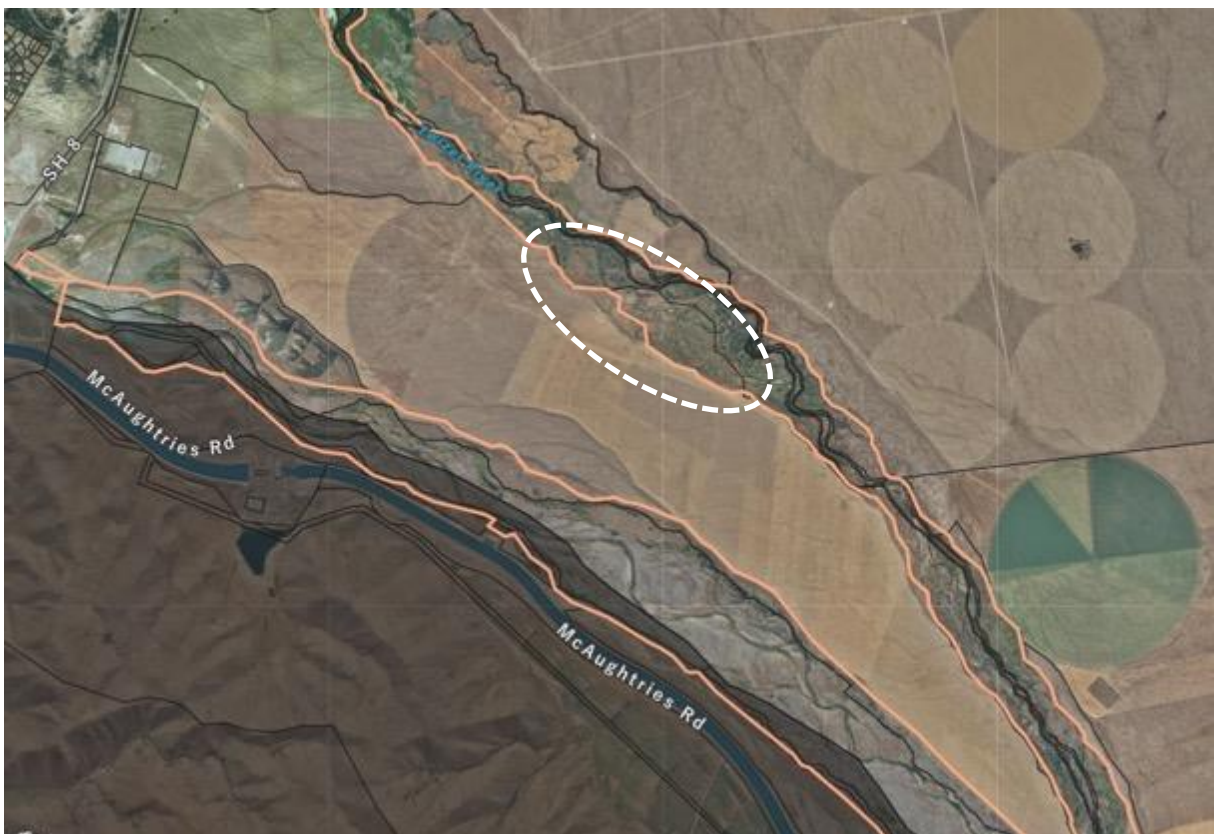
Figure 4: Mackenzie District Council Map Viewer Flood Protection Vegetation Boundary

- An approximately 36ha area on the northern side of the site appears to be at a lower level with increased vegetation than elsewhere, potentially within the flood plain to the Twizel River. This broadly coincides with an area designated on the Mackenzie District Council Map Viewer as Flood Protection Vegetation Boundary (a draft boundary line of areas of vegetation retained under the Soil Conservation and Rivers Control Act) (Figure 4).

It is not clear if the Flood Protection Vegetation Boundary presents a significant development constraint in that area (e.g. earthworks restrictions). It is also noted that this area and an additional area are within a Braided River Bird Habitat which may also restrict construction / earthworks activities.

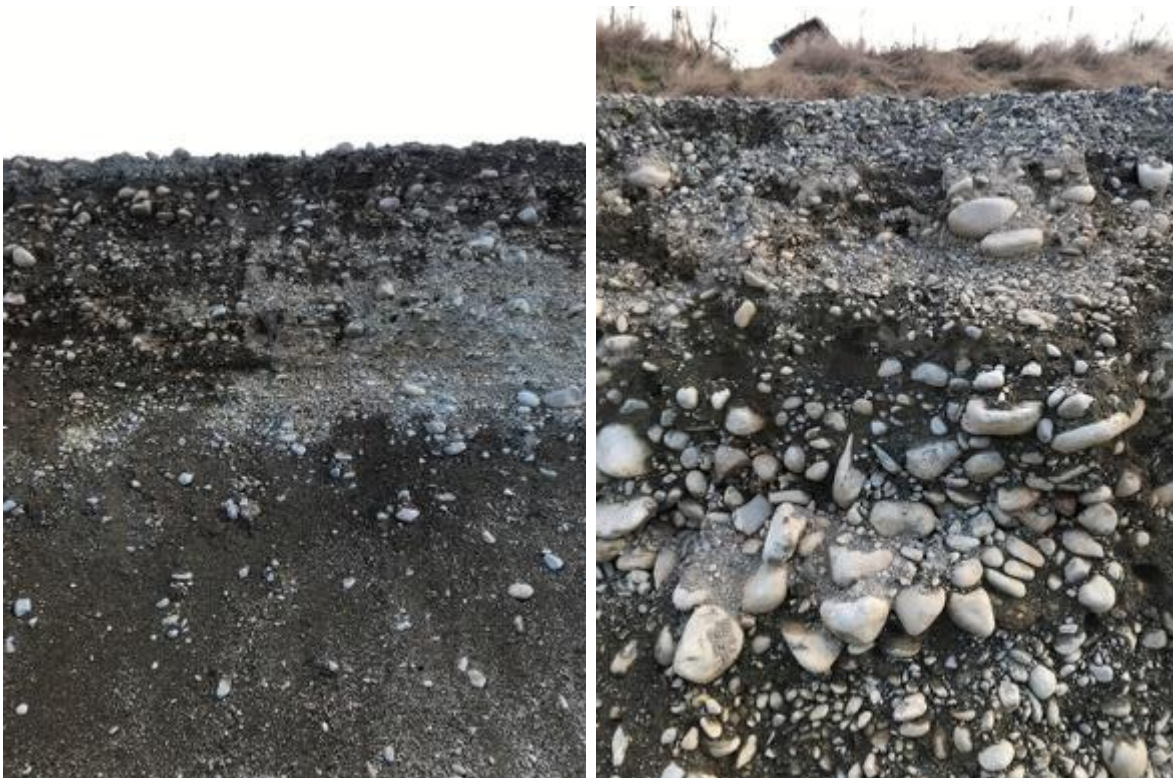
Figure 6: Client Photos from the Quarry Walls

Photos of the Q2a soils in the banks of the quarry were taken by the client during a visit to the site in September 2021 (Figure 6). These confirm the gravelly nature of the soils and of note indicate areas with frequent cobbles and boulders.

Constraint	Comment
High density ground with cobbles / boulders	<p>The limited available information suggests that the Q2a ground is likely to have high bearing capacity, which may present an abnormal constraint to the installation of driven C-piles to resist uplift on the solar panels due to the potential difficulty in driving the C-piles into a dense gravel and the probability of striking obstructions (cobbles or boulders). The Q1a material is likely to be less dense but may still contain cobbles and boulders.</p> <p>It is likely that there will be variability across the site rendering an assessment of cost risk difficult at this stage.</p>
Filled Ground	<p>No evidence of filled areas has been raised in this report. However, intrusive works have not been undertaken and it cannot however be discounted that localised unrecorded rubbish pits are possible. It is also</p>

1. A series of test pits be undertaken across the site in order to assess the consistency, strength and description of the shallow soils, and if developing within the soils mapped as Q1a (Figure 7), to confirm the presence of shallow ground water.
2. Whilst bearing capacity is not anticipated to be an issue for the relatively light weight solar panels, it is considered that the preferred method of driving 2mm thick C-piles to achieve the required uplift capacity may be problematic due to the anticipated high density of the ground and presence of cobbles/boulders. Therefore, it is recommended that test piling be undertaken across areas of the site to be developed. The test piles will assess the suitability of C-piles, test the pull-out capacity per length of pile. If necessary, these investigation works can be used to confirm the suitability of an alternative foundation solution.

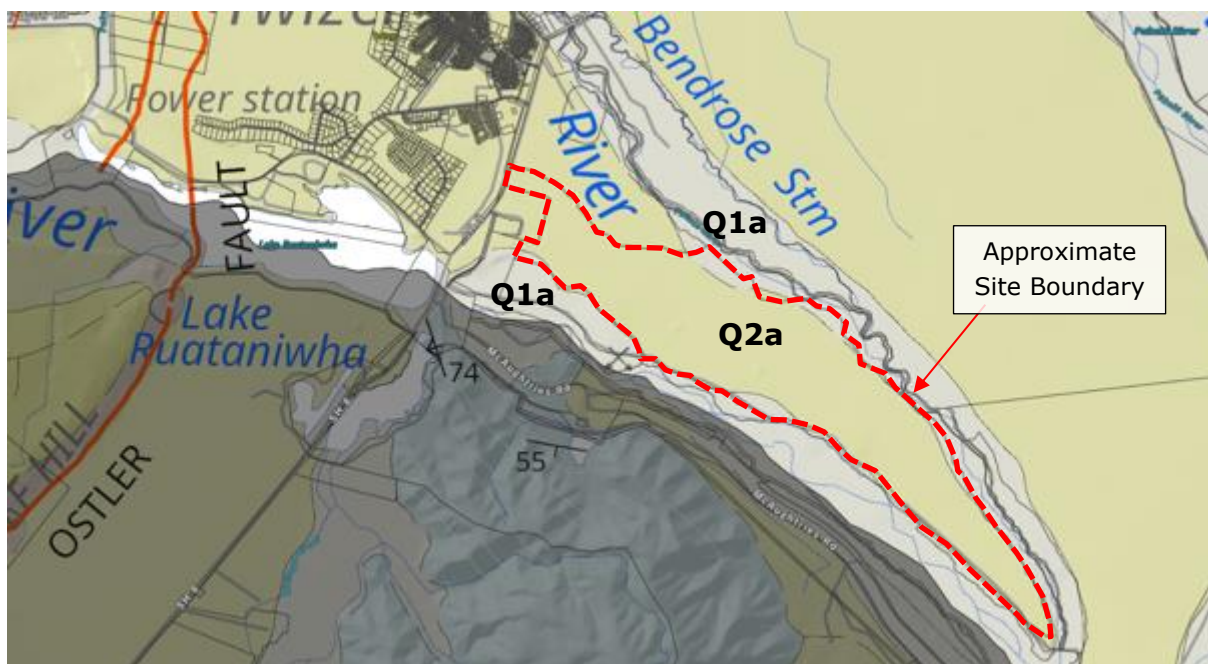
Figure 7: Excerpt from the GNS 1:250,000 Map

An excerpt from the GNS 1:250,000 map is shown in Figure 7. The active Ostler Fault is shown approximately 4km west of the site.

The 'New Zealand Active Fault Database' (Institute of Geological and Nuclear Sciences Limited, 2004) indicates that the nearest active fault is the Ostler Fault, located approximately 4km west of the site (Figure 7). The fault is an oblique strike-slip, with a moderate slip rate and recurrence interval of 2000 to 3500 years.

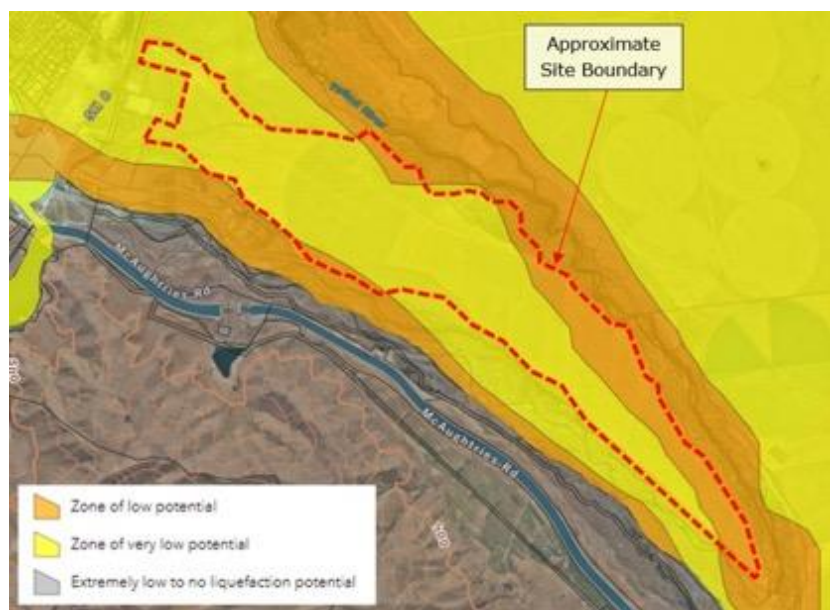
Figure 9: Map of liquefaction Susceptibility

The 'Waimata, Mackenzie and part Waitaki liquefaction susceptibility (2008)' map layer indicates that the site is located within an area as having 'very low' risk of liquefaction. The areas close to the Twizel River to the north, and the Ohau River, to the south, are shown to be at a 'low' risk of liquefaction (Figure 4). It is inferred that the Q2a deposits are those zoned 'very low potential' and the Q1a deposits 'low potential'.

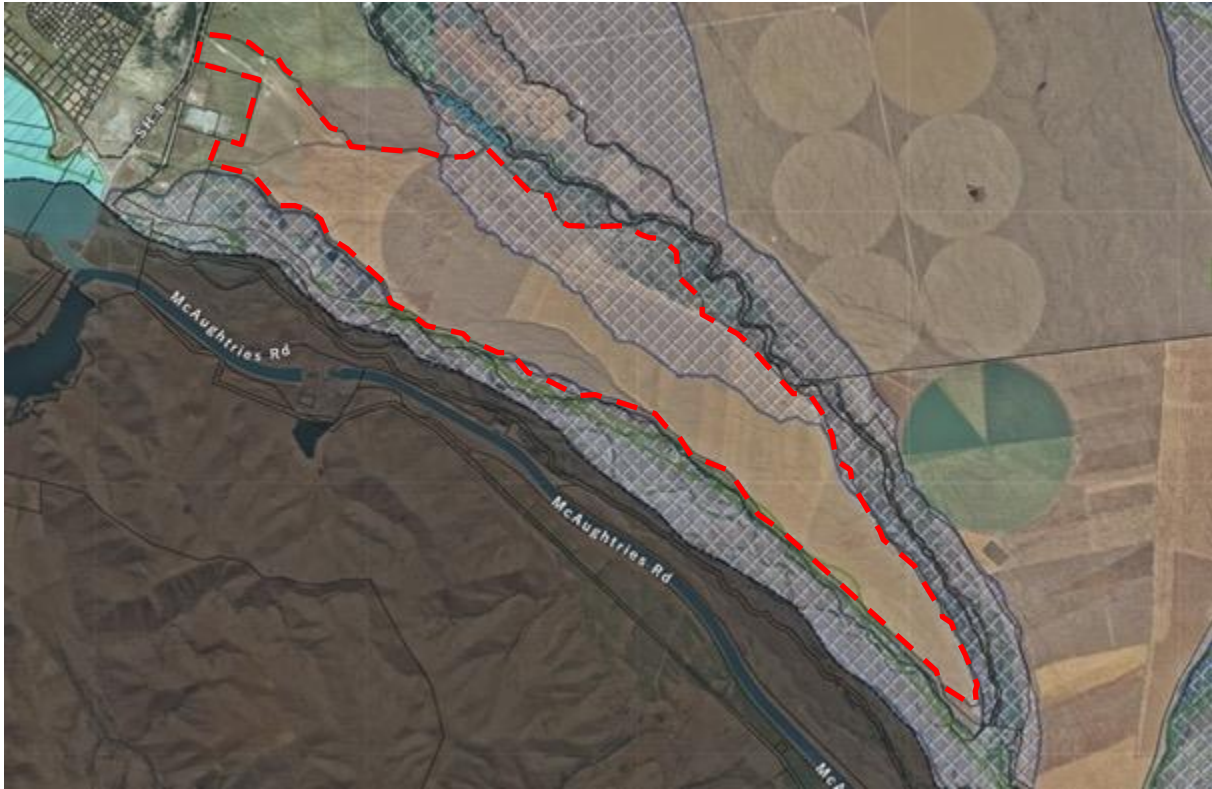
Figure 10: Excerpt from the Mackenzie District Council Map Viewer Operative District Plan Layer Showing the Hydro Electricity Inundation Hazard Areas

The Mackenzie District Council Map Viewer Operative District Plan layer does not indicate a potential flooding area to be on the site, though it indicates an area of the site is within an area zoned 'Hydro Electricity Inundation Hazard Area' (Figure 10).

The District Plan indicates that 'The Hydro-electricity inundation hazard areas are for District Plan purposes only and do not identify, warrant, or guarantee the safety of any area in the unlikely event of a dam or canal breach. Best practice methods have been used to identify all potentially affected areas, however actual areas affected could differ, for example if flow paths change due to landform changes'.
