# Bendigo-Ophir Gold Project Freshwater Ecological Assessment

**Santana Minerals Ltd  
Matakanui Gold Ltd**

*May 2023*

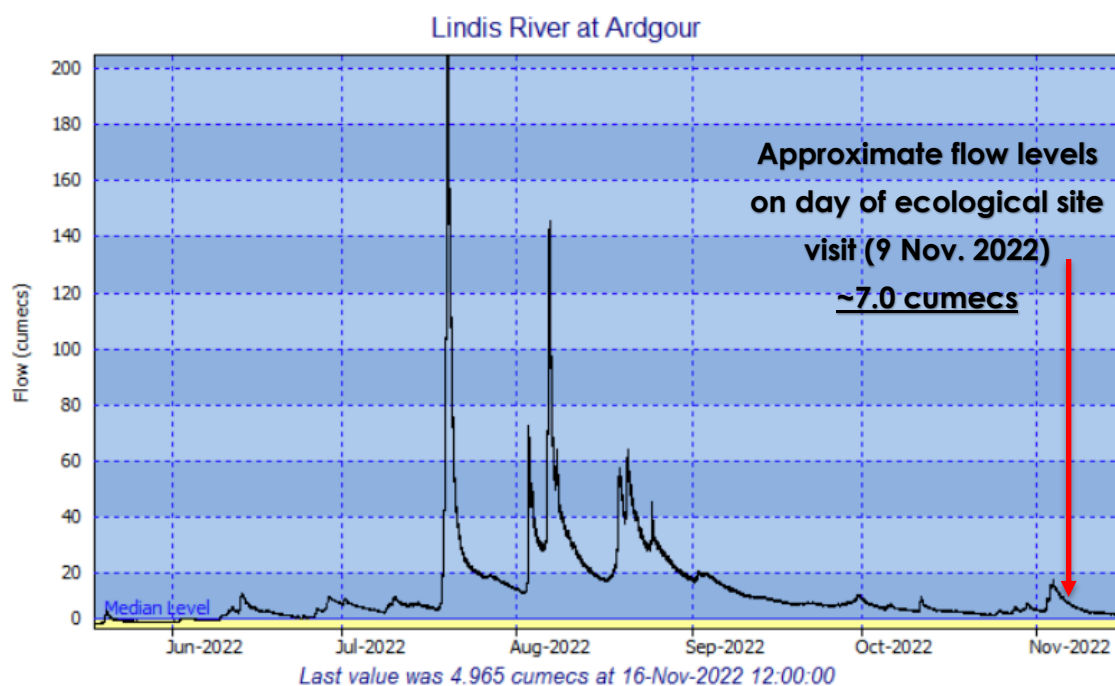
**Figure 3: Lindis River at Ardour Road: historical river levels ([www.orc.govt.nz/managing-our-environment/water/water-monitoring-and-alerts/upper-clutha/lindis-at-ardour](http://www.orc.govt.nz/managing-our-environment/water/water-monitoring-and-alerts/upper-clutha/lindis-at-ardour)).**

As a proxy for rainfall and historical river levels in the area, the Otago Regional Council (ORC) measures flow in cumecs at the Lindis River at Ardgour Road, approximately 5.7 km away (Figure 3). At the day of site visit (9 November 2022) the flow was approximately 7 cumecs, and the median flow for this site is 3.5 cumecs (ORC, 20220).

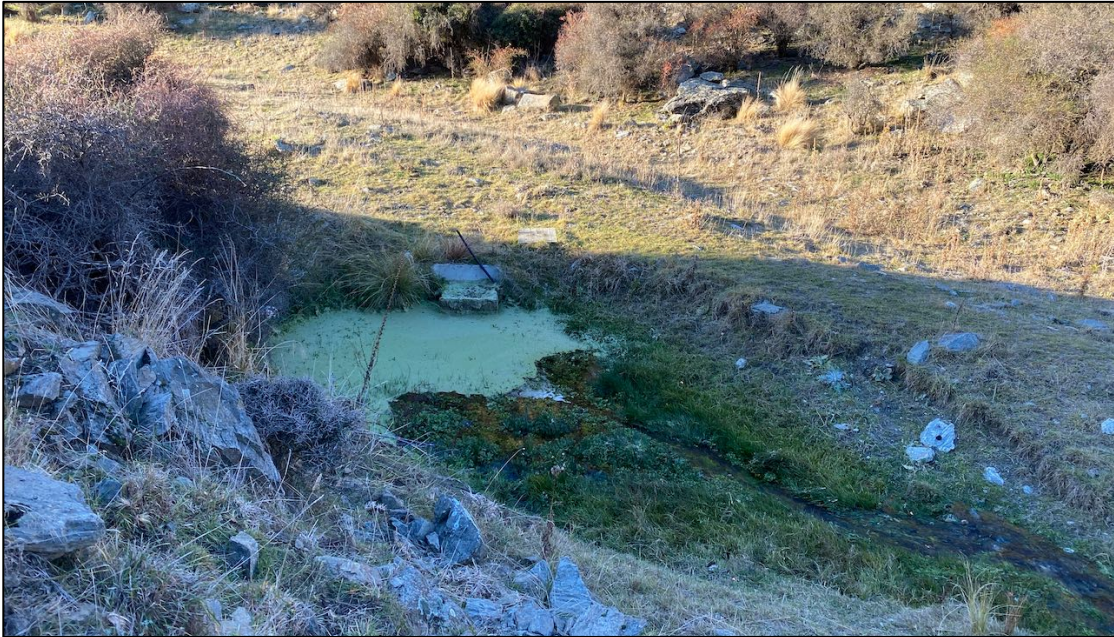
**Figure 4: Lower Shepherds Creek irrigation weir at 100% capture.**

Sample SC1 (Figure 9) was located within lower Shepherds Creek, downstream of the potential Phase 1 site and just upstream of the irrigation water take shown in Figure 4. The upstream catchment area from station SC1 is 12.18 km<sup>2</sup>. SC1 was sampled in a channelised riffle/run, adjacent to a wetted area, meandering through the valley floor. The sample was collected at the maximum creek depth of 22 cm, with an overall creek width of 70 cm and a wetted width of over 3 m. Sample substrate consisted of 80% gravels and 20% sand/silts, loosely compacted. Water clarity was clear with no noticeable odour. Riparian vegetation consisted of grasses, mixed shrubs and Matagouri (*Discaria toumatou*) nearby. Periphyton was sparse with dense macrophytes observed. Submerged grasses and roots lined the creek bank, indicating moderate base flow conditions (see Figure 3 for relative flow scale). Stock access to the creek was apparent.

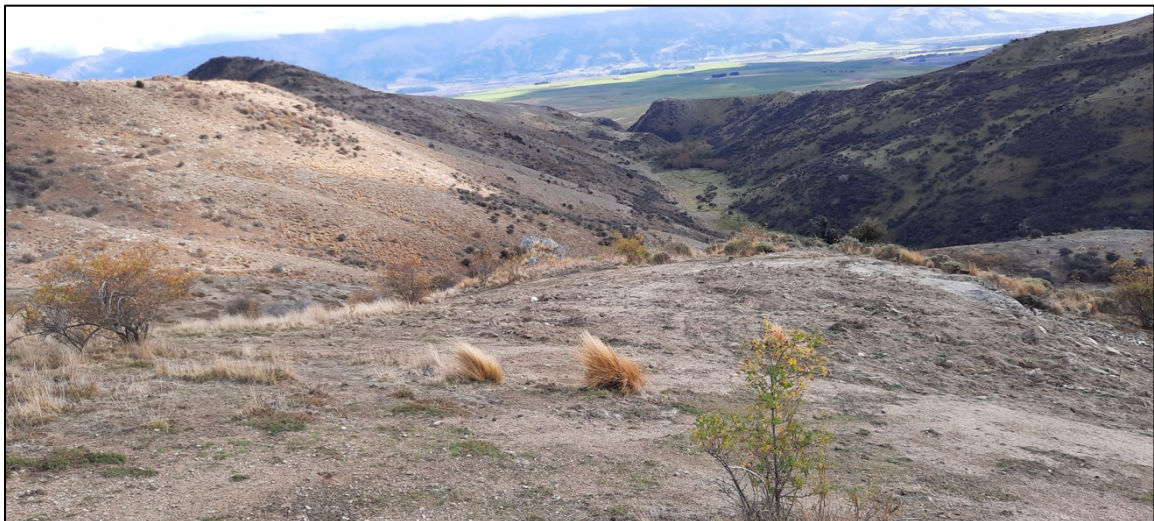
**Figure 5: Come-in-Time prospect site on left of photo and Shepherds Creek Valley looking northwest with the Bendigo Terrace in the distance (4 July 2022).**

The site is located on the northeast side of Lake Dunstan in the Dunstan Mountains with catchments open to the northwest onto the intervening fluvio-glacial sediments of the Cromwell-Tarras valley. Flow rates for the tributaries are not known; however, the creeks are likely to fluctuate strongly and exhibit a wide range of seasonal and spatial variability in baseflow and stormflow and response to rain events. The landscape is strongly water limited with excess energy available for evapotranspiration leading to a semi-arid to arid landscape (Figure 5), likely modest rates of groundwater recharge, and low streamflow per unit area (yield) (e3s, 2022).

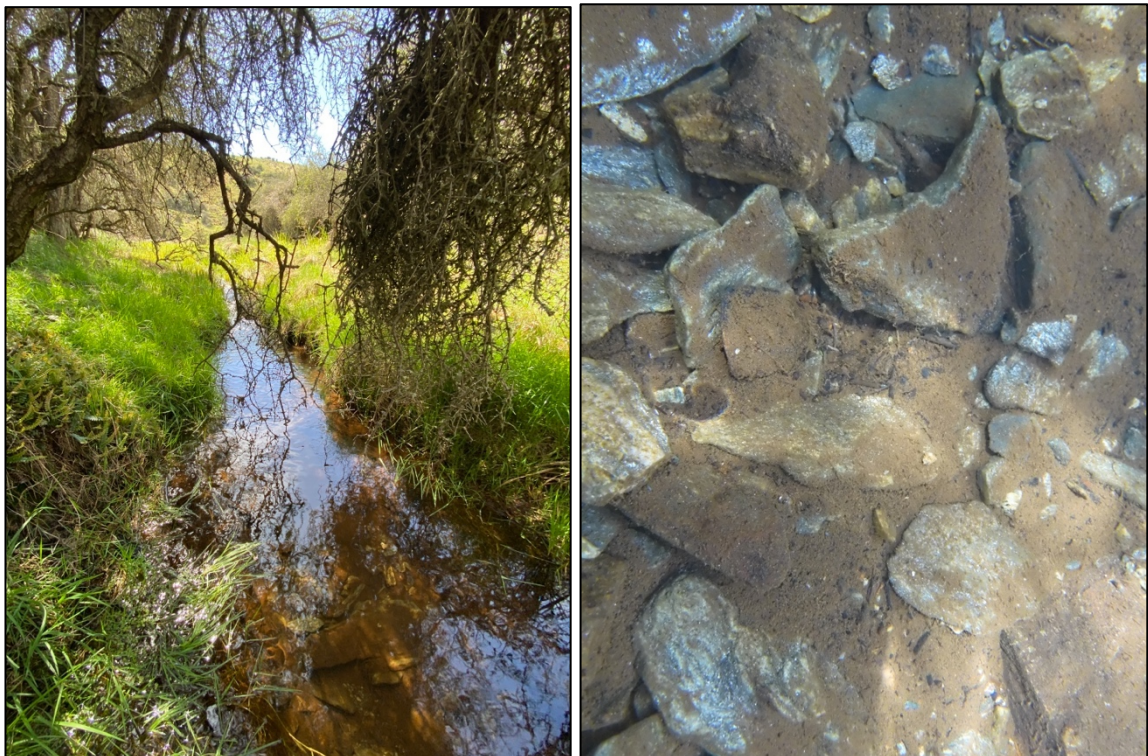
**Figure 7: Site RS1 looking upstream (left) and benthic substrate (right).**

RS1 (Figure 7) was sampled within Rise & Shine Creek, a tributary of the larger Bendigo Creek. This site was located on the downstream edge of the potential Phase 1 exploration site (Rise & Shine). The upstream catchment area from station RS1 is 4.33 km<sup>2</sup>. RS1 was sampled in a run just downstream from a riffle and small waterfall (40 cm). The sample was collected at the maximum creek depth of 20 cm, with an overall creek width of 1 m and a wetted width of 2 m. Sample substrate consisted of 30% cobbles, 60% gravels and 10% sand/silts, loosely compacted. Water clarity was clear (~80%) with no noticeable odour or tannins and riparian vegetation mostly shaded (80%) this area. Riparian vegetation consisted of rank grasses and scattered ferns within a dense Matagouri (*Discaria toumatou*) grove. Periphyton was common (>60%) with no macrophytes present. Submerged grasses and roots lined the creek bank, indicating moderate base flow conditions (see Figure 3 for relative flow scale). Stock access was apparent.

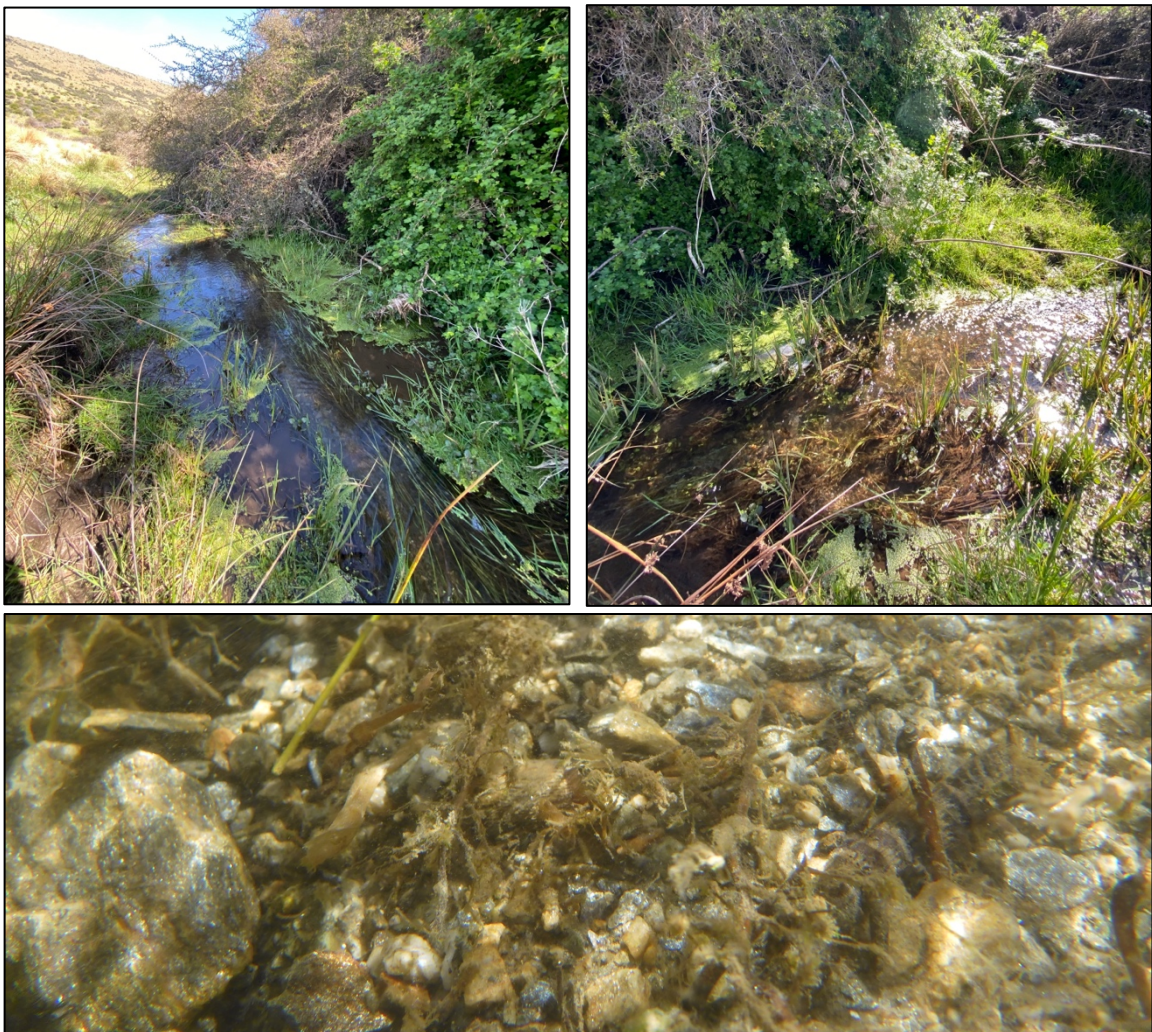
**Figure 8: Site RS2. Downstream (top left), upstream (top right), benthic substrate (bottom).**

Sample RS2 (Figure 8) was also located within Rise & Shine Creek, upstream from RS1 and the potential Phase 1 site footprint. The upstream catchment area from station RS2 is 2.97 km<sup>2</sup>. The sample collected was an aggregate of two sites, with the second located approximately 25 m upstream in similar habitat. Both were sampled in a fast run at the maximum creek depth of 9 cm, with an overall creek width of 90 cm and a wetted width of 140 cm. Sample substrate consisted of 60% gravels and 40% sand/silts, loosely compacted. Water clarity was clear (~80%) with no noticeable odour or tannins and riparian vegetation partially shaded (50%) most of this area. Riparian vegetation consisted of mainly rank grasses, with shrubland to the north consisting of mixed Matagouri (*Discaria toumatou*) and *Carex secta* scattered throughout. Sparse periphyton was noted with scattered macrophytes mixed with submerged grasses and roots, indicating moderate base flow conditions (see Figure 3 for relative flow scale). Stock access was apparent.

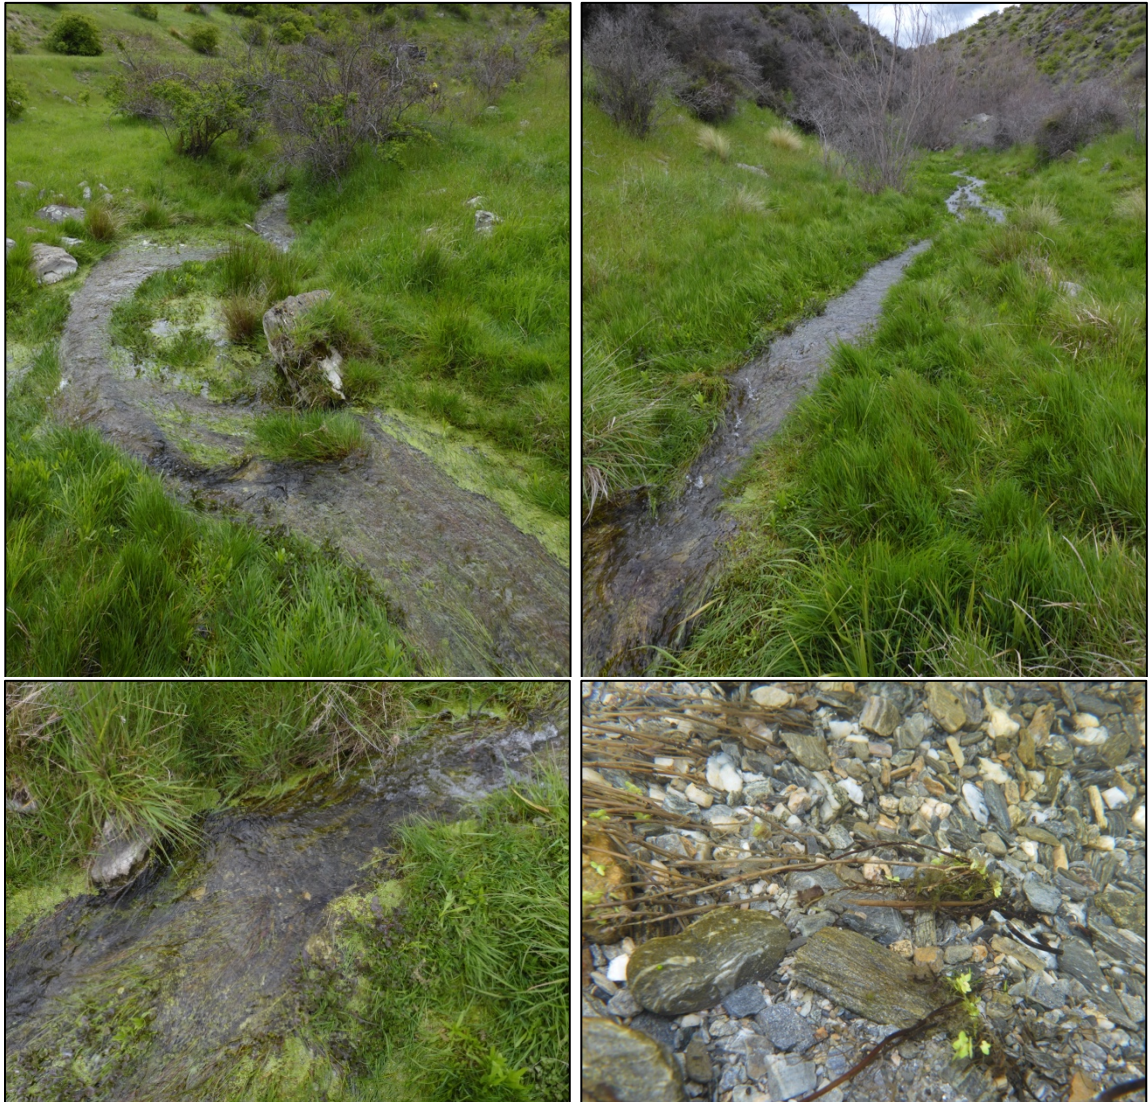
**Figure 9: Sample SC1. Top row (left to right): looking downstream, looking upstream. Bottom row (left to right): sample site, benthic substrate.**

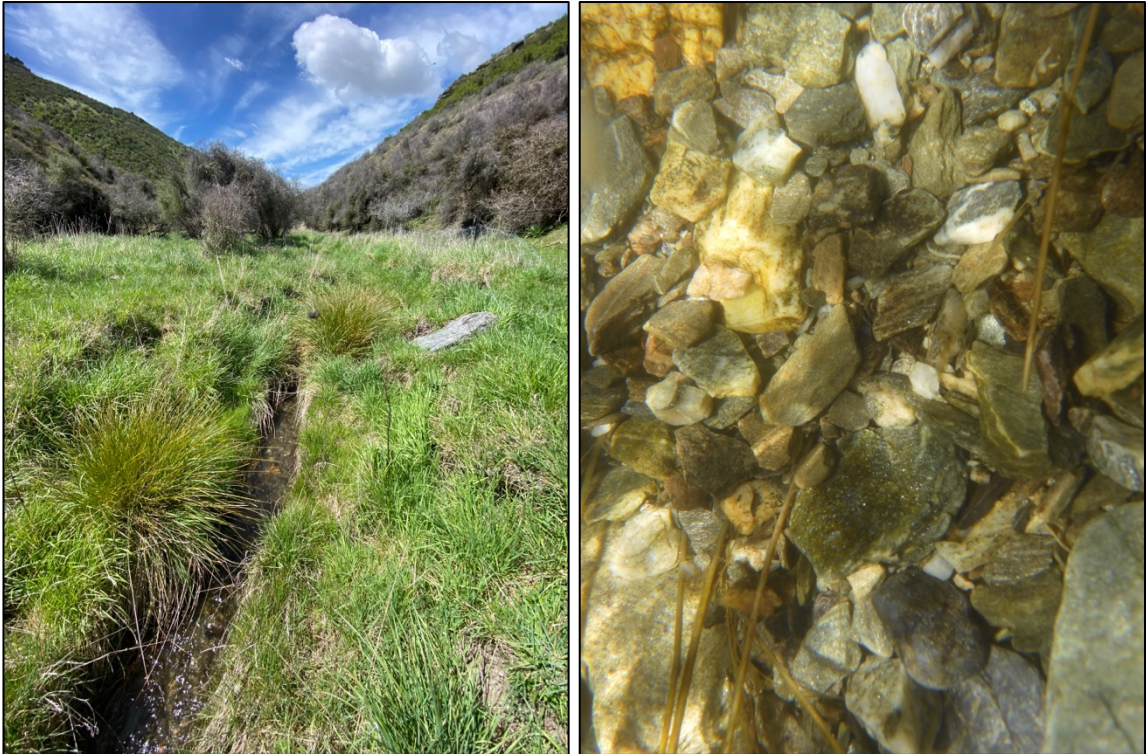
**Figure 11: Site SC3. Upstream (left), benthic substrate (right).**

Sample SC3 (Figure 11) was located within Shepherds Creek upstream of the potential Phase 1 site. The upstream catchment area from station SC3 is 7.92 km<sup>2</sup>. SC3 was sampled in a narrow and channelised riffle, meandering through the valley floor. The sample was collected at the maximum creek depth of 10 cm, with an overall creek width of 60 cm and a wetted width of ~1 m. Sample substrate consisted of 10% cobbles, 80% gravels and 10% sand/silts, loosely compacted. Water clarity was clear with no noticeable odour or tannins and the area was generally exposed with shading only due to the deep channel of the creek. Riparian vegetation consisted of rank grasses and scattered *Carex secta* with mixed shrubs and Matagouri (*Discaria toumatou*) nearby. Periphyton was common (>60%) on roots with no macrophytes observed. Submerged grasses and roots lined the creek bank, indicating moderate base flow conditions (see Figure 3 for relative flow scale). Stock access to the creek was apparent.

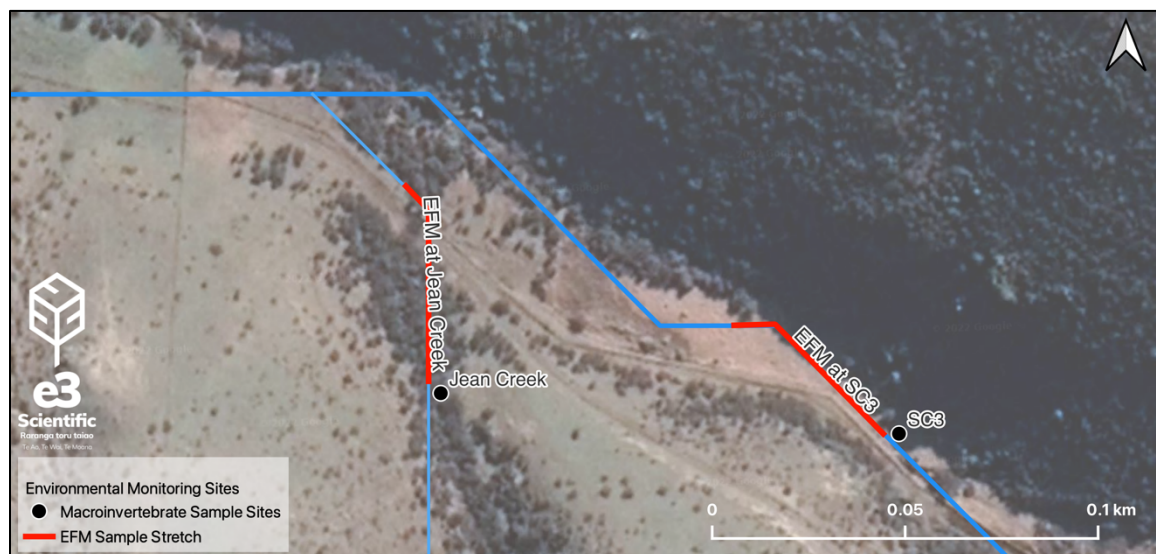
**Figure 13: EFM sampling stretch example for upper Shepherds Creek (site SC3 and Jean Creek). EFM sampling was conducted for 50 m stretches downstream from the identified macroinvertebrate sample sites.**

At each ecological monitoring site (see Figure 6), a stretch of approximately 50 m was sampled downstream from the recorded site GPS waypoint (as seen in Figure 13). Although a continuous stretch of fishing was attempted, this was not always possible due to topography and dense vegetation at spots. All sites were fished prior to any instream macroinvertebrate sampling and any macroinvertebrates

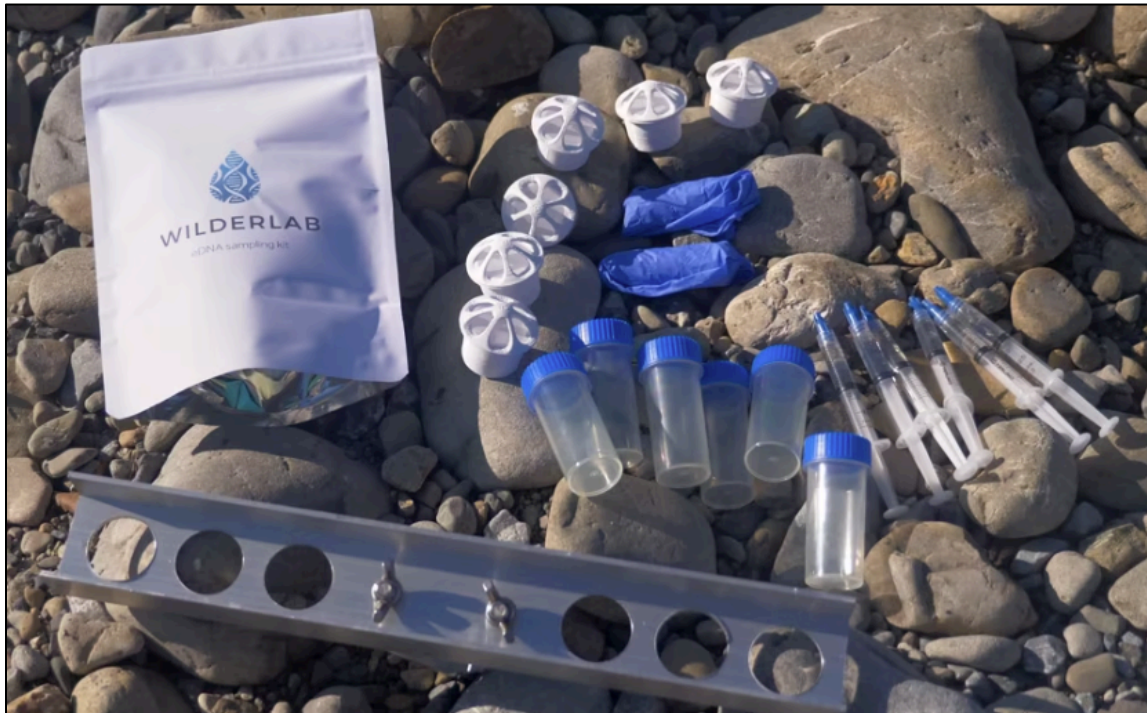
**Figure 14: WilderLab passive eDNA sampling kit (WilderLab, 2022).**

eDNA sampling and analysis was completed through WilderLab NZ Ltd ([www.wilderlab.co.nz](http://www.wilderlab.co.nz)). WilderLab provides pre-packaged eDNA sampling kits (Figure 14) and post-sample analysis. For all eDNA analysis, the 'basic' analysis package was used. WilderLab's eDNA metabarcoding produces a list of *"all DNA sequences detected within a broad taxonomic group (e.g. fish, insects, birds, mammals) and the number of times each appears in the sample. The DNA sequences are then compared against a reference database to assign species names and characterise the community as a whole. This method requires an extensively tested set of PCR 'primers' and a well-curated reference database. [WilderLab] has developed and optimised a suite of primers especially suited to New Zealand's unique flora and fauna, and curated an extensive reference database for each of these assays using data from both public and private sequence repositories (WilderLab, 2022)."* (Appendix A)

Passive eDNA samplers (Figure 14 & Figure 15) were used alongside electric fishing effort to provide additional accuracy in assessing presence or absence of fish populations within both Shepherds and Bendigo Creeks. Full eDNA analysis results are provided in Appendix C. No fish species were found within Shepherds nor Rise and Shine Creeks. Fish species were only identified within lower Bendigo Creek (Figure 7; eDNA-1 A & B) below the proposed works area. Fish species that were identified within these two lower Bendigo Creek samples include kōaro (*Galaxias brevipinnis*), unidentified galaxiid species and brown trout (*Salmo trutta*). At this location, the three fish species were identified during both (separate) sampling events. Based on these results it appears that the fish species identified via eDNA in lower Bendigo Creek are most likely not originating from the Rise and Shine Creek catchment and this stream, along with Shepherds Creek, does not currently support fish species.

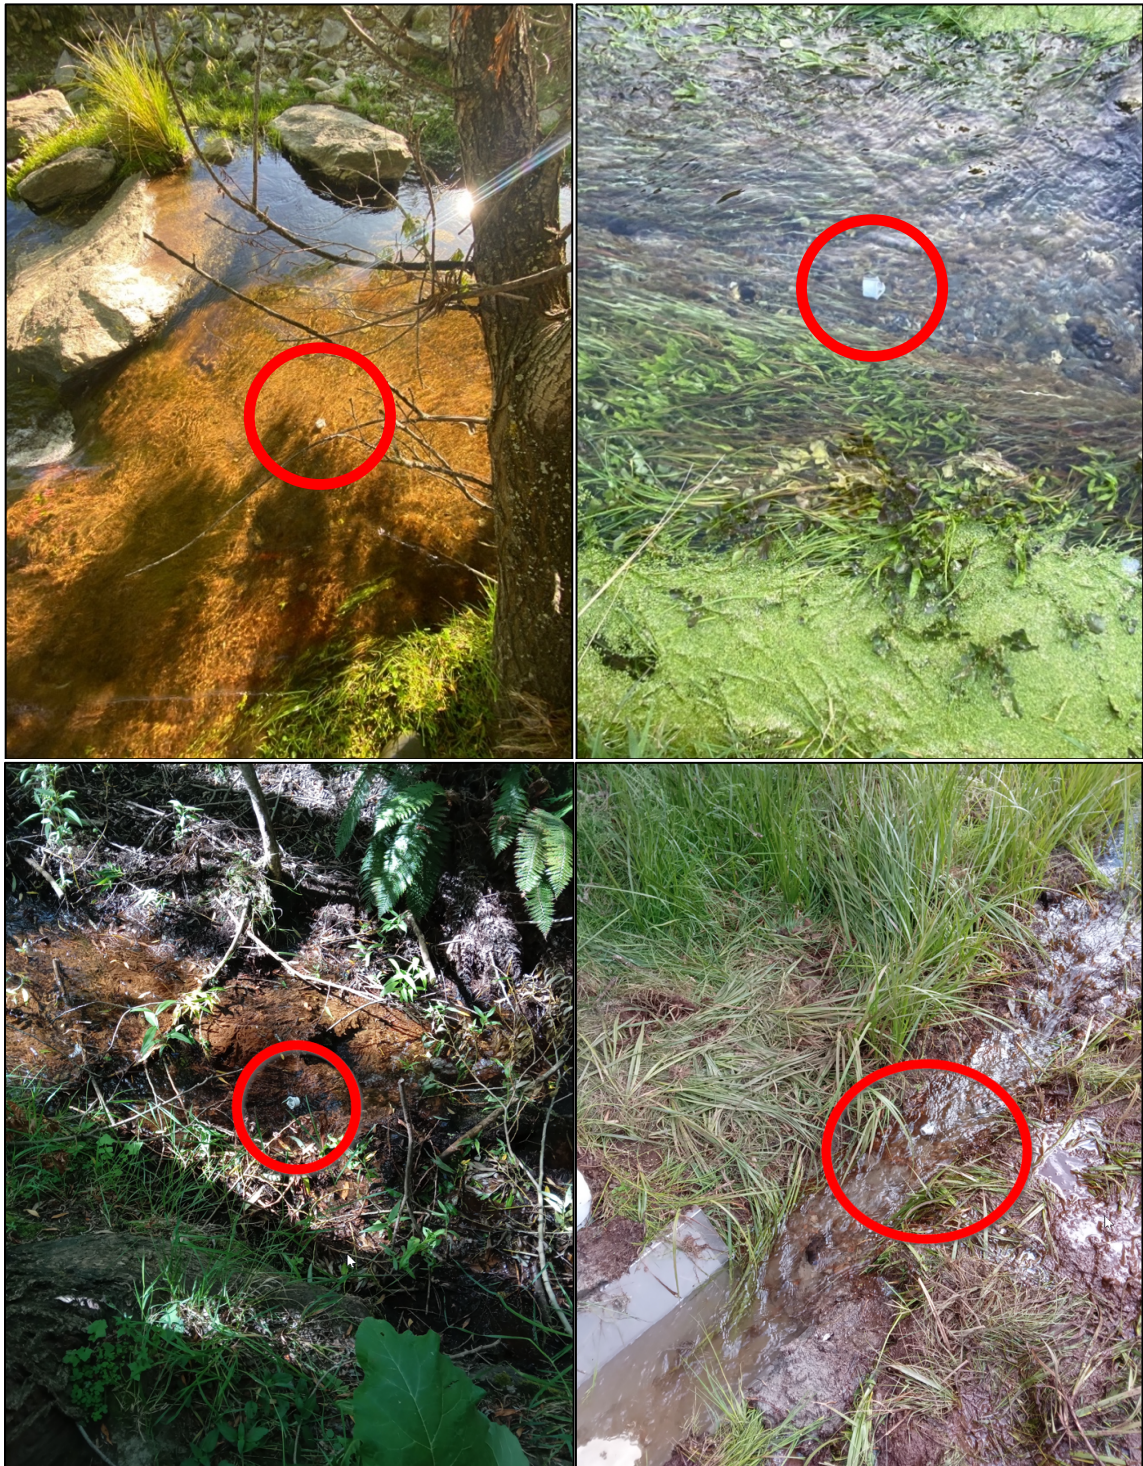
**Figure 15: WilderLab eDNA passive sample kits (circled in red) deployed at Bendigo Creek (top left), Shepherds Creek (top right), \*Alta (upper Bendigo) (lower left), and \*Rise & Shine at RS1 (lower right). \*Samples and images collected/attained by Matakanui Gold.**

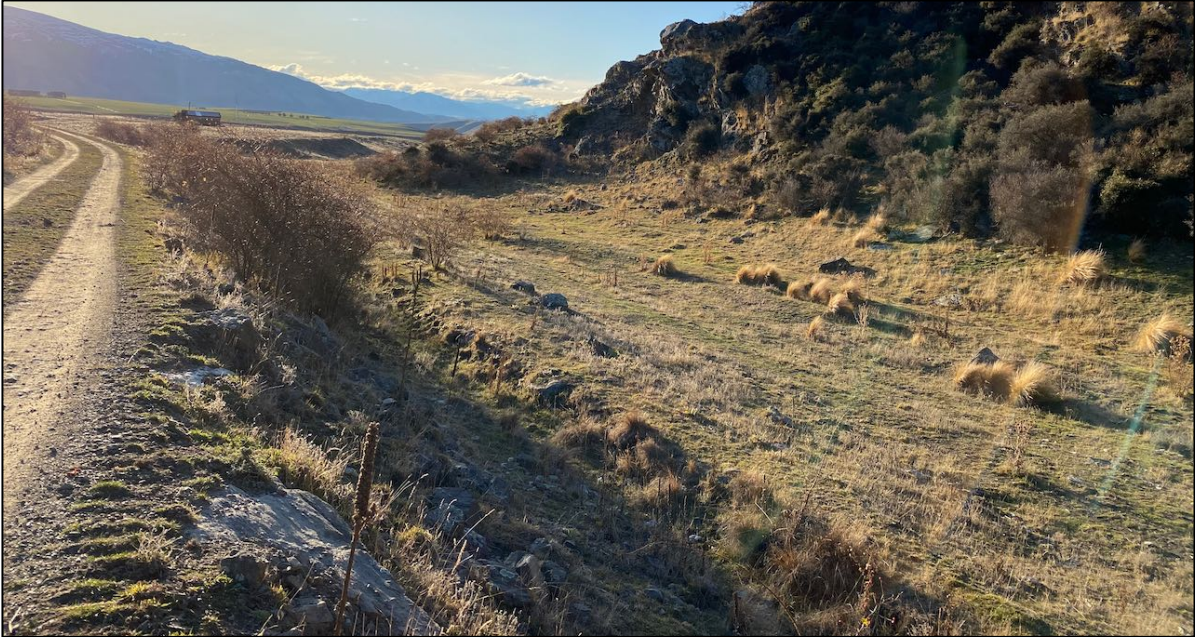
**Figure 20: Shepherds Creek below the weir and SC1 monitoring site with no overland water flow.**

At the time of observation, no connectivity was present in Shepherds Creek, with a dry creek bed found below the base of the Dunstan range (see Figure 20). As discussed in Section 2.1, surface flow and overall stream connectivity is considered highly variable, seasonal and rainfall-dependant. Despite this, surface water connectivity for both networks is historically evident in erosional pathways and terrain analysis.

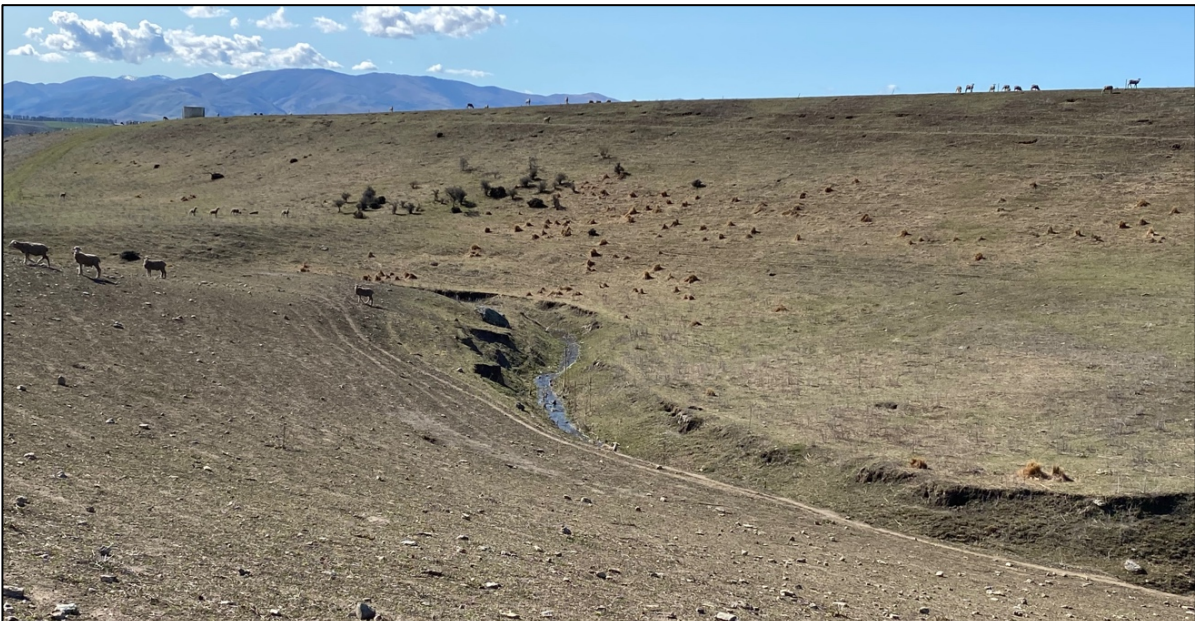
**Figure 21: Shepherds Creek (on 22 September 2022) below the weir and SC1 monitoring station.**

During one of the monthly water quality assessments on 22 September 2022, e3s hydrologists did observe surface flow below the Shepherds Creek weir (Figure 21). Due to private property and inaccessibility, e3s was unable to assess how far down surface flows went during this time; however, it is highly unlikely this surface flow continued to the confluence with the Lindis River.

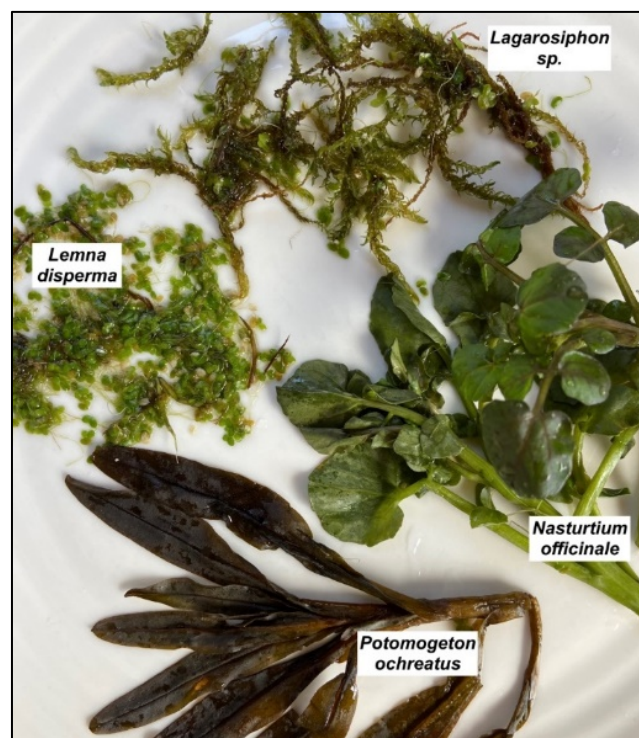
**Figure 22: Macrophytes (submerged vascular plants) of Bendigo and Shepherds Creeks.**

1. Exotic watercress (*Nasturtium officinale*),
2. Native – Not Threatened blunt pondweed (*Potamogeton ochreatus*)
3. Native – Not Threatened Duckweed (*Lemna disperma*)
4. Exotic Lagarosiphon spp. (*Lagarosiphon major*),

The lower reaches of Shepherds Creek, in the vicinity of monitoring station SC1, contained all macrophyte species. Duckweed occurred sporadically at slow moving sections on the lower sections and *Lagarosiphon* tended to correlate with larger rocky substrates. Watercress was moderately common and consistent upstream and other species could be considered sparse or non-existent upstream. At nearly all observed locations grass and grass roots were submerged within the water, indicating relatively high, or above average water levels at time of survey.
