Kings Quarry Stage 2 Expansion

Freshwater Ecology Residual Effects Analysis Report

for: Kings Quarry Limited

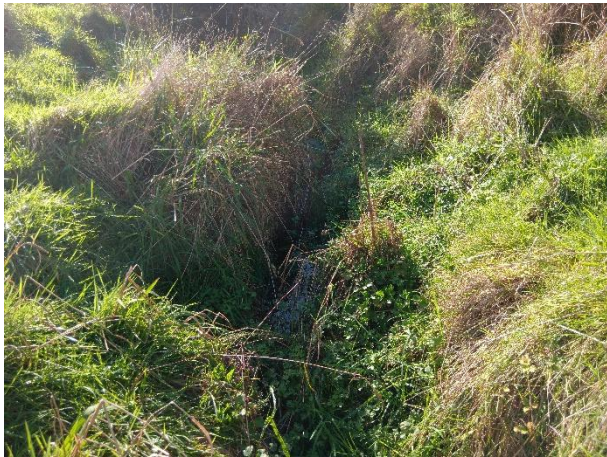
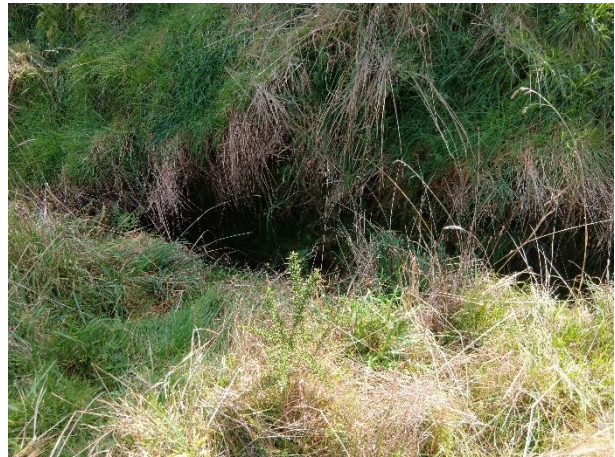
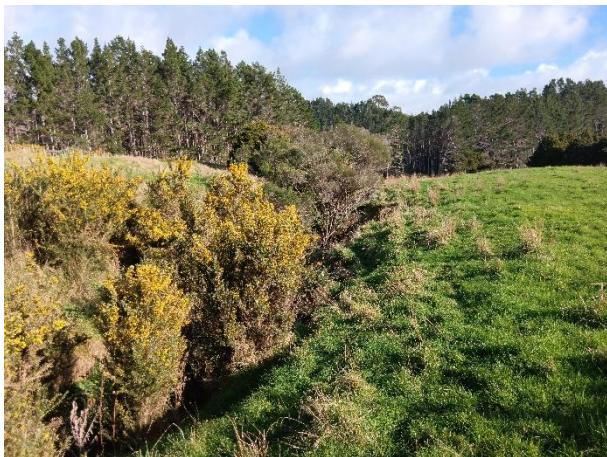
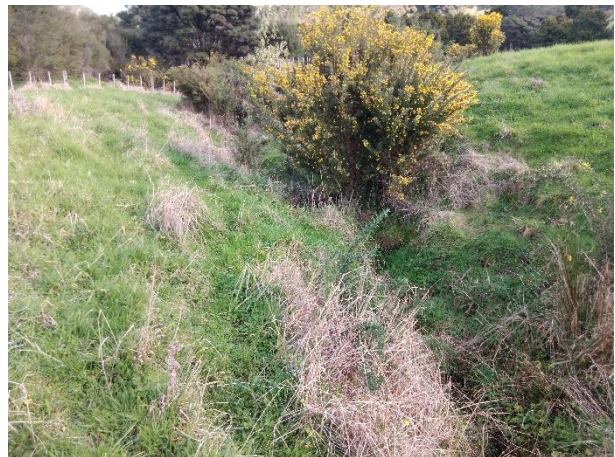
SEV1 was undertaken on intermittent Stream 1a, and used as a representative assessment of Stream 1b, as both watercourses share comparable channel characteristics, stream classification and surrounding land use (Photo 1 to Photo 4).

Photo 1. Stream 1a

Photo 2. Stream 1b

Photo 3. Stream 1a

Photo 4. Stream 1b

The intermittent streams had an average width of 0.57m (0.24 m – 0.83 m) and an average depth of 0.08 m (0.01 m – 0.17m), with water slow flowing. The banks were highly incised throughout the entirety of both reaches restricting connectivity to the floodplain, with the exception of the headwaters which showed evidence of bank collapse due to stock access.

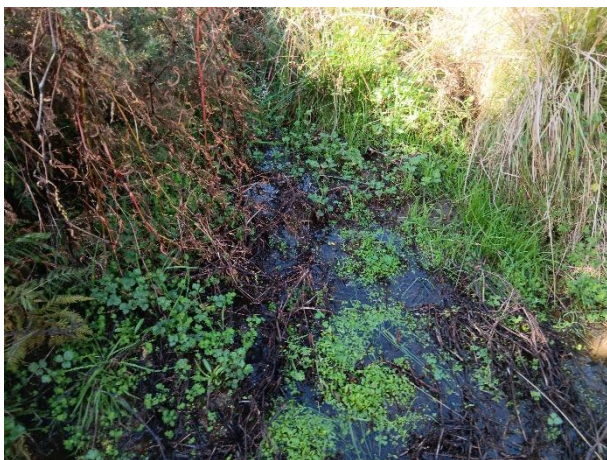
Photo 5. Macrophyte cover

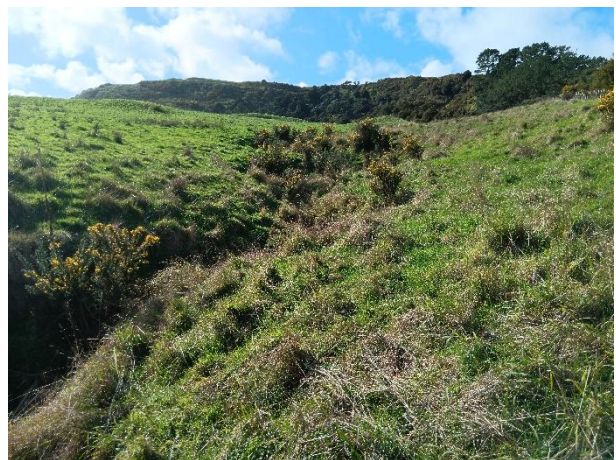
Photo 6. Topography and bank incision provided good shade.

The riparian yard of Stream 1a and 1b was poor, and consisted of rank pasture grasses, and gorse with a small stand of native trees present on the downstream reach. This low-quality riparian yard provided very low riparian yard functions such as filtration and bank stability. However, the topography of the site and channel incision provided good shade to the length of the reach (Photo 6).

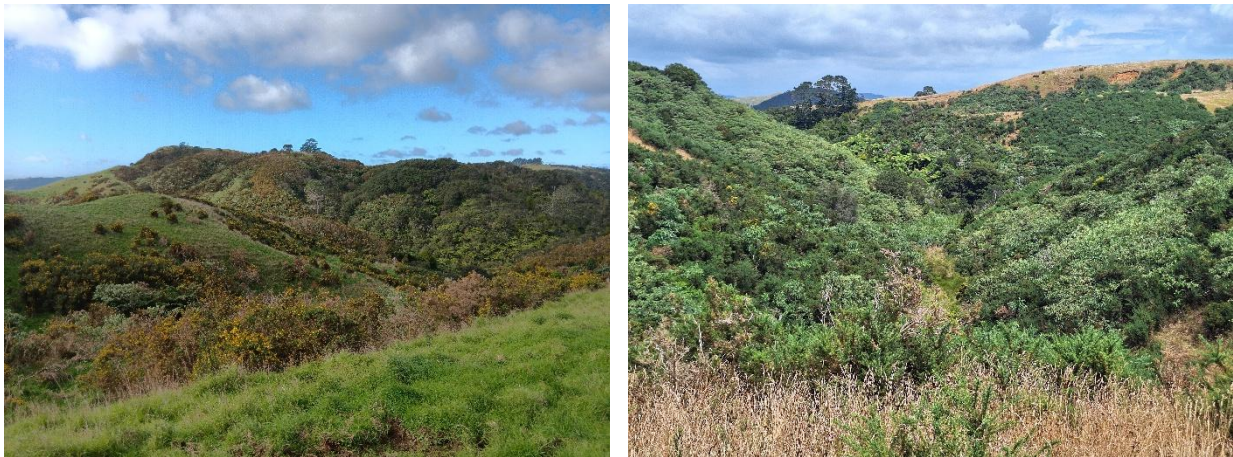
Photo 7 & Photo 8. Extent of gorse and noxious vegetation restricting access through Stream 2's catchment

The catchment of Stream 2 is located on the eastern side of the site, where dense gorse is present (Figure 4; Photo 7 & Photo 8). SEV2 was able to be undertaken in an area where gorse density was lower, on intermittent Stream 2a. This assessment is considered representative of 1,038 m of stream present throughout this catchment (Stream 2a – 2g).

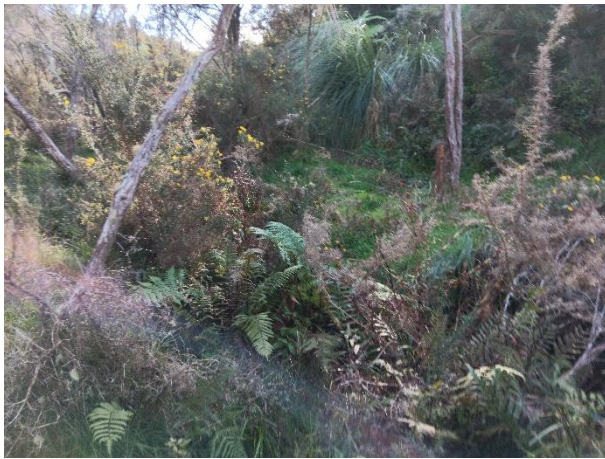
Photo 9. Primarily exotic riparian yard.

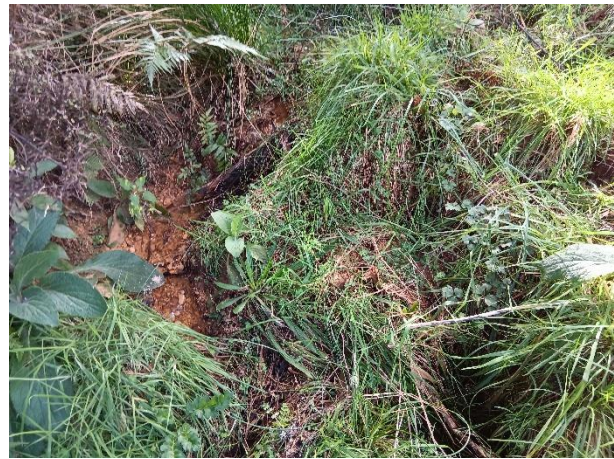
Photo 10. Bank slumping and damage present in the reach

Stream 2a had an average width of 0.34 m (0.18 m– 0.49 m), and an average depth of 0.04 m (0.02 m – 0.14 m). The assessed reach (SEV2) was heavily impacted by stock access and pugging, resulting in bank slumping and sediment deposition into the channel, which restricts natural water flow in some sections of the reach (Photo 10). Despite these impacts, the overall shallow banks provided some connectivity to the floodplain.

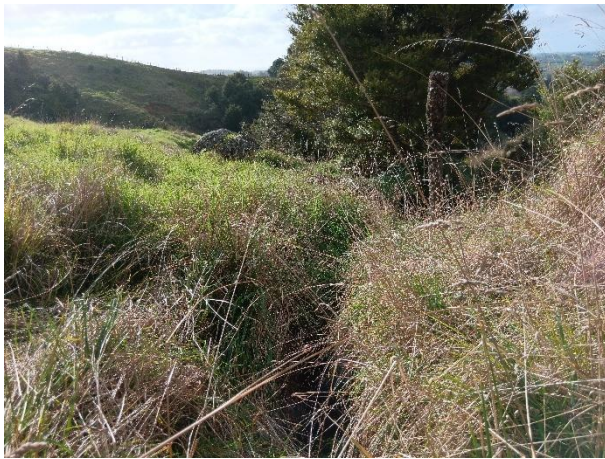
Photo 11. Stream 3a and 3b had highly incised banks.

Stream 3a had an average width of 0.45 m (0.12 m – 0.50 m), with an average water depth of 0.04 m (0.02 m – 0.18 m). Similarly, to Stream 1a, Stream 3a contained highly incised stream banks (Photo 11), restricting connectivity to the floodplain and it is likely all flows would be contained within the channel. The dominant substrate throughout SEV3 was silts, however a good proportion of rocky substrates and bedrock was present throughout. This indicates the level of silt to be unnaturally high and likely generated by the lack of riparian yard and land use practices. Hydrological heterogeneity was low, with shallow runs, pools and cascades present (Photo 12), however the topography and gradient of the stream bed would likely restrict the reach to climbing capable species during periods of flow.

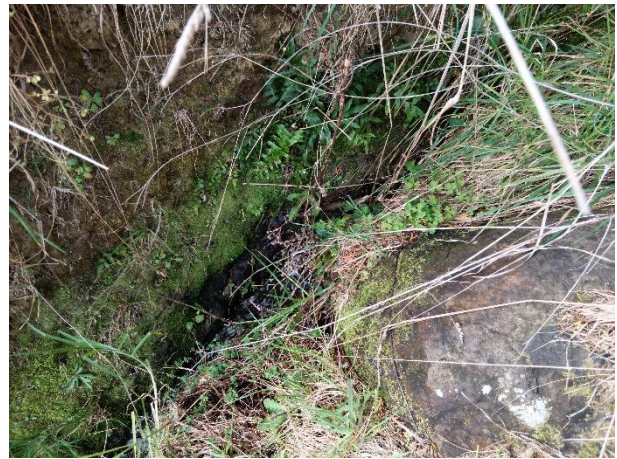
Photo 12. Narrow wetted width within Stream 3a

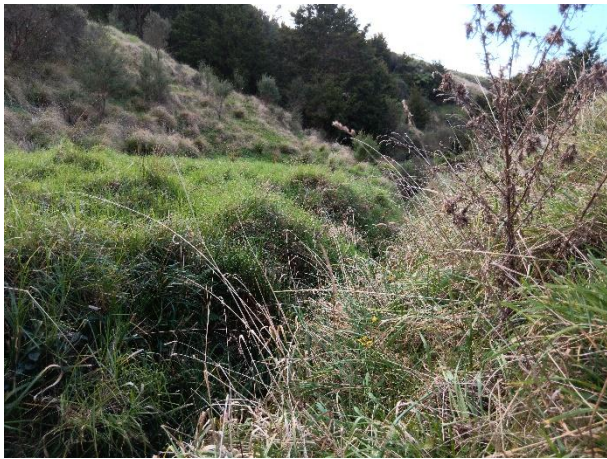
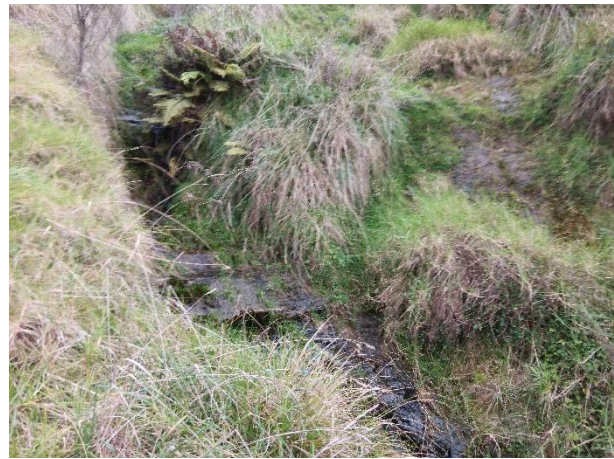
Photo 13. Incised channel

Photo 14. Waterfall system.

The permanent reach (Stream 4a) had an average width of 0.6 m (0.34 m – 1.52 m), and an average depth of 0.08 m (0.01 – 0.28 m). Stream 4a was classified as a permanent stream, and was flowing well at the time of assessment, with a variety of hydrology including runs, pools, chutes and waterfalls, however areas of still pools were present (Photo 13, Photo 14).

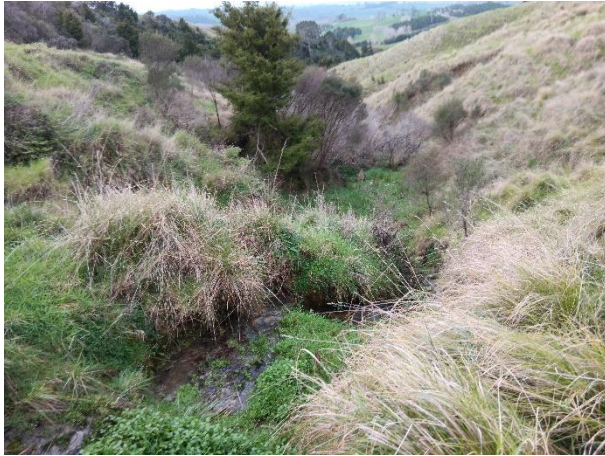
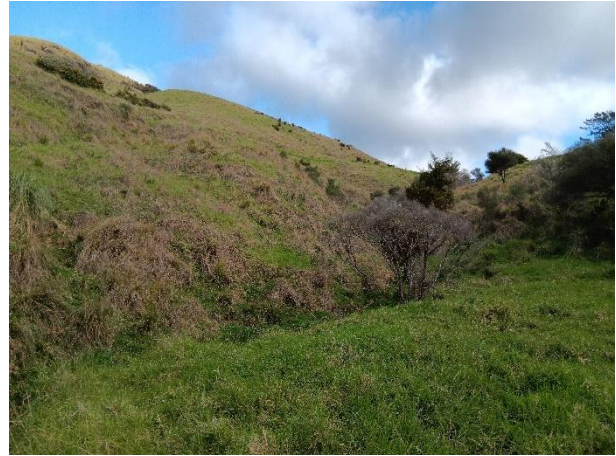
Photo 15. Upper portion riparian yard.

Photo 16. Lower portion with non-woody banks.

Riparian vegetation throughout Stream 4a predominantly consisted of grazed grasses with discrete patches of indigenous vegetation such as red matipo (*Myrsine australis*), kānuka, and ponga. Whilst canopy cover through the reach was low, shade was high due to the topography of the area (Photo 15 and Photo 16). Riparian yard functions such as filtration and bank stability were considered to be low due to the prevalence of grazed pasture grasses.

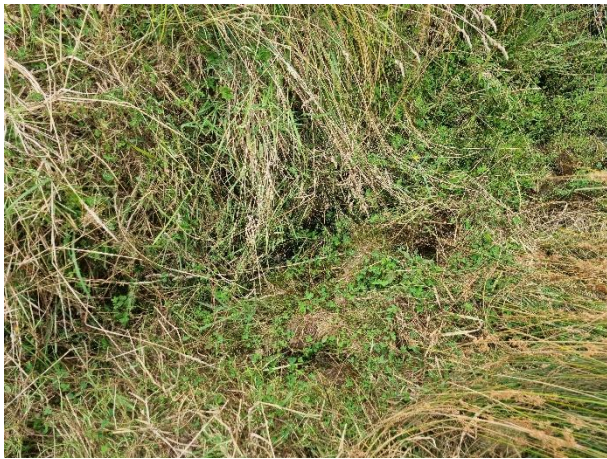
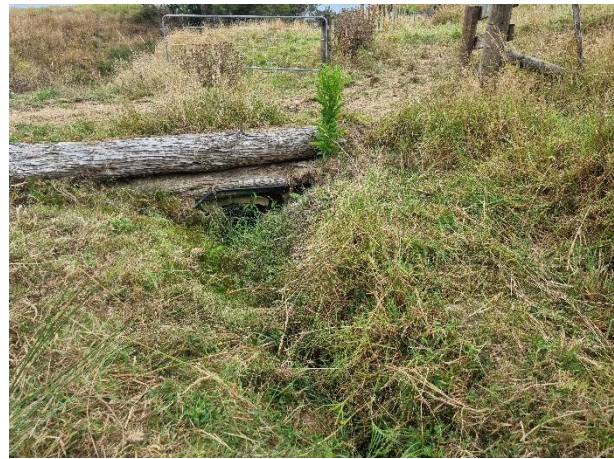
Photo 17. Upper reach of Stream 5

Photo 18. Small farm crossing Stream 5 exits the site through and flows through the neighbouring property.

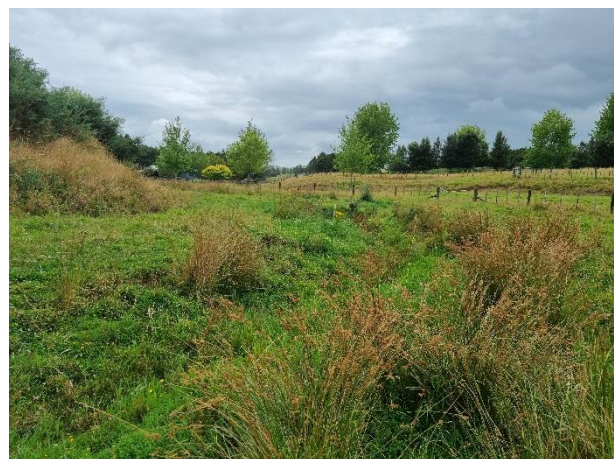
Photo 19. Lower reach of Stream 5 where it exits the wetland

Photo 20. Lower reach of Stream 5.

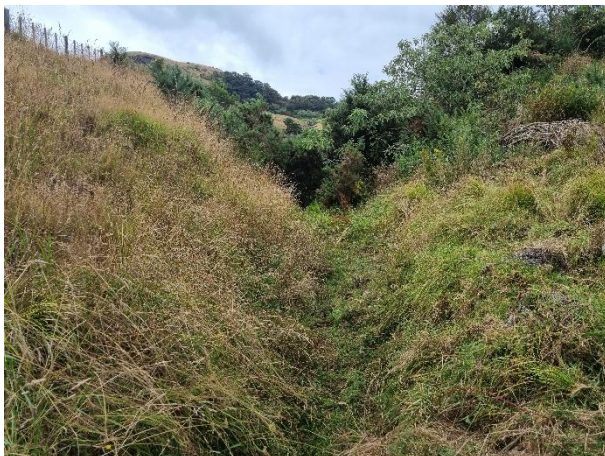
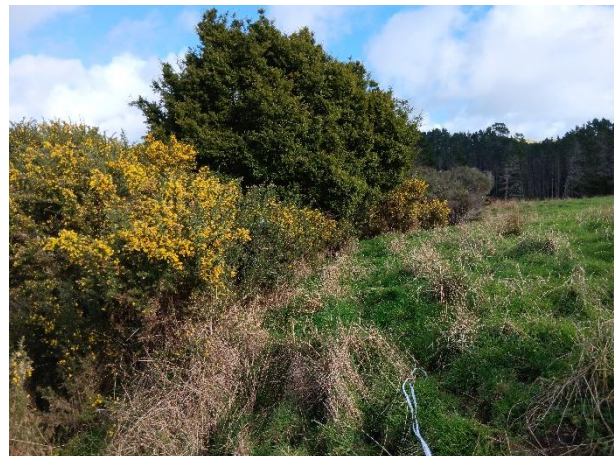
Photo 21. Looking upstream towards Stream 6b riparian vegetation

Photo 22. Looking upstream where Stream 6a starts

Stream 6a is located on the south-western portion of the site, directly downstream of Stream 1a, while Stream 6b is situated immediately upstream of Stream 5a (Figure 5 & Figure 6). SEV1 was used as the representative SEV for Stream 6a & 6b, however SEV functions such as shade, riparian yard factors and connection was scored higher due to the presence of a partially vegetated riparian yard (Photo 21, Photo 22).

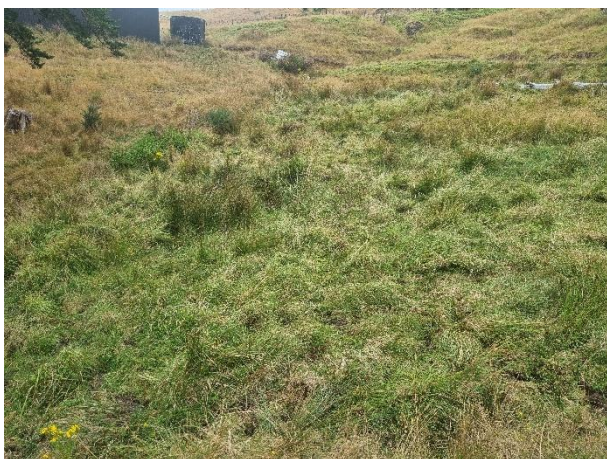
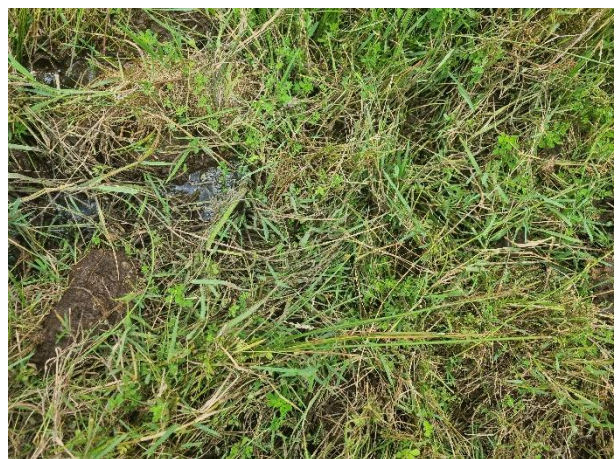
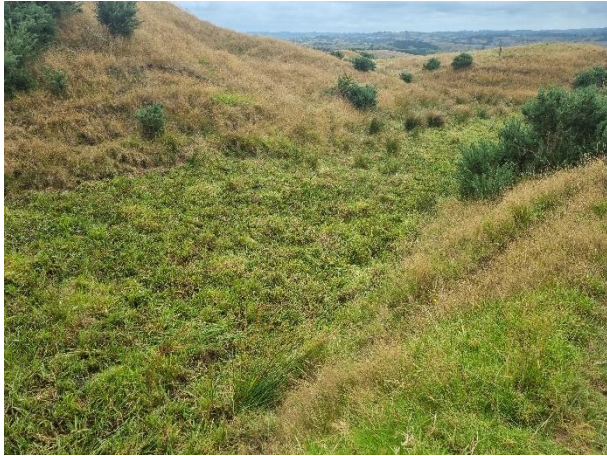
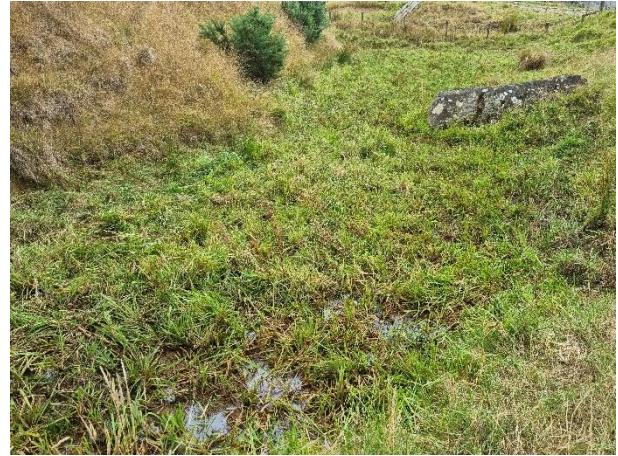
Photo 23. Upper portion of Wetland 1a vegetation

Photo 24. Bed conditions in upper portion of Wetland 1a

**Photo 25. Monoculture in lower portion of Wetland 1a**

**Photo 26. Bed condition in lower portion of Wetland 1a.**

The entirety of Wetland 1 was unfenced and severely impacted by stock access, with extensive pugging and grazing observed, especially throughout the lower portion (Wetland 1b). The wetland was permanently saturated with one hydrological unit, where non-channelised water flows through vegetation (Photo 24). No open water or areas of pools were present, with the exception of the pugging holes (Photo 26). The wetland buffer is limited in how it can form protective services to the wetland, with the vegetation consisting of rank pasture grasses or gorse.

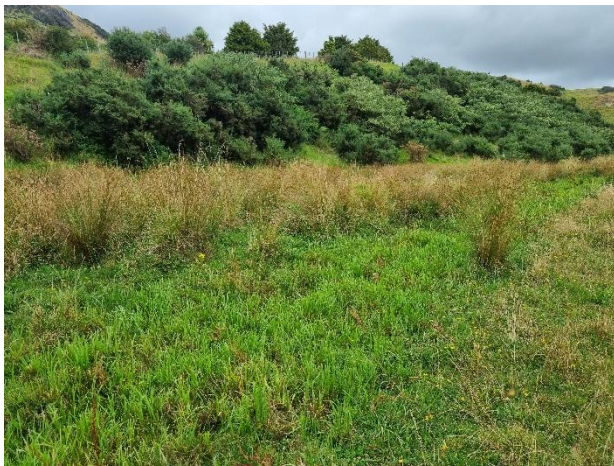
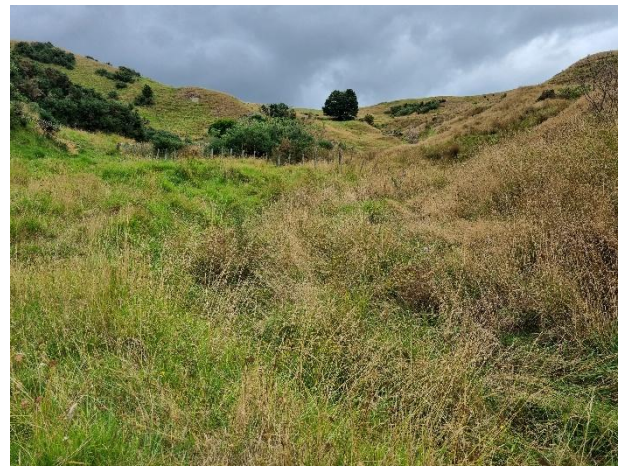
**Photo 27. Wetland 1b**

**Photo 28. Wetland 1b where it discharges to Stream 5b**

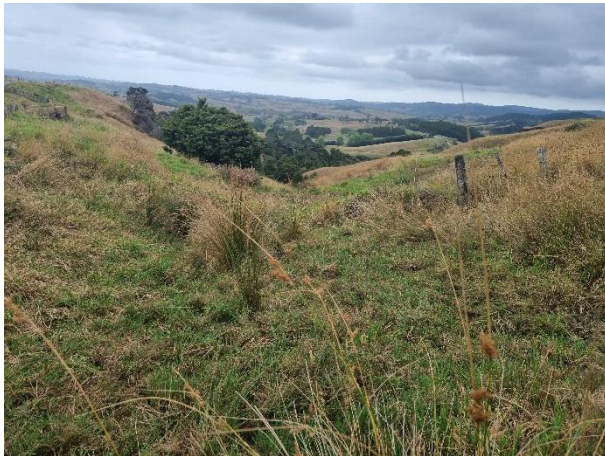
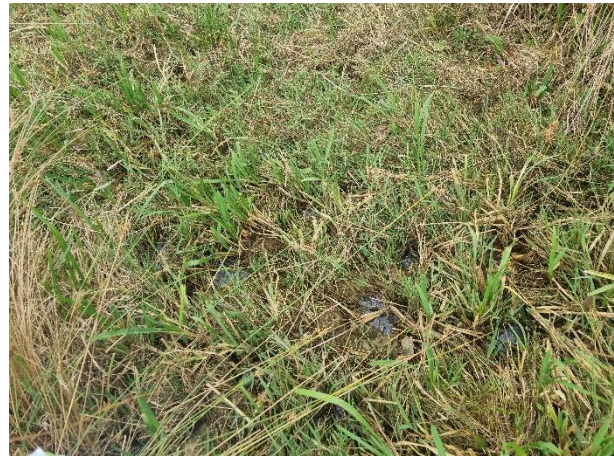
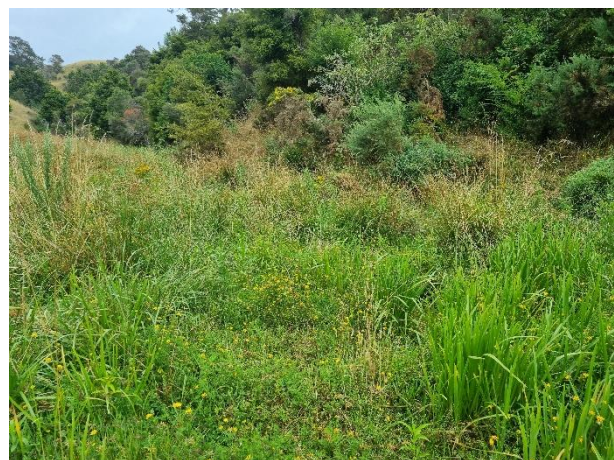
Photo 29. Upper wetland 2 vegetation.

Photo 30. Bed condition of Upper Wetland 2.

Photo 31. Variable riparian vegetation on the largest portion of Wetland 2

Photo 32. Typical vegetation composition within the large portion of Wetland 2

The wetland was not fenced and impacted by livestock through pugging and grazing. Standing water and saturated soils were present throughout the wetland, however the bed damage from livestock has likely restricted water flows through the wetland to be still or very slow flowing (Photo 31, Photo 32). Like Wetland 1, the wetland buffers were poor and did not provide any protective services and consisted of grazed pasture grasses.

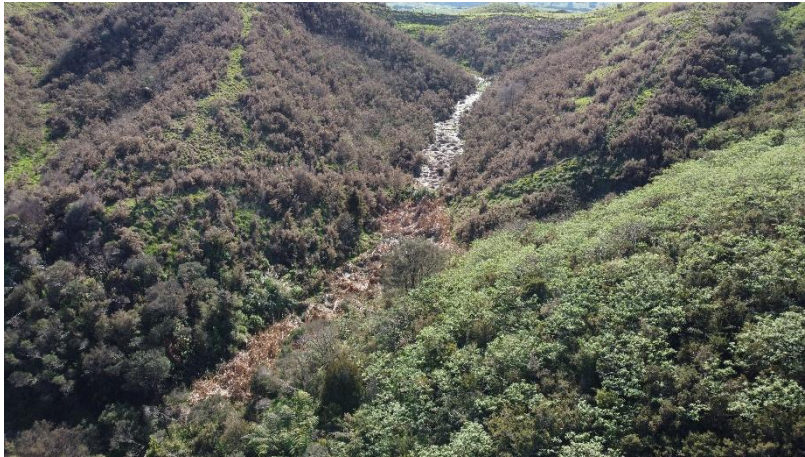
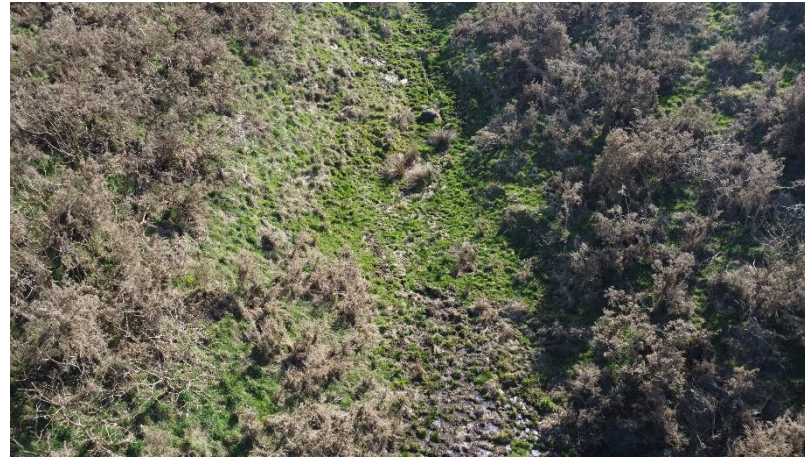
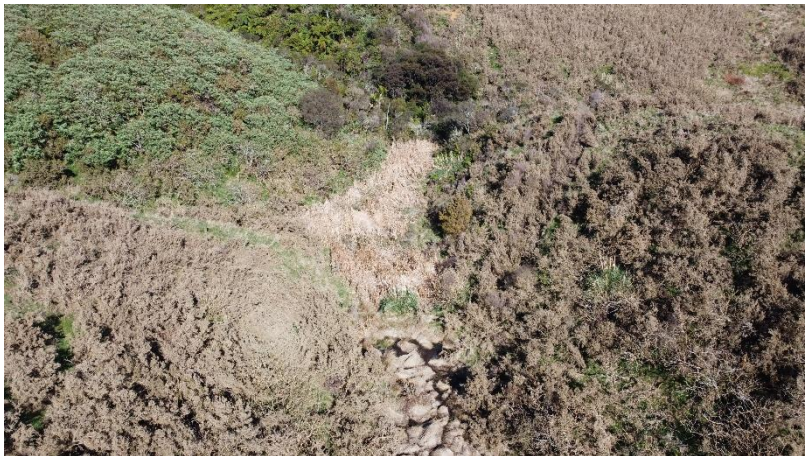
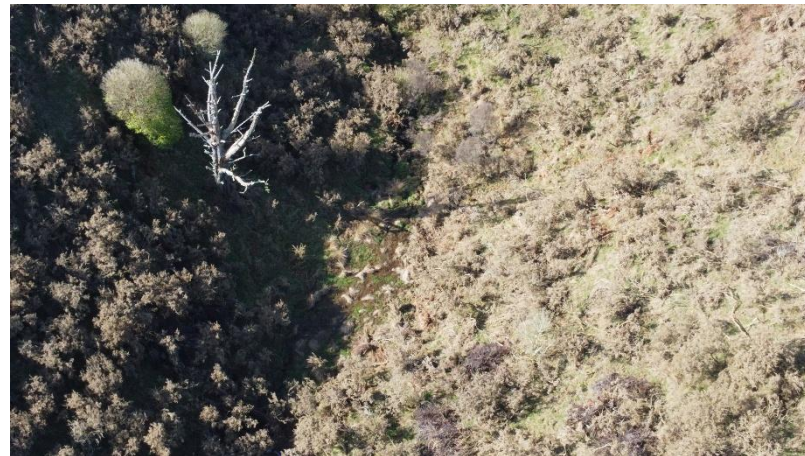
Photo 33 – Photo 36. Typical wetland characteristics within Wetland 3a, 3b and 3c.

Wetland 3 cumulatively consists of three wetlands (Wetland 3a – 3c), located within the same catchment as Stream 2 (Figure 4). Due to the topography and site conditions, these wetlands were surveyed via high quality drone imagery (Photo 33 – Photo 36). Collectively, they form low-value palustrine wetlands situated at the base of gullies, with widths of up to 14 m wide and a cumulative area of 752 m².

Vegetation within the wetlands was dominated by herbaceous species, with evidence of stock access, including pugging depressions. It is likely these wetlands were historically stream systems that, through stock access, these conditions have facilitated the development of natural inland wetland features. This is apparent when compared to streams (Stream 2), where shading and reduced stock intrusion have maintained more defined stream channels. Drone imagery confirmed the presence of standing water and saturated soils in more exposed areas. Hydrology within these wetlands is likely characterised by sheet flow through vegetation and discrete pools. Riparian vegetation was poor, consisting of gorse with pampas and woolly nightshade, however the lower extents closest to the SEA has a higher proportion of mature indigenous vegetation.

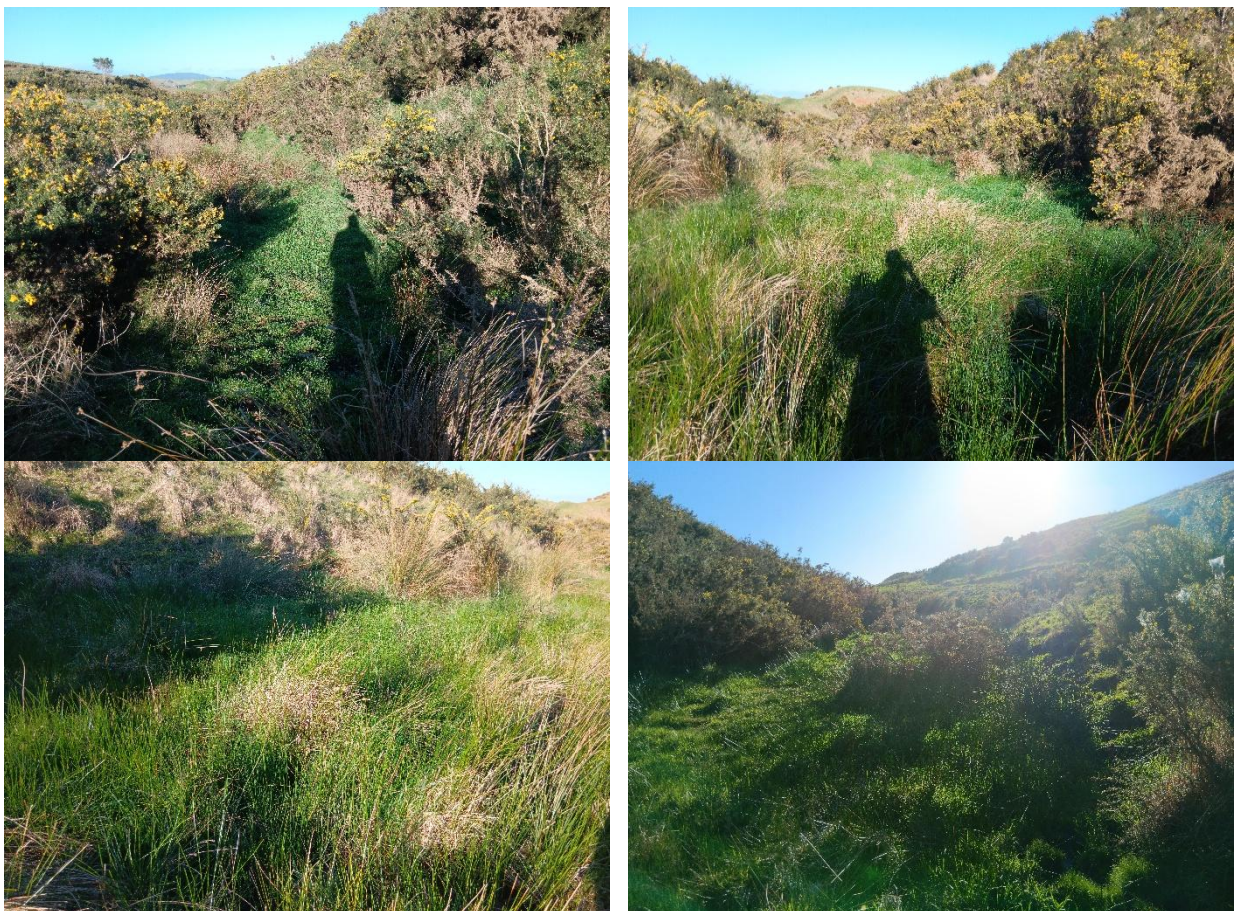
Photo 37-40. Typical wetland characteristics within Wetland 4a and 4b.

Hydrological conditions consisted of standing water and boggy ground, though dense vegetation limited the degree of open water pooling. Evidence of livestock access and damage was present, with the wetland bed and banks pugged, however the high density of gorse within the riparian yard may have limited the degree of stock access.
