FULTON HOGAN LIMITED

JUNCTION TERRACES (PARKBURN QUARRY), MOUNT PISA

**PRELIMINARY GEOTECHNICAL ASSESSMENT
FOR PROPOSED RESIDENTIAL DEVELOPMENT**

REF: GL21-022.1

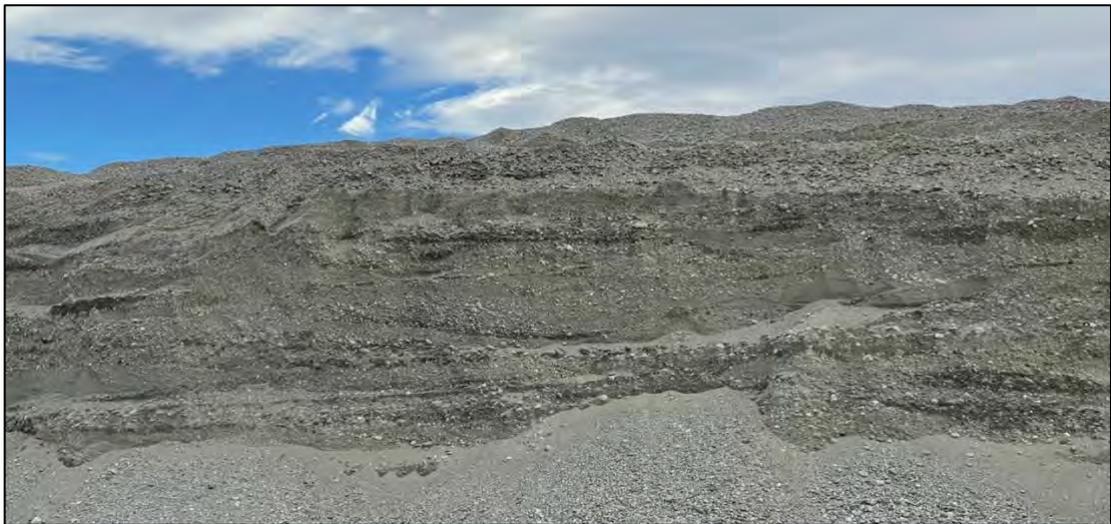
The following photograph was taken of the current working face and shows the typical vertical sequence of the outwash gravels.

Figure 1: Outwash Deposits Vertical Sequence

The natural gravel sequence below any loess and uncontrolled fill comprises sandy GRAVELS with cobbles and occasional boulders. The material is loose to tightly packed. The sand is generally coarse grained, with the gravels well graded and subangular to subrounded.

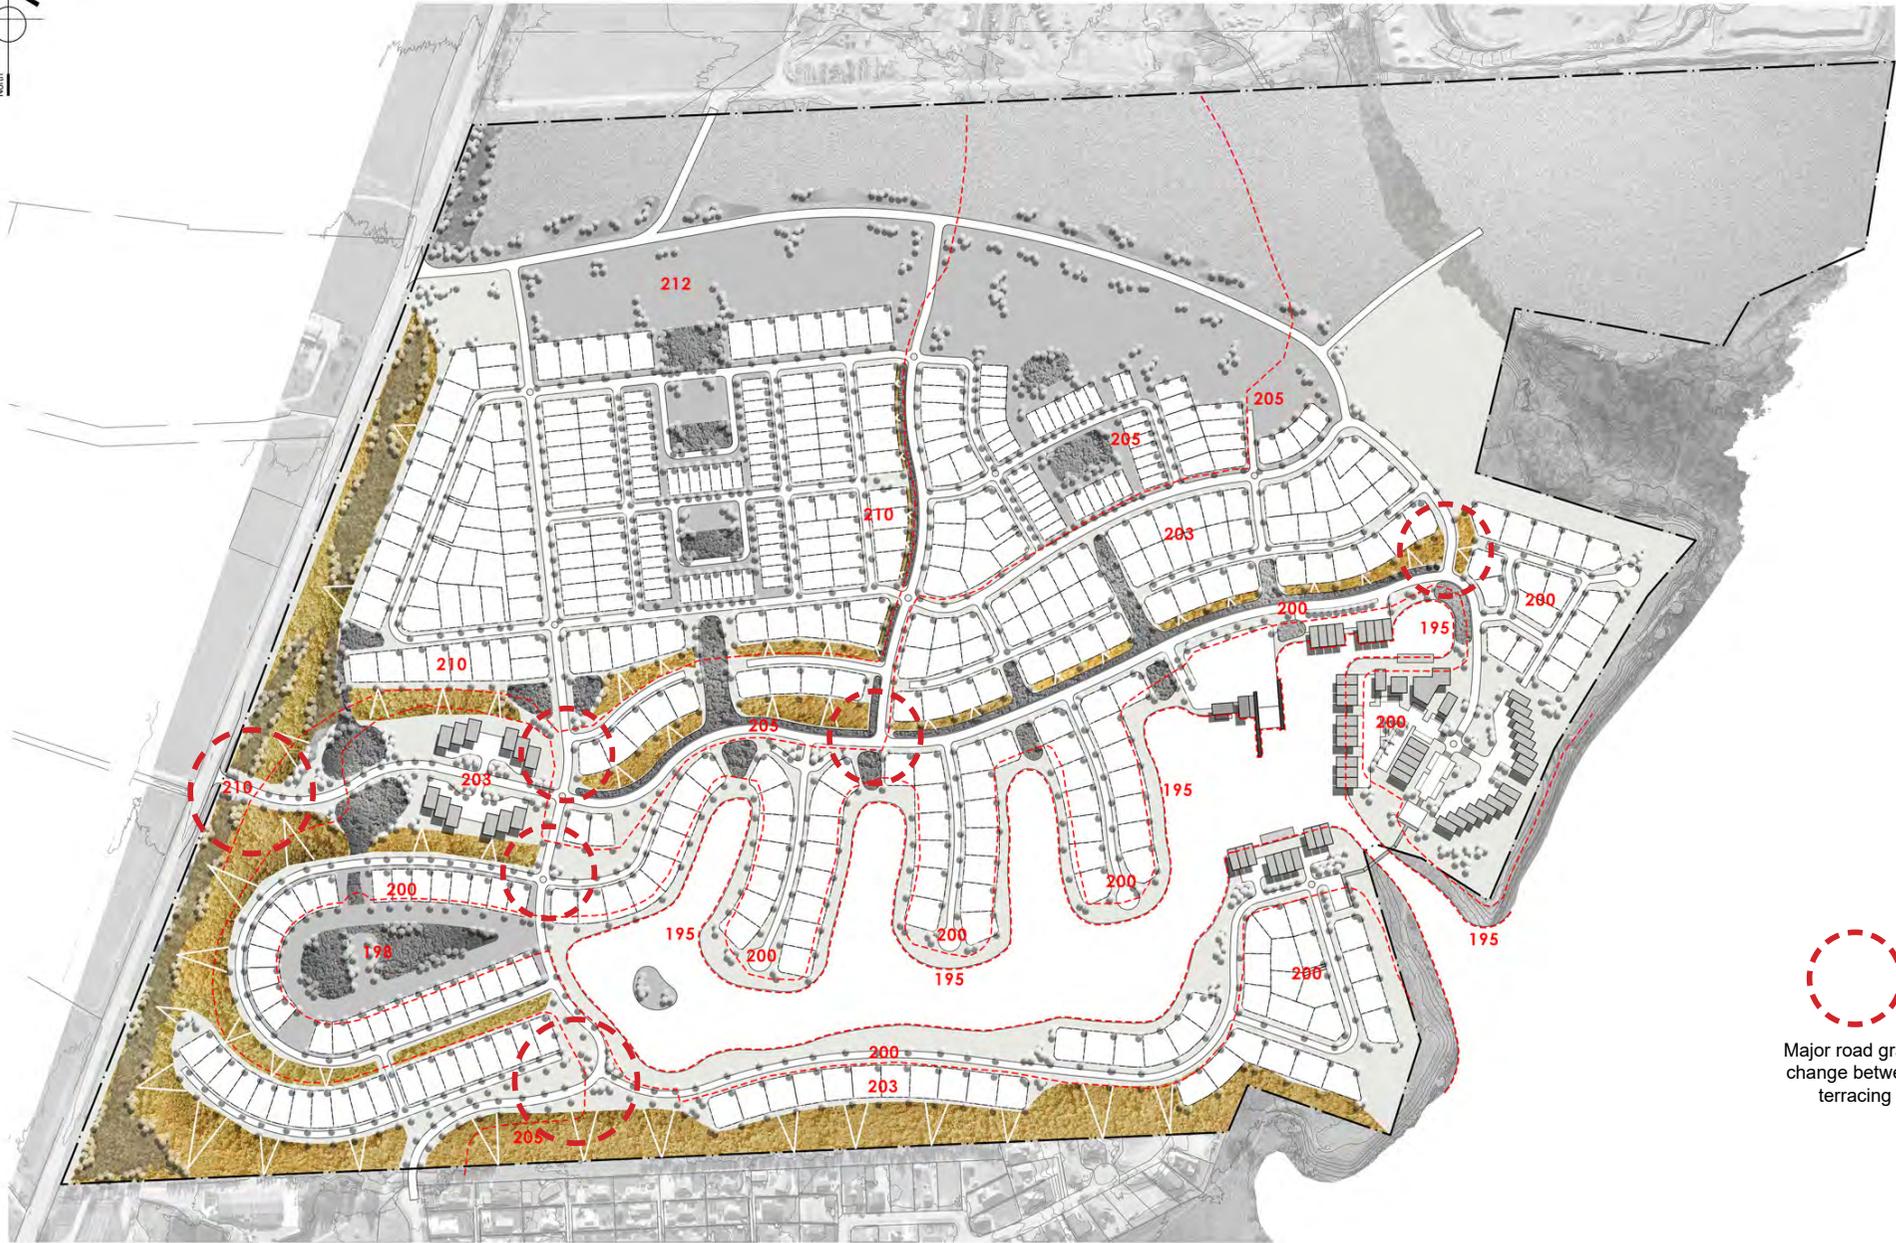
Major road grade change between terracing

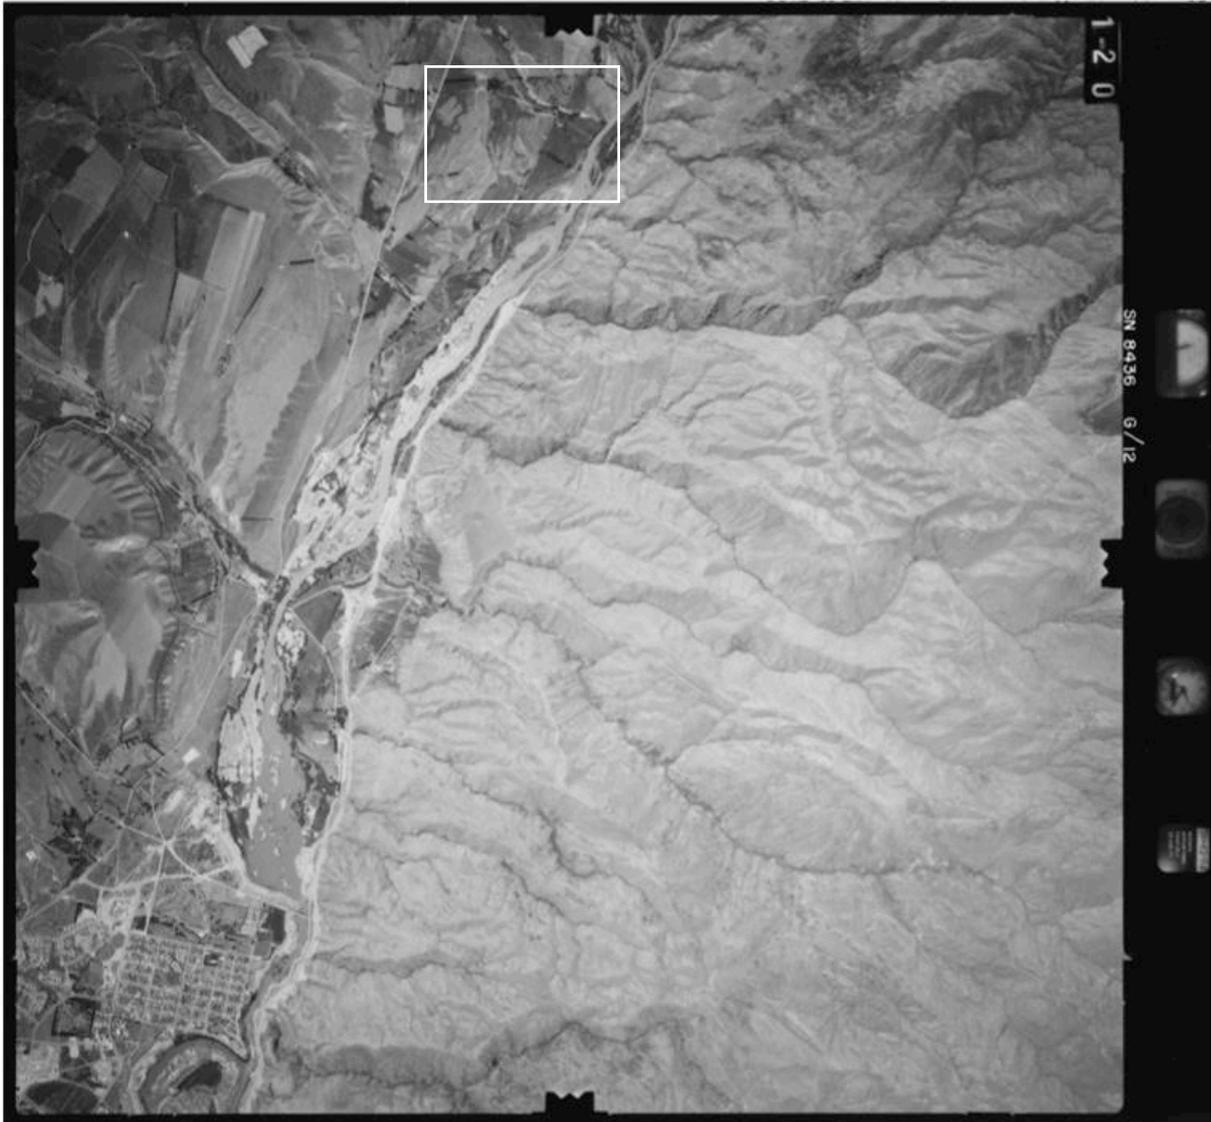
1984 Aerial Photograph

Date	Description
Pre 1984	Open fields/paddocks. Clutha River in its original alignment prior to the flooding to form Lake Dunstan.
1984	The road off the highway currently used for the Quarry access road is shown in the current configuration. The road served a single dwelling and associated outbuildings, beyond which appears to be orchards and farmland. Park Burn shown as a braided stream discharging into the Clutha River.

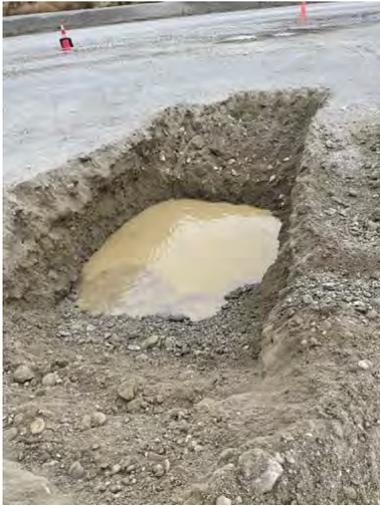
Test Pit 101 - Pit

0.5		OUTWASH DEPOSITS		Sandy GRAVEL with cobbles and occasional small boulder, greyish brown. Loose to tightly packed, dry. Sand coarse grained, gravels well graded subangular to subrounded. Cobble subrounded. Strong water ingress from 1.0m depth.

Groundwater was encountered in the first three test pits, completed on the basal floor of the quarry in the southern section of the property. TP101 recorded groundwater at 1.1m below ground level, with rapid ingress terminating the test pit. TP102 recorded the greatest depth to groundwater at 1.9m, with TP103 at 1.6m depth below ground level.

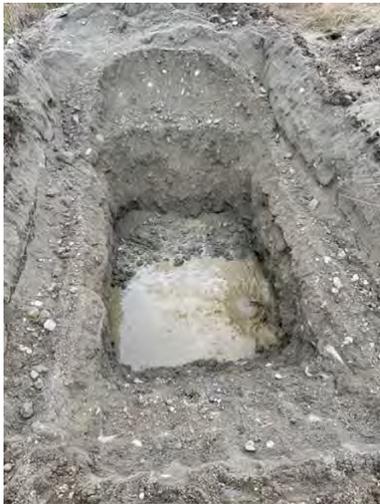
Test Pit 102 - Pit

0.5
1.0		OUTWASH DEPOSITS		Sandy GRAVEL with cobbles and occasional small boulder, greyish brown. Loose to tightly packed, dry. Sand coarse grained, gravels well graded subangular to subrounded. Cobble subrounded. Storing water ingress at 1.8m.

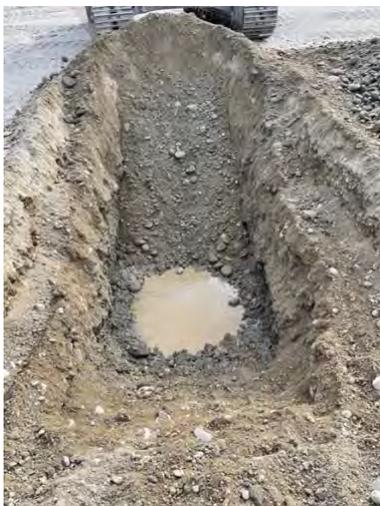
Test Pit 103 - Pit

—
0.5		OUTWASH DEPOSITS		Sandy GRAVEL with cobbles and occasional small boulder, greyish brown. Loose to tightly packed, dry. Sand coarse grained, gravels well graded subangular to subrounded. Cobble subrounded. Water ingress at 1.6m.
