*Auckland Council*

*W-REF: P25-609*

# STREAM EROSION ASSESSMENT

## Milldale North (Stage 14 – 17) Substantive Application

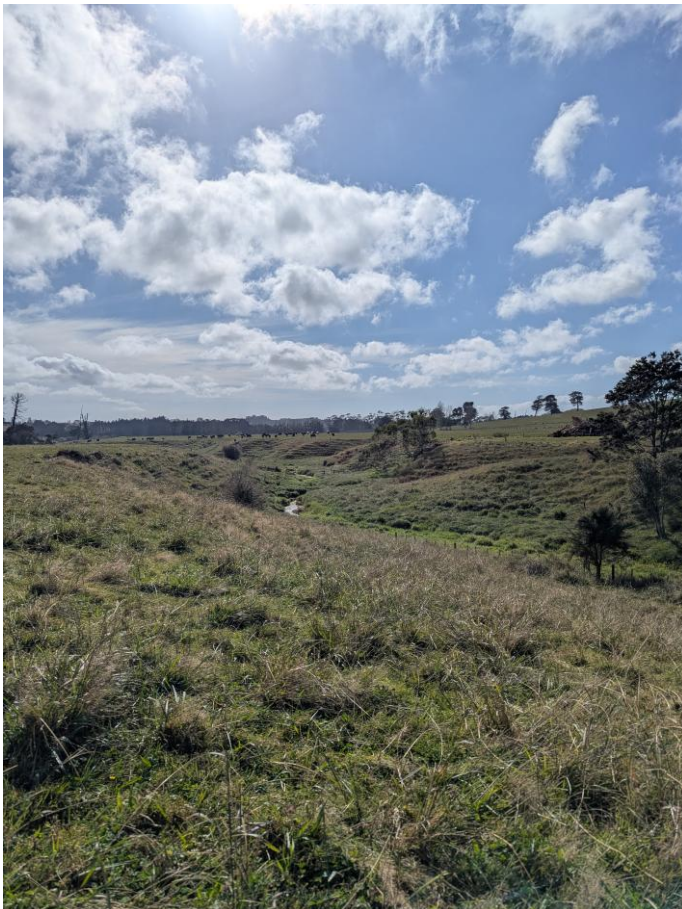
Figure 3. Example of the Orewa River flowing between terrace margins, with narrow floodplain pockets present on either side.

The Orewa River is largely confined within relic terrace margins (Figure 3) through the upper and mid-reach extent, with only narrow floodplain pockets present on either side of the channel. Channel width varies considerably along the assessed extent, from approximately 2 m in confined upper sections to wide ponded zones of up to ~10 m. The channel exhibits a meandering planform with alternating pool-riffle-run sequences, transitioning between narrow confined reaches and broader ponded reaches (Figure 4). Notable planform features include a large outer meander identified as an erosion hotspot within Segment 1, and a further large meander bend downstream of the Tributary 2 confluence (Segment 3) with an inner point populated by mature pine trees. Mid-channel and lateral bars are present throughout, including bank-attached bars and vegetated islands formed around woody debris and large trees (Figure 5).

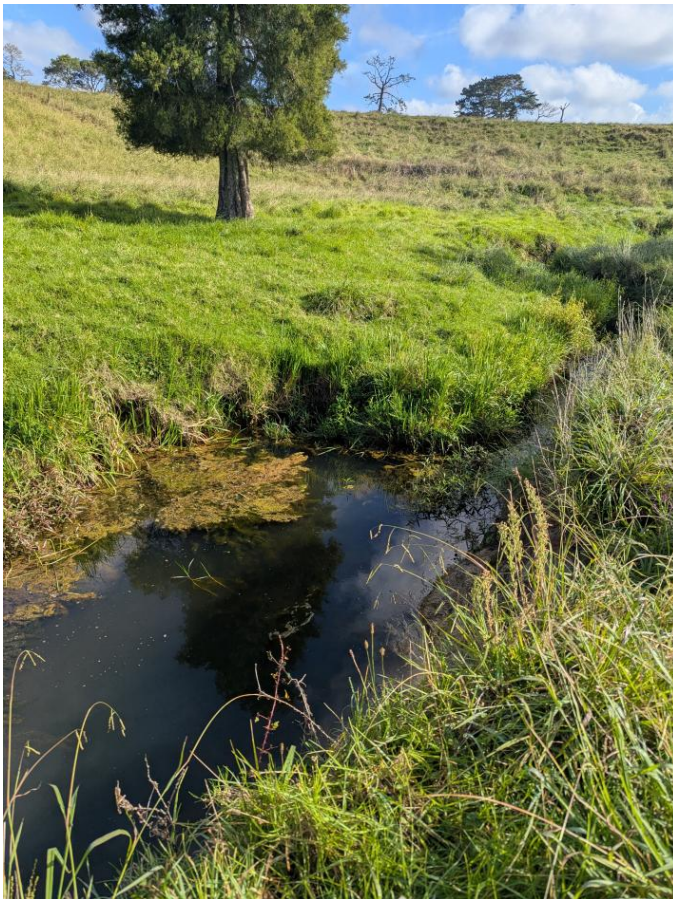
Figure 4. Example of the channel transitioning between wide, ponded reaches and narrow, confined reaches.

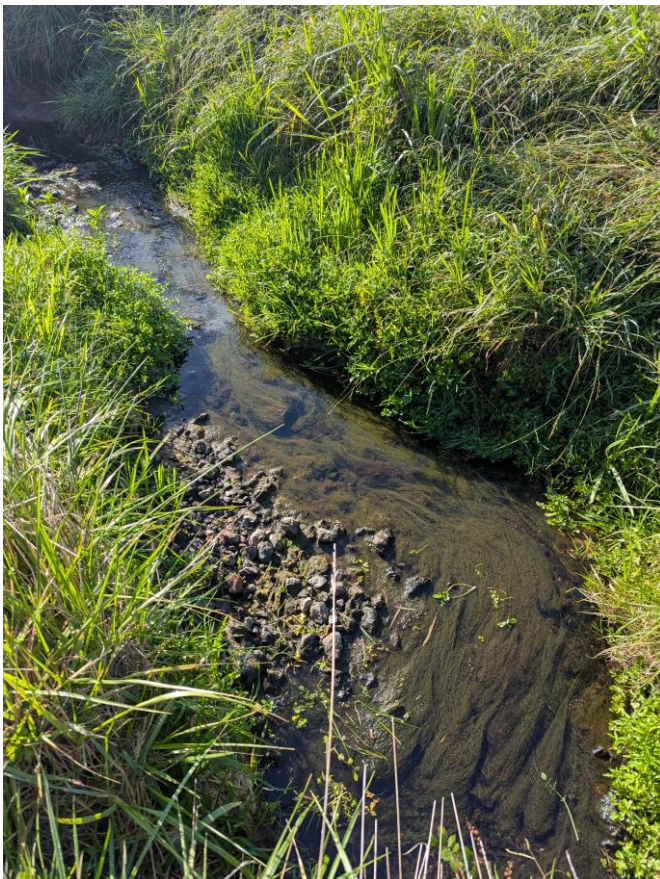
Figure 5. Example of lateral bars within the Orewa River, most commonly observed in Segment 1.

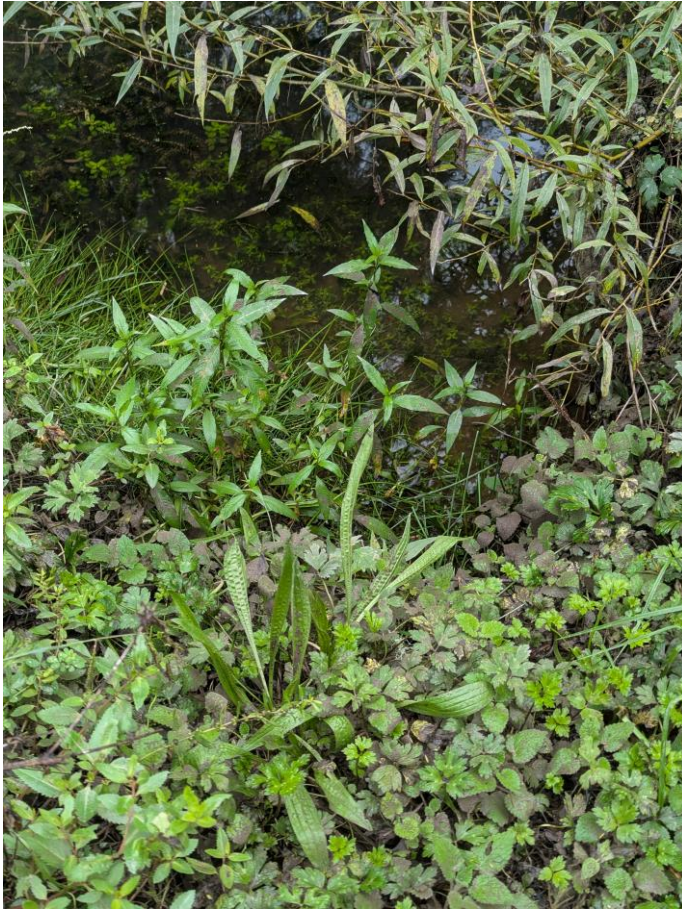
Figure 8. Evidence of silty deposition following the storm event that preceded the Day 2 site visit.

Bed substrate is poorly sorted and angular, comprising large cobble-sized clasts alongside sand to pebble material (Figure 7), observed throughout Segments 1 and 2; the origin of the larger cobble material is unknown. Substrate becomes harder to observe within Segment 3 due to increased flow depth and the general absence of exposed morphological units. A forced riffle sequence with an armour layer beneath matted vegetation was identified downstream of the Gervin Road culvert (Segment 1), along with large rocks in-channel at this same location interpreted as anthropogenically placed. Silty and muddy deposition was observed on outer banks downstream of the Tributary 2 confluence (Segment 3), approximately 1 m above base flow level, indicating flow levels following the recent storm event were substantially elevated above those observed at the time of assessment (Figure 8).

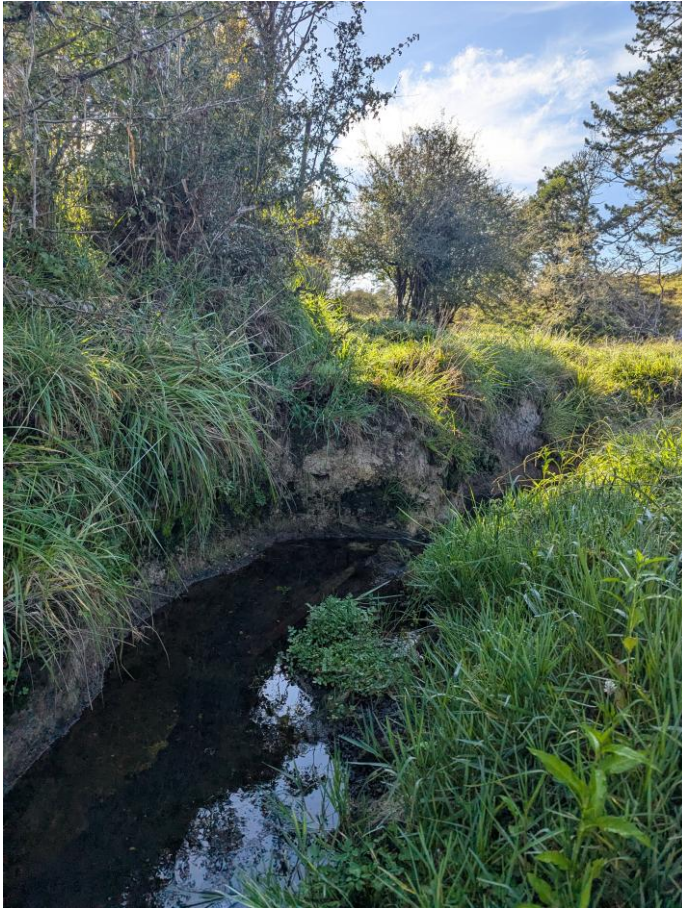
Figure 9. Example of highly incised cohesive banks.

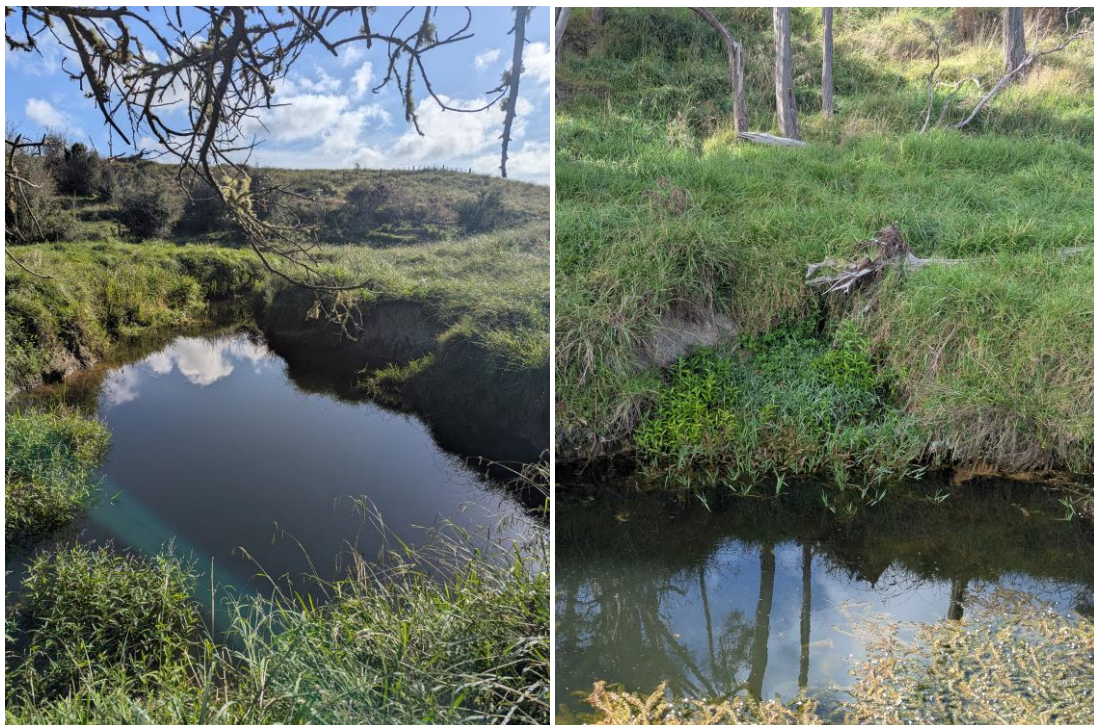
Figure 10. Geomorphic hotspot within Segment 1, outer meander erosion and inner bank slumping just downstream.

Instability within this broadly stable system is concentrated at a small number of discrete locations rather than being system wide. The most notable of these is the Segment 1 erosion hotspot meander (approximately chainage 958 m), where active outer-bank erosion, a rotational slump on the inner bank, and marked local channel widening were observed. Two knickpoints downstream of the Tributary 2 confluence in Segment 3 similarly indicate localised grade adjustment, with incision visibly more pronounced between the two grade controls. On Tributary 2, localised slumping at the confluence-approach grade change was directly corroborated by the GCD results (Figure 29), which identified a concentrated zone of elevated change in the lower approximately 100 m of the tributary.

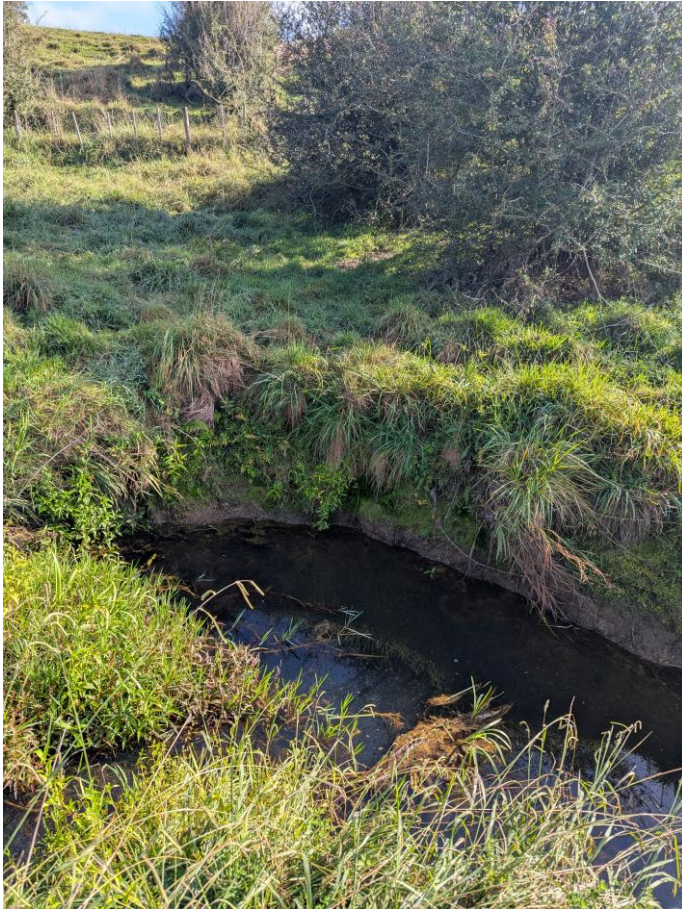
Figure 11. One of many locations indicating bank undercutting.

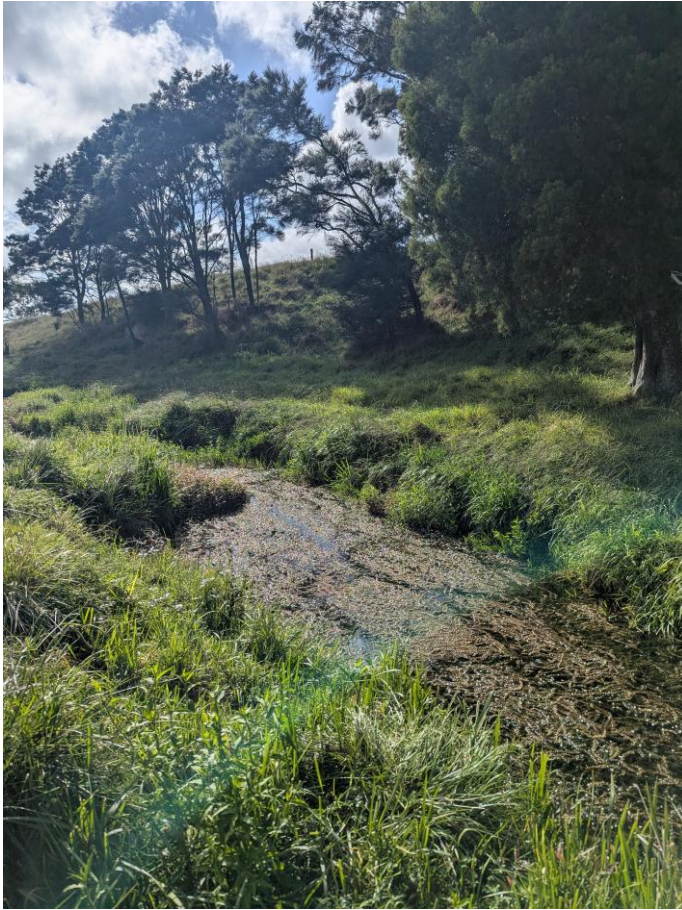
Figure 12. Example of the upper segments, where riparian vegetation is largely absent and grass extends to the bank edge.

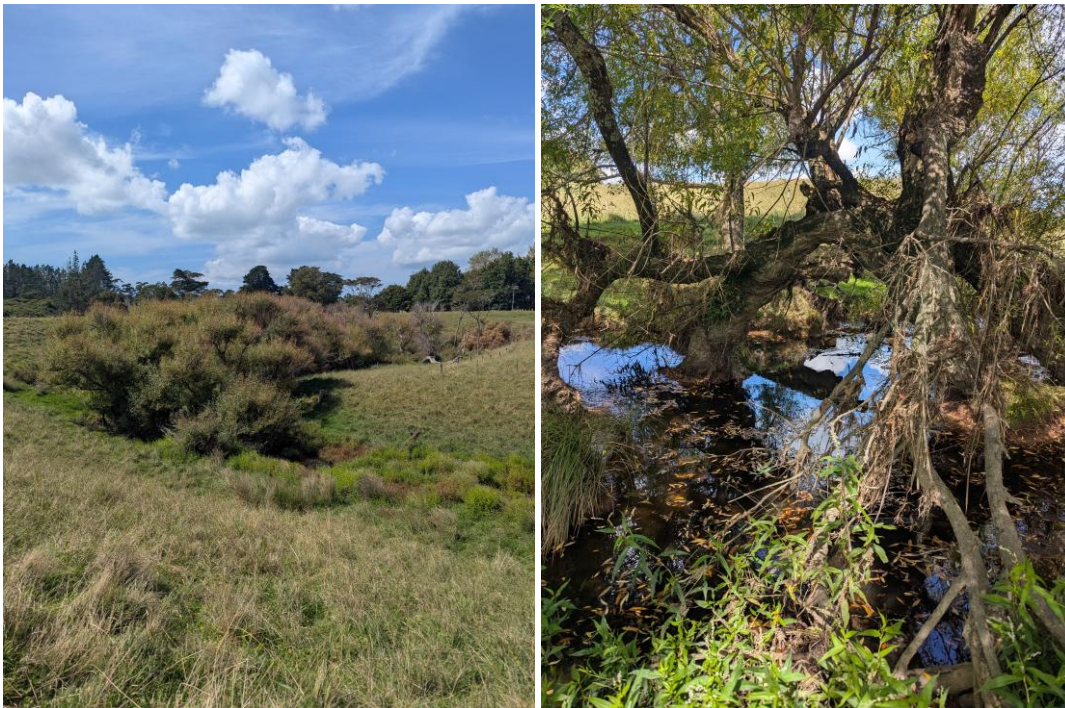
Figure 13. Transition from Segment 2 to Segment 3, marked by the change from no riparian corridor to a lush, established one.

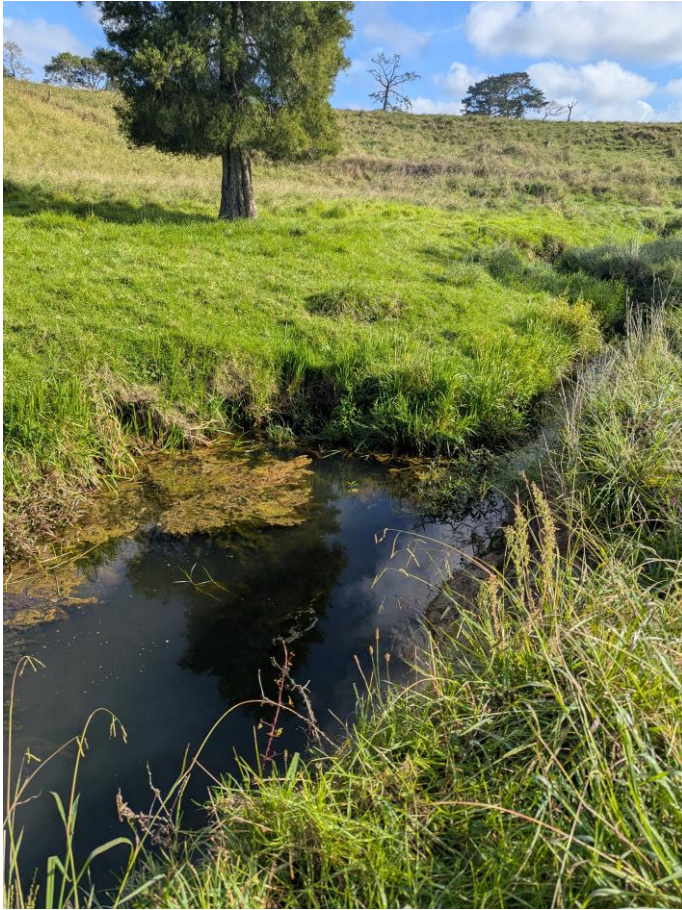
Figure 15. Example of a disconnected floodplain, with the surrounding upper terraces confining the narrow floodplain pockets.

Floodplain connectivity is limited throughout much of the assessed extent, with the channel confined by relic terrace and only narrow pocket floodplains present on either side; connectivity appears marginally improved in the lower-mid reach relative to further upstream, though the channel remains largely disconnected from a functioning floodplain across most of its length (Figure 15).

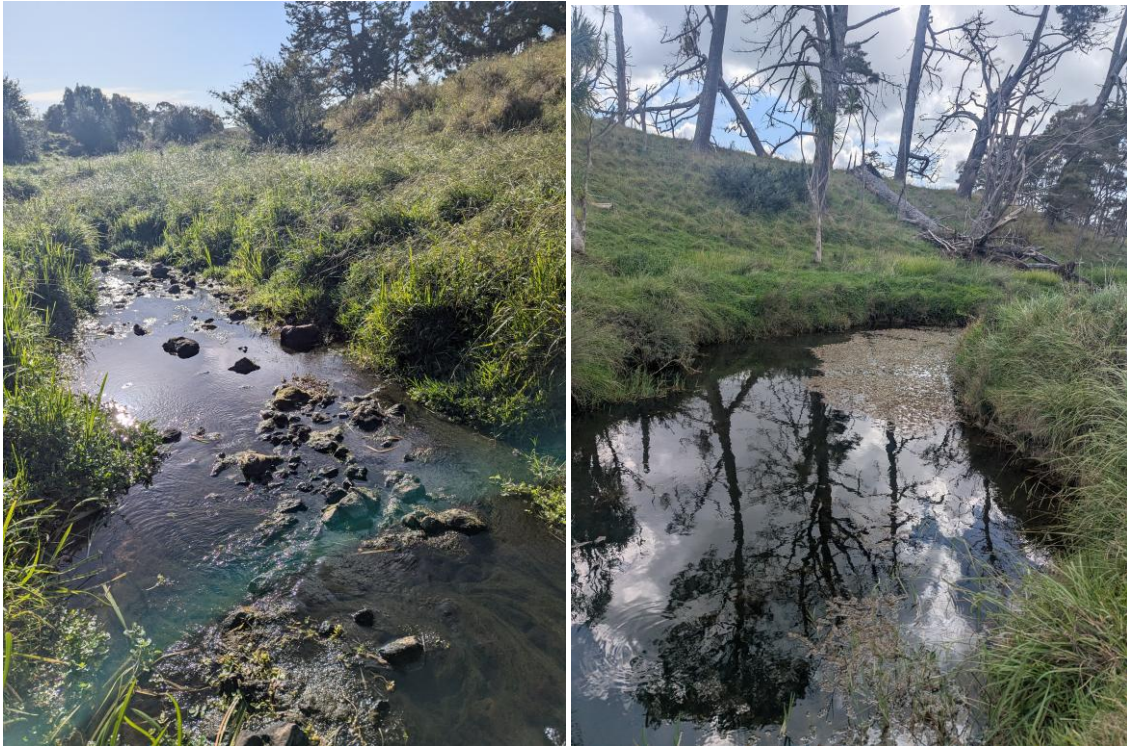
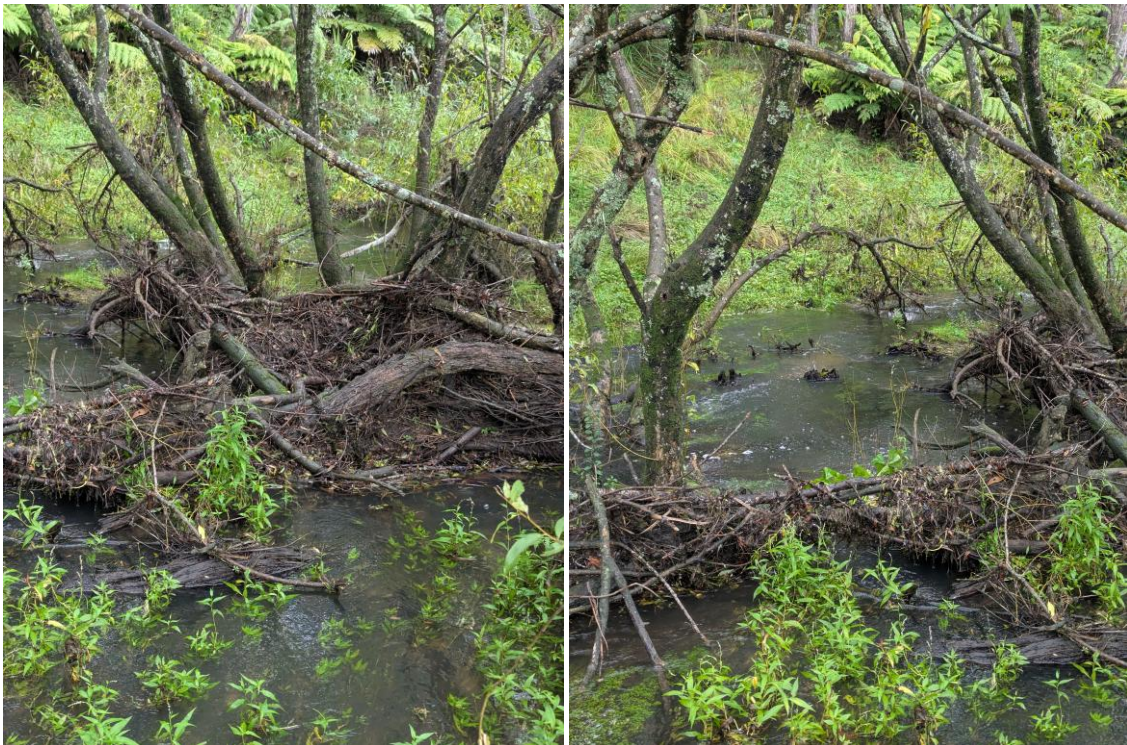
Figure 16. Hydraulic diversity changed markedly in Segment 3, with alternating riffle sequences, glides and pools.

Figure 17. Hydraulic diversity changed markedly in Segment 3, with alternating riffle sequences, glides and pools.

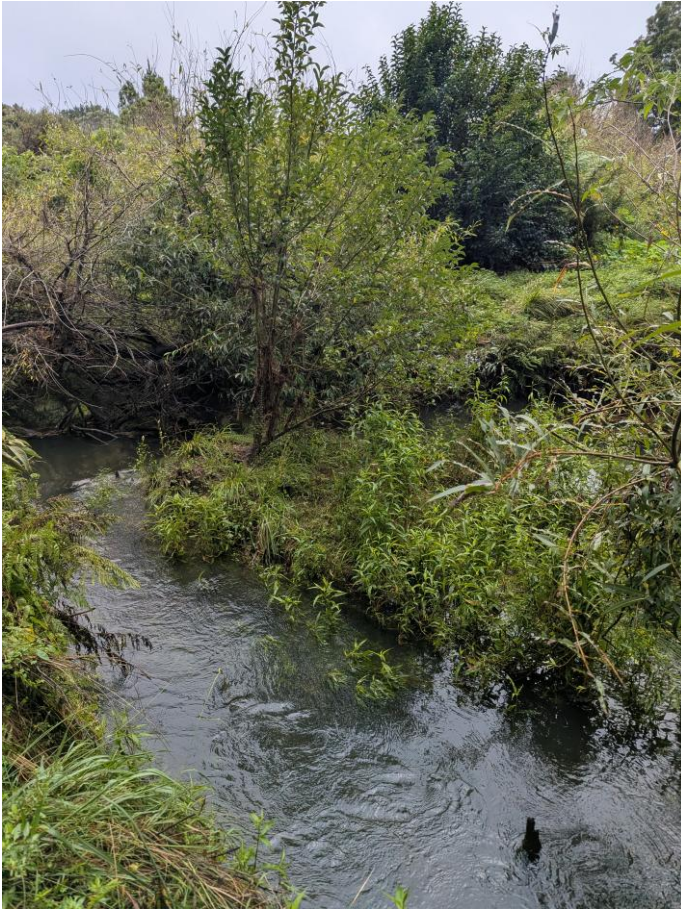
Figure 18. Example of flood chute activation following the storm event the week prior.

Base flow through the Day 1 reach (upstream extent to Tributary 2 confluence) was dominantly slow or standing, with limited hydraulic diversity. Flow depth increased progressively downstream through this reach, from approximately 200 mm near the upstream extent to 1.2-1.5 m in Segment 2 (Figure 16). Hydraulic diversity increases markedly downstream of the Tributary 2 confluence, with laminar, turbulent, glide and riffle sequences all present, and bankfull conditions observed on the true left (Figure 17). Flood chutes - channels activated during higher flow events - were identified downstream of the confluence, providing evidence of lateral flow extent during flood conditions (Figure 18).

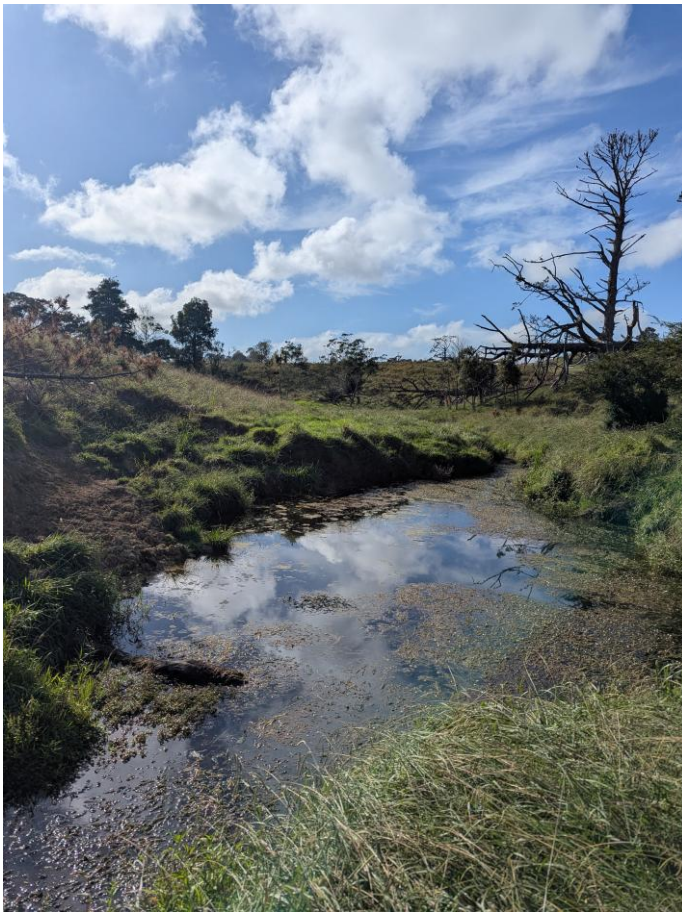
Figure 19. Ponded backwater zone with scum and vegetation bloom, suggestive of nutrient or effluent input.

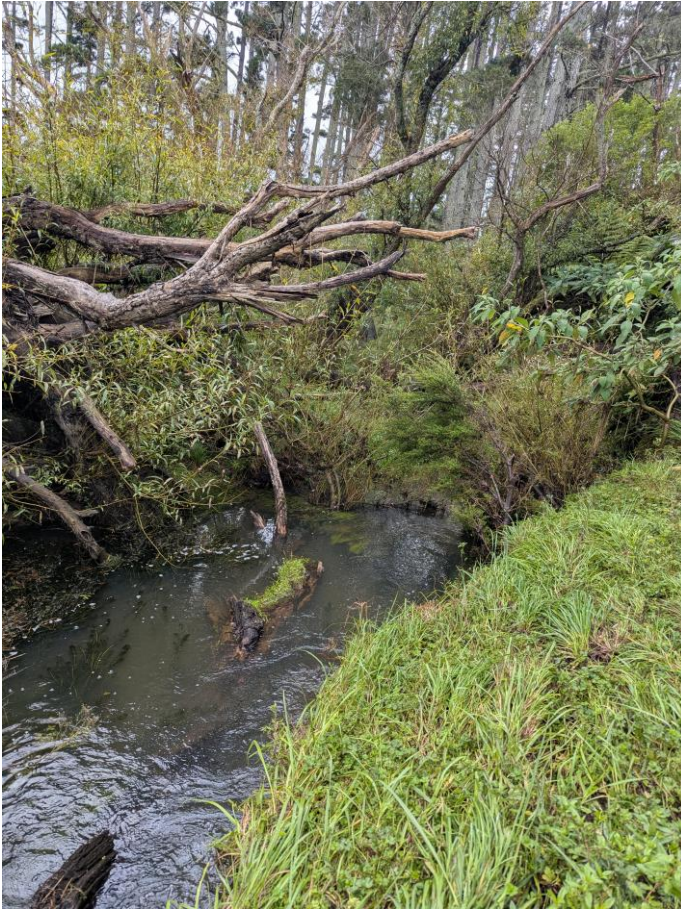
Figure 20. Image denoting the lead up to the double knickpoint location and drop in stream grade.

Two closely-spaced knickpoints were identified downstream of the Tributary 2 confluence, with a further knickpoint noted further downstream; the channel appears more incised between the two closely-spaced knickpoints, indicating localised acceleration of incision between these grade controls (Figure 20). Evidence of a recent flood event (attributed to a storm the week prior to Day 2) includes a trash line and debris veneer on the outer bend of a large pine-tree meander, an inner meander bank height of approximately 2 m above base flow indicating flood stage at this location, flattened grasses confirming flow overtopping of the inner bank, and silty/muddy deposition approximately 1 m above base flow further downstream (Figure 21). These indicators, combined with the confined and incised channel form and cohesive bank material, are consistent with localised, knickpoint-driven grade adjustment at discrete locations within an otherwise stable channel.

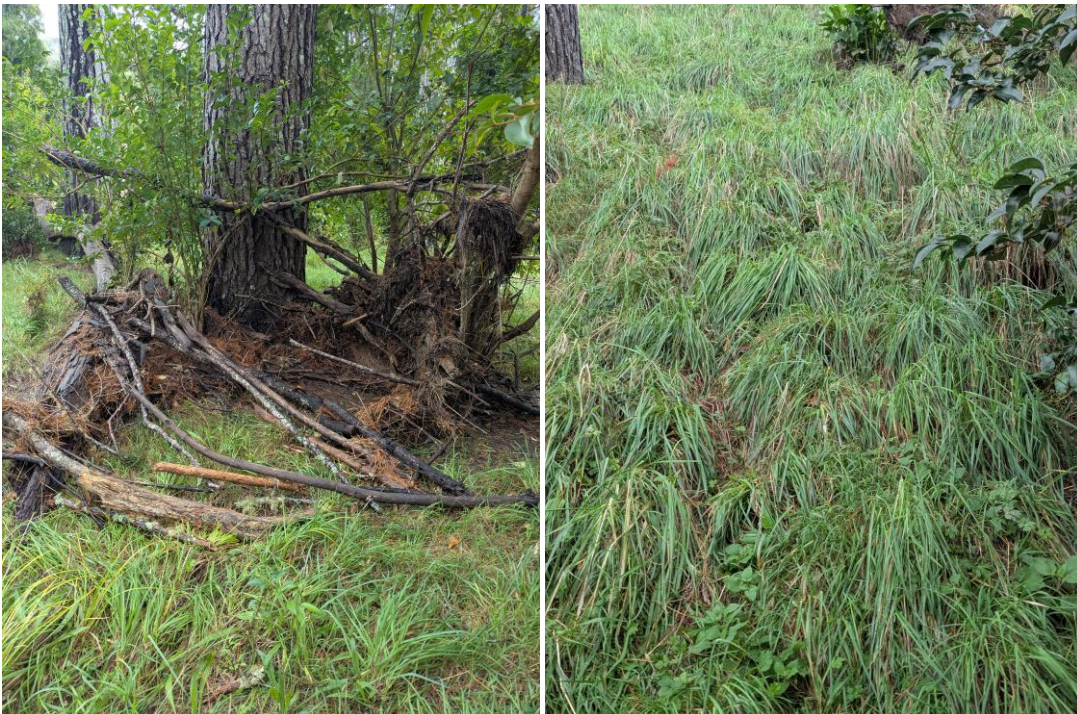
Figure 21. Leaf litter and woody debris marking where floodwater flowed across the upper meander bends in the pine-dominated section of Segment 3, with flattened grass indicating flow direction during the flood event.

Isolated evidence of floodplain activation during flood flow was nonetheless observed, despite the generally disconnected character of the corridor at base flow. At the Segment 3 pine tree meander section of river, flow was observed to have overtopped the inner bank during a storm event the week prior to the Day 2 site visit, evidenced by flow-aligned grasses and a trash line approximately 2 m above base flow level, with flood chutes and silty deposition further downstream providing additional evidence of the channel's lateral extent during elevated flow.

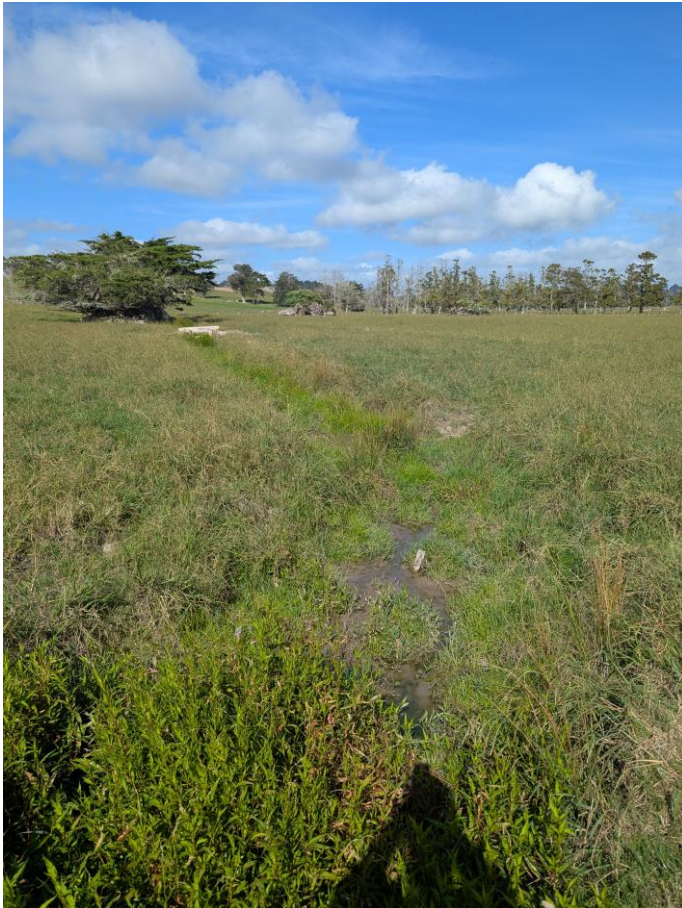
Figure 22. Example of the characteristics of Tributary 1: a narrow farm drain with standing water and dense instream vegetation.

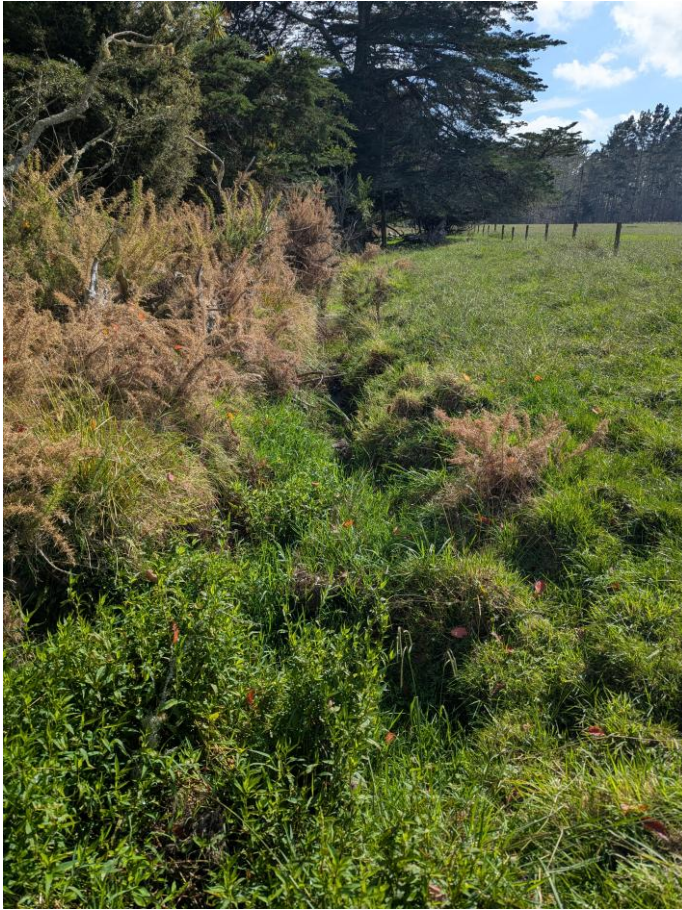
Figure 23. Example of Tributary 2: a narrow, incised farm channel with a riparian corridor present, dense instream vegetation, and low/standing flow.

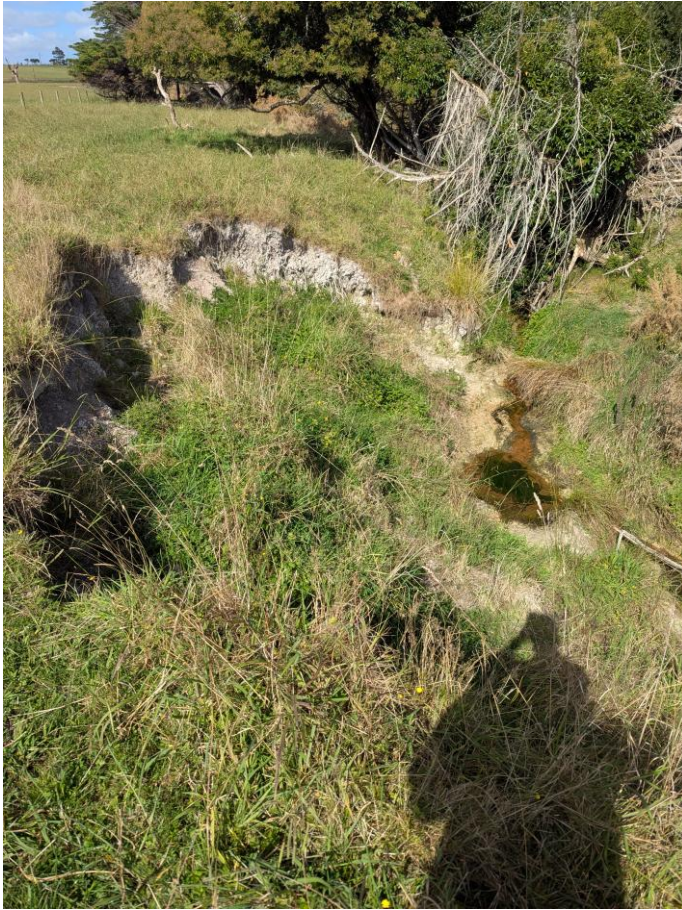
Figure 24. Localised slumping at the lower extent of Tributary 2, near the gradual grade change in the stream bed.

Unlike Tributary 1, a riparian corridor is present along the true left bank from approximately the midpoint of the tributary (marked by a farm culvert crossing) through to the confluence with the Orewa River. As with Tributary 1, the channel gradually steepens approaching the confluence, remaining narrow but flowing through a larger depression before discharging into the Orewa. Localised slumping was observed at this grade-change zone (Figure 24), corresponding to the concentrated change signal identified in the Geomorphic Change Detection results for the lower ~100 m of Tributary 2 (Section 5.2), indicating genuine bank instability at this location.
