Ref: 147007 Rangitoopuni Stream Width

RE: Width of watercourse through Lot 2 DP 590677, Riverhead

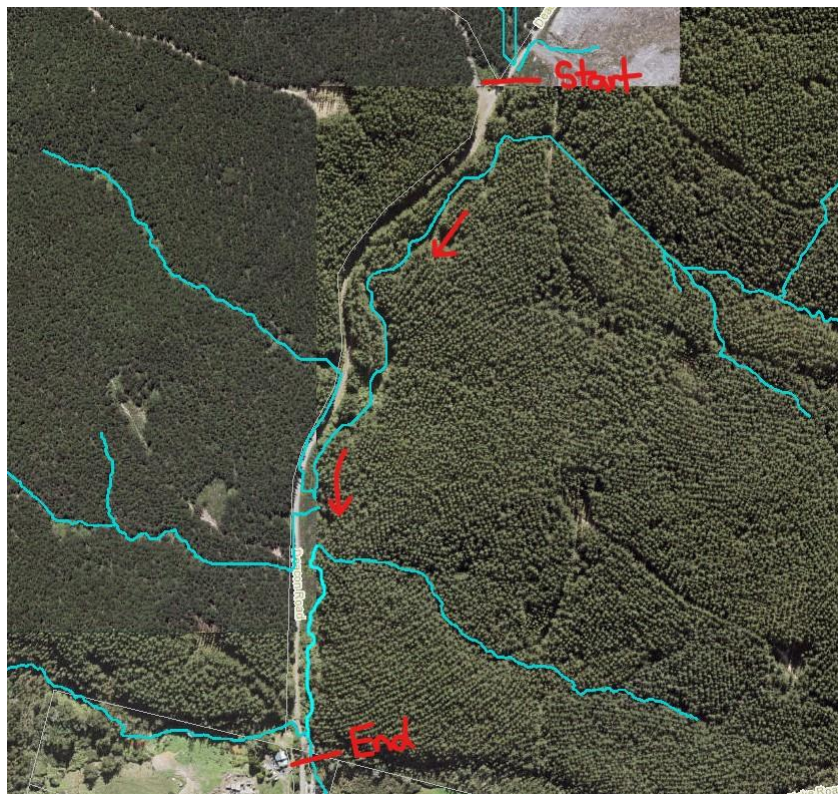
Figure 1 – site plan from GeoMaps.

I, [REDACTED] – Licensed Cadastral Surveyor, have reviewed measurement data taken by a survey team operating under my direction, to determine the width of a permanent watercourse which flows through the above-mentioned site. The length of the watercourse is approximately one kilometre long through the site. See Figure 1 site plan below.

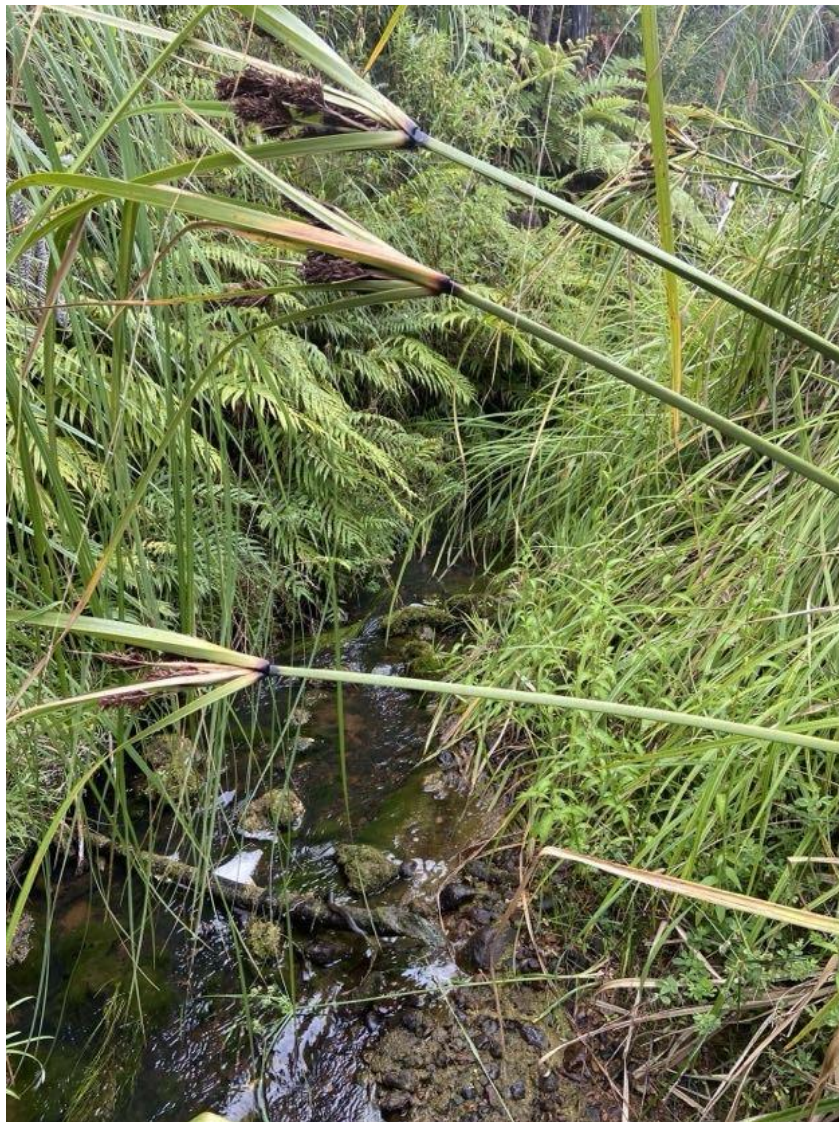
The watercourse is a permanent stream. There are areas where the water is shallow and flowing slowly, but also areas where the water is pooled and deeper. When one parts the vegetation, the banks of the watercourse are readily identifiable with a clear edge. I consider that this meets the definition of 'bed' as described in Section 2 of the Resource Management Act 1991.

Refer to Figures 2, 3, 4 & 5 below which are photographs to the typical watercourse along its length.

Figure 2 – typical stream cross section photograph.

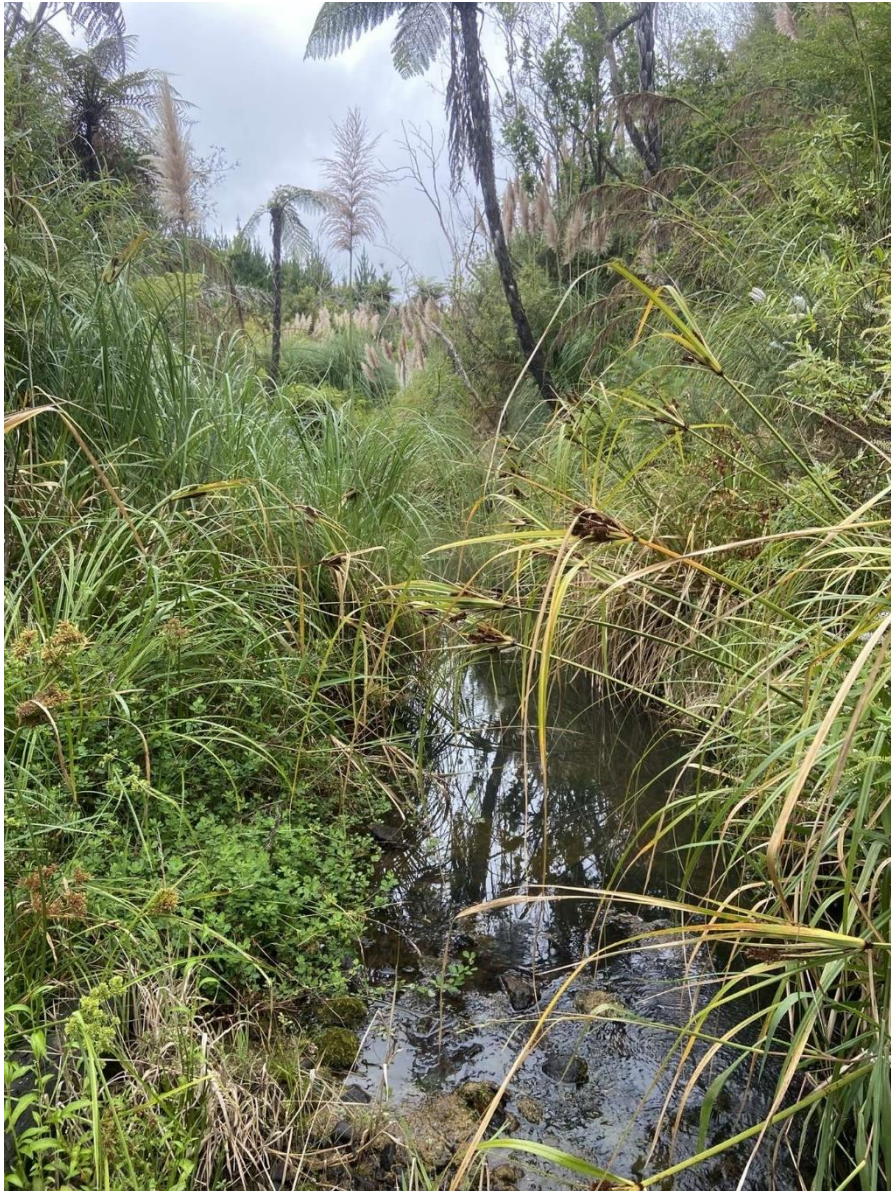
Figure 3 – typical stream cross section photograph.

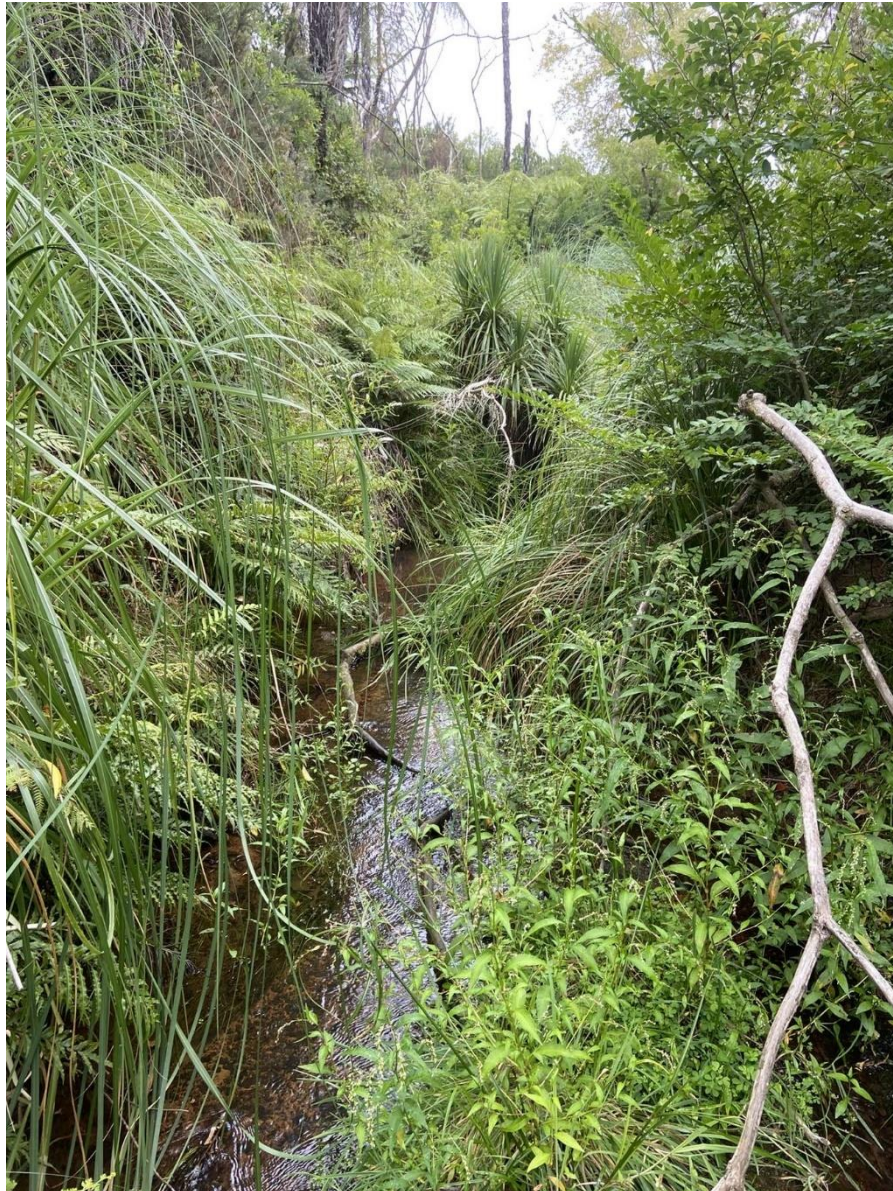
Figure 4 – typical stream cross section photograph.

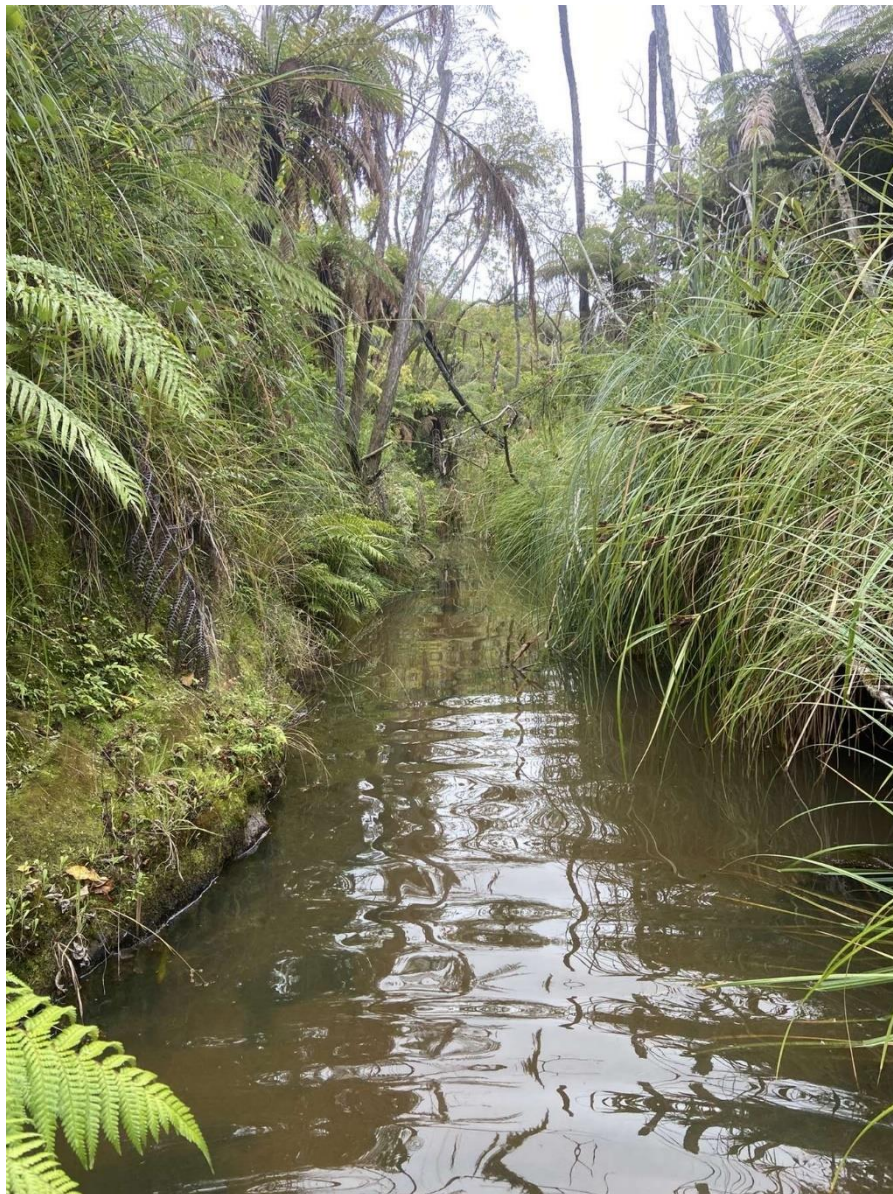
Figure 5 – typical stream cross section photograph.

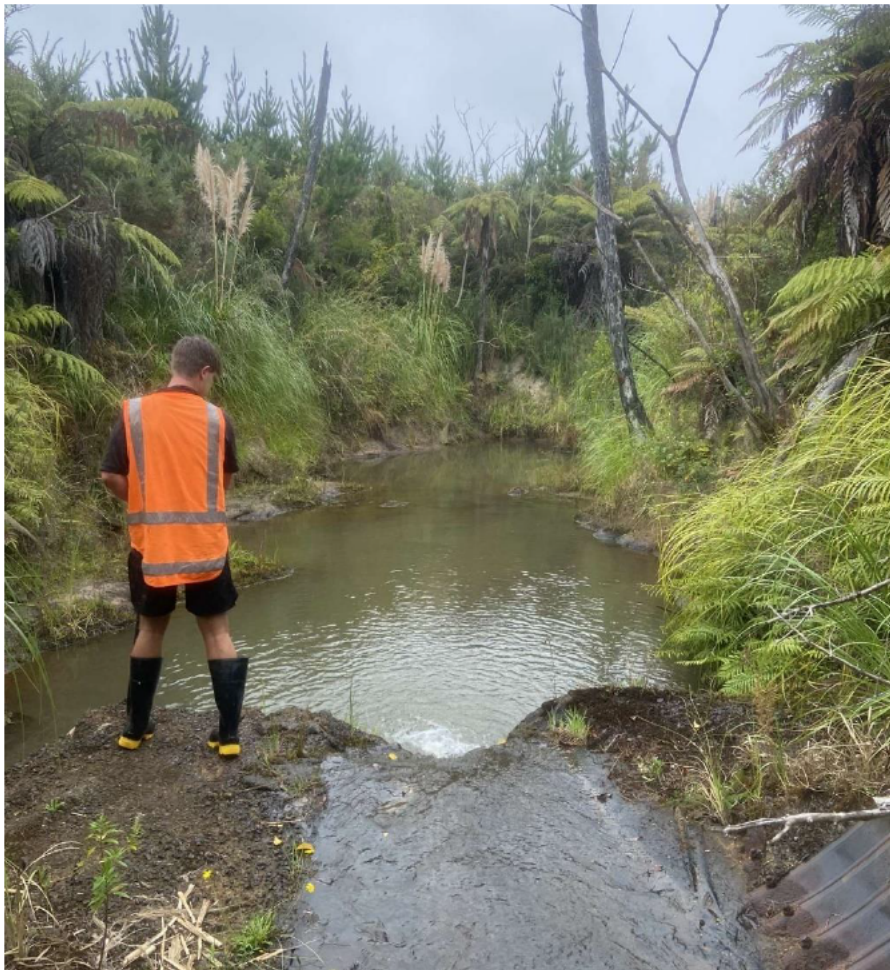
As can be seen in the data in Table 1, much of the widths are less than 3.0m wide. However, there are localised areas where the banks are wider than 3.0m. These areas are where obstructions have caused the stream to become turbulent, and form localised plunge pools.

Refer to Figure 6 below which is a photograph of a localised plunge pool from a culvert outfall.

Figure 6 – example of a localised plunge pool caused by a culvert outfall.
