BOREHOLE LOG - MH05-23

Client: Fulton Hogan Land Development Limited
Project: Waterloo Creek Bridge
Site Location: Milldale Stage 10/11
Project No.: AKL2023-0202
Date: 11/09/2023

PHOTOGRAPH SHEET - MH05-23

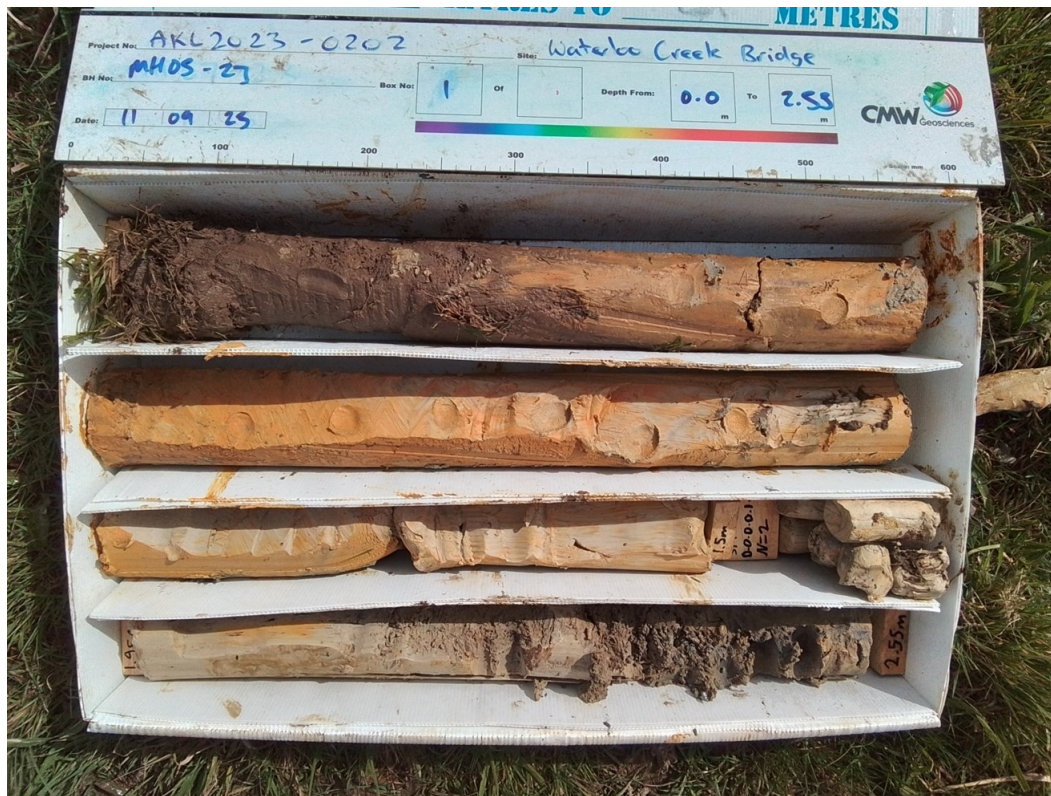
MH05-23: 0.00m - 2.55m

29.2			OL: Organic SILT: Dark brown. Low plasticity. Minor rootlets. (Topsoil)																	
				29.0			CH: Silty CLAY: Brown mottled orange. High plasticity. (Alluvium)

1.5	SPT = (0,0,2) N* = 2, Recovery = 450mm		1			W	F							100								OB / PQ3
					2											100								SPT
				27.1			ML: Clayey SILT with minor fine sand: Brownish grey mottled orange. Low plasticity. (Alluvium)									100								OB / PQ3

3.0	SPT = (0,0,0) N* = 0, Recovery = 450mm		3		... at 2.65m, Becoming Clayey SILT. Brownish grey mottled orange. Minor rootlets and manganese staining.	S	S							100								SPT

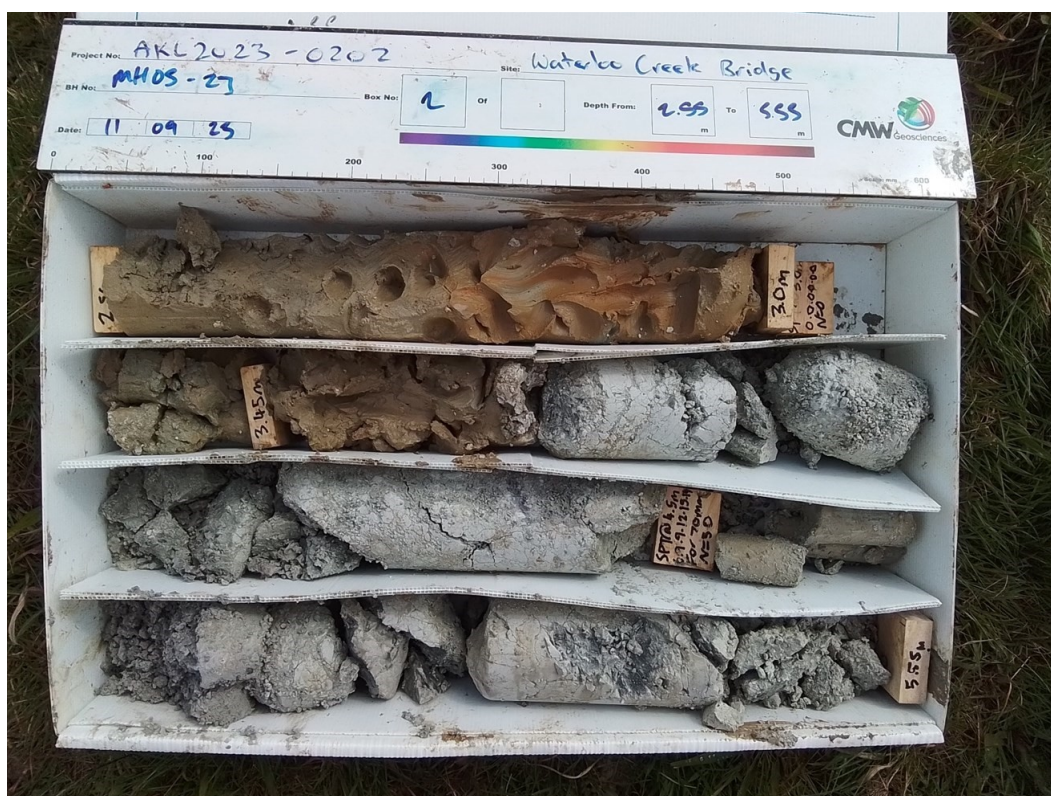
MH05-23: 2.55m - 5.55m

25.6			... from 3.65m to 3.70m, Core loss																	
		4.5	SPT = (15,21,29/145mm) N* = 50+, Recovery = 300mm		4		Highly weathered, grey, massive, SILTSTONE. Extremely weak : Blocky fabric. (Mangakahia Complex)									143								OB / PQ3

24.4												75								SPT
				24.2			GP: Fine to medium, grey, SILTSTONE GRAVEL.: Fine to medium, subangular. In a fine to medium sand matrix. Poorly graded. (Mangakahia Complex)									100	77							OB / PQ3

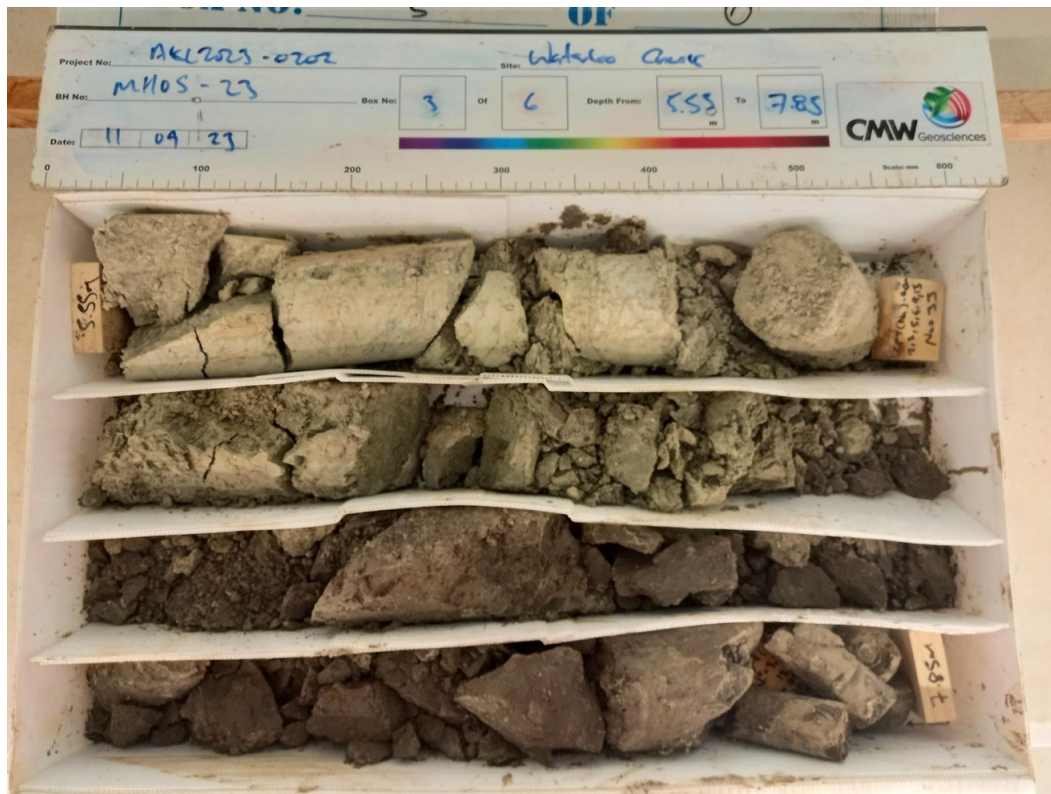
MH05-23: 5.55m - 7.85m

6.0	SPT = (5,11,22) Nc = 33		6		Moderately weathered, grey, massive, SILTSTONE. Very weak: Blocky fabric. (Mangakahia Complex)																	
				23.2			Highly weathered, grey, massive, SILTSTONE. Very weak: Blocky fabric. (Mangakahia Complex)									100								SPT

22.4			Highly weathered, dark brown, massive, MUDSTONE. Extremely weak : Blocky fabric (Hukerenui Mudstone)									100	100							SPT
		7.5	SPT = (12,22,28/140mm) N* = 50+, Recovery = 350mm		8											100								SPT
					9		... from 9.00m to 9.65m, Core loss

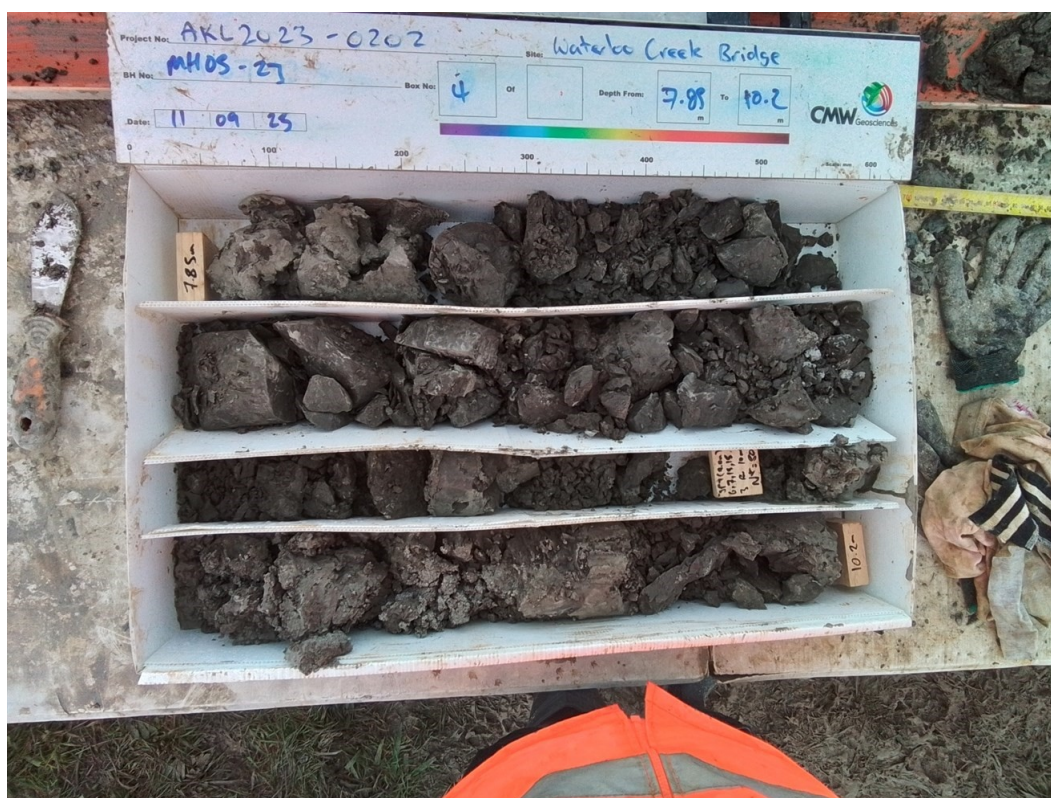
MH05-23: 7.85m - 10.20m

9.0	SPT = (13,30,20/85mm) N* = 50+		9		... from 9.65m to 10.00m, Becoming Completely weathered MUDSTONE. Retrieve as Clayey SILT. Brown. Low Plasticity.									100								
					10		... from 9.90m to 10.00m, Becoming with minor fine to medium grained sand.									100								OB / PQ3

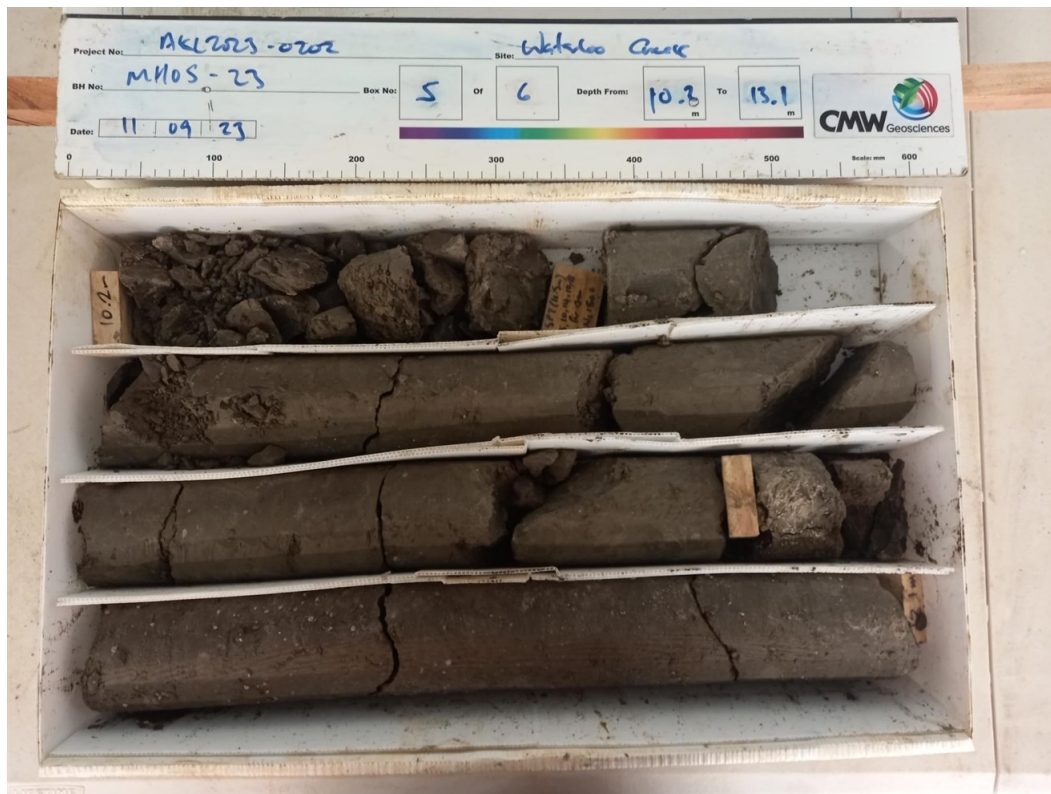
MH05-23: 10.20m - 13.10m

10.5	SPT = (15,32,18/70mm) Nc = 50+	18.4			Slightly weathered, brownish grey, massive, MUDSTONE. Extremely weak; Blocky fabric. Microfractures. (Hukerenui Mudstone)										0															SPT	11.3-11.4m:SZ,45°,Medium to coarse, subangular MUDSTONE gravels in a clayey matrix. 11.5m:JN,60°,UN,R,CL,CN,

12.0	SPT = (17,22,18/70mm) Nc = 50+														0															SPT	
			13.5	SPT = (17,32,18/70mm) Nc = 50+														0															SPT	
			15.0	SPT = (17,31,19/78mm) Nc = 50+		15		Borehole terminated at 15.00 m									0																SPT	13.0m:JN,10°,CL, 13.4m:JN,35°,UN,R,CL,CN, 14.2m:JN,45°,CL,
						16																												
						17																												
						18																												
						19																												
						20

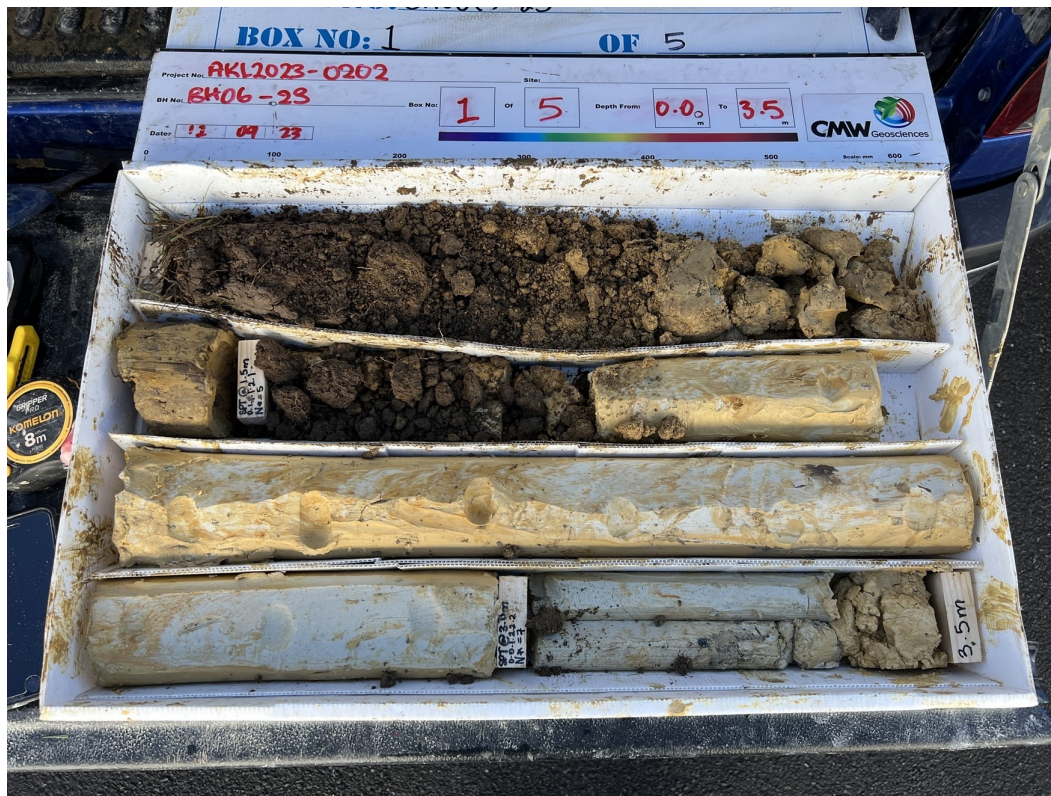
MH06-23: 0.00m - 3.50m

19-09-2023			41.0			OL: Organic SILT : Dark brown. Low plasticity. Some rootlets. (Topsoil)	St

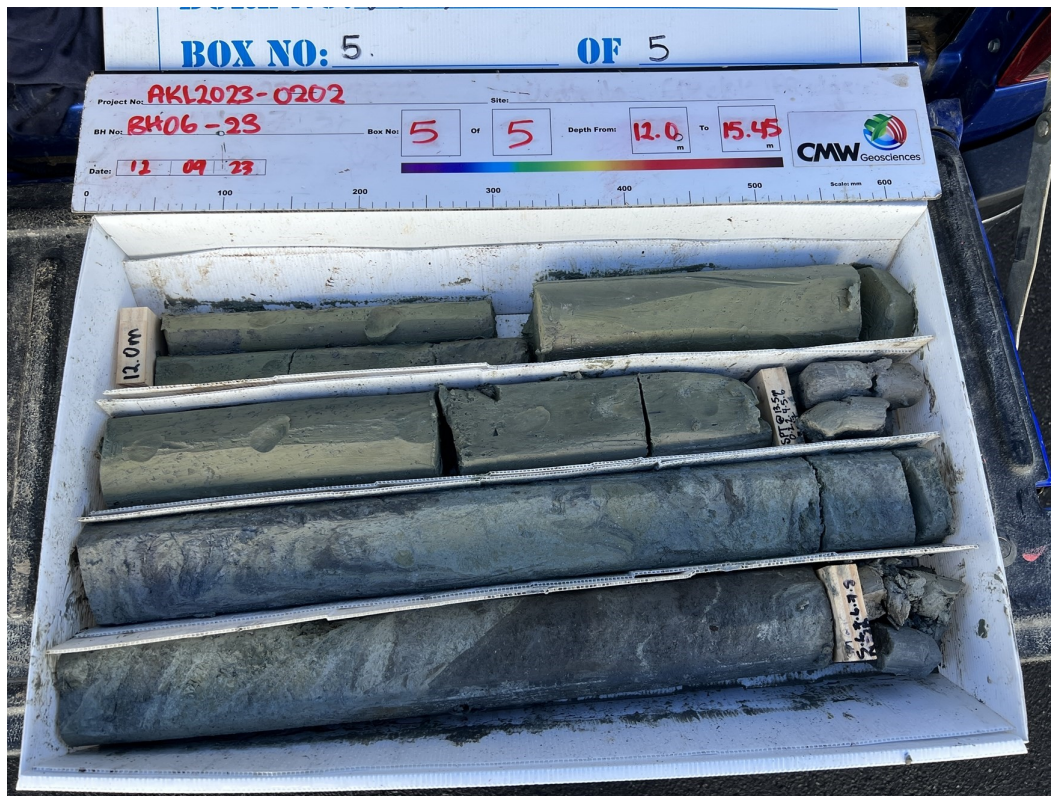
MH06-23: 12.00m - 15.45m

12.0	SPT = (4,9,13) N* = 22, Recovery = 450mm		23.0	12										100	100											SPT
		13.5	SPT = (10,18,25) N* = 43, Recovery = 300mm			13	Highly weathered, grey, highly fractured but tightly interlocked SILTSTONE: Very weak. (Mangakahia Complex)							100	100										TT/HQ3	SPT		
					14										67	67										TT/HQ3		SPT

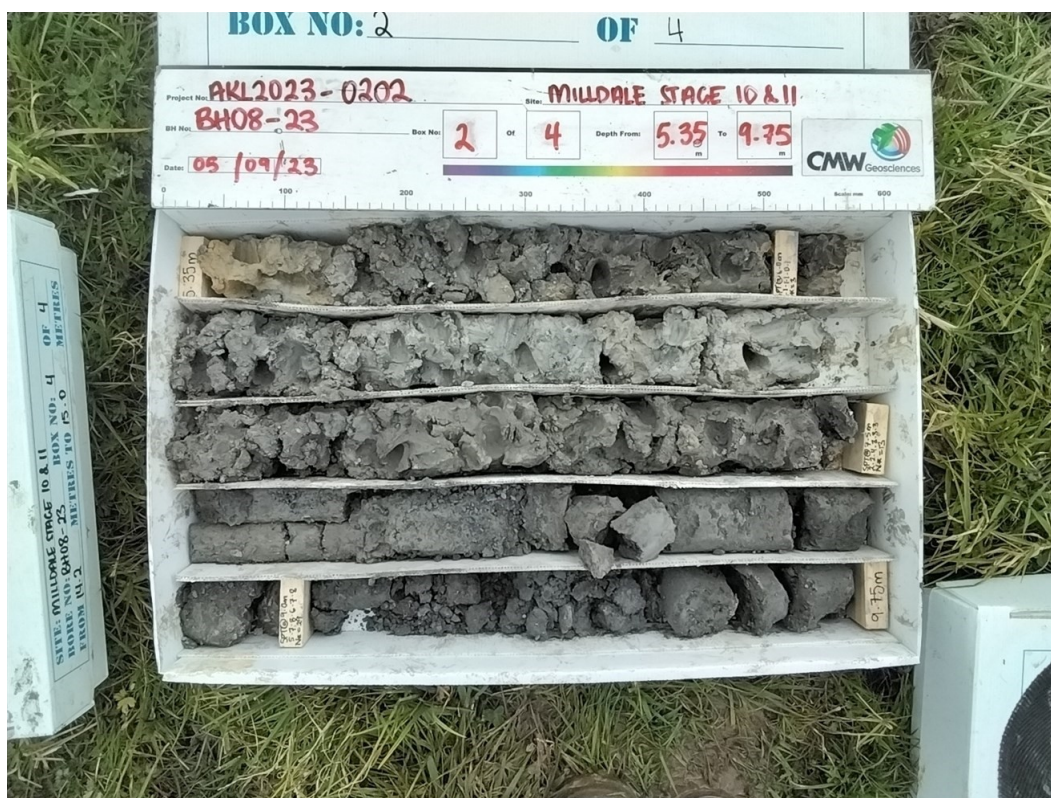
MH08-23: 5.35m - 9.75m

7.5	SPT = (4,7,6) N* = 13, Recovery = 450mm	27.1	8		Highly weathered. Dark grey. SILTSTONE. Extremely weak. Highly fractured, angular, tightly interlocking fabric. Gravel is fine to medium. (Mangakahia Complex)									22								SPT	
					9											48								TT / HQ3

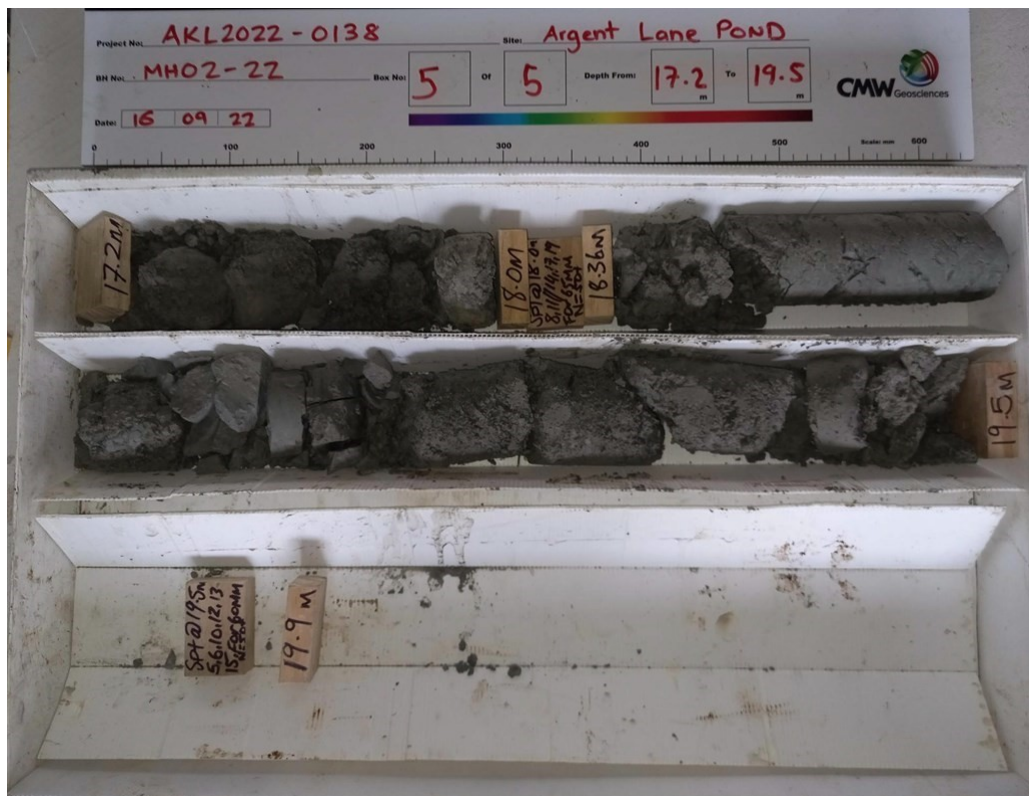
17.2m- 19.5m

16.5	SPT = (9,18,27) N* = 45		17		Completely weathered grey SILTSTONE. Extremely weak. Recovered as clayey SILT. Low plasticity. Some large gravel to cobble sized angular silt blocks. Random orientated fractured structure.: (Mangakahia Complex)															SPT		
								ML: Sandy and gravelly SILT: Grey. Low plasticity. Derived from completely weathered to highly weathered SILTSTONE. (Mangakahia Complex)							51	0							TT / HQ3

18.0	SPT = (19,31,19/65mm) N* = 50+		18		Completely weathered grey SILTSTONE. Extremely weak. Recovered as clayey SILT with some large gravel to cobble sized silt blocks. Sheared structure. : (Mangakahia Complex)															SPT		
								Highly weathered grey SILTSTONE. Extremely weak. Sheared structure. Partially recovered as angular fractured blocks. : (Mangakahia Complex)							84	26							TT / HQ3

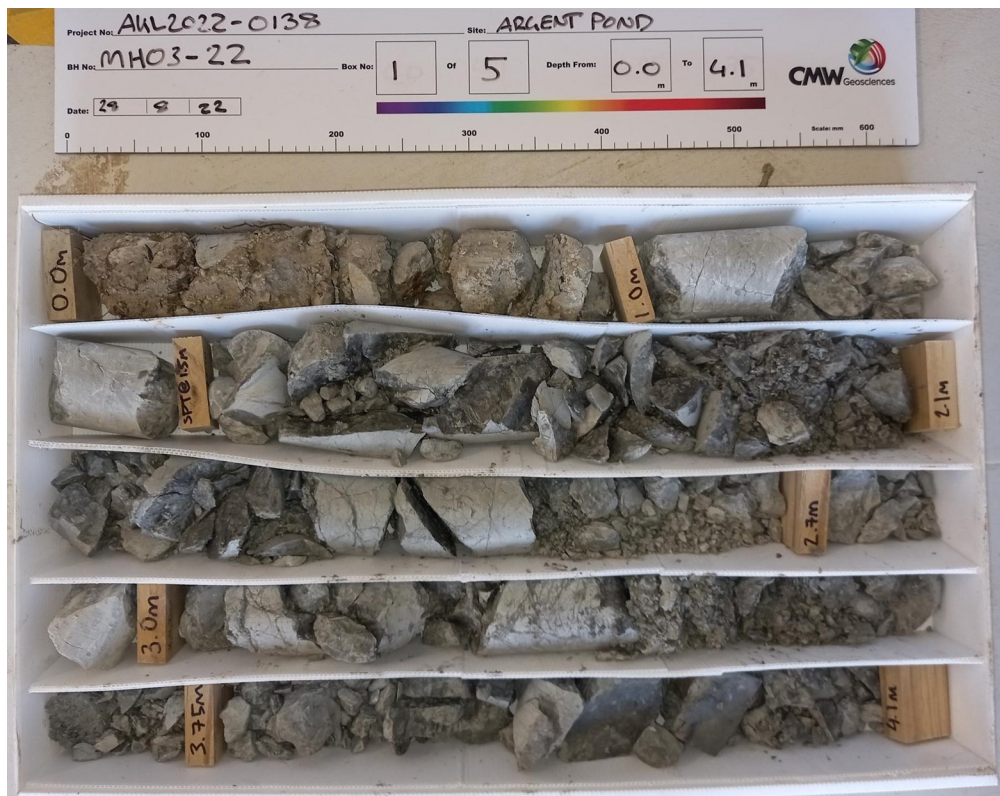
0.0m- 4.1m

45.0			Limestone: Highly weathered. light grey streaked white. Fine Fabric. Highly fractured, Angular large gravel to cobble size blocks. Limonite oxidation on blocks. (Northland Allochthon)								45	0

1.5	SPT = (50/75mm) Nc = 50+		1		Limestone: Highly weathered. light grey streaked dark grey. Fine Fabric. Randomly orientated micro fractures and randomly orientated mudstone seams. fractures into angular jagged large gravel to cobble size (Northland Allochthon)								60	0
